System Performance Review Great Northern Peninsula

June 2003

**Acres International Limited
Oakville, Ontario**

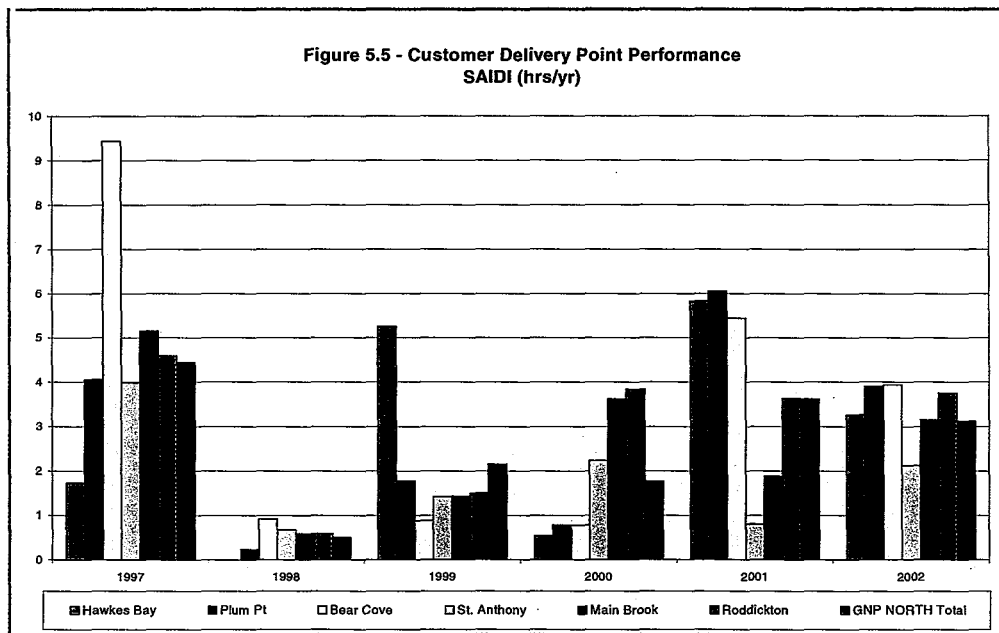
Figure 5.5 shows a yearly variation in SAIDI indices for the customers of the aforementioned six delivery points in the Northern GNP area. With the exception of Bear Cove in 1997 and Hawkes Bay and Plum Point in 2001, the customer SAIDI values for each delivery point as well as for the overall GNP North area are within the reasonable practical range found in the utility industry. As discussed above, the increased trend during 2002 – 2003 period may be attributed to an outage of TL259 138-kV circuit due to a broken cross arm at a structure. Being a section in the radial supply chain, the outage of this element caused interruptions to all the other delivery points in the GNP North area.

In 2001, the SAIDI index values for Hawkes Bay, Plum Point and Bear Cove are high relative to the other delivery points. The SAIDI values for these three communities are also relatively high as compared to the SAIDI values for customers at the other three delivery points. This is primarily due to the standby generation contribution to the SAIDI statistics for customers served by St. Anthony, Main Brook and Roddickton delivery points.

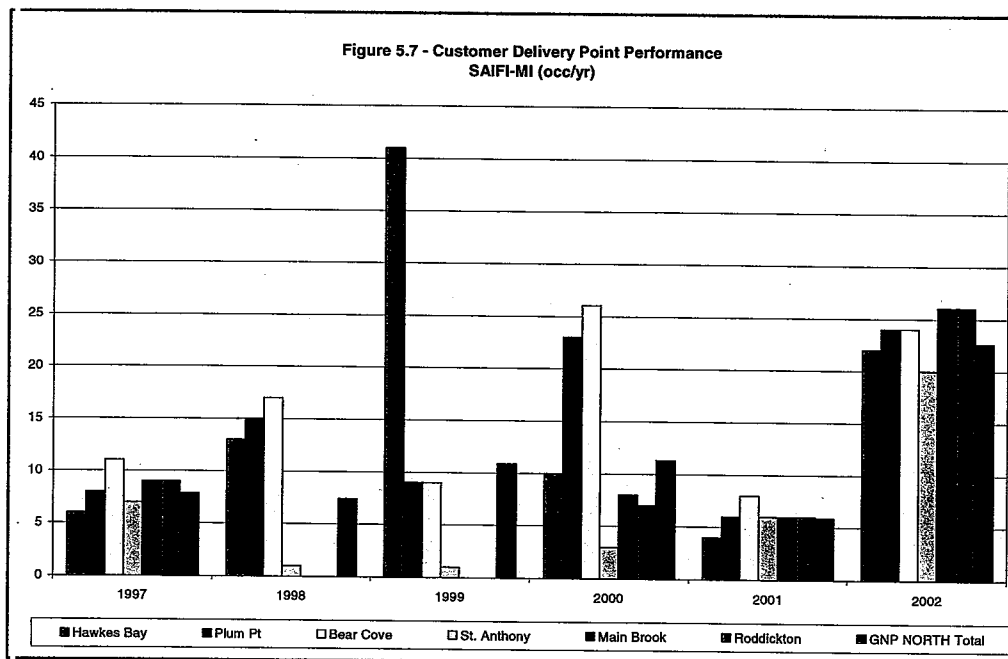
In 2002, the SAIFI-MI indices exhibit poor reliability performance for all the delivery points. In addition, the SAIFI-MI index value for Hawkes Bay is extremely high during 1999, as TL-227 69 kV circuit experienced a high number of interruptions due to adverse weather. The SAIFI-MI indices for Plum Point and Bear Cove delivery points are also quite high for 1998 and 2000 periods. In contrast, the SAIFI-MI indices for the other three delivery points demonstrate good performance during 1997 and 2001 periods but their performance declined in 2002. As discussed above, the reliability performance difference in the two sets of delivery points is primarily due to the use of manual closing on the northerly circuits prior to July 2001.

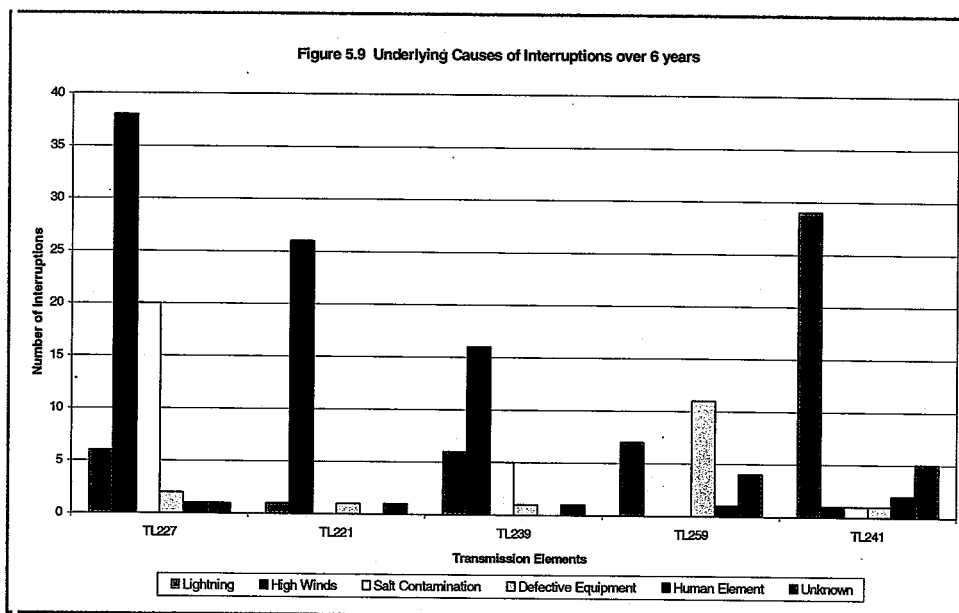
Over a six-year period from January 1st, 1997 and December 31st, 2002, Figure 5.9 shows the number of interruptions that occurred on different transmission line sections of the GNP region and presents their underlying causes of interruptions.

The results indicate that most of these interruptions occurred on the 69 kV line sections and the majority of them were caused by high winds and salt spray instigating insulation failure. It is pertinent to note that the outage of TL227 rarely affects six delivery points in the GNP North area. For reference, TL221 only affects Hawkes Bay, because of its radial nature.

The southern section (TL-239) of 138 kV line also experienced a high number of interruptions due to the same underlying cause.

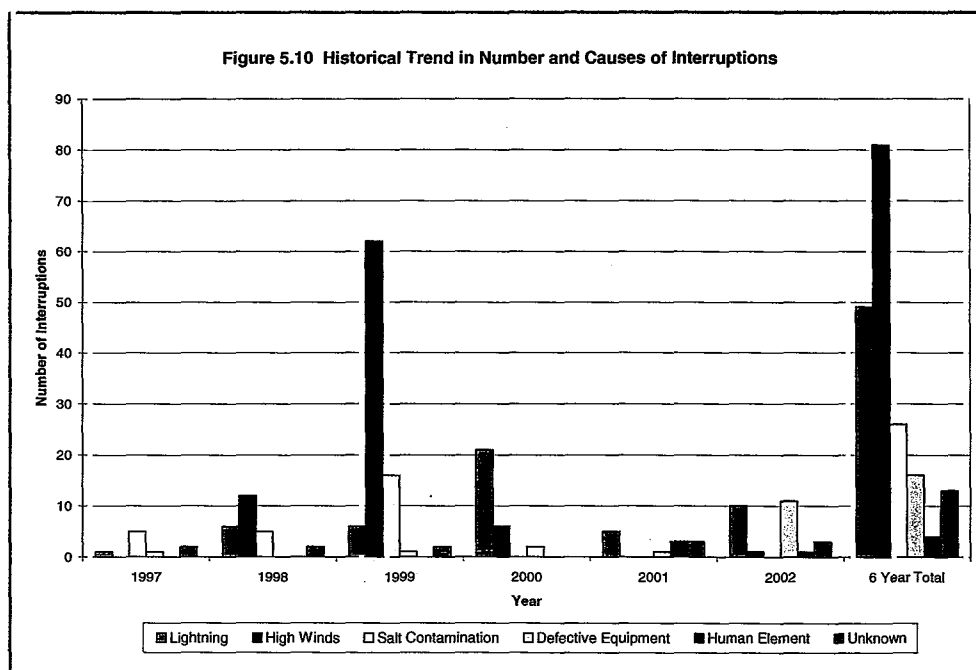
Figure 5.10 (next page) presents the historical results for underlying causes of interruptions for a six-year period. The largest number of interruptions occurred in 1999, and most of these were caused by high winds, and the second largest number occurred in 2000, which were predominantly caused by lightning. The causes of other interruptions are small in number. The results show that the lowest number of interruptions occurred in 2001.

The transmission line interruptions due to high winds and salt spray have reduced significantly during the last three years. In particular, the following projects have helped reduce these occurrences that are further discussed in Section 5.3:

- 1) Replacement of insulators on TL239 in 1999
- 2) Rerouting of entire TL262 line in 2001
- 3) Partial replacement of insulators on TL226 and TL227 during 2001 and 2002

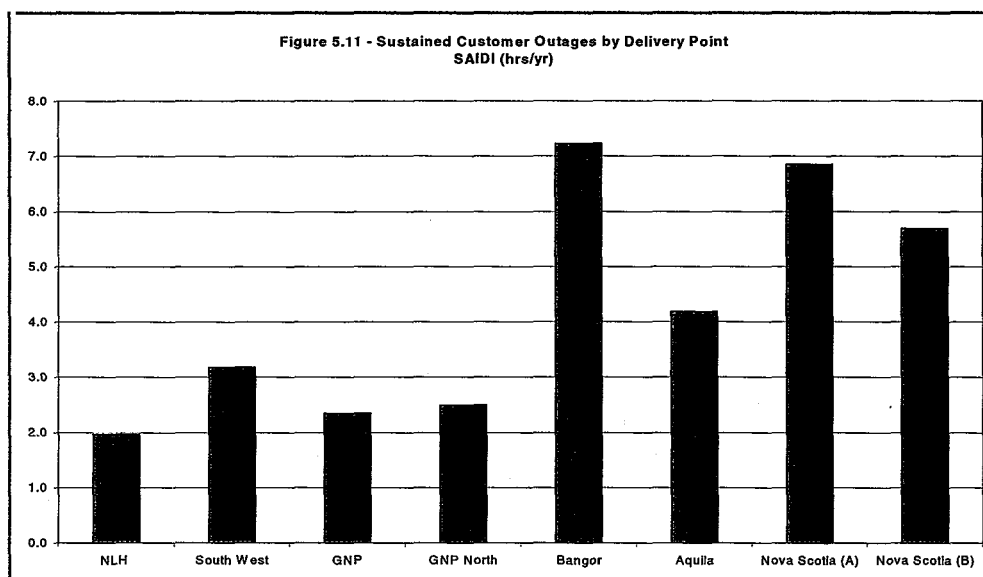
For the GNP and GNP North areas, primarily two performance indices SAIDI and SAIFI have been evaluated and compared with other circuits within Hydro system and other utilities operating similar circuits in comparable circumstances. Figure 5.11 compares delivery point SAIDI values for five-year data. The graph below shows that GNP North area compares favorably with Hydro statistics and the SAIDI values are significantly low in comparison to three other utilities.

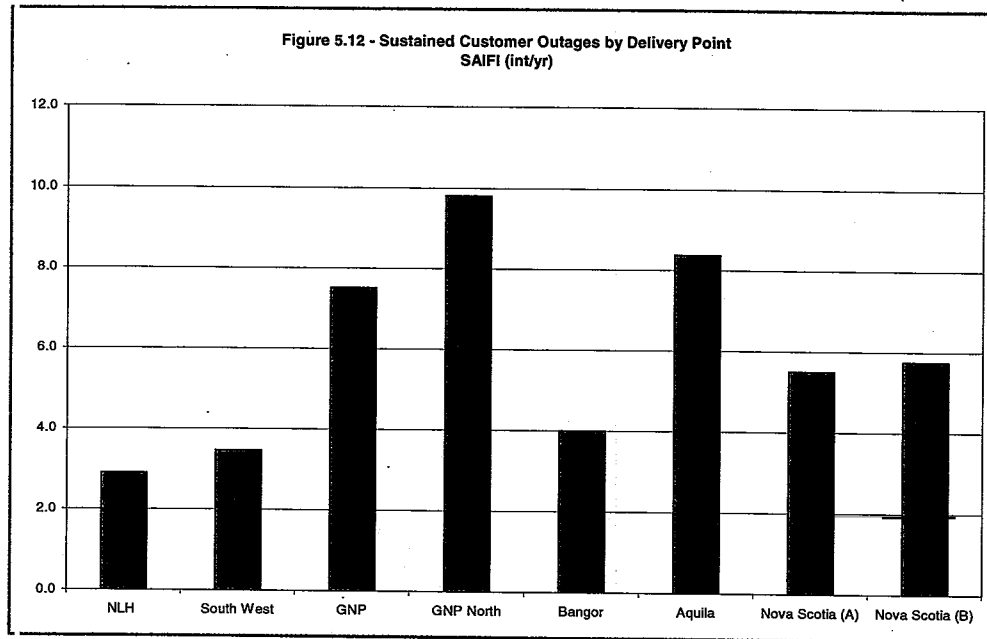
Similarly, Figure 5.12 shows a comparison of delivery point SAIFI values for those delivery points that are served by radial circuits operating in similar circumstances. The results indicate that the GNP North area values are the highest among the sample. This is mainly due to the fact that the delivery points in the GNP region are served by a significantly longer radial circuit among all compared.

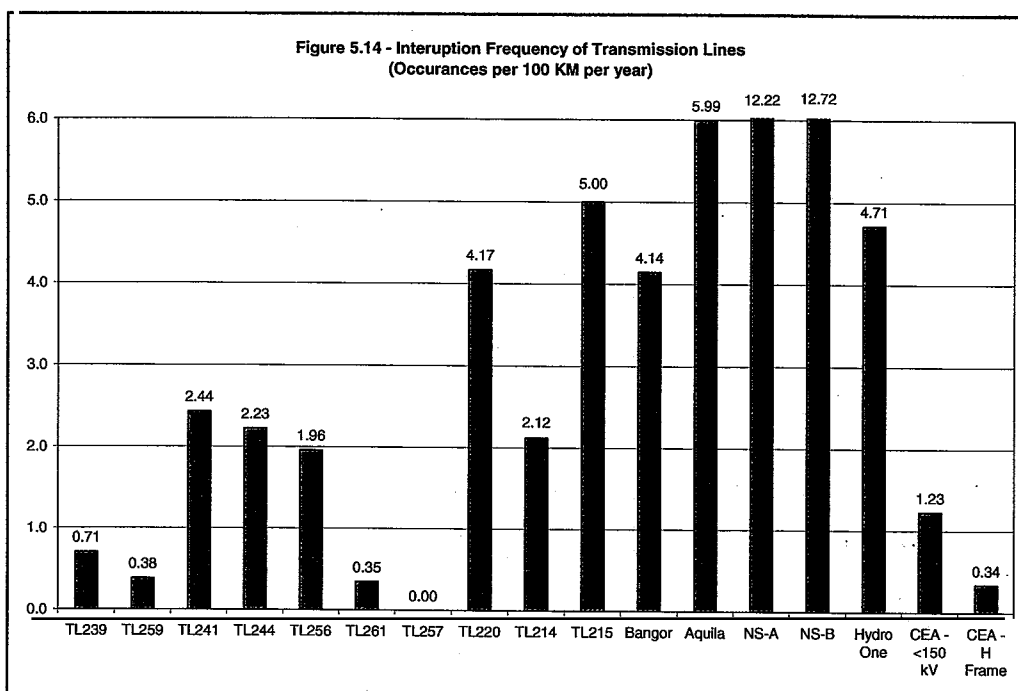
Figure 5.14 shows frequency of sustained occurrences per 100 km for each of the line sections serving the GNP and South West Regions in Hydro's system. The statistics for five similar circuits from four different utilities and CEA statistics enumerating the average frequency of interruption for all reporting utilities are also shown on the graph. As before, an event on TL220 has been excluded.

The figure below shows that the frequency of interruptions for five sections of the 138 kV transmission circuit is relatively high in comparison to the last two sections of 69 kV circuit that serve St. Anthony and Roddickton communities. This is due to the lower level of exposure to the extreme weather and environmental conditions. Within the Hydro system, the frequency of interruption results for the GNP transmission circuits are much better than the frequency statistics of the transmission lines serving South West region and TL-220 circuit. The performance is also better than the Nova Scotia Power circuit that operates in a similar environment. In addition, the GNP transmission system performance is relatively better in comparison to the circuits belonging to Bangor Hydro,

Aquila and Hydro One Networks. It may be recognized that these circuits may be radial but their operating environment is relatively less severe.

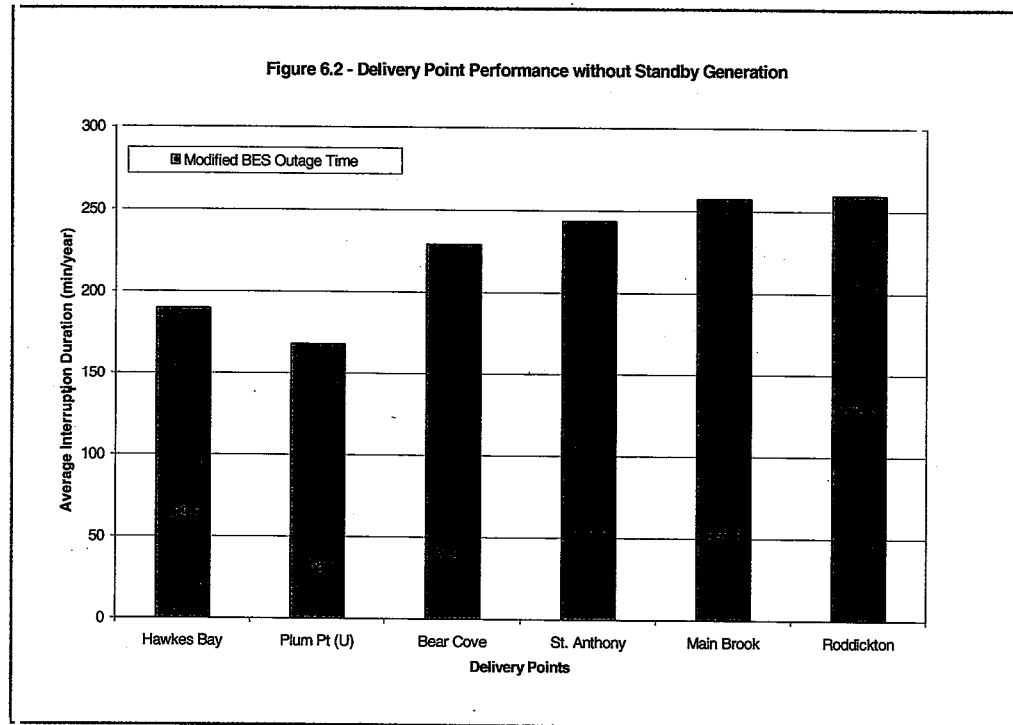
St. Anthony delivery point experiences the highest reliability impact, as the average annual duration of interruptions increased by more than 100%. Similarly, reliability performance of Main Brook and Roddickton delivery points would deteriorate significantly with the complete removal of generation from Roddickton, as being the primary source of standby generation. However, as per the past experience, the impact on Hawkes Bay reliability performance is not that significant. But the impact would have

been more if the generation had dispatched after the usual time delay during sustained outages. There is an insignificant impact of standby generation on Plum Point and Bear Cove delivery points.

At the same time, it is worthwhile to mention that these reliability indices, in respect of all the six delivery points, are well within the minimum performance standards followed in other parts of the country.
