NEWFOUNDLAND AND LABRADOR HYDRO

2005 CAPITAL BUDGET

SUBMISSION TO PUBLIC UTILITIES BOARD

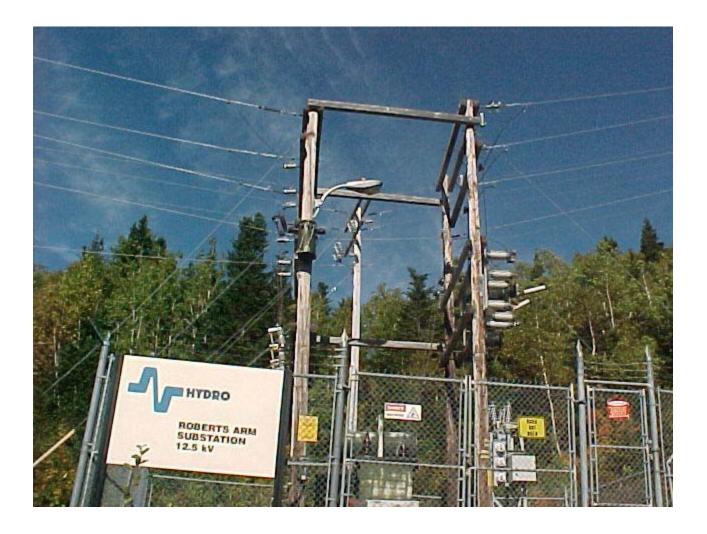
Roberts Arm Substation

View showing structures and line terminals

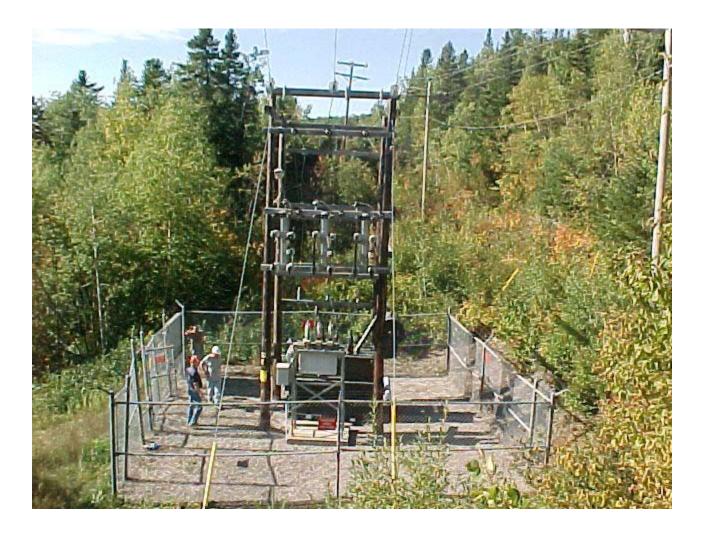
Roberts Arm Substation

View showing congestion in station limiting use of maintenance equipment

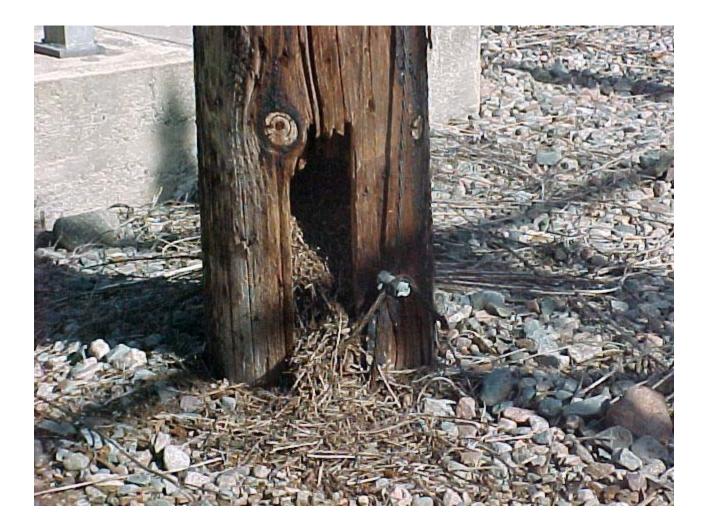
Roberts Arm Substation

View showing deterioration of poles due to ant infestation

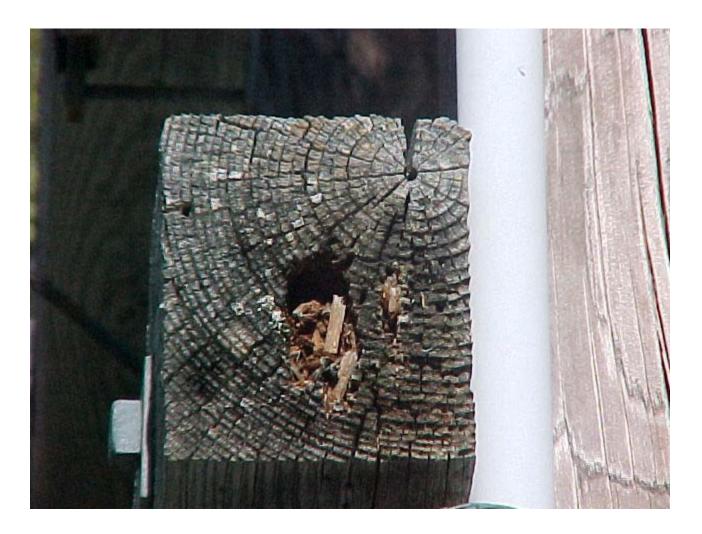
Roberts Arm Substation

View showing deterioration of crossarms

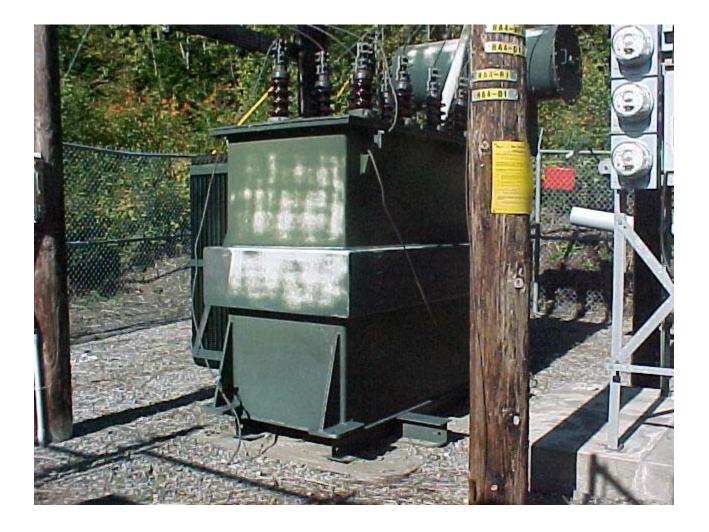
Roberts Arm Substation

View showing equipment condition

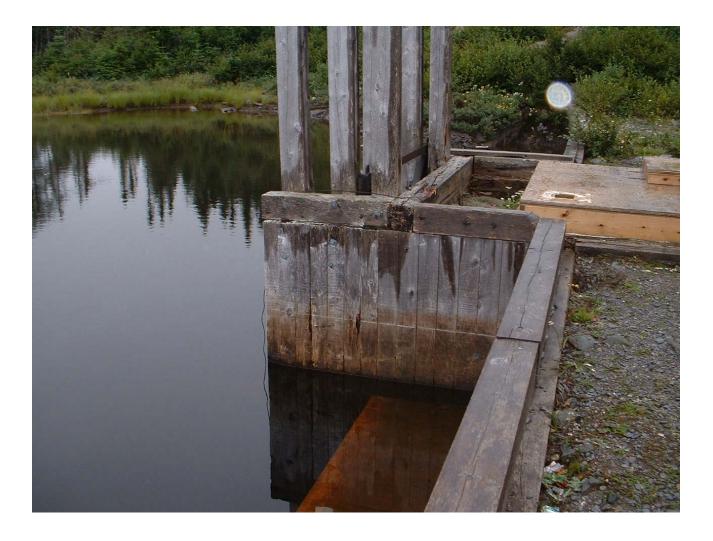
Roddickton Mini Hydro Dam

View showing dam

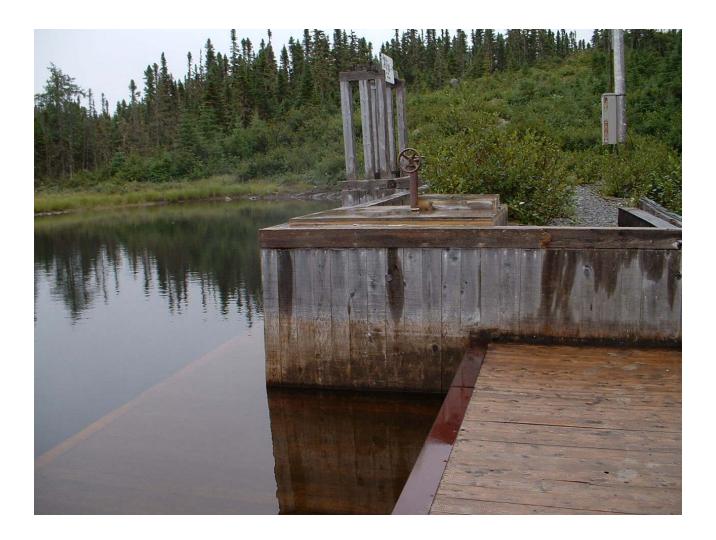
Roddickton Mini Hydro Dam

View showing intake

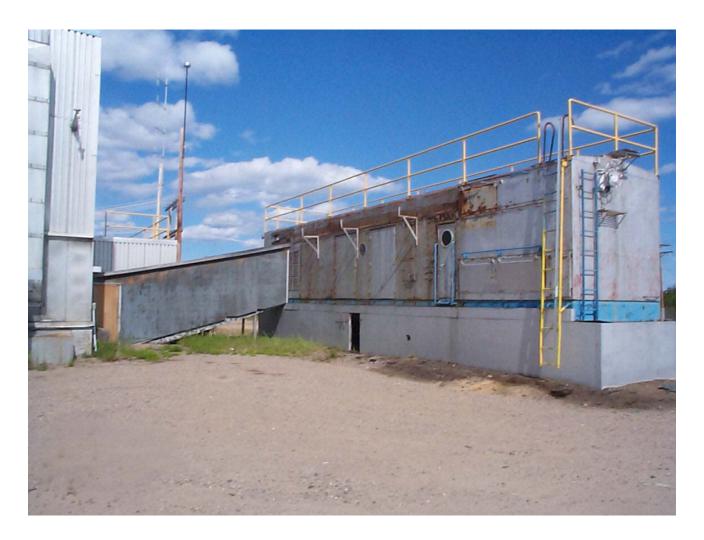
Goose Bay North Plant Upgrade Building Systems

View showing G5 module damage

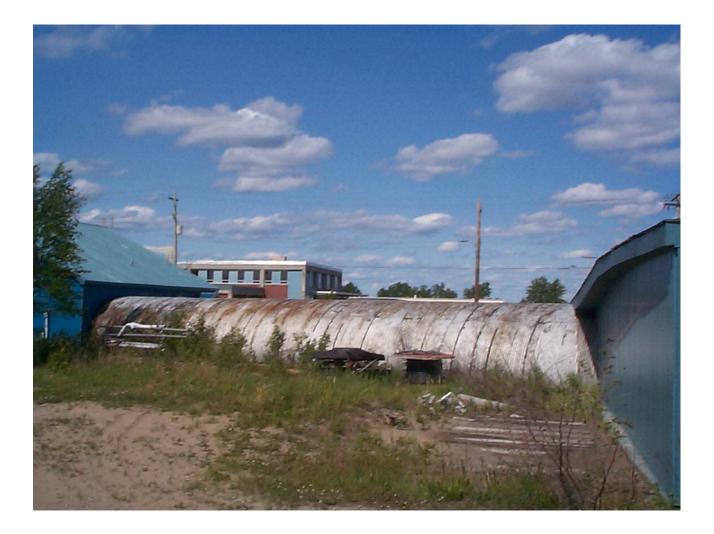
Goose Bay North Plant Upgrade Building Systems

View showing access tunnel

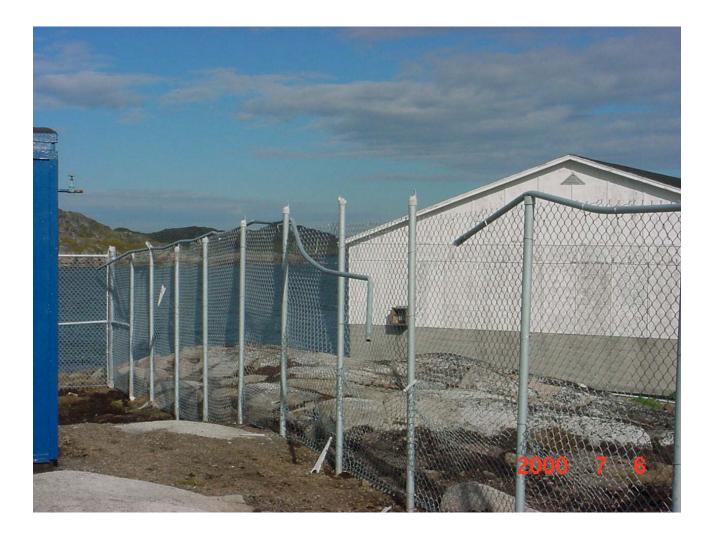
Black Tickle Upgrade Diesel Plant

View showing fencing

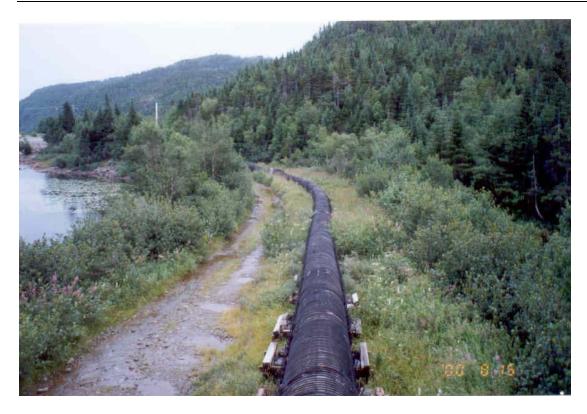
Photo #1: View of penstock, August 2000.

The penstock profile has several flat sections and one reverse section in the mid to upper half of the penstock, see photos #1 & #2. The reverse grade increases the probability of the penstock collapse during operation, when the Plant is fully loaded. The only protection from collapse is a vacuum breaker valve located at the mid-point of the line. This valve is designed to break any vacuum that may cause a collapse. It is critical that this valve is kept in good working condition to ensure that it will operate as required. Recent problems experienced include a fire in the valve enclosure and a malfunction of the valve.

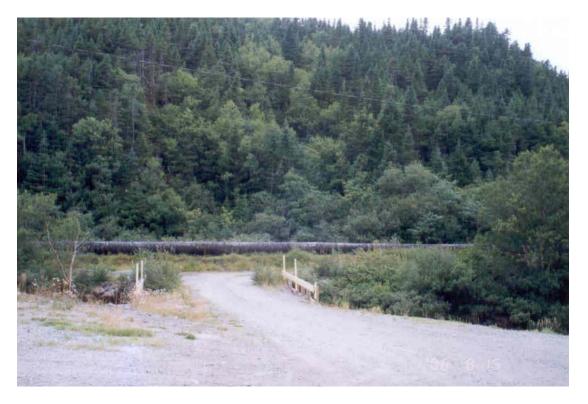
Photo #2: View of flat and reverse section of penstock, August 2000.

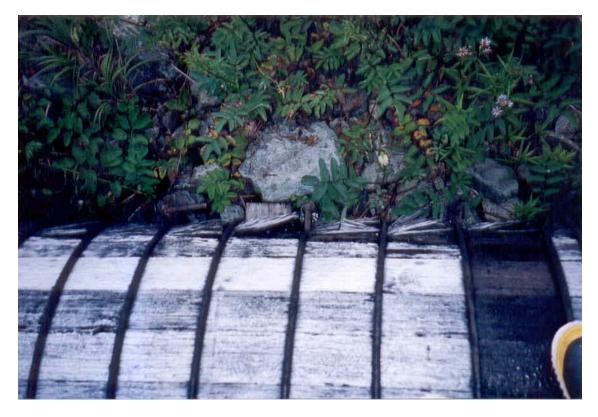
Photo #3: View of brooming between metal bands, August 2000.

Various inspections of the penstock have indicated that there is joint leakage between the staves, brooming at stave ends and between steel bands and crushing of the staves along the spring line or top of the penstock. The brooming and crushing is worse at the lower end of the penstock, which is subject to higher pressures. The crushing and brooming indicates delamination between the wood fibers and deterioration of wood, see photos #3 & #4. The rate and areas of deterioration continues to grow with the age of the structures.

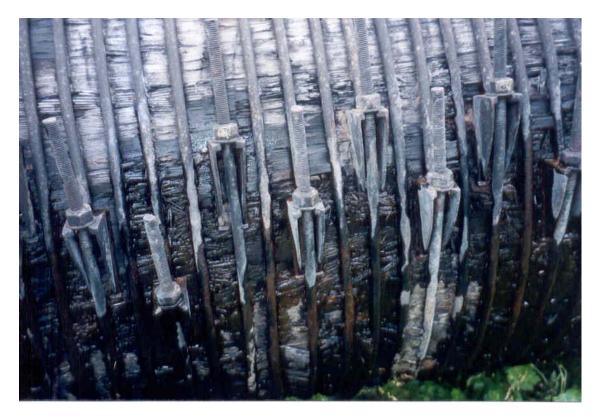
Photo #4: View of crushing and brooming of wooden staves, August 2000.

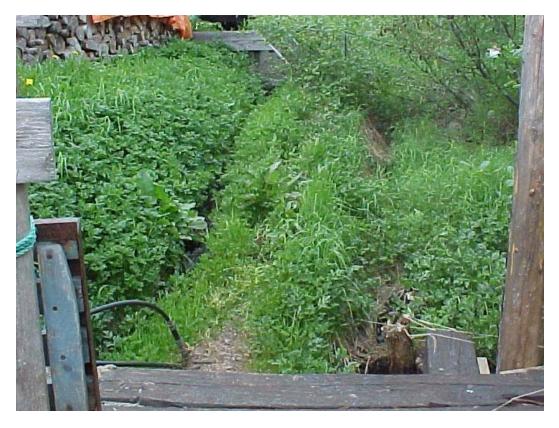
Photo #5: Vegetation growth around and on penstock, June 2001.

Also along the length of the penstock, areas of moss and other vegetation are growing directly on the penstock; see photos #5 & #6. Vegetation growth typically retains moisture and cause stave deterioration. In some cases the vegetation can be parasitic to the wood stave. Vegetation thrives because of continuous water supply leaking from the penstock. The cost of removing the vegetation continues to increase.

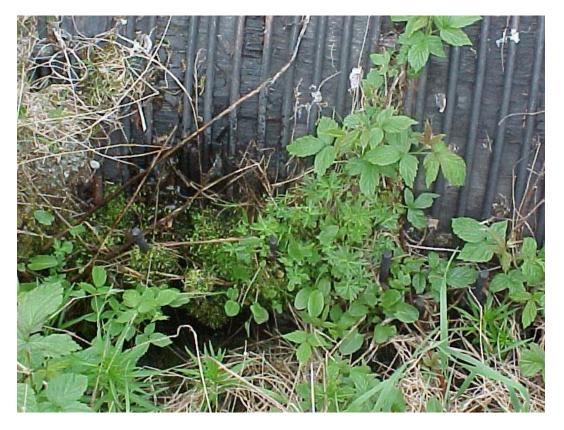
Photo #6: Moss and other vegetation growing directly on penstock, June 2001.

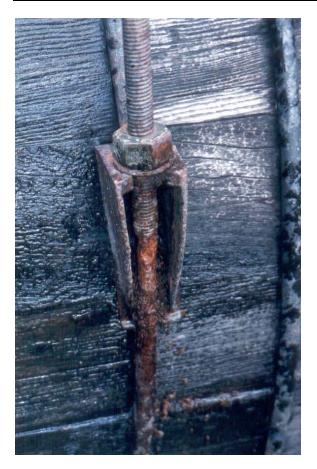
Photo #7: View of corrosion below threads, August 2000.

There are approximately 12,000 steel bands used to maintain the shape and integrity of the penstock. All of the bands show various signs of rusting, corrosion and deterioration. Also, in recent years some bands have been observed with significant corrosion below the threads on the band, see photos #7 & #8. These bands are required to be replaced or new ones installed adjacent to the old ones (where possible). In addition, there is bright, visible corrosion on the majority of the steel bands that do not receive direct sunlight. These areas include the penstock enclosure, buried section of the penstock and at the road crossings. In these same areas it is difficult if not impossible to replace the steel bands because of the limited access. Also, in several locations it is impossible to replace the bands unless the penstock is dewatered, because of the decreased band spacing and the higher pressure on the lower half of the penstock. However, frequent dewatering of the penstock is not recommended because of its aged and deteriorated condition.

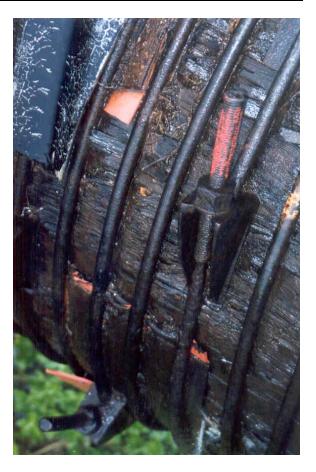
Photo #8: View of corrosion on metal bands, August 2000.

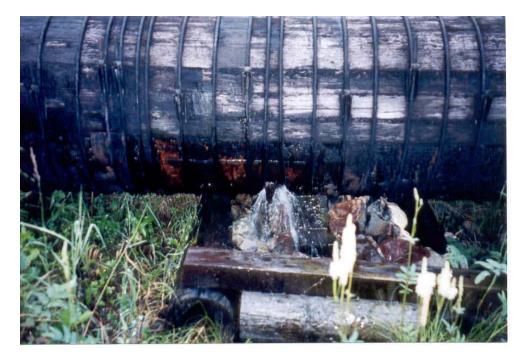
Photo #9: Water leaking from penstock, August 2000.

Leaking of the penstock joints have been observed since at least 1968, see photos #9, #10 & #11. The leaks were sometimes repaired by driving nails into the leaking area, this method however tends to promote deterioration of the wooden staves, see photo #12. The more common method of sealing the leaks involved the installation of small steel plates under the existing steel bands or by adding new bands between the existing ones in the area of the leak, see photo #13. The penstock has been dewatered approximately 4-5 times since 1989 to repair the leaks. During one event, the penstock was dewatered for approximately 5-6 days, which allowed the wood staves to dry out and shrink in size. When the penstock was watered up there were a significant number of additional leaks of various sizes, which required lengthy time and effort spent to correct and seal the new leaks. Based on this experience, the penstock has been dewatered and watered up during the same day to repair any leaks in the penstock. However, each time the penstock is dewatered, additional leaks appear when the penstock is watered up again. Overall, the dewatering of the penstock is a significant activity that creates just as many or more leaks than those that are repaired.

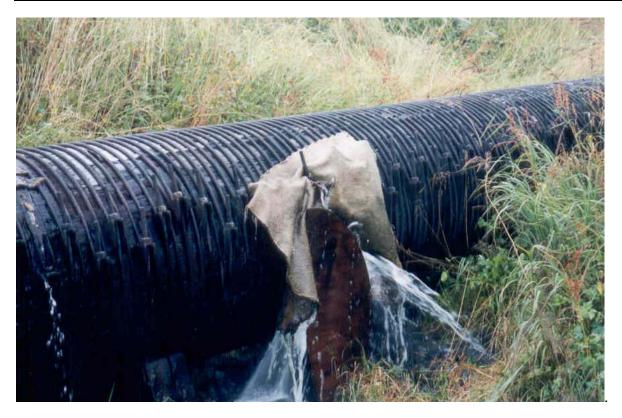
Photo #10: Water leaking from penstock, August 2000.

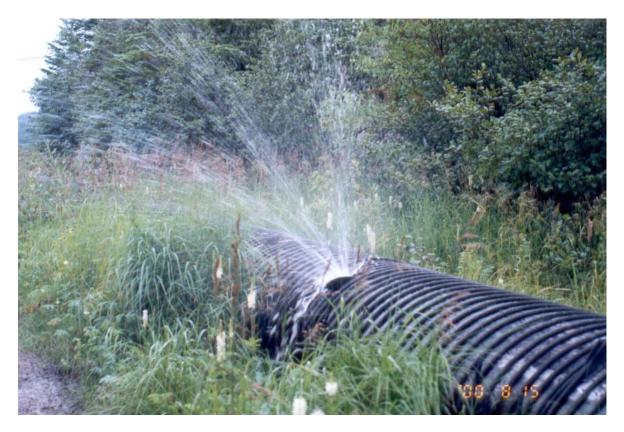
Photo 11: View of water leaking from penstock, August 2000.

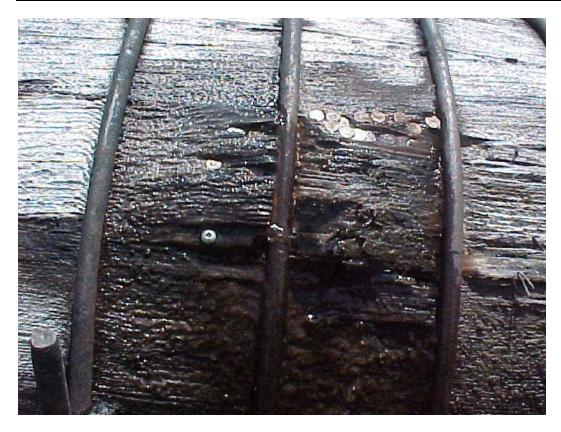
Photo #12: Nails driven into penstock to stop leaks, June 2001.

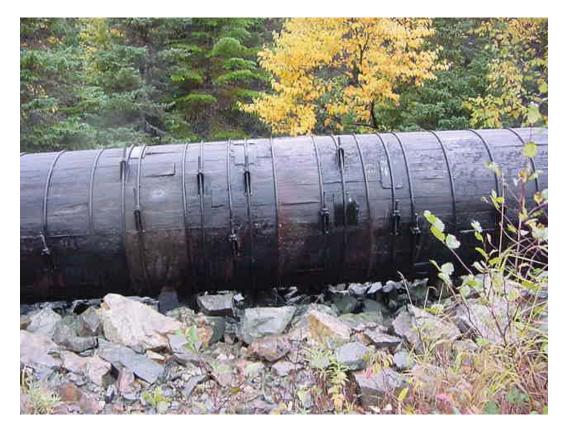
Photo #13: Metal patches placed under new bands to stop leaks, October 2003.

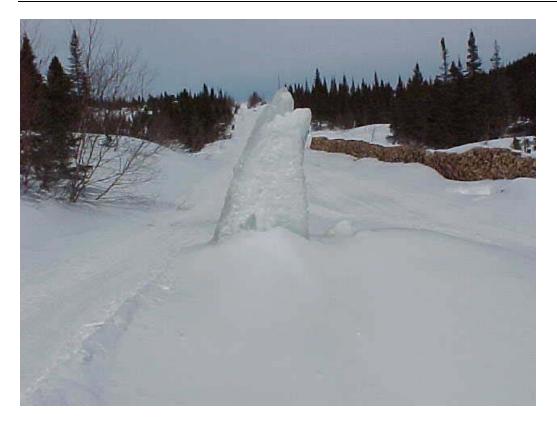
Photo 14: Ice formation above penstock, April 2001.

The formation of ice was investigated during the winter of 2001 and several observations were made. The ice formations were fed from the penstock by the constant flow of running (leaking) water. The ice formations extended down over the sides of the penstock to the ground. One ice formation observed was 8 ft high and 3 ft long at its base, the average ice formation was 5 - 6 ft in height, see photo #14. The danger caused by the ice formations is that the ice loads or large ice chunks could severely damage or rupture the weakened penstock. Another key area of ice formation was under the penstock enclosure. The leaking water causes large ice formations under the enclosure around the area of the access road, see photo #15. Besides adding a substantial load to the penstock and its support structure, it also interrupts local traffic (this sometimes leads to unsupervised demolition of the ice).

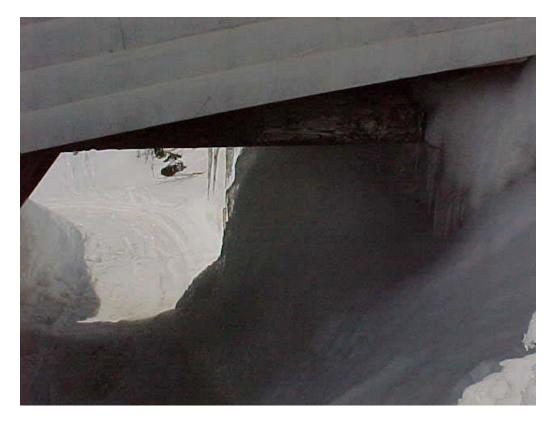
Photo 15: Ice formations under penstock enclosure, April 2001. For location of ice formation refer to Photo #18.

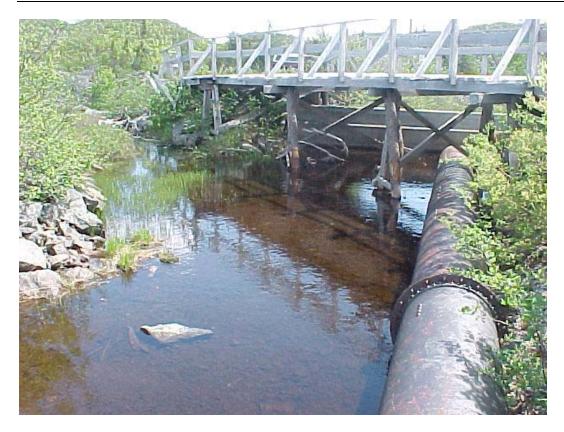
Photo #16: Accumulation of water behind concrete cut-off dam, June 2001.

The first section of the penstock, from the intake to approximately 80 ft downstream, is fabricated from riveted steel plate; refer to location #1 on map SA-1 and photos #16 & #17. Because of the age of this steel section of penstock plus the fact that it has been partially or totally submerged for years, it continues to deteriorate. In addition, the concrete saddles for this section are also damaged. This section of penstock will likely be required to be replaced at the same time as the adjacent wooden penstock.

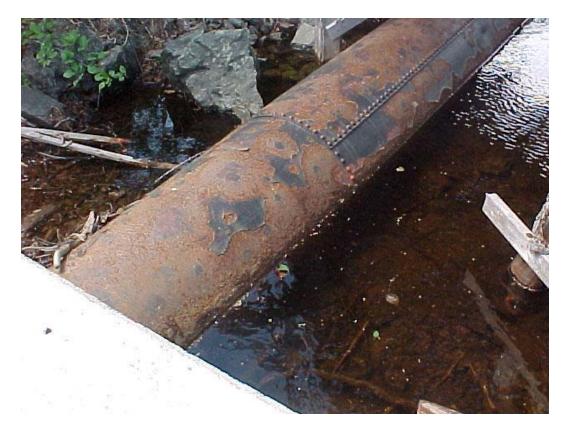
Photo #17: Steel section of penstock, partially submerged in water, June 2001.

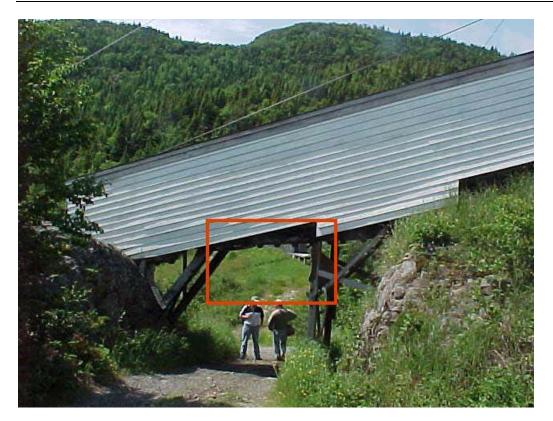
Photo 18: Penstock enclosure over access road, July 2002. Highlighted area indicates location of ice formation shown in Photo #15.

There is a section of the penstock, located just above the community, which crosses over a small access road, refer to location #2 on map SA-2. There are two critical areas with this location; the support structure and enclosure, see photos #18 & #19.

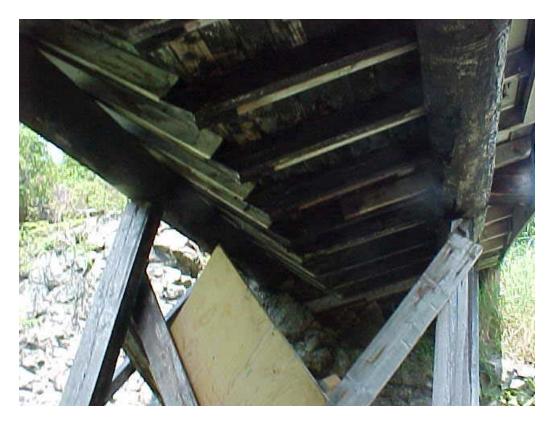
Photo 19: Support structure for penstock enclosure, July 2002.

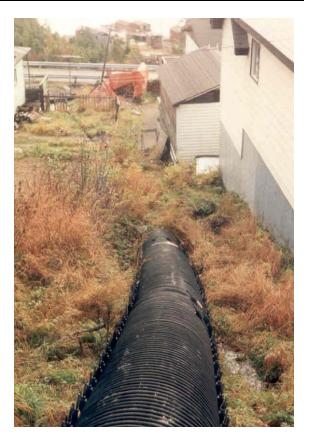
Photos #20 & #21: View of penstock passing through community, October 1992.

The penstock passes through the middle of the community and at times, is within a few feet of the adjacent houses; see photos #20 & #21. Also a considerable length of the penstock, approx. 200 ft is buried, refer to location #3 on map SA-2 and see photo #22. In 1998, a section of the buried penstock was excavated and it was observed that the penstock is supported on cradles, similar to the rest of the penstock. Buried penstocks are designed to be fully supported along their length, the discovery of cradles supporting the penstock in the buried section, suggests that the penstock was not designed to be buried. The burial of the penstock subjects it to additional loads from the overburden soil and live loads from vehicles, skidoos, woodpiles, etc. In addition, there is very poor drainage around the penstock causing the penstock to be submerged in water. The risk associated with this section of penstock is high because of additional loading, moist conditions and lack of maintenance; there is a high probability of failure of this section of the penstock.

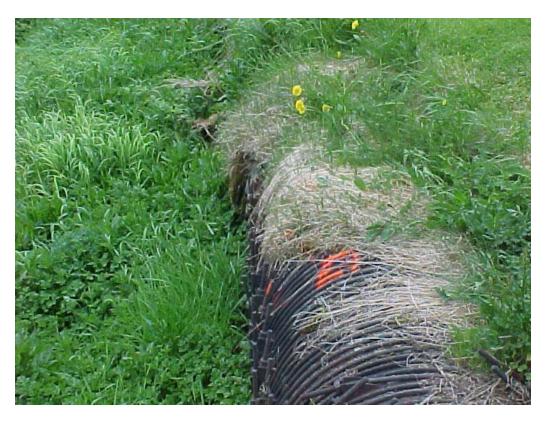
Photo #22 Buried section of penstock in community, June 2001.

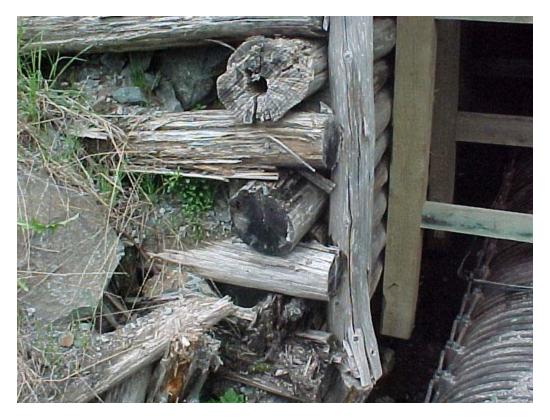
Photo 23: View of bottom portion of bridge abutment, June 2001.

Some of the existing bridge components were constructed in 1971 and they are showing obvious signs of deterioration. The bottom section (approx. lower ³/₄) of the bridge abutments are constructed from local untreated timbers and they are deteriorating, see photo #23. It appears that the only thing keeping the abutments from collapsing is a framework of pressure treated timber braced between the existing abutments, which were installed several years ago, see photo #24. The department of Works, Services and Transportation have indicated that they have no plans to replace this structure in the near future.

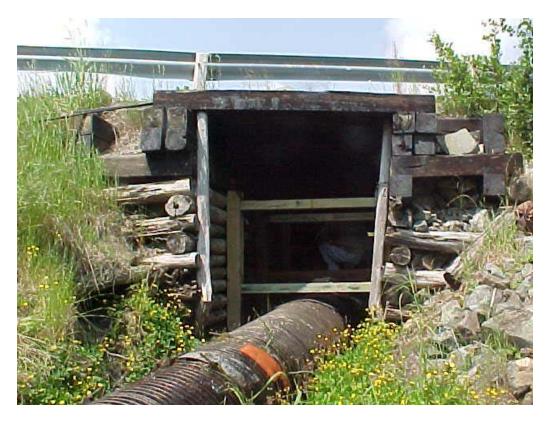
Photo 24: Road bridge over penstock, note timber reinforcement between abutments, July 2002.

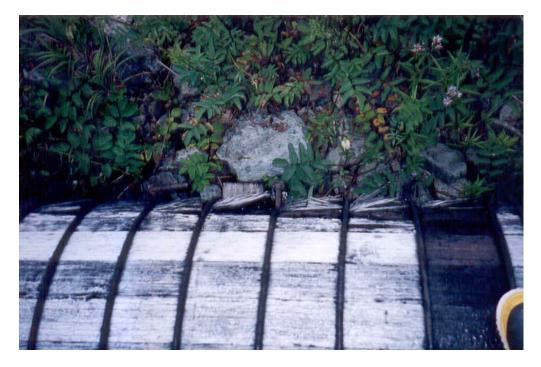
Photo #25: Loss of protective coating on penstock and bleaching of the wood, August 2000.

The original wooden penstock components were coated with creosote to provide protection from deterioration and sunlight. Typically a wood penstock would be recoated with creosote every 5-10 years to maintain the protective coating. This penstock has not been coated for at least 15 years (due to environmental restrictions on the use of creosote) and as a result the majority of the wooden penstock has no protection coating, especially along the top, see photo #25. The lack of protective coating has accelerated the deterioration of the wooden staves.

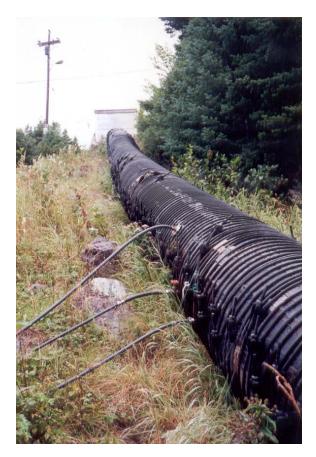
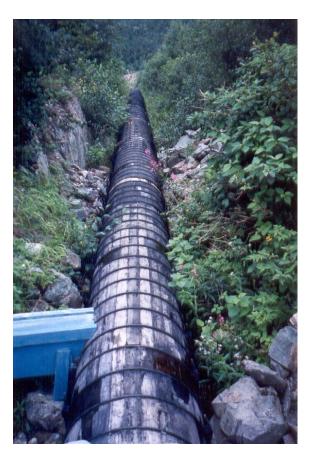
Photos #26 & #27: Water take-offs to adjacent homes (left) and Nugget Pond gold mine security building (right), August 2000.

As indicated earlier, the penstock passes through the community and in several locations the penstock is within a few feet from homes and roadways. The proximity of the penstock to the homes has encouraged many residents to tap into the penstock for a source of water, see photos #26 & #27. These taps were constructed without any permission from Hydro and in several locations have been abandoned and leaking water, see photo #28. In addition, all terrain vehicles and skidoos travel over and under the penstock, which imposes additional loads and stresses on the penstock. In the upper half of the penstock, there is firewood stacked adjacent to the penstock, see photo #29, and in several places there are cuts in the penstock from chainsaws. The use

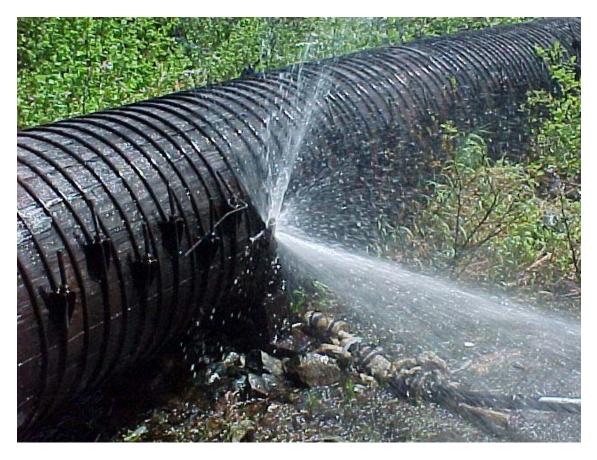
Photo #28: Location of abandoned water tap in penstock, June 2001.

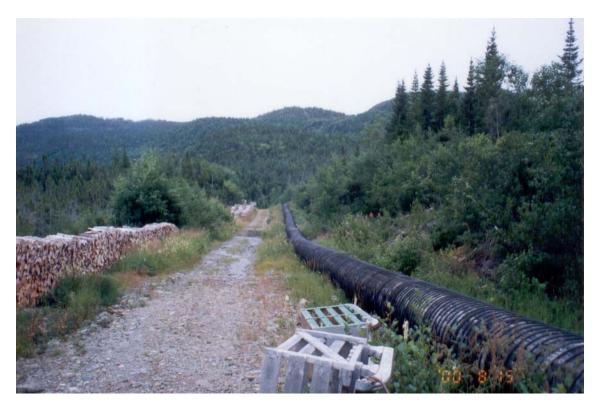
Photo #29: View of access road and firewood adjacent to penstock, August 2000.

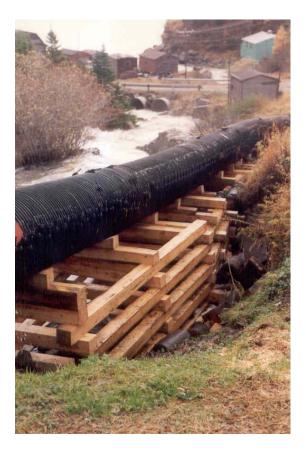
Photos #30 & #31: Timber support added under penstock after erosion of embankment, October 1992.

The lower section of the penstock passes under the main access road to the community and then proceeds along the side of a brook towards the powerhouse, refer to location #5 on map SA-2. In 1992 high water levels in the brook caused a section of the embankment under the penstock to erode. Untreated timber cribbing was installed along side of the brook to support the penstock, see photos #30 & #31. The timber support is 15 years old and is still subject to brook damage. The penstock has also developed a noticeable dip in elevation at this location resulting in more leaks.

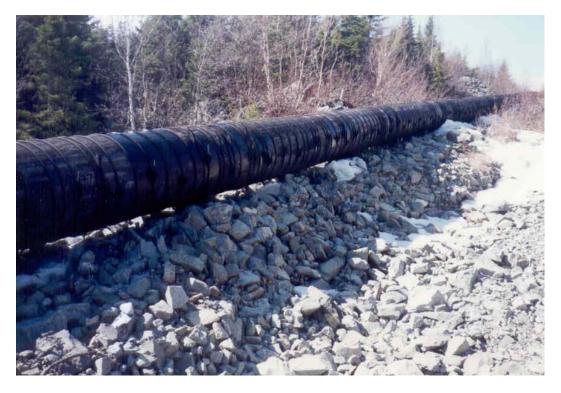
Photo #32: View of rocks and gravel washed up against penstock, April 1996.

In 1996 water overtopped Snook's Arm main dam and caused flooding downstream. The flooding caused a 200 ft section of the access road to the Nugget Pond gold mine to be washed away. The flooding caused a significant amount of rock and debris to move downstream and adjacent to the penstock. Though, the majority of the rock debris was removed, however some of the rocks remain next to the penstock, see photos #32 & #33. This rock debris probably has and will continue to impose stresses on the penstock and, which over time, may displace the penstock transversely. Another similar event would likely have a major impact on this section of the aged and weakened penstock.

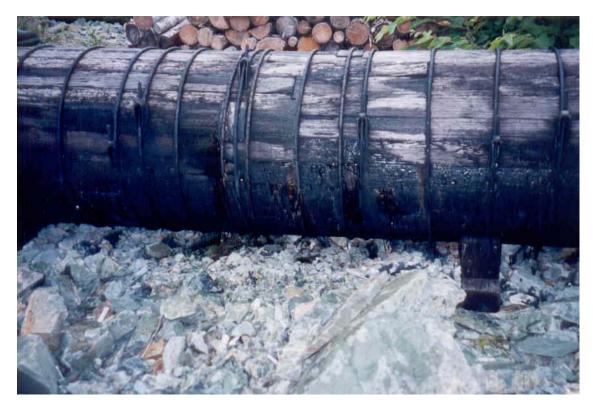
Photo #33: View of rocks and gravel under penstock, August 2000.

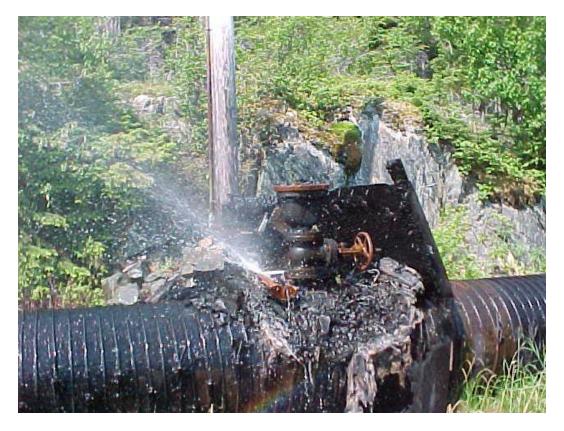
Photo 34: Fire damage to vacuum breaker valve enclosure, July 2002.

In 2002 a fire occurred in the valve enclosure around the vacuum breaker valve, see photos #34 & #35. The fire was caused by a malfunction of the heat tracing and caused the destruction of the valve enclosure and damage to the valve. Luckily, there was no apparent damage to the penstock. However, the vacuum breaker valve did require repair. And, as stated earlier, if this valve fails to operate when required, the penstock may collapse.

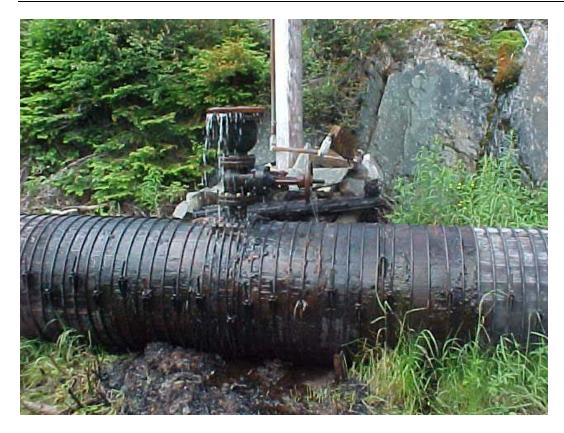
Photo 35: Vacuum breaker valve after fire, July 2002.

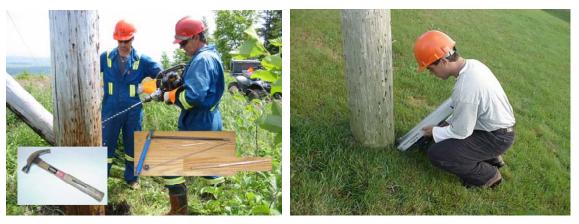
Figure 3.4a - Inspection Tools

- Visual inspection from groundline to the top of the pole including
 - Climbing inspection;
 - Excavation near the ground line;
- Sound and bore (Fig. 3.4a);
- NDE measurement (strength) only for poles (**Fig. 3.4b** and **c**);
- Core samples and retention level analysis (samples); and
- Selected sample tests at MUN (destructive Fig. 3.4d).

Fig. 3.4a depicts the tools required to carry out inspection based on sounding and boring. Fig. 3.4b depicts the Resistograph, which through the use of a 3mm drilling needle and resistance measurement, profiles the poles core. Fig. 3.4c shows the nondestructive PoleTest tool for strength evaluation based on ultrasonic principle. Fig. 3.4d depicts the full-scale test bench developed at Memorial University's Engineering laboratory for

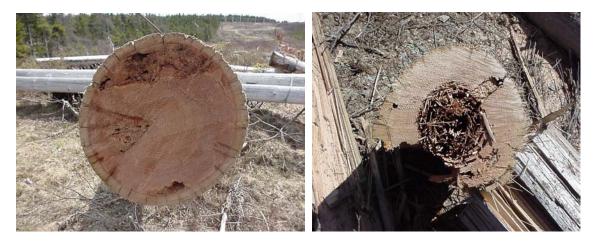
Fig. 3.19a – Internal Decay

Fig. 3.19b – Carpenter Ant Damage

Fig. 3.19a & b show the condition of the collapsed poles due to rot and carpenter ant damage. It also shows the importance of pole treatment and follow-up inspections to ensure that the poles are reliable for transmitting power and safe to climb for future inspections and maintenance work. NLH does not have a structured pole inspection, testing and treatment program at present with particular reference to life-extension of wood pole transmission lines. Therefore it is quite likely that many of the older poles may be exposed to severe decay due to fungi attack. Without a proper inspection and subsequent treatment program, the life of these poles cannot be extended significantly beyond 40 years.

As illustrated in **Fig. 3.3** the depletion of preservative could be quite rapid once the retention has gone below the threshold level. The consequences of this depletion, and associated strength degradation have been shown in **Figs. 3.19a & b**.

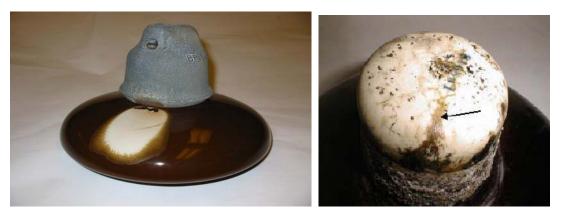
Fig. 3.22a – Flashed Insulator

Quite often, the primary cause of the insulator failure is the corrosion of the steel pin in the cap and pin assembly. In the pin area the surface leakage current is concentrated and this causes a dry band formation. Dry band formation leads to partial discharges and eventually causes severe spark erosion. This coupled with the natural corrosion process, reduces the net area of the pin to a point that it is no longer able to support the tensile load. In addition, the corrosion process creates stresses which tend to induce radial cracks in the porcelain insulator.

Fig. 3.22b – Cement Crack (CEA, 2003)
