NEWFOUNDLAND AND LABRADOR HYDRO

2006 CAPITAL BUDGET

SUBMISSION TO PUBLIC UTILITIES BOARD

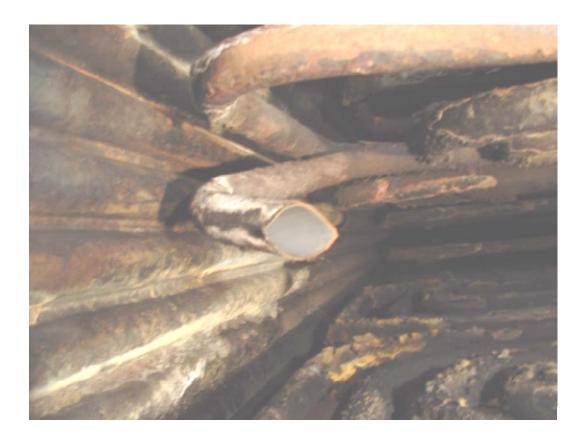
Failed superheater tube 2005-02-05

Holyrood Unit No. 2 with an installed capacity of 175 MW is a significant portion of Hydro's generation capacity and must be maintained to ensure system reliability and capability. The frequency of repairs to this section of the superheater has increased dramatically in recent years. Since 2004-04-01, five failures have occurred, removing the unit from service for approximately five days each time. The total cost to repair a single failure is approximately \$25,000, although it can be much greater if the failure occurs in an area which is difficult to access. Tube wall thickness has deteriorated to below that required by the Province's Boiler and Pressure Vessel Act (which uses the internationally recognized ASME Boiler and Pressure Vessel Code as its design standard). In the fall of 2004, 11 of the 31 plattens in the upper section and five of the 31 plattens in the lower section were surveyed and found to be below the thickness required by Code. Many locations were found where the tube thickness is less than the 80% that is required under the Boiler and Pressure Vessel Code. When a tube failure occurs, the boiler must be immediately shut down due to the high rate of water loss. The repair time varies depending on the extent of damage caused by the burst tube. If these superheater platens are not replaced, the frequency of tube failures will increase and boiler reliability will suffer significantly, compromising Hydro's ability to service its customers. The attached photos illustrate the damage.

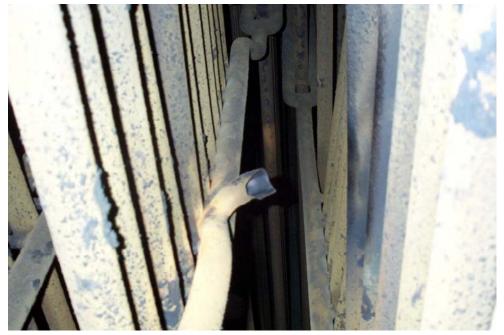
Failed superheater tube 2005-04-05

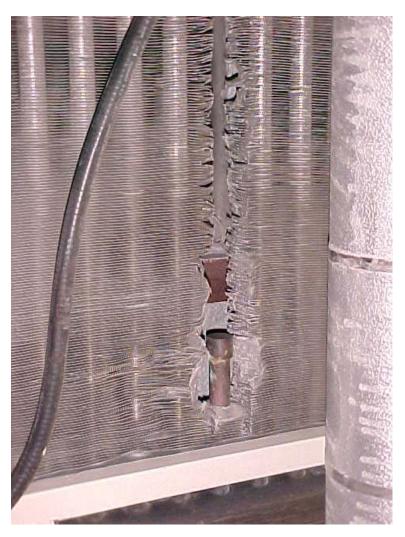
Steam coil with one ruptured tube removed and its connection capped

powerhouse, to protect the health of personnel. As well, there are safety concerns were tubes to rupture in a confined space in the presence of operating/maintenance personnel. The attached photos illustrate the condition of the steam coils.

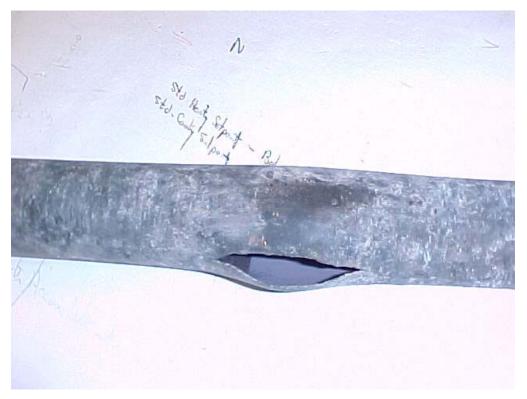
Ruptured steam tube

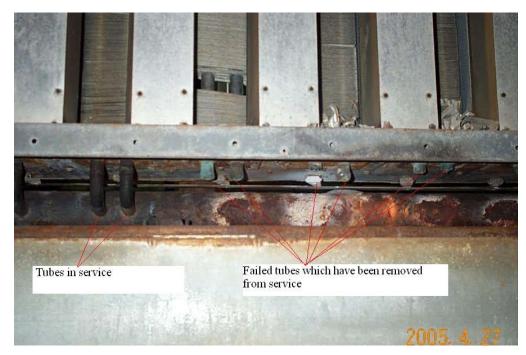
Steam coil section with failed tubes

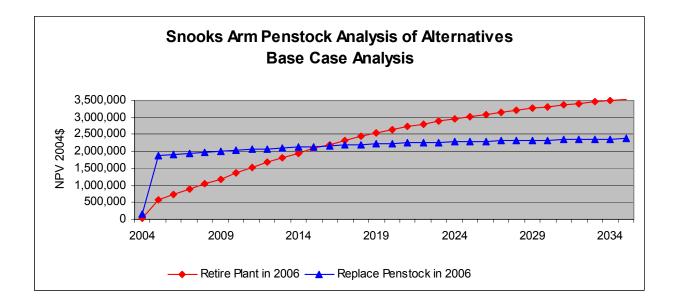
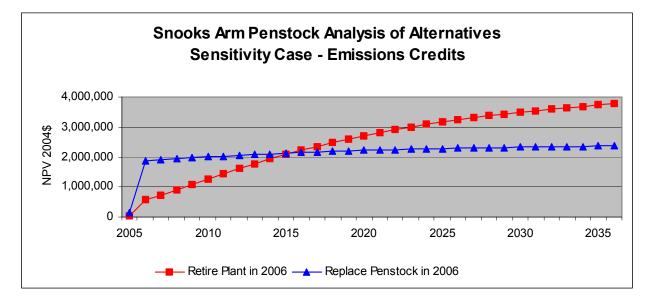
Snooks Arm Penstock Replacement Option 1 - Full Replacement in 2005/6

A summary of the detailed economic analysis (attached) is presented in the following table and graphs. Note that while the capital cost has increased, there has been a significant increase in the value of avoided fuel at Holyrood that has the overall effect of increasing the economic viability of the penstock replacement project.

Snook's Arm Penstock Replacement Comparison of Alternatives									
	CPW Preference Against Plant Retirement Alternative								
	CPW (2004\$)	Payback Period							
Base Case:									
Full Replacement in 2006	\$1,161,092	11 Years							
Sensitivity Case – Emissions Costs:									
Full Replacement in 2006	\$1,398,735	10 Years

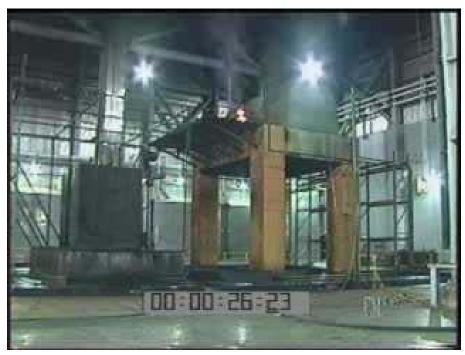
Test facility. The object at left represents a lubricating oil tank, the pedestals at centre represent the turbine/generator support structure and the cylindrical object on top of the pedestal represents the turbine/generator.

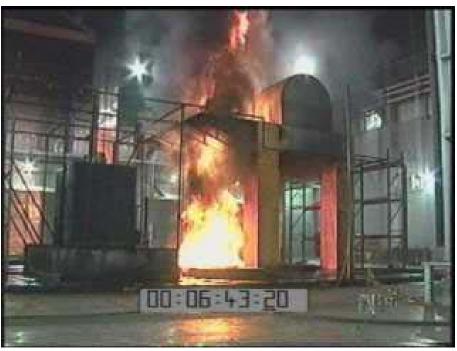
Fire test, mimicking the failure of an oil line, with burning oil flowing down from the turbine/generator to the plant floor

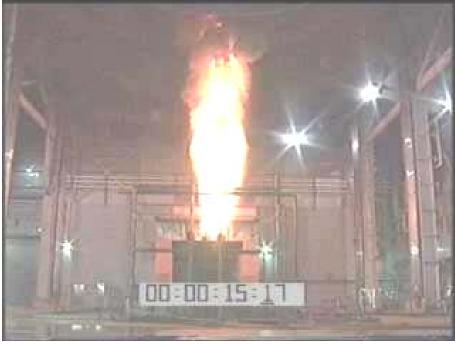
Spray fire test, mimicking a stream of burning oil from a pressurized lubricating oil pipe.

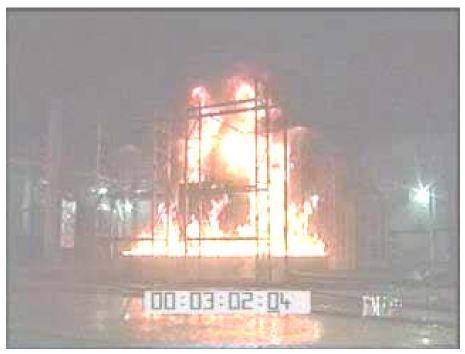
Pool fire test, mimicking burning oil which would collect on the ground floor of a plant during an oil system fire.

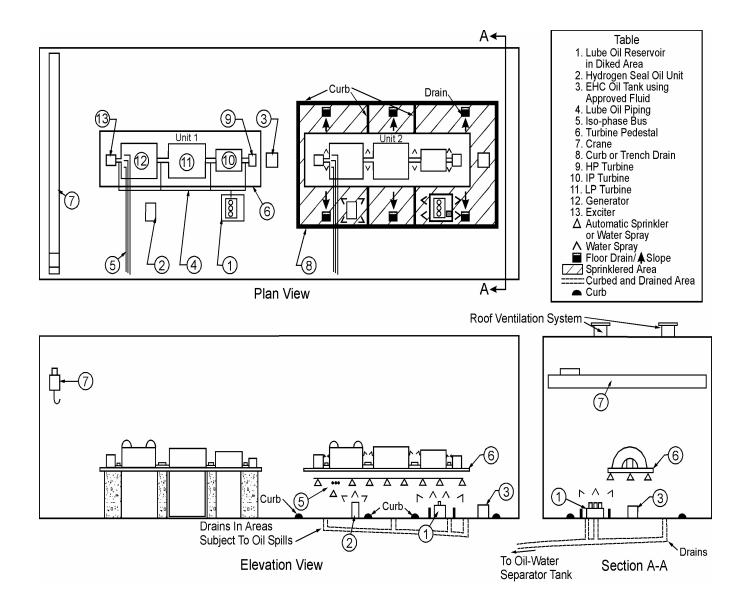
Figure 2.1 Local protection layout for unenclosed steam turbines and generators

See Figures 2.1 and 2.2 for a general conceptual layout of local protection, containment, and drainage.

2. Consider subdividing large containment areas by use of additional curbing or drain trenches, where feasible, to limit the potential pool size (see Figs. 2.1 and 2.2).

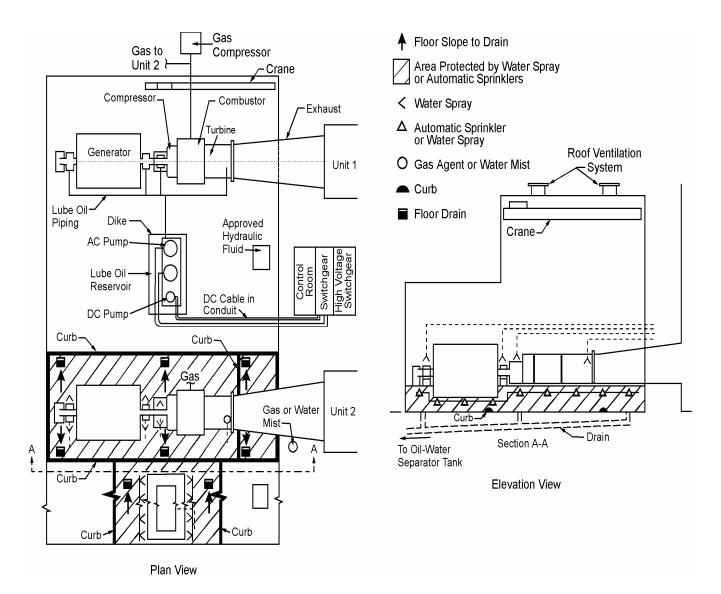
Figure 2.2 Local protection layout for unenclosed combustion turbines and generators

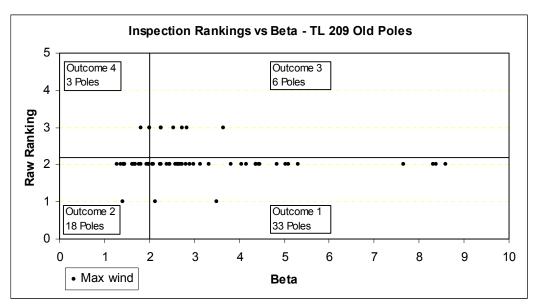
Fig. 1 Summary Plot For Suspension Structures (Pole Bending) –Beta Values Versus Condition Ranking

This matrix table provides four possible outcomes for future mitigations. The method is developed only for one failure mode "pole bending" at this time. It is equally applicable to other failure mode scenarios such as vertical failure mode of the cross arm or buckling failure mode of the angle and/or dead end structures. Work is underway in developing the reliability based methodology for these other failure modes and eventually all failure modes will be evaluated using the matrix table. Failure modes will be coordinated with the field inspection data to provide specific mitigation actions for each line component. The ultimate objective is that all failure modes will be evaluated using the "Condition Matrix" table. Figure 1 shows a typical plot for the reliability versus condition matrix for TL 209.

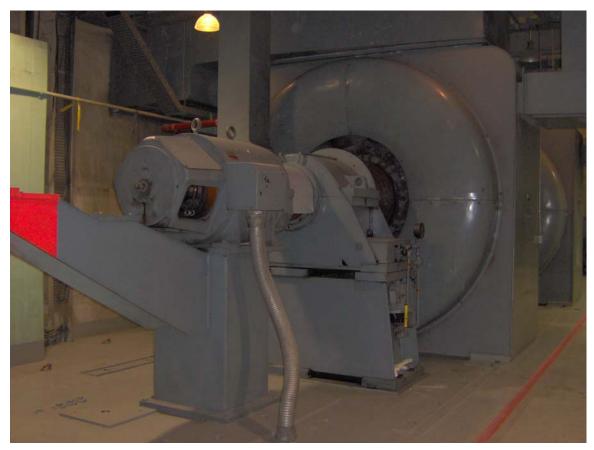
Figure 1 – 50 Hz Rotor (2005)

Readings of the insulation values of the 50 Hz rotor since 1998 remain very low (approximately 200 to 300 kohms.) The readings for the 60 Hz rotor, unlike the 50 Hz rotor, improved after cleaning.

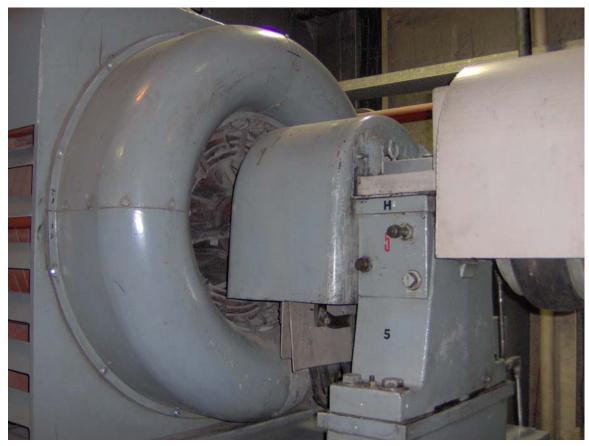
Figure 2 – 60 Hz Rotor (2005)

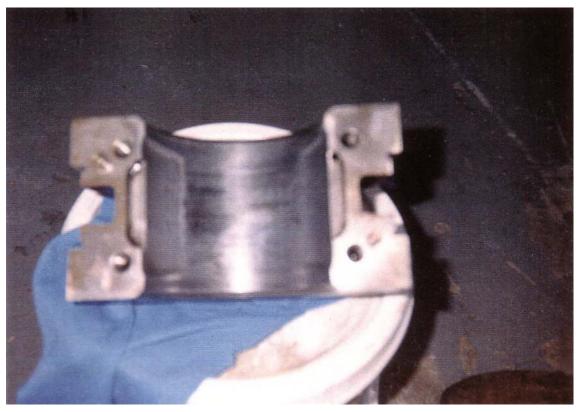
Figure 3 – Top Half of the Pedestal Bearing (1998)

It is incorrect to state that this bearing has been wiped. This bearing has been partially wiped. A wiped bearing would likely cause damage due to contact between the shaft and the bearing shell. A machine cannot be operated with a wiped bearing. The bearing should be replaced as soon as possible. It is running at higher than normal temperatures, as evidenced by the condition of the oil, and bearing failure is possible. This could cause shaft damage and a lengthy outage.

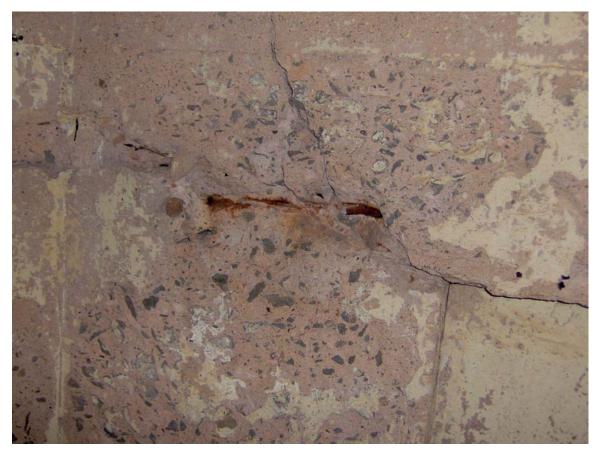
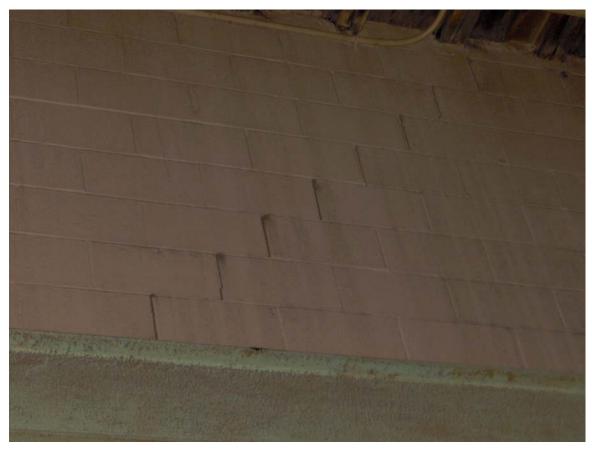
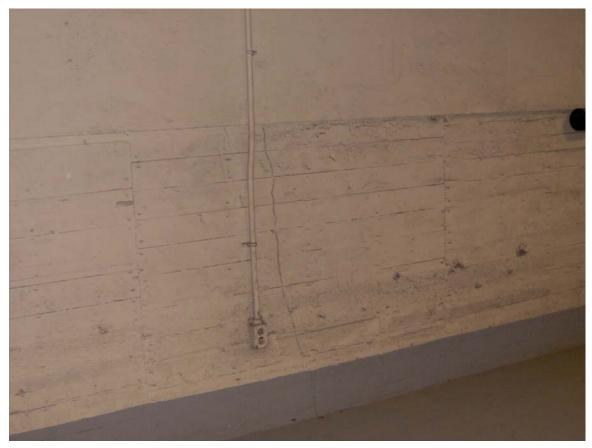
Figure 4 – Example of Crack in Wall (2005)

Figure 5 – Example of Crack in Wall (2005)

Figure 6 – Example of Crack in Wall (2005)

Repairs have been made to the roof and stairwell ceiling. Caulking has been applied to building cracks when possible to decrease the ingress of dirt and dust. The overall condition of the building remains poor.

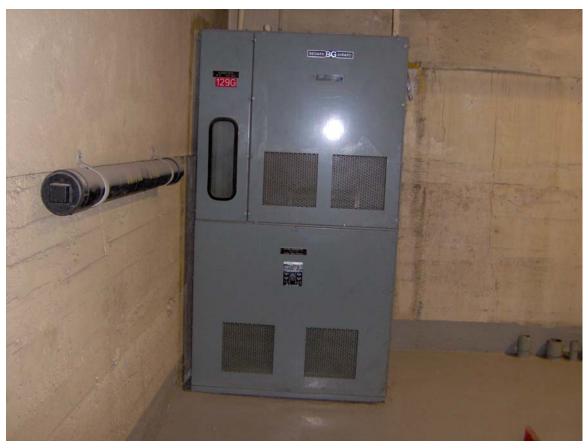
Figure 7 – Neutral Grounding Transformer (2005)

The risk of an oil leak from these transformers is small. A dry type transformer would be more susceptible to problems caused by the accumulation of dust and dirt.

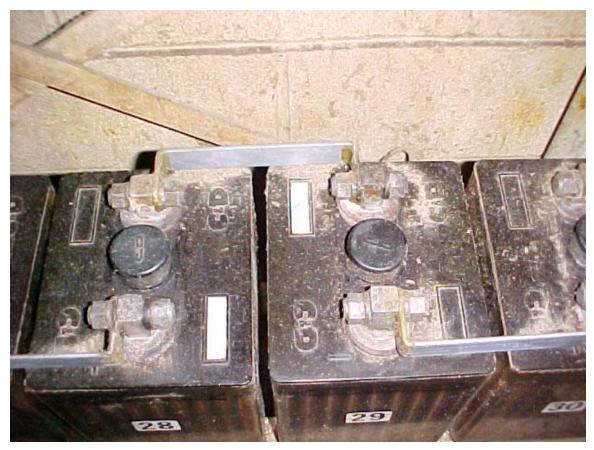
Figure 8 - Close-up of Battery Bank (2001)

An overhead shield and lighting has been installed. The hydrogen gases from the bank are not being exhausted. The battery bank is scheduled for replacement in 2005 under a capital project ("Replace Battery Banks – Various Stations and Lines"), which also includes the replacement of several other battery banks. The total project cost is \$165,700. The cost of replacing the Corner Brook frequency converter's battery bank is roughly \$40,000. The building's ventilation system, in addition to providing cooling air for the transformers and converter, exhausts hydrogen gases from the battery bank.

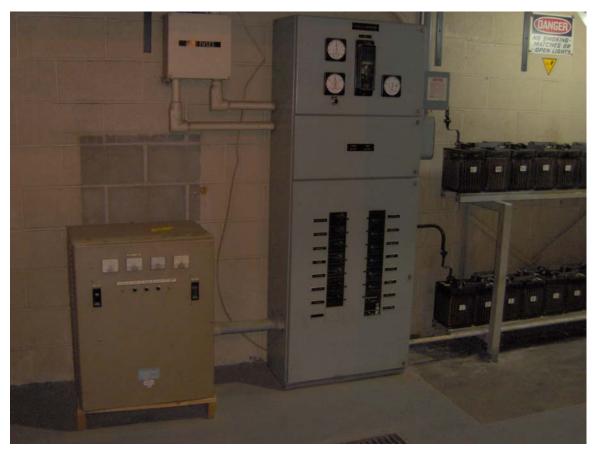
Figure 9 – Battery Charger & DC Panel (2005)

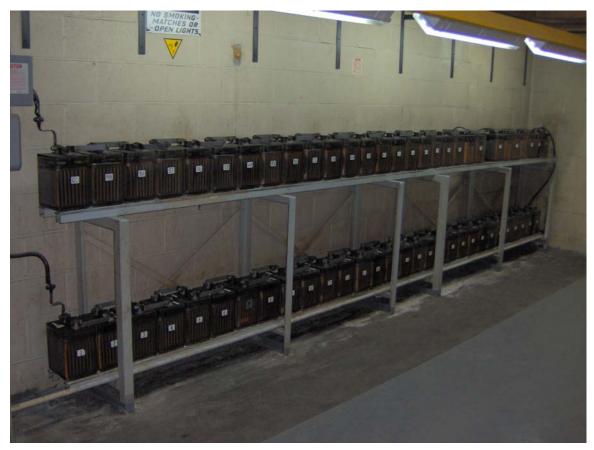
Figure 10 – Battery Bank {Scheduled For Replacement} (2005)

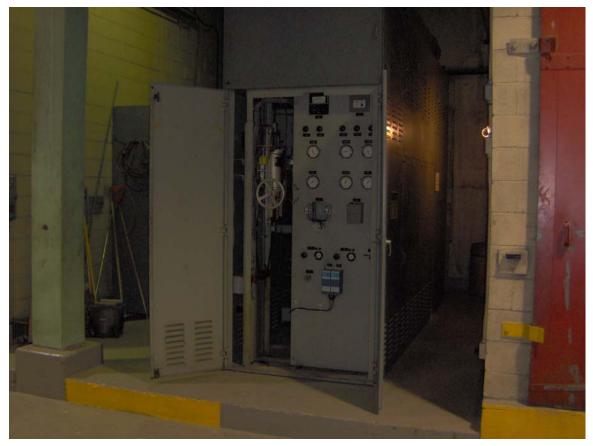
Figure 11 – Liquid Rheostat (2005)

The building and piping asbestos insulation has been removed. The chamber of the liquid rheostat is asbestos lined and is still in service. This site has been identified under Hydro's Asbestos Abatement Program and is scheduled to be inspected this summer. The results of the inspection will determine the course of action required by Hydro.

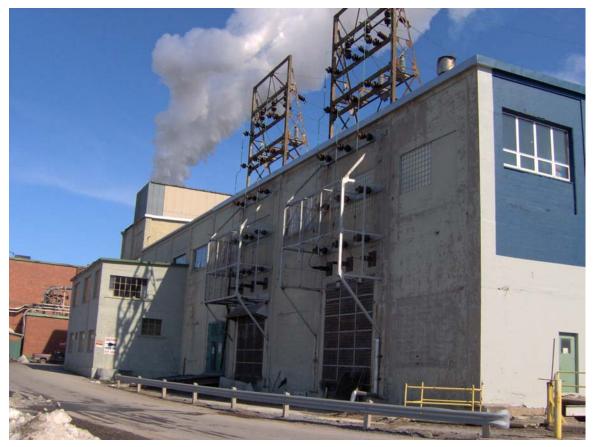
Figure 13 – Towers and External 66 kV Bus (2005)

The entrance bushings for the 500 mcm conductor to transformer T2 are damaged and should also be replaced (cost estimate = \$12,200 for each of the twelve bushings). These bushings are not scheduled for replacement this year.

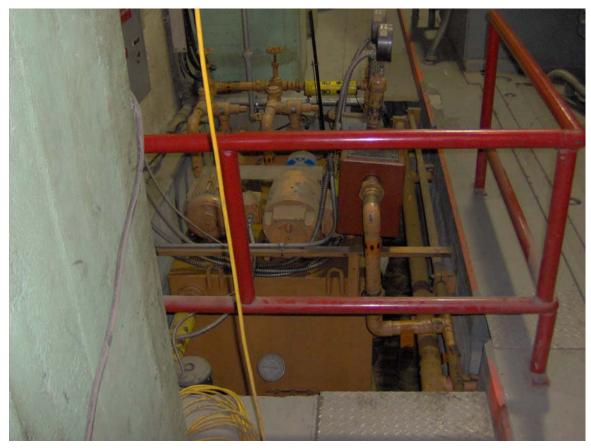
Figure 15– Main Lube Oil Pump (2005)

- The main lube oil pump is nearing the end of its service life. The cost of replacing this pump is estimated to be \$7,000. This work should be budgeted and completed within the next couple of years.

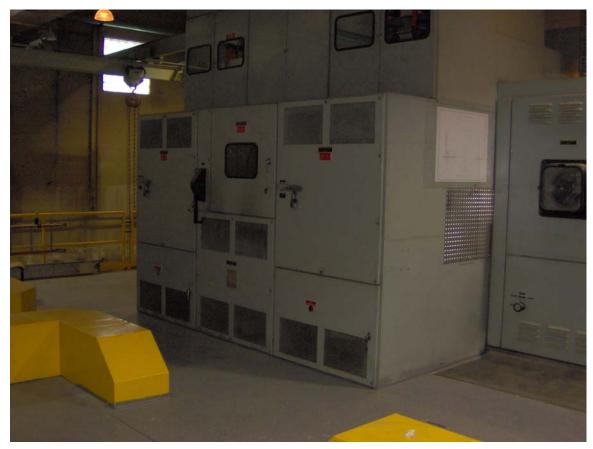
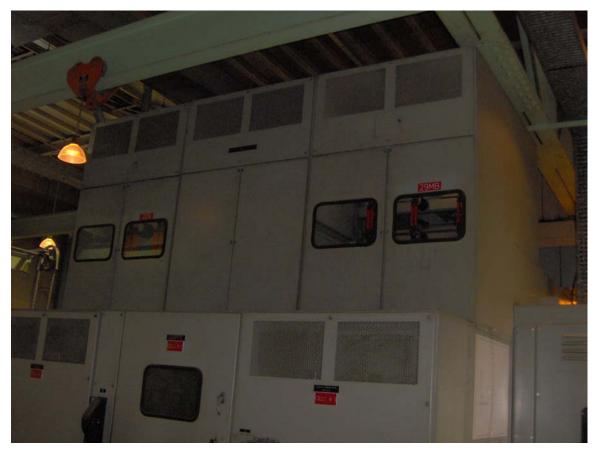
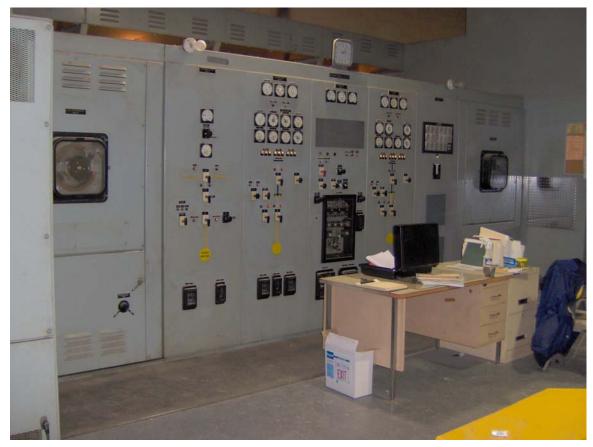
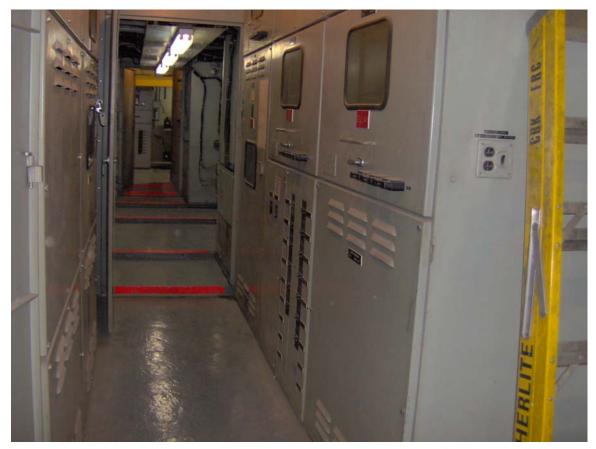
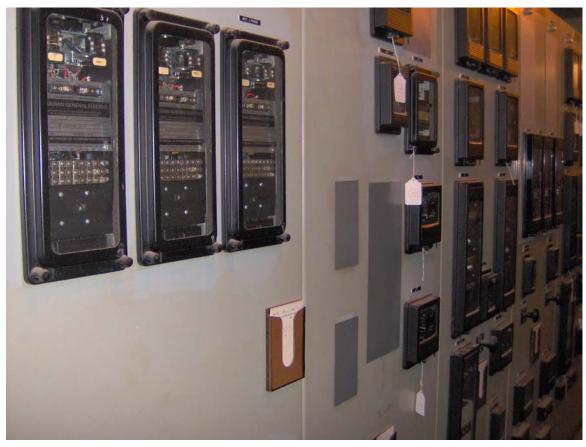
Figure 16 – Frequency Converter Switchgear (2005)

Figure 17 – Frequency Converter Switchgear (2005)

Figure 18 – Frequency Converter Switchgear (2005)

Figure 19 – Frequency Converter Switchgear (2005)

Figure 20 – Frequency Converter Switchgear (2005)

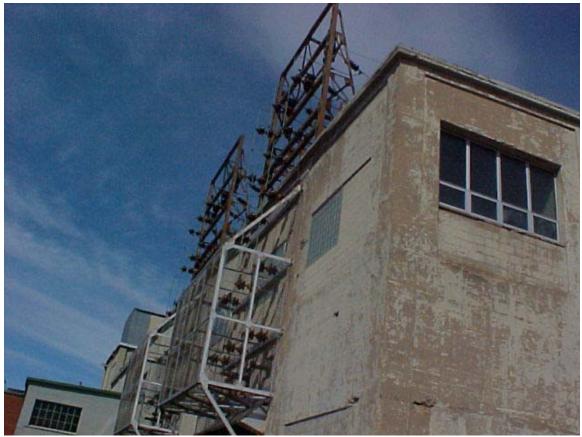
There are currently 2 steel towers on top of the Frequency Converter Building that support conductors between the Frequency Converter and No. 1 Substation. Each tower is approximately 25' high x 18' wide x 6' deep, and is fabricated from steel angle, plate, and tower bolts. All of these components are hot dip galvanized.

Take Off Towers and External 66 kv Bus associated with the Frequency Converter at Corner Brook Pulp and Paper.

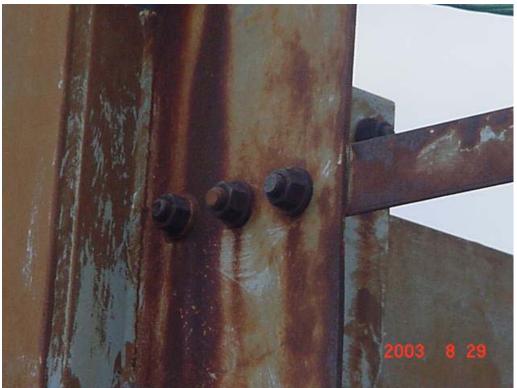
Both towers are in good condition, including the bolted connections and leg anchors. Approximately 80 percent of the surface area of both towers is lightly corroded with some signs of mild pitting. Although maintenance of these steel towers is not urgent, it is recommended that a protective coating be applied to prevent any further deterioration of the structural steel. A two to three year delay in carrying out this maintenance would be acceptable.

Take Off Tower for T1, bolted connection, leg to horizontal brace, light corrosion.

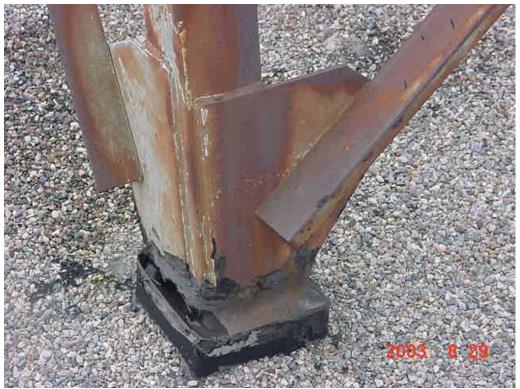
Take Off Tower for T2, leg anchor, light corrosion and mild pitting.

As a protective coating, it is recommended that a good quality zinc or aluminium rich self priming paint be used. Surface preparation shall be in accordance with the SSPC-SP-2 standard (hand tool cleaning). Hydro currently stocks a high quality product that would be suitable for use on the towers. This product is Galvacon GC-243 cold galvanizing compound, however, it is quite expensive at \$232.00 per gallon.

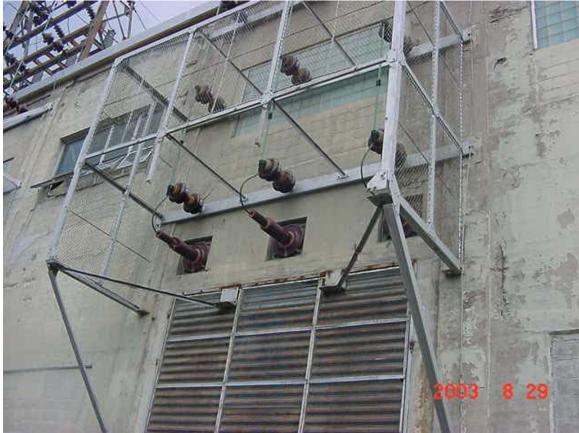
Last year, in order to facilitate the removal of T2 from the Frequency Converter Building, part of the protective structure that prevents the incidental contact between the 66 kv Bus and Mill Personnel/Equipment was removed. For safety reasons it is recommended that this structure be reinstated to its original condition as soon as possible. See drawing No. 401-S-16-Rev. 2.

Protective Structure for T2 External 66 kv Bus, steel frame and wire mesh removed.

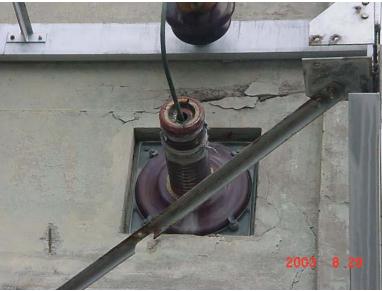
Both A and C phase entrance insulators for the 500 MCM Conductor leading to T2 have sustained considerable physical damage, resulting in reduced leakage distances and an increased probability of flashover. It is recommended that both A and C phase insulators be replaced as soon as a suitable substitute can be found. The existing insulators are vintage 1966, Canadian Porcelain, 69 kv, 350 BIL, catalogue No. 1216. Dave Hicks of TRO Engineering has been contacted for assistance in locating the replacement insulator.

Damaged A phase entrance insulator.

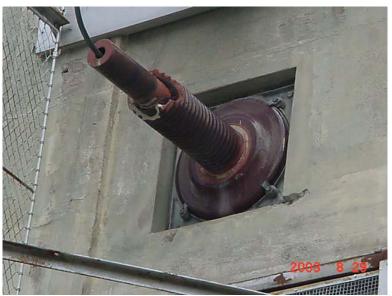
Damaged C phase entrance insulator.

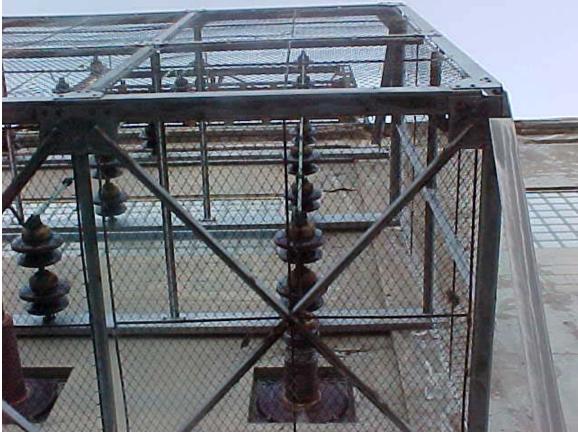
The current 66 kv Bus arrangement on the frequency converter building is supported by C.O.B. pincap and suspension insulators. These types and make of insulators have been failing at an ever increasing rate in many of our terminal stations, distribution, and transmission lines. Therefore, it would be prudent to consider changing out these insulators within the next several years. The pincap insulators are vintage 1966, C.O.B., catalogue No. 37769 (double units), 36 units would require replacement. The suspension insulators are vintage 1966, C.O.B., ball and socket type, catalogue No. 32436. 12 strings of 5 units would require replacement. Hydro currently stocks suitable station post and suspension type insulators for this work.

C.O.B. pincap insulators, 66 kv Bus CBPPL frequency converter building.

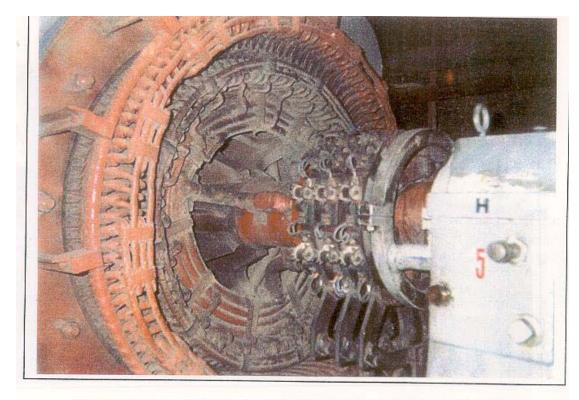
Photo 1: Dust and dirt on the machine windings and rotor - August 19, 1998

- The entire facility is covered with dust and dirt and accumulated residue from the pulp mill operation. The ventilation system is faulty and the building shell has numerous cracks, which allow penetration of debris. The entire facility requires cleaning, particularly the converter itself. The ventilation system should also be brought up to current standards.

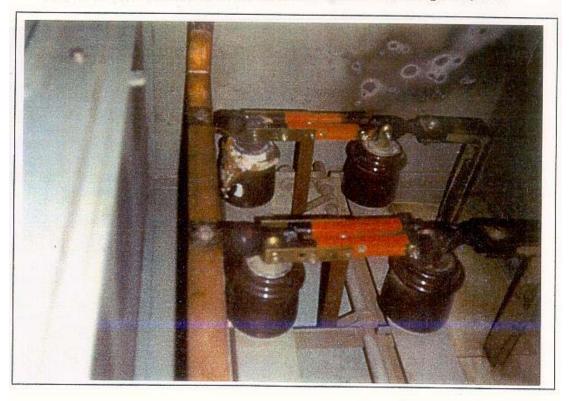
Photo 2: Arcing and burning found in cubicle - August 19, 1998

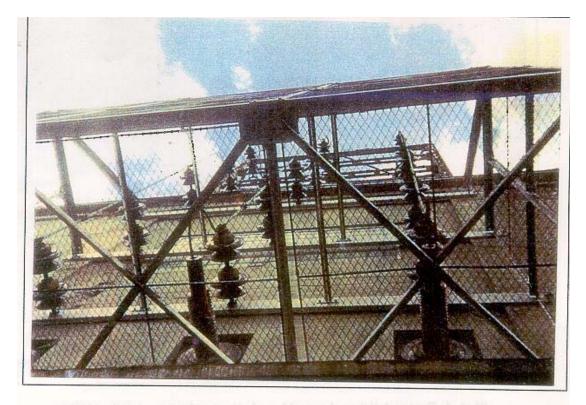
Photo 3: Damaged bushings outside the converter building - August 19, 1998

- The pedestal bearing has been wiped and should be replaced.
- The building requires repair. Concrete and bricks have fallen from the roof and building sides and damaged the bushings and post insulators. Building cracks have allowed entrance of the wood debris associated with operation of the paper mill. The ceiling in the stairwell is temporarily repaired using a sheet of plywood. This should be permanently repaired.

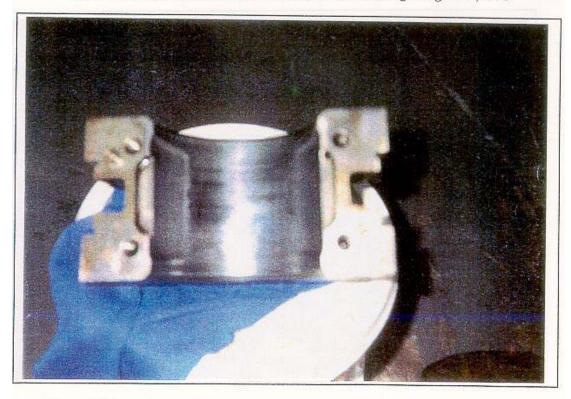
Photo 4: Shows scoring that has occurred on the pedestal bearing which has failed - August 19, 1998

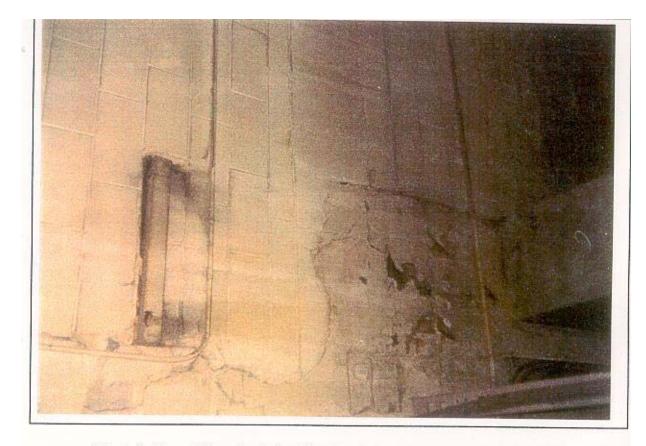
Photo 5: Type of structural deterioration in the building - August 19, 1998

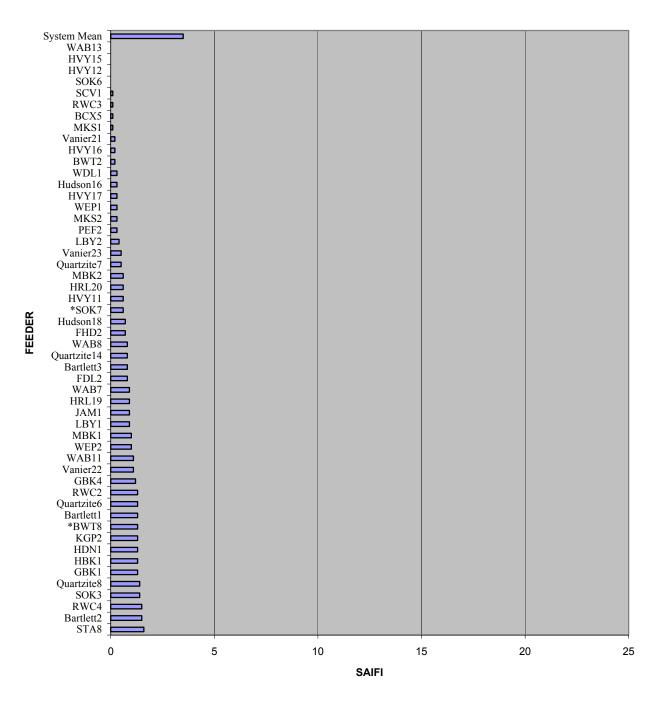
5 YEAR AVERAGE SAIFI - SHEET 1 OF 2

<u>Appendix 1</u> <u>5-Year Average Normalized SAIFI (1999 to 2003) – Interconnected Systems</u>

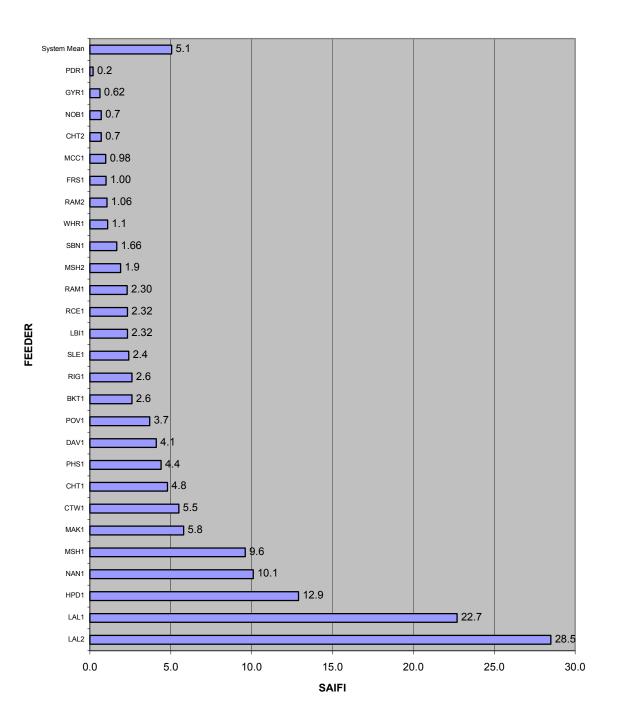
5 Year (1999 to 2003) Average Saifi

5-Year Average Normalized SAIFI (1999 to 2003) – Isolated Systems

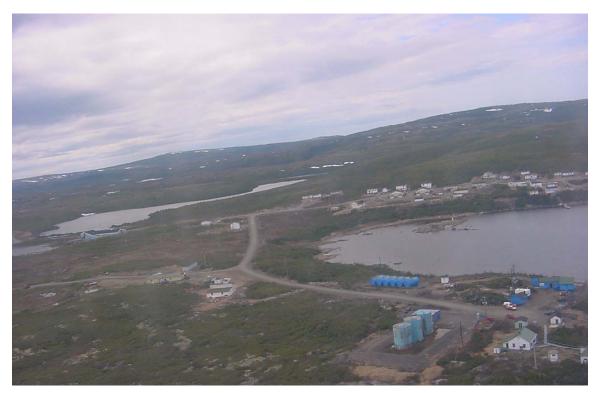
Photo # 1—St Lewis Diesel Plant Site showing a) Plant (Blue Bldg to the right with Mobile Unit (White Bldg. in front of Plant), b) Hydro Fuel Storage Tank Farm (6 Horizontal Tanks to the left).

The Blue Building and Three Vertical Tanks in the foreground are owned by the Canadian Coast Guard.

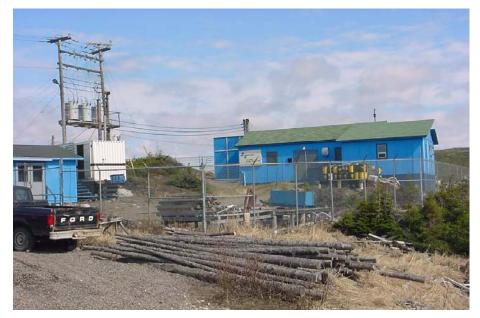
Photo #2---St Lewis Diesel Plant ---Note Extensions a) Office to the right and b) Storage Room to the left and rear.

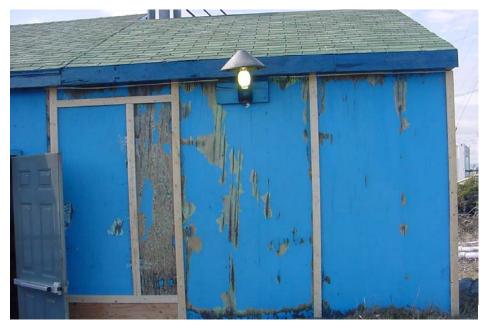
Photo #4—St Lewis Plant—Rear View Showing Deterioration of Siding

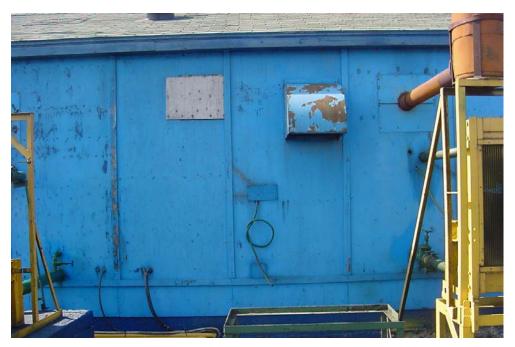
Photo #5—St Lewis Plant—Rear View Showing Wall Penetrations

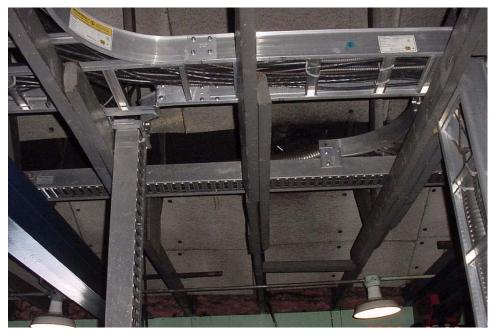
Photo #9—St Lewis Plant—Interior View Showing Wooden Trusses

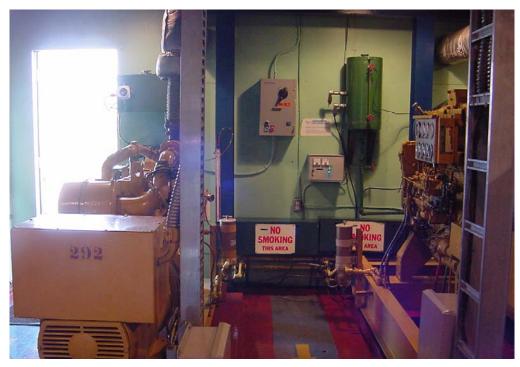
Photo #11—St Lewis Plant—Interior View Showing Space Between Units

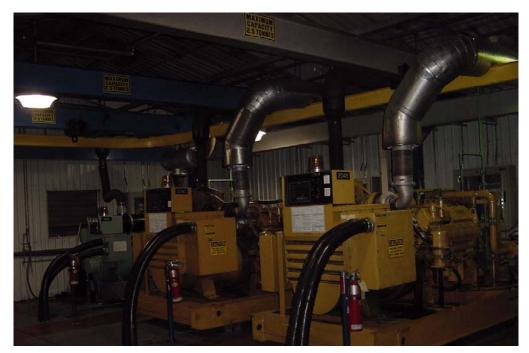
Photo #12—St Lewis Plant—Interior View Showing Three (3) Units

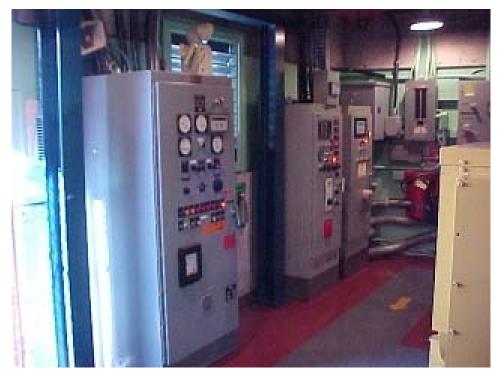
Photo #15—St Lewis Plant—Interior View Showing Congestion

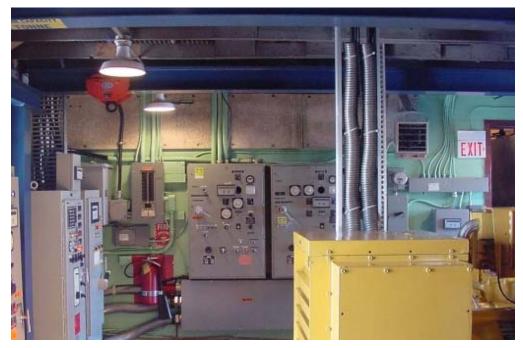
Photo #16—St Lewis Plant—Interior View Showing Congestion

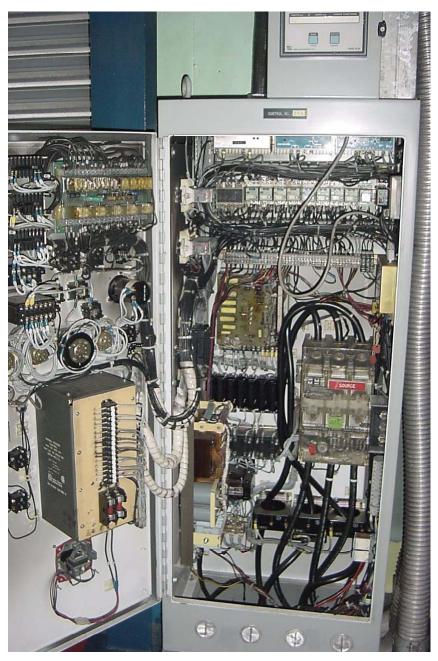
Photo #17—St Lewis Plant—Interior of Switchgear

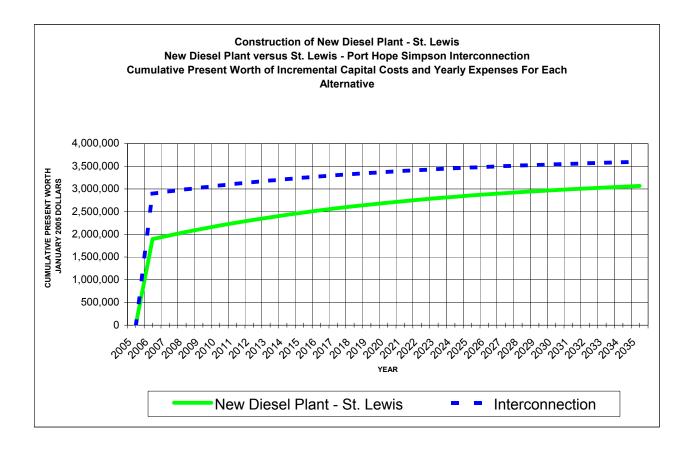
A summary of the detailed economic analysis (attached) is presented in the following table and graph. Over a 30 year period, the new Diesel Plant alternative has a CPW preference of \$530,732 and has a positive CPW from the beginning.

New Diesel Plant - St. Lewis versus St. Lewis – Port Hope Simpson Interconnection Comparison of Alternatives							
	CPW Preference of						
	New Diesel Plant Alternative						
	CPW (2005\$)	Payback Period					
Base Case	\$530,732	Immediate

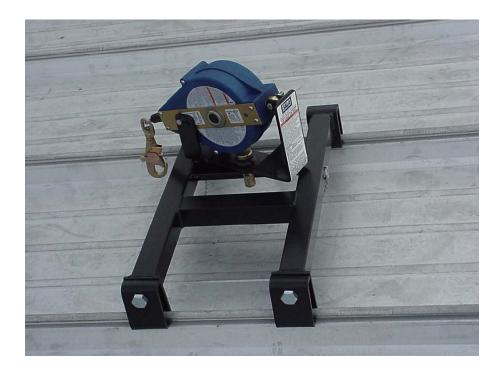
The following are pictures of typical examples of the Fall Protection Systems which will be installed.

Photo # 1—Natuashish Diesel Plant—Travel Restraint Device attached to Metal Roof's Standing Seam

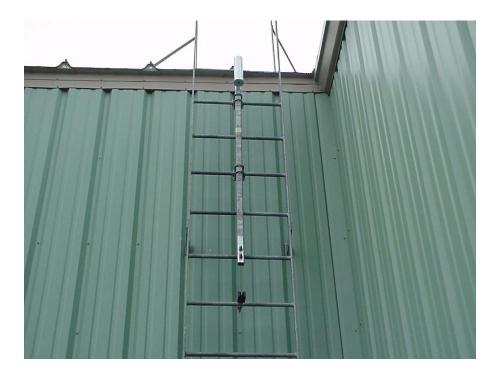
Photo # 2---Natuashish Diesel Plant---T-Rail attached to Building Access Ladder.

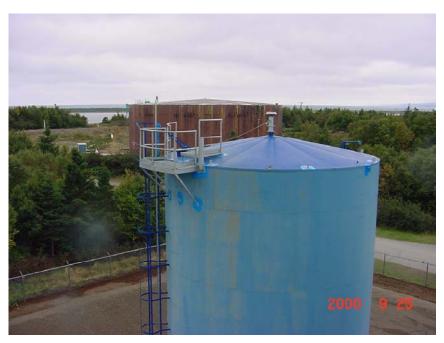
Photo # 3—Stephenville Gas Turbine Generating Station (STGTGS)

Fuel Storage Tank with T-Rail Attached to Ladder and Safety Wire Attached to Tank Center Vent

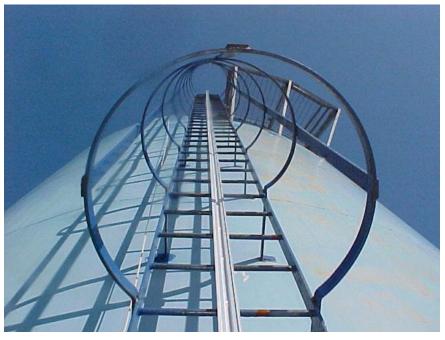
Photo # 4—STGTGS--- Fuel Storage Tank with T-Rail Attached to Ladder

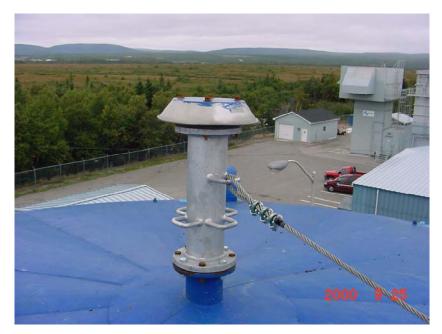
Photo # 5—STGTGS Fuel Storage Tank with Safety Wire Attached to Tank Center Vent

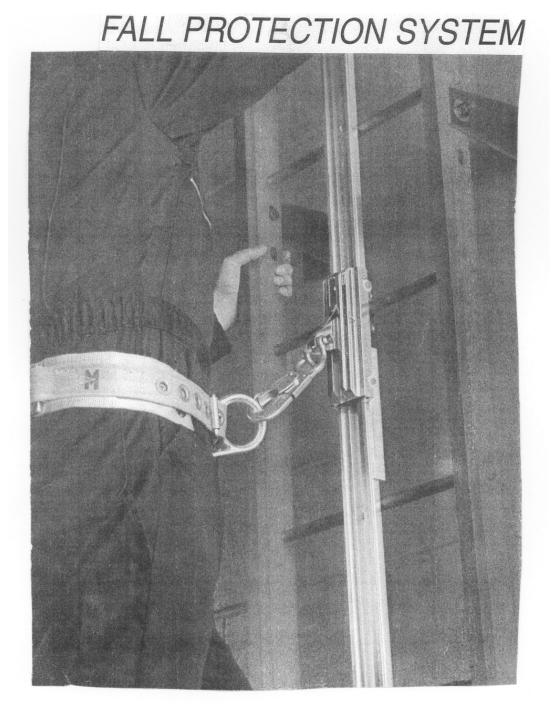
Photo # 6—Typical Arrangement for Worker Attachment to Ladder's T-Rail

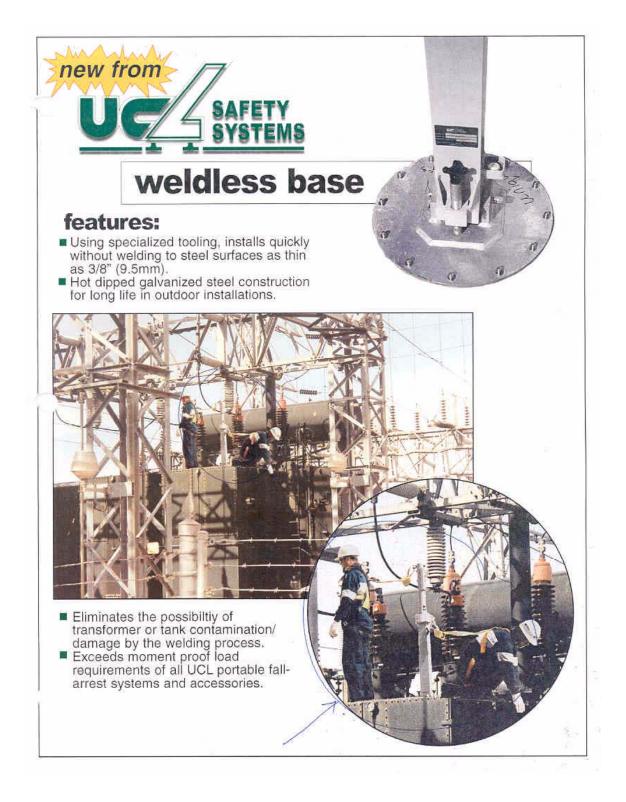
Photo # 7—Showing Workers attached to a Portable Pole which will be Attached to Transformers as required

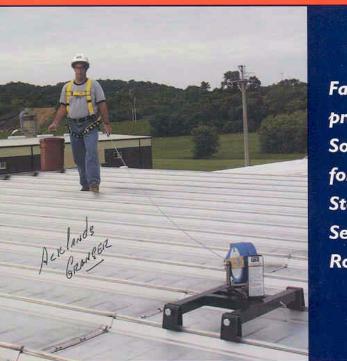
For use on flat or sloped structural standing seam roofs

Photo # 8—Standing Seam Roof Anchor Similar to Ones Installed at New Diesel Plants in Nain and Natuashish
