**Newfoundland Power  
2004 Capital Budget Application  
Filing Contents**

**Volume I  
Application, Schedules and Prefiled Evidence**

**Volume II  
Expenditure Details, Reports and Studies**

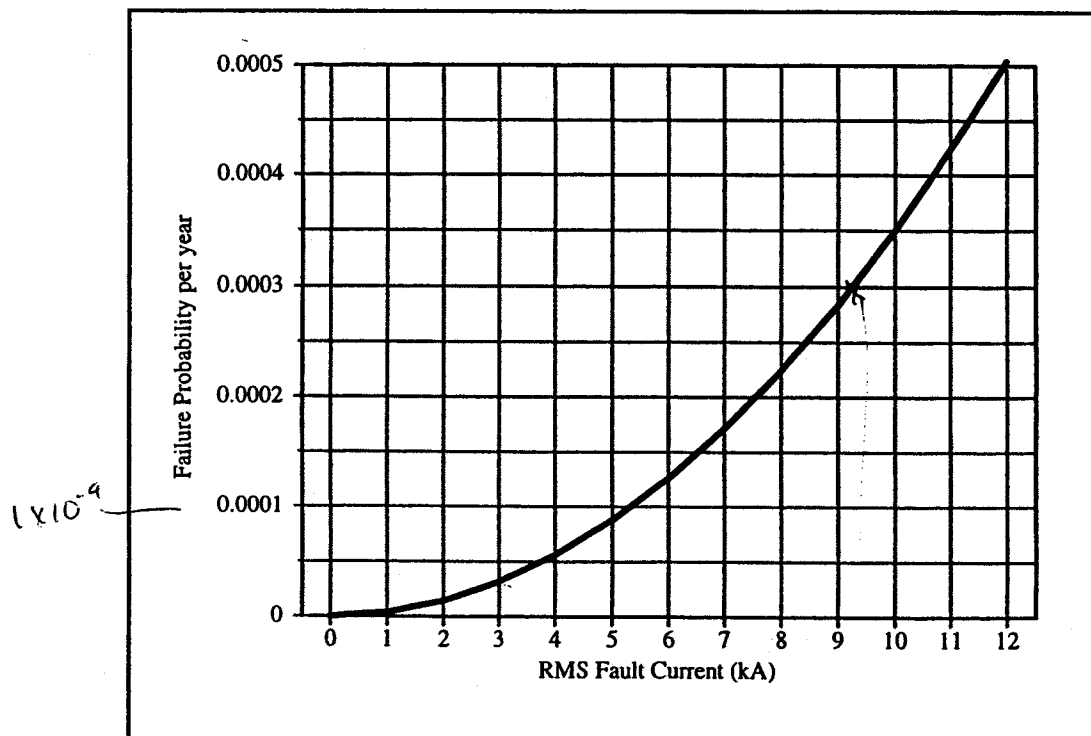
An alternative, simpler procedure, can also be derived from the test results. The graph in Figure 6 shows the effect of available fault current on probability of eventful failure. Failure probability can be estimated from Figure 6 for typical conditions (i.e. an asymmetry factor of 1.2 and a transformer failure rate of 0.03) or calculated using equation 1 for different system conditions.

Figure 6 Eventful Tank Failure Probability Vs RMS Fault Current

Figure 6 on page 17 of the report outlines the probability of an eventful failure for a particular transformer versus fault current. The probability ranges from approximately  $4 \times 10^{-5}$  at 3000 amps,  $8.6 \times 10^{-5}$  at 5000 amps to  $34 \times 10^{-5}$  at 10,000 amps.

- Step 1 Use Figure 6 (page 15) to determine the probability of eventful tank failure given available fault current (if unknown use  $5 \times 10^{-5}$  to be conservative)
- Step 2 Determine the number of hours in a year a person is within 7 m of the pole and divide by the number of hours in a year (8760).
- Step 3 Multiply the two numbers together. Is it less than  $5 \times 10^{-7}$ ? If yes, then no action is required. Note that the hours must be  $> 8$  per year for action to be required.

To illustrate the use of Figure 6 or equation 1, consider an example using typical values for the parameters. In this case, consider that a transformer with a 30 year life ( $\lambda = 0.03$ ) is installed at a location with a 5 kA fault current and AF=1.2. Using either Figure 6 or equation 1, the probability of having an eventful transformer tank failure is  $8.6 \times 10^{-5}$ . This is the lower end of the average range

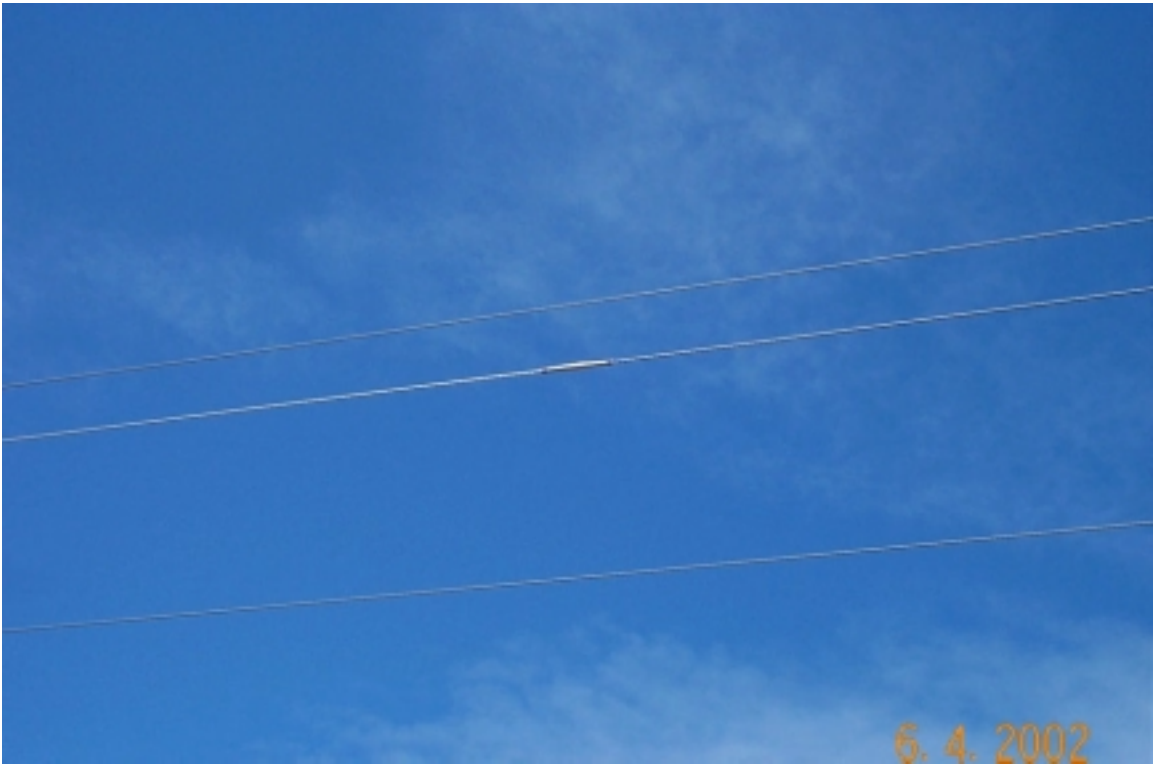
**In-service Automatic Sleeve**

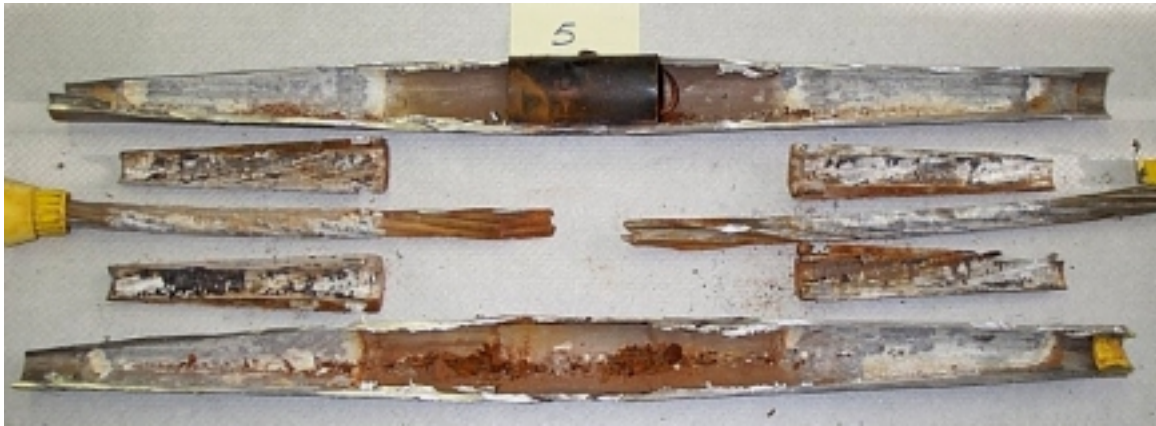
### **Automatic C Sleeve – Topsail Road**

This sleeve is a Reliable 7653 for 1/0 aluminum conductor and is date coded 93. It was removed from tap off Topsail Road, St. John's. There is severe corrosion inside the sleeve with significant salt contamination on the jaws and conductor. The spring has rusted and almost turned to powder. This is very similar to the sleeve removed from Placentia following the open neutral.

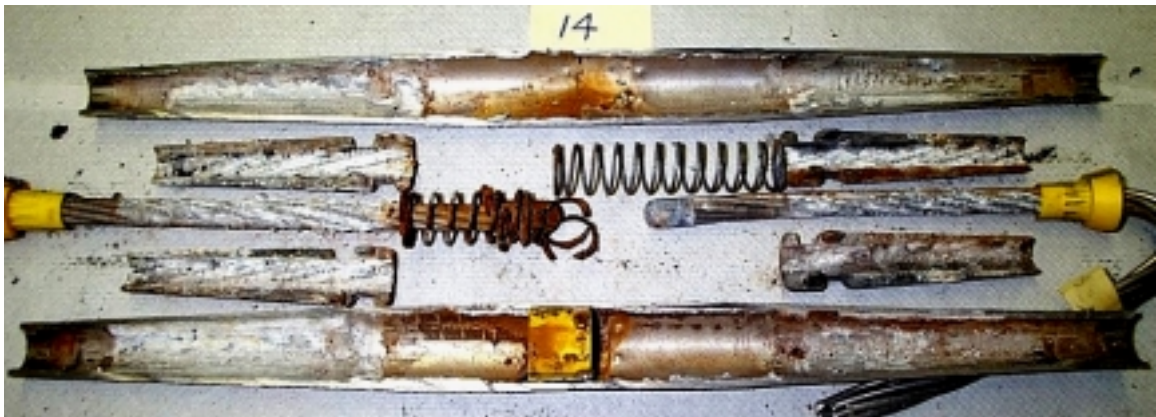
### **Automatic Sleeve - Glovertown**

This sleeve is a Fargo GL-406 for 1/0 aluminum conductor and is date coded 01 99. It was removed from Glovertown. It was installed in 1997. There is severe corrosion on the jaws and conductor. The spring and guide cap is rusted on the left.

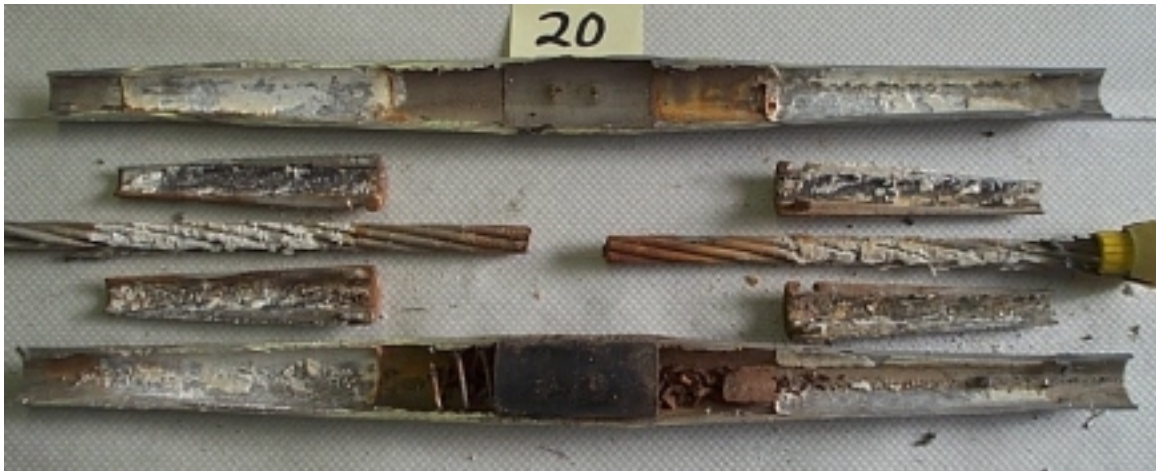
#### **Automatic Sleeve – Turk's Cove**

This sleeve is a Reliable 7653 for 1/0 aluminum conductor and is date coded 93. It was installed in Turk's Cove on NCH-02 around 1993. There is severe corrosion on the jaws and conductor. The springs have rusted away.

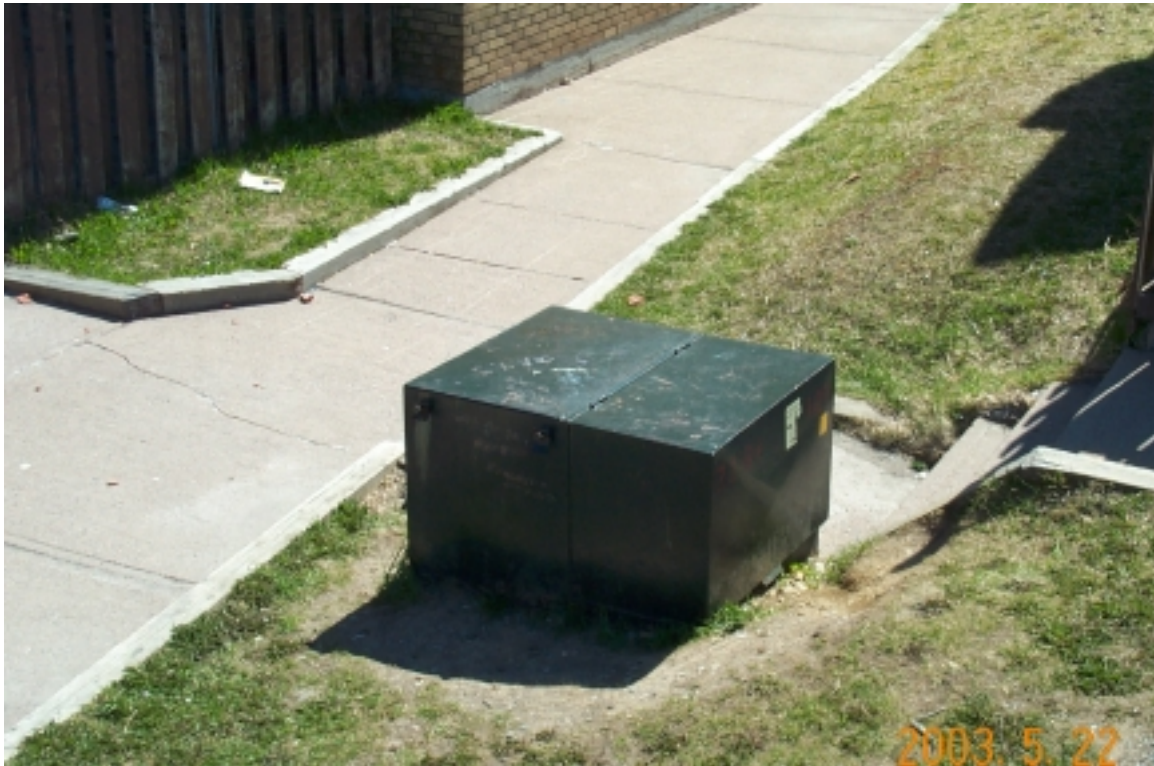
The padmount transformers installed in conjunction with the underground distribution systems in Virginia Park, Mount Pearl and Elizabeth Park are nearing the end of their 30-year lives. These transformers are exposed to service conditions that significantly shorten their useful lives including: backfilling around the base of transformers by property owners (see Figure 3), exposure to road salt and mechanical damage from snowplows or other sources.
