# **Application for Approval of Capital Projects Necessary for the Continued Operation of the Holyrood Thermal Generation Station**

An Application to the Board of Commissioners of Public Utilities

## Holyrood Supplemental Projects Overview Report

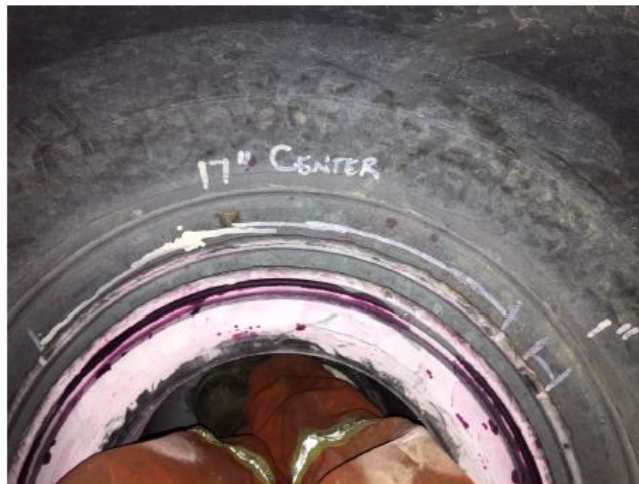
Figure 2: 17" Crack on Main Valve Seat

Holyrood TGS turbine valves are overhauled in three-year cycles based on Hydro’s historic operating experience, and in accordance with the OEM recommendations and industry standard practice. Valves undergo regular testing during operation to ensure that they are working properly. The Unit 2 turbine valves were last overhauled in 2017 by GE. During that overhaul, the service contractor identified conditions that indicated refurbishment of certain equipment was required. Examples of findings from previous valve overhaul projects are provided in Figures 1 through 4.

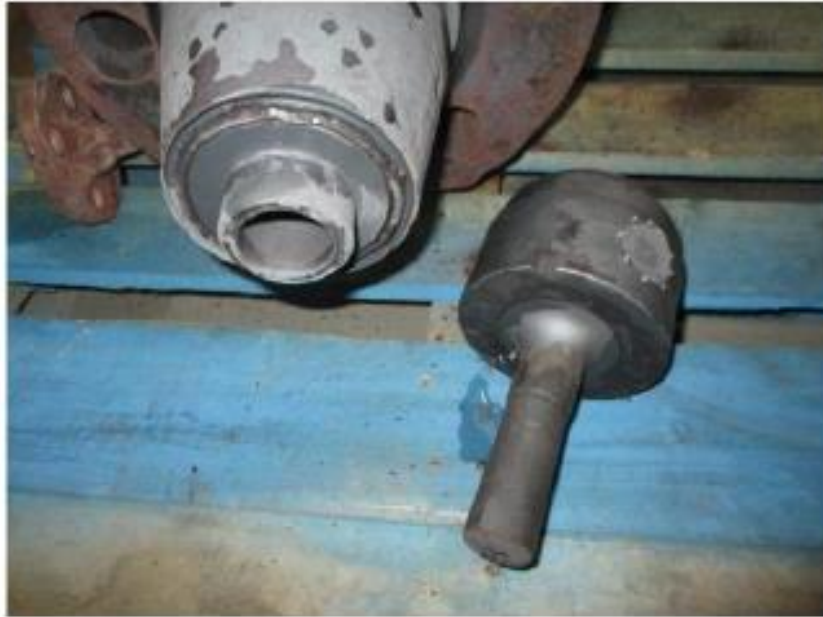
Figure 3: Control Valve with Broken Stem

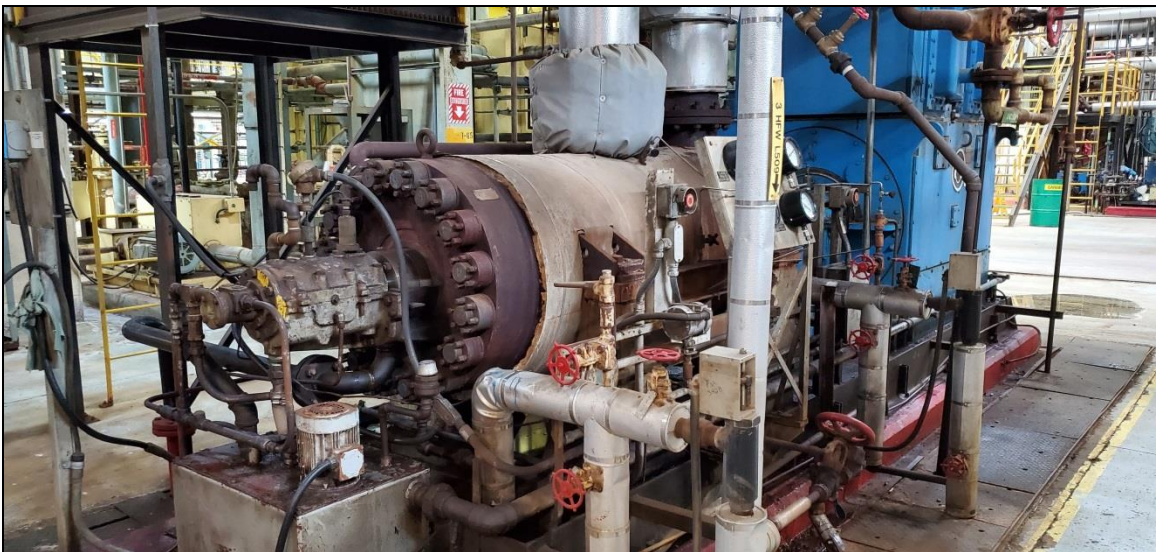
11 The Holyrood TGS Unit 3 boiler feed pump west, shown in Figure 1, was placed in service in 1980. The  
12 pump has eleven stages of impellers and is driven by a 3,000 horse power motor. It is capable of  
13 pumping 4,119 litres per minute at a pressure of 18,616 kPa. It draws feed water at a temperature of  
14 148°C before pumping it to the high pressure heaters.

**Figure 1: Unit 3 Boiler Feed Pump West**

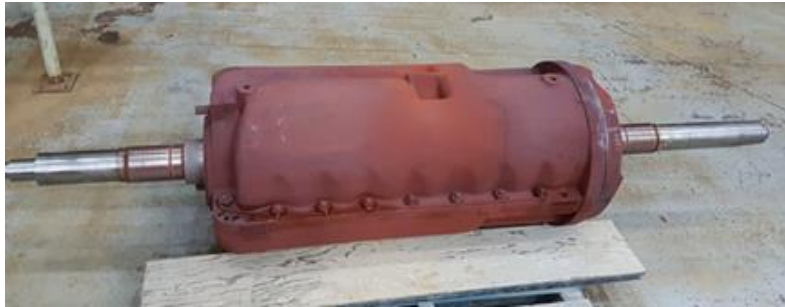
1 of the Unit 3 boiler feed pumps prior to the next winter operating season. Figure 2 shows the volute  
 2 impeller cartridge.

**Figure 2: Refurbished Volute Impeller Cartridge**

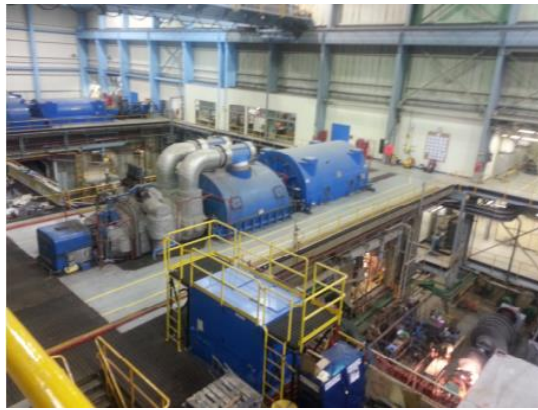
2 The three major components of the Holyrood TGS units are the power boiler, turbine, and generator.  
3 The turbine and generator are shown in Figure 1. Through combustion of No. 6 fuel oil, the power boiler  
4 provides high-energy steam to the turbine. The turbine is directly coupled (or connected) to the  
5 generator and provides the rotating energy necessary for the generator to produce rated output power.  
6 To maintain safe and reliable operation, the generators are overhauled on a six-year cycle. The last  
7 overhaul for the Unit 2 generator was in 2014. Given that its operation during the past six years has  
8 been consistent with previous overhaul cycles, an overhaul is required at this time.

**Figure 1: Holyrood TGS Unit 2 Turbine Generator**
