1 Q. **Reference: Tab 2; Volume II: Rewind Unit 3 Stator - Holyrood**

<h1 style="margin: 0;">Engineering Sheet</h1>		Doc. No.	GAE-2019-0063	Rev.	0
		Date: 2019-01-31			
Customer Newfoundland and Labrador Hydro (HFLH)		Department/Section Hitachi Power Systems Service Department Generator Global Service Engineering Group			
Project Holyrood Thermal Generating Station Unit #3 Generator		Prepared <i>R.Umezu</i>			
Subject Estimation of residual lifetime of stator windings		Checked <i>D.Lunney</i>			
		Approved <i>S.Muramatsu</i>			
		PM			
		Relevant Section			
		Subcontractor

Doc. No. **GAE-2019-0063**

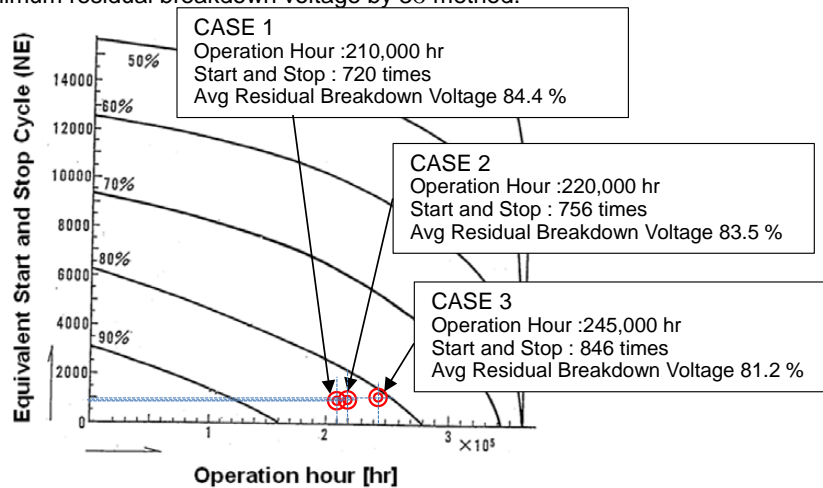
Using insulation deterioration test data of each deterioration factor, we developed the NY Map shown in Figure 3. The graph is based on average value of each deterioration test data, and Figure 3 shows "Average Residual Breakdown Voltage". A generator is composed of many coils and **residual life is determined by the weakest coil**. We, therefore, should estimate the weakest bars residual breakdown voltage.

Figure 3: NY map of Epoxy Resin Insulation System

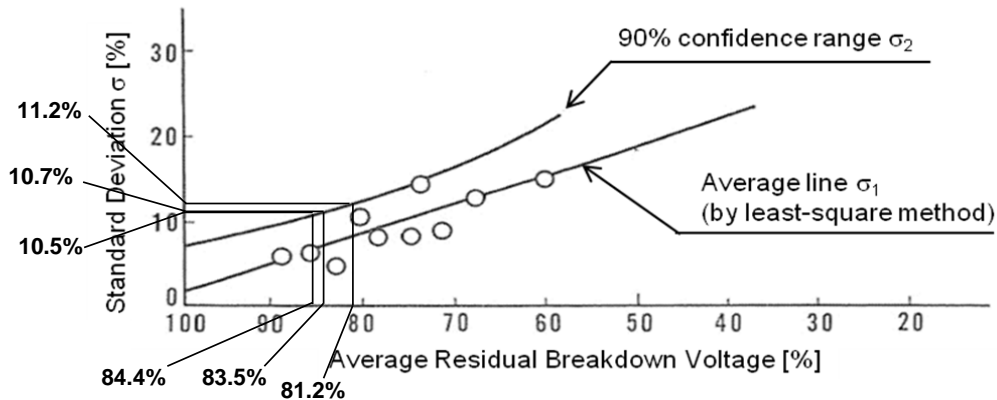
In order to estimate the weakest bars residual breakdown voltage, MHPS utilizes the relationship between the average residual breakdown voltage and standard deviation (Figure 4). Figure 4 is based on sampling coils test result which have been accumulated over extensive years of testing. In the Figure 4, we first determine average line σ₁, and determine 90% confidence range σ₂. Then, we estimate minimum residual breakdown voltage by 3σ method.

Figure 4: Relation between Average BDV and Standard Deviation
