**Re: Application for Approval of Capital Expenditures for Section Replacement and Weld Refurbishment for Bay d'Espoir Hydroelectric Generating Facility Penstock 1 – Penstock Lining Assessment**

# Attachment 1

Bay d'Espoir – Penstock Lining Assessment & OPCC  
Front End Engineering and Design (2670034.01)

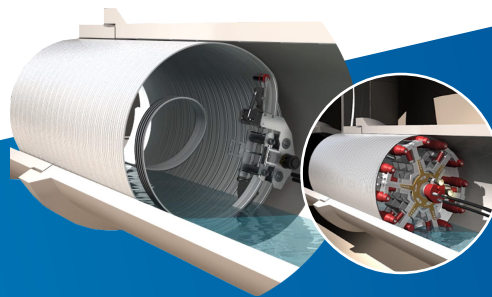
# INSTALLATIONS

*For installations, a continuous strip of PVC is fed from a spool above ground into the winding machine. From there, the machine continuously winds the profile to construct the PVC liner within the host pipe. We offer 3 different winding methods based upon the host pipe.*

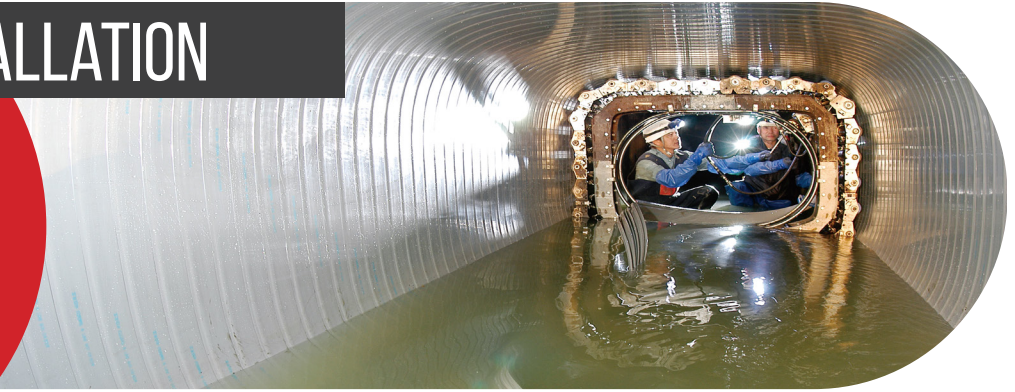
# LIVE FLOW INSTALLATION

Bypass pumping often reaches 15% - 25% of the total project bid. As Spiral Wound liners can be installed in live flow, the cost of flow management is often eliminated if not significantly reduced.

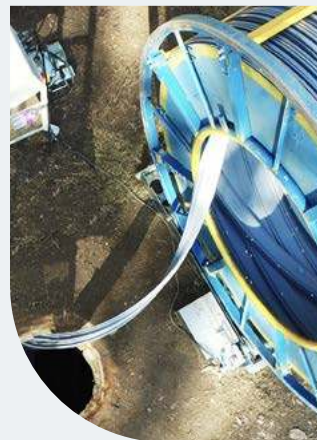
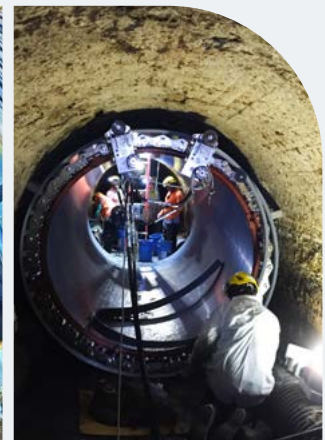
## Installation

A steel-reinforced PVC profile strip is wound into the pipe by a traverse winding machine. The machine travels the length of the pipeline while constructing the liner at a fixed diameter. Grout is then introduced to fill the annular space; either part of the structural liner or just as a gap filler to uniformly transfer loads onto the liner. Grout type depends upon dimensions of the pipe and overall project conditions.

SPR™ is a Spiral Wound pipe lining method for large diameter sewers, storm drains and culverts. SPR™ lines both round and non-round shapes, providing fully structural rehabilitation. The machine travels the length of the pipeline while constructing the liner at a fixed diameter.
