Newfoundland and Labrador Hydro

Condition Assessment Final Report

Condition Assessment of Ten Diesel Plants

H333005-0000-10-236-0001

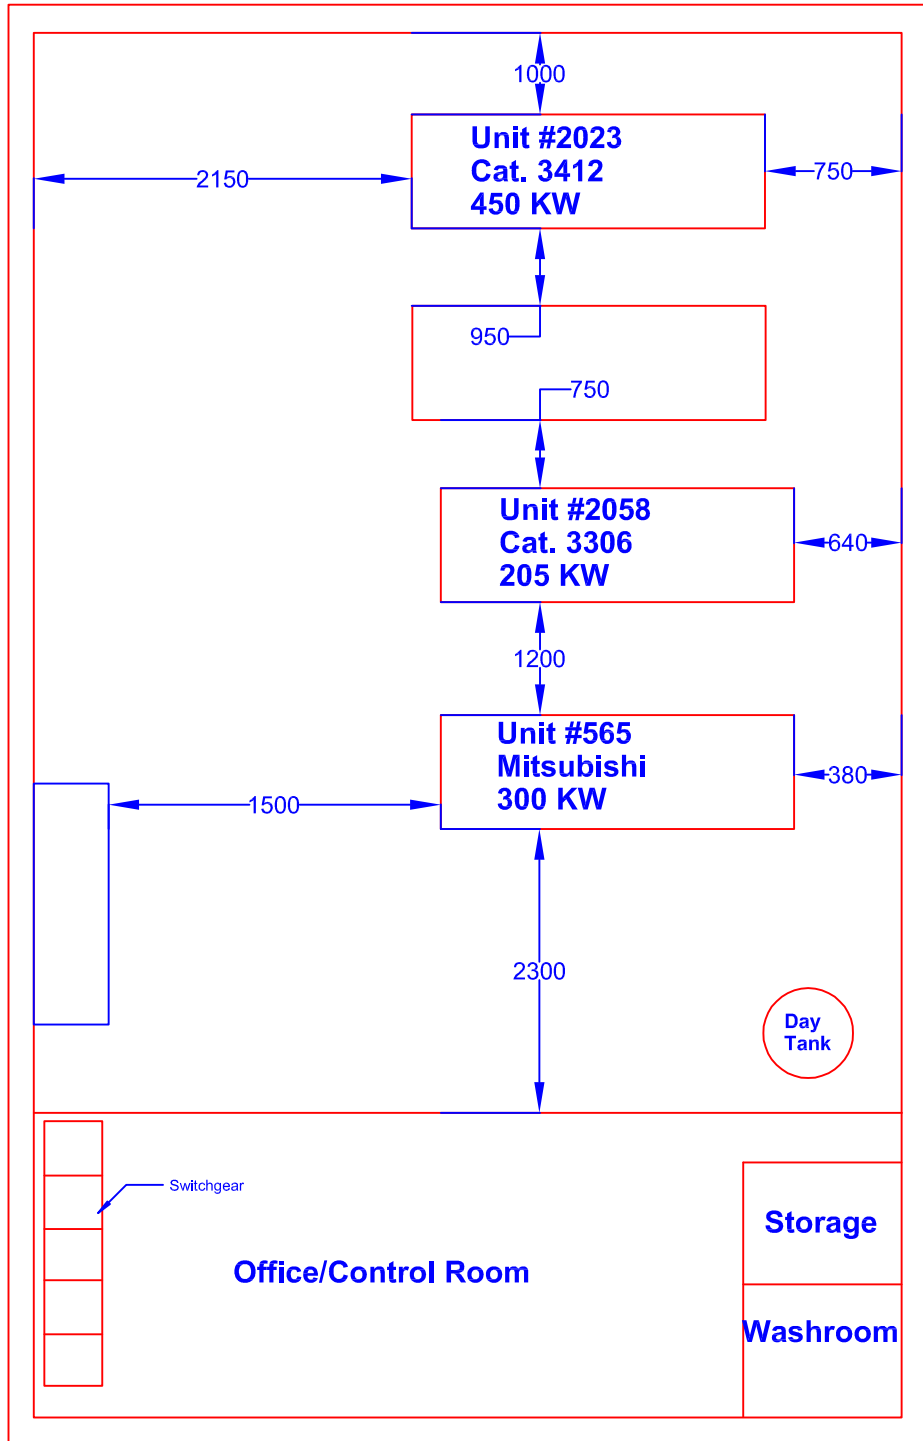
1. There is a Mobile at this site - Caterpillar 3412, 450 KW
2. This is permanent to replace Unit #297 inside the plant.
