RE: Rolling 12 Month Performance of Hydro's Generating Unit Reports

**QUARTERLY REPORT
ON
PERFORMANCE OF GENERATING UNITS
FOR THE QUARTER ENDED SEPTEMBER 30, 2015**

NEWFOUNDLAND AND LABRADOR HYDRO

October 19, 2015

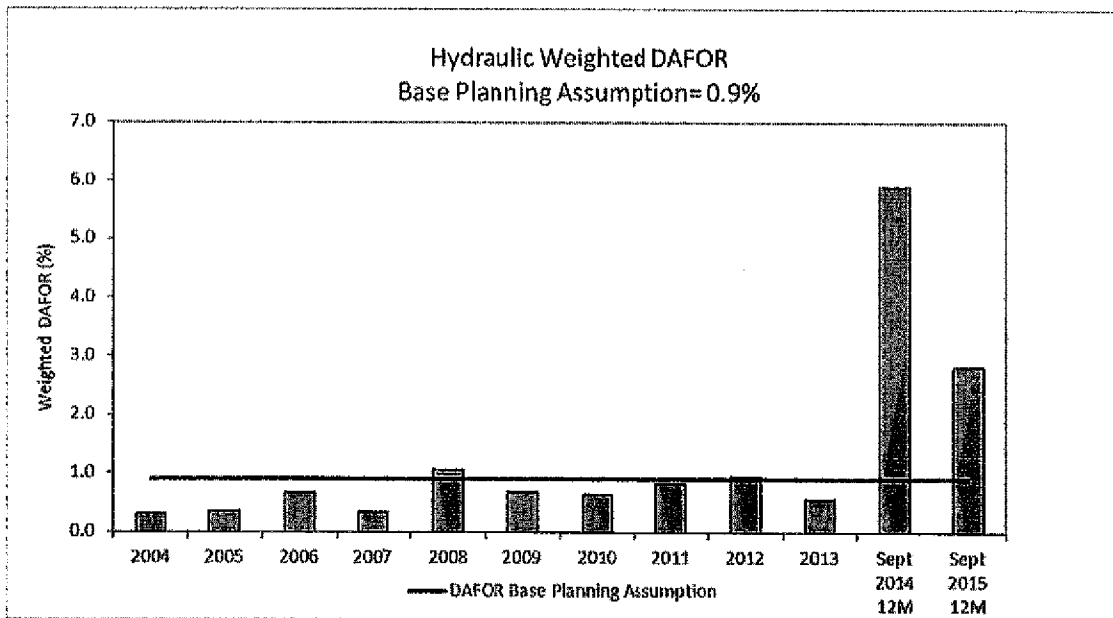
Generating Unit	Maximum Continuous Unit Rating (MW)	12 months ending September 2014 (%)	12 months ending September 2015 (%)	Hydro Generation Base Planning Assumption (%)
<i>All Hydraulic Units - weighted</i>	954.4	5.89	2.82	0.90
Hydraulic Units				
Bay D'Espoir 1	76.5	0.03	25.6	0.90
Bay D'Espoir 2	76.5	3.04	0.00	0.90
Bay D'Espoir 3	76.5	0.00	0.00	0.90
Bay D'Espoir 4	76.5	0.75	0.23	0.90
Bay D'Espoir 5	76.5	0.19	2.46	0.90
Bay D'Espoir 6	76.5	58.59	0.00	0.90
Bay D'Espoir 7	154.4	2.08	0.00	0.90
Hinds Lake	75	0.11	0.32	0.90
Upper Salmon	84	1.27	0.98	0.90
Granite Canal	40	1.53	1.51	0.90
Cat Arm 1	67	0.00	0.63	0.90
Cat Arm 2	67	1.39	1.42	0.90
Paradise River	8	0.65	0.19	0.90

1 The weighted "All Hydraulic Units" DAFOR was 2.82% for the current 12 month period
2 ending September 30, 2015. The forced outage and derating of Unit 1 at Bay d'Espoir was
3 the primary contributor to the DAFOR of 2.82% as compared to a base planning assumption
4 of 0.9%.

11 The Bay d'Espoir Unit 1 DAFOR of 25.6% compared to the base planning assumption of 0.9%
12 was the result of a forced extension of a planned outage. The planned annual maintenance
13 was scheduled from April 26 to May 15, 2015. The extension is the result of having to
14 replace the turbine bearing. It was identified in the annual work plan to check the turbine
15 bearing clearances due to an increase in bearing temperatures. The bearing clearances were
16 checked and damage was found to the turbine bearing, so it was replaced with a new
17 bearing. Vibration issues continued with the unit after the bearing was replaced, which
18 extended the planned outage. Two vibration experts, Hydro staff, as well as the Original
19 Equipment Manufacturer were involved in troubleshooting the issue, with the unit
20 eventually being returned to service at reduced capacity. The original turbine bearing was
21 reinstalled after being refurbished (with reduced clearances), and while the vibration issue

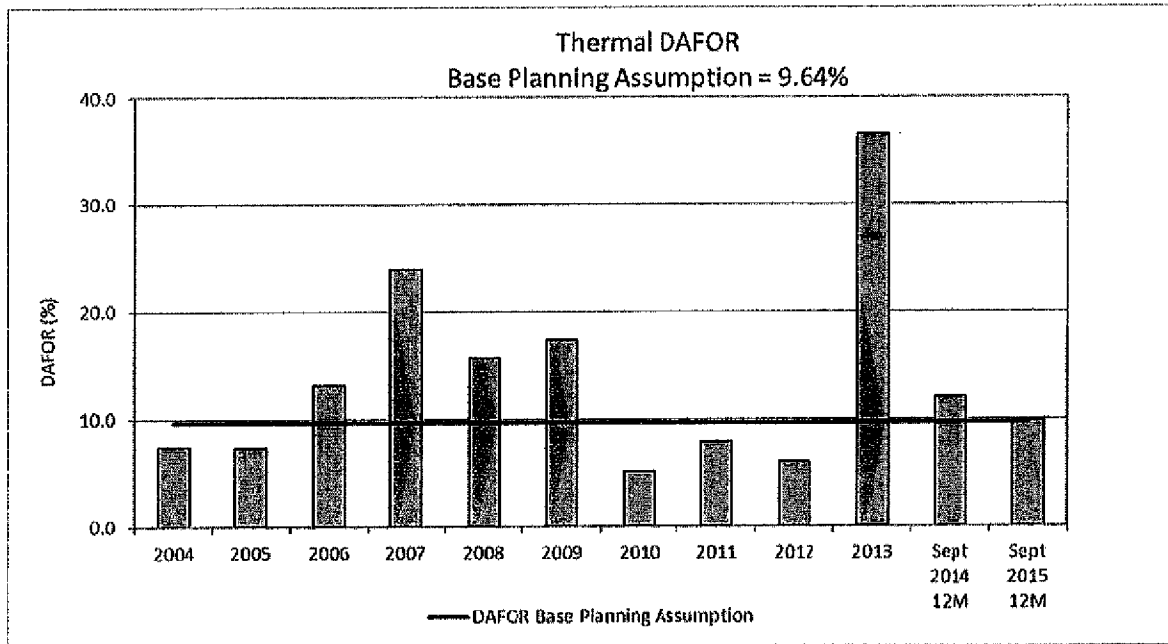
Generating Unit	Maximum Continuous Unit Rating (MW)	12 months ending September 2014 (%)	12 months ending September 2015 (%)	Hydro Generation Base Planning Assumption (%)
<i>All Thermal Units - weighted</i>	490	12.00	9.86	9.64
Thermal Units				
Holyrood 1	170	16.73	12.22	9.64
Holyrood 2	170	6.53	7.15	9.64
Holyrood 3	150	11.65	10.08	9.64

11 For the 12-month period ending September 30, 2015, the weighted all thermal units DAFOR
 12 of 9.86% was not materially different than the assumed Hydro generation base planning
 13 DAFOR value of 9.64%, and improved compared to the previous 12-month period rate of
 14 12.00%. The variance compared to plan in the current period was primarily attributable to

1 an exceedance for Unit 1 DAFOR. Unit 2 performance, at 7.15%, was better than the base
2 planning assumption of 9.64%. Unit 3 DAFOR improved compared to that of the previous
3 period of 11.65% and finished the current period at 10.08% compared to a plan of 9.64%.

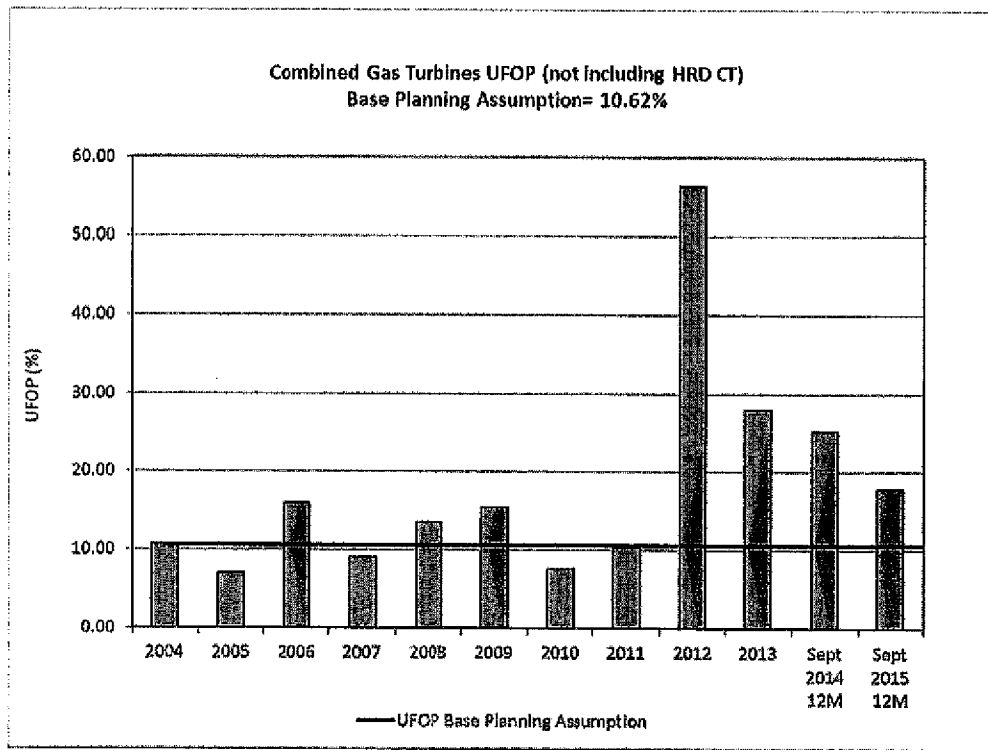
Combustion Turbine Units	Maximum Continuous Unit Rating (MW)	12 months ending September 2014 (%)	12 months ending September 2015 (%)	Hydro Generation Base Planning Assumption (%)
Holyrood CT*	123.5		5.01	5.00

*data presented from March to September 2015 only

3 The combined gas turbines UFOP base planning assumption was exceeded in the current
 4 period primarily due to the Hardwoods and Stephenville gas turbines' UFOP.
