1 **Q. (response to CA-NP 14) How does NP decide if the next increment of cost to**  
2 **improve reliability is of value to consumers? Please provide an actual example.**

12  
13 The Company's Distribution Reliability Initiative (the "DRI") is directly focused at  
14 improved distribution reliability and is an actual example (on a policy level) of how  
15 Newfoundland Power decides whether investment in reliability is justified.

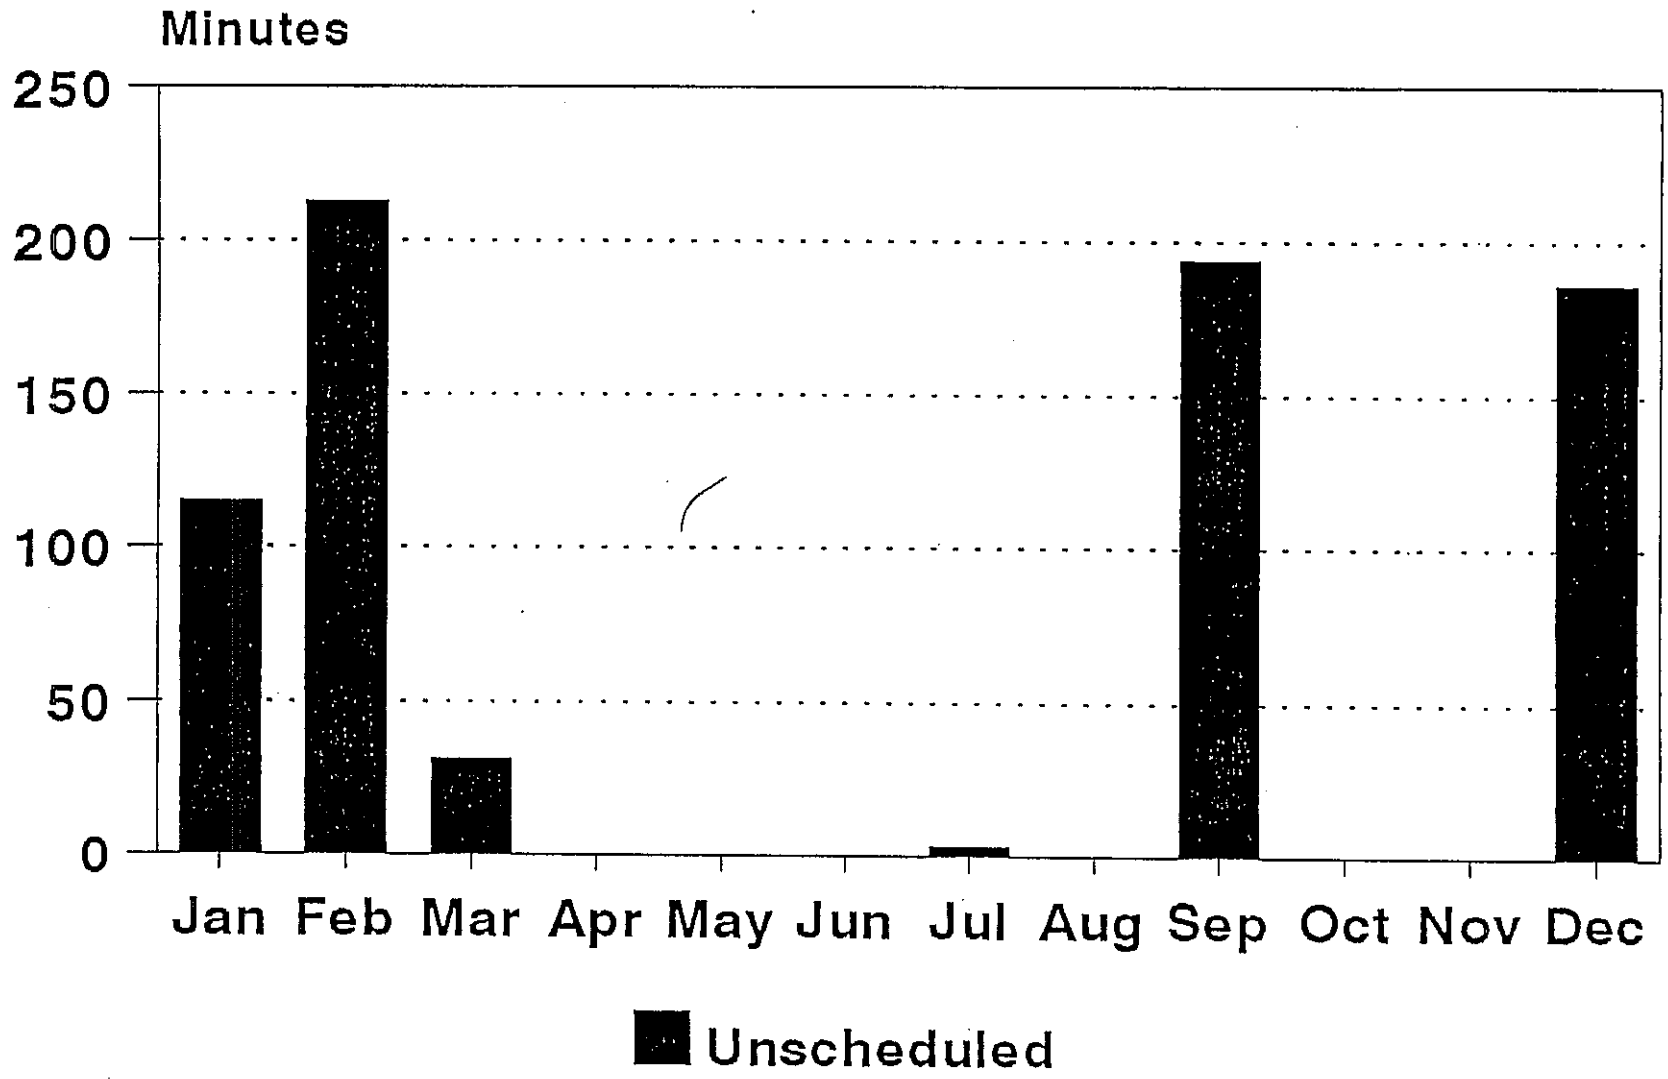
Fig. # 5 (Excludes the Dec. 08 outage)

# Average Duration of Interruptions Branch, 1994

Also provided are graphic depictions of the frequency, average duration and total interruption time for 1994 interruptions by month (Figure 4, 5 & 6). From these it can be seen that January and December had the highest number of unscheduled interruptions. This is due to the weather conditions at that time of year. High winds combined with icing place extra loading on the line.
