**Re: Newfoundland and Labrador Hydro - The Board's Investigation and Hearing into  
Supply Issues and Power Outages on the Island Interconnected System – Rolling 12  
Month Performance of Hydro's Generating Units**

Quarterly Report on Performance of Generating Units  
For the Quarter ended September 30, 2018

*A Report to the Board of Commissioners of Public Utilities*

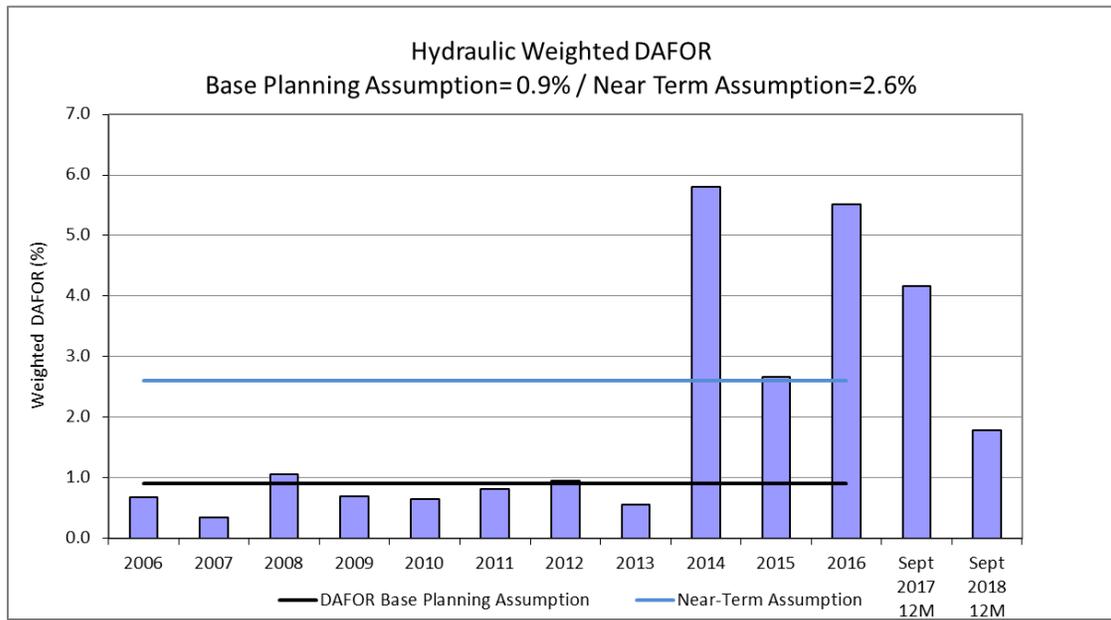
**Figure 1: Hydraulic Weighted DAFOR**

1 Considering the individual units' performance, the assumed Hydro generation base planning  
2 DAFOR was materially exceeded for Bay d'Espoir Unit 1 and Bay d'Espoir Unit 2.<sup>10</sup> Also, Cat Arm  
3 Unit 1 exceeded the base planning assumption for the current period.

4  
5 The Bay d'Espoir Unit 1 DAFOR of 8.24%<sup>11</sup> and Unit 2 DAFOR of 11.66%<sup>12</sup> exceeded the base  
6 planning assumption of 0.9% and the near-term assumption of 3.9% for an individual Bay  
7 d'Espoir unit. This was due to Units 1 and 2 being removed from service on November 4, 2017  
8 as a result of a leak in Penstock 1, which provides water to both units. A consultant and  
9 contractor were engaged in the process to provide recommendations for refurbishment, and to  
10 return the penstock to reliable service. The penstock was returned to service on  
11 December 8, 2017. Hydro received the final root cause report and is implementing the findings,  
12 including the execution of condition assessment work approved by the Board in P.U. 23(2018).  
13 The 2018 condition assessment, field inspection component, of the three Bay d'Espoir  
14 penstocks is now complete. Hydro is working with its consultant on a detailed report that will

13  
14 Note that the data for 2006 to 2016 in Figures 1 through 7 are annual numbers (January 1 to  
15 December 31), while the data for 2017 and 2018 are 12-month rolling numbers (October 1 to  
16 September 30 for each year).

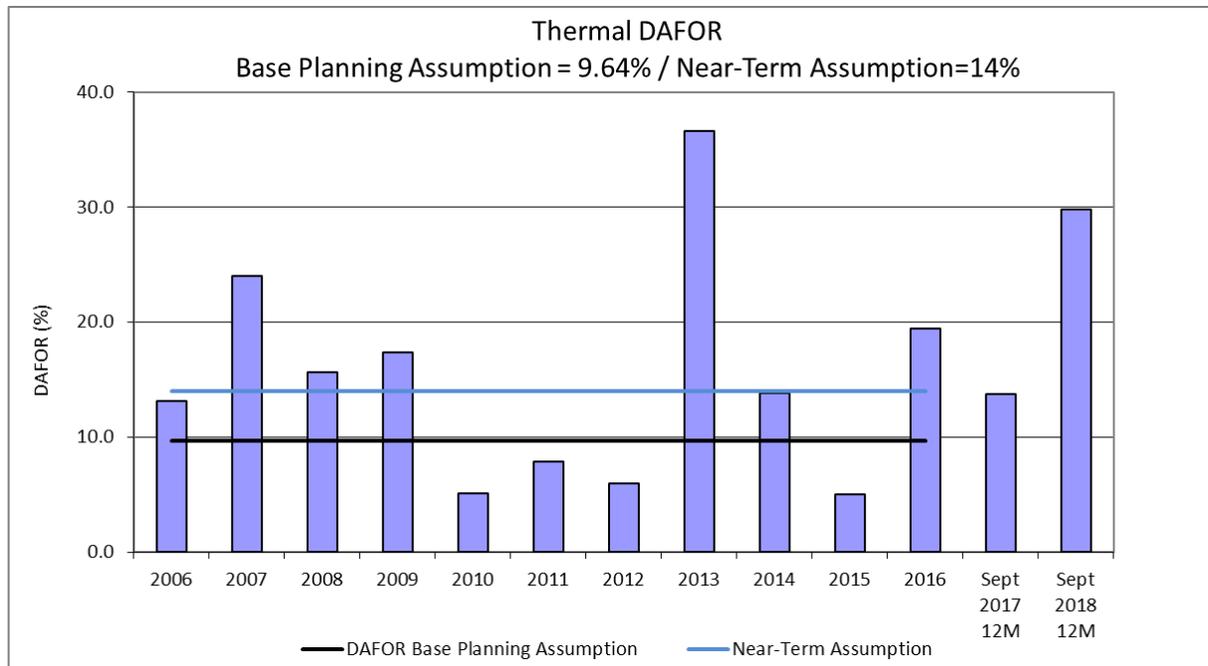
**Figure 2: Thermal DAFOR**

1 For the 12-month period ending September 31, 2018, the weighted DAFOR for all thermal units  
2 of 29.77%<sup>13</sup> is above the assumed Hydro generation base planning DAFOR value of 9.64%, and  
3 the near-term assumption of 14.00%. Unit 1 DAFOR was 35.49% and Unit 2 DAFOR was 30.64%.  
4 The performance for both Units 1 and 2 was above the base planning assumption of 9.64% and  
5 the near-term assumption of 15% (Unit 1) and 10% (Unit 2). Unit 3 DAFOR was 18.17%, which is  
6 above the base planning assumption of 9.64% and the near-term assumption of 18.0%.

4  
5 For the Holyrood thermal units, the forced outage rate of the current period ending September  
6 2018 is 29.77%<sup>4</sup>, which is above the base planning assumption of 9.64%, the sensitivity of  
7 11.64% (refer to Section 3), and above the near-term planning assumption of 14.00%.<sup>7</sup> This is  
8 primarily caused by an airflow derating on Unit 1 and Unit 2 that continued in 2017 and 2018  
9 and an extended forced outage on Unit 1 in February 2018.

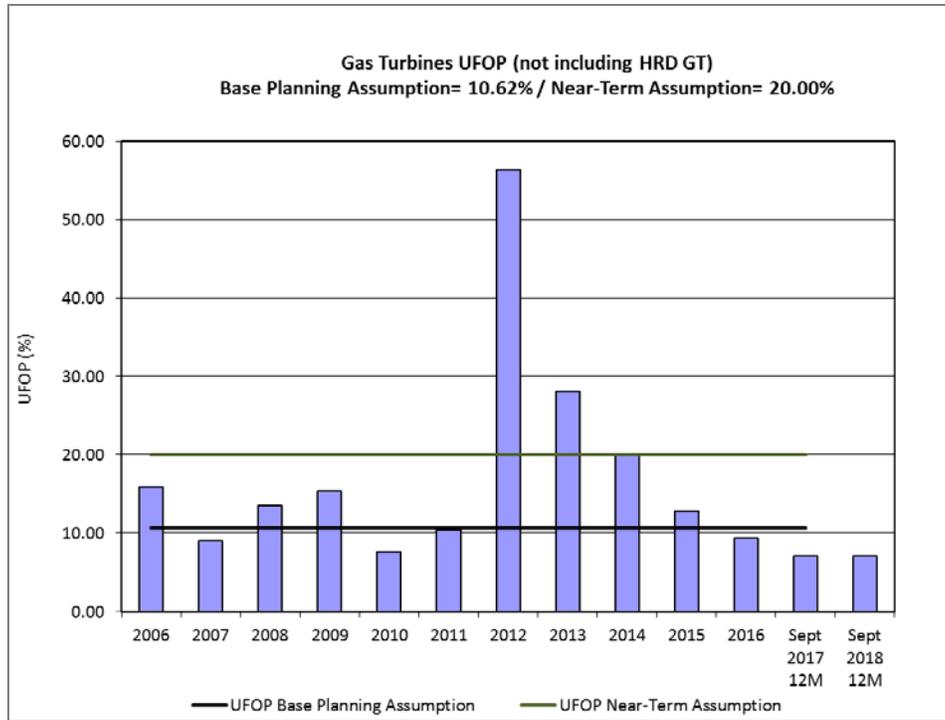
**Figure 3: Gas Turbine UFOP – Hardwoods/Happy Valley/Stephenville Units**

8 The combined UFOP for the Hardwoods, Happy Valley and Stephenville gas turbines was 7.03%  
 9 for the 12-month period ending September 30, 2018 (see Table 6 and Figure 3). This is below  
 10 the base planning assumption of 10.62%, and the near-term assumption of 20.00%. The current  
 11 period UFOP was essentially the same as the previous period UFOP of 7.06%. The Hardwoods  
 12 UFOP for the current period is 3.19%, which is better than the base planning assumption of  
 13 10.62%. The Stephenville UFOP for the current period is 4.95%, which is better than the base  
 14 planning assumption of 10.62%. Happy Valley's UFOP is 15.39% for the current period, which is  
 15 above the base planning assumption of 10.62%.

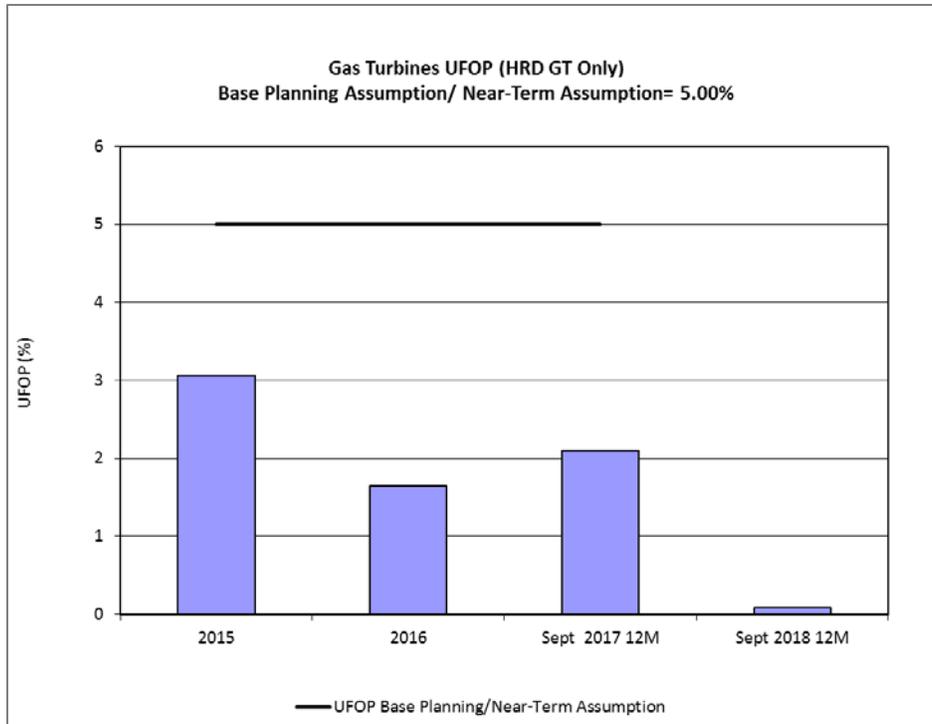
Figure 4: Gas Turbine UFOP – Holyrood Unit

- 1 The Holyrood (HRD) GT UFOP of 0.08% for the current period is better than the base and near-
- 2 term planning assumptions of 5.00% (see Table 7 and Figure 4).

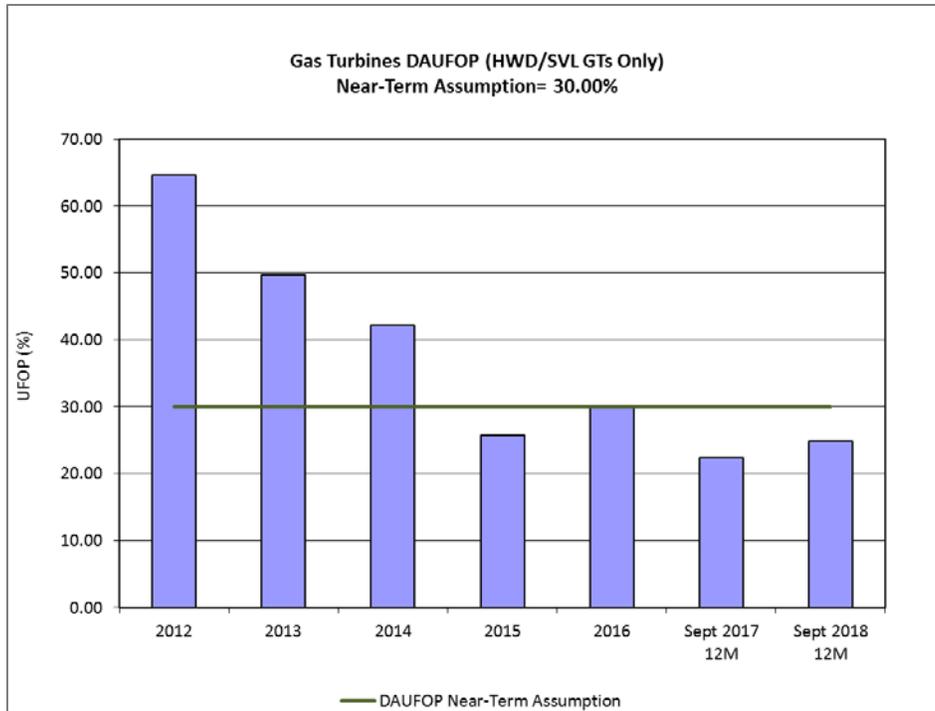
**Figure 5: Gas Turbine DAUFOP – Hardwoods/Stephenville Units**

2 The combined DAUFOP for the Hardwoods and Stephenville gas turbines was 24.83% for the  
 3 12-month period ending September 30, 2018 (refer to Table 8 and Figure 5). This is below the  
 4 near-term planning assumption of 30.00%. The Hardwoods DAUFOP for the current period is  
 5 14.47%, which is better than the near-term planning assumption of 30.00%. The Stephenville  
 6 UFOP for the current period is 51.20%, which is above the near-term planning assumption of  
 7 30.00%.

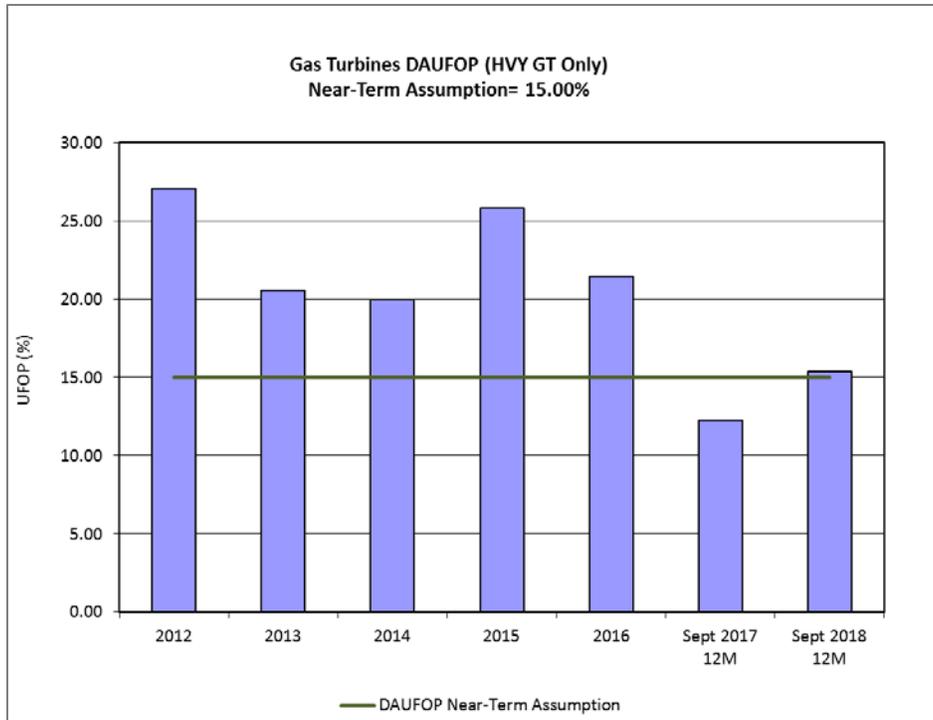
**Figure 6: Gas Turbine DAUFOP – Happy Valley Unit**

- 1 The DAUFOP for the Happy Valley gas turbine was 15.39% for the 12-month period ending
- 2 September 30, 2018 (refer to Table 9 and Figure 6). This is above the near-term planning
- 3 assumption of 15.00%.

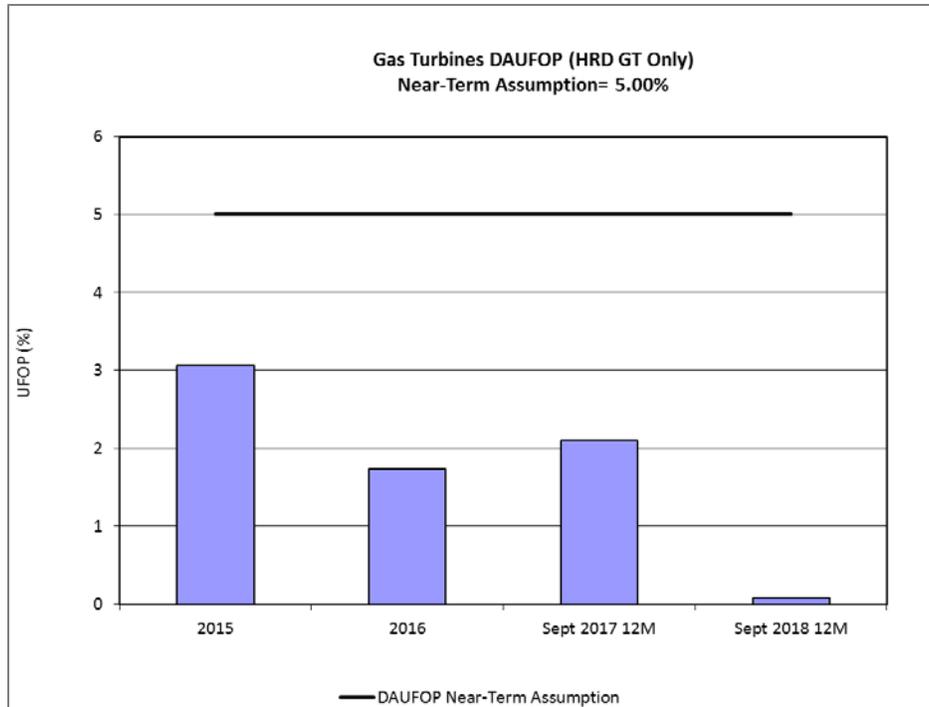
**Figure 7: Gas Turbine DAUFOP – Holyrood Unit**

- 1 The Holyrood gas turbine DAUFOP of 0.08% for the current period is better than the near-term
- 2 planning assumption of 5.00% (see Table 10 and Figure 7).
