**A REPORT TO
THE BOARD OF COMMISSIONERS OF PUBLIC UTILITIES**

**QUARTERLY REPORT
ON
PERFORMANCE OF GENERATING UNITS
FOR THE QUARTER ENDED DECEMBER 31, 2016
NEWFOUNDLAND AND LABRADOR HYDRO**

January 16, 2017

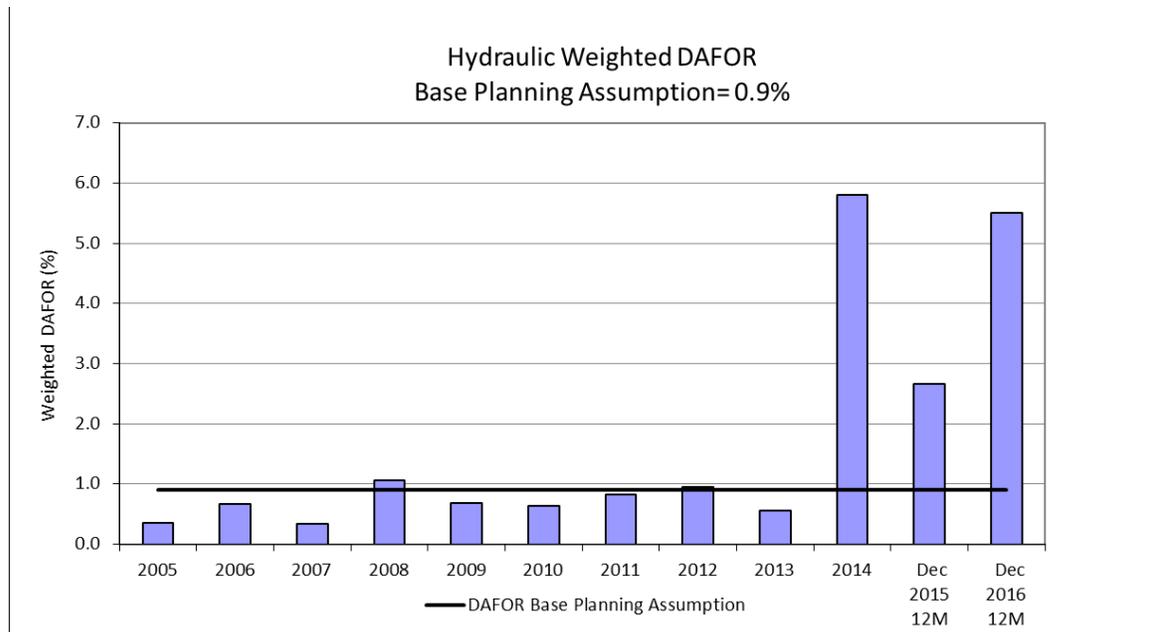
2 Considering the individual units performance, the assumed Hydro generation base planning DAFOR
3 was materially exceeded for Bay d’Espoir Unit 1 and Bay d’Espoir Unit 2. Also, there were
4 exceedances compared to base planning assumption for Granite Canal, Cat Arm Unit 1 and Paradise
5 River for the current period.

7 The Bay d’Espoir Unit 1 DAFOR of 30.87% and Unit 2 DAFOR of 33.90%, compared to the base
8 planning assumption of 0.9% were impacted by the units being removed from service on two
9 separate occasions as a result of a leak in Penstock 1, which provides water to both Units 1 and 2.
10 The first event occurred on May 21, 2016. A consultant was engaged to conduct an investigation into
11 the issue, which contributed the leak to a localized issue caused by, what was suspected to be, a
12 defect at the weld. A repair procedure was provided on June 2, 2016, with repairs carried out and
13 completed on June 3, 2016. Unit 1 was returned to service on June 3, 2016, at 1938 hours and Unit 2
14 returned to service a short time later at 2014 hours.

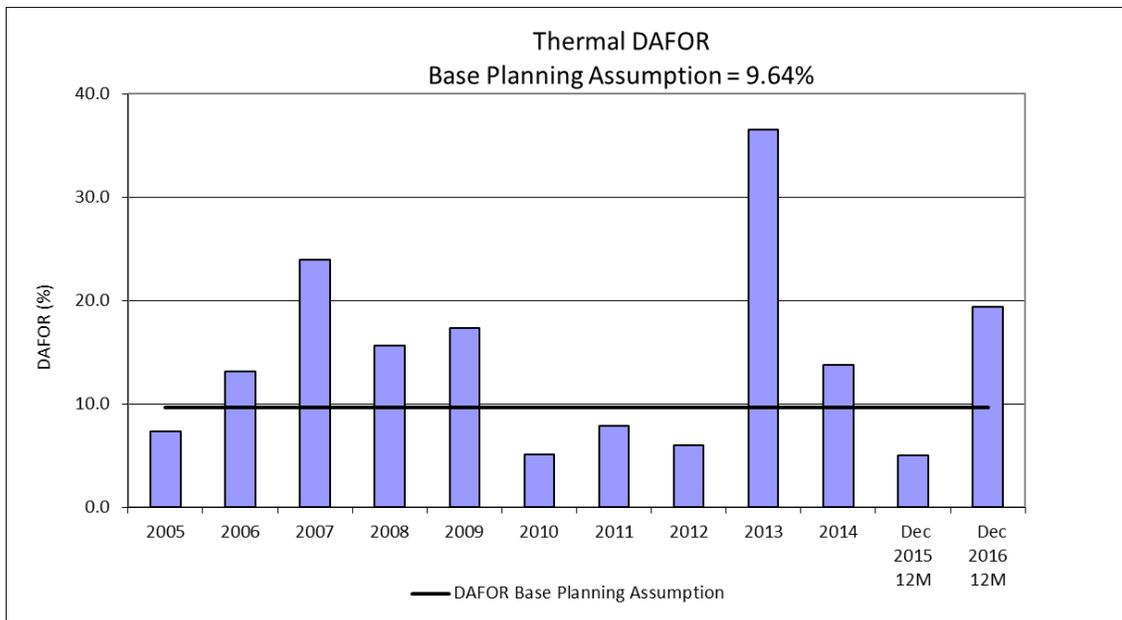
Generating Unit	Maximum Continuous Unit Rating (MW)	12 months ending December 2015 (%)	12 months ending December 2016 (%)	Hydro Generation Base Planning Assumption (%)
All Thermal Units - weighted	490	5.04	19.42	9.64
Thermal Units				
Holyrood 1	170	4.94	24.55	9.64
Holyrood 2	170	1.89	26.69	9.64
Holyrood 3	150	9.37	2.41	9.64

1 For the 12-month period ending December 31, 2016, the weighted DAFOR for all thermal units, of
2 19.42% is above the assumed Hydro generation base planning DAFOR value of 9.64%, and also
3 exceeded the previous 12-month period rate of 5.04%. Unit 1 DAFOR was 24.55% and Unit 2 DAFOR
4 was 26.69%, and the performance for both units was above the base planning assumption of 9.64%.
5 Unit 3 DAFOR was 2.41%, which is better than the base planning assumption of 9.64%. It is
6 estimated that approximately half of the 19.42% DAFOR for the plant in 2016 is due to deratings and
7 complications from the boiler tubes.
