**Re: Reliability and Resource Adequacy Study Review – Additional Considerations of the Labrador-Island Link Reliability Assessment and Outcomes of the Failure Investigation Findings**

## **Reliability and Resource Adequacy Study**

### **Additional Considerations of the Labrador-Island Link Reliability Assessment and Outcomes of the Failure Investigation Findings**

Assessment of Labrador Island Transmission Link (LIL) Reliability in Consideration of Climatological Loads-Phase II Haldar & Associates Inc. November 2021

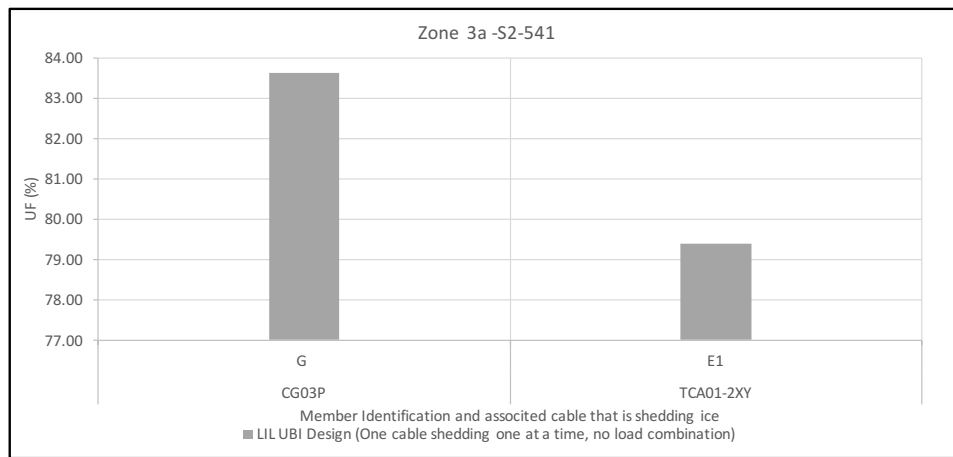
Figure 2.2 (b) - S2-541 (Members Identification and UF) For LIL Design UBI (No Load Combination)

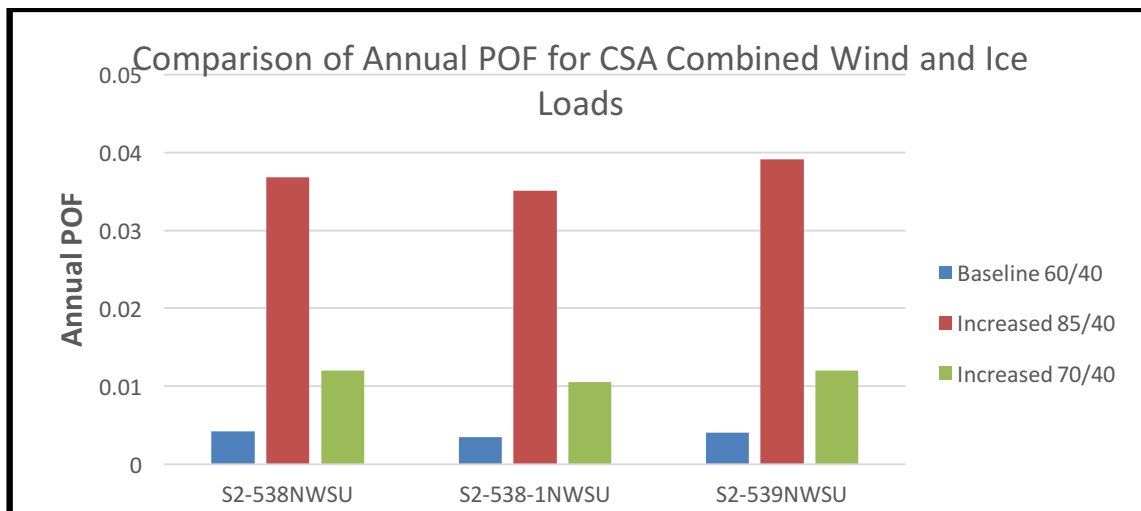
214 Figure 2.4 presents the annual POF of three towers in Section 3a for two CSA combined loads and  
215 one intermediate load that was selected by NLH. This comparison is for CSA combined loads without  
216 topography consideration (no wind speed up, NWSU). The annual POF can vary between 0.4% to  
217 4% for 60%/40%, 70%/40% and 85%/40% load combinations for wind plus ice loads. The factor  
218 60% is applied to reference wind speed and 40% applied to vertical cable ice load. Figure 2.5 presents  
219 the screenshot for two load cases and shows the members (mostly leg members) where members'  
220 capacities have been exceeded significantly under CSA 60826-10 increased load combination (85/40).  
221 All these mast members are under severe compressive loads and significantly above the design capacity  
222 (very high use factors) that could lead to mast failure.

225 **Figure 2.4 - Impact of CSA Load Combination on Annual Probability of Failures of Structures in**  
226 **Zones 3a (Glaze Ice Section)**

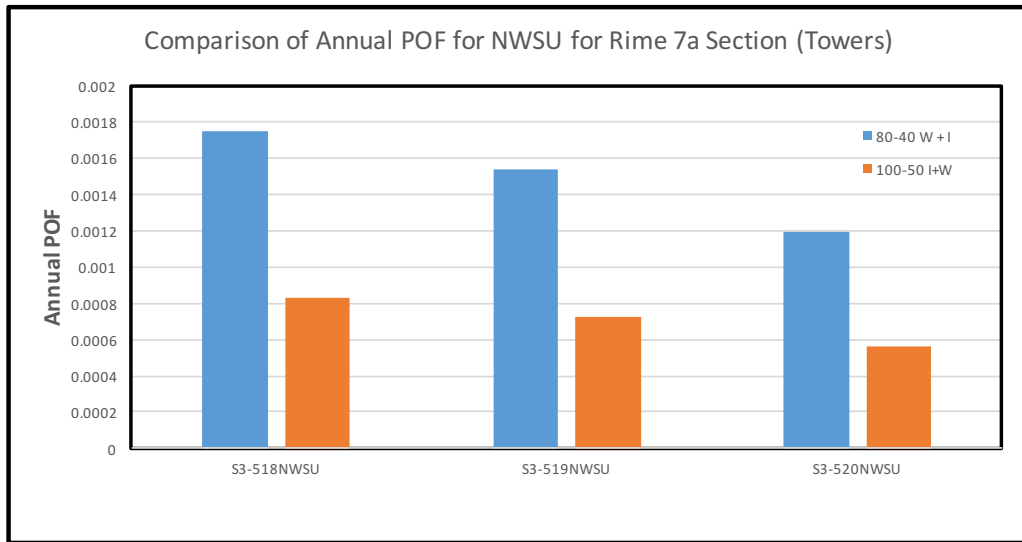
250  
 251 **Figure 2.7 - Impact of CSA Load Combination on Annual Probability of Failure of Structures in**  
 252 **Zone 7a (Rime Ice Section)**  
 253

Figure 2.6 presents the annual POF comparison for “wire support system” in section 3a while Figures 2.7 and 2.8 presents the similar comparison for “structure support system” and “wire support system” in Section 7a (rime ice section) respectively. It is to be noted that all rime ice section it is only two load cases for combined loads: (A) 100% full ice load and 50% of reference wind speed and (B) 80% reference wind speed and 40% of full ice load. The load case A is like the increased load referred in CSA 60826-10 (upper limit of reference wind) but the Case B considers only 80% not 85%. The earlier

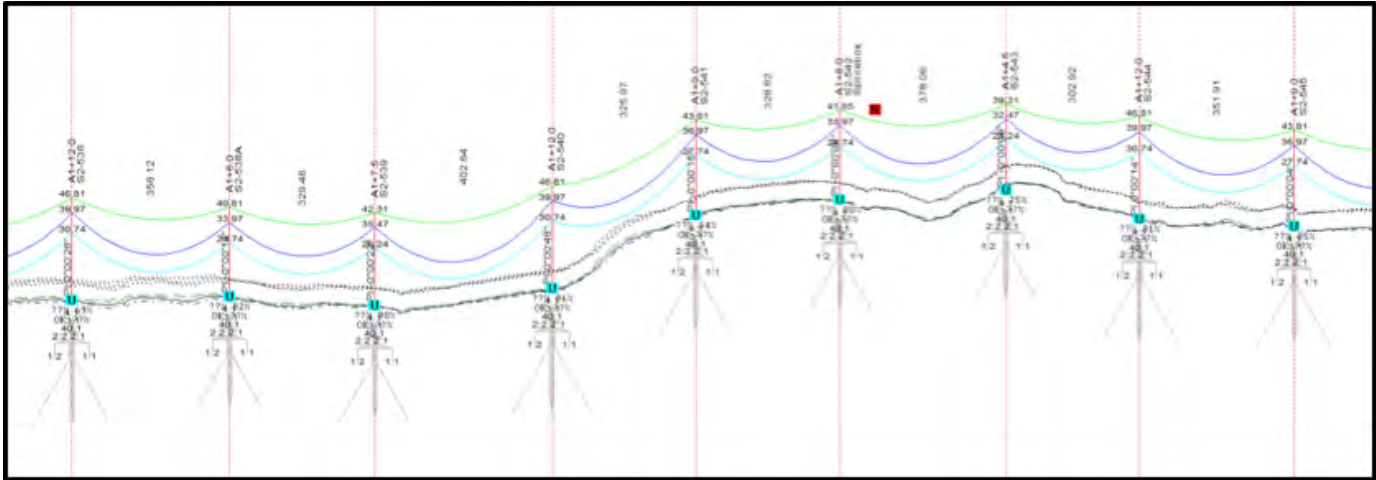
307  
308 Figure 2.9a presents the part of Section 3a that consists of the three towers (S2 538, 538A, and 539)  
309 that WEEE has identified as locations where the influence of topography cannot be ignored and are

315  
316 **Figure 2.9 (a) - Locations of Three Towers on a Typical Plan and Profile of Section 3a**  
317

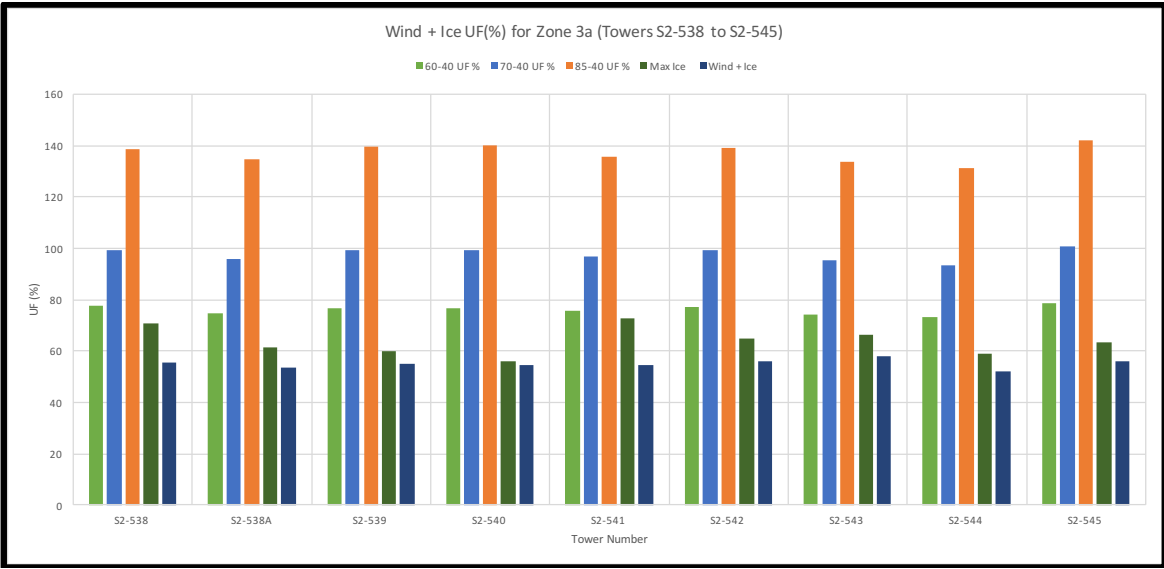
310 significant. Figures 2.9(b) and (c) present the relative use factors that these towers are subjected for  
311 various load scenarios. Also, in these figures, LIL design ice and combined wind and ice loads are  
312 included for comparison. Figure 2.10 presents a typical CFD analysis field contour that shows the  
313 wind speed effect on towers located in Labrador.  
314

318  
319 **Figure 2.9 (b) - Use Factor Comparison for Wind Plus Ice Loads**  
320

782 The LIL combined load of 25mm radial ice and 60kmh of wind for Section 3a appears to be below  
 783 the CSA minimum load because 60kmh wind is 50% of the reference wind speed for this section of  
 784 the line. The 25mm ice thickness along the route (at structure location) is approximately 10% above  
 785 (0.4gl) what is needed to meet the bare minimum of CSA fixed cable ice load. The overall return  
 786 period for the LIL design combined wind and ice load appears to be below the 50-year return period  
 787 criterion stipulated in CSA 60826-10. This is also reflected in the plot where a comparison is made  
 788 among various use factors for a tower # S2-539 in Figure 2.9b and in Figure 3.4.

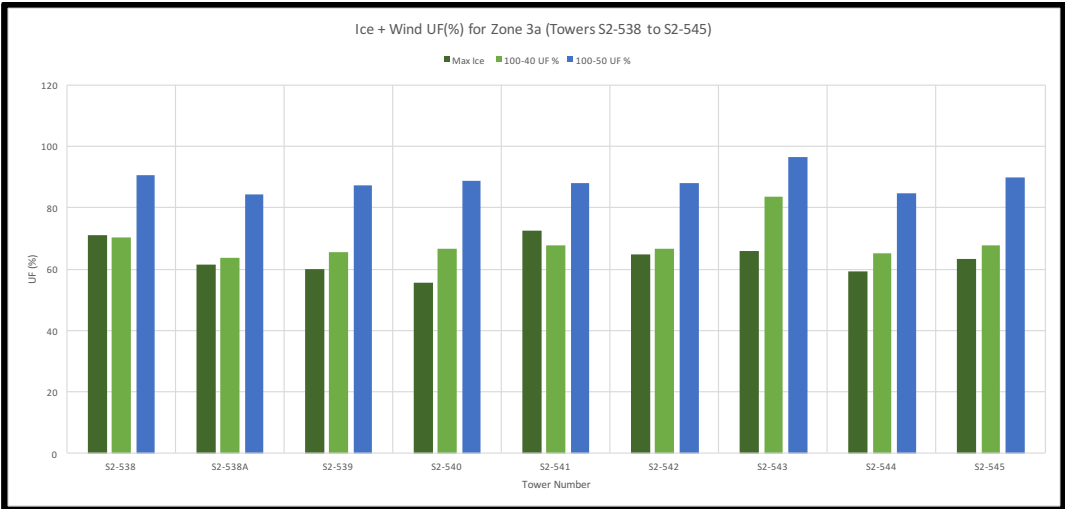
Figure 2.9 (c) - Use Factor Comparison for Ice Plus Wind Load

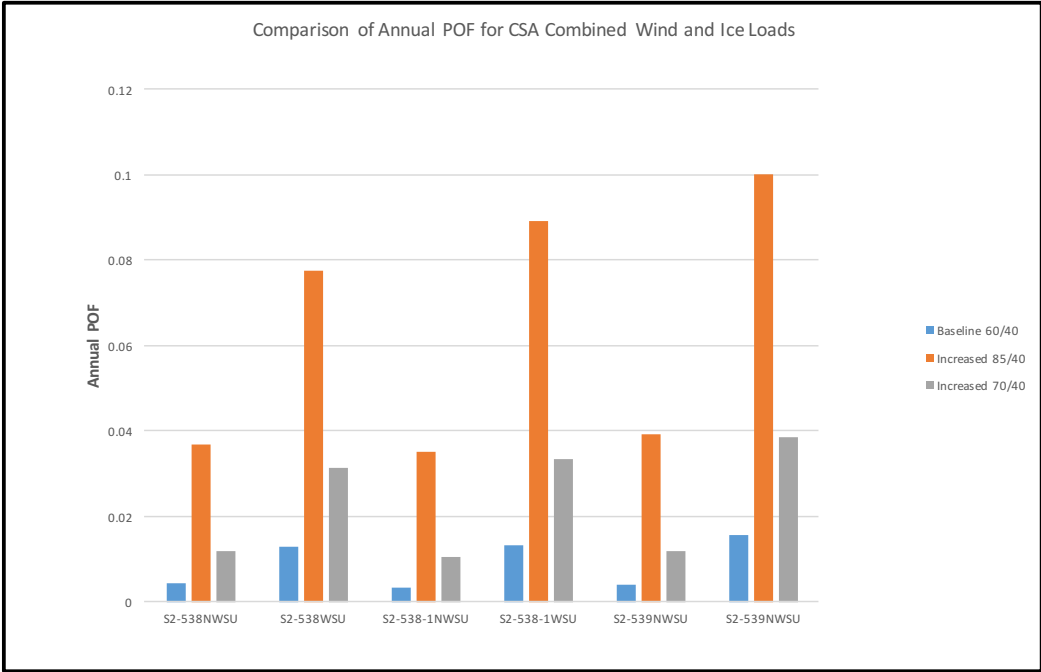
Figures 2.11 presents the comparison of annual POF of three towers in section 3a where the effects of combined wind an ice loads are considered with or without the influence of topography. NWSU refers to no wind speed up effect while WSU indicates that local topography (wind speed up effect has been considered. All wind plus ice loads are based on CSA 60826-10. The Annual POF can vary between 0.4% to 10% depending on the specific criterion used.

334  
 335 **Figure 2.11 - Impact of Topography Effects (WSU) on Annual Probability of Failures of Structures in**  
 336 **Zones 3a (Glaze Ice Section)**

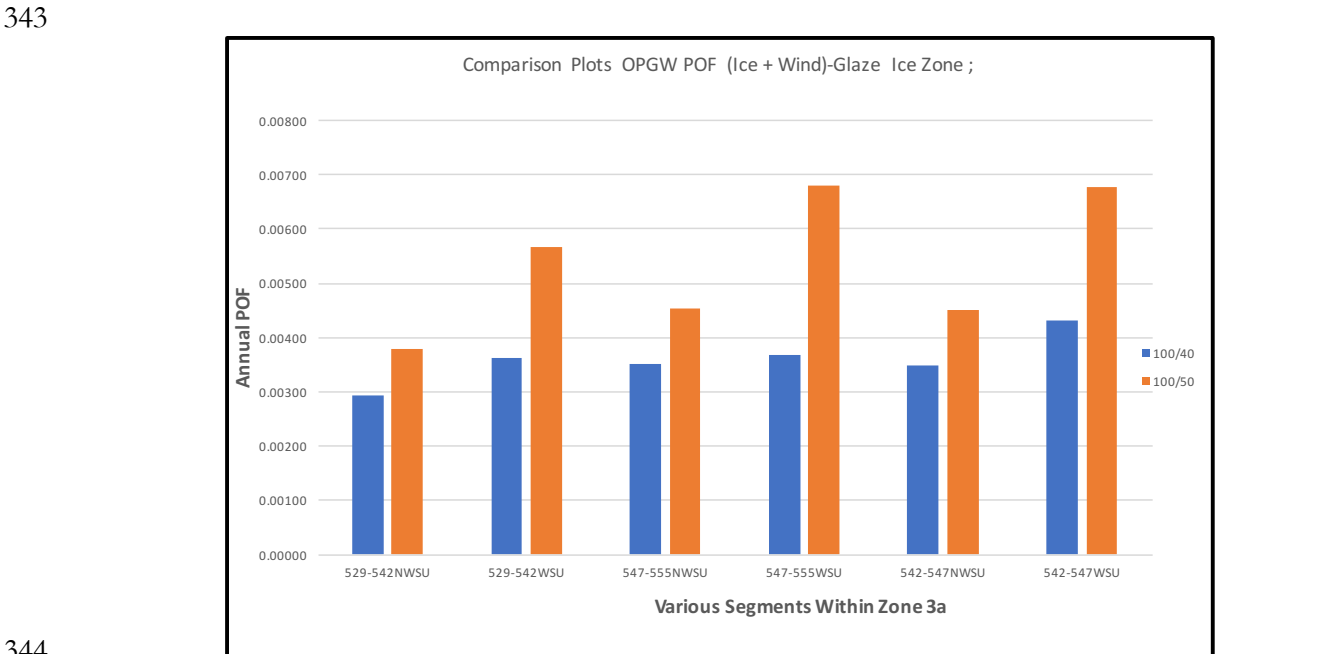
337  
 338 Figure 2.12a presents the comparison of annual POF of OPGW cable in section 3a with or without  
 339 the influence of local topography of the “wire support” system. Figure 2.12b presents the same for  
 340 sections 3a, 6 and 8b where the local topography effects were considered. Again, the comparison of  
 341 annual POF is done with or without the influence of topography. Figure 2.13 presents the Screenshot  
 342 of S2-539 tower under WSU effect with increased CSA 60826-10 combined loads.

344  
 345 **Figure 2.12 (a) - Impact of Topography Effects (WSU) on Annual Probability of Failure of OPGW in**  
 346 **Zone 3a**

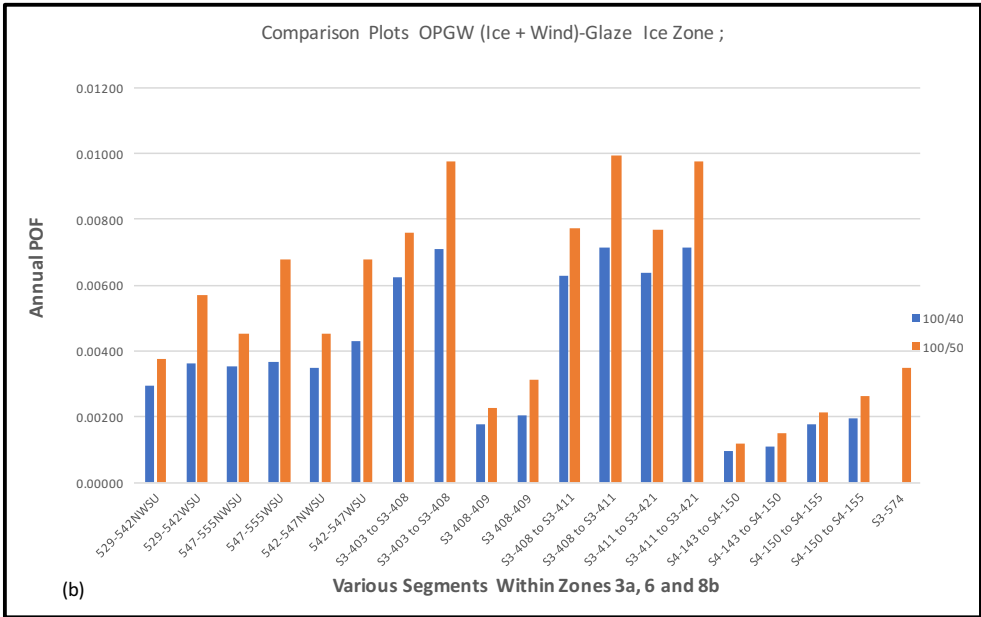
347  
 348 **Figure 2.12 (b) - Impact of Topography Effects (WSU) on Annual Probability of Failure of OPGW in**  
 349 **Sections 3a, 6 & 8b**

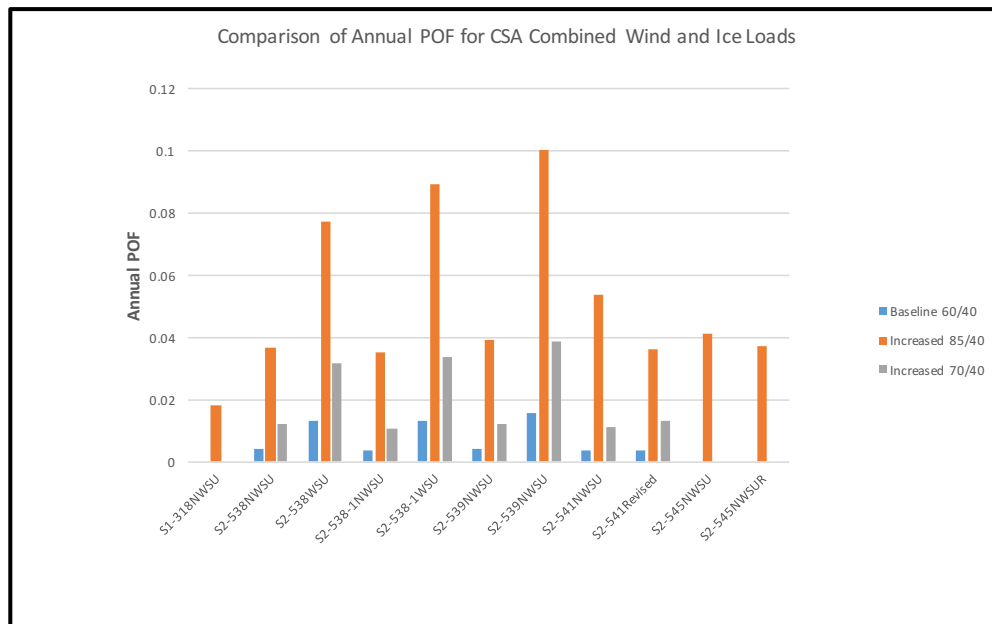
724  
725 **Figure 3.4 - Influence of Topography on Annual POF on LIL (part of Section 3a)**

710 In this study, three towers, S2-538, S2-538A, and S2-539, in Section 3a have been identified as being  
711 in locations where influence of topography needs to be considered. Accordingly, structural analysis  
712 was conducted, and results show that the annual POF for these three towers would vary from 8% to  
713 10% considering WSU effects coupled with CSA 60826-10 increased combined loads. The annual  
714 POF would be 3.8%-4.1% when WSU effects are not considered (NWSU). This significant increase  
715 should be understood in view of the explanation given in the previous section. Figure 3.4 presents a  
716 comparison of the POF for these towers located in Section 3a where the analysis results are compared  
717 for NWSU and WSU. Two towers, (S2-541, S2-545), which are near to the above three towers but are  
718 in locations where topography effects are not significant (NWSU) are also included in the analysis for

719 reference. One tower from Zone 1 (S1-318) has also been added for increased load as a reference. It  
720 is to be noted that for an intermediate value of CSA 60826-10 load combination (70/40), the POFs  
721 for S2-539 are 1.2% and 3.84% for NWSU and WSU respectively. These values correspond to 51-  
722 year and 23-year return period respectively.  
723

798 A comparison of UF presented in Figure 3.4 shows that for tower S2-539 in Section 3a, the LIL UF  
799 for combined wind and ice load is 70% of the baseline CSA 60826-10 load value that was used in the  
800 earlier report (Haldar, 2021). CSA 60826-10 baseline wind plus ice UF is closer to the extreme design  
801 wind load effect reported (76% vs. 80%) but still slightly lower than the extreme wind load effect.  
802 For increased load without topography effect (NWSU), this design LIL UF is 40% of the use factor  
803 reported (Figure 3.4). For increased load with WSU effect, this design LIL UF is little over 25%.  
804 Accordingly, to satisfy the CSA 60826-10 increased load combination coupled with the influence of  
805 topography effect, the LIL line section in Zone 3a requires a design load envelope that needs to  
806 accommodate the significant increase in the combined wind and ice load effects than what was used

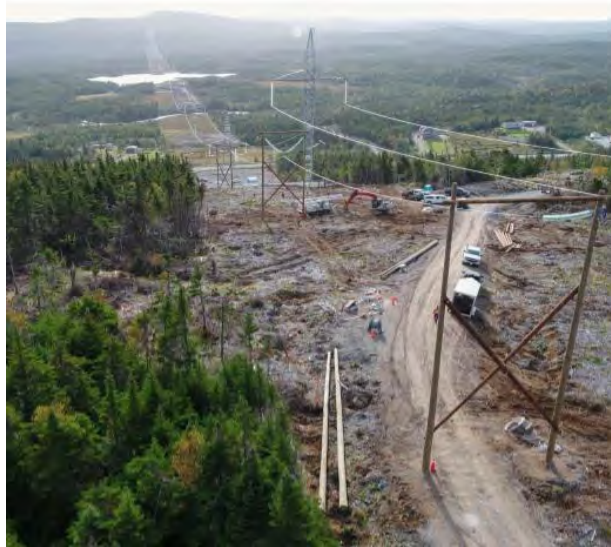
Figure 2: Wooden Pole Solution Used in 2018 Mock Exercise

In the event of a failure of multiple tangent towers on the line, installation of a wood pole bypass line is an option to temporarily restore power until restoration of the permanent line is completed. This method was tested in a 2018 mock exercise, which is further detailed later in this report.

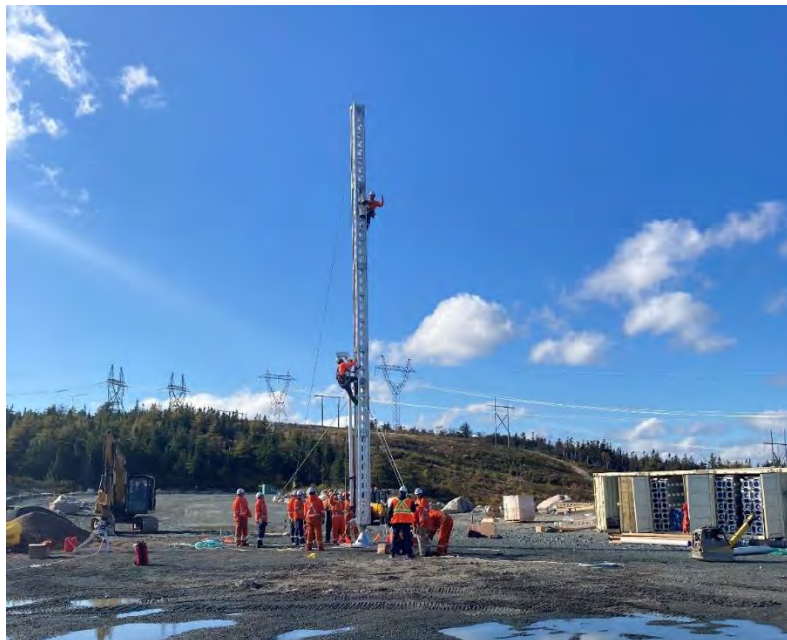
**Figure 3: ERS Mock Exercise at Soldiers Pond**

ERS are structures designed to be installed quickly in the event of line failure. ERS towers are typically lightweight, modular aluminum structures and are associated with polymer insulators, hardware, and guying components. The lightweight modular components allow transportation to remote and difficult-to-access sites, either by land or helicopter. Unlike typical permanent transmission structures, an ERS design is driven by flexibility rather than optimization as it provides for many different structural concepts.
