1 Q. Please provide copies of Hydro's forecasted availability measures and the actual availability
2 measures for 2016-2018 for both hydraulic and thermal production assets.

5 A. For Newfoundland and Labrador Hydro's ("Hydro") forecast availability measures and
6 actual measures for the last three years please refer to:

8 • PUB-NLH-015, Attachment 1 for Hydro's "Quarterly Report on Performance of
9 Generating Units for the Quarter Ended March 31, 2016;"

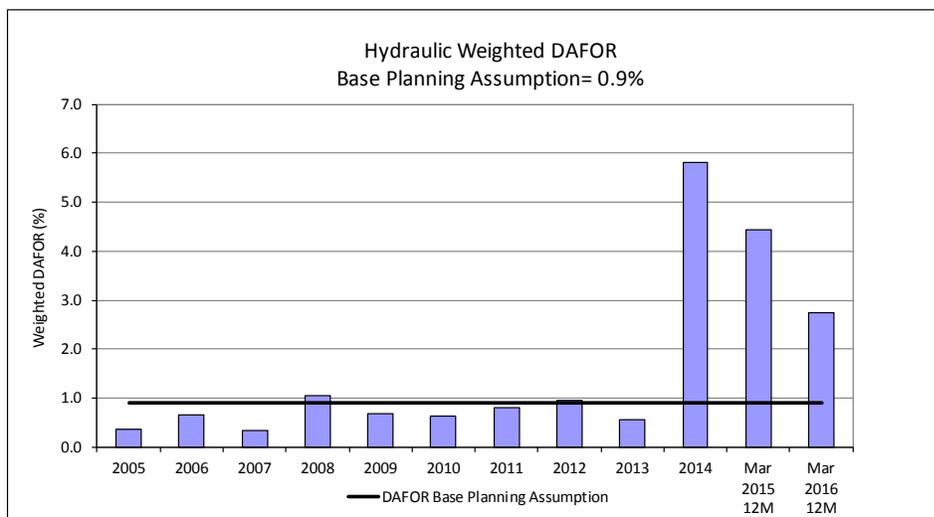
Generating Unit	Maximum Continuous Unit Rating (MW)	12 months ending March 2015 (%)	12 months ending March 2016 (%)	Hydro Generation Base Planning Assumption (%)
All Hydraulic Units - weighted	954.4	4.45	2.76	0.90
Hydraulic Units				
Bay D'Espoir 1	76.5	0.03	26.91	0.90
Bay D'Espoir 2	76.5	0.01	0.07	0.90
Bay D'Espoir 3	76.5	0.00	0.00	0.90
Bay D'Espoir 4	76.5	0.64	0.42	0.90
Bay D'Espoir 5	76.5	0.18	3.09	0.90
Bay D'Espoir 6	76.5	45.48	0.00	0.90
Bay D'Espoir 7	154.4	2.10	0.00	0.90
Hinds Lake	75	0.21	0.16	0.90
Upper Salmon	84	2.22	0.00	0.90
Granite Canal	40	0.32	2.07	0.90
Cat Arm 1	67	0.62	0.01	0.90
Cat Arm 2	67	1.34	1.39	0.90
Paradise River	8	0.00	0.24	0.90

1 The weighted “All Hydraulic Units” DAFOR was 2.76% for the current 12 month period ending March
2 31, 2016. The forced outage and derating of Unit 1 at Bay d’Espoir was the primary contributor to
3 the DAFOR of 2.76% as compared to a base planning assumption of 0.9%.

4 Considering the individual units performance, the assumed Hydro generation base planning DAFOR
5 was materially exceeded for Bay d’Espoir Unit 1. Also, there were exceedances compared to base
6 planning assumption for Bay d’Espoir Unit 5, Granite Canal and Cat Arm Unit 2, for the current
7 period.

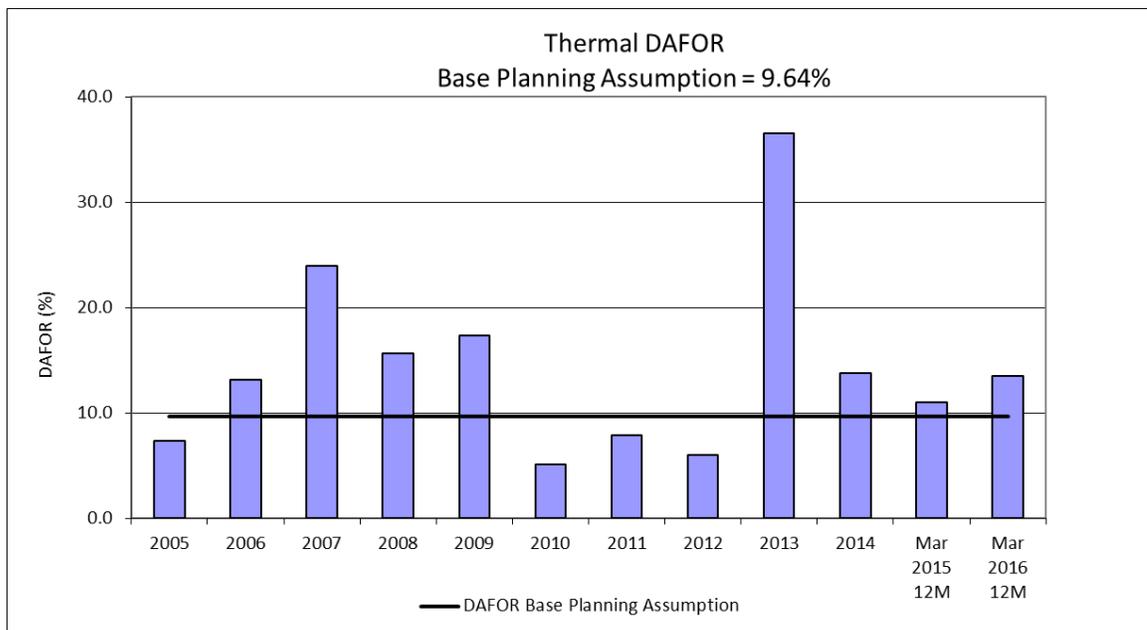
Generating Unit	Maximum Continuous Unit Rating (MW)	12 months ending March 2015 (%)	12 months ending March 2016 (%)	Hydro Generation Base Planning Assumption (%)
<i>All Thermal Units - weighted</i>	490	10.99	13.54	9.64
Thermal Units				
Holyrood 1	170	15.45	12.28	9.64
Holyrood 2	170	11.94	18.33	9.64
Holyrood 3	150	5.55	8.98	9.64

10 For the 12-month period ending March 31, 2016, the weighted DAFOR for, all thermal units, of
 11 13.54% is above the assumed Hydro generation base planning DAFOR value of 9.64%, and also
 12 exceeded the previous 12-month period rate of 10.99%. Unit 1 DAFOR was 12.28% and Unit 2

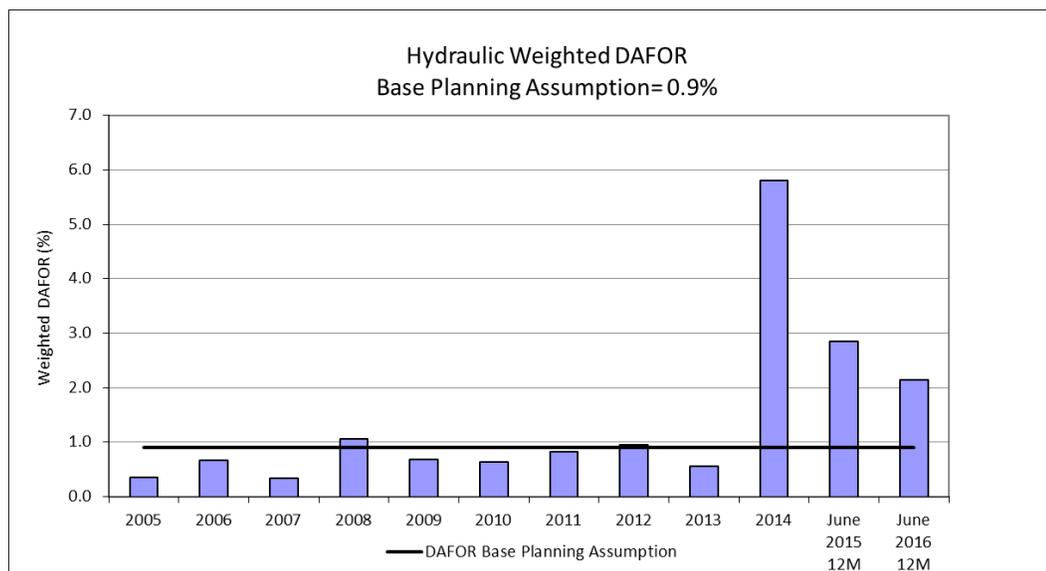
Generating Unit	Maximum Continuous Unit Rating (MW)	12 months ending June 2015 (%)	12 months ending June 2016 (%)	Hydro Generation Base Planning Assumption (%)
All Hydraulic Units - weighted	954.4	2.85	2.15	0.90
Hydraulic Units				
Bay D'Espoir 1	76.5	13.75	17.69	0.90
Bay D'Espoir 2	76.5	0.00	7.44	0.90
Bay D'Espoir 3	76.5	0.00	0.00	0.90
Bay D'Espoir 4	76.5	0.23	0.11	0.90
Bay D'Espoir 5	76.5	0.00	3.36	0.90
Bay D'Espoir 6	76.5	15.39	0.00	0.90
Bay D'Espoir 7	154.4	0.84	0.00	0.90
Hinds Lake	75	0.30	0.05	0.90
Upper Salmon	84	1.17	0.00	0.90
Granite Canal	40	0.37	1.83	0.90
Cat Arm 1	67	0.60	0.01	0.90
Cat Arm 2	67	1.91	0.21	0.90
Paradise River	8	0.00	0.31	0.90

1 Considering the individual units performance, the assumed Hydro generation base planning
2 DAFOR was materially exceeded for Bay d’Espoir Unit 1. Also, there were exceedances
3 compared to base planning assumption for Bay d’Espoir Unit 2, Bay d’Espoir Unit 5, and
4 Granite Canal for the current period.

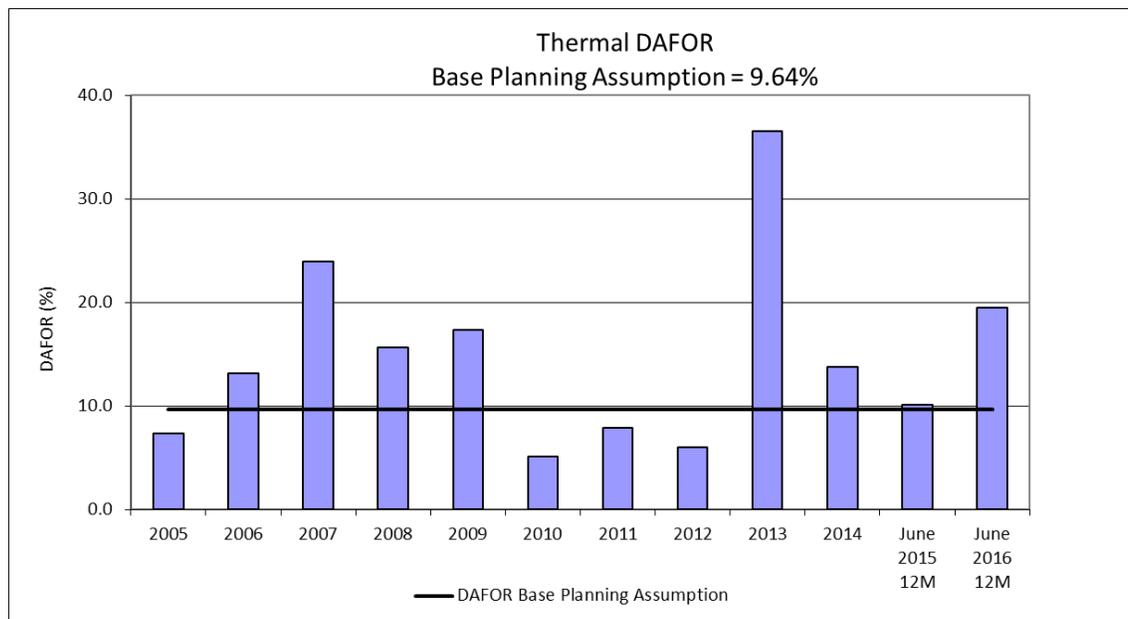
Generating Unit	Maximum Continuous Unit Rating (MW)	12 months ending June 2015 (%)	12 months ending June 2016 (%)	Hydro Generation Base Planning Assumption (%)
<i>All Thermal Units - weighted</i>	490	10.06	19.45	9.64
Thermal Units				
Holyrood 1	170	13.20	20.66	9.64
Holyrood 2	170	11.06	26.46	9.64
Holyrood 3	150	5.67	8.91	9.64

9 For the 12-month period ending June 30, 2016 the weighted DAFOR for all thermal units of
 10 19.45% is above the assumed Hydro generation base planning DAFOR value of 9.64%, and
 11 also exceeded the previous 12-month period rate of 10.06%. Unit 1 DAFOR was 20.66% and

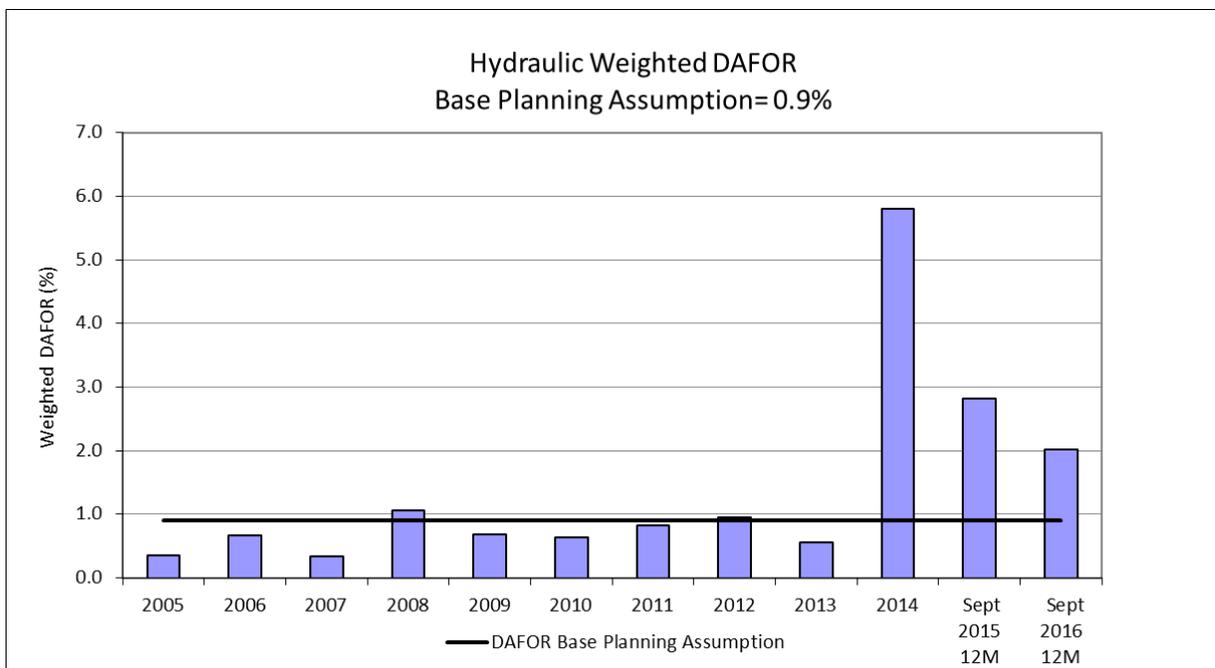
Generating Unit	Maximum Continuous Unit Rating (MW)	12 months ending September 2015 (%)	12 months ending September 2016 (%)	Hydro Generation Base Planning Assumption (%)
All Hydraulic Units - weighted	954.4	2.82	2.02	0.90
Hydraulic Units				
Bay D'Espoir 1	76.5	25.64	10.57	0.90
Bay D'Espoir 2	76.5	0.00	13.52	0.90
Bay D'Espoir 3	76.5	0.00	0.00	0.90
Bay D'Espoir 4	76.5	0.23	1.33	0.90
Bay D'Espoir 5	76.5	2.46	0.63	0.90
Bay D'Espoir 6	76.5	0.00	0.18	0.90
Bay D'Espoir 7	154.4	0.00	0.00	0.90
Hinds Lake	75	0.32	0.06	0.90
Upper Salmon	84	0.98	0.00	0.90
Granite Canal	40	1.51	1.72	0.90
Cat Arm 1	67	0.63	0.13	0.90
Cat Arm 2	67	1.42	0.00	0.90
Paradise River	8	0.19	5.16	0.90

Considering the individual units performance, the assumed Hydro generation base planning DAFOR was materially exceeded for Bay d'Espoir Unit 1 and Bay d'Espoir Unit 2. Also, there

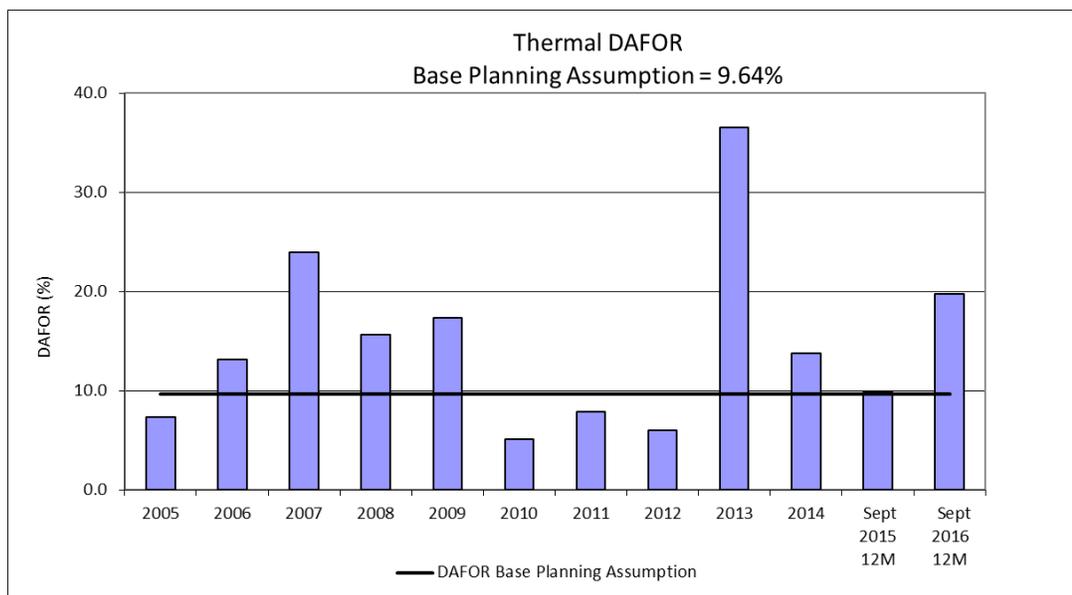
Generating Unit	Maximum Continuous Unit Rating (MW)	12 months ending September 2015 (%)	12 months ending September 2016 (%)	Hydro Generation Base Planning Assumption (%)
All Thermal Units - weighted	490	9.86	19.72	9.64
Thermal Units				
Holyrood 1	170	12.22	25.46	9.64
Holyrood 2	170	7.15	25.64	9.64
Holyrood 3	150	10.08	2.86	9.64

2 For the 12-month period ending September 30, 2016, the weighted DAFOR for all thermal
3 units, of 19.72% is above the assumed Hydro generation base planning DAFOR value of
4 9.64%, and also exceeded the previous 12-month period rate of 9.86%. Unit 1 DAFOR was
5 25.46% and Unit 2 DAFOR was 25.64%, and the performance for both units was above the
6 base planning assumption of 9.64%. Unit 3 DAFOR was 2.86%, which is significantly better
7 than the base planning assumption of 9.64%.

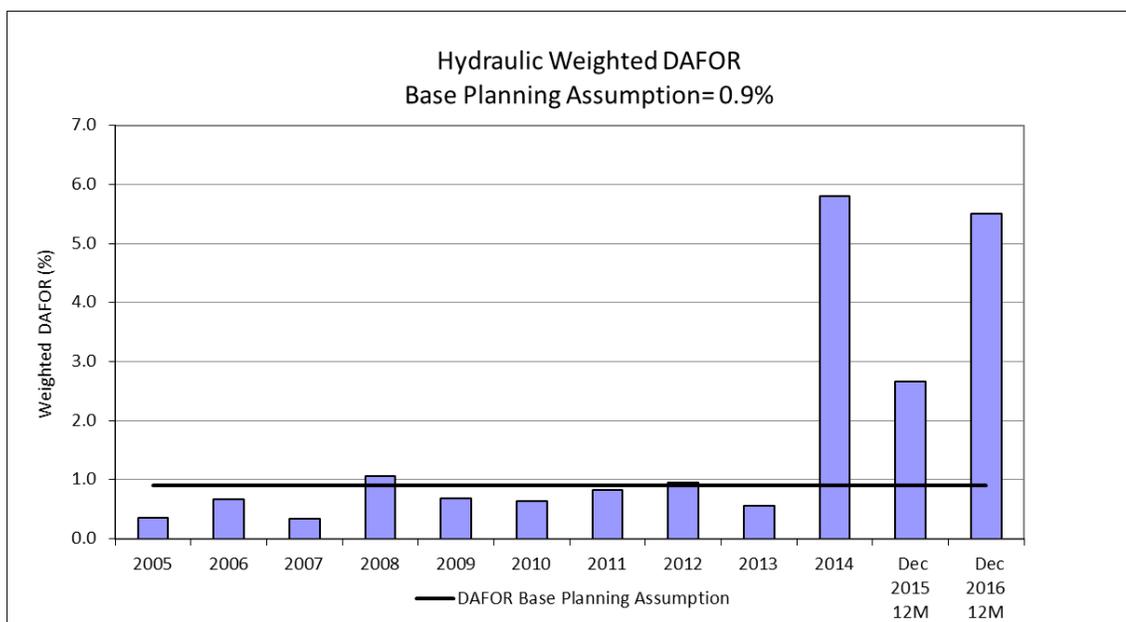
Generating Unit	Maximum Continuous Unit Rating (MW)	12 months ending December 2015 (%)	12 months ending December 2016 (%)	Hydro Generation Base Planning Assumption (%)
<i>All Hydraulic Units - weighted</i>	954.4	2.66	5.51	0.90
Hydraulic Units				
Bay D'Espoir 1	76.5	25.35	30.87	0.90
Bay D'Espoir 2	76.5	0.06	33.90	0.90
Bay D'Espoir 3	76.5	0.00	0.00	0.90
Bay D'Espoir 4	76.5	0.28	0.93	0.90
Bay D'Espoir 5	76.5	2.54	0.56	0.90
Bay D'Espoir 6	76.5	0.00	0.18	0.90
Bay D'Espoir 7	154.4	0.00	0.00	0.90
Hinds Lake	75	0.16	0.24	0.90
Upper Salmon	84	0.00	0.06	0.90
Granite Canal	40	1.88	1.36	0.90
Cat Arm 1	67	0.01	1.02	0.90
Cat Arm 2	67	1.41	0.00	0.90
Paradise River	8	0.24	7.08	0.90

2 Considering the individual units performance, the assumed Hydro generation base planning DAFOR
3 was materially exceeded for Bay d’Espoir Unit 1 and Bay d’Espoir Unit 2. Also, there were
4 exceedances compared to base planning assumption for Granite Canal, Cat Arm Unit 1 and Paradise
5 River for the current period.

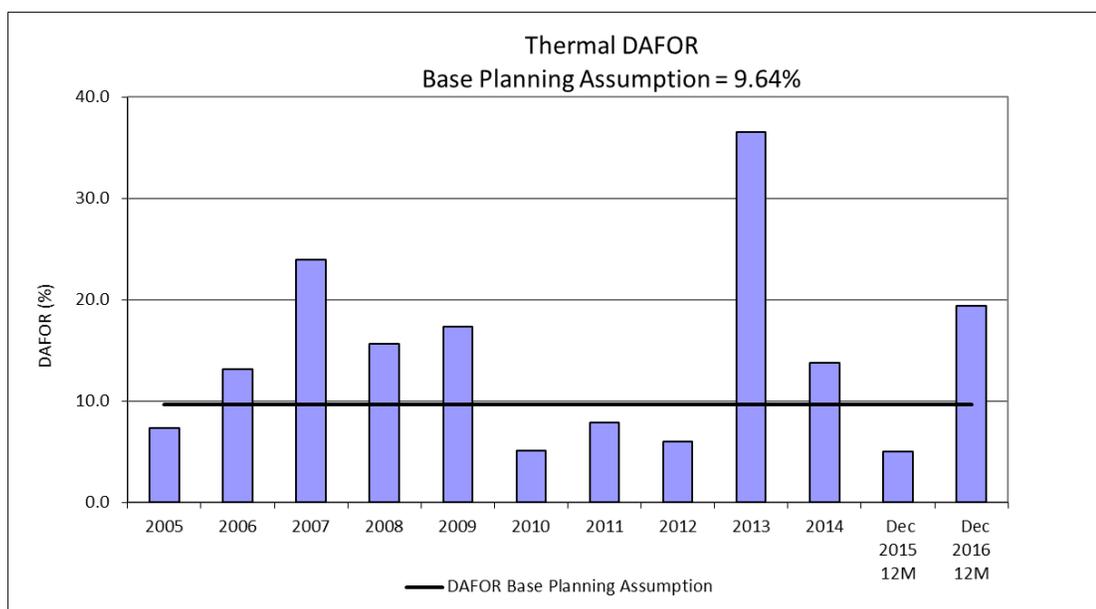
1 For the 12-month period ending December 31, 2016, the weighted DAFOR for all thermal units, of
2 19.42% is above the assumed Hydro generation base planning DAFOR value of 9.64%, and also
3 exceeded the previous 12-month period rate of 5.04%. Unit 1 DAFOR was 24.55% and Unit 2 DAFOR
4 was 26.69%, and the performance for both units was above the base planning assumption of 9.64%.
5 Unit 3 DAFOR was 2.41%, which is better than the base planning assumption of 9.64%. It is
6 estimated that approximately half of the 19.42% DAFOR for the plant in 2016 is due to deratings and
7 complications from the boiler tubes.

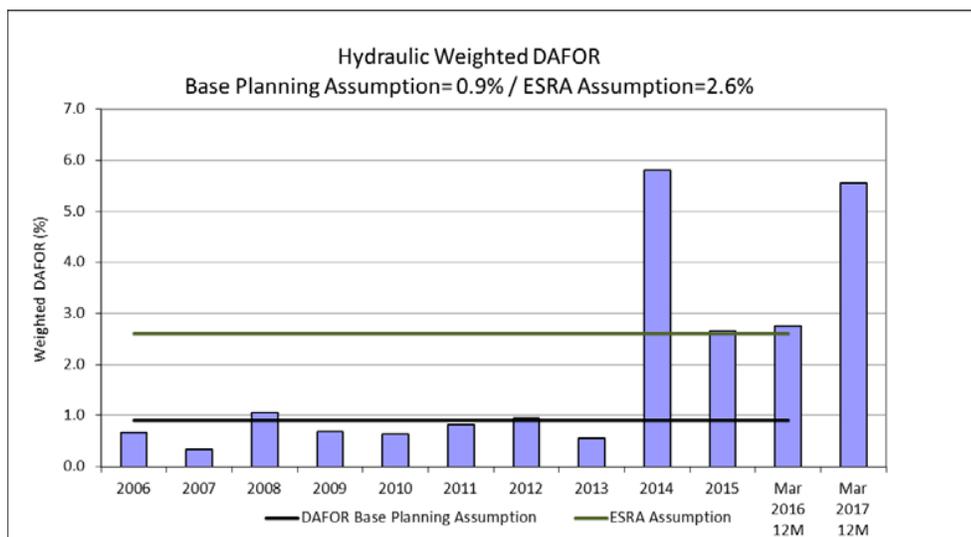
Figure 1: Hydraulic Weighted DAFOR

Generating Unit	Maximum	12 months ending	12 months ending	Hydro Generation	ESRA Planning
	Continuous Unit Rating (MW)	March 2016 (%)	March 2017 (%)	Base Planning Assumption (%)	Assumption (%)
All Hydraulic Units - weighted	954.4	2.76	5.55	0.90	2.60
Hydraulic Units					
Bay D'Espoir 1	76.5	26.91	30.54	0.90	3.90
Bay D'Espoir 2	76.5	0.07	31.30	0.90	3.90
Bay D'Espoir 3	76.5	0.00	0.02	0.90	3.90
Bay D'Espoir 4	76.5	0.42	0.69	0.90	3.90
Bay D'Espoir 5	76.5	3.09	0.48	0.90	3.90
Bay D'Espoir 6	76.5	0.00	1.31	0.90	3.90
Bay D'Espoir 7	154.4	0.00	0.00	0.90	3.90
Cat Arm 1	67	0.01	1.02	0.90	0.70
Cat Arm 2	67	1.39	0.00	0.90	0.70
Hinds Lake	75	0.16	0.25	0.90	0.70
Upper Salmon	84	0.00	0.91	0.90	0.70
Granite Canal	40	2.07	1.16	0.90	0.70
Paradise River	8	0.24	6.94	0.90	0.70

1 Considering the individual units' performance, the assumed Hydro generation base planning
2 DAFOR was materially exceeded for Bay d'Espoir Unit 1 and Bay d'Espoir Unit 2. Also, there
3 were exceedances compared to base planning assumption for Bay d'Espoir Unit 6, Granite
4 Canal, Cat Arm Unit 1 and Paradise River for the current period.

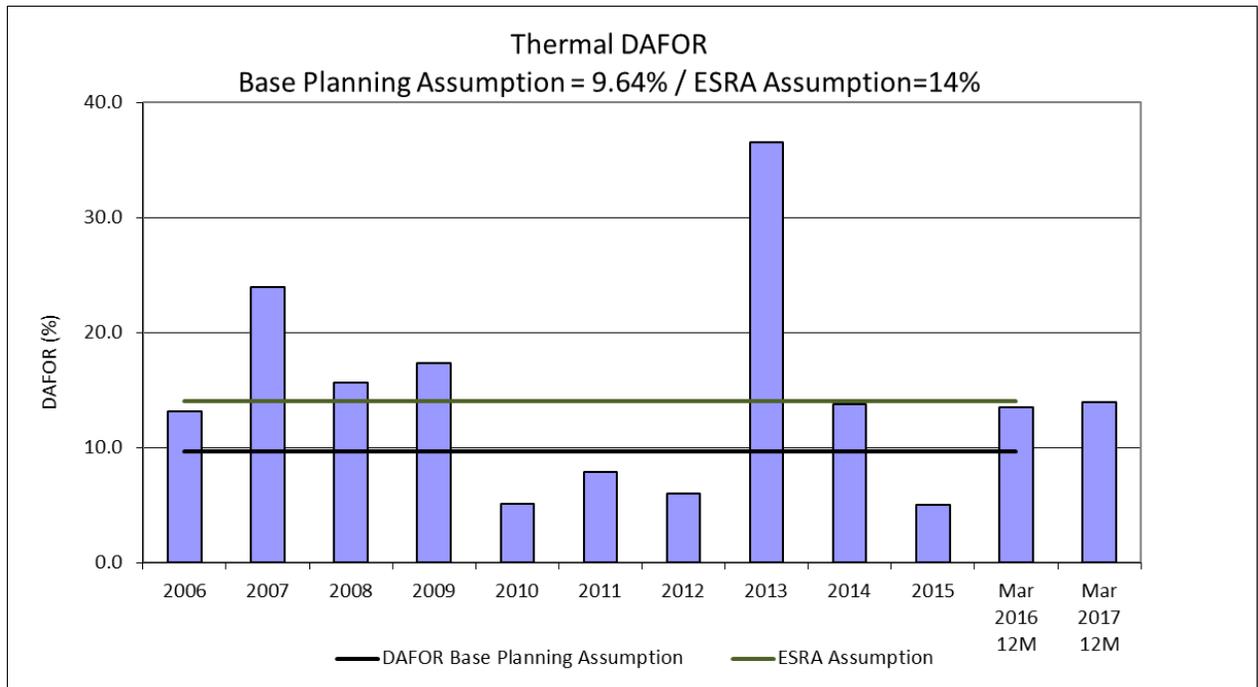
Figure 2: Thermal DAFOR

Generating Unit	Maximum Continuous Unit Rating (MW)	12 months ending March 2016 (%)	12 months ending March 2017 (%)	Hydro Generation Base Planning Assumption (%)	ESRA Planning Assumption (%)
<i>All Thermal Units - weighted</i>	490	13.54	13.96	9.64	14.00
Thermal Units					
Holyrood 1	170	12.28	20.49	9.64	15.00
Holyrood 2	170	18.33	14.92	9.64	10.00
Holyrood 3	150	8.98	3.06	9.64	18.00

1 For the 12-month period ending March 31, 2017, the weighted DAFOR for all thermal units, of
 2 14.56% is above the assumed Hydro generation base planning DAFOR value of 9.64%, and
 3 comparable to the ESRA assumption of 14.00%. Unit 1 DAFOR was 20.49% and Unit 2 DAFOR
 4 was 14.92%. The performance for both Units 1 and 2 was above the base planning assumption
 5 of 9.64% and the ESRA assumption of 15% (Unit 1) and 10% (Unit 2). Unit 3 DAFOR was 3.06%,
 6 which is better than the base planning assumption of 9.64% and ESRA assumption of 18.0%.

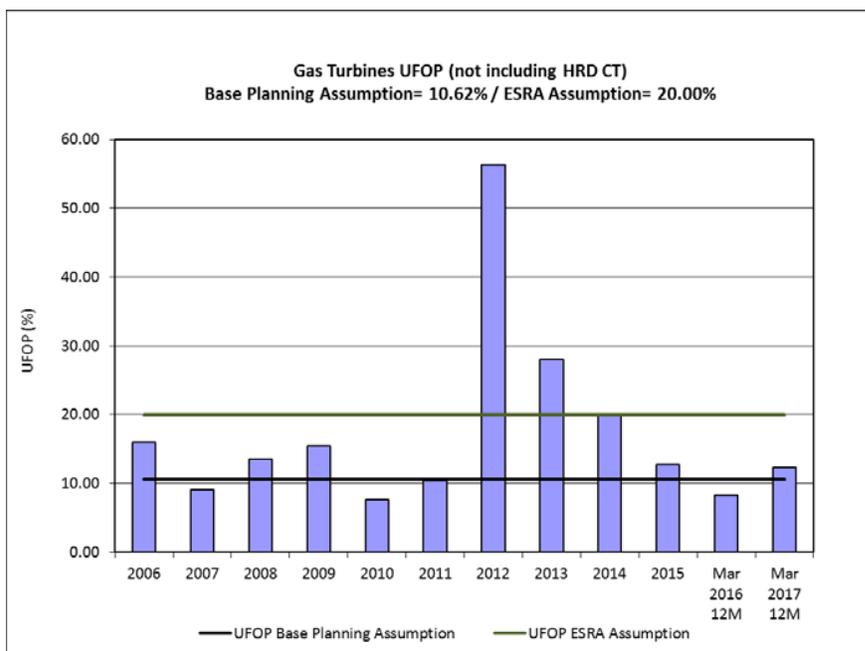
Figure 3: Gas Turbine UFOP

Combustion Turbine Units	Maximum Continuous Unit Rating (MW)	12 months ending March 2016 (%)	12 months ending March 2017 (%)	Hydro Generation Base Planning Assumption (%)	ESRA Planning Assumption (%)
Holyrood CT	123.5	2.81	2.24	5.00	5.00

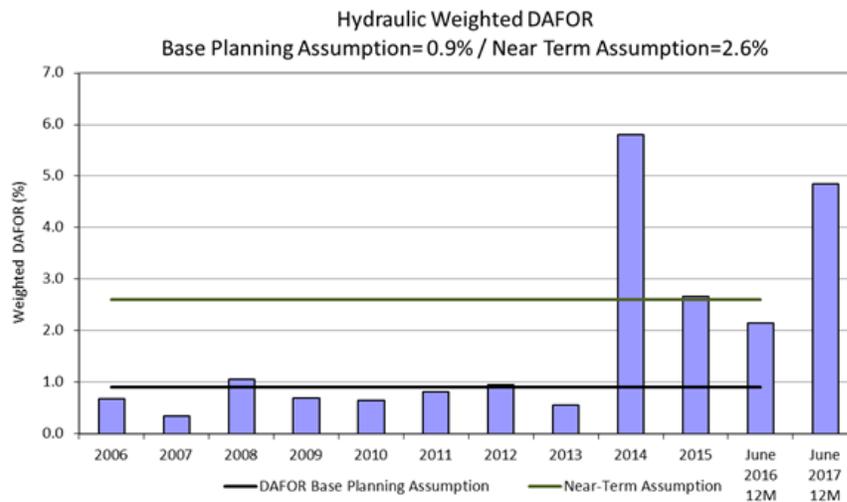
Figure 1: Hydraulic Weighted DAFOR

Generating Unit	Maximum	12 months	12 months ending	Hydro Generation	
	Continuous Unit Rating (MW)	ending June 2016 (%)	June 2017 (%)	Base Planning Assumption (%)	Near-Term Planning Assumption (%)
All Hydraulic Units - weighted	954.4	2.15	4.85	0.90	2.60
Hydraulic Units					
Bay D’Espoir 1	76.5	17.69	23.04	0.90	3.90
Bay D’Espoir 2	76.5	7.44	26.75	0.90	3.90
Bay D’Espoir 3	76.5	0.00	0.02	0.90	3.90
Bay D’Espoir 4	76.5	0.11	0.97	0.90	3.90
Bay D’Espoir 5	76.5	3.36	0.00	0.90	3.90
Bay D’Espoir 6	76.5	0.00	1.30	0.90	3.90
Bay D’Espoir 7	154.4	0.00	0.00	0.90	3.90
Cat Arm 1	67	0.01	1.02	0.90	0.70
Cat Arm 2	67	0.21	0.00	0.90	0.70
Hinds Lake	75	0.05	1.14	0.90	0.70
Upper Salmon	84	0.00	0.86	0.90	0.70
Granite Canal	40	1.83	1.15	0.90	0.70
Paradise River	8	0.31	7.58	0.90	0.70

1 Considering the individual units’ performance, the assumed Hydro generation base planning
 2 DAFOR was materially exceeded for Bay d’Espoir Unit 1 and Bay d’Espoir Unit 2. Also, there
 3 were exceedances compared to base planning assumption for Bay d’Espoir Unit 6, Granite
 4 Canal, Cat Arm Unit 1, Hinds Lake and Paradise River for the current period.

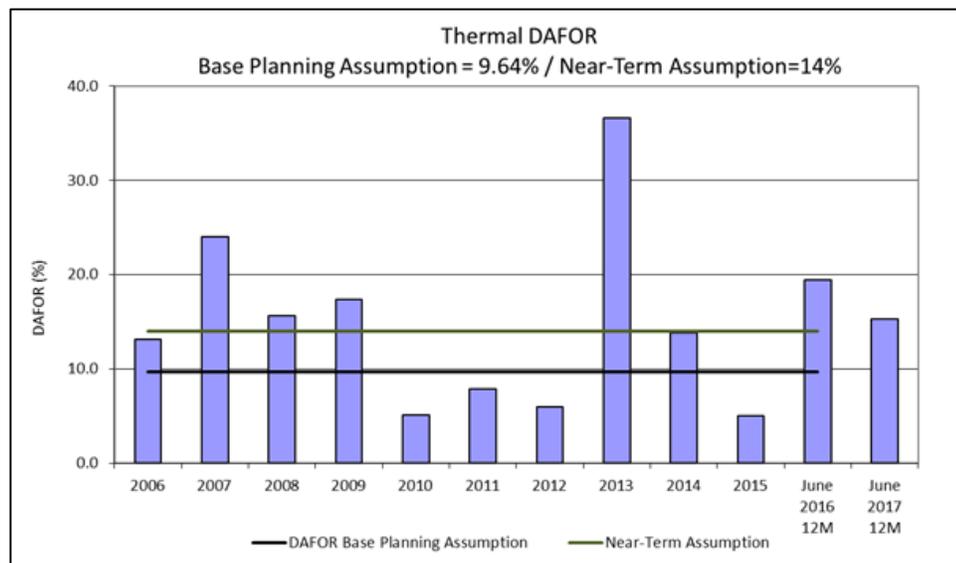
Figure 2: Thermal DAFOR

Generating Unit	Maximum Continuous Unit Rating (MW)	12 months ending June 2016 (%)	12 months ending June 2017 (%)	Hydro Generation Base Planning Assumption (%)	Near-Term Planning Assumption (%)
<i>All Thermal Units - weighted</i>	490	19.45	15.27	9.64	14.00
Thermal Units					
Holyrood 1	170	20.66	21.33	9.64	15.00
Holyrood 2	170	26.46	19.57	9.64	10.00
Holyrood 3	150	8.91	3.29	9.64	18.00

1 For the 12-month period ending June 30, 2017, the weighted DAFOR for all thermal units, of
2 15.27% is above the assumed Hydro generation base planning DAFOR value of 9.64%, and
3 comparable to the near-term assumption of 14.00%. Unit 1 DAFOR was 21.33% and Unit 2
4 DAFOR was 26.46%. The performance for both Units 1 and 2 was above the base planning
5 assumption of 9.64% and the near-term assumption of 15% (Unit 1) and 10% (Unit 2). Unit 3
6 DAFOR was 3.29%, which is better than the base planning assumption of 9.64% and near-term
7 assumption of 18.0%. The majority of the 15.27% DAFOR for the plant is due to deratings from
8 airflow issues in the 2016/2017 winter season and deration after the replacement of failed
9 boiler tubes in 2016.

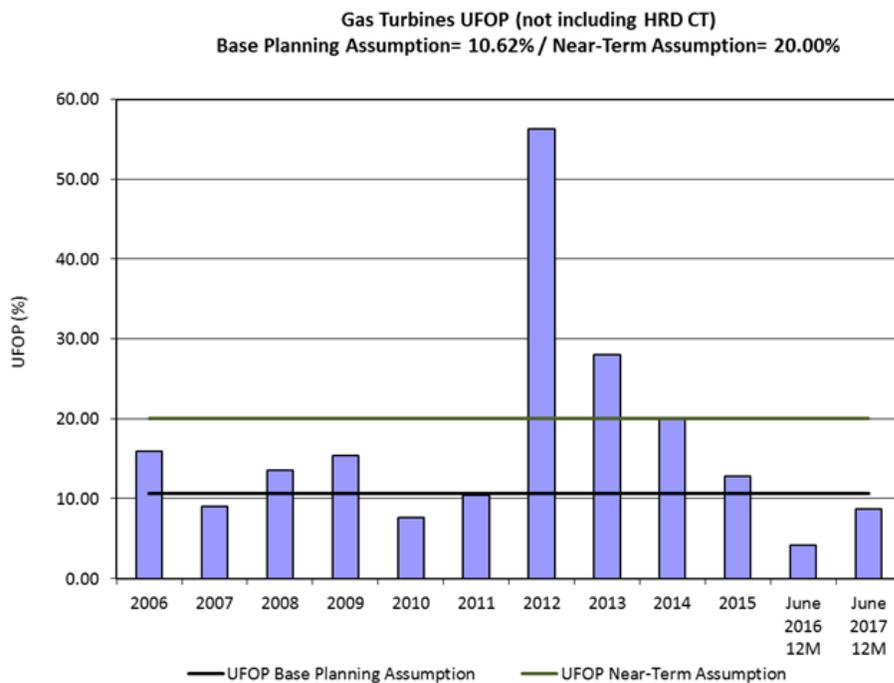
Figure 3: Gas Turbine UFOP

Combustion Turbine Units	Maximum Continuous Unit Rating (MW)	12 months ending June 2016 (%)	12 months ending June 2017 (%)	Hydro Generation	
				Base Planning Assumption (%)	Near-Term Planning Assumption (%)
Holyrood CT	123.5	2.53	2.46	5.00	5.00

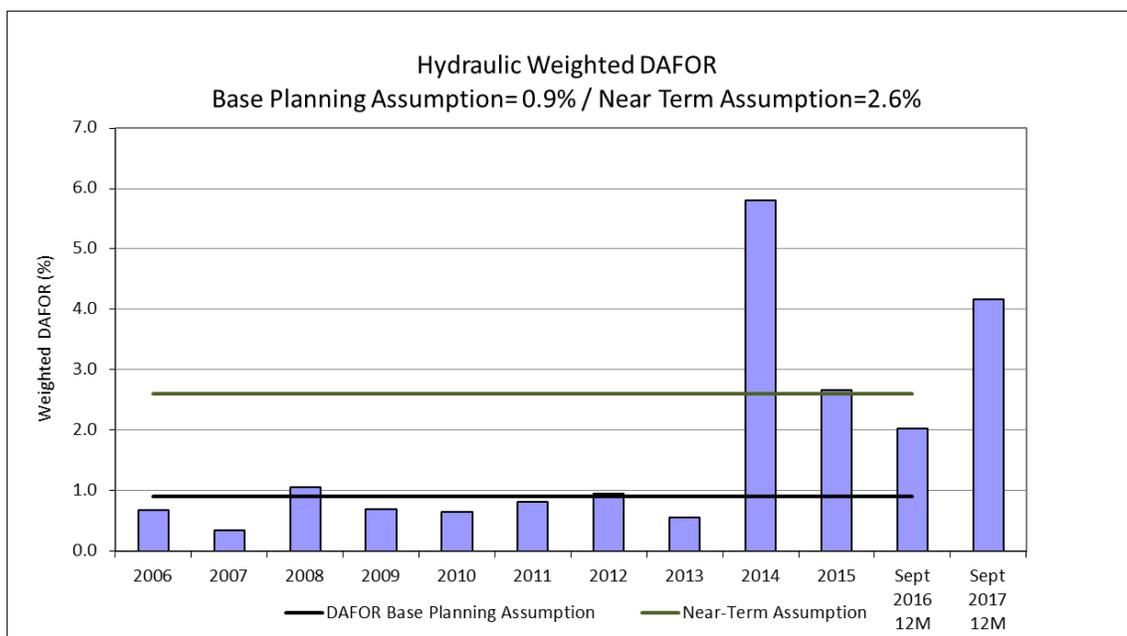
Figure 1: Hydraulic Weighted DAFOR

Generating Unit	Maximum Continuous Unit Rating (MW)	12 months ending September 2016 (%)	12 months ending September 2017 (%)	Hydro Generation Base Planning Assumption (%)	Near-Term Planning Assumption (%)
<i>All Hydraulic Units - weighted</i>	954.4	2.02	4.17	0.90	2.60
Hydraulic Units					
Bay D'Espoir 1	76.5	10.57	19.88	0.90	3.90
Bay D'Espoir 2	76.5	13.52	25.77	0.90	3.90
Bay D'Espoir 3	76.5	0.00	0.03	0.90	3.90
Bay D'Espoir 4	76.5	1.33	0.23	0.90	3.90
Bay D'Espoir 5	76.5	0.63	0.00	0.90	3.90
Bay D'Espoir 6	76.5	0.18	1.35	0.90	3.90
Bay D'Espoir 7	154.4	0.00	1.80	0.90	3.90
Cat Arm 1	67	0.13	1.06	0.90	0.70
Cat Arm 2	67	0.00	0.08	0.90	0.70
Hinds Lake	75	0.06	1.09	0.90	0.70
Upper Salmon	84	0.00	0.87	0.90	0.70
Granite Canal	40	1.72	0.00	0.90	0.70
Paradise River	8	5.16	4.05	0.90	0.70

- 1 Considering the individual units' performance, the assumed Hydro generation base planning
- 2 DAFOR was materially exceeded for Bay d'Espoir Unit 1 and Bay d'Espoir Unit 2. Also, there
- 3 were exceedances compared to base planning assumption for Bay d'Espoir Unit 6, Bay d'Espoir
- 4 Unit 7, Cat Arm Unit 1, Hinds Lake and Paradise River for the current period.

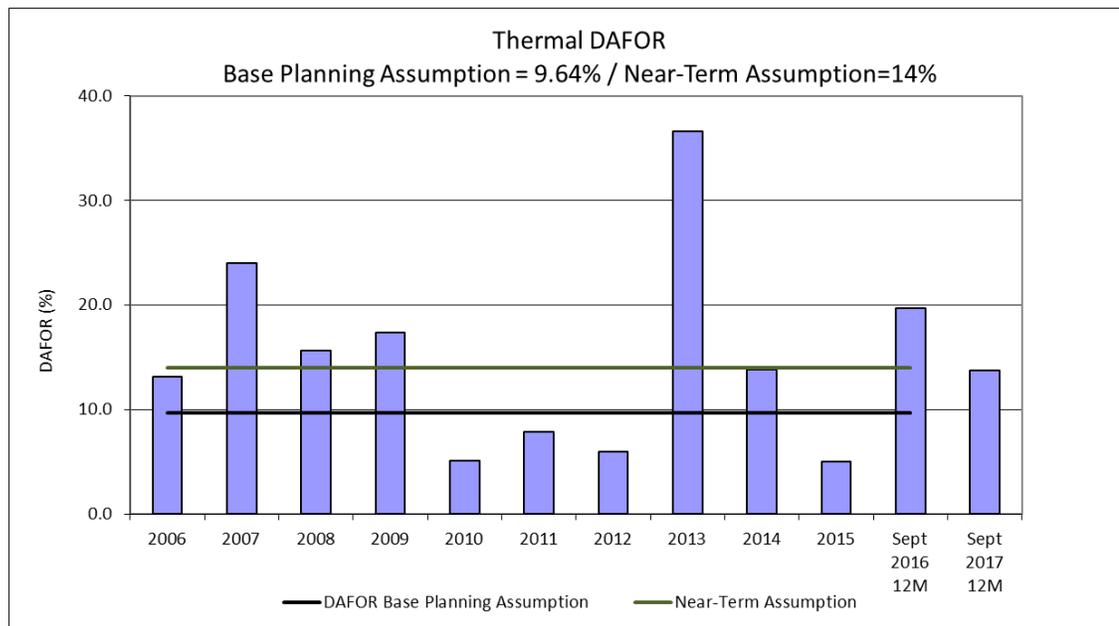
Figure 2: Thermal DAFOR

Generating Unit	Maximum Continuous Unit Rating (MW)	12 months ending September 2016 (%)	12 months ending September 2017 (%)	Hydro Generation Base Planning Assumption (%)	Near-Term Planning Assumption (%)
<i>All Thermal Units - weighted</i>	490	19.72	13.77	9.64	14.00
Thermal Units					
Holyrood 1	170	25.46	18.23	9.64	15.00
Holyrood 2	170	25.64	18.27	9.64	10.00
Holyrood 3	150	2.86	4.44	9.64	18.00

1 For the 12-month period ending September 30, 2017, the weighted DAFOR for all thermal units,
 2 13.77%, was above the assumed Hydro generation base planning DAFOR value of 9.64%;
 3 however, below the near-term assumption of 14.00%. Unit 1 DAFOR was 18.23% and Unit 2
 4 DAFOR was 18.27%. The performance for both Units 1 and 2 was above the base planning
 5 assumption of 9.64% and the near-term assumption of 15% (Unit 1) and 10% (Unit 2). Unit 3
 6 DAFOR was 4.44%, which is better than the base planning assumption of 9.64% and near-term
 7 assumption of 18.0%. The majority of the 13.77% DAFOR for the plant is due to deratings from
 8 airflow issues in the 2016/2017 winter season on Unit 1 and Unit 2.

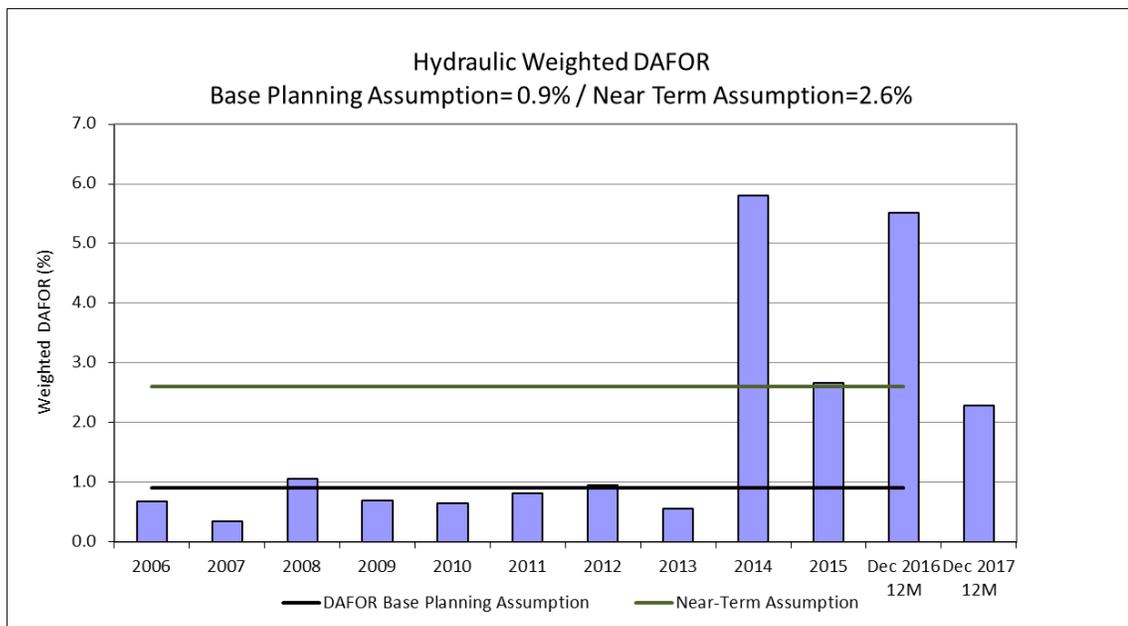
Figure 1 Hydraulic Weighted DAFOR

- 1 Considering the individual units' performance, the assumed Hydro generation base planning
- 2 DAFOR was materially exceeded for Bay d'Espoir Unit 1 and Bay d'Espoir Unit 2. Also, there
- 3 were exceedances compared to base planning assumption for Bay d'Espoir Unit 6, Bay d'Espoir
- 4 Unit 7, and Paradise River for the current period.

1 The Bay d’Espoir Unit 1 DAFOR of 9.33% and Unit 2 DAFOR of 14.11% exceeded the base
2 planning assumption of 0.9% and the near-term assumption of 3.9% for an individual Bay
3 d’Espoir unit. This was due to Units 1 and 2 being removed from service on November 4, 2017
4 as a result of a leak in Penstock 1 which provides water to both units. The leak occurred in the
5 same area where similar leaks had occurred in 2016, which initiated further investigation and
6 subsequent intervention. A consultant (Hatch) was engaged in the process to provide
7 engineering analysis and recommendations to return the penstock to reliable service. Extensive
8 inspection and testing was completed, which resulted in the damaged section being completely
9 removed, and replaced with a new plate that was overlaid with a second plate. All additional
10 suspect areas were also cleaned, re-welded, and overlaid with additional plates. Additional

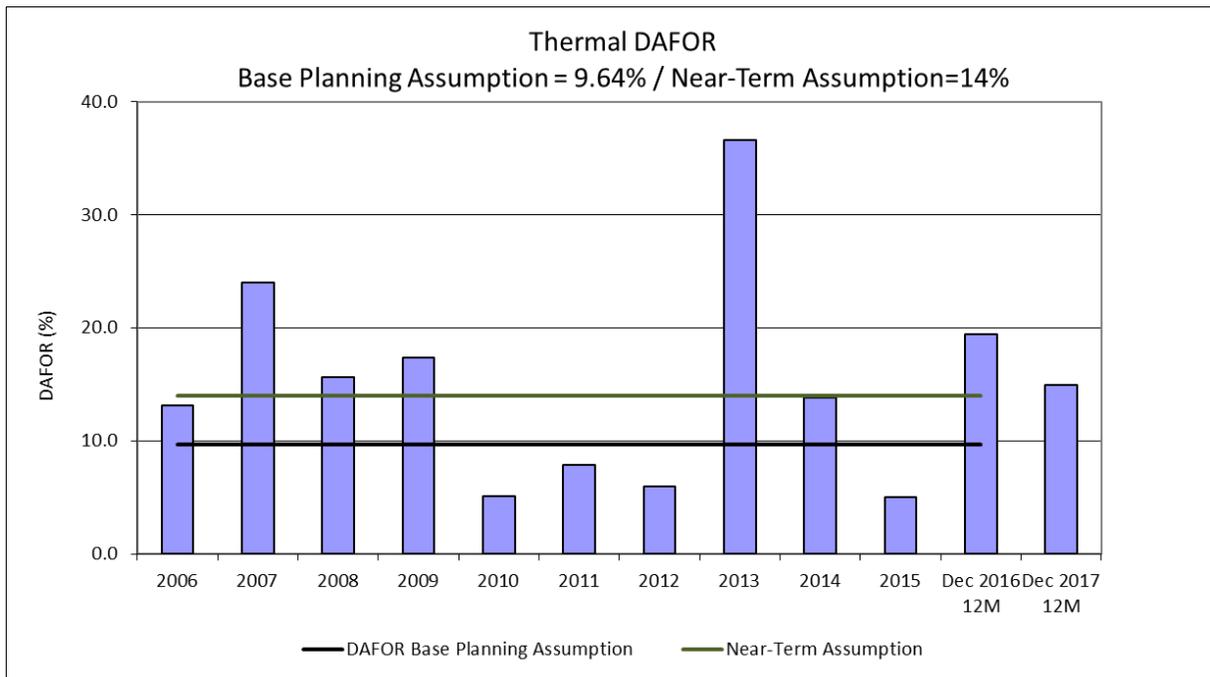
Figure 2 Thermal DAFOR

- 1 For the 12-month period ending December 31, 2017 the weighted DAFOR for all thermal units
- 2 of 14.91% is above the assumed Hydro generation base planning DAFOR value of 9.64% and the
- 3 near-term assumption of 14.00%⁷. Unit 1 DAFOR was 19.35% and Unit 2 DAFOR was
- 4 19.14%.The performance for both Units 1 and 2 was above the base planning assumption of
- 5 9.64% and the near-term assumption of 15% (Unit 1) and 10% (Unit 2). Unit 3 DAFOR was

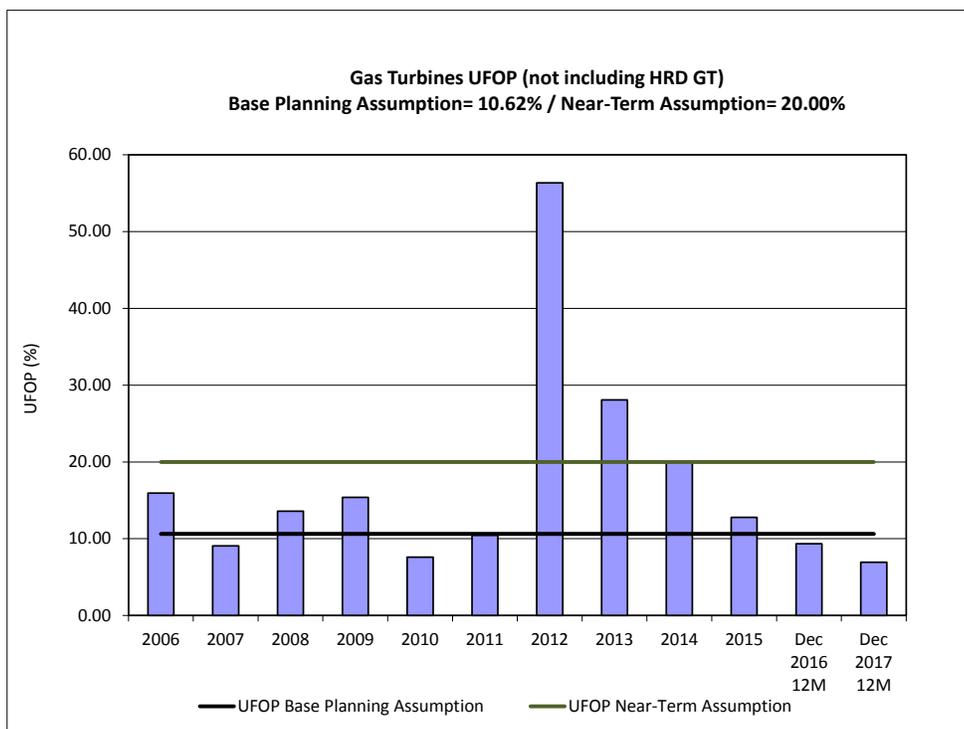
Figure 3 Gas Turbine UFOP – HWD/HVY/SVL Units

12 The combined UFOP for the Hardwoods, Happy Valley and Stephenville gas turbines was 6.93%
13 for the 12-month period ending December 31, 2017 (see Table 6 and Figure 3). This is below the
14 base planning assumption of 10.62% and the near-term assumption of 20.00%. The current
15 period UFOP declined from the previous period UFOP of 9.35%. The Hardwoods UFOP for the
16 current period is 2.91%, which is better than the base planning assumption of 10.62%. The
17 Stephenville UFOP for the current period is 5.59%, which is better than the base planning
18 assumption of 10.62%. Happy Valley's UFOP is 19.32% for the current period compared to
19 5.03% in the previous period.

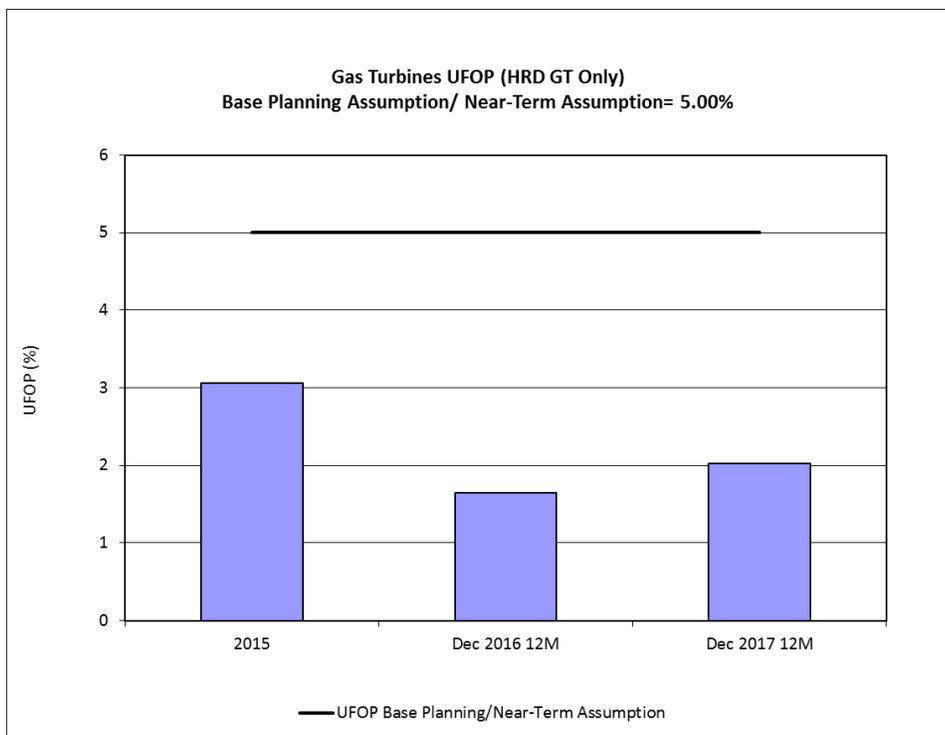
Figure 4 Gas Turbine UFOP – HRD Unit

- 1 The Holyrood (HRD) GT UFOP of 2.02% for the current period is better than the base planning
- 2 and near-term assumptions of 5.00% (see Table 7 and Figure 4).

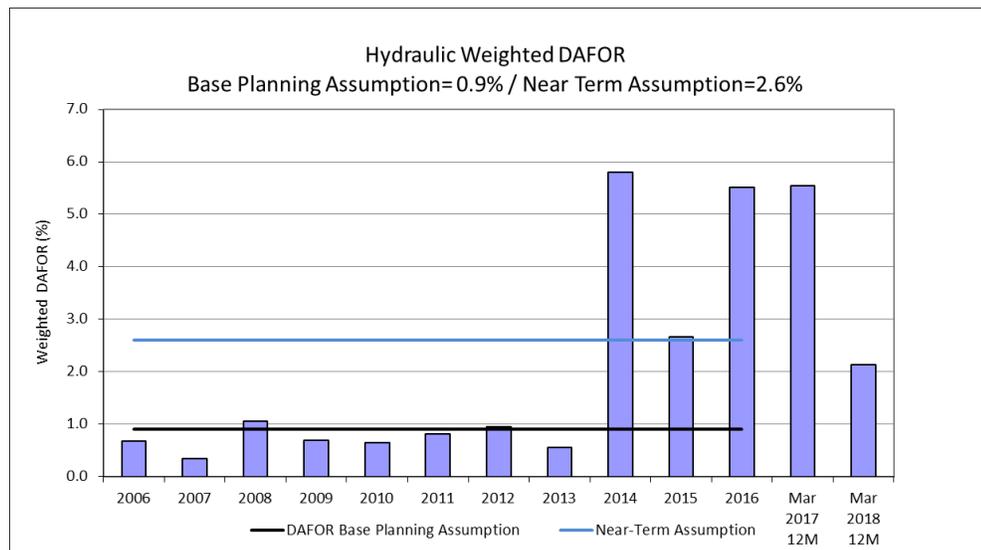
Figure 1: Hydraulic Weighted DAFOR

- 1 Considering the individual units' performance, the assumed Hydro generation base planning
- 2 DAFOR was materially exceeded for Bay d'Espoir Unit 1 and Bay d'Espoir Unit 2. Also, there
- 3 were exceedances compared to base planning assumption for Bay d'Espoir Unit 7, and Paradise
- 4 River for the current period.

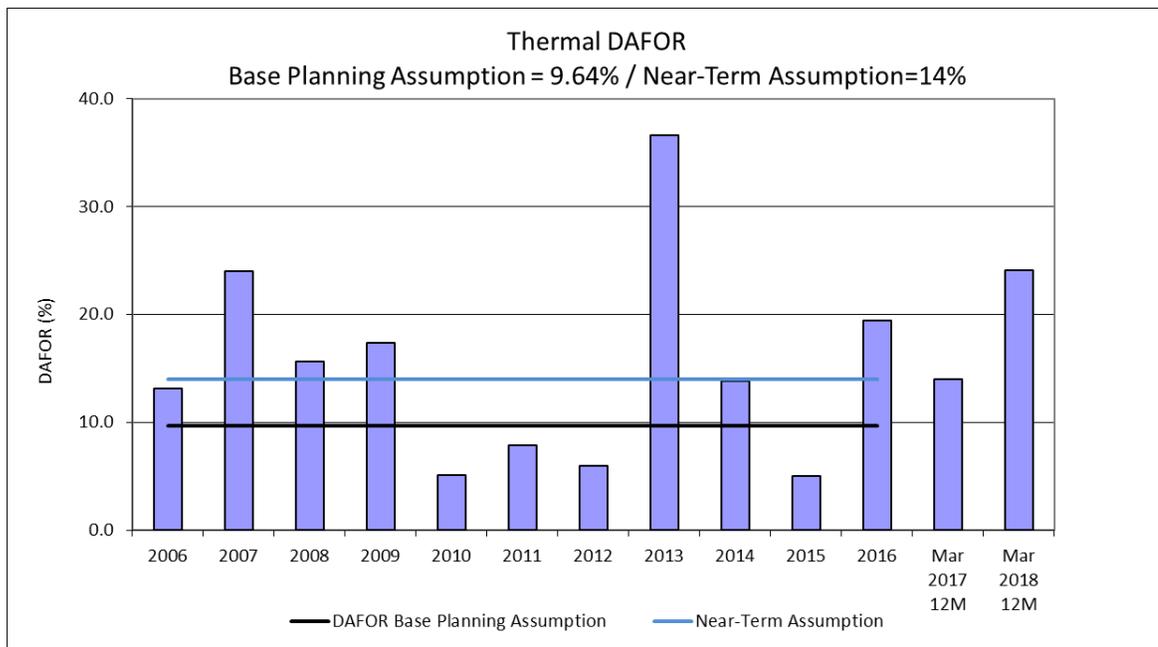
Figure 2: Thermal DAFOR

1 For the 12-month period ending March 31, 2018, the weighted DAFOR for all thermal units of
 2 24.90% is above the assumed Hydro generation base planning DAFOR value of 9.64% and the
 3 near-term assumption of 14.00%⁷. Unit 1 DAFOR was 31.66% and Unit 2 DAFOR was
 4 25.36%. The performance for both Units 1 and 2 was above the base planning assumption of
 5 9.64% and the near-term assumption of 15% (Unit 1) and 10% (Unit 2). Unit 3 DAFOR was
 6 14.03%, which is above the base planning assumption of 9.64% but below the near-term
 7 assumption of 18.0%.

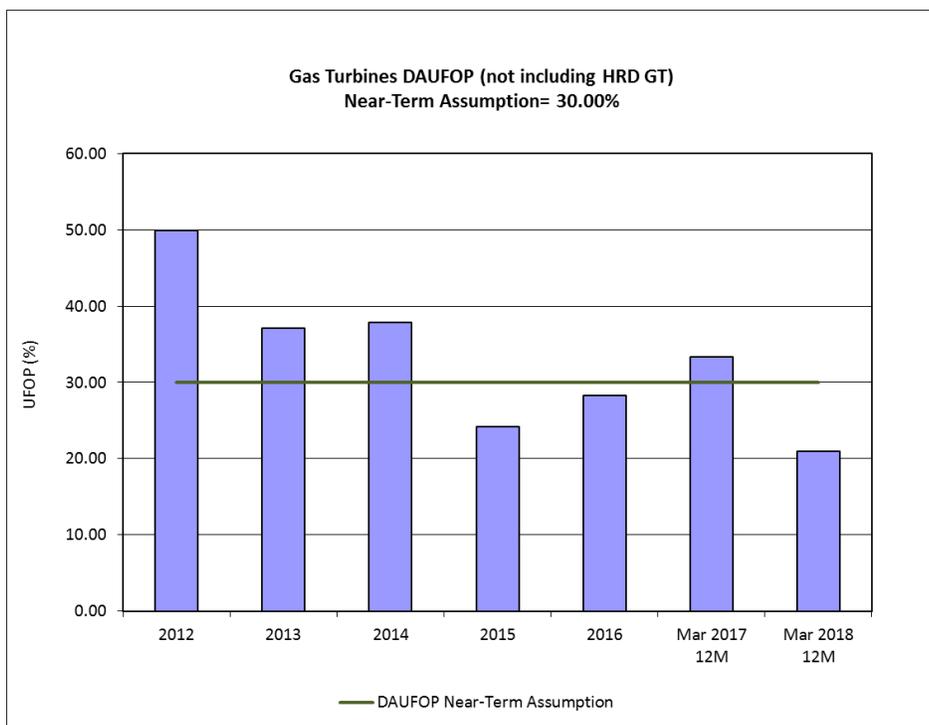
Figure 5: Gas Turbine DAUFOP – HWD/HVY/SVL Units

1 The Stephenville Gas Turbine DAUFOP for the period is impacted by the unavailability of End A
2 as a result of an exhaust bellows failure at Hardwoods Gas Turbine End A on December 28,
3 2017. End A was unavailable at this time due to issues with the power turbine rear bearing
4 which requires the bearing to be replaced. Hydro decided to remove the bellows from End A at
5 Stephenville and install it at Hardwoods End A to return that Unit to full capacity. It is currently
6 expected that the Stephenville Gas Turbine will be returned to full capacity at the end of July
7 2018.

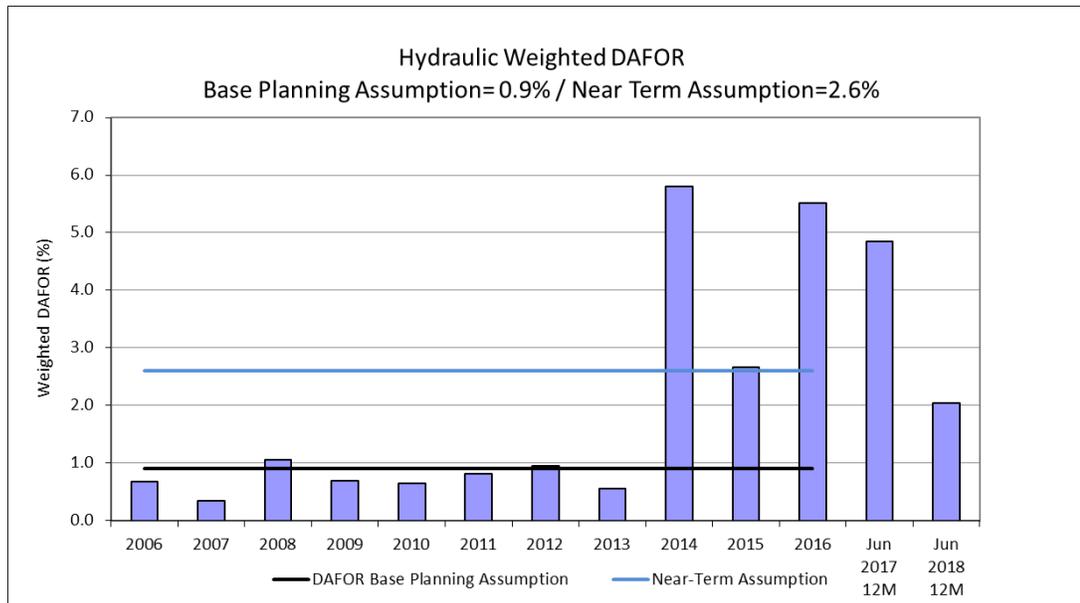
Figure 1: Hydraulic Weighted DAFOR

1 Considering the individual units' performance, the assumed Hydro generation base planning
 2 DAFOR was materially exceeded for Bay d'Espoir Unit 1 and Bay d'Espoir Unit 2. Also, there
 3 were exceedances compared to base planning assumption for Bay d'Espoir Unit 7 for the
 4 current period.

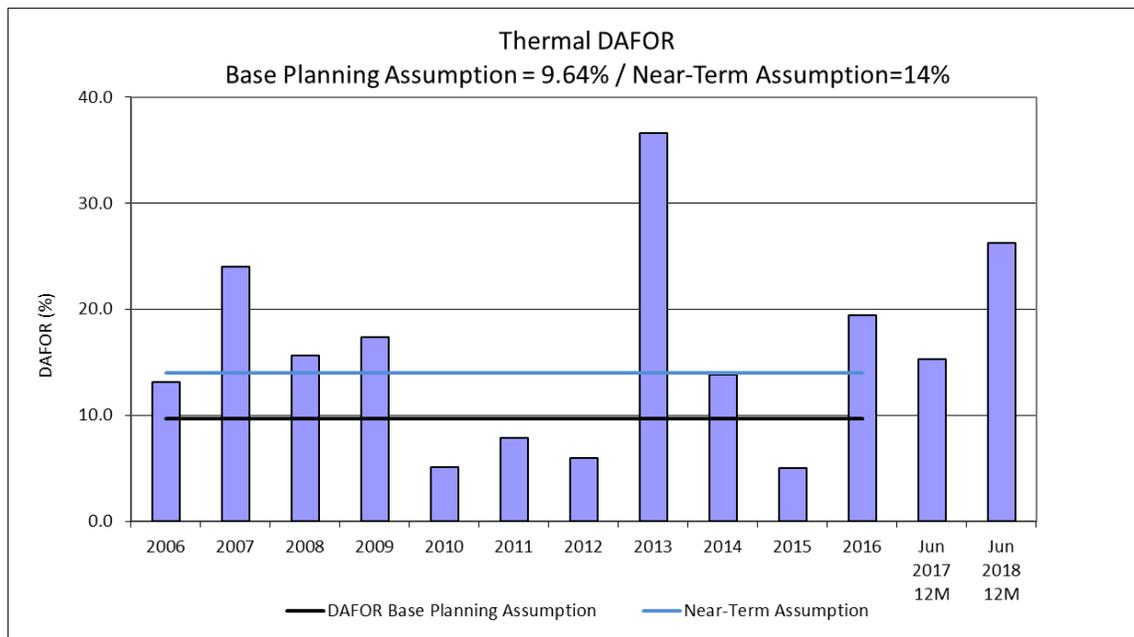
Figure 2: Thermal DAFOR

1 For the 12-month period ending June 31, 2018, the weighted DAFOR of 26.22% for all thermal
 2 units is above the assumed Hydro generation base planning DAFOR value of 9.64%, and the
 3 near-term assumption of 14.00%.⁷ Unit 1 DAFOR was 32.30% and Unit 2 DAFOR was 26.62%.
 4 The performance for both Units 1 and 2 was above the base planning assumption of 9.64% and
 5 the near-term assumption of 15% (Unit 1) and 10% (Unit 2). Unit 3 DAFOR was 16.60%, which
 6 is above the base planning assumption of 9.64% but below the near-term assumption of 18.0%.
