1 Q. Please provide copies of Hydro's forecasted availability measures and the actual availability
2 measures for 2016-2018 for both hydraulic and thermal production assets.

5 A. For Newfoundland and Labrador Hydro's ("Hydro") forecast availability measures and
6 actual measures for the last three years please refer to:

8 • PUB-NLH-015, Attachment 1 for Hydro's "Quarterly Report on Performance of
9 Generating Units for the Quarter Ended March 31, 2016;"

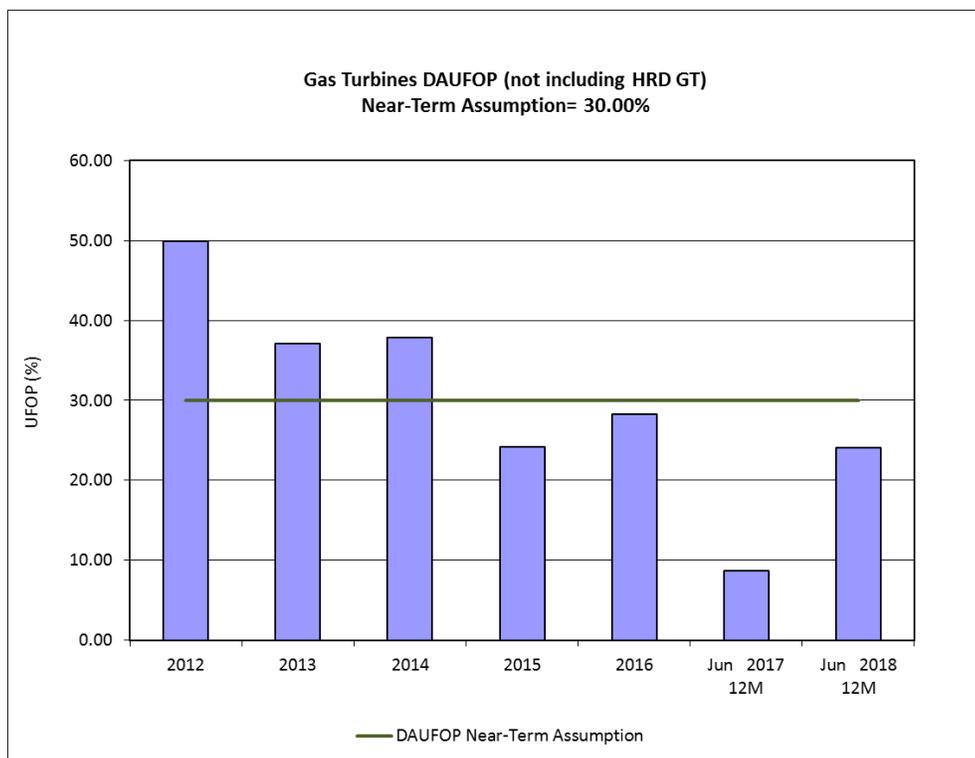
Figure 5: Gas Turbine DAUFOP – HWD/HVY/SVL Units

1 The Stephenville gas turbine DAUFOP for the period was impacted by the unavailability of End A
2 as a result of an exhaust bellows failure at Hardwoods gas turbine End A on December 28, 2017.
3 End A was unavailable at this time due to issues with the power turbine rear bearing which
4 requires the bearing to be replaced. Hydro decided to remove the bellows from End A at
5 Stephenville and install it at Hardwoods End A to return that Unit to full capacity. It is currently
6 expected that the Stephenville gas turbine will be returned to full capacity in August 2018.

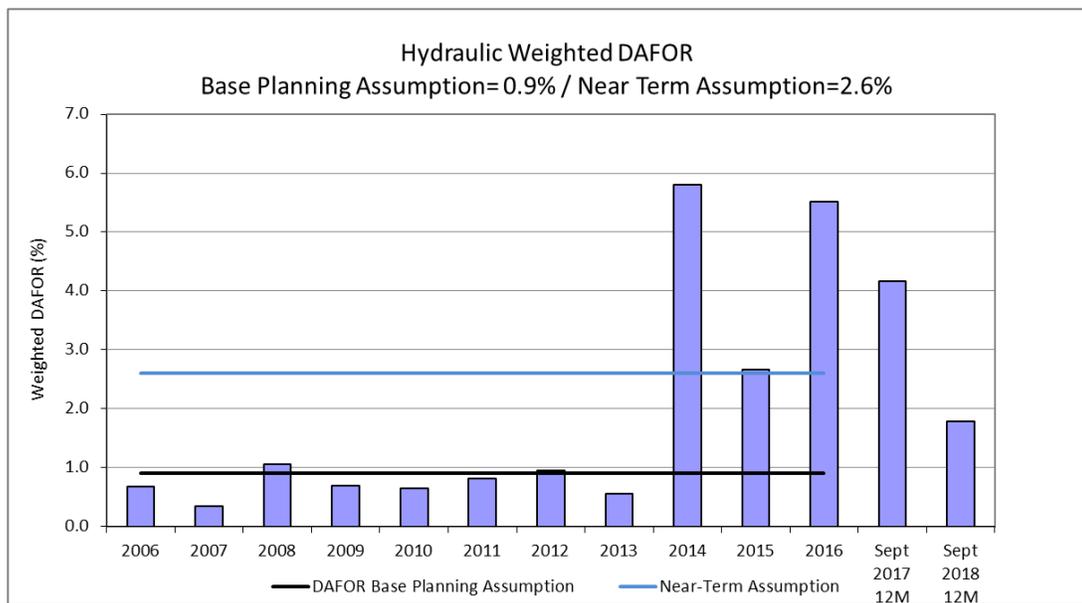
Figure 1: Hydraulic Weighted DAFOR

1 Considering the individual units' performance, the assumed Hydro generation base planning
2 DAFOR was materially exceeded for Bay d'Espoir Unit 1 and Bay d'Espoir Unit 2.¹⁰ Also, Cat Arm
3 Unit 1 exceeded the base planning assumption for the current period.

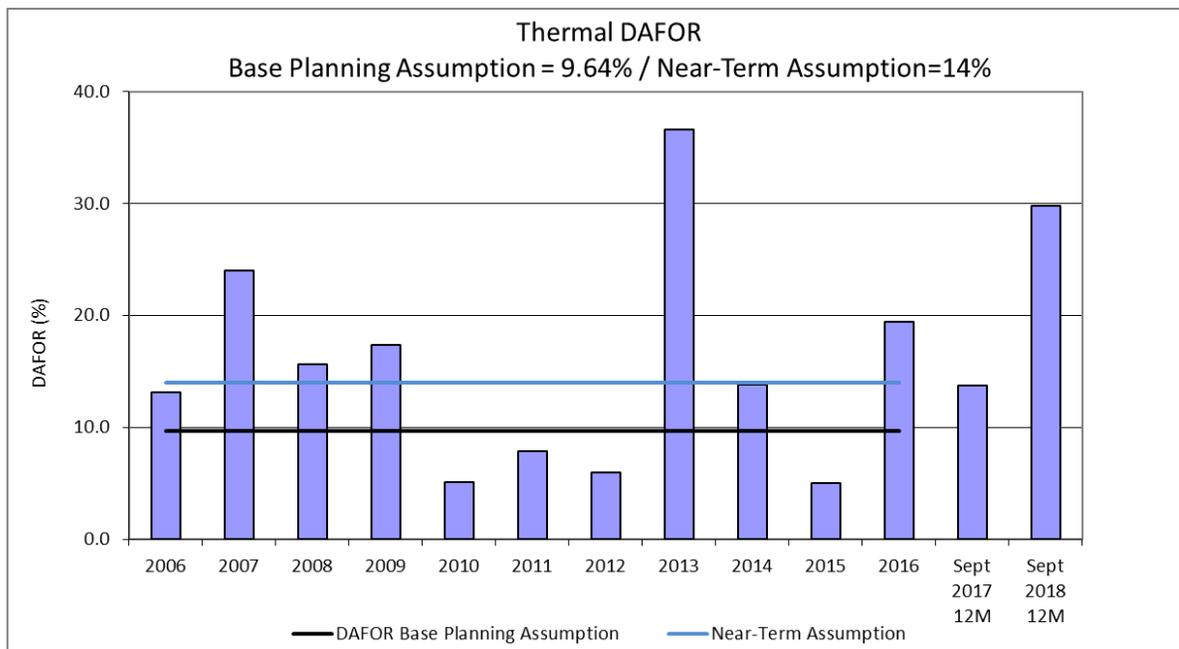
Figure 2: Thermal DAFOR

1 For the 12-month period ending September 31, 2018, the weighted DAFOR for all thermal units
2 of 29.77%¹³ is above the assumed Hydro generation base planning DAFOR value of 9.64%, and
3 the near-term assumption of 14.00%. Unit 1 DAFOR was 35.49% and Unit 2 DAFOR was 30.64%.
4 The performance for both Units 1 and 2 was above the base planning assumption of 9.64% and
5 the near-term assumption of 15% (Unit 1) and 10% (Unit 2). Unit 3 DAFOR was 18.17%, which is
6 above the base planning assumption of 9.64% and the near-term assumption of 18.0%.

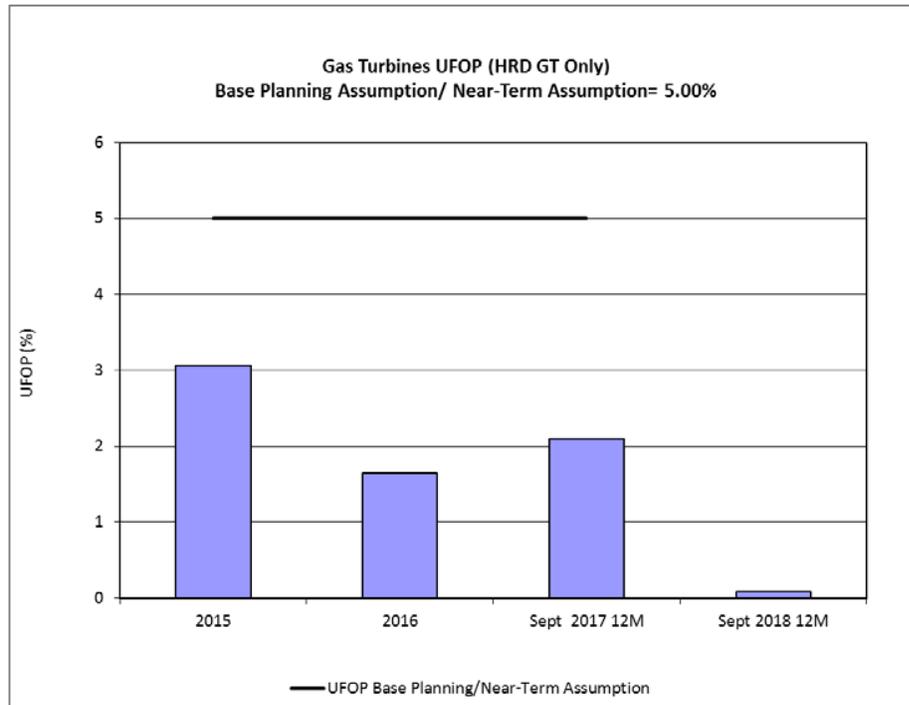
Figure 4: Gas Turbine UFOP – Holyrood Unit

- 1 The Holyrood (HRD) GT UFOP of 0.08% for the current period is better than the base and near-
- 2 term planning assumptions of 5.00% (see Table 7 and Figure 4).

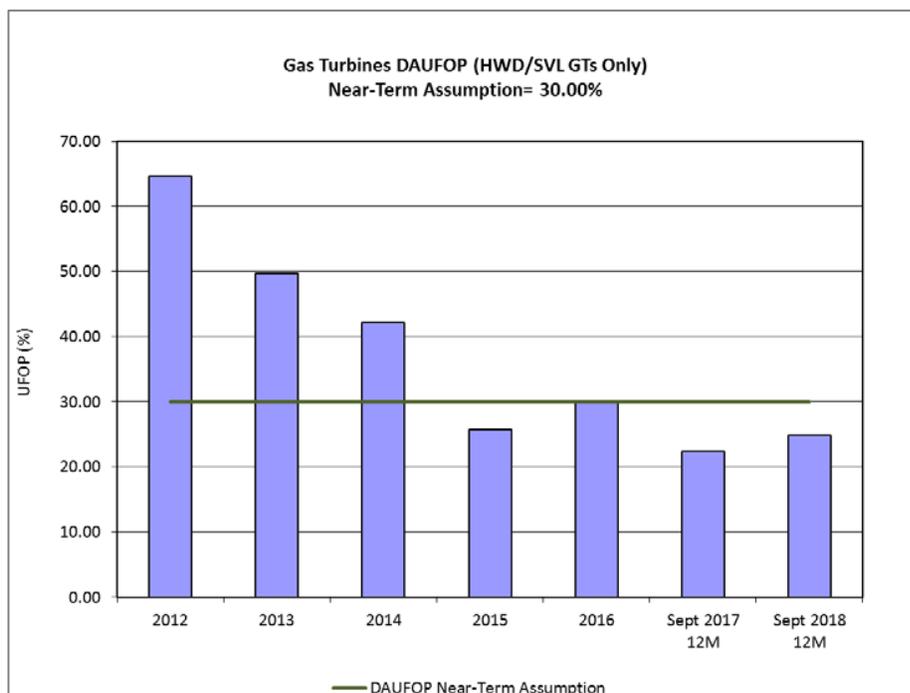
Figure 5: Gas Turbine DAUFOP – Hardwoods/Stephenville Units

2 The combined DAUFOP for the Hardwoods and Stephenville gas turbines was 24.83% for the
 3 12-month period ending September 30, 2018 (refer to Table 8 and Figure 5). This is below the
 4 near-term planning assumption of 30.00%. The Hardwoods DAUFOP for the current period is
 5 14.47%, which is better than the near-term planning assumption of 30.00%. The Stephenville
 6 UFOP for the current period is 51.20%, which is above the near-term planning assumption of
 7 30.00%.

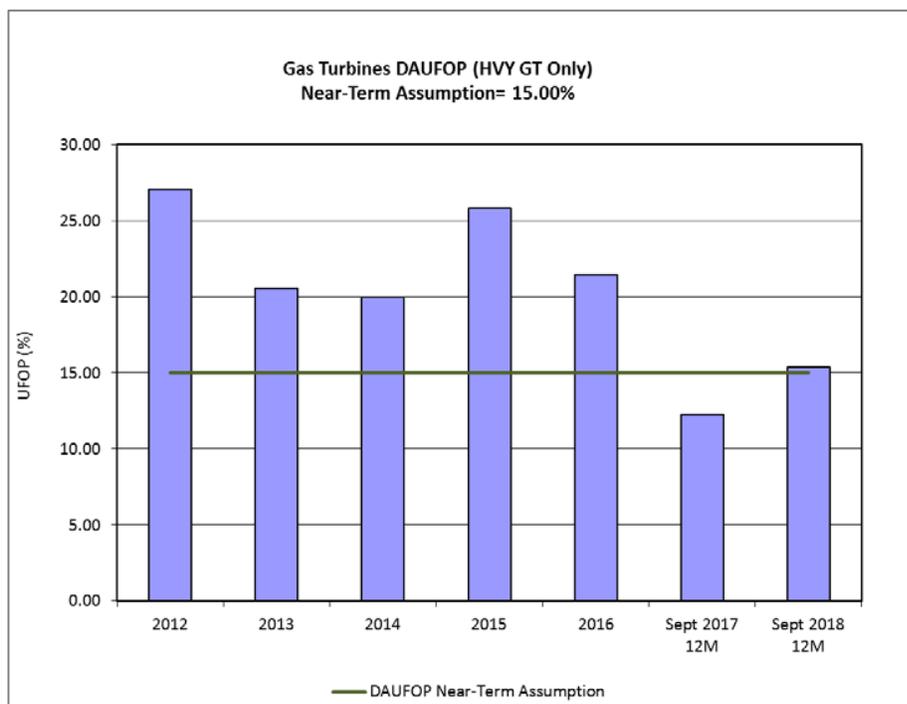
Figure 6: Gas Turbine DAUFOP – Happy Valley Unit

- 1 The DAUFOP for the Happy Valley gas turbine was 15.39% for the 12-month period ending
- 2 September 30, 2018 (refer to Table 9 and Figure 6). This is above the near-term planning
- 3 assumption of 15.00%.

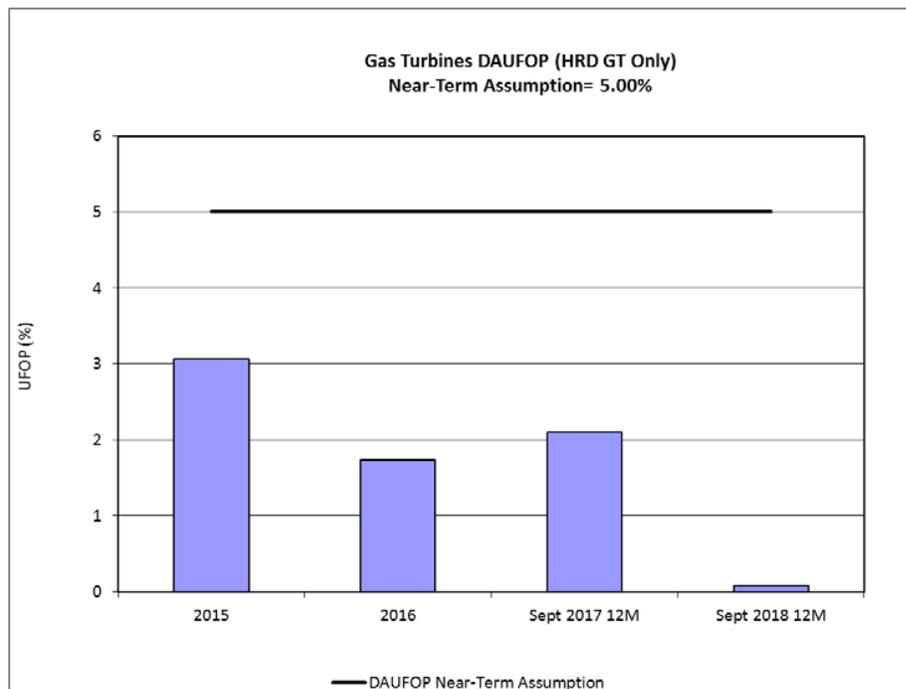
Figure 7: Gas Turbine DAUFOP – Holyrood Unit

- 1 The Holyrood gas turbine DAUFOP of 0.08% for the current period is better than the near-term
- 2 planning assumption of 5.00% (see Table 10 and Figure 7).

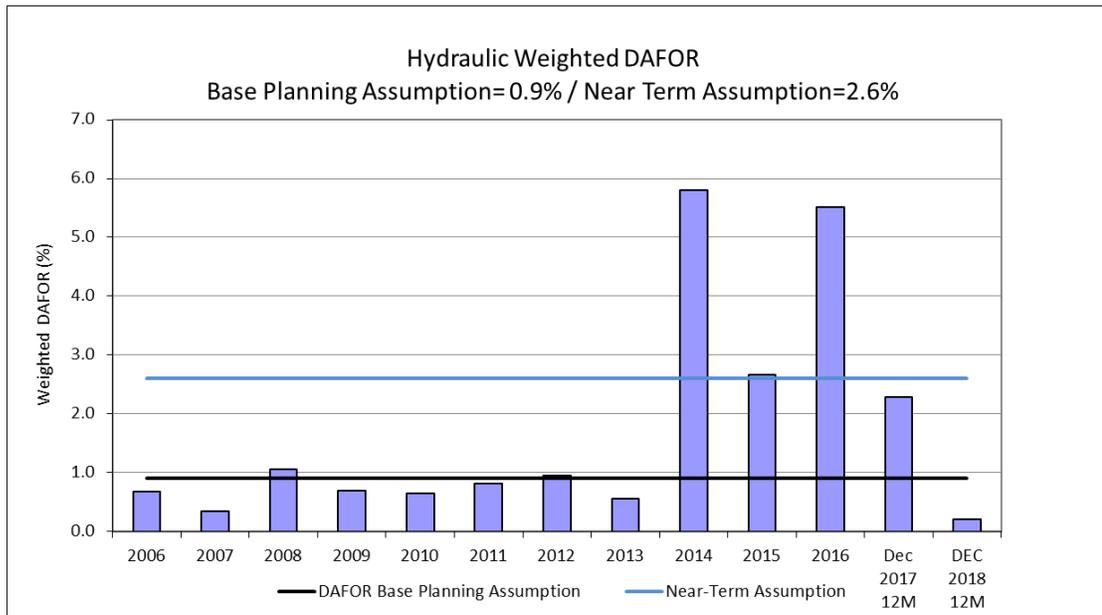
Figure 1: Hydraulic Weighted DAFOR

- 1 Considering the individual unit performance, the Hydro generation base planning DAFOR was
- 2 exceeded for Cat Arm Unit 1 for the current period.

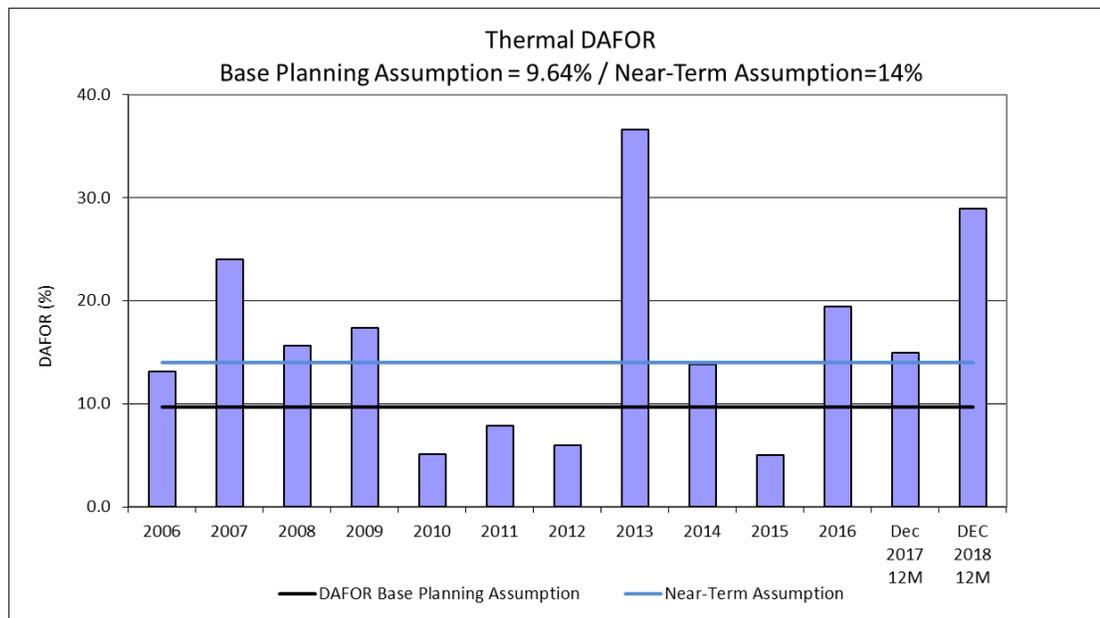
Figure 2: Thermal DAFOR

1 For the 12-month period ending December 31, 2018, the weighted DAFOR for all thermal units
 2 of 28.97%⁹ is above the assumed Hydro generation base planning DAFOR value of 9.64%, and
 3 the near-term assumption of 14.00%. Unit 1 DAFOR was 36.66% and Unit 2 DAFOR was 24.03%.
 4 The performance for both Units 1 and 2 was above the base planning assumption of 9.64% and
 5 the near-term assumption of 15% (Unit 1) and 10% (Unit 2). Unit 3 DAFOR was 22.80%, which is
 6 above the base planning assumption of 9.64% and the near-term assumption of 18.0%.

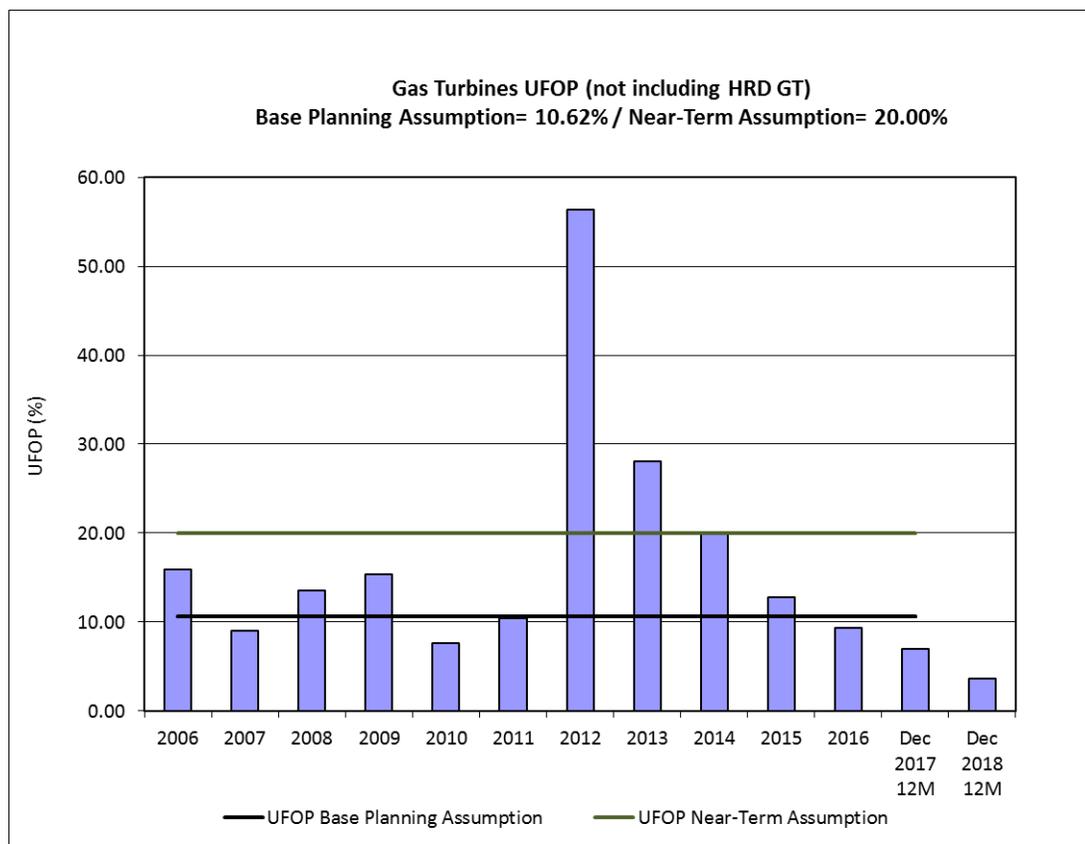
Figure 3: Gas Turbine UFOP – Hardwoods/Happy Valley/Stephenville Units

13 The combined UFOP for the Hardwoods, Happy Valley and Stephenville gas turbines was 3.62%
14 for the 12-month period ending December 31, 2018 (see Table 6 and Figure 3). This is below the
15 base planning assumption of 10.62%, and the near-term assumption of 20.00%. The current
16 period UFOP is significantly better than the previous period UFOP of 6.93%. The Hardwoods
17 UFOP for the current period is 4.80%, which is better than the base planning assumption of
18 10.62%. The Stephenville UFOP for the current period is 1.45%, which is better than the base
19 planning assumption of 10.62%. The Happy Valley UFOP is 2.11% for the current period, which
20 is below the base planning assumption of 10.62%.

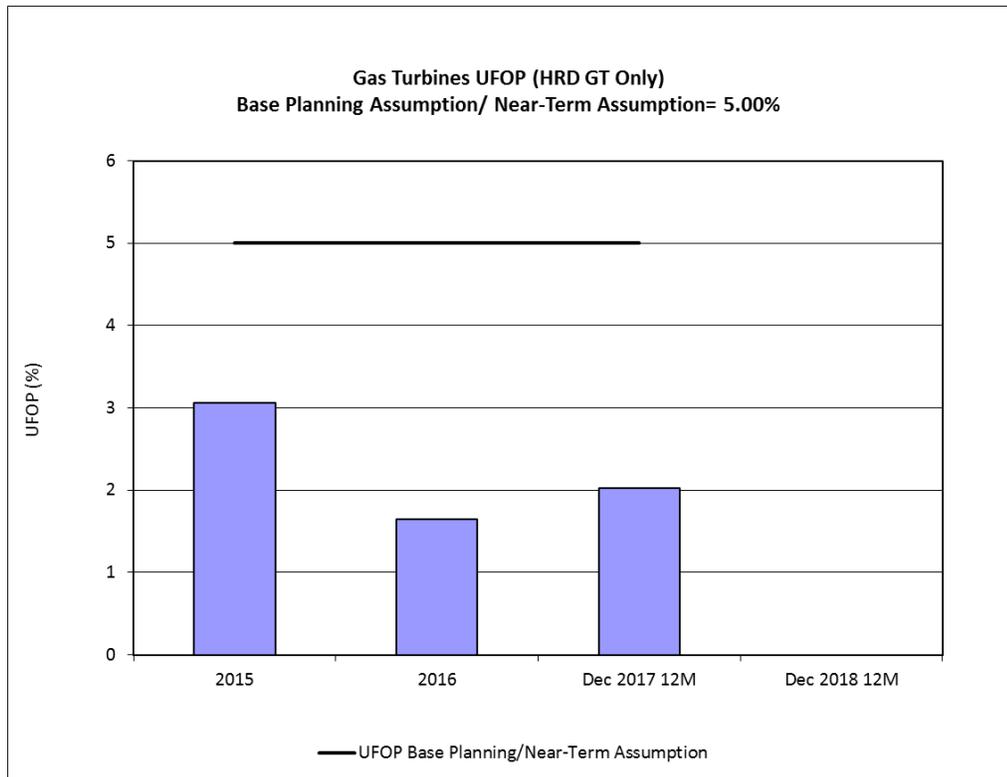
Figure 4: Gas Turbine UFOP – Holyrood Unit

- 1 The Holyrood UFOP of 0.00% for the current period is better than the base and near-term
- 2 planning assumptions of 5.00% (see Table 7 and Figure 4).

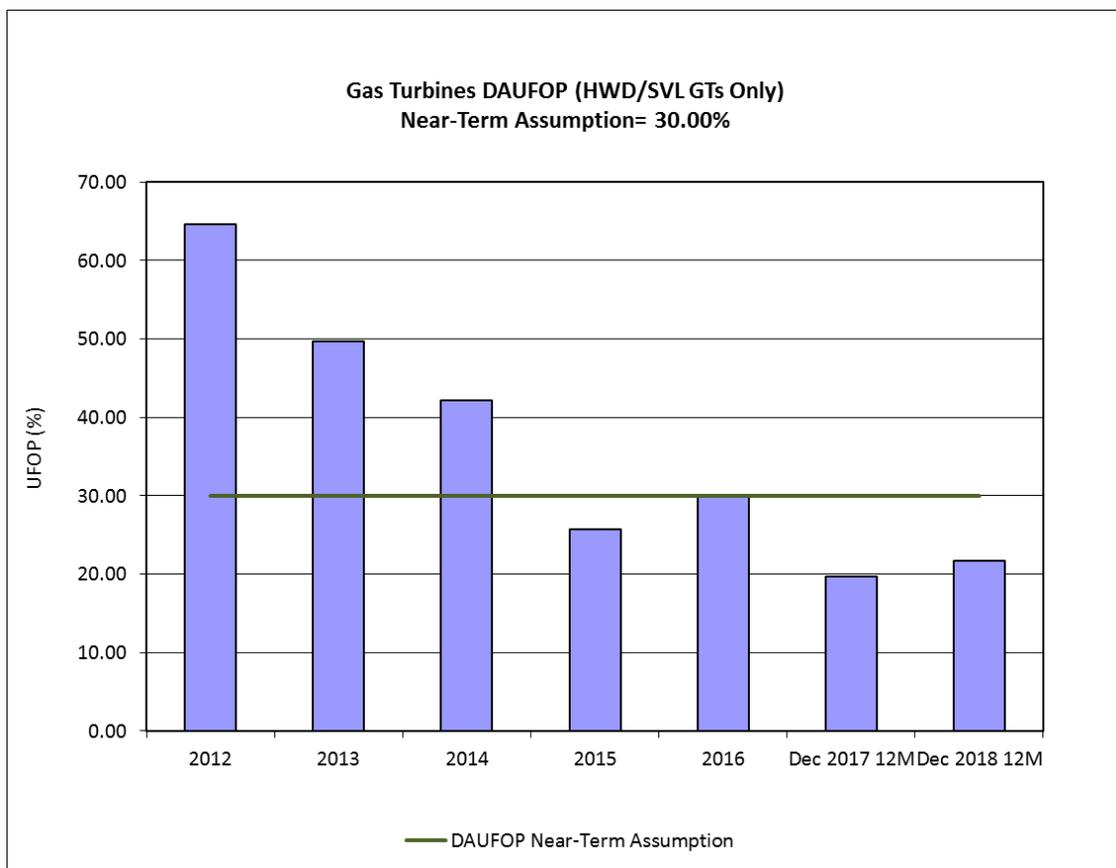
Figure 5: Gas Turbine DAUFOP – Hardwoods/Stephenville Units

2 The combined DAUFOP for the Hardwoods and Stephenville gas turbines was 21.67% for the
 3 12-month period ending December 31, 2018 (refer to Table 8 and Figure 5). This is below the
 4 near-term planning assumption of 30.00%. The Hardwoods DAUFOP for the current period is
 5 8.28%, which is better than the near-term planning assumption of 30.00%. The Stephenville
 6 DAUFOP for the current period is 47.48%, which is above the near-term planning assumption of
 7 30.00%.

1 The Stephenville gas turbine DAUFOP for the period is impacted by the unavailability of End A
2 as a result of an exhaust bellows failure at Hardwoods gas turbine End A on December 28, 2017.
3 Stephenville End A was unavailable at this time due to issues with the power turbine rear
4 bearing, which required the bearing to be replaced. Hydro decided to remove the bellows from
5 End A at Stephenville and install it at Hardwoods End A to return that unit to full capacity.

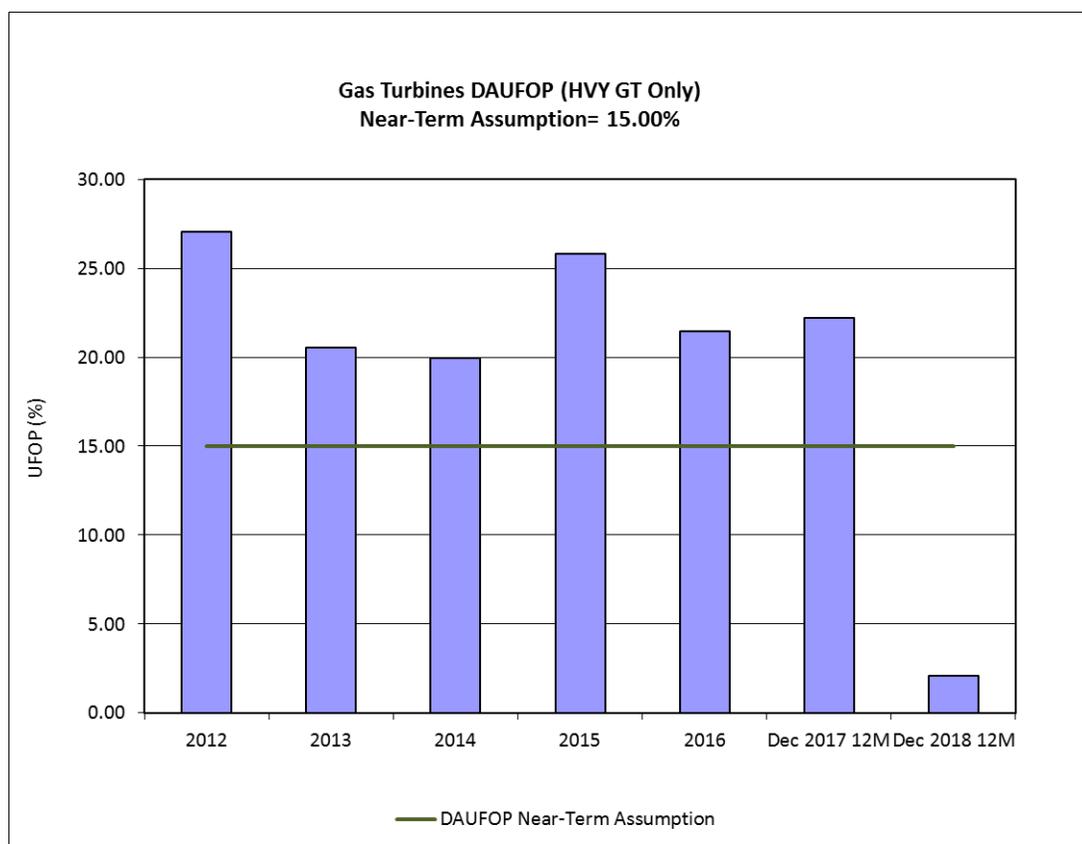
Figure 6: Gas Turbine DAUFOP – Happy Valley Unit

- 1 The DAUFOP for the Happy Valley gas turbine was 2.11% for the 12-month period ending
- 2 December 31, 2018 (refer to Table 9 and Figure 6). This is below the near-term planning
- 3 assumption of 15.00%.

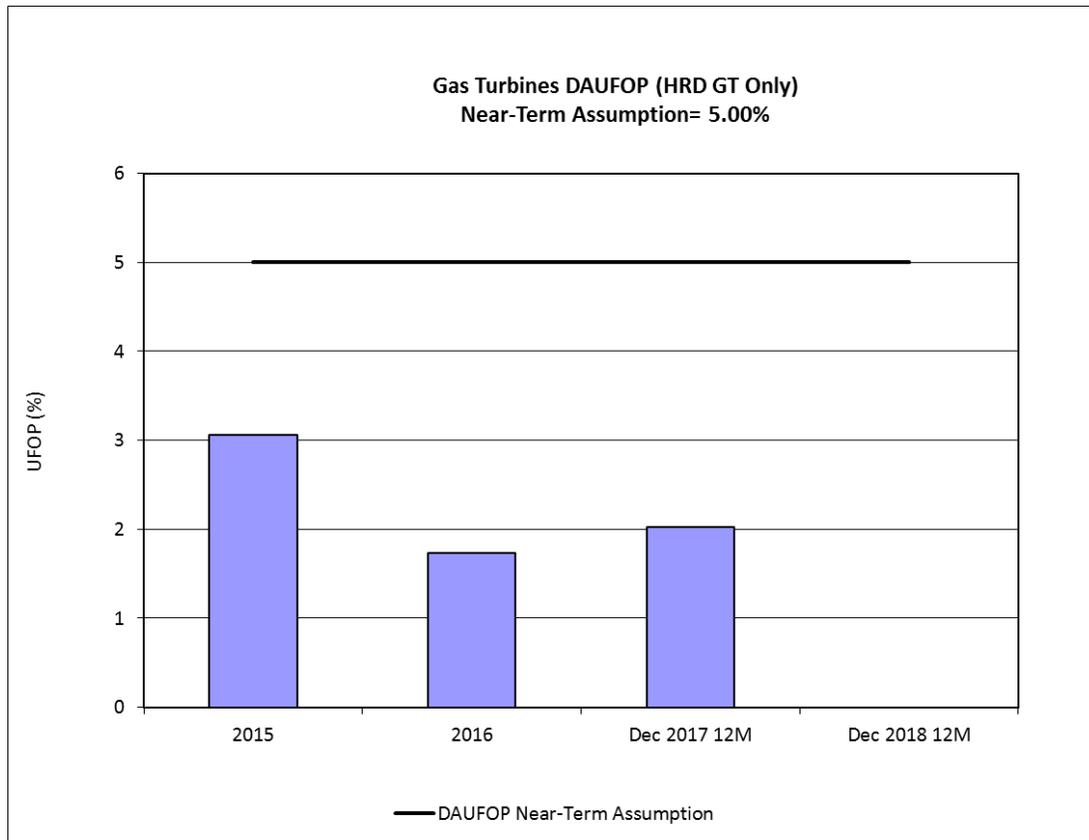
Figure 7: Gas Turbine DAUFOP – Holyrood Unit

- 1 The Holyrood gas turbine DAUFOP of 0.00% for the current period is better than the near-term
- 2 planning assumption of 5.00% (see Table 10 and Figure 7).
