*Arguments against the use of the ELG*

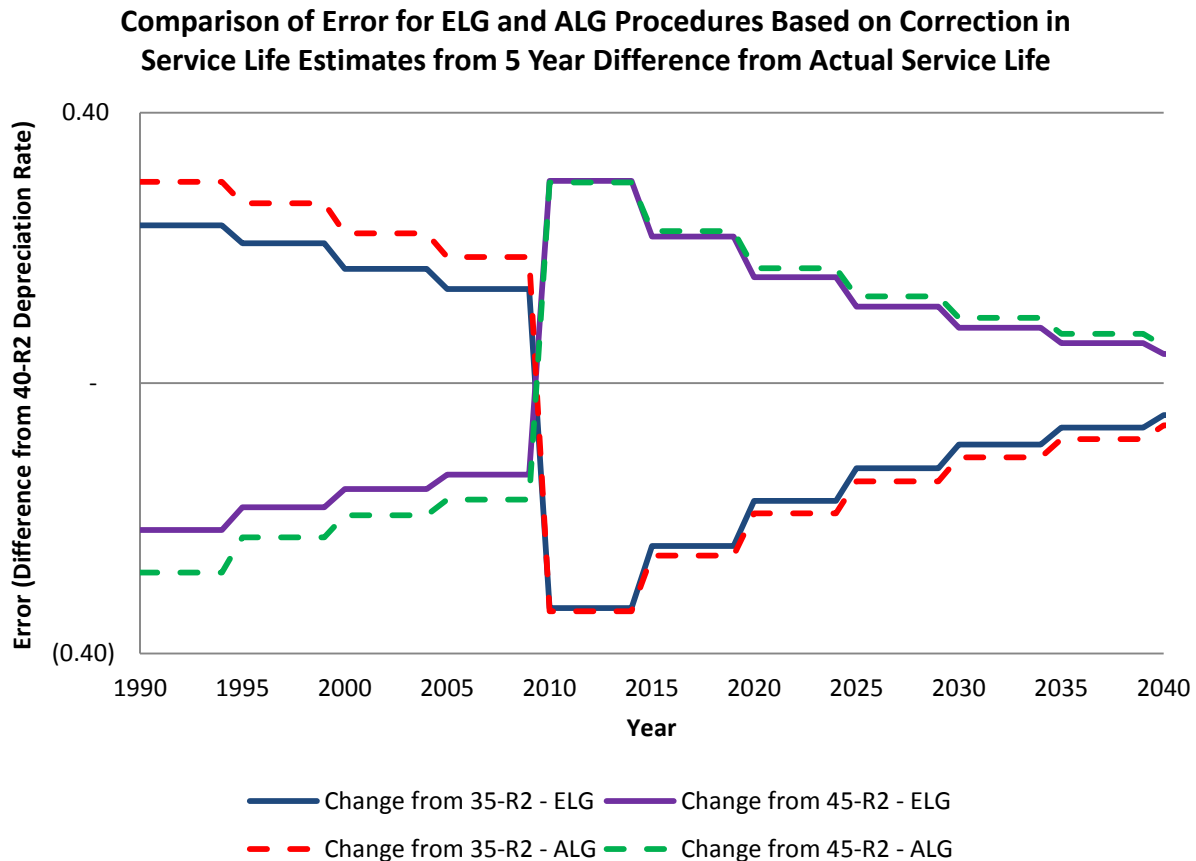
Figure 1 shows the results of this analysis. The solid lines in the chart represent the differences in depreciation rates between scenarios 2 and 3 and scenario 1 for the ELG procedure, and the dashed lines represent the same for the ALG procedure. As the chart shows, at the time of the correction in service life in 2010, the both the ELG and ALG procedures show a similar difference from depreciation rates based on the correct estimate. However, both before and after the change the ALG depreciation rates show a higher degree of error. This analysis indicates there is no basis to conclude that ELG depreciation rates show a higher degree of error.
