LOWER CHURCHILL RIVER RIVERBANK STABILITY REPORT

Grand Riverkeeper Labrador, Inc.

On specific questions regarding the formation of the Churchill River Valley and comments on stability issues related to the North Spur

The intent of this Report is to explain the extraordinary features of the Churchill River Valley, and to comment on North Spur stability regarding the proposed future impoundment.

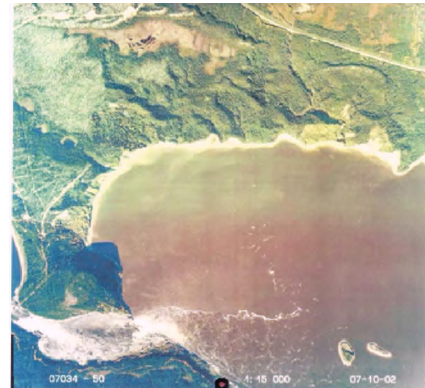
The exceptional depth of the riverbed — about 70 metres — immediately downstream of Muskrat Falls is due to a whirlpool in which the water current is so strong that sedimentation of the eroded marine sediments originating from the upper Churchill Valley cannot take place.

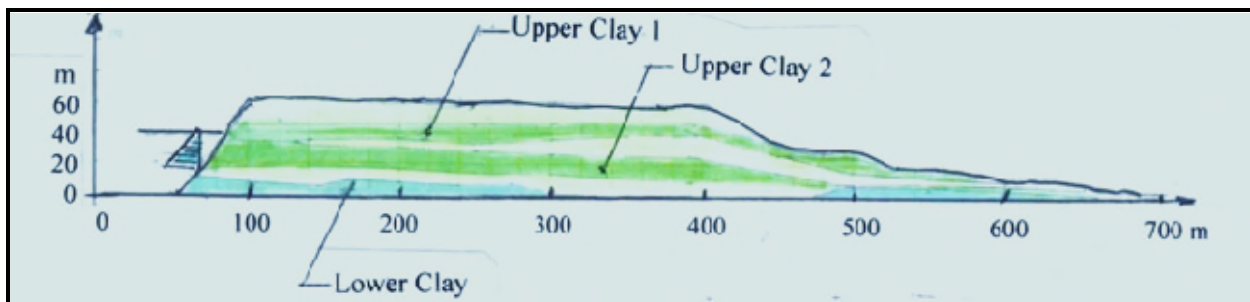
Figure 3.1. Section B-B through the North Spur showing main sedimentary features according to the *NALCOR Report* [3]

As indicated in Table 1, the layers of Upper Clay 1 and 2 consist of lean silty clays with a permeability $k \approx 1 \times 10^{-7}$ m/sec.

The yellow area corresponds to the data given by NALCOR [2] in respect of Liquid Limits and the Plasticity Indices applying to the Upper Clays Nos. 1 and 2 shown in Figure 3.1.

Figure 4.4 shows the typical condition, with marine sediments of mostly uniformly graded sands and silts resting on a clay layer with properties similar to those in the Upper Clay layer 2 (in Figure 3.1 related to the North Spur).

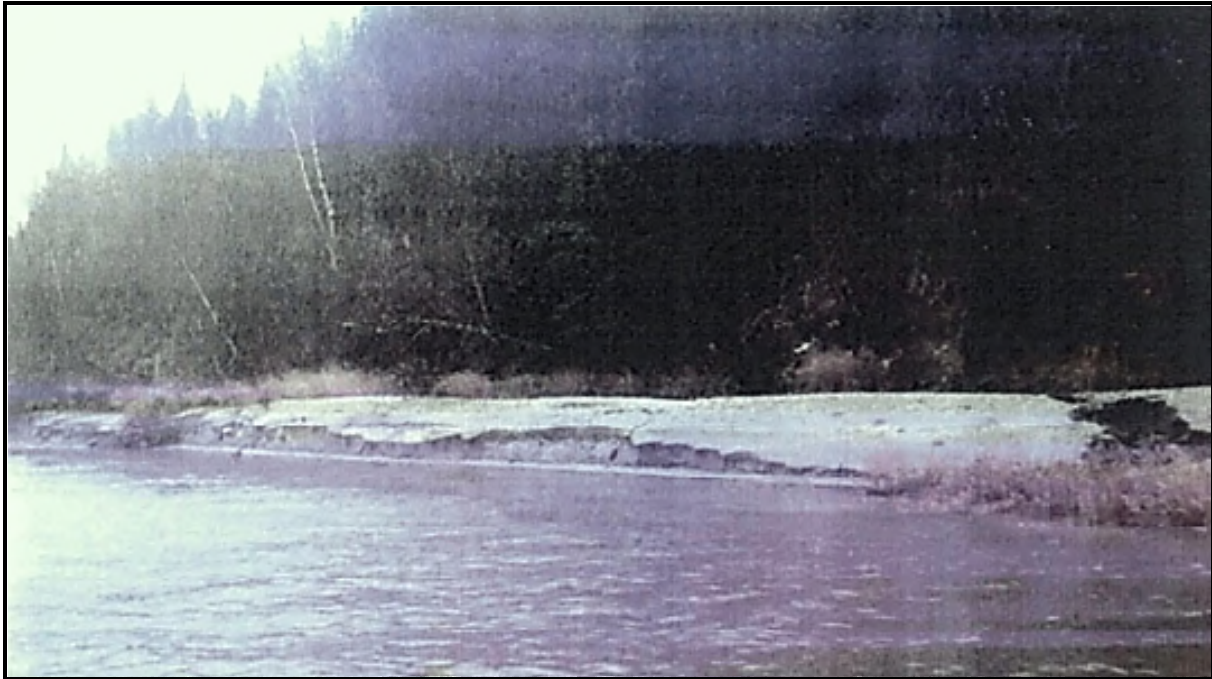
Figure 3.5. Clay exposure a few hundred metres upstream of the large 2014 landslide shown in Figure 4.3 (Photo: Eldred Davis)

Figure 3.5 shows a large exposure of the type of lean clay discussed in Section 2. The effect of merely repeated stamping with a foot was enough to cause visible wavelike movement of the clay surface, indicating sensitivity and high propensity to soil liquefaction.

Another important, easily identifiable property of this clay layer was its propensity to being eroded. The large erosion scar on the picture has been caused by water trickling during rain. Many other smaller recent erosion scars were to be seen — of which one is right in the centre of the riverside scarp in the picture.

In other words, the lean clay in the exposure matches the description in Section 2.3, and which is briefly defined in Section 2.4. This means that the clay content of the mixed soil is highly under-consolidated, thus indicating propensity to soil liquefaction. The specific features of the Churchill River Valley with its shallow riverbed and steep unstable riversides are mainly due to this specific soil condition.

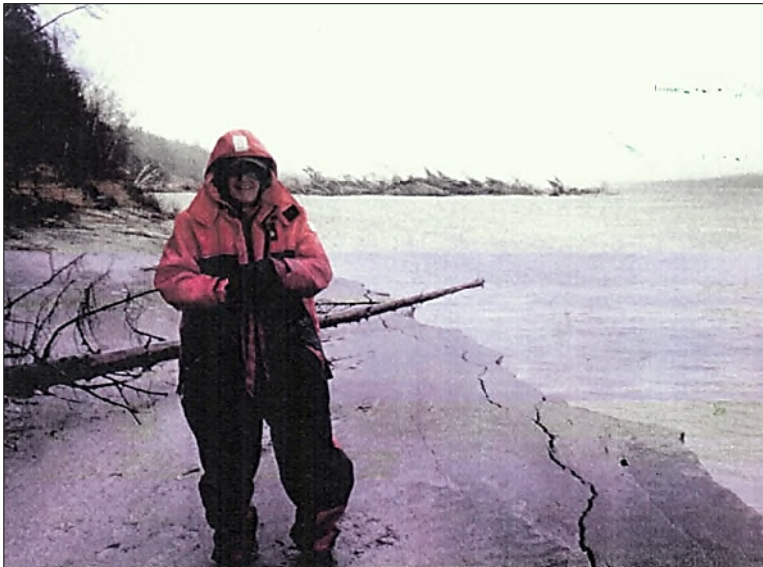
Figure 3.6. Clay exposure close to river water level

Figure 3.6 below illustrates another feature of the clay exposures. Although the scarp forming the riverbank is only 1 to 1.5 metres high — the river being very shallow here — deep cracks have developed in the clayey soil, indicating impending local failure. This means that the cohesive strength of the mixed silty, sandy clay is only in the order of 4 to 6 kN/m², since the shear resistance to avoid failure is about $c \approx 0.20 \times \rho \times g \times H = 0.2 \times 19 \times 1.5 \approx 6 \text{ kN/m}^2$.

The 2014 landslide is seen in the background. (Photo: Eldred Davis, 27 October 2014)

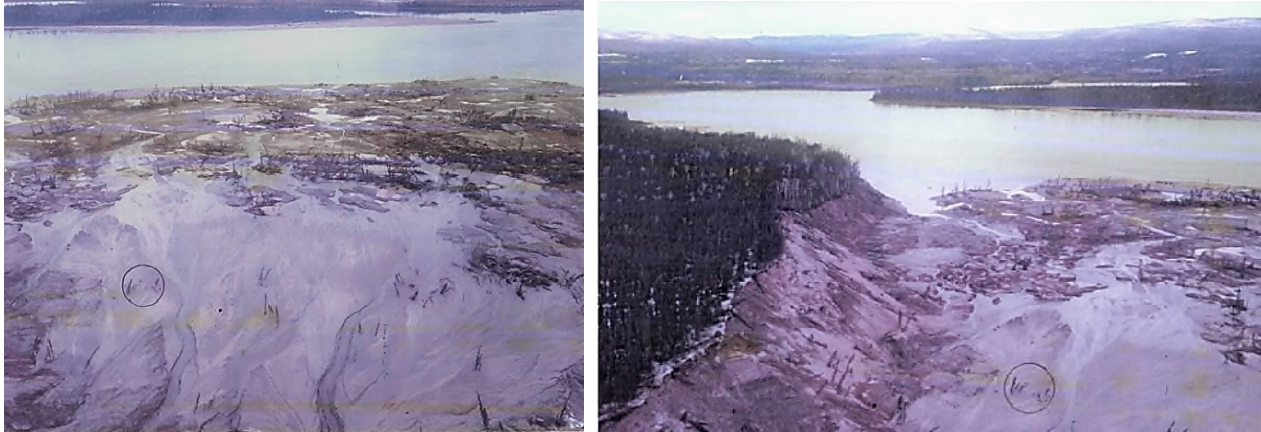
Figures 4.2a and 4.2b. The Edward Island landslide (200?). These two photos have been taken from different angles and aerial positions. The enormous extent of the landslide can be seen by considering that the encircled areas represent the same locality. (Photos: Cabot Martin)

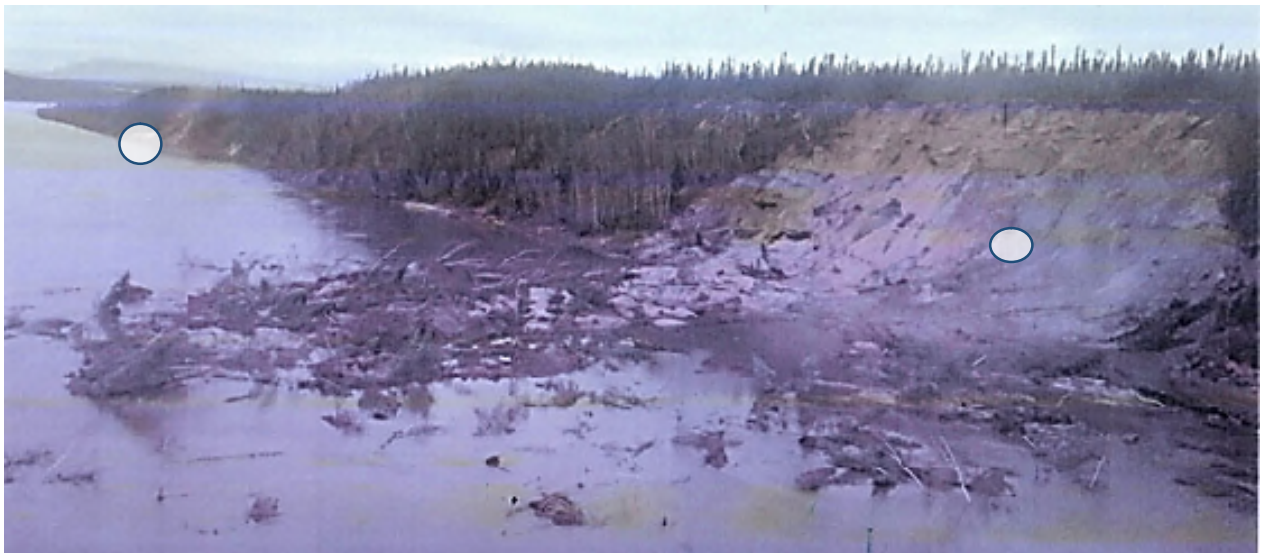
Figure 4.3. The 2014 large landslide south of Muskrat Falls: widening of the Churchill River Valley by large “quick-clay” slides. (Photo: Cabot Martin)
