**Re: Reliability and Resource Adequacy Study Review – Assessment of Labrador-Island Link
Reliability – Revision 1**

Labrador-Island Link Reliability Assessment – Summary Report

Attachment 1: Assessment of Labrador Island Transmission Link (LIL) Reliability in Consideration of Climatological Loads

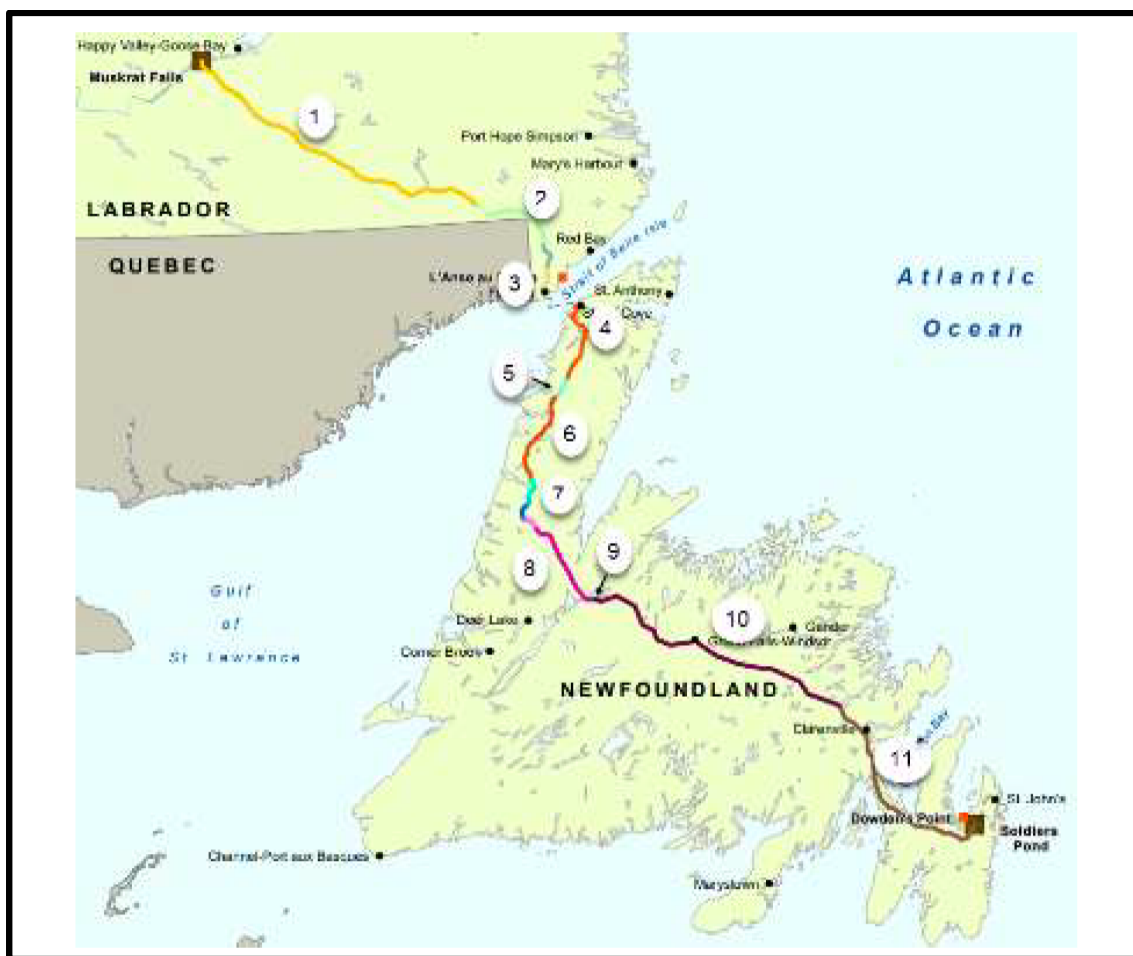
The ± 350 kV HVdc line route extends from the Muskrat Falls generating station in Labrador to the Strait of Belle Isle, before passing under the Strait of Belle Isle via an underwater submarine cable system to the Island of Newfoundland. From the Strait, the HVdc transmission line follows the western coast of the Great Northern Peninsula (GNP), crosses the Long-Range Mountains (LRM), passes south of Grand Falls, and terminates at the Soldier's Pond Terminal station near St. John's. The HVdc line passes through a region of the LRM known for severe in-cloud glaze and rime icing conditions (Figure 1.4, Zone 7 and Figure 1.5). The line in the Southern Labrador section is also vulnerable to both severe glaze and rime icing conditions. The 1093 km consists of 388km in Labrador and 705km in Newfoundland. The DC line is fully integrated in the island's AC system and transports energy to the Maritimes via a sub-sea cable link. Figure 1.4 presents the layout of the HVdc line configuration.

Figure 1.4 LIL Routing with Main Segments Identified (11 Main Loading Zones, EFLA 2020)

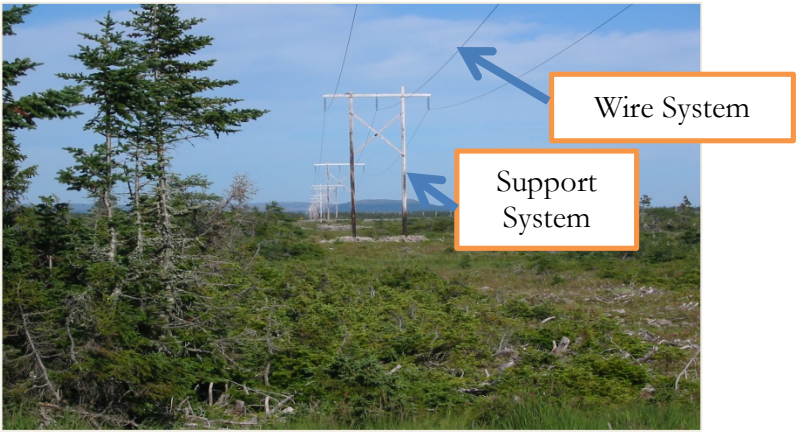
Figure 2.6 A Typical Wood Pole H-Frame Line System

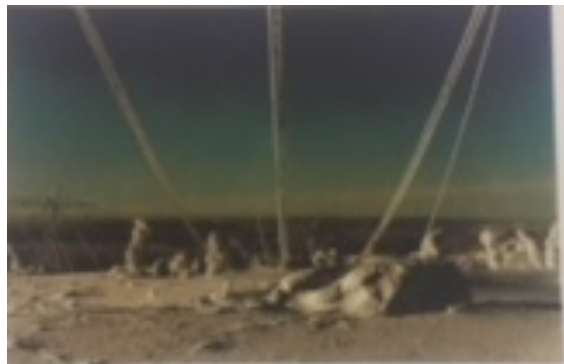
A similar event occurred in December 1995 that led to an initial DLS violation. This event caused outages because a U-bolt got damaged initially and eventually failed as the icing event continued. In both cases, it appears that the event started with the violation of DLS criterion and led to inoperable line due to the severe icing conditions that continued. No structural damage was experienced in 1995 and in 1997. The event in 1995 led to ULS because of the failed U-bolt.

Figure 3.3 735 KV AC Line Failure at Churchill Falls (Heavy Icing on Conductors)

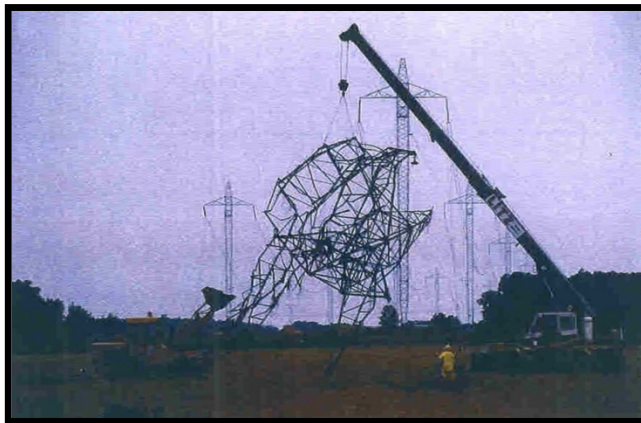
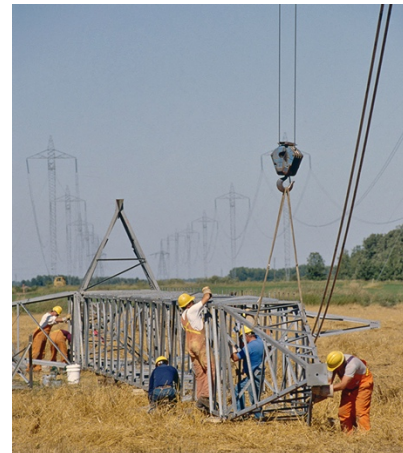
In the early hours of September 5, 1996, a severe thunderstorm moved through the rural area immediately northwest of Winnipeg. Seventeen guyed steel towers of the two parallel HVDC transmission lines collapsed (Figure xx), causing the complete failure of the Radisson-Dorsey Transmission System carrying 2020 MW. In addition, 3 steel towers and 18 wood pole structures were damaged. The storm was a microburst wind (non-synoptic wind) that produced extremely high intensity wind (HIW) that caused downward pressure and lateral winds that moved through a narrow strip approximately 2 km wide. Based on the damage evidence, it was estimated that low end wind speed that occurred in the area was equivalent to an Enhanced Fujita scale F1 wind speed of 180 km/h. It took almost four days to restore power. Since this line failure, Manitoba Hydro has invested significant R & D funds to understand better the effects of HIW on transmission lines.

Figure 3.4 DC Tower Failure under Microburst (High Intensity Wind, MH Bipole Lines)

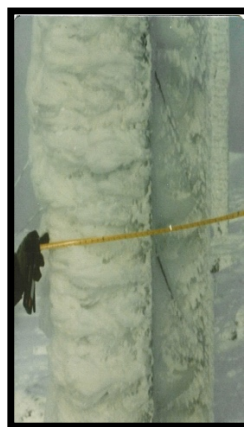
To study the icing phenomenon along the proposed HVdc transmission line route, NLH installed several ice monitoring test stations (test spans and guyed towers at specific locations along the route) and operated these stations from 1979-87. Figure 4.4 depicts a typical icing event that was observed on a test tower located in a southern part of Labrador.

Figure 4.4 Observed Rime Icing in Labrador

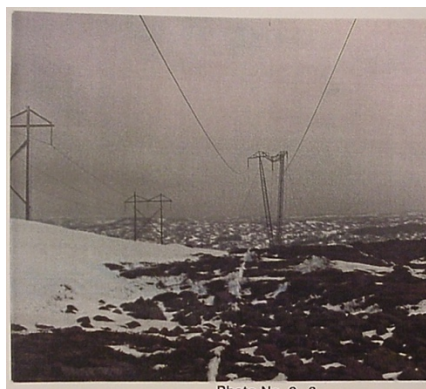
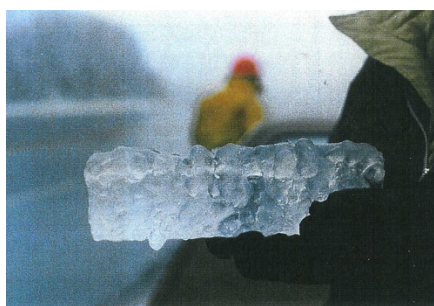
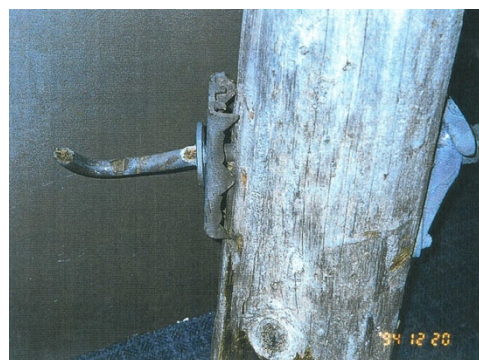
Figure 8.3 (a) Figure 8.3 Bridge Failure of a Guyed-V Suspension Tower in 1988 (b) Large Angle Tower Failure near Hawke Hill (1988 Storm) (c) aa glaze ice sample during 1984 storm on the Avalon Peninsula and (d) Failure of a Forged Eye Bolt in 1994

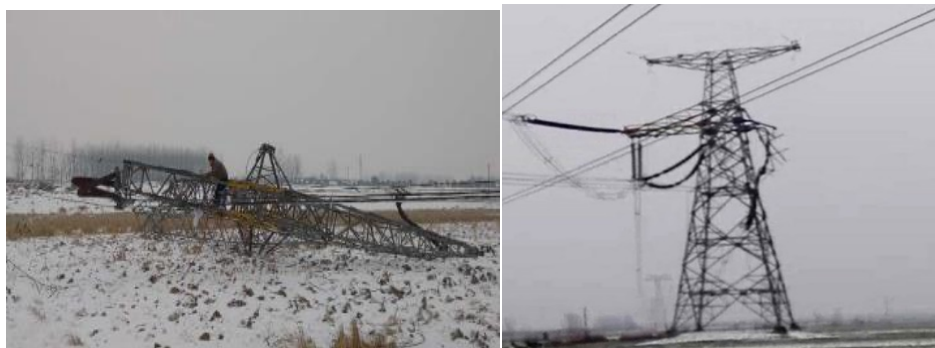
Figure 8.8a Photo of the collapsed tower and (b) Tower's cross arm failure (Liu, 2021)
