**Newfoundland Power Inc.  
2007 Capital Budget Application  
Filing Contents**

## Rattling Brook Hydro Plant Refurbishment

Prepared by:  
Gary L. Murray, P.Eng.

March 2006

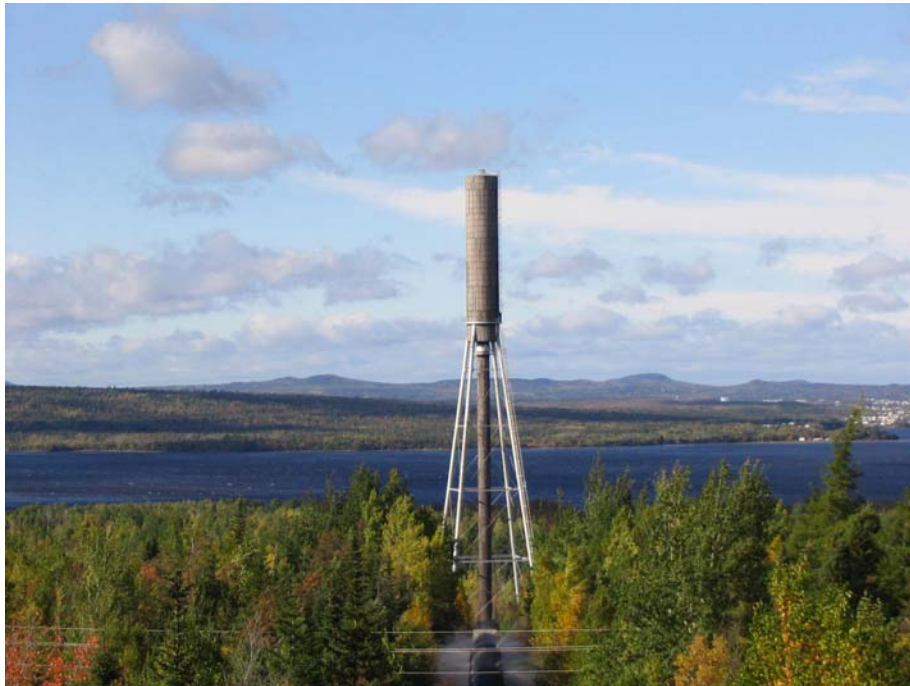
**Figure 6: View of Surge Tank**

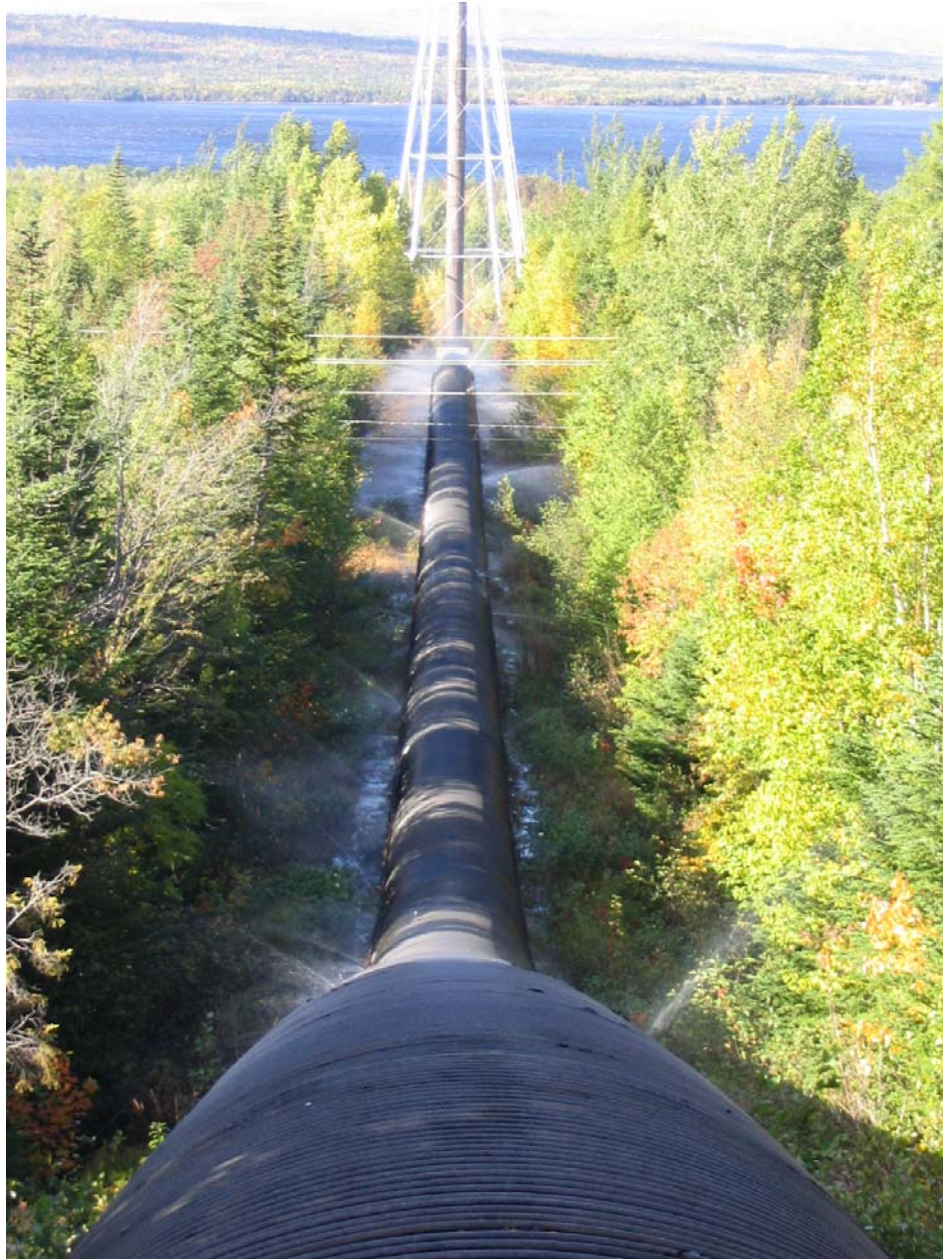
The woodstave penstock is 48 years old and is in poor condition with excessive deterioration and significant leakage along the spring line. The penstock bedding is saturated resulting in localized settlement of the pipe, with the penstock resting on the ground in a number of locations. In recent years, a number of major leaks have resulted in undermining of the support structure in several locations. Leakage is expected to worsen causing operational difficulties, increasing maintenance costs and lost energy. It is proposed to replace the woodstave penstock in 2007.

**Figure 7: Lower Section of Woodstave Penstock**

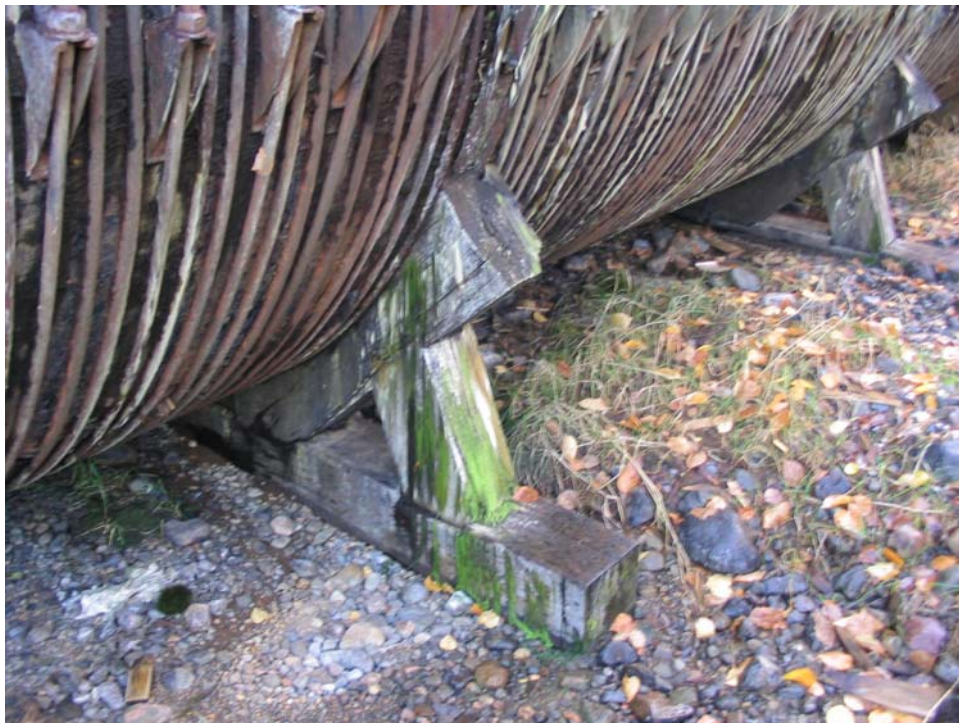
**Figure 11: Settlement of Penstock Supports**

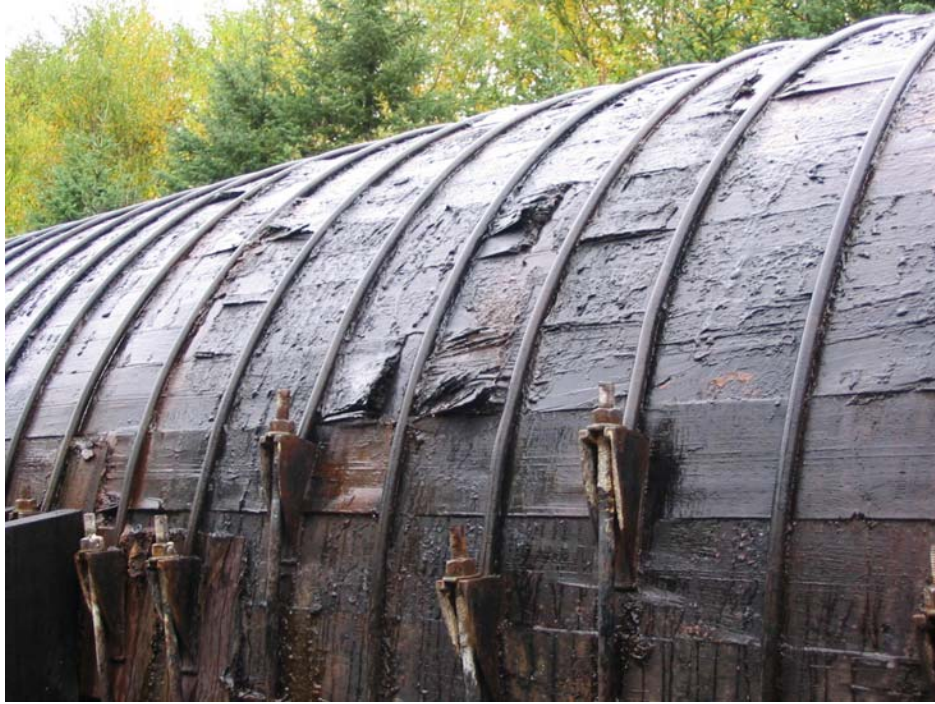
**Figure 12: Crushing of Woodstaves**

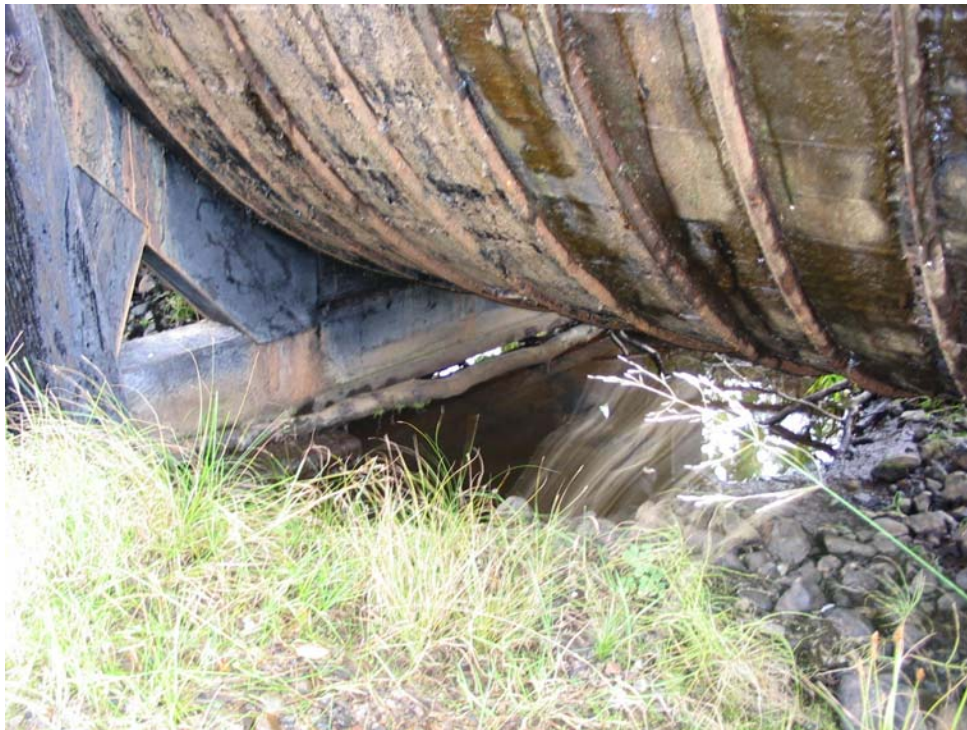
**Figure 13: Undermining of Penstock Bedding**

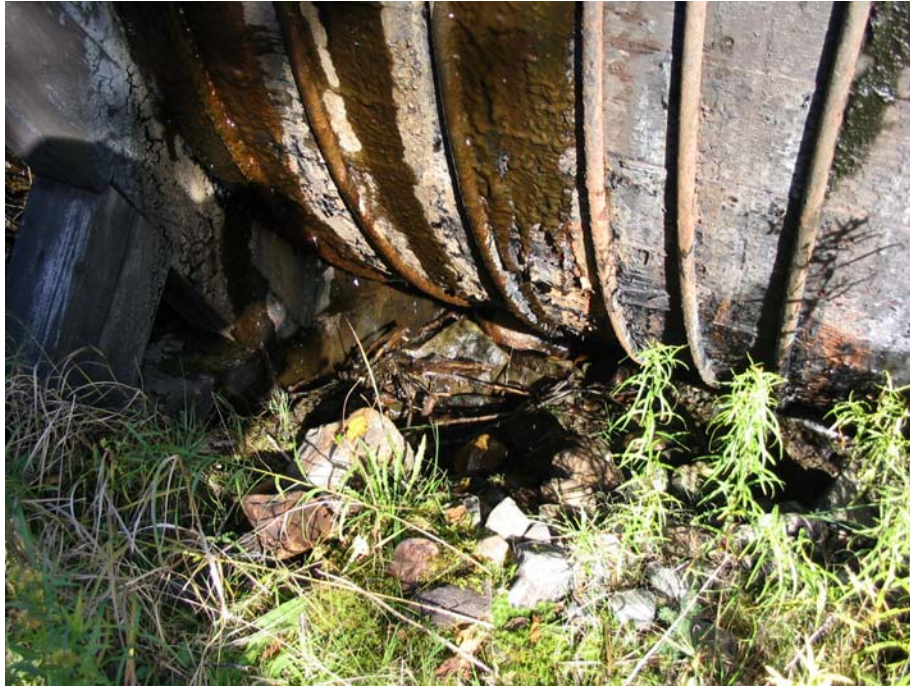
**Figure 14: Settlement of Penstock into Bedding**

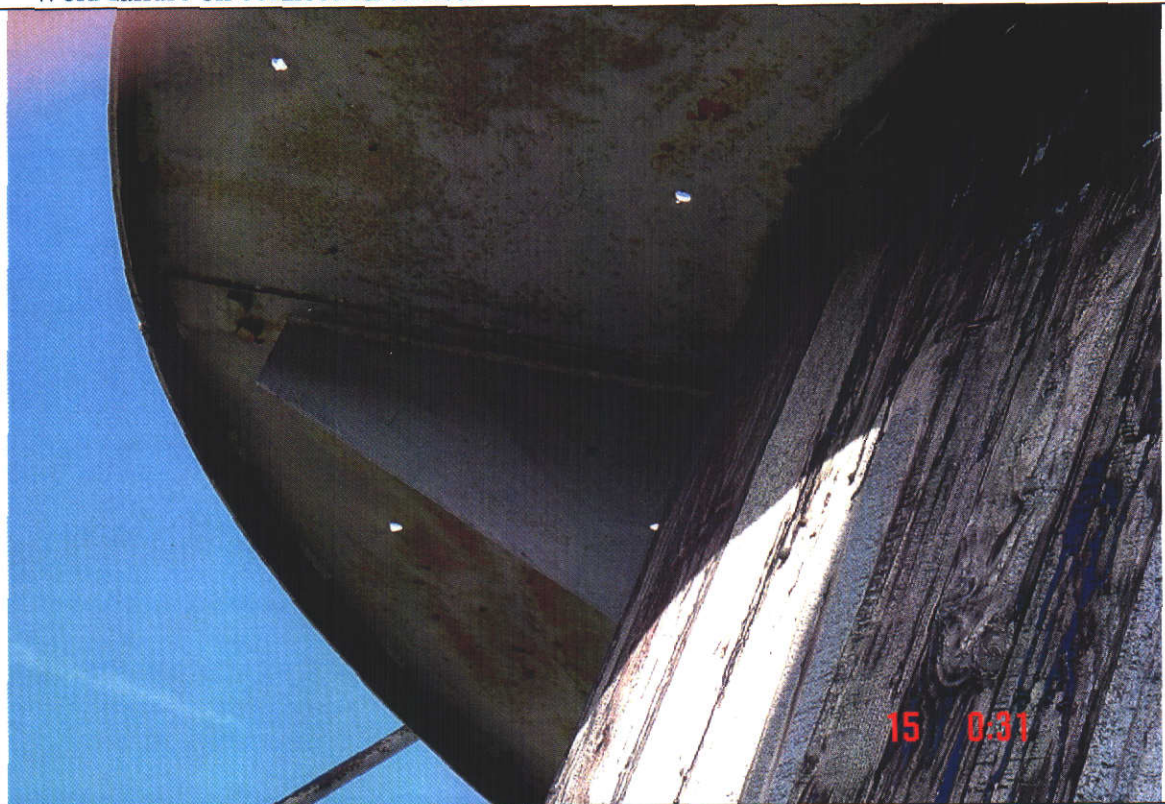
6. Compression ring and walkway at EL.207'.

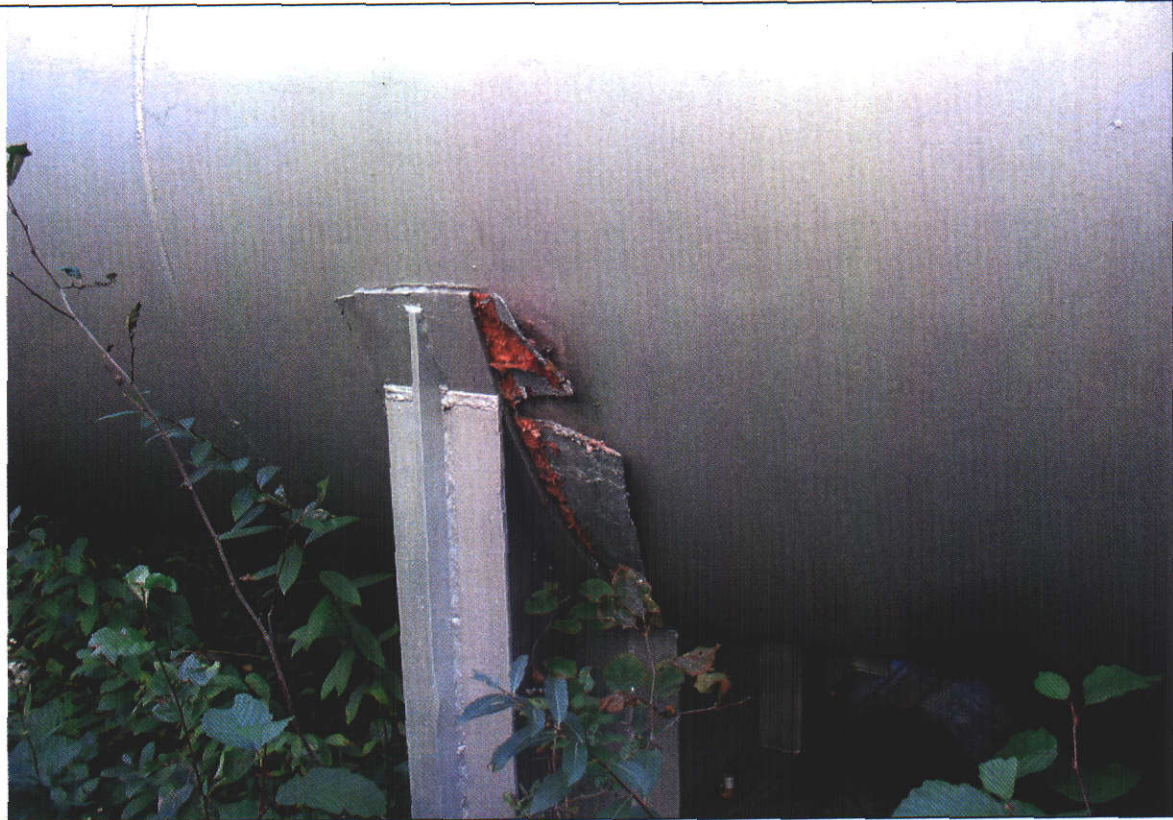
11. Penstock saddle slider.

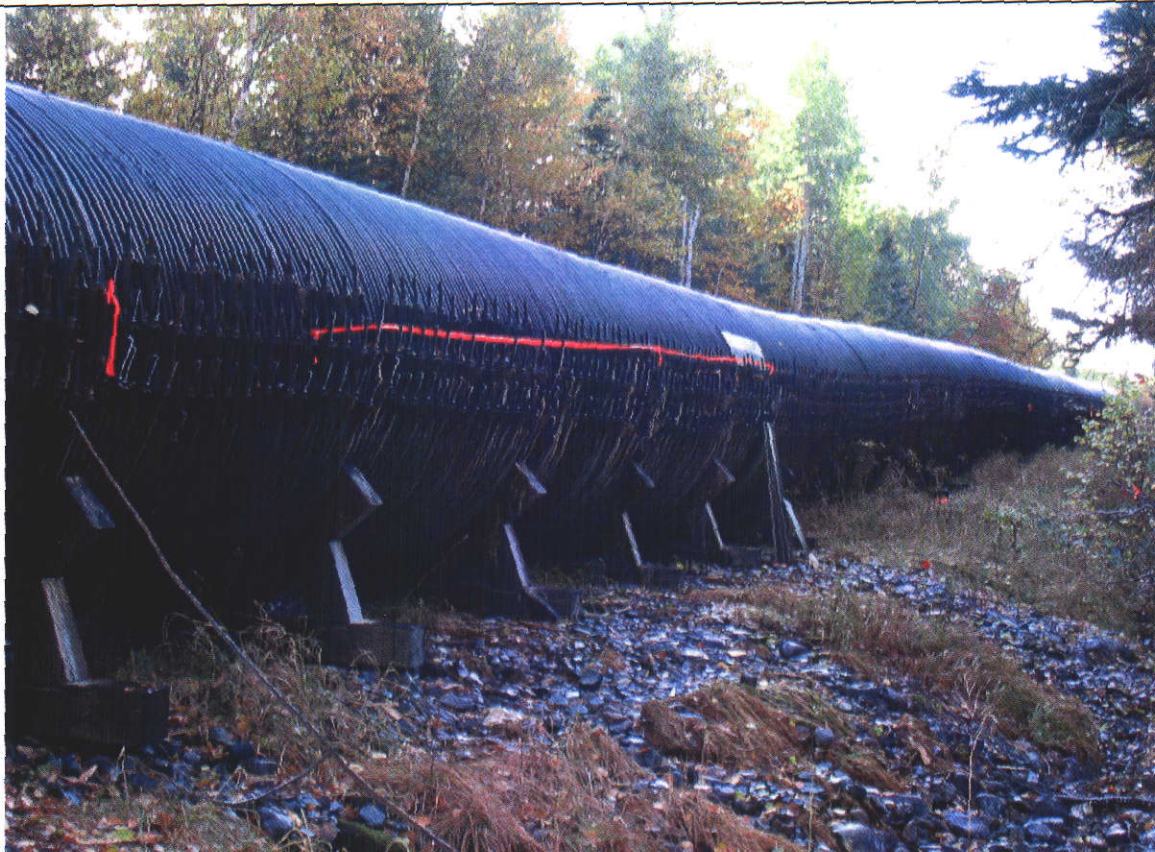
15. Wood stave penstock typical patch plate location marking.

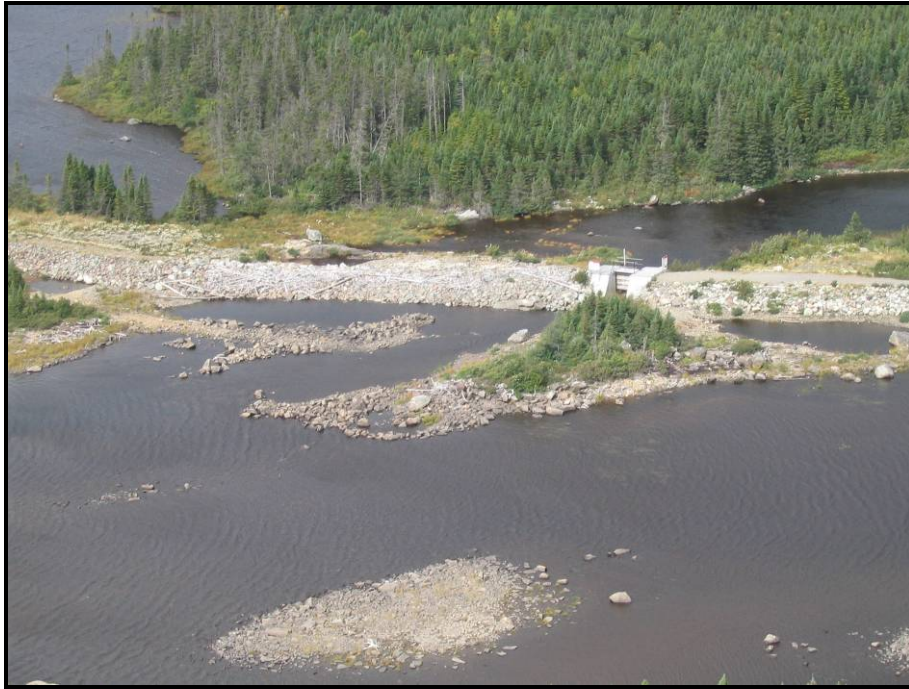
**Figure 1: Aerial Shot of Frozen Ocean Lake Infrastructure**

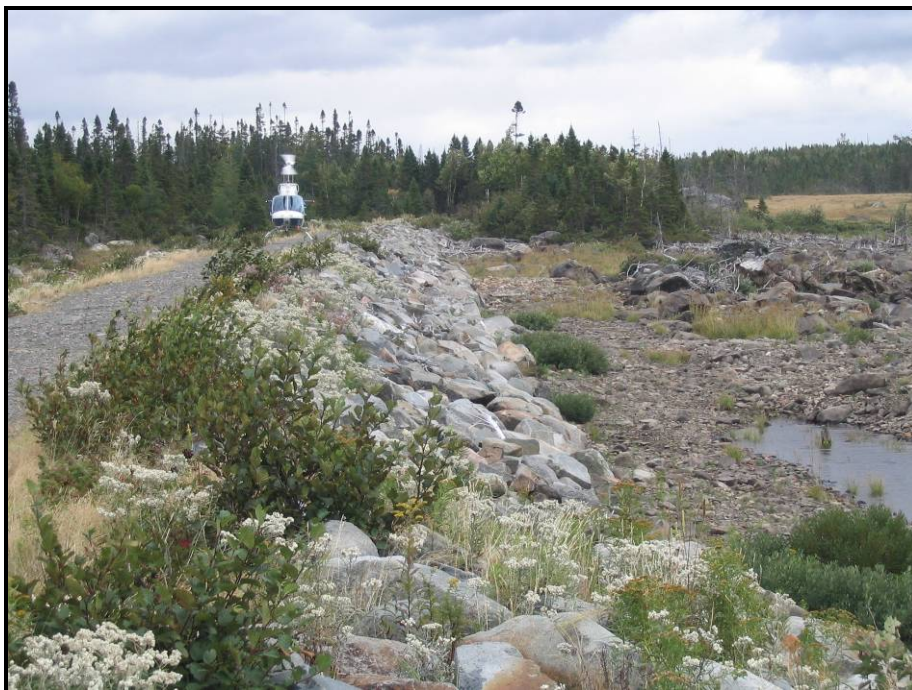
**Figure 2: Frozen Ocean Lake Dam**

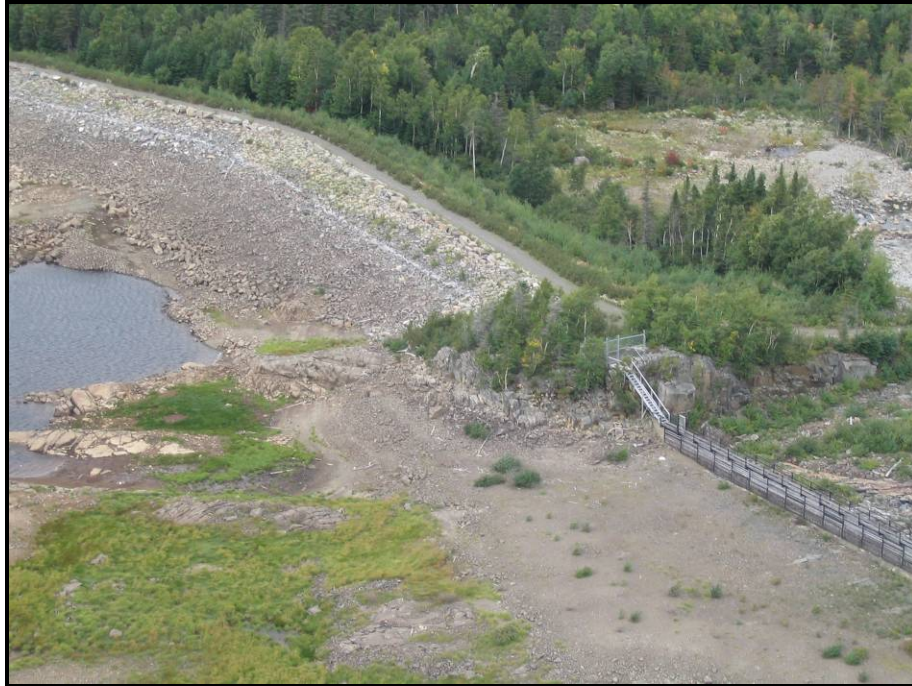
**Figure 3: Aerial Shot of Rattling Lake Dam and Spillway**

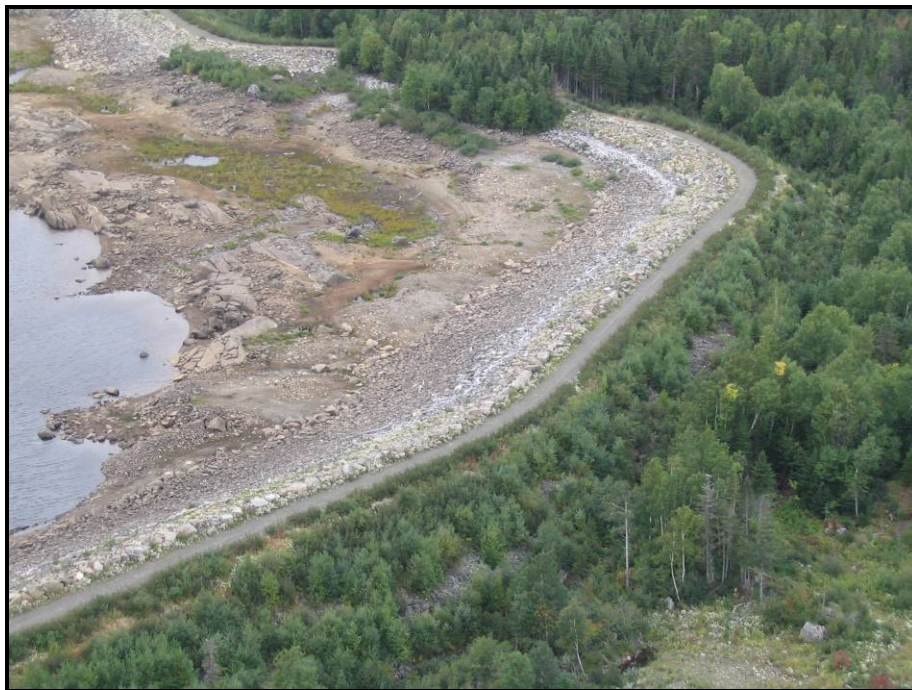
**Figure 4: Rattling Lake Dam (Note excessive vegetation on downstream face)**

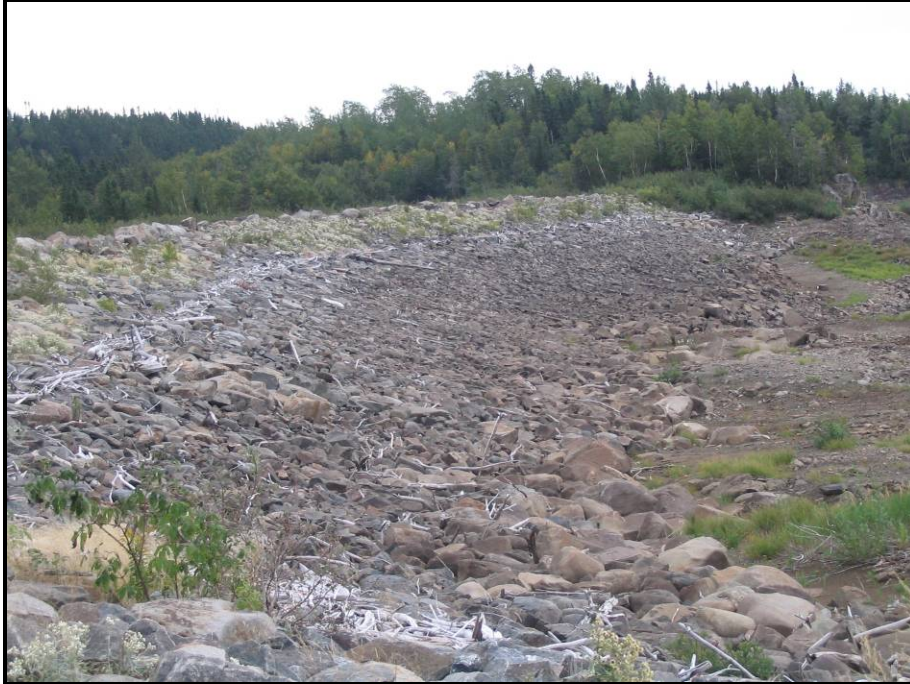
**Figure 5: Rattling Lake Dam (Upstream Face)**

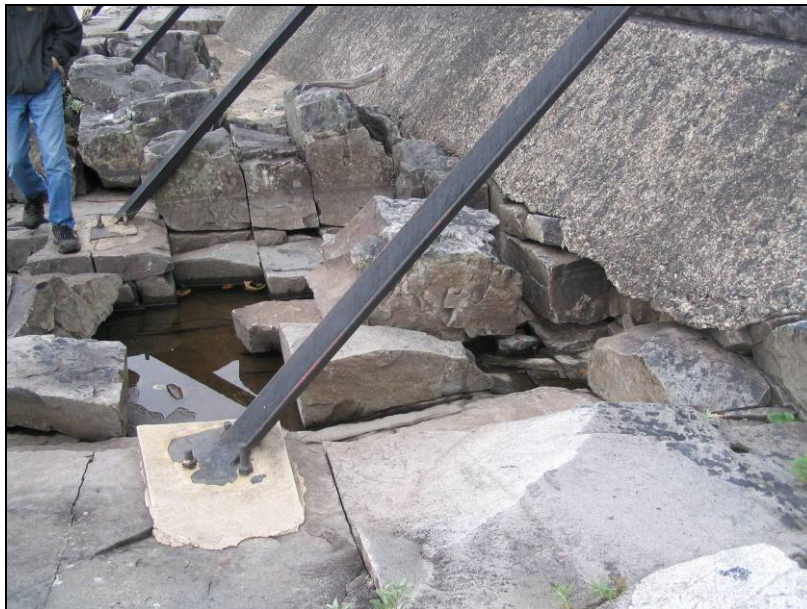
- Concrete crest continues to show signs of deterioration due to weathering and aging. Exposed aggregate and spalling was observed throughout.
- Walkway timbers are showing continuing signs of deterioration and should be replaced in some locations.
- On the downstream end of the spillway there is a significant amount of fractures in the bedrock foundation along the downstream toe. Undercutting is evident throughout the concrete and bedrock interface.

**Figure 2: Undercutting of Concrete/Bedrock Interface**

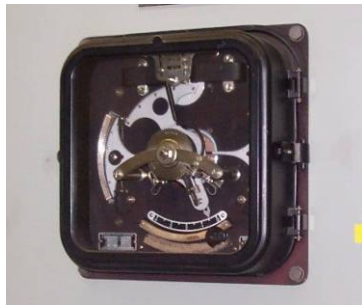
**Figure 5 - Voltage Regulator**

Both units have Brown Boveri voltage regulators (figure 5) with mechanical operating mechanisms and have been manufacturer discontinued. These units will be replaced with digital voltage regulators.

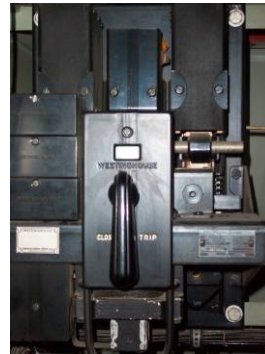
**Figure 6 - Field Breaker**

The Field Breakers (figure 6) on both units are original to the 1958 installation, are obsolete and lack a sufficient number of auxiliary contacts required by the PLC control system being installed. New field breakers will be installed in the new switchgear lineup. The power cables from the exciters to the generators via the field breaker are also original to the plant and will be replaced as they are at the end of their service life.

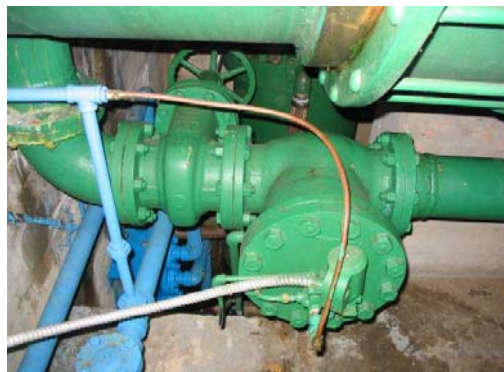
**Figure 3 - Bypass Valve**

Each system has a 6 inch manual drain valve (figure 2) and a 6 inch manual bypass gate valve (figure 3). All valves are original equipment with the exception of the water actuated bypass valve on unit no. 2 which was replaced in 2001 and is in good condition.

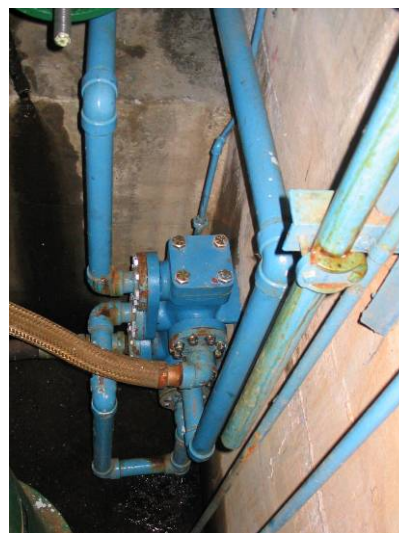
**Figure 4 - Valve Actuator**

The existing butterfly and bypass valves for each unit are water actuated via a 2 inch 5-way control valve as shown in figure 4. Both 5-way control valves were refurbished in 2004 however, the original piping remains. Manual operation of the valves was at one time possible by means of a hand pump circuit and auxiliary water supply, but this system is no longer functional.

This system will be decommissioned and the valve actuators replaced with 125 VDC electric actuators.

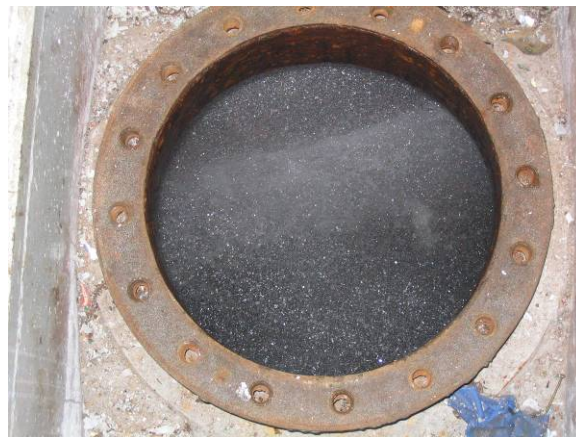
Figure 7 – Scroll Case Access Hatch

During the site visit, it was difficult to conduct an internal inspection of the turbines because of the excessive leakage past the two main inlet butterfly valves. On both units, when the scroll case access hatch was opened (figure 7), the field of view was clouded by the significant spray of water originating around the butterfly valve disc. To mitigate this problem the drain valve was opened and a plywood barricade was placed downstream of the butterfly and drain valves. Even with this barricade in place, there was still a considerable amount of water interfering with the inspection.

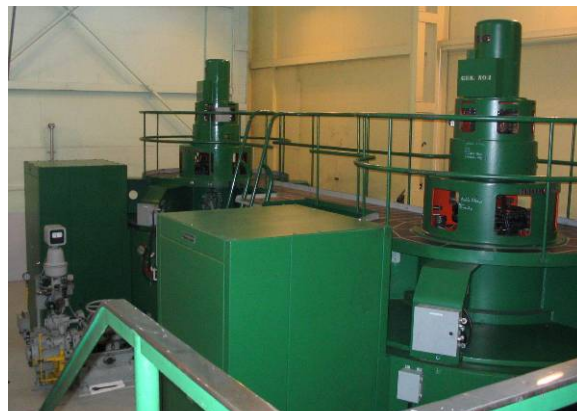
Figure 11 – Generator Gallery

The generator stator on unit no. 1 was rewound in 2004 and the exciter received a minor overhaul that included cleaning and painting. In addition new leads, brackets, and insulators were installed on the exciter. Electrically the exciter's test results were good.

During the rewind project, the braking system was overhauled and air lines were replaced with all new flexible high pressure lines, the brake cylinders were overhauled, and all new brake pads were installed.

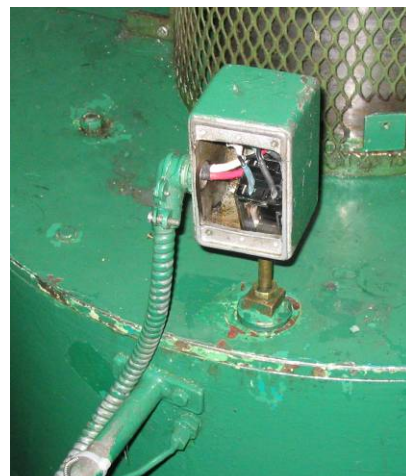
Figure 12 – Bearing Oil Level Switch

The existing oil level switches on the bearings (figure 12) provide alarm contacts only. These will be replaced with new sensors that are also capable of transmitting an analog signal to the unit PLC.

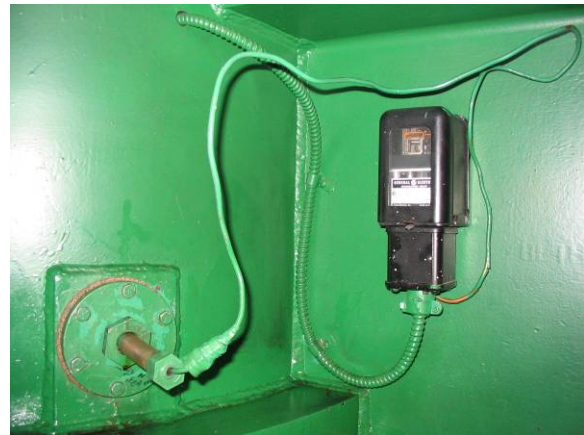
Figure 13 – Bearing Temperature Switch

The temperature of each bearing shell is measured with a capillary tube temperature thermal bulb (figure 13). These will be replaced since they are contact only and there is no analog signal which can be transmitted to the PLC.

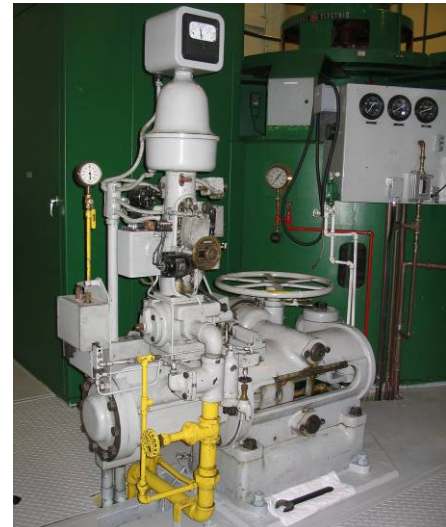
**Figure 16 – Woodward Governor**

Mechanically, both Woodward governors (figure 16) at Rattling Brook are in good condition and have operated reliably. Despite the fact that Woodward no longer supports its product to any great extent, parts, service, and training are now available from non-OEM providers.

The governors at Rattling Brook will be mechanically overhauled as part of the upgrades recommended in the Electrical Equipment Assessment Report. The functionality of the governors in terms of unit control capabilities is also found in this report.

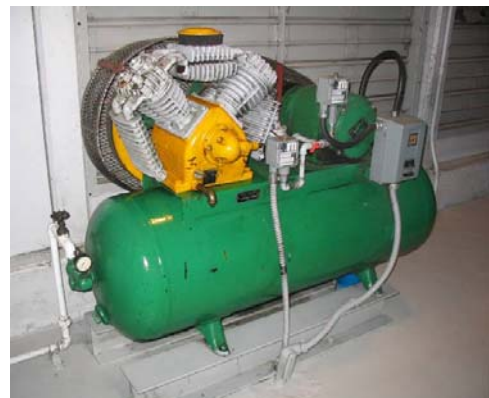
**Figure 17 – Air Compressor**

The central air compressor supplies the braking system on each unit as well as the actuators for the air intake and recirculation operable dampers. This compressor (figure 17) is original 1958 vintage equipment and will be replaced.

Upgrades will also be completed on the entire compressed air system, which is also original equipment. This includes replacement of the piping, valves, regulator, filters, separators, gauges, and related equipment.

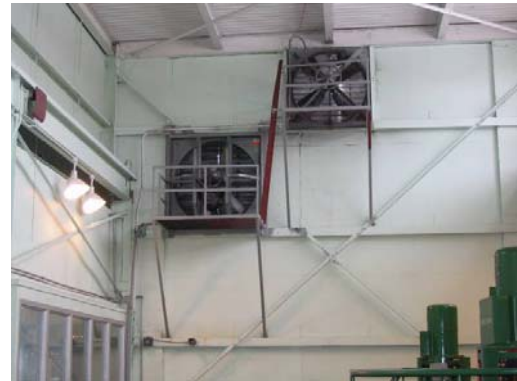
**Figure 20 – Building Exhaust Fans**

Two of the 1.5 hp building exhaust fans, located at each end of the plant building are original equipment. These fans are in good condition with operable back draft dampers and bird screens. The additional 15 hp exhaust fan, which was installed in 1993, is in good working condition and is equipped with a functional back draft damper and a bird screen. The nameplate information on all three fans indicates that all are suitable for operation at 208 Volts.

At present each fan is controlled by a dedicated thermostat, each with a slightly different temperature set point. These thermostats will be replaced and the fan control system will now be tied into the plant PLC system to improve energy efficiency.
