Install Infrared Scanning Ports – Happy Valley Gas Turbine

Category: Generation – Gas Turbines

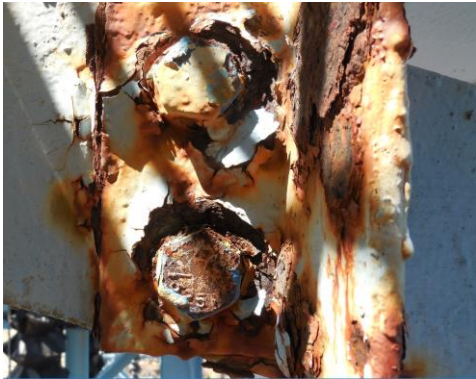
The Salmon River Spillway monorail hoist was replaced in 2016. During replacement of the monorail hoist, an internal engineering inspection of the monorail beam and associated structural mounts was completed. The inspection revealed deterioration of the components and repair/refurbishment work was required to reliably operate the monorail hoist in the long term. Issues included noticeable head scaling on structural mounting bolts, scaling on structure steel, uneven surfaces for monorail hoist rollers, and alignment gaps between monorail beam sections as seen in Figure 9 to Figure 13. Affected areas generally show signs of corrosion and degradation of support mounts and hardware.

Figure 9: Structure Bolt Scaling

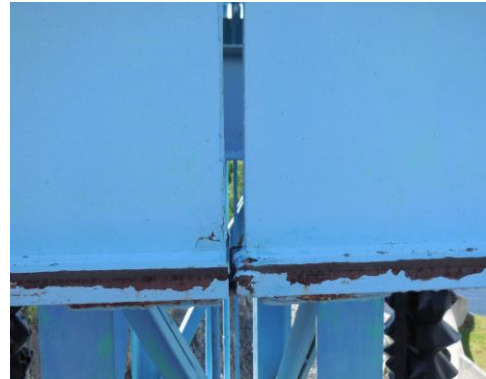
Figure 10: Alignment Gaps in Monorail Beam

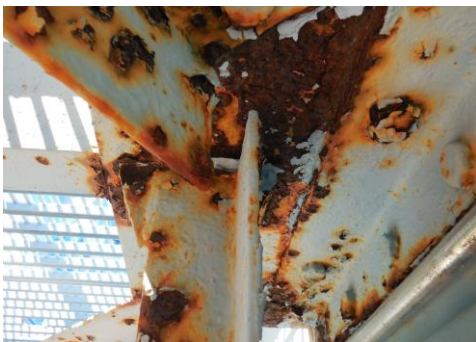
Figure 11: Scaling on Structural Steel

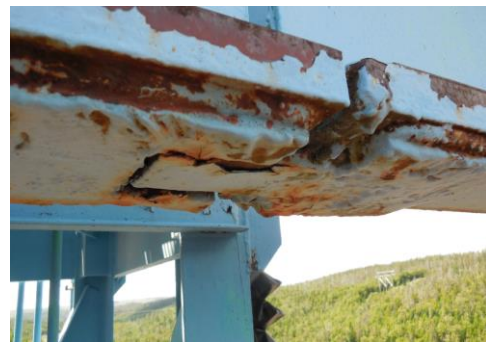
Figure 12: Monorail Beam Scaling

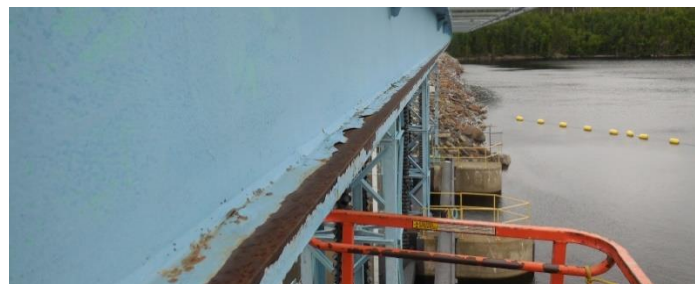
Figure 13: Corrosion along the Monorail Beam Roller Plates
