Re: Newfoundland Power's 2015 Capital Budget Application

**Pierre's Brook Hydro Plant
Penstock Replacement and Surge Tank Refurbishment**

June 2014

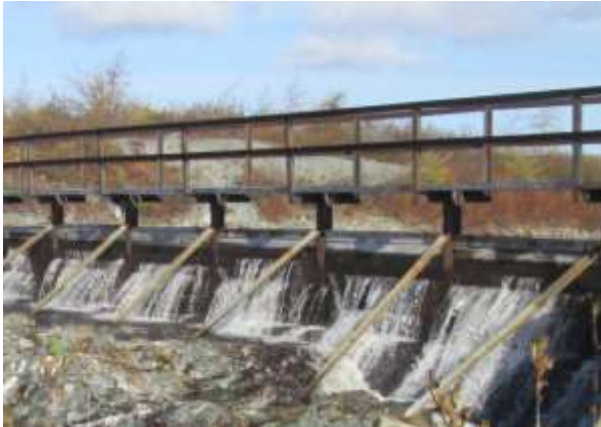
Replacing the stop log spillway with a concrete overflow spillway and replacing the access walkway will address dam safety deficiencies and remove a significant public and employee safety hazard as well as increase production at the Horse Chops and Cape Broyle hydro developments as a result of reduced leakage.

Figure 1 – Slender Structure, Significant Leakage

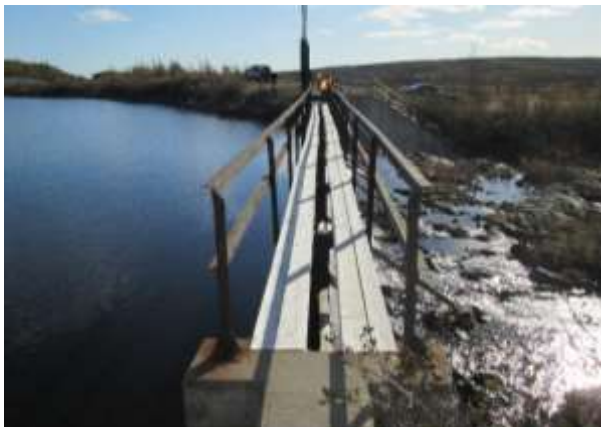
Figure 2 – Access Walkway

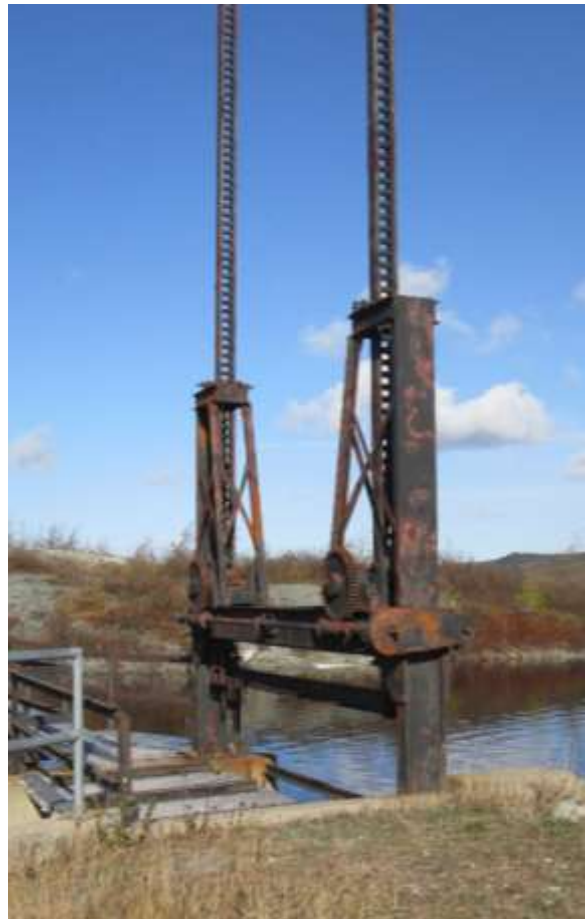
Figure 3 – Stop Log Lift

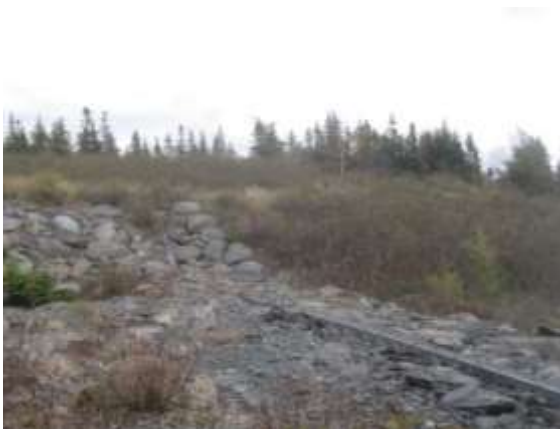
Figure 4 – Undersized Riprap and Damaged Spillway Core

¹¹ See Figure 4. The final riprap design will require stone size of 700-1,000 mm in diameter. The existing riprap has a maximum sizing of approximately 700 mm with a median size significantly lower.

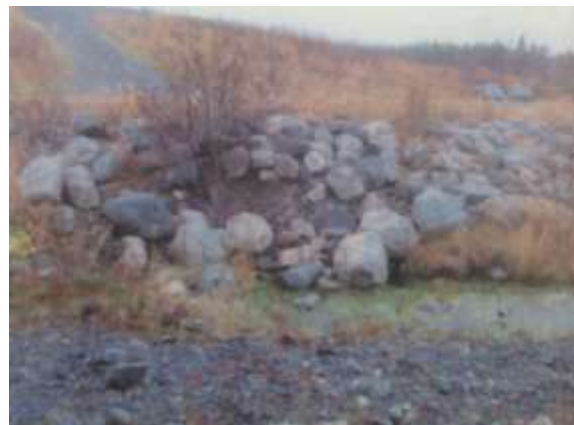
Downstream of the spillway, the spill channel follows along a section of the toe of the dam. Some armour stone is present, however during recent spill events some displacement of this stone has occurred.¹³ Larger sized armour stone is required to ensure erosion of the dam toe does not occur.

Figure 5 – Eroded Armour Stone

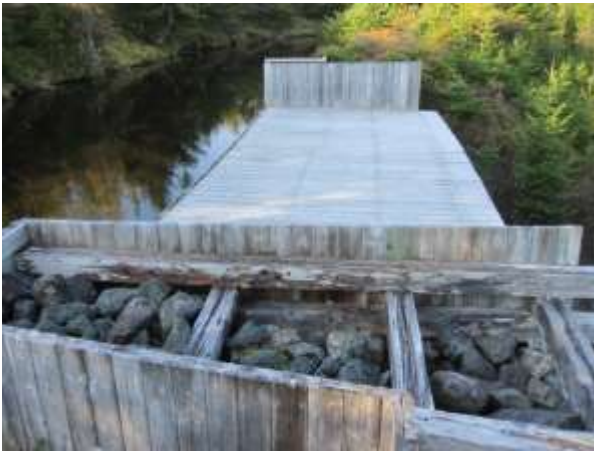
The Franks Canal Spillway is located on the Franks Pond Canal and is a part of the Tors Cove - Rocky Pond hydroelectric development. The Franks Canal Spillway was reconstructed in 1978. The purpose of this spillway is to protect the canal embankment from high water levels by releasing excess water during periods of high inflow. This project involves replacing the existing timber crib and rock fill spillway with a new timber structure.¹⁵ Replacement of the timber crib structure is required as the structural timber and decking has deteriorated over time, particularly at the abutments. Replacement is required to maintain safe, reliable operation of this canal.

Figure 6 – Franks Canal Spillway

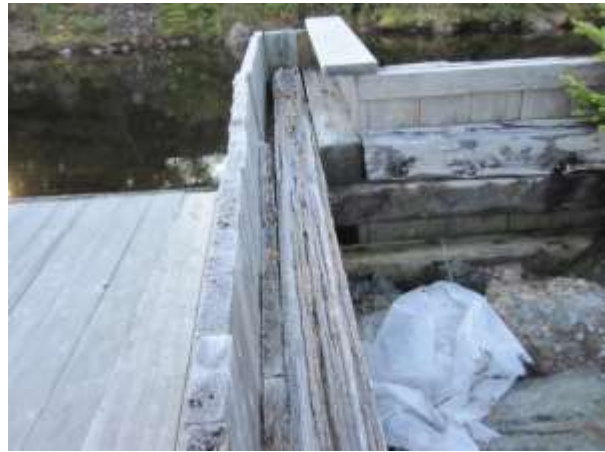
Figure 7 – Deteriorated Timber

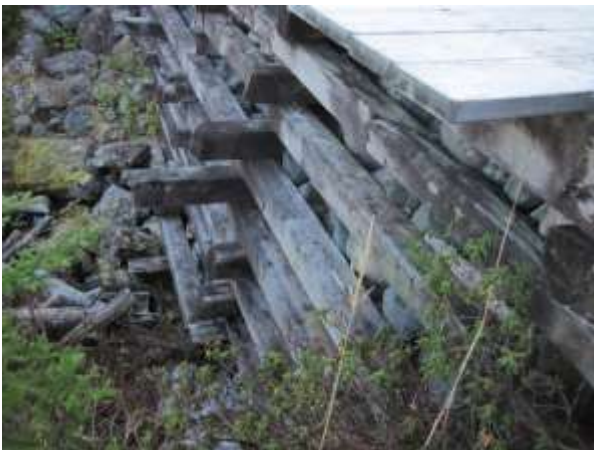
Figure 8 – Downstream Side of Spillway

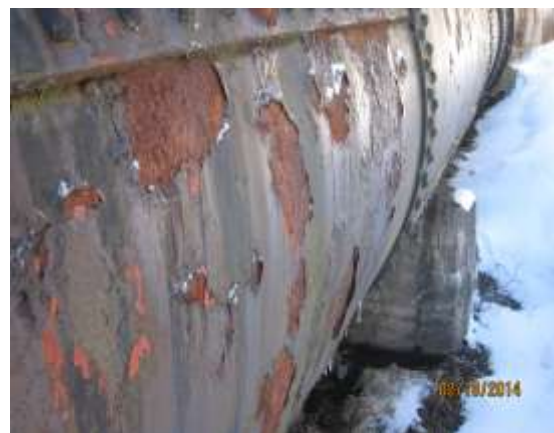
The 83 year old steel penstock section was refurbished in 1965. Overall, the steel penstock appears to be in generally good condition. Figure 2 shows how the exterior coating has failed over much of the steel penstock surface however no significant loss of wall thickness or pitting was observed. Rivet heads and riveted joints are in good condition. The access hatch in this section is in good condition. Some corrosion and minor leakage was identified on the single expansion joint. Based on the small amount of leakage, the joint is good condition and likely only requires re-packing.

Figure 2 - Steel Penstock

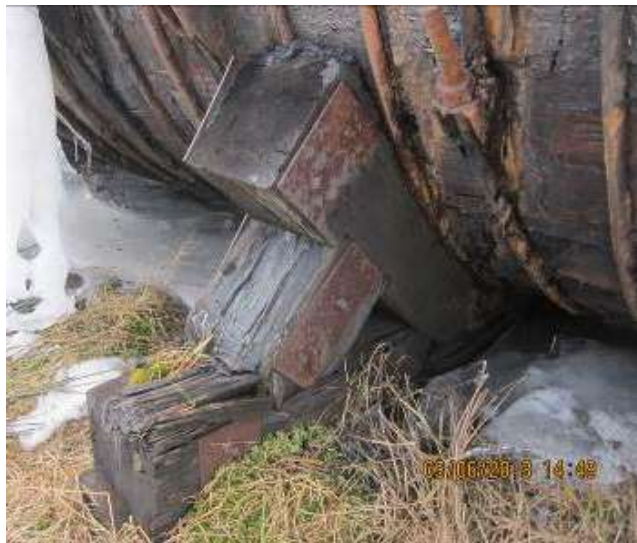
Figure 3 - Deteriorated Cradle

Over the entire length of the penstock, the bedding is saturated due to leakage as well as the deterioration of the drainage system over time. In places, saturation of the penstock bedding has resulted in the localized rotting and settling of the support cradles which in turn has caused sagging and misalignment of the penstock.

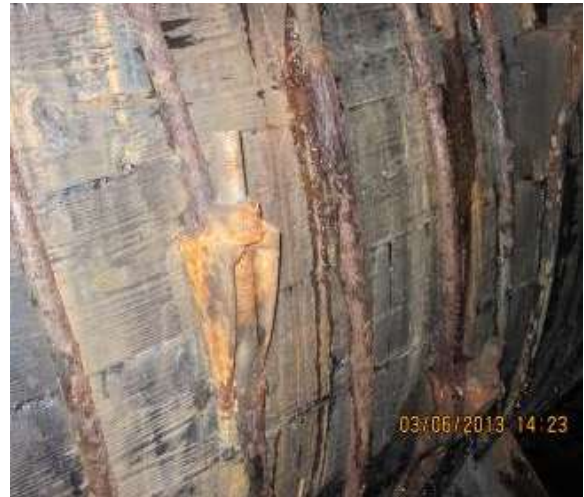
Overall the steel bands, shoes and nuts are in good condition however localized corrosion exists near areas of heavy leakage. There is excessive corrosion of steel bands, shoes and nuts at the point where the penstock crosses under Route 10 as a result of road de-icing salt used during the winter.¹⁰ The bands in the deteriorated areas cannot be tightened or adjusted to facilitate maintenance. Additional bands have been added in the past to ensure structural integrity in this area however they are also corroded.

Figure 4 - Bands at Route 10

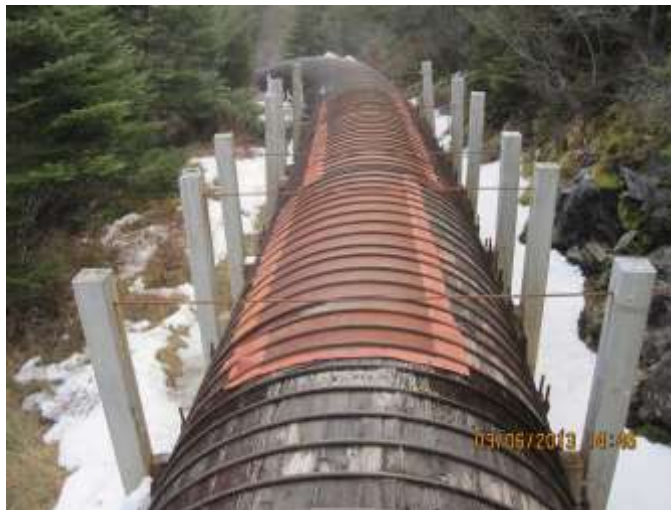
Figure 5 - Additional Support at Blowout

In the mid 1990's a blowout of the penstock occurred approximately 170 m upstream of the surge tank. AMEC notes that the blowout occurred near the area where the largest relative internal pressure swings occur during generator starts and stops. As a result, the penstock in this area would have the greatest tendency to ovalize.¹² AMEC attributes this tendency to ovalize along with the poor lateral support provided by the 120° cradles as the principal contributing factors of the blowout. As shown in Figure 5 additional timber supports were installed to provide the additional required lateral support, stabilizing the pipe in this area.

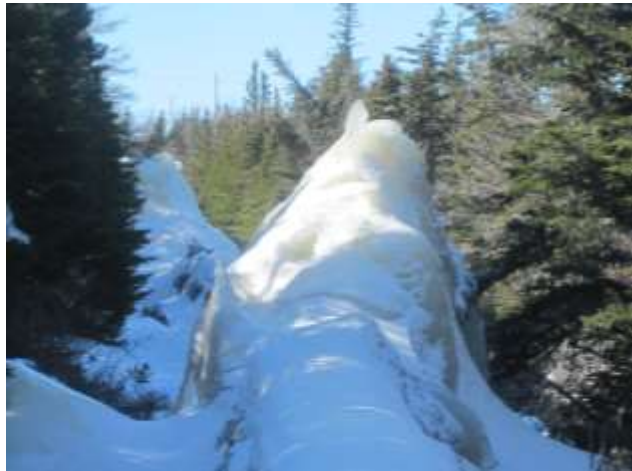
Figure 6 - Ice Formations

As shown in Figure 6 the current amount of leakage causes significant ice buildup in winter months. Ice buildup can cause overloading of the cradles and foundations when the ground thaws and the ice structure collapses. Significant lateral forces can occur if the leakage and ice buildup is predominantly on one side. Jacking or lifting may also occur if ice builds up under the penstock. As the staves continue to deteriorate, the likelihood of a major ice related problem will increase.

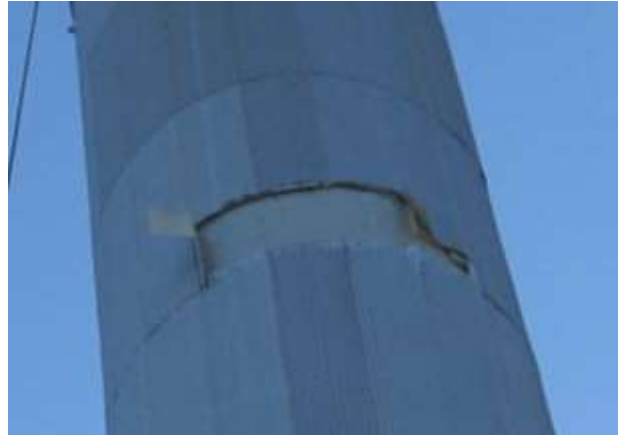
The frost casing is most likely to fail during high wind conditions. Failures in high wind conditions from high on the surge tank could potentially have debris travelling significant distances. This poses a safety hazard to the general public and energized power lines in the immediate area of the surge tank.

Figure 7 - Frost Casing Failure 2013

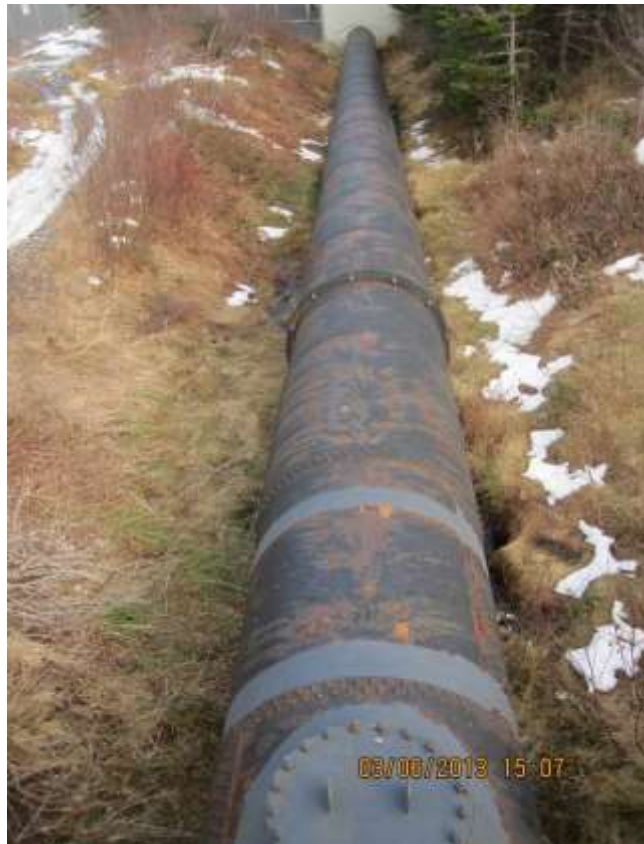
Figure 1: Steel Penstock – Coating Failure

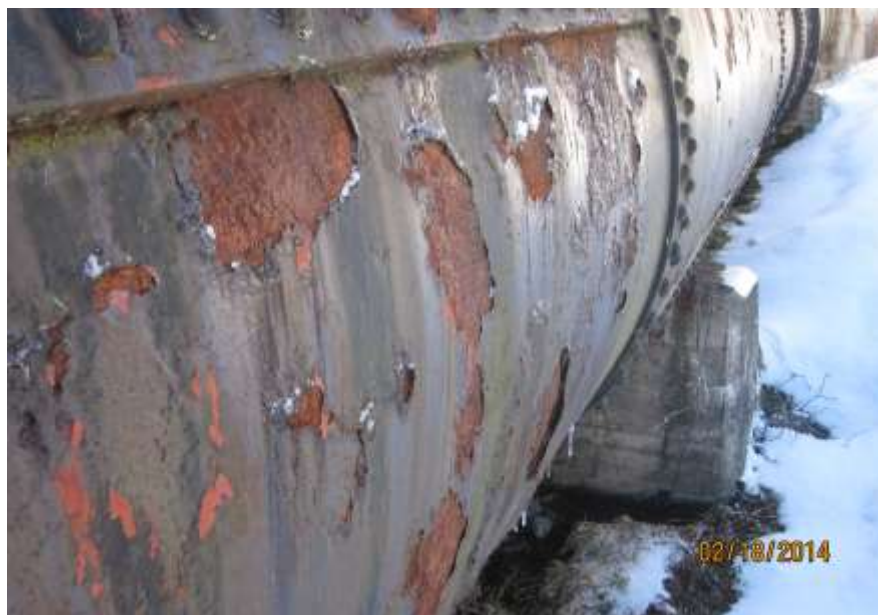
Figure 2: Coating Failure and Surface Cracks on Cradle

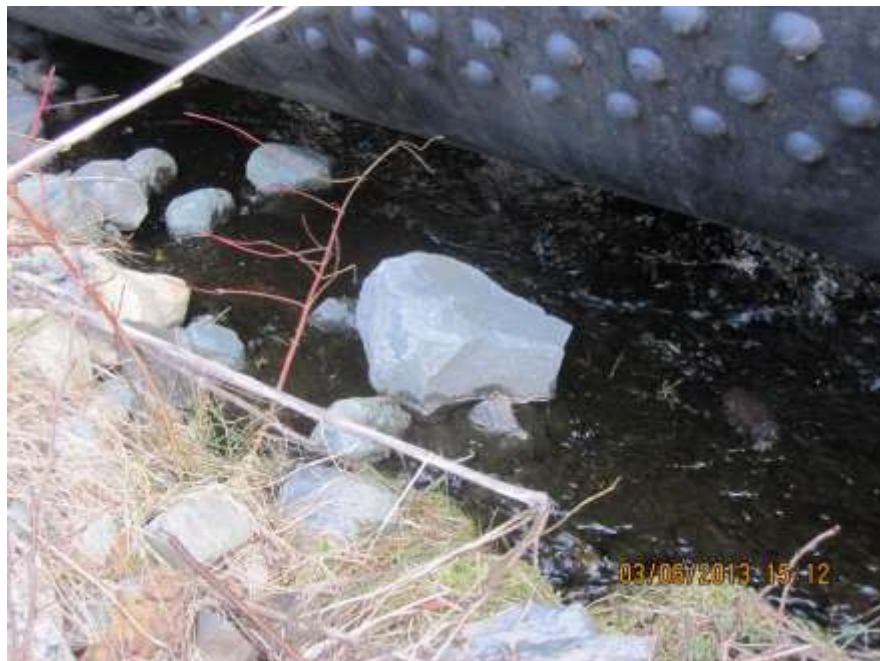
Figure 4: Water Flowing Along Penstock Bed

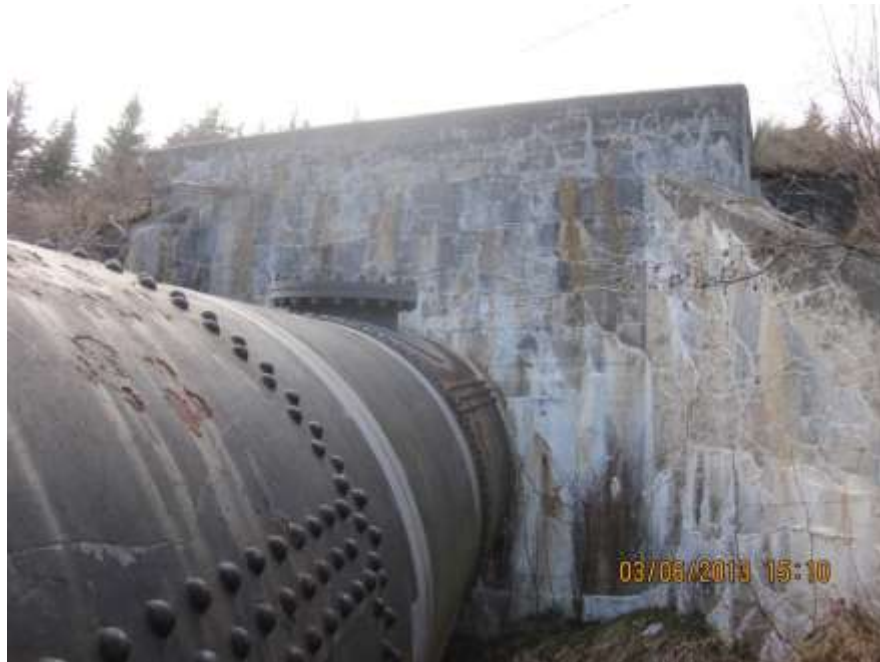
Figure 5: Deteriorated Anchor Block at Transition

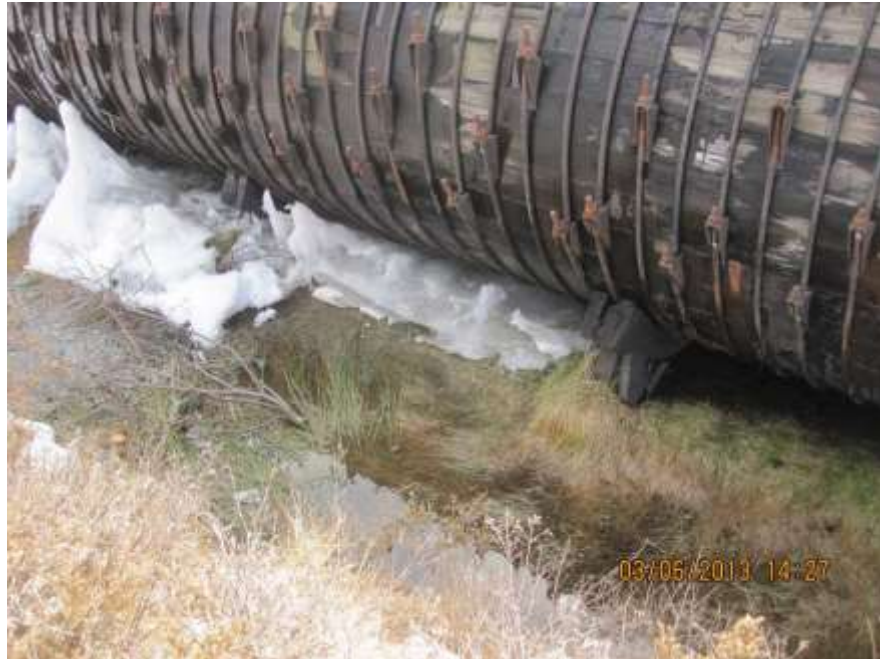
Figure 7: Deteriorated Cradle (Typical) and Saturated Penstock Bed

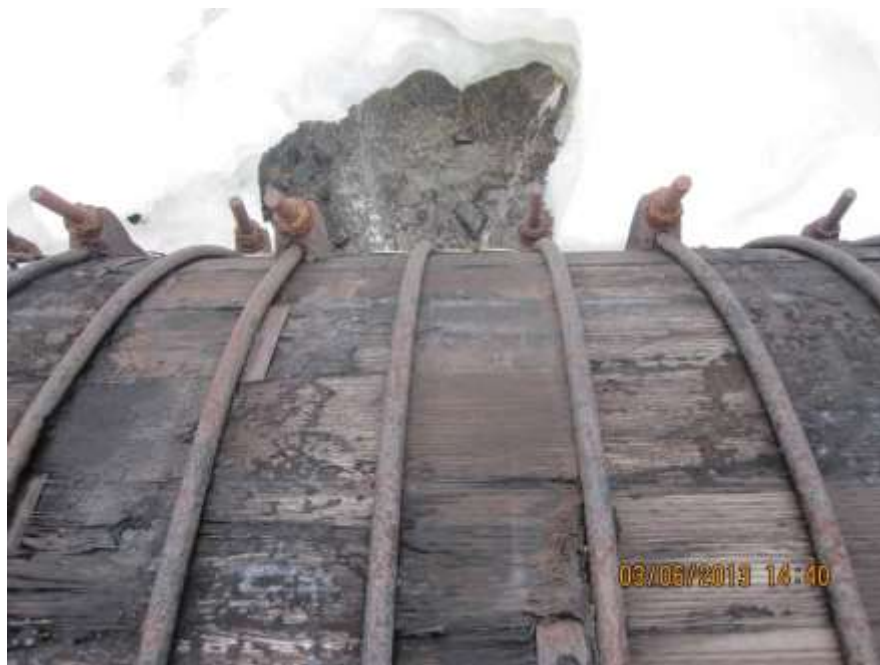
Figure 8: Corroded Bands and Nuts

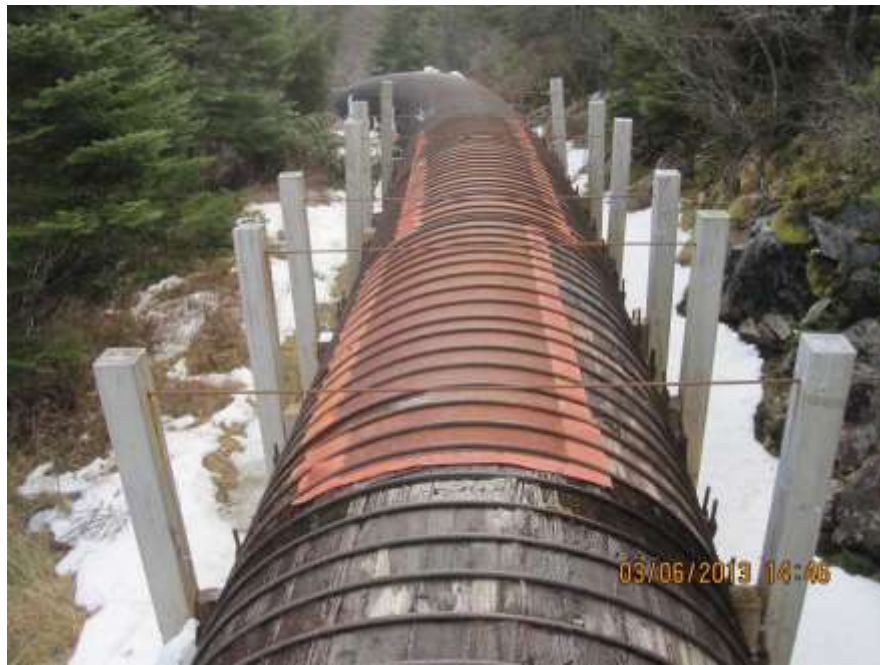
Figure 9: Repair and Stabilization of Past Blowout

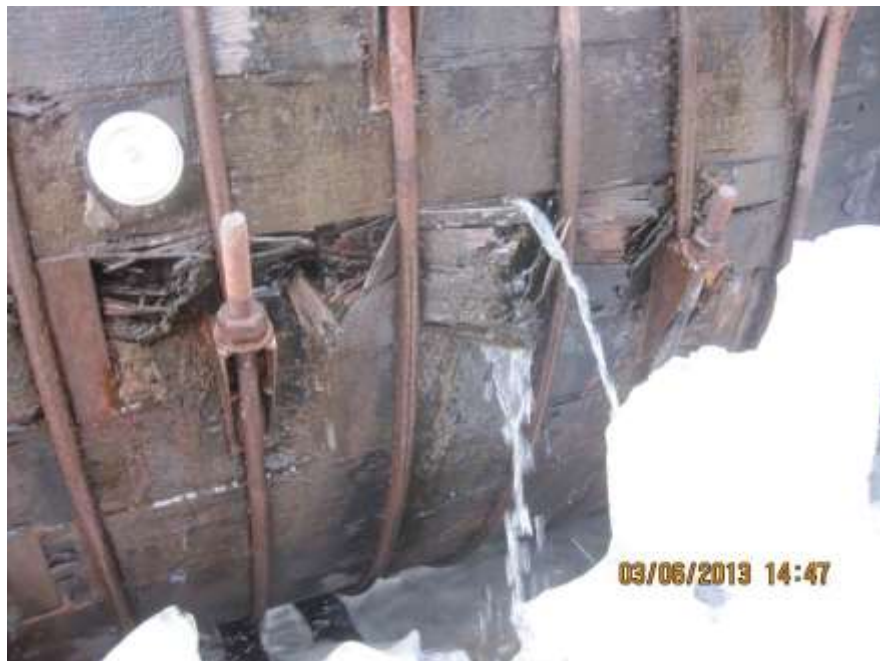
Figure 10: Crushed Stave

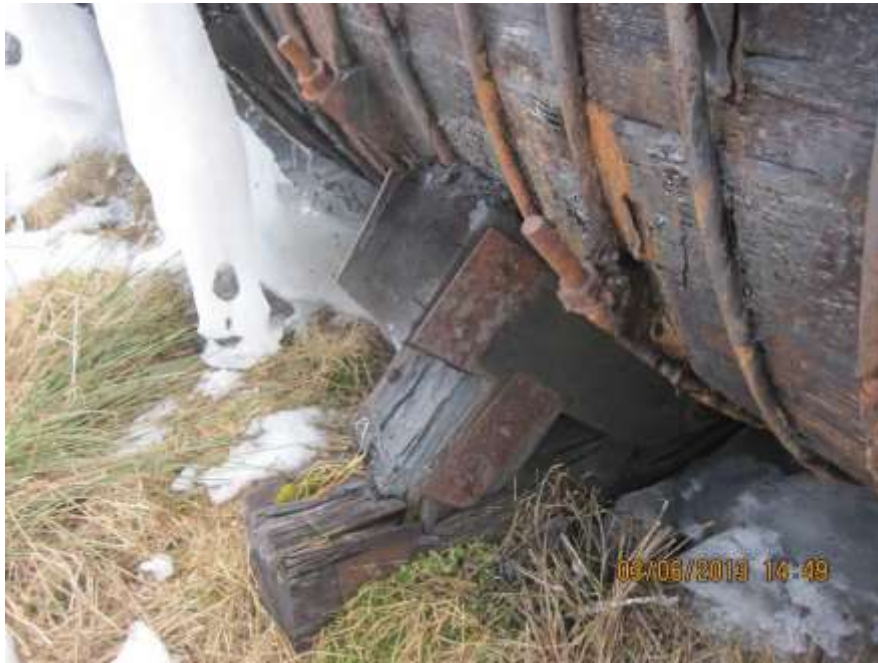
Figure 11: Deteriorated Cradle with Previous Steel Plate Reinforcement

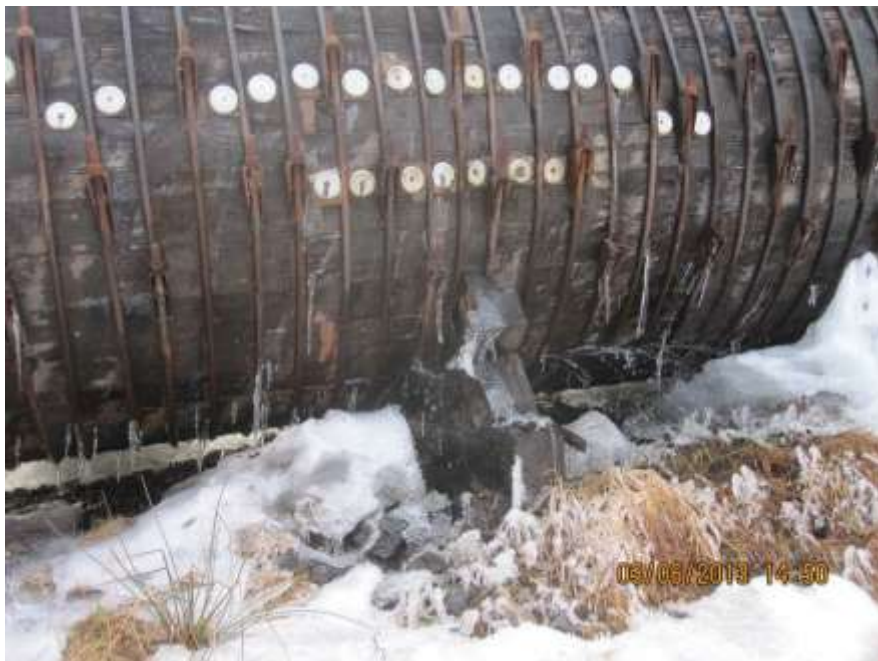
Figure 12: Leak Repair along Springline

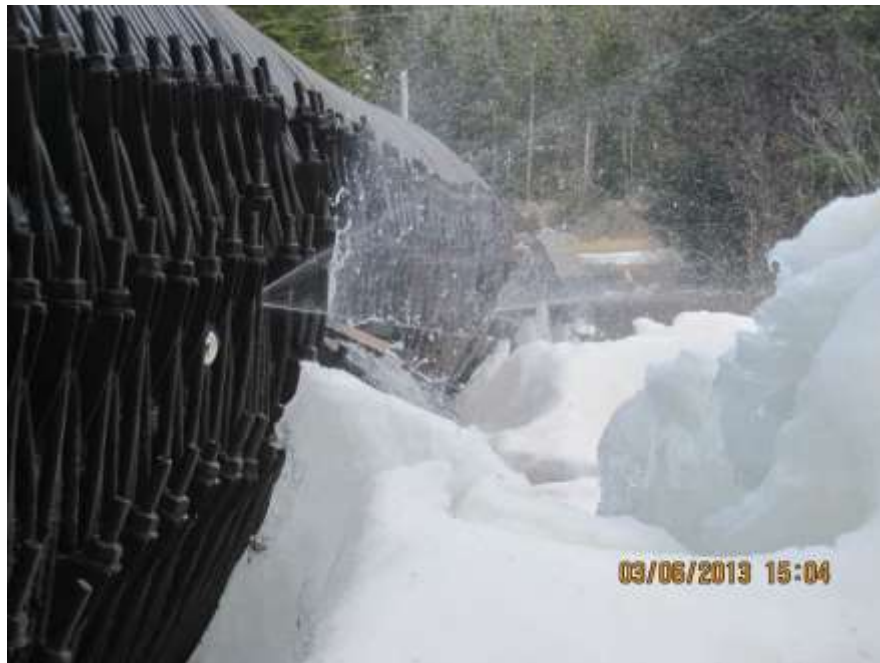
Figure 13: Leaks along Springline

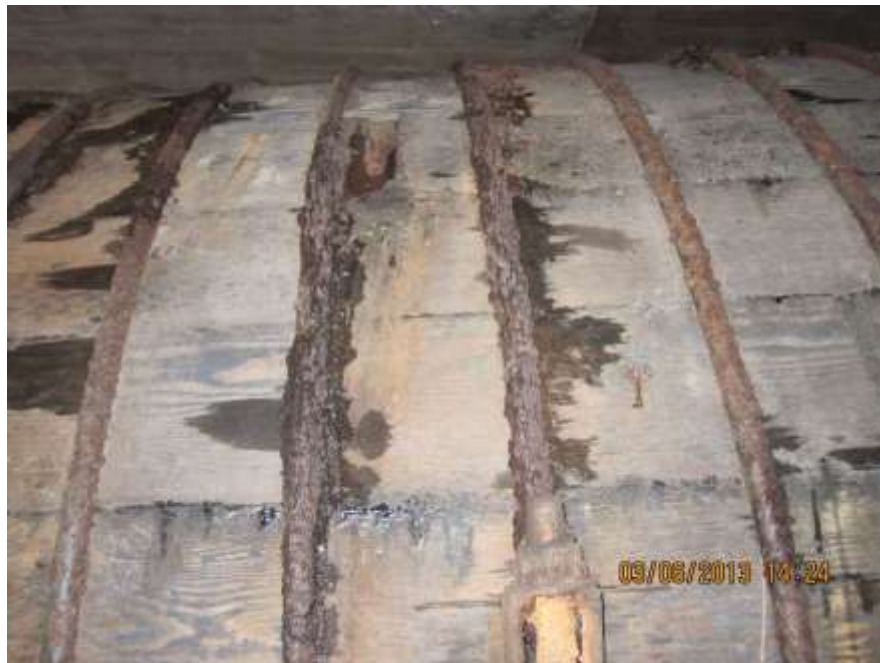
Figure 15: Severely Corroded Bands (near Route 10 crossing)

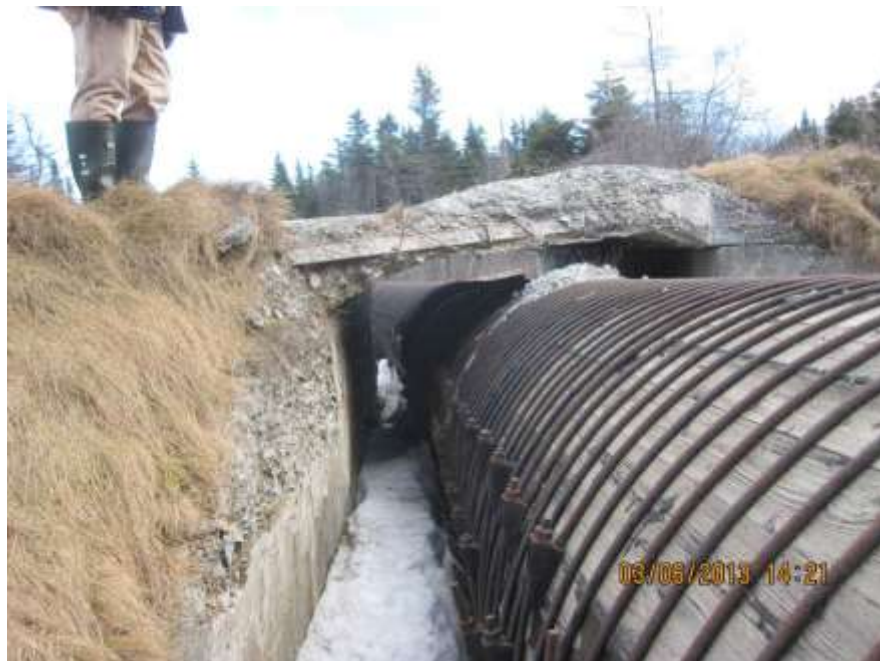
Figure 16: Deteriorated Bridge across Penstock Right of Way

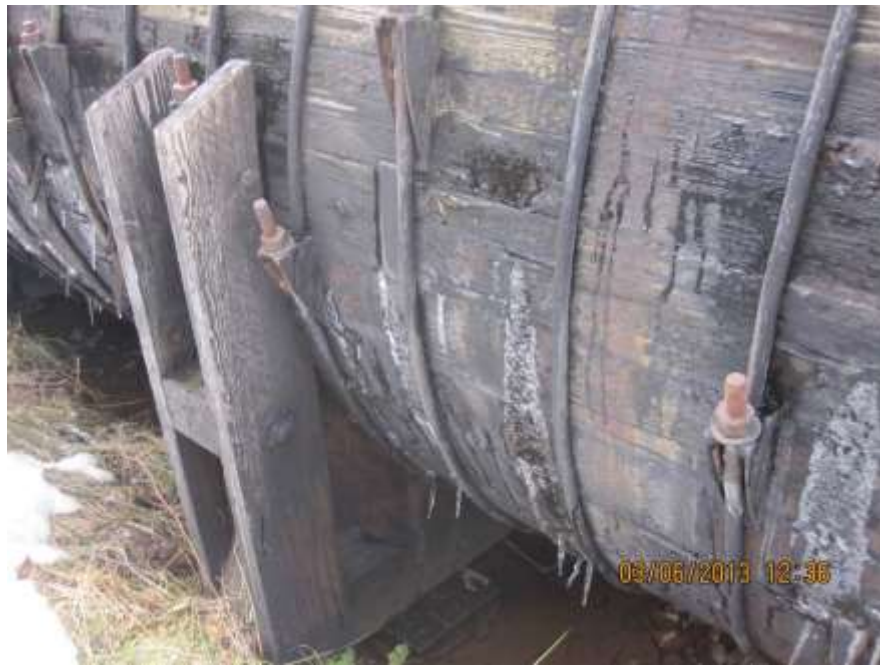
Figure 17: Typical 190 Degree Cradle (Note: Top of cradle not supporting pipe)

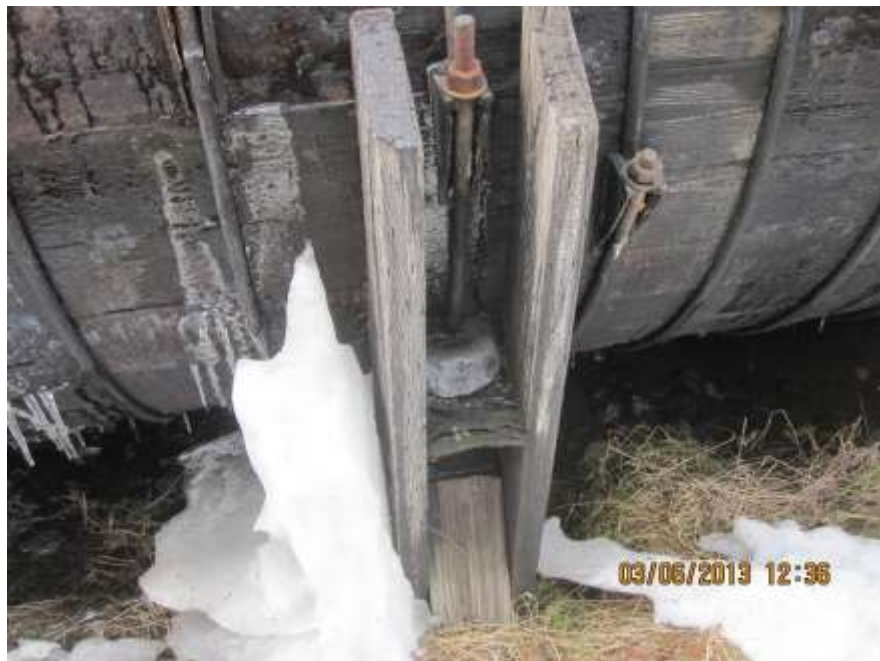
Figure 18: Deteriorated 190 Degree Cradle

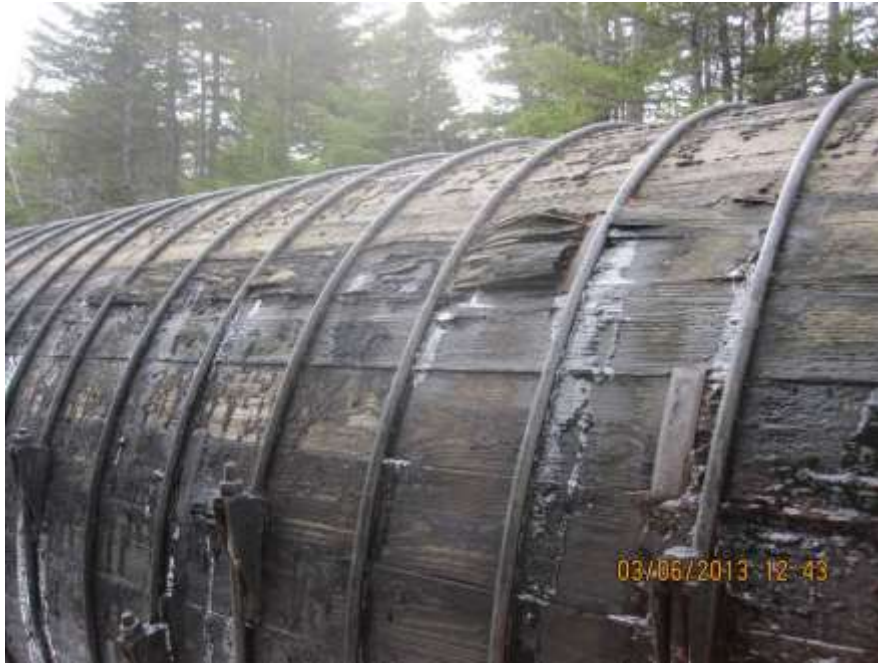
Figure 19: Deteriorated Stave

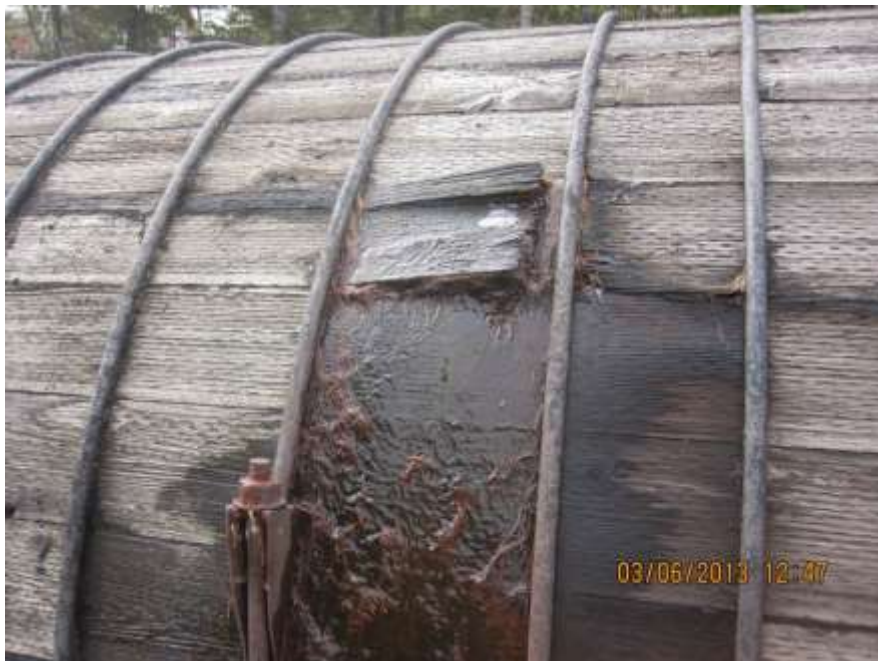
Figure 20: Broomed Stave End (Note: absence of preservative)

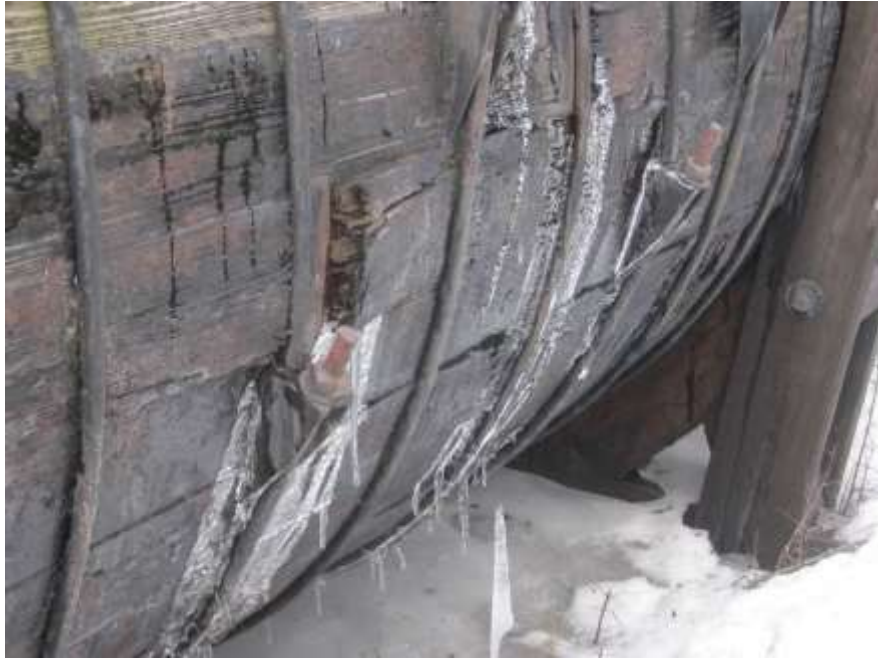
Figure 21: Deteriorated Stave End

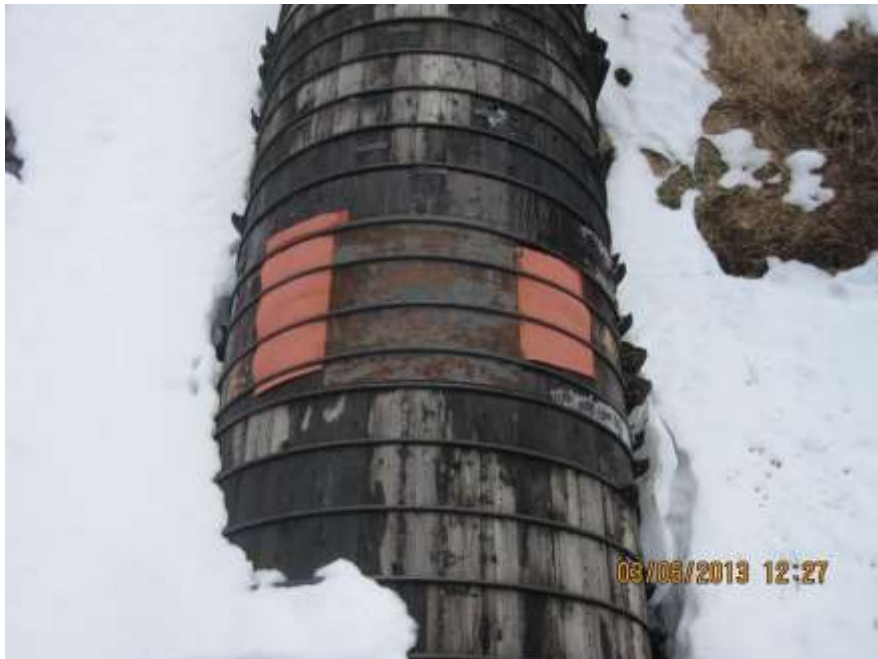
Figure 22: Previous Repairs

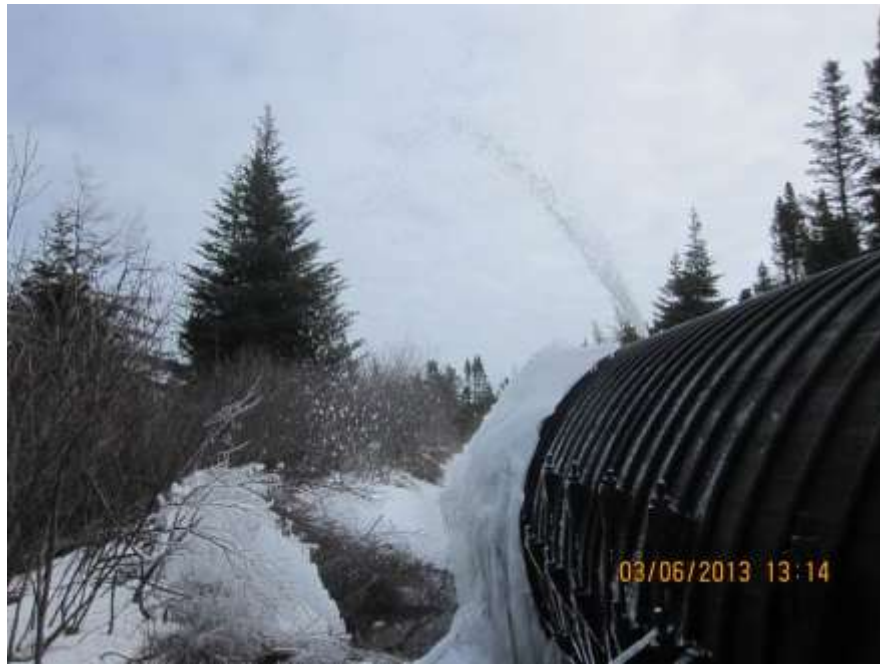
Figure 23: Leakage and Ice Buildup

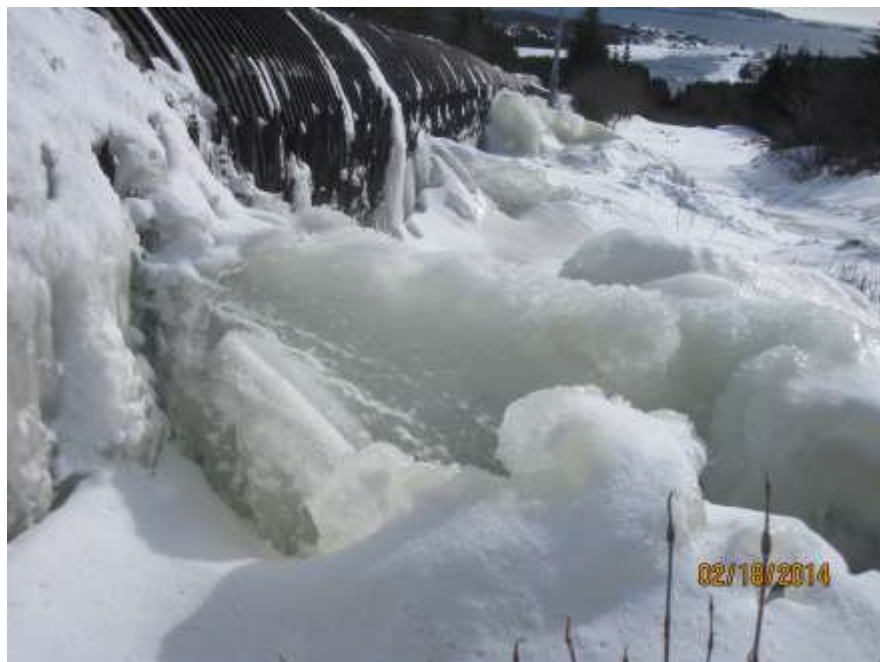
Figure 24: Ice Buildup

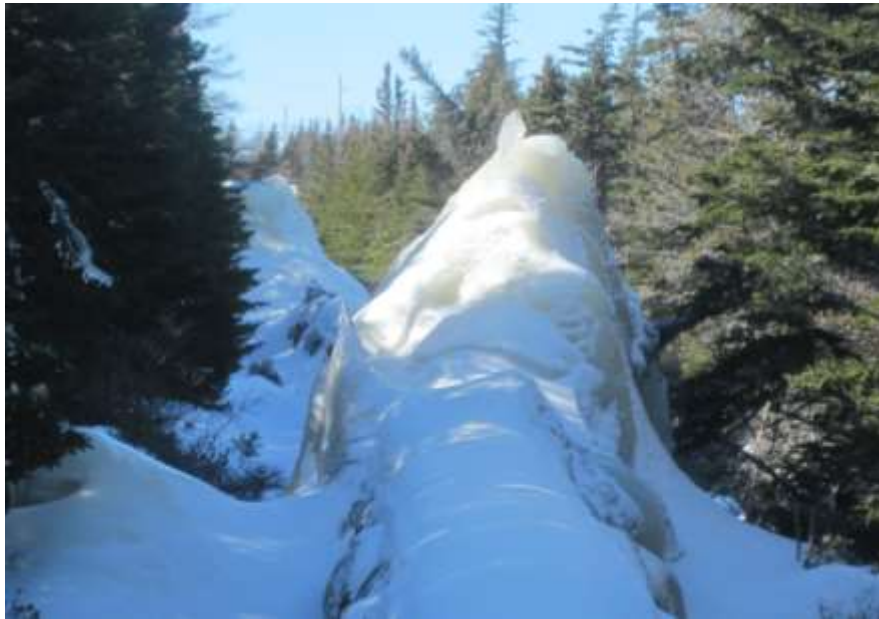
Figure 25: Ice Towers

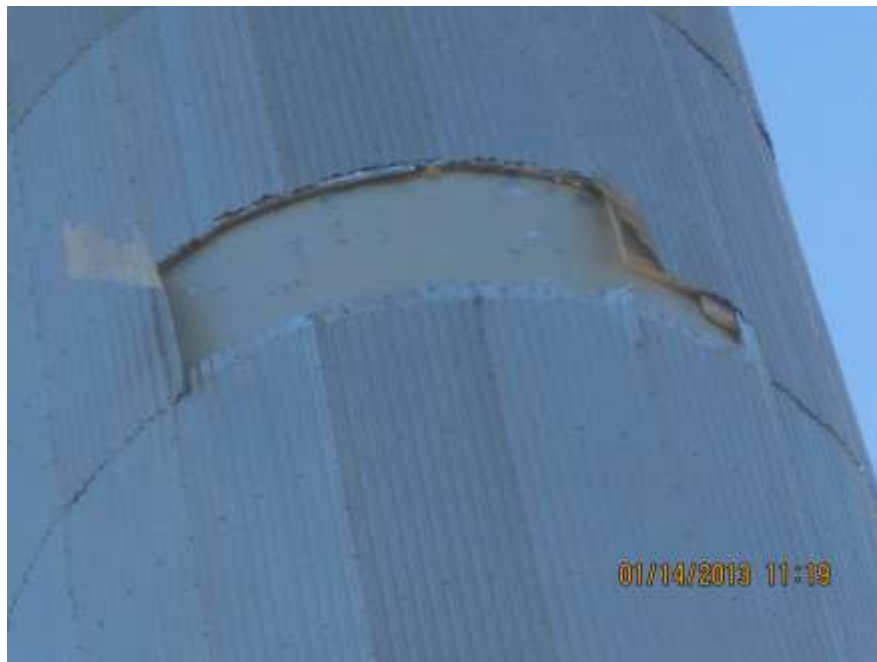
Figure 27: Frost Casing Failure – January 2013

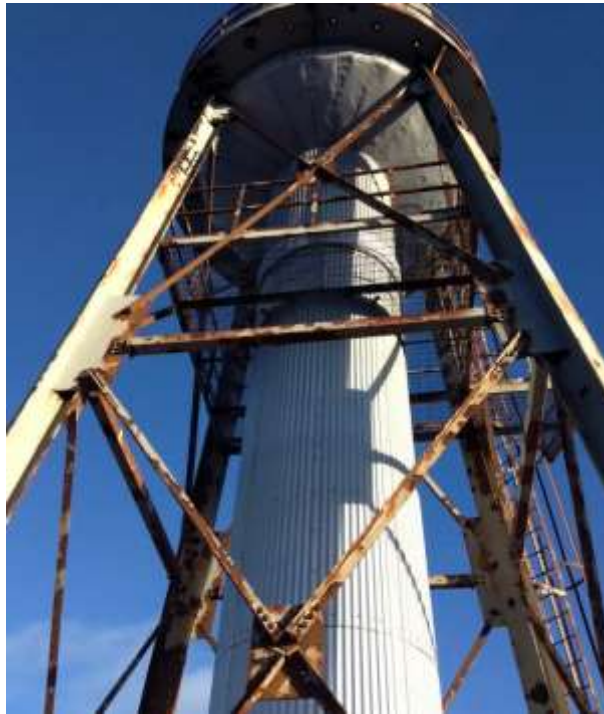
Figure 28: Deteriorated Coating – Surge Tank Support

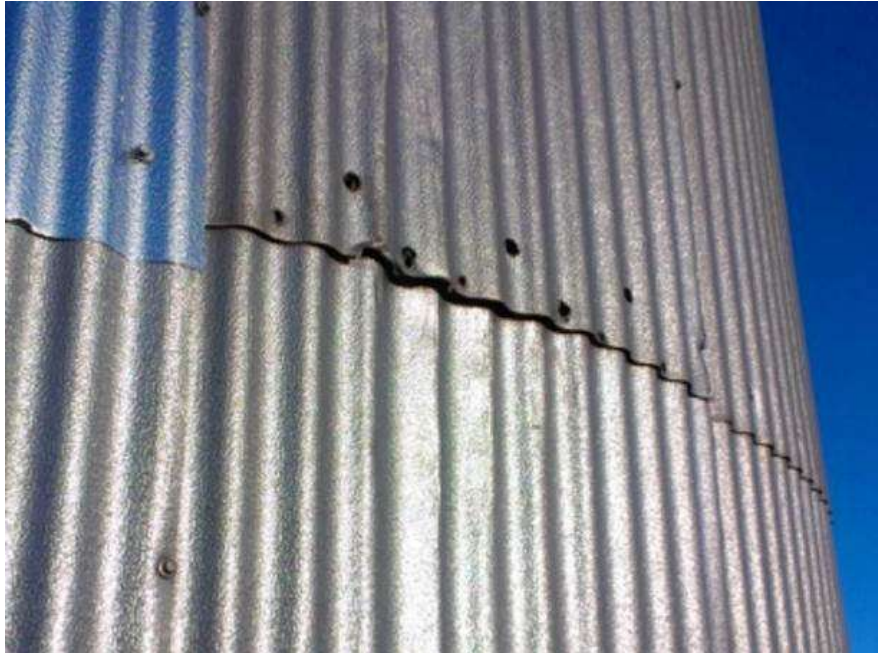
Figure 30: Screws Pulled Through Cladding

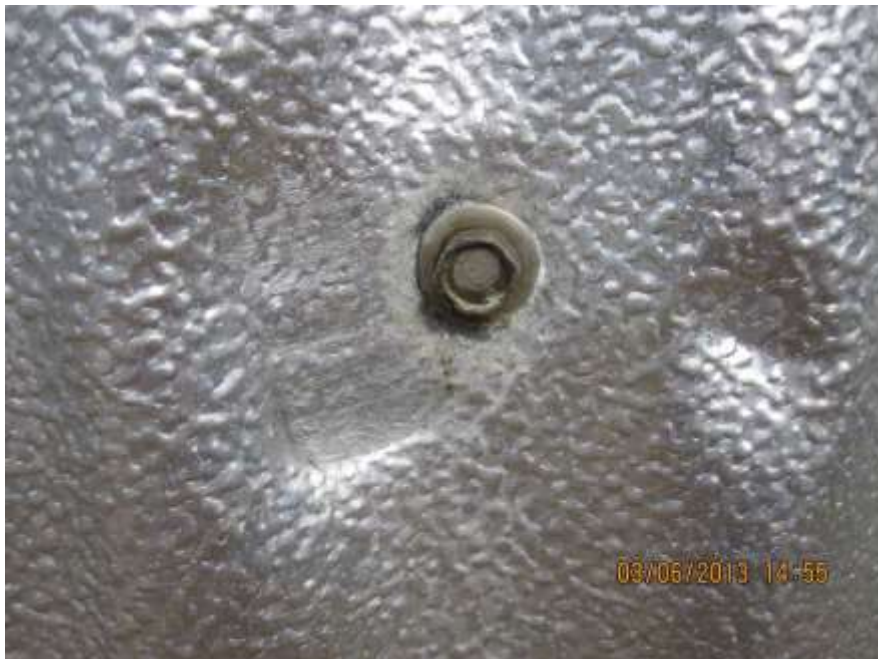
Figure 31: Corrosion at Fastener

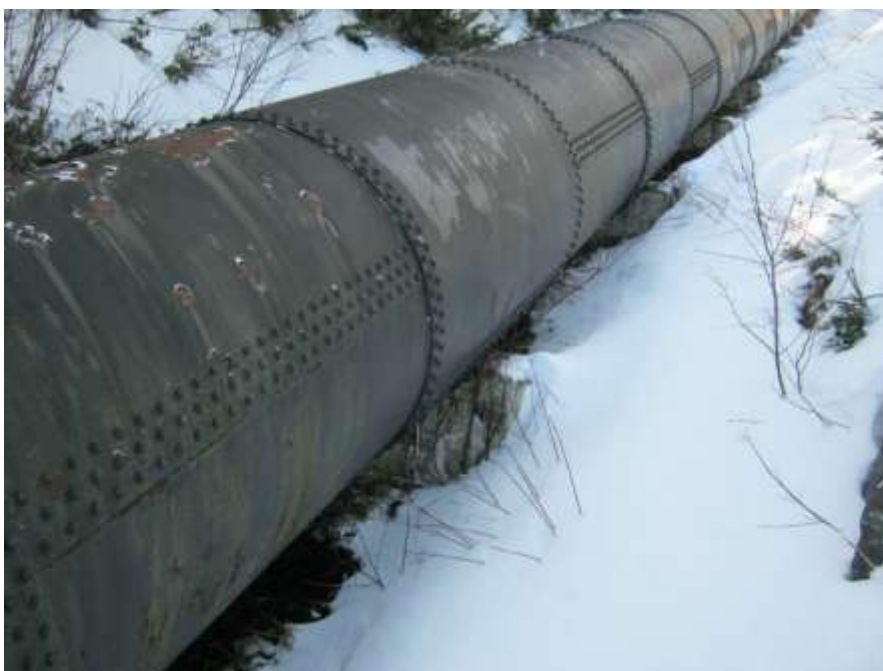
Photo C-4: General condition of steel penstock

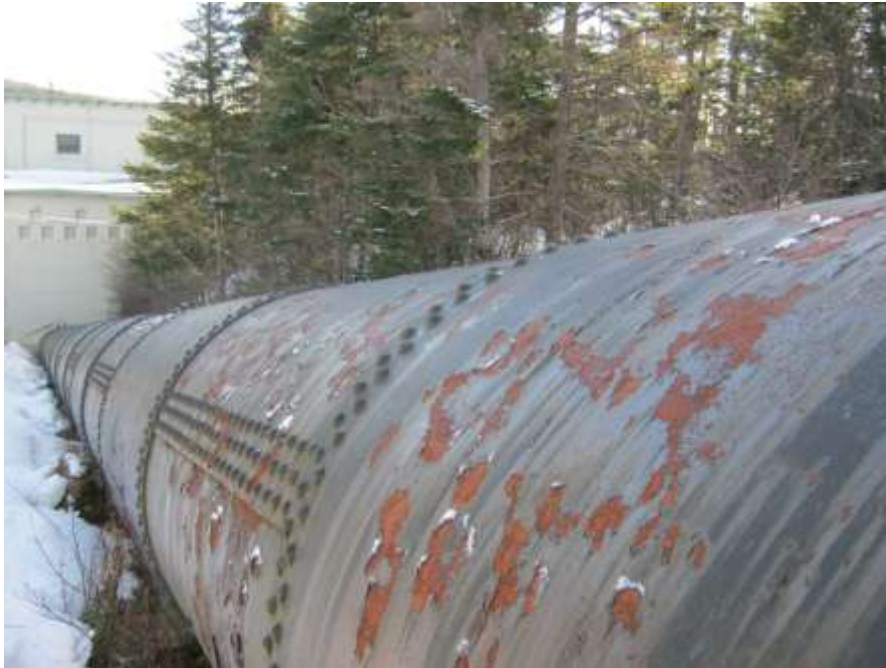
Photo C-5: General condition of steel penstock shell

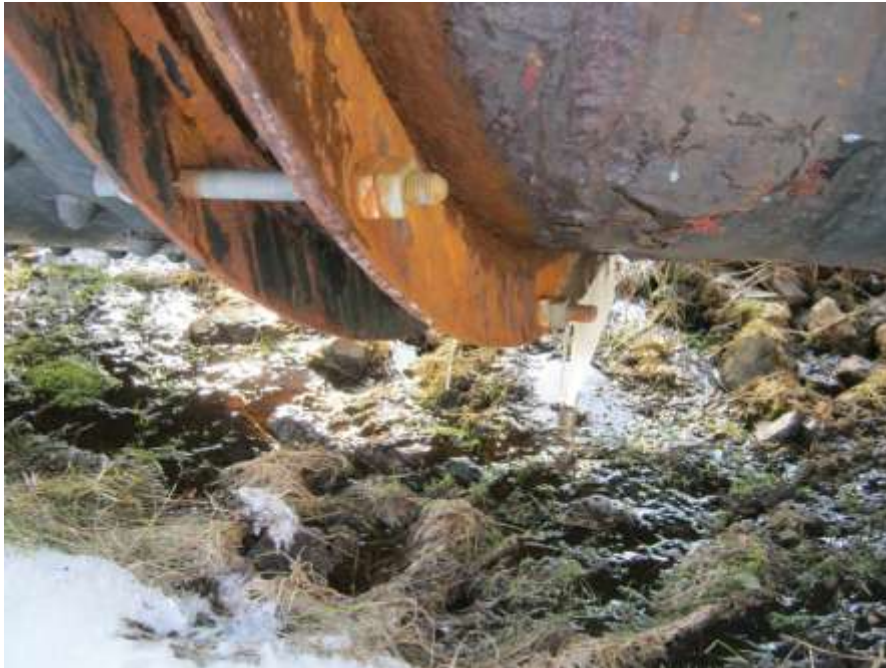
Photo C-9: Underside of penstock at mechanical expansion joint, showing minor leakage

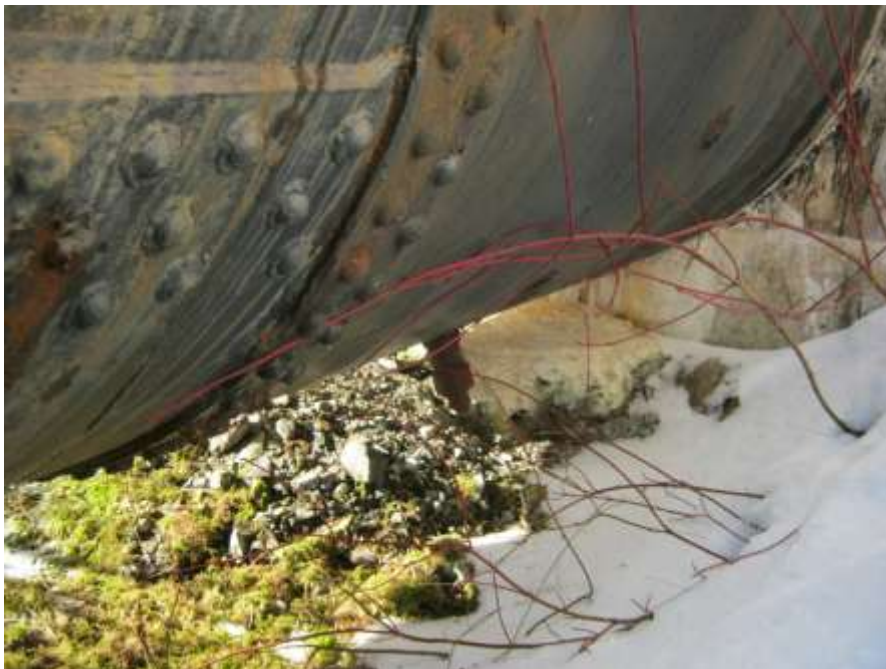
Photo C-10: Tap at underside of penstock near anchor block
