Re: Newfoundland Power's 2015 Capital Budget Application

**Pierre's Brook Hydro Plant
Penstock Replacement and Surge Tank Refurbishment**

June 2014

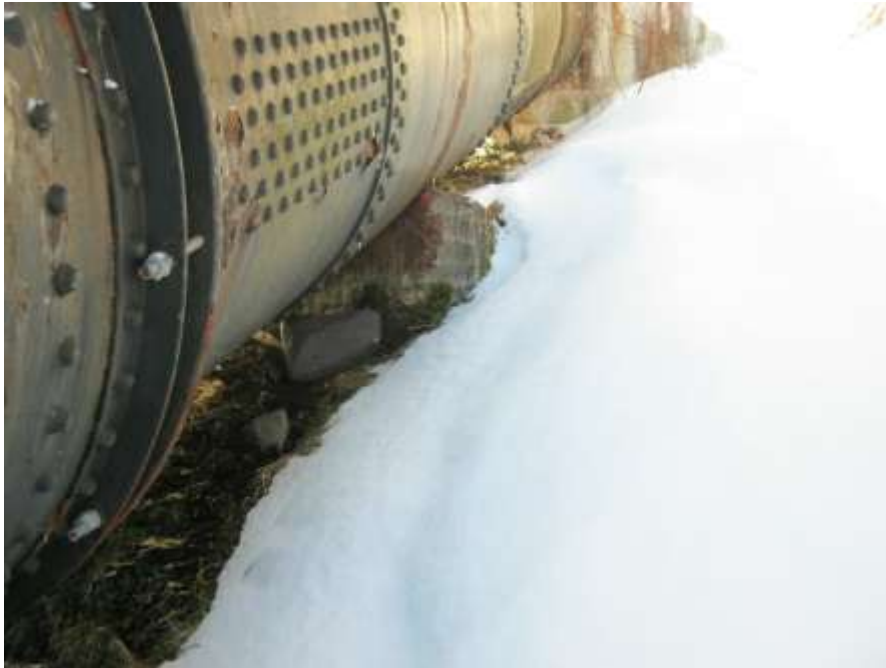
Photo C-11: Typical concrete cradle support

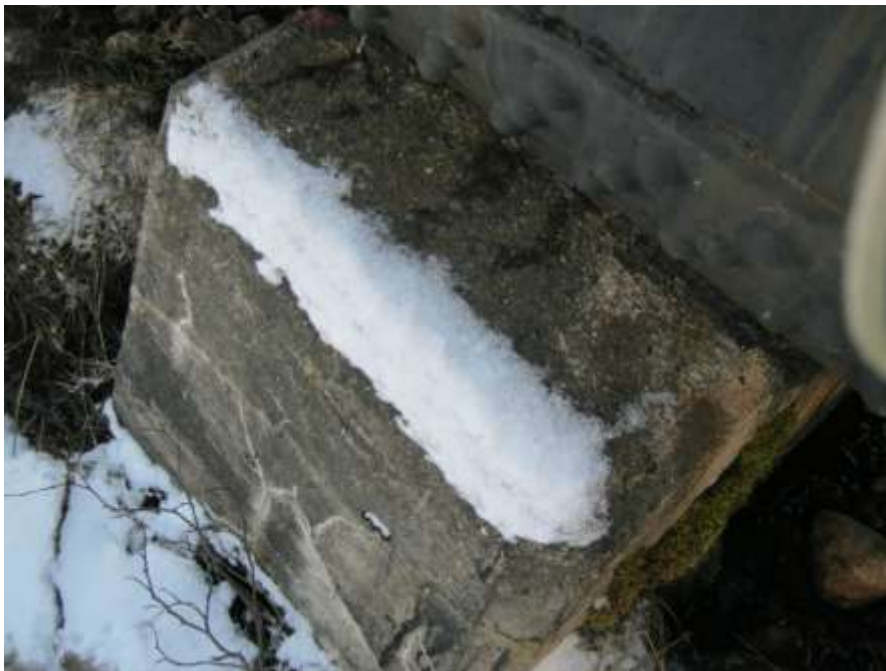
Photo C-12: Concrete cradle support showing signs of deterioration

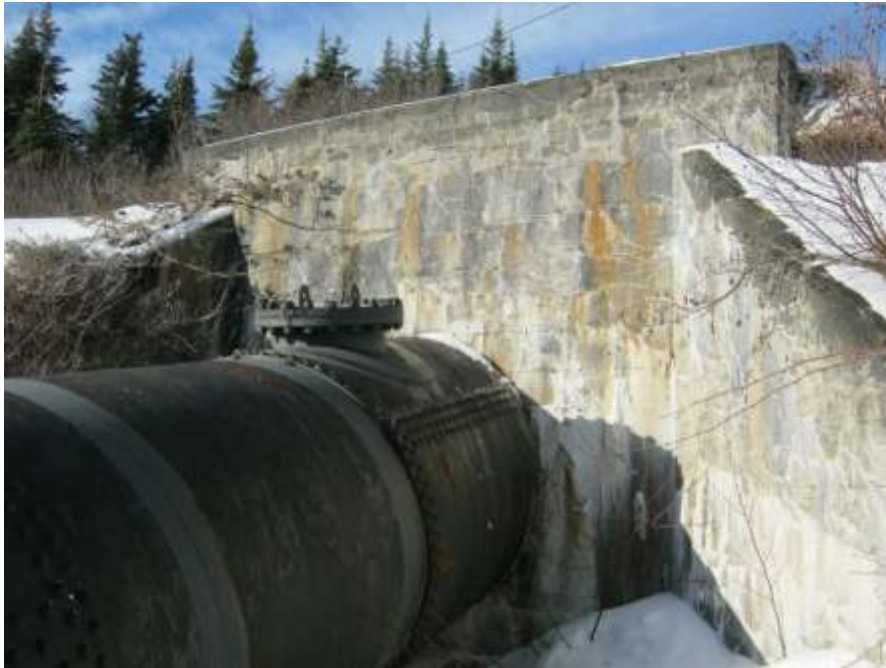
Photo C-13: Anchor block at upstream end of steel penstock

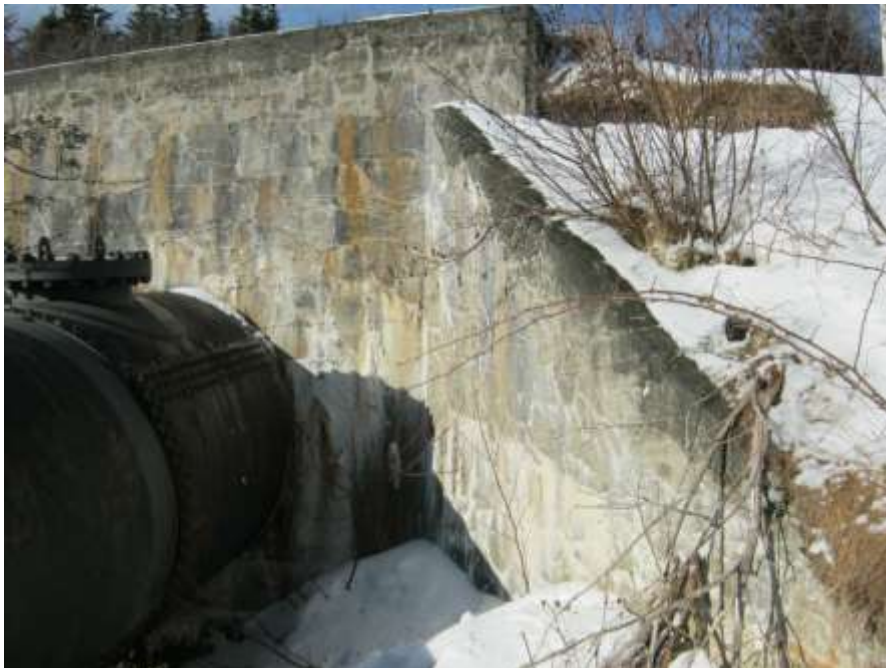
Photo C-14: Anchor block at upstream end of steel penstock

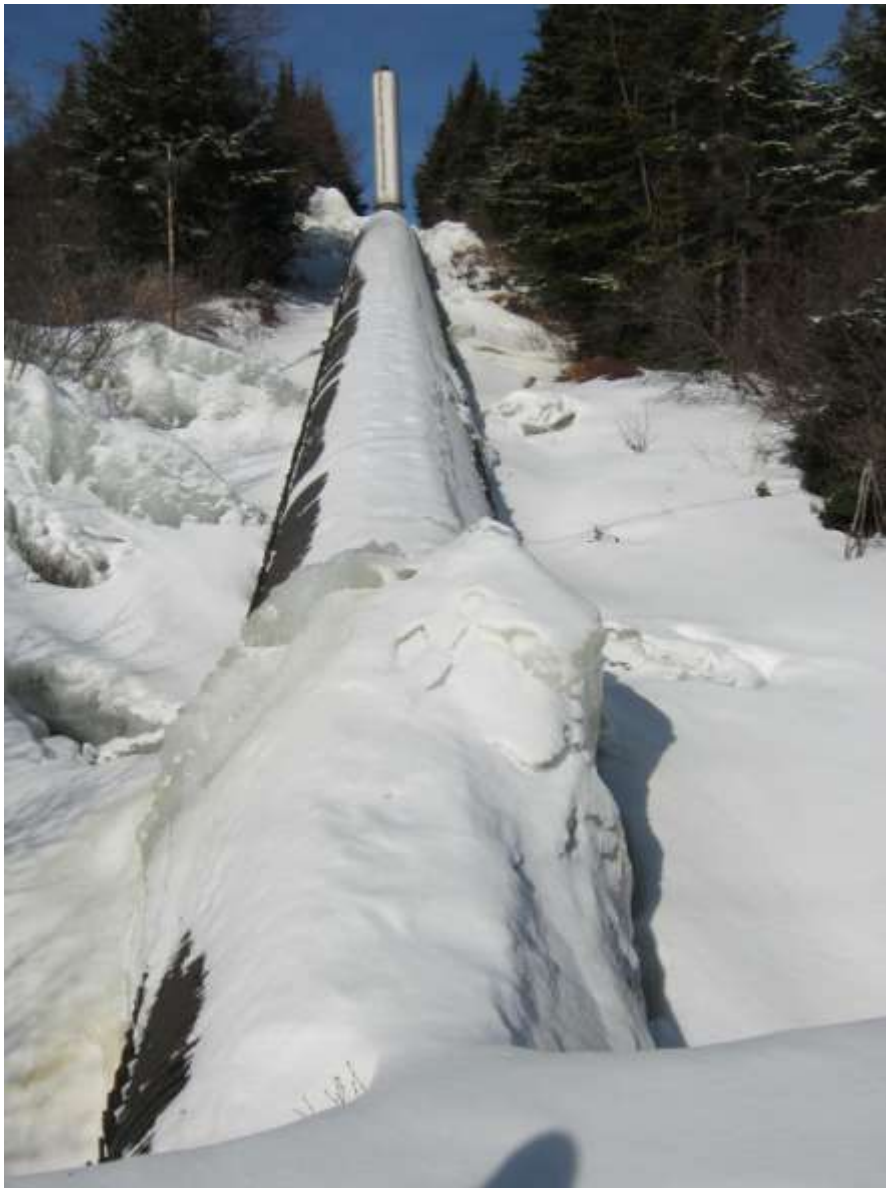
Photo C-15: Looking upstream at wood stave penstock from anchor block to surge tank

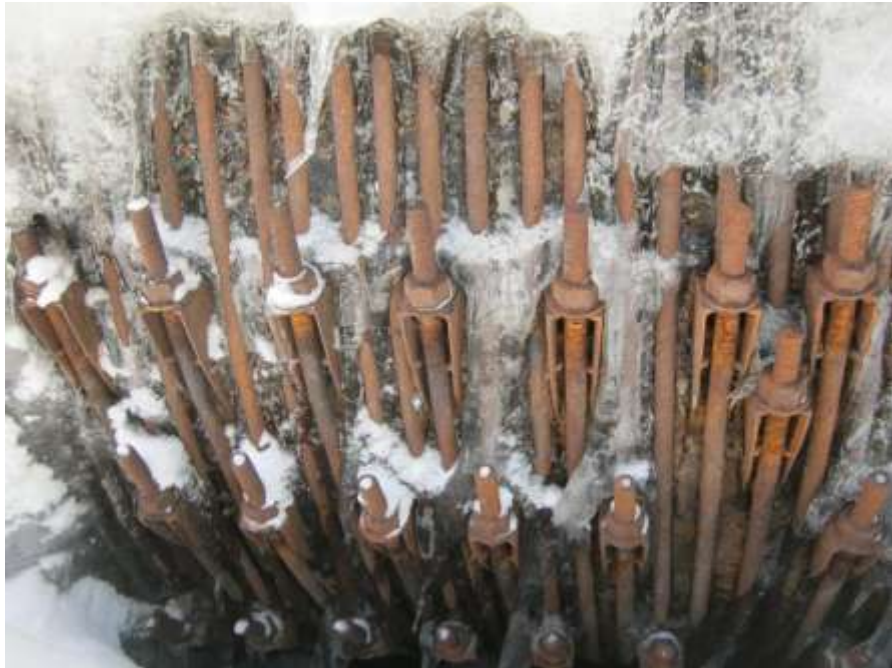
Photo C-16: Bands near downstream end of wood stave penstock

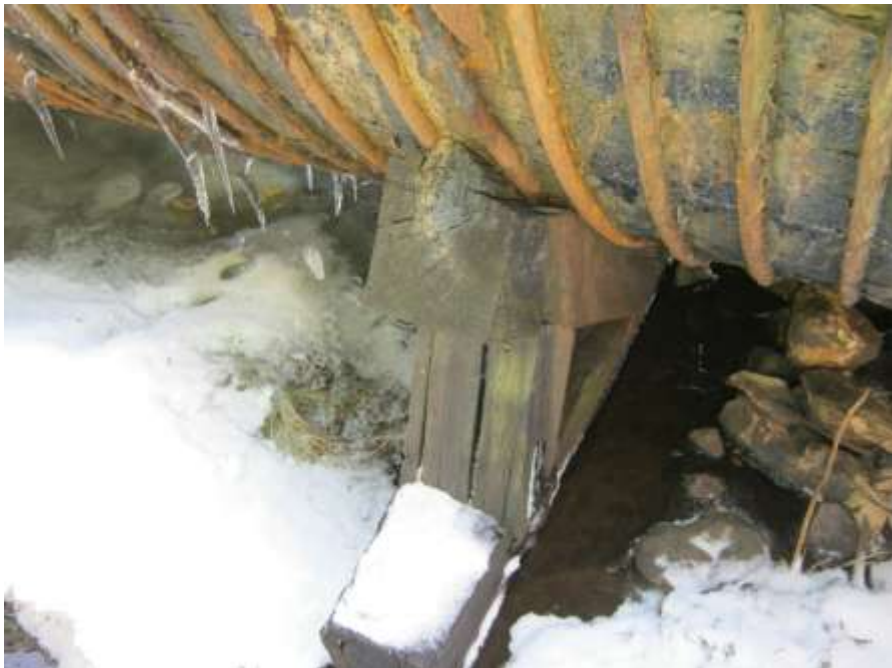
Photo C-19: Deteriorated cradle

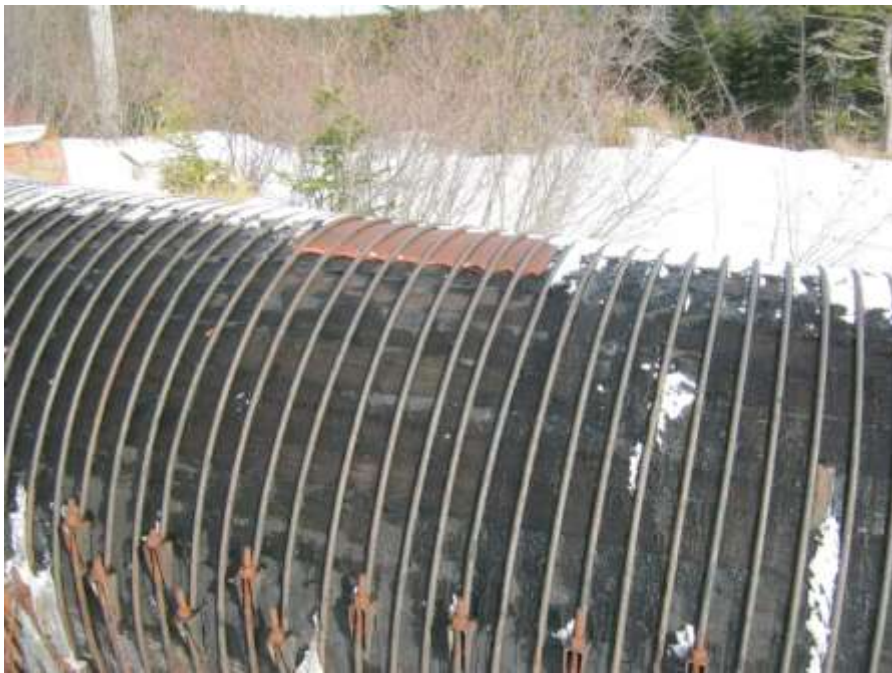
Photo C-21: Metal patch in top of penstock

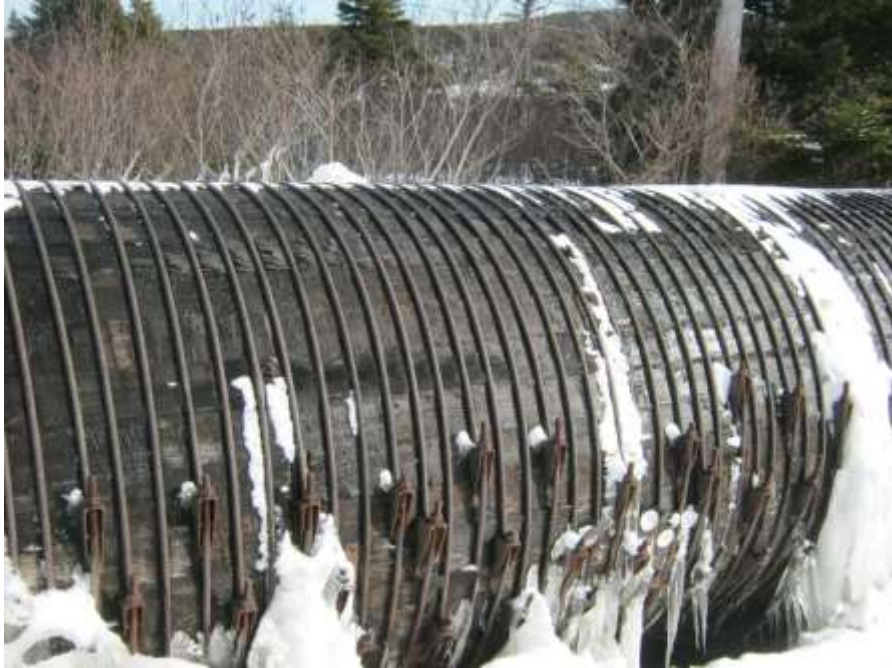
Photo C-22: Example of delaminated stave, and repairs to reduce leakage along the springline

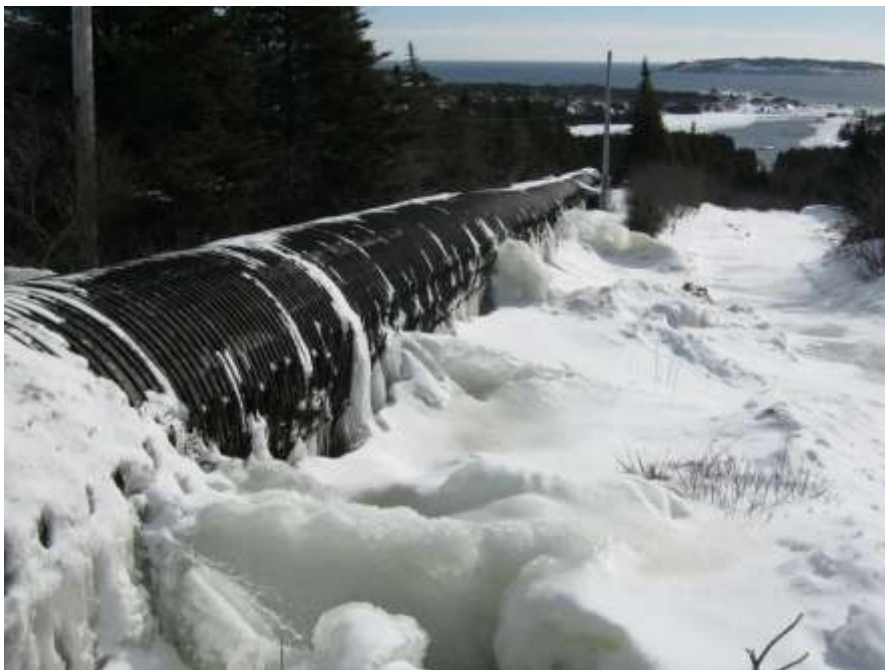
- 3) The observed sag in the penstock immediately downstream of the surge tank is likely the result of foundation settlement, but appears to have stabilized.

Photo C-24: Penstock immediately downstream of surge tank, showing leakage and sagging

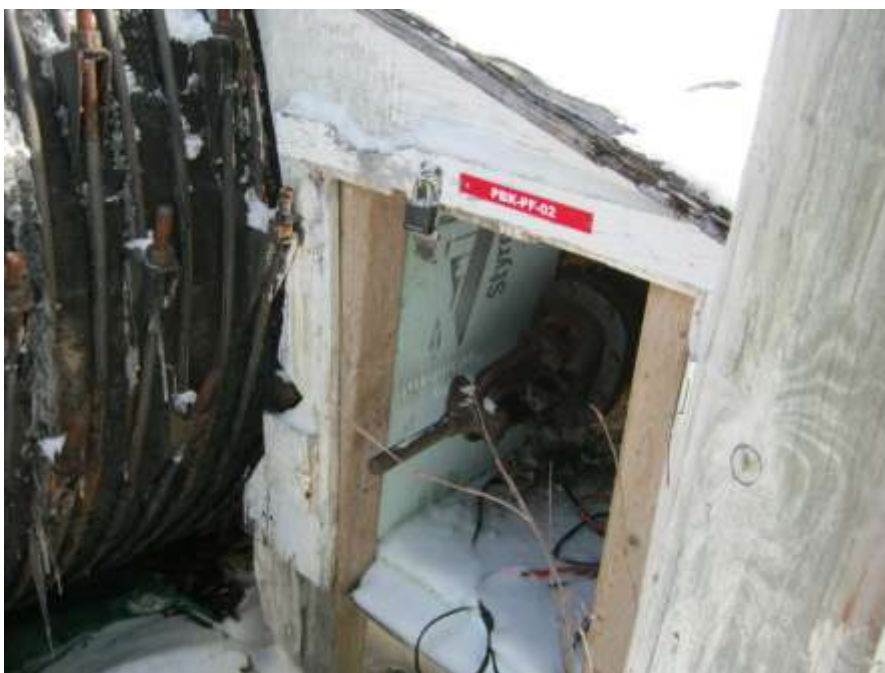
Photo C-25: Water supply line from side of penstock

- 1) Reinstate the electrical heat tracing to the area where the water supply line to the fish plant taps into the side of the wooden penstock
- 2) The exterior coating on the surge tank tee should be replaced

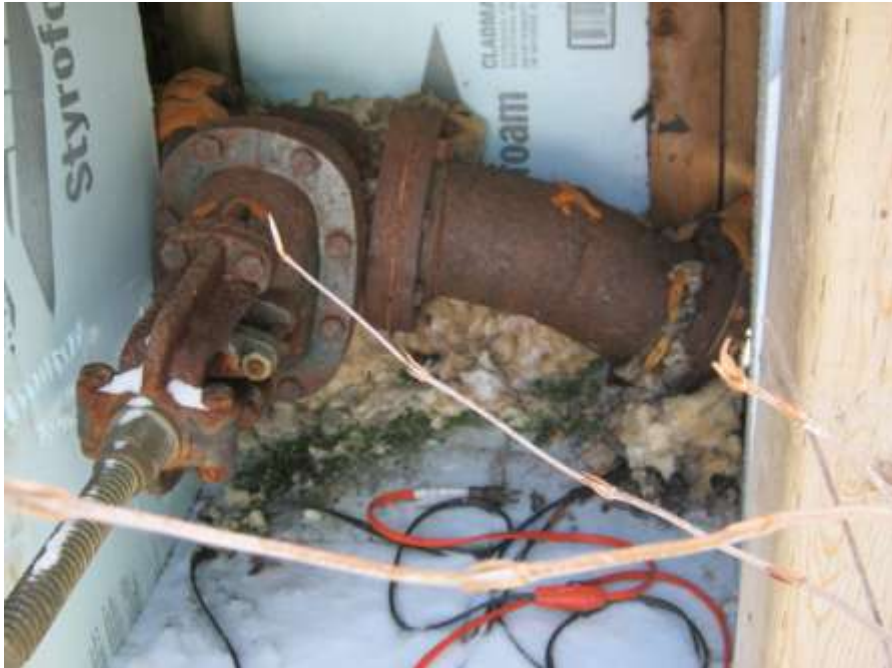
Photo C-26: Water supply line from side of penstock

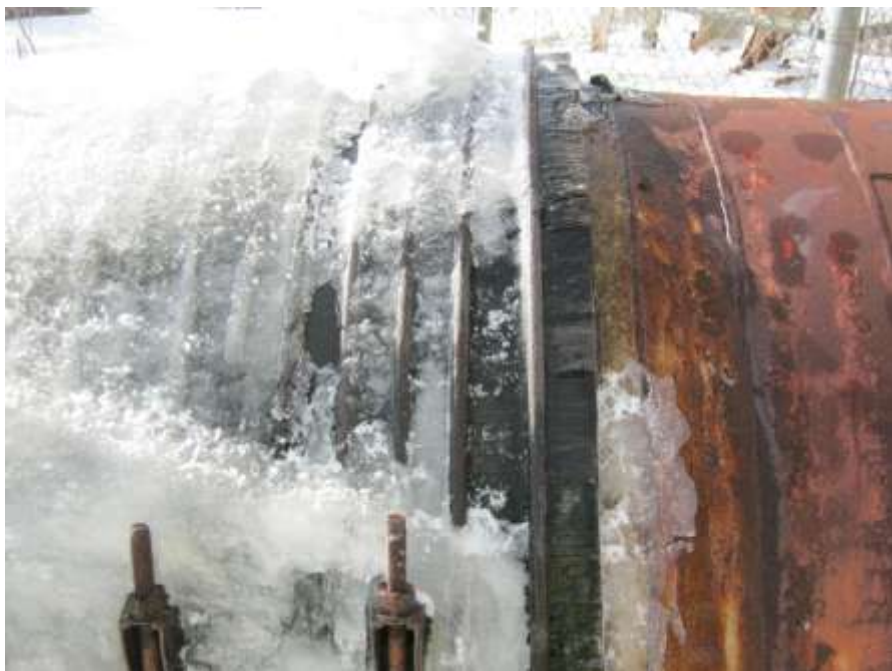
- 1) The steel in the surge tank tee appears to be in generally good condition, but it requires refurbishment to maintain its reliability and long term performance

Photo C-27: Wood stave connection to downstream end of surge tank tee

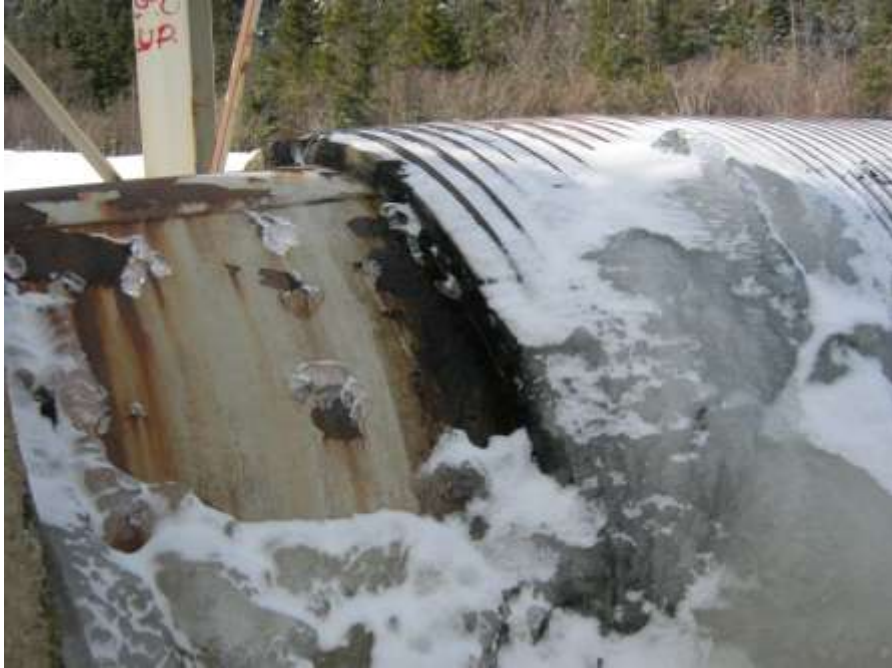
Photo C-28: Wood stave connection to upstream end of surge tank tee

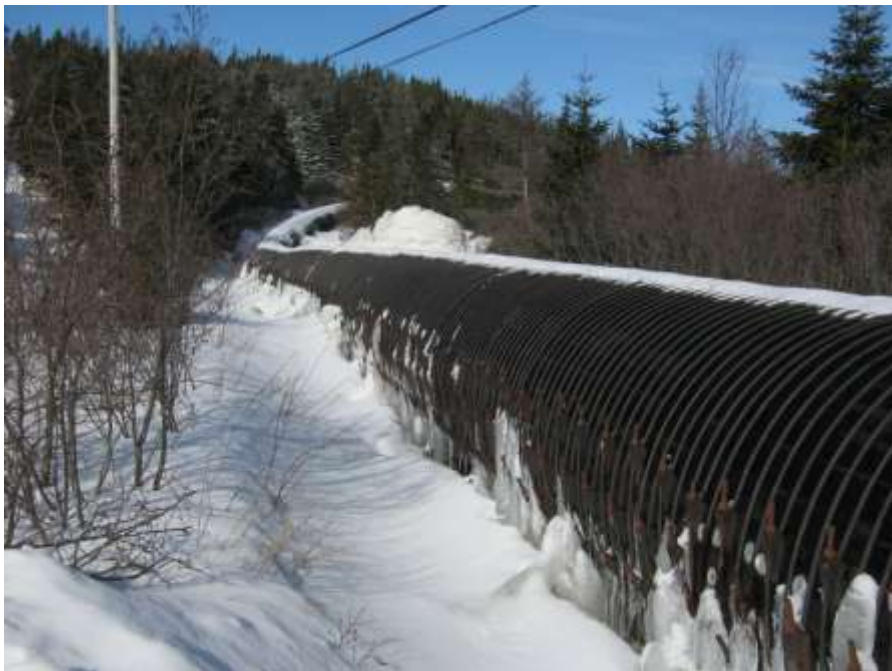
Photo C-29: Wood stave penstock immediately upstream of surge tank

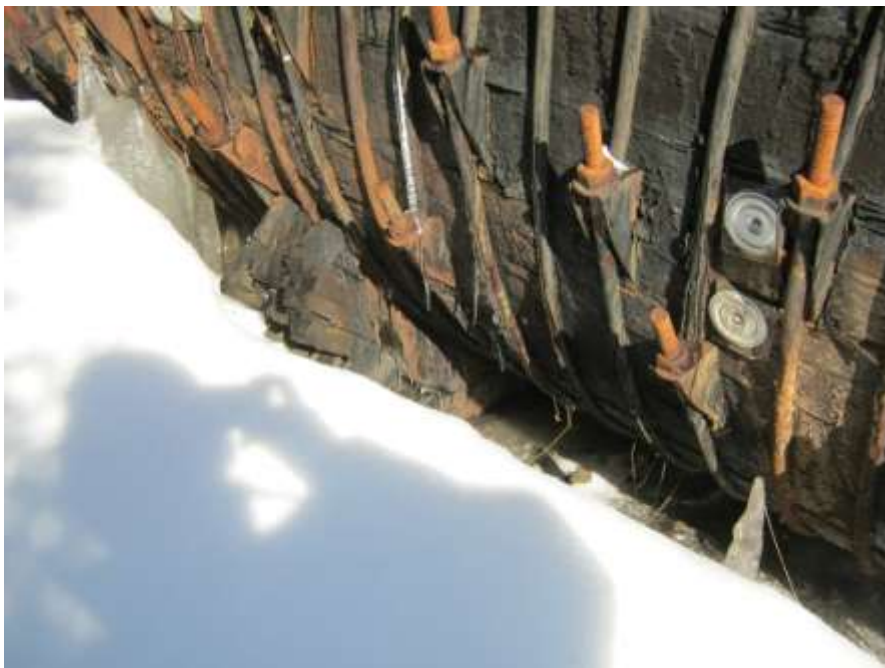
Photo C-30: Deteriorated cradles, staves and patching upstream of surge tank (typical)

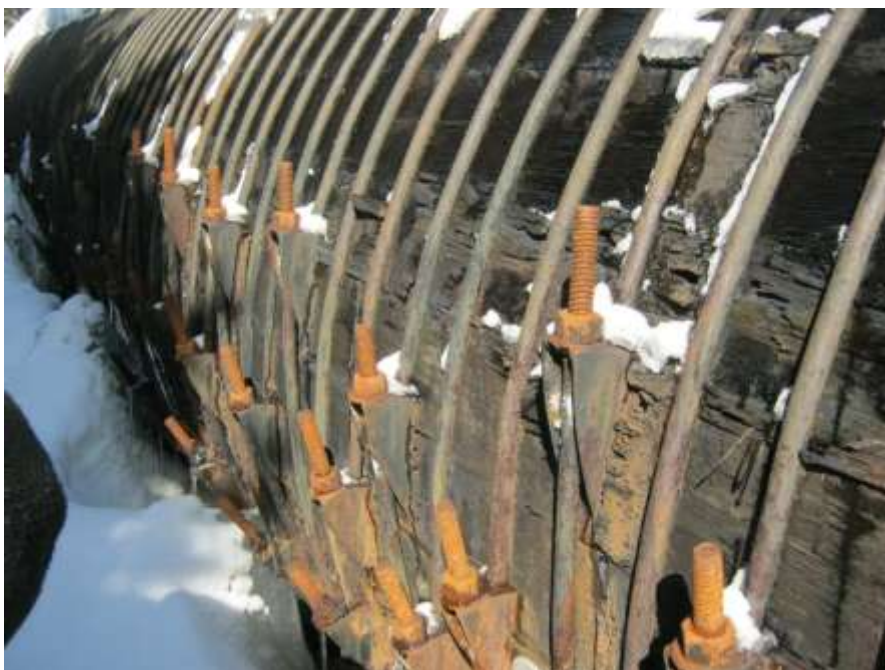
Photo C-31: Deteriorated staves upstream of surge tank (typical)

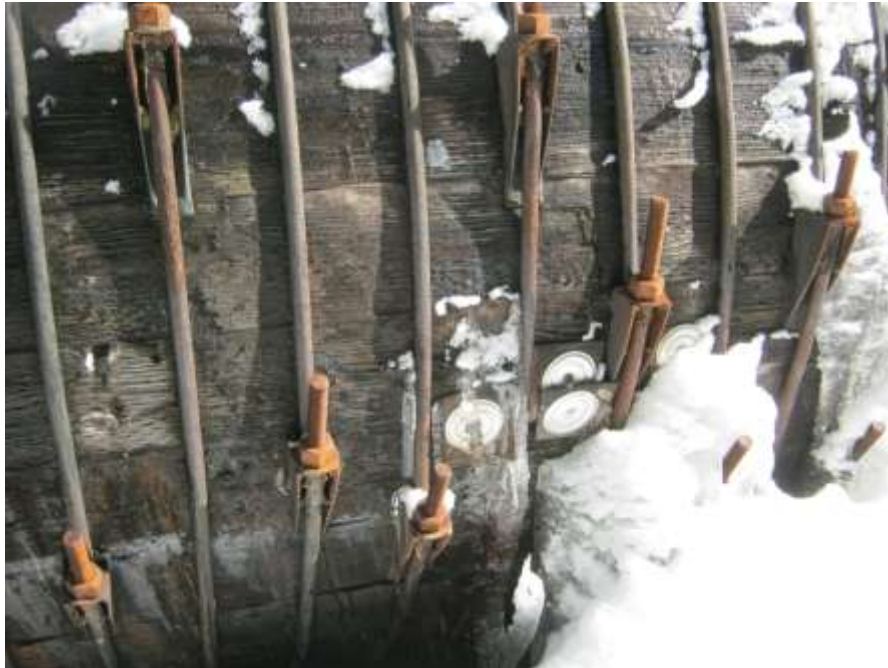
Photo C-32: Deteriorated staves and patching on springline upstream of surge tank (typical)

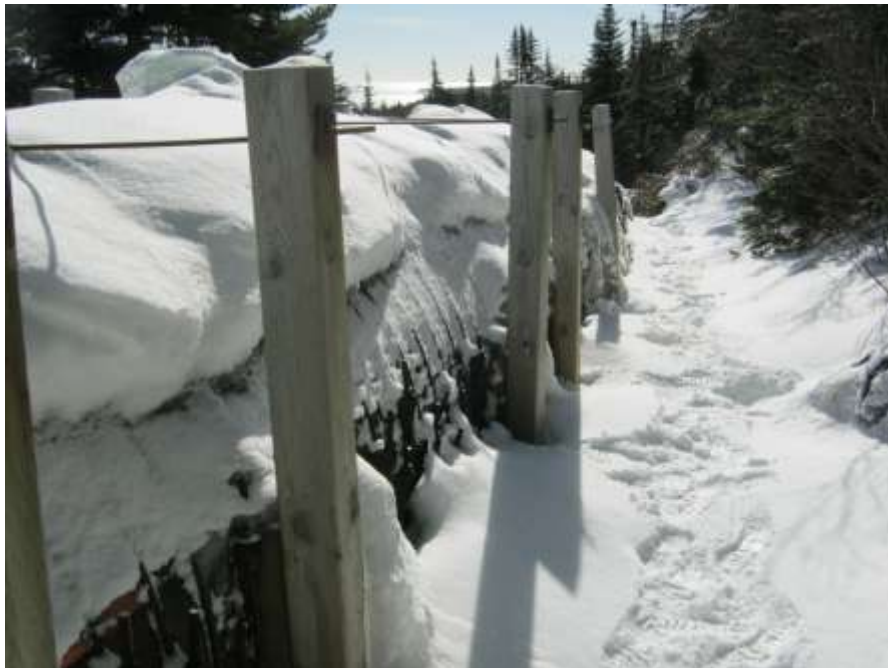
Photo C-33: Modifications at location of previous blow-out

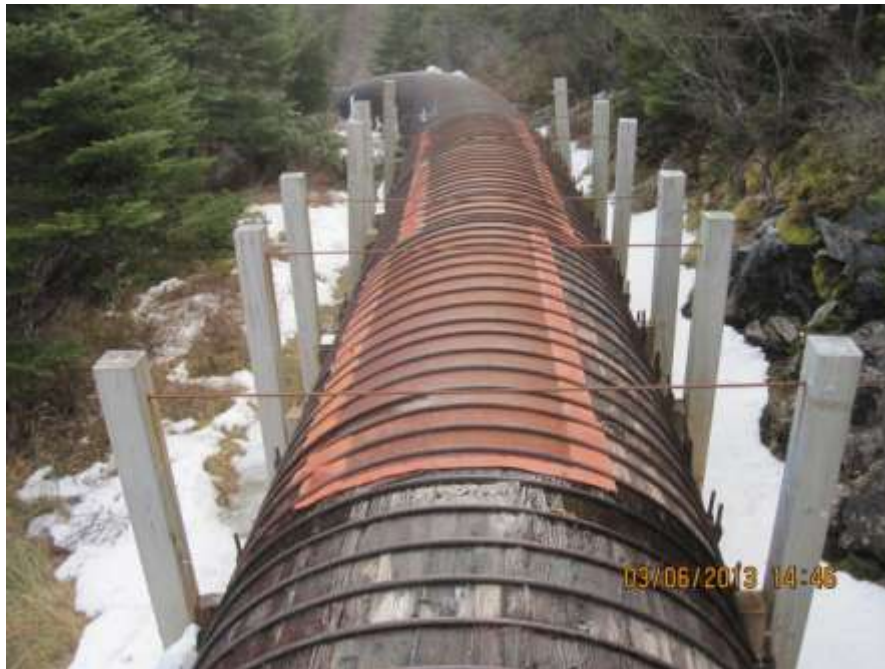
Photo C-34: Modifications at location of previous blow-out

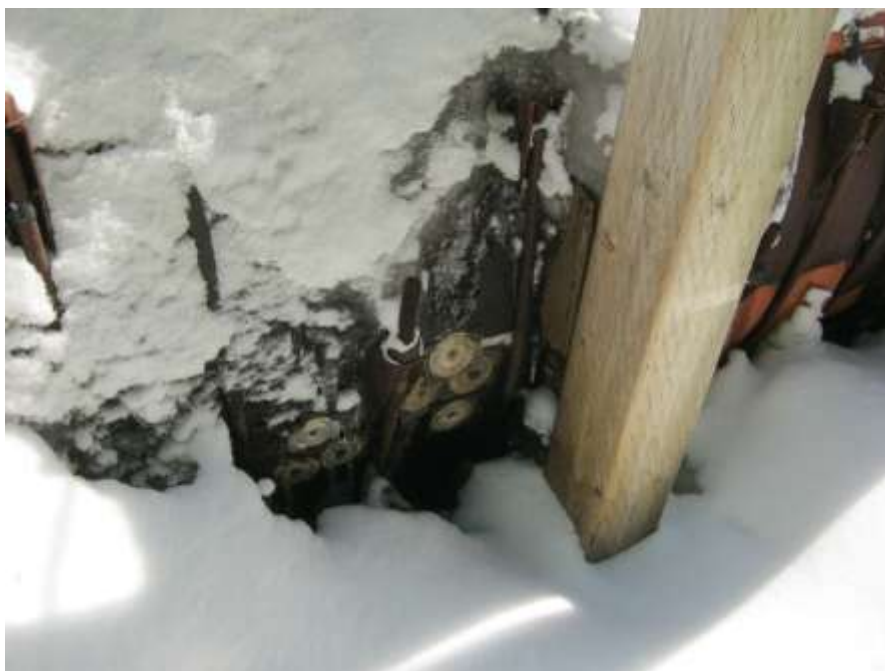
Photo C-35: Patching at springline at location of previous blow-out

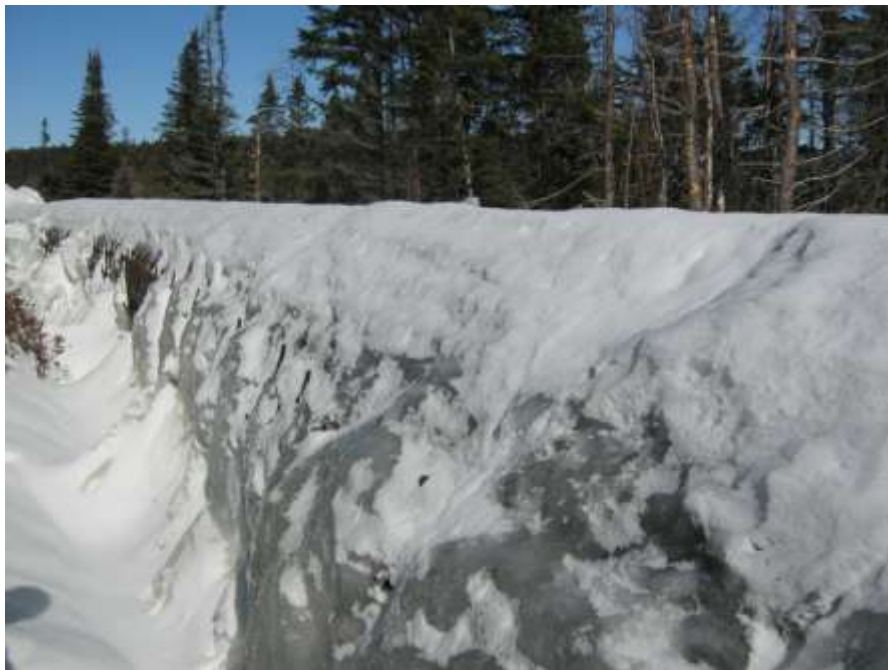
Photo C-36: Leakage along springline upstream, of previous blow-out

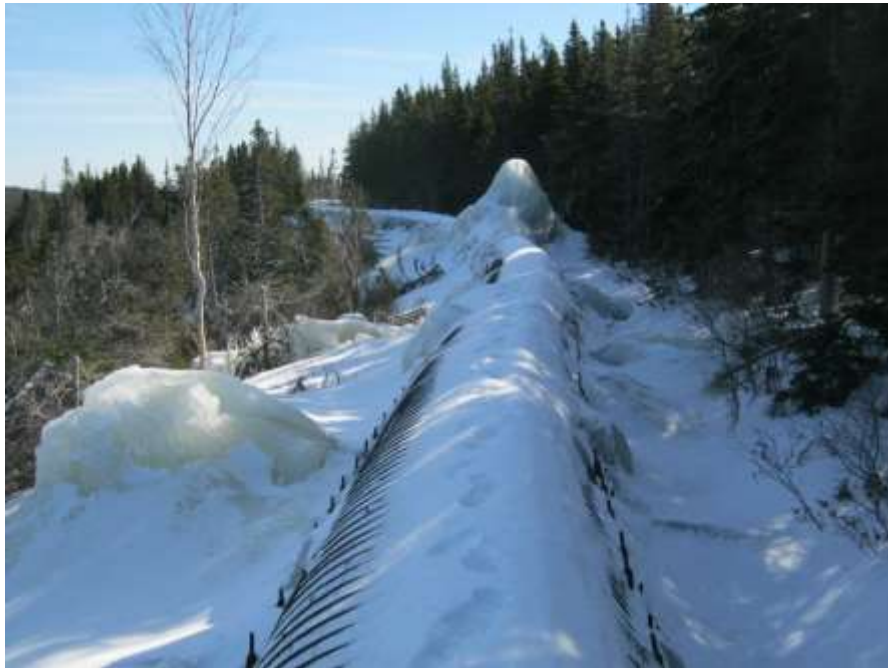
Photo C-38: General view of penstock showing leakage

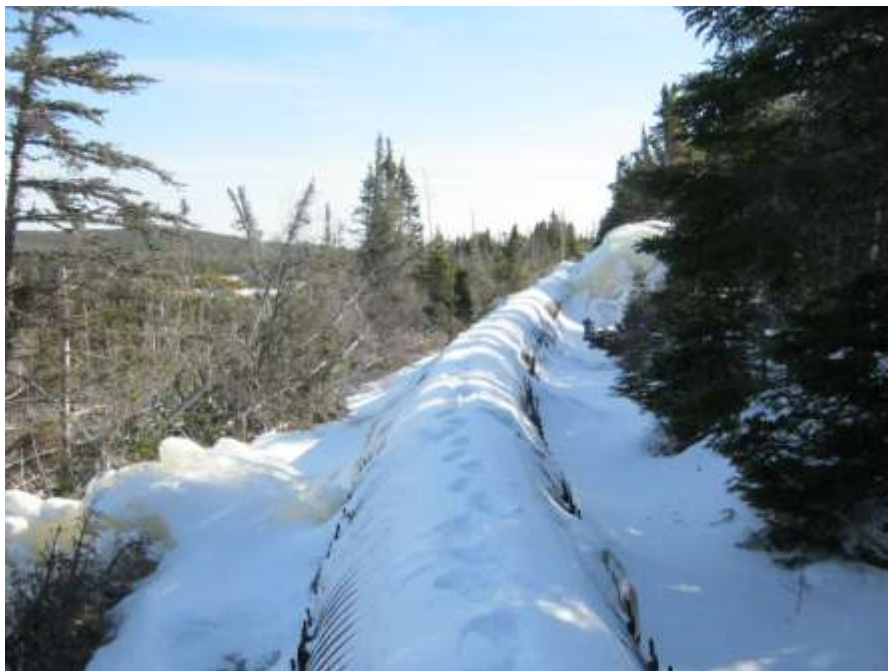
Photo C-39: General view of penstock showing leakage

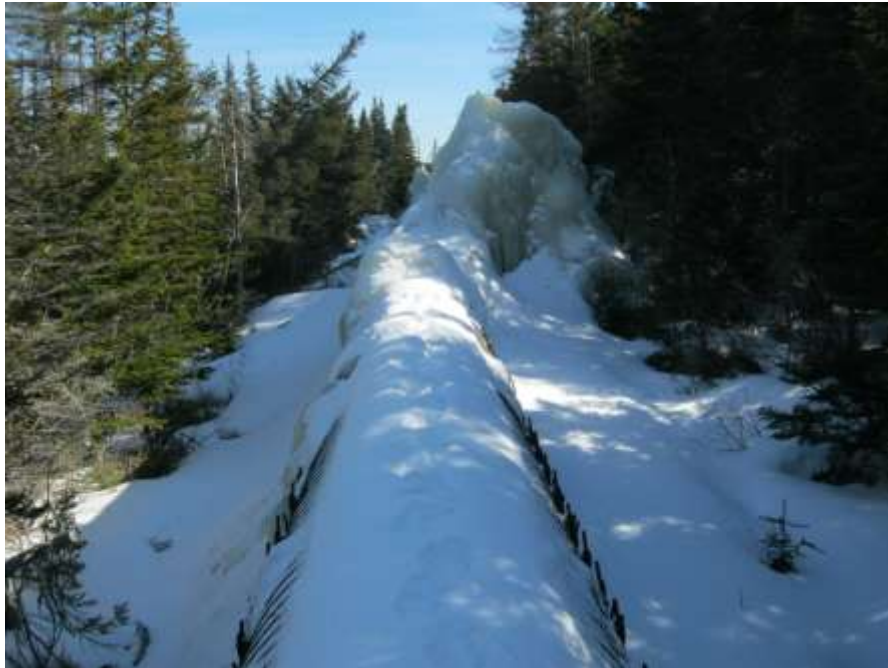
Photo C-40: General view of penstock showing leakage

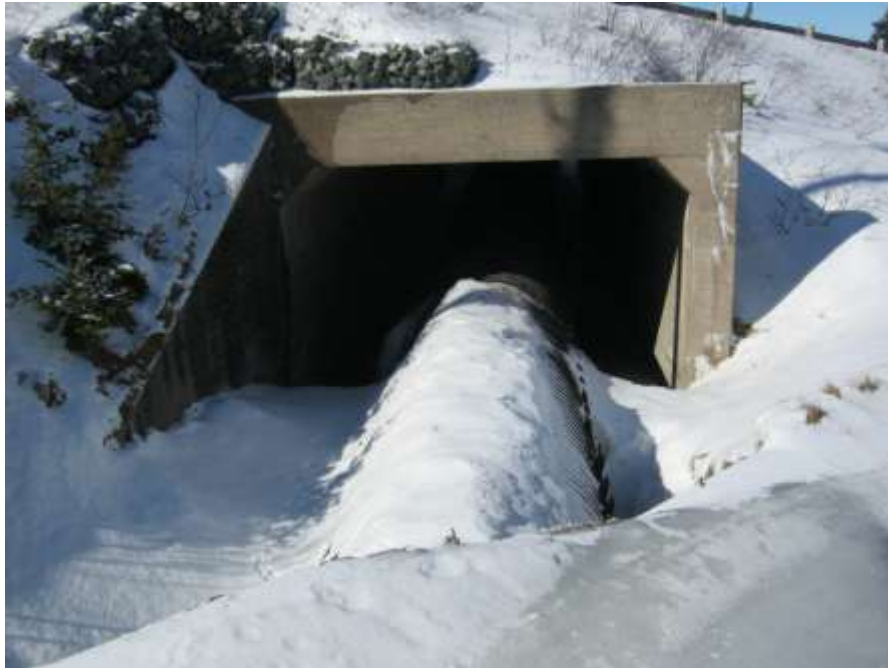
Photo C-42: Penstock at highway crossing

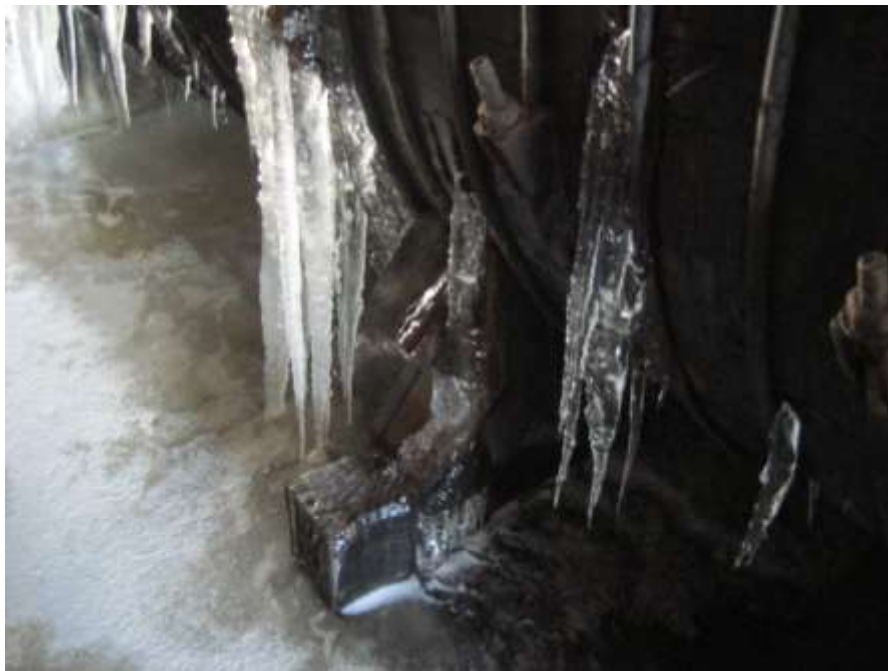
Photo C-43: Cradles at location of highway crossing

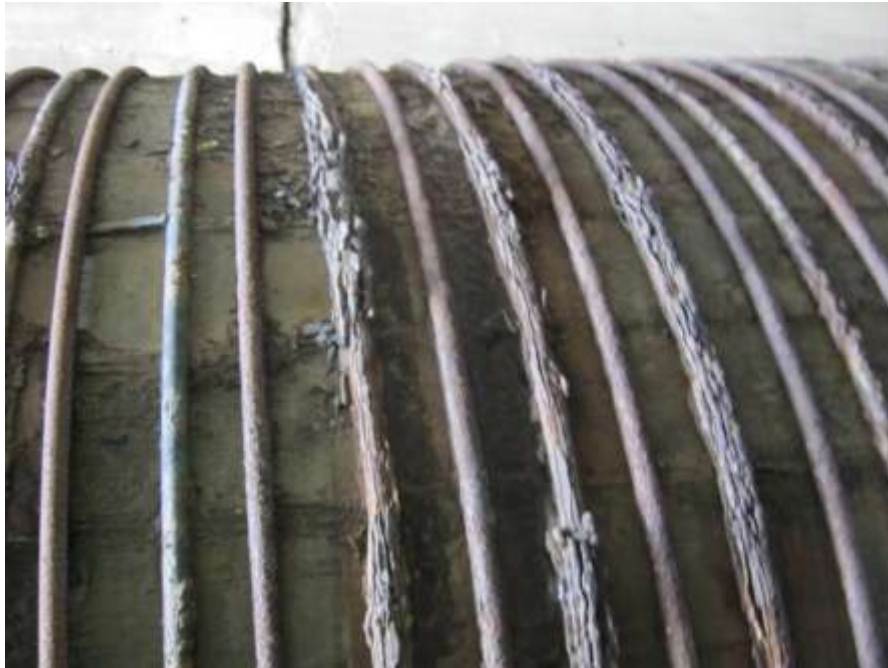
Photo C-44: Corroded bands under highway crossing

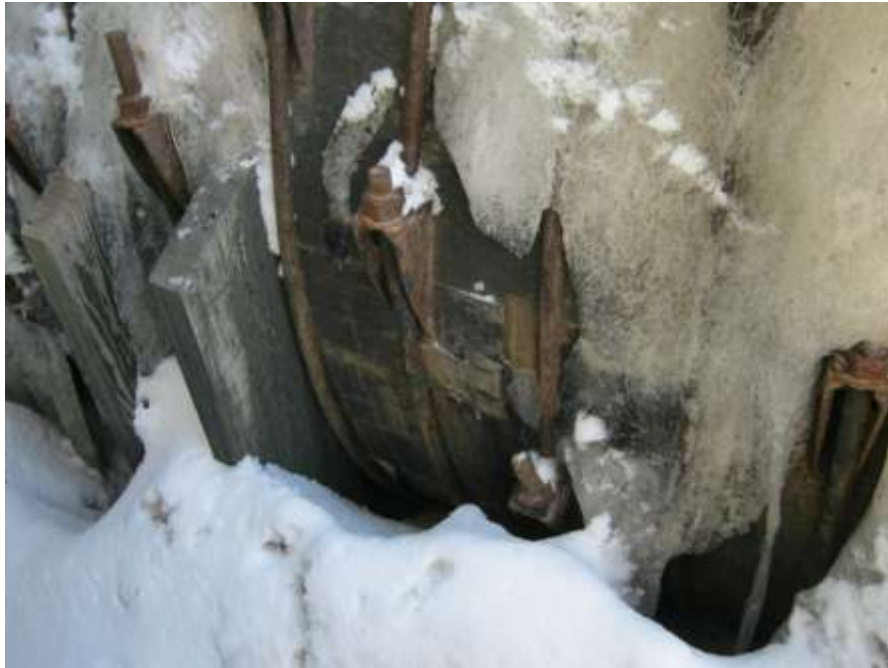
Photo C-46: Typical damaged end of stave

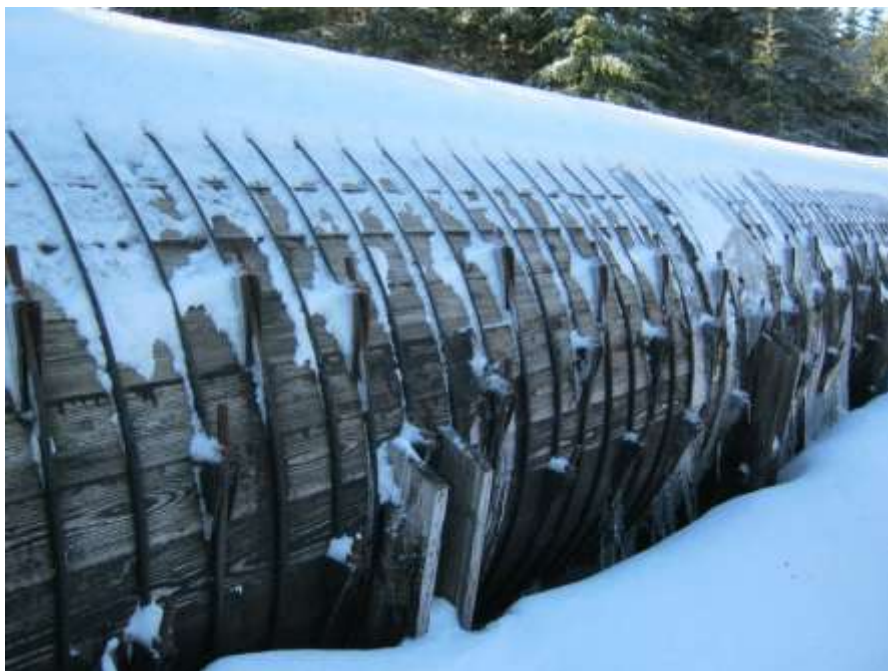
Photos C-47 and C-48 show the preservative treatment to be leached out of the wood. This is typical along this entire length of penstock. Photos C-49 to C-62 show typical examples of stave delamination, brooming, poor preservative treatment, and leakage along the length of the penstock. Photos C-57 and C-63 show examples of poor drainage of the penstock bed, which can lead to rotten staves and cradles, and settlement of the cradles. Photo C-64, which is the length of penstock immediately downstream of the dam, shows the poor condition of the preservative treatment. Photo C-65 shows the most upstream end of the penstock where it enters a corrugated metal pipe culvert on the downstream face of the dam. This culvert was reportedly installed around the wood stave penstock in this area when the downstream face of the dam was flattened. For access reasons, it was not possible to inspect the short length of penstock inside this culvert.

Photo C-47: Typical condition of wood stave preservative treatment upstream of highway crossing

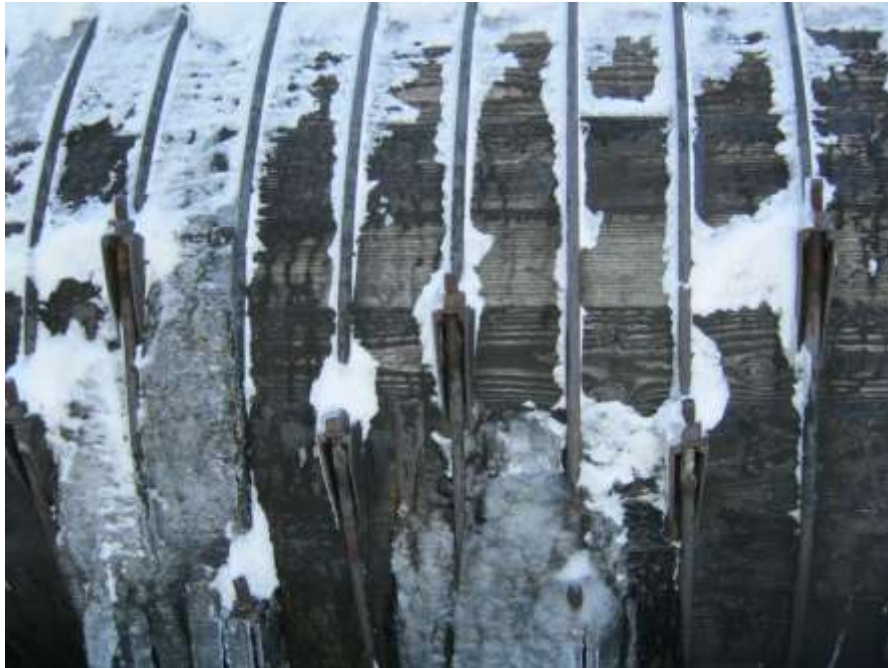
Photo C-48: Typical condition of wood stave preservative treatment upstream of highway crossing

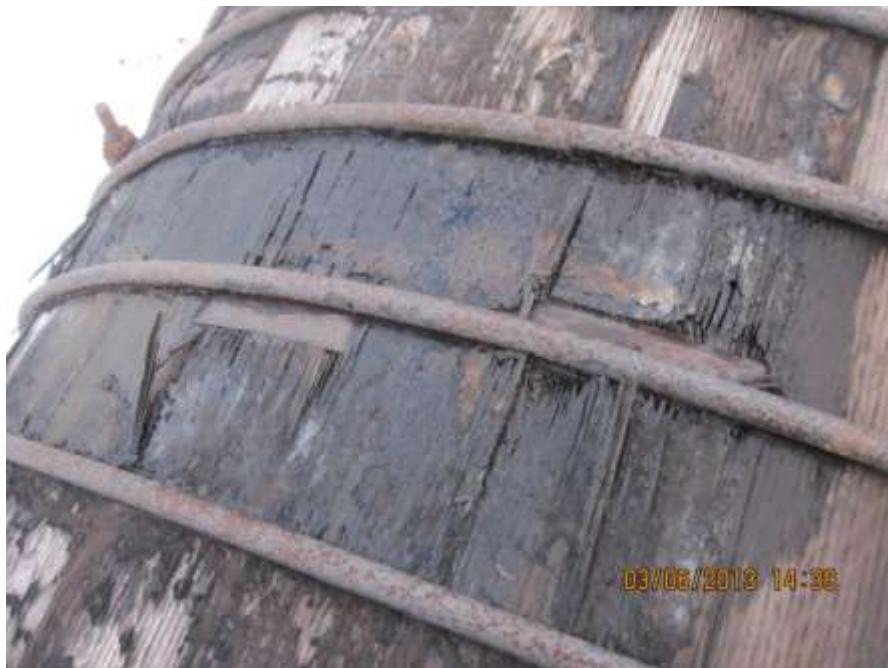
Photo C-49: Damaged ends of wood staves

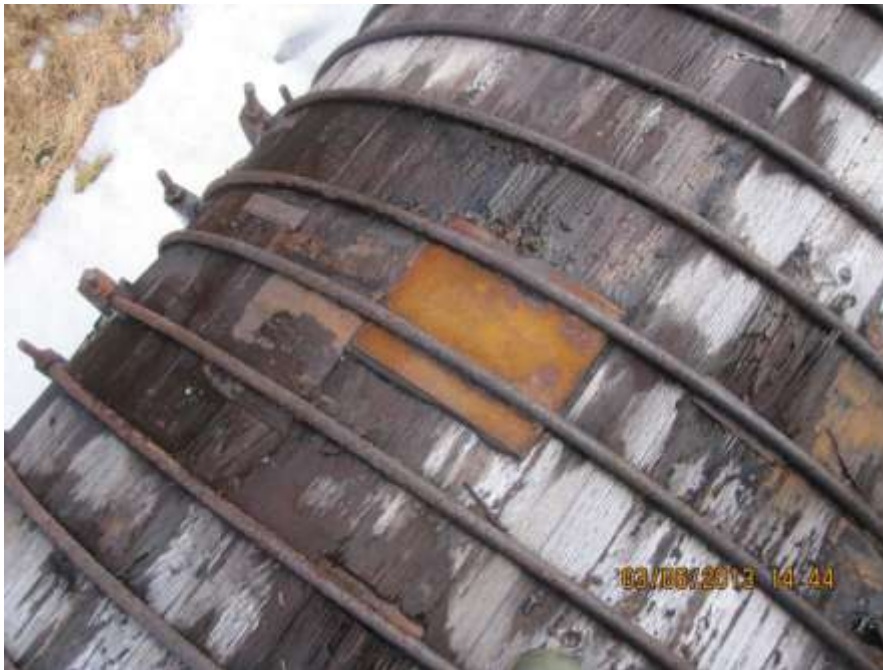
Photo C-50: Repairs and deteriorated staves

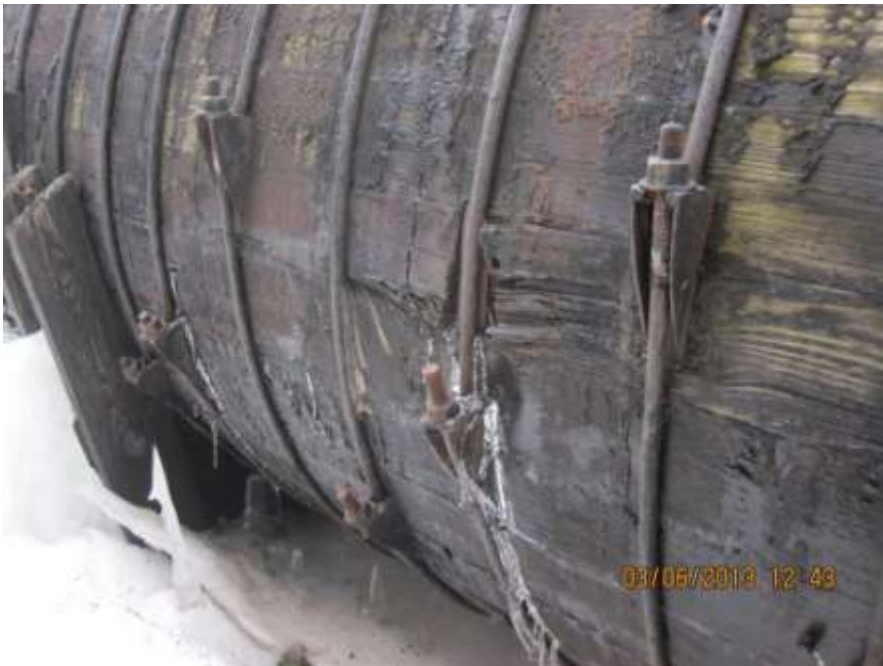
Photo C-51: Damaged ends of wood staves

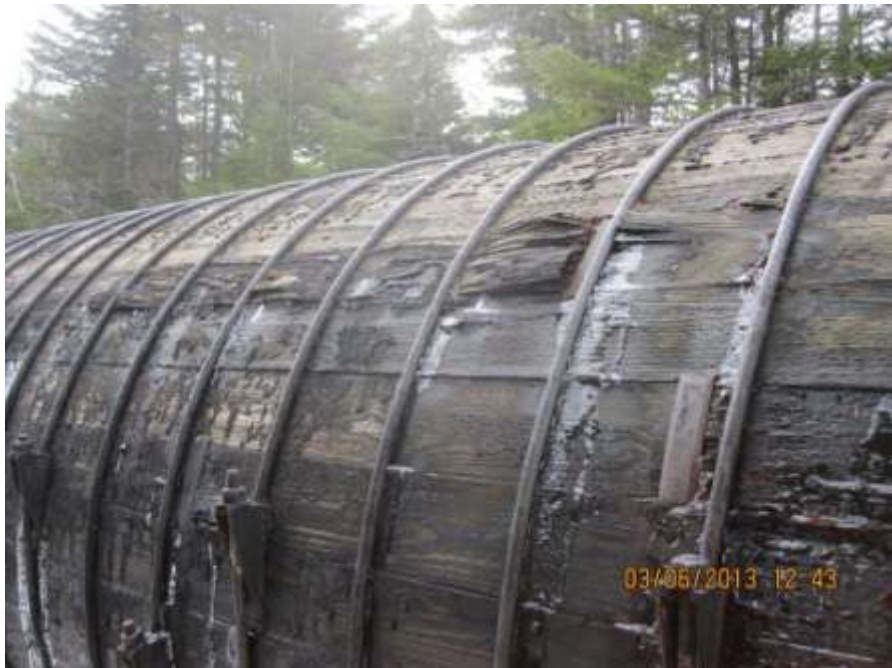
Photo C-53: Delaminated wood stave with broomed end

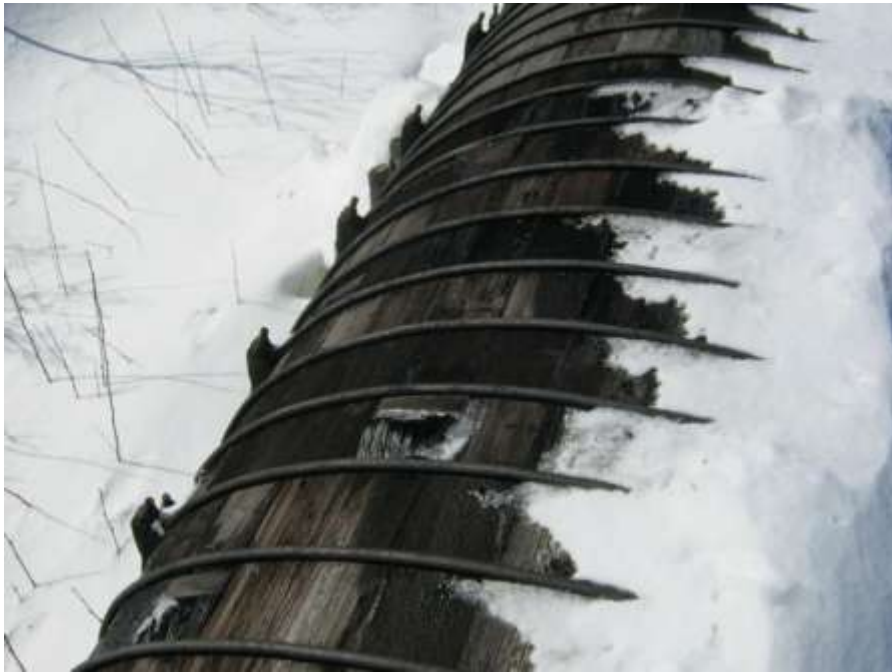
Photo C-54: Delaminated wood stave with broomed end
