Re: Newfoundland Power's 2015 Capital Budget Application

**Pierre's Brook Hydro Plant
Penstock Replacement and Surge Tank Refurbishment**

June 2014

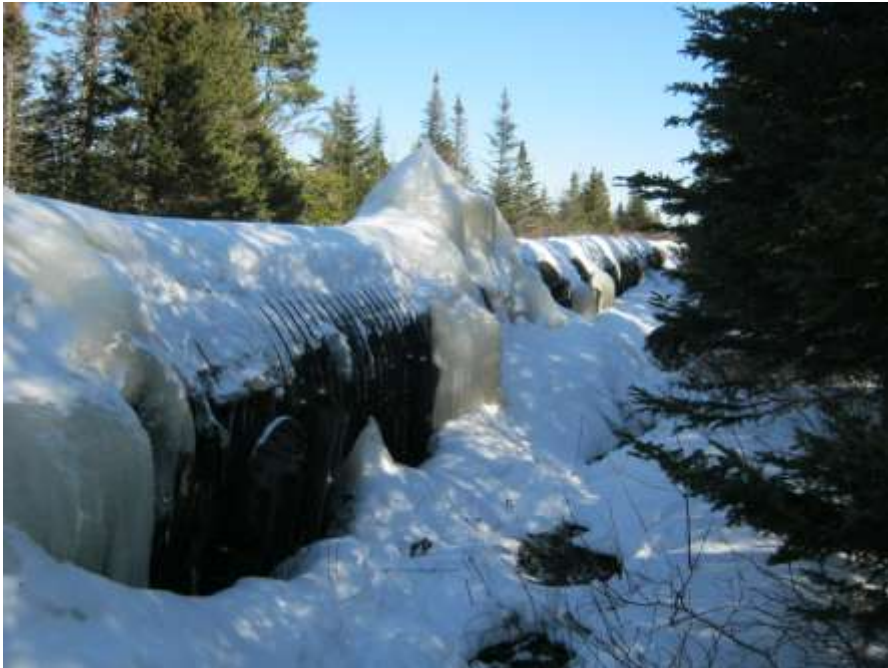
Photos C-47 and C-48 show the preservative treatment to be leached out of the wood. This is typical along this entire length of penstock. Photos C-49 to C-62 show typical examples of stave delamination, brooming, poor preservative treatment, and leakage along the length of the penstock. Photos C-57 and C-63 show examples of poor drainage of the penstock bed, which can lead to rotten staves and cradles, and settlement of the cradles. Photo C-64, which is the length of penstock immediately downstream of the dam, shows the poor condition of the preservative treatment. Photo C-65 shows the most upstream end of the penstock where it enters a corrugated metal pipe culvert on the downstream face of the dam. This culvert was reportedly installed around the wood stave penstock in this area when the downstream face of the dam was flattened. For access reasons, it was not possible to inspect the short length of penstock inside this culvert.

Photo C-56: Widespread leakage along springline of pipe

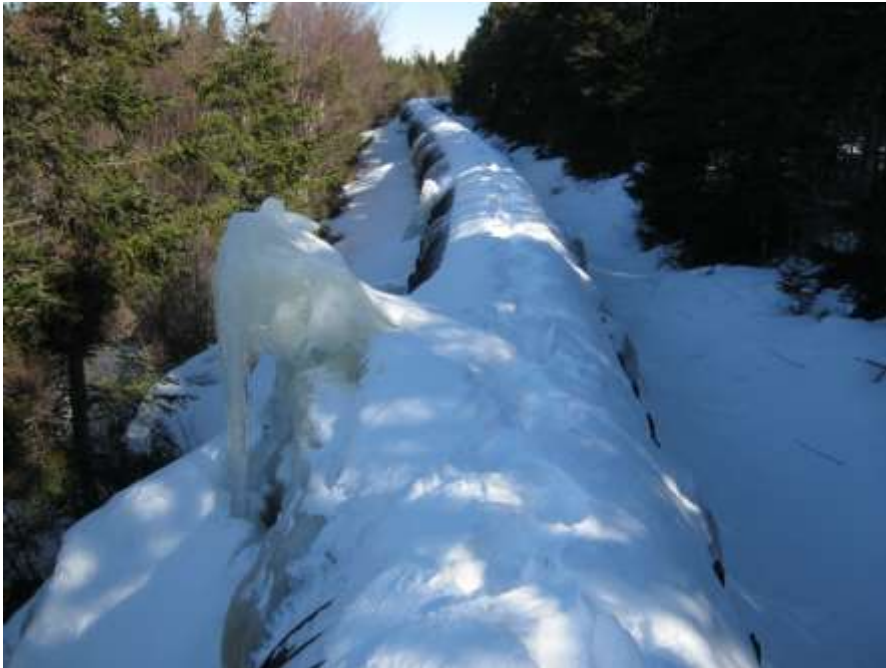
Photo C-58: Areas of significant leakage

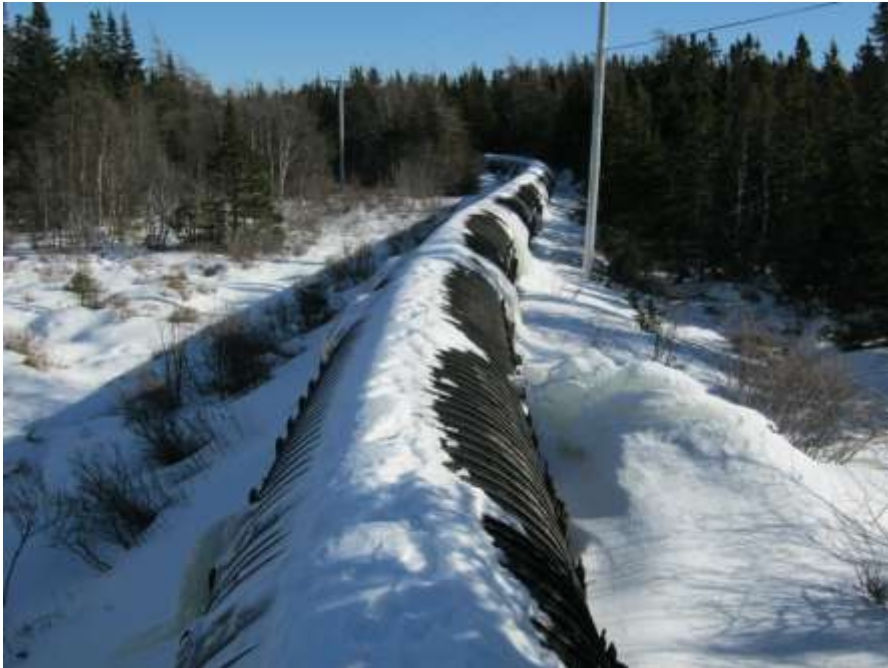
Photo C-60: Leakage along springline of penstock

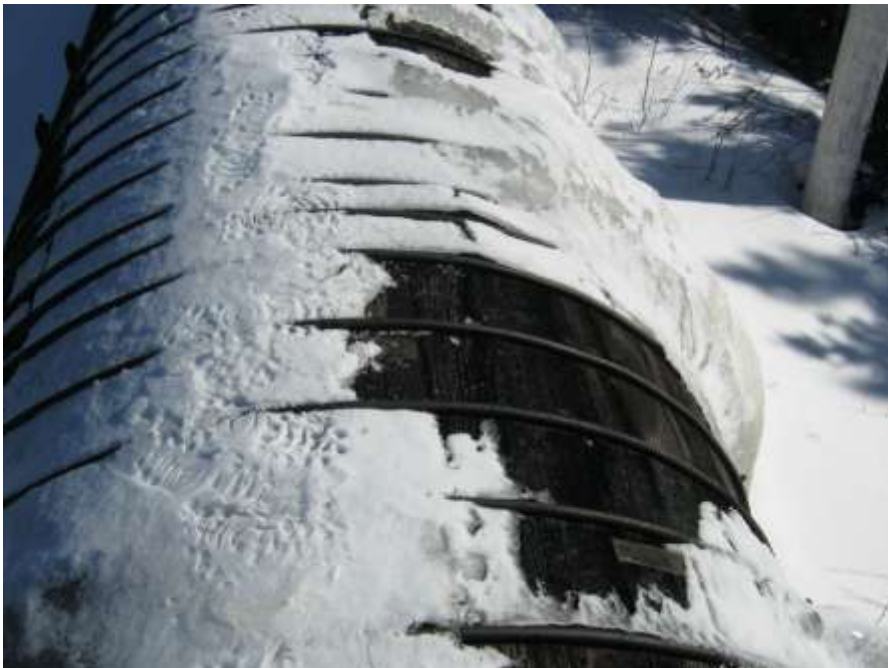
Photo C-61: Damaged ends of wood stave

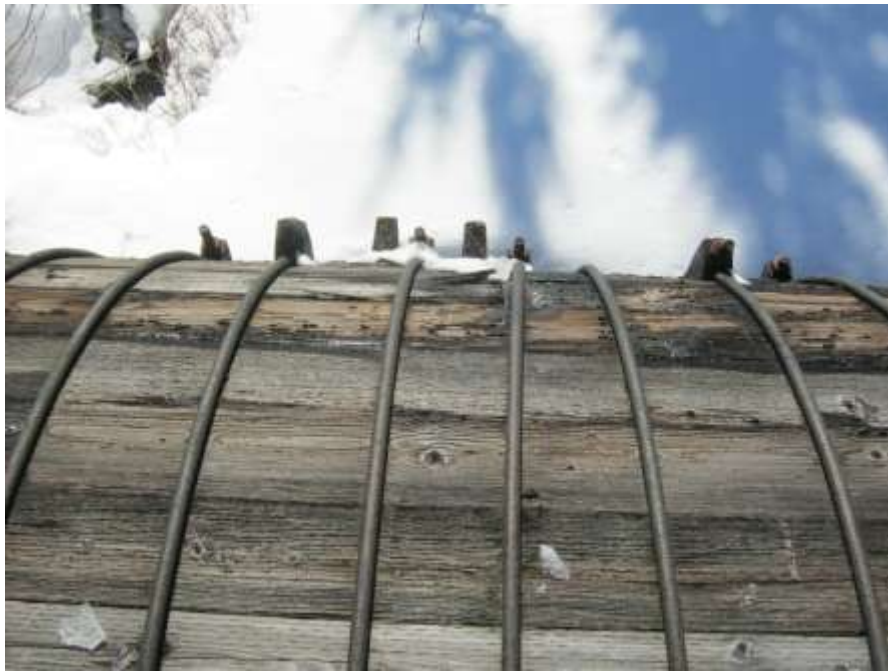
Photo C-62: Typical damaged ends of wood stave and poor preservative treatment

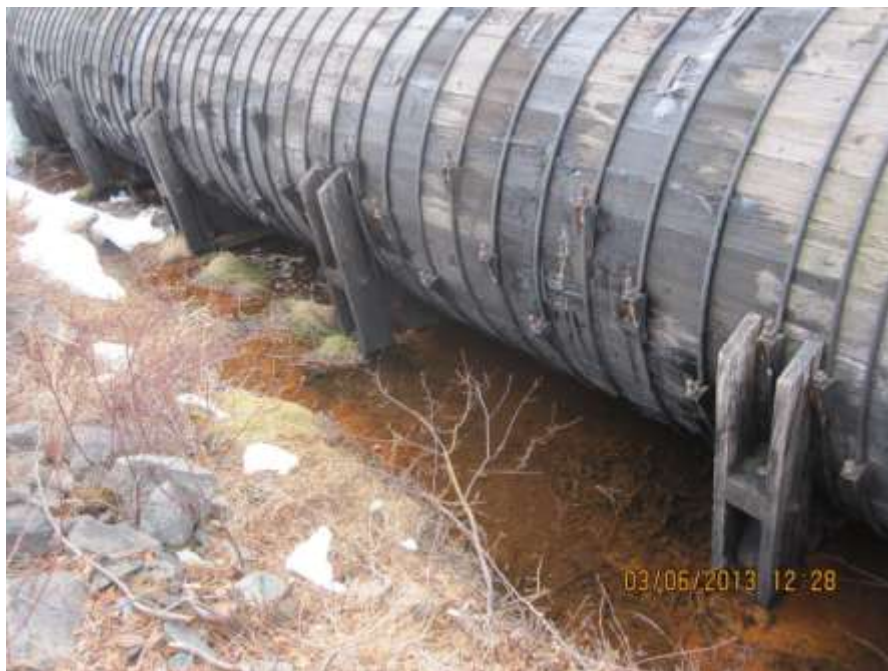
Photo C-63: Poor drainage of penstock bed

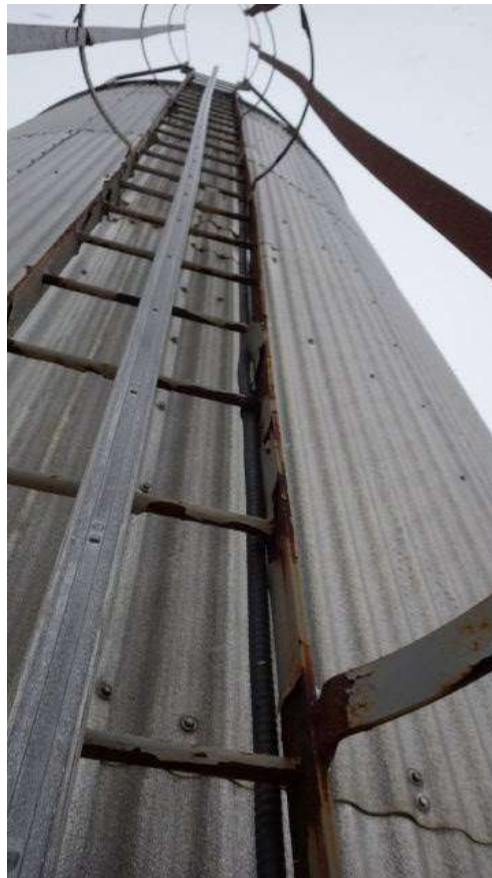
Location: Ladder on the tank (Upper section of ladder)

Description: General photo. Coating breakdown and corrosion. Deformation on members of backscratchers are typical on both ladder systems.

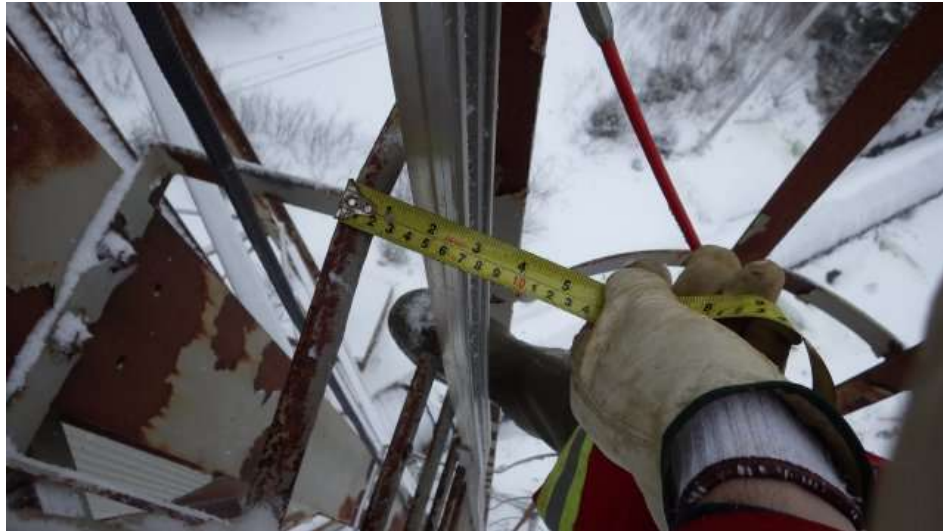
Location: Ladder at the platform below the tank

Description: Deflection on the rung, approx. 15mm.

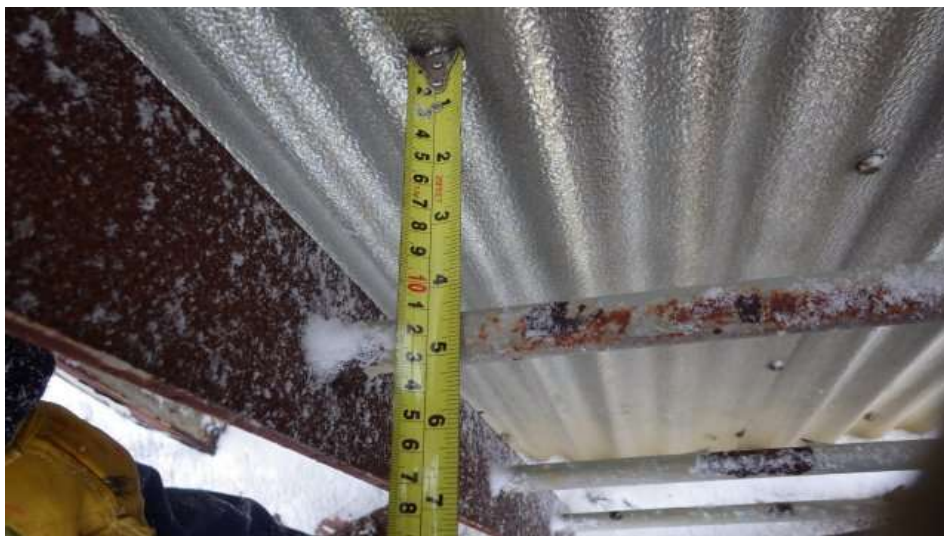
Location: Ladder on the tank

Description: Ladder rungs are 5 inches away from the cladding.

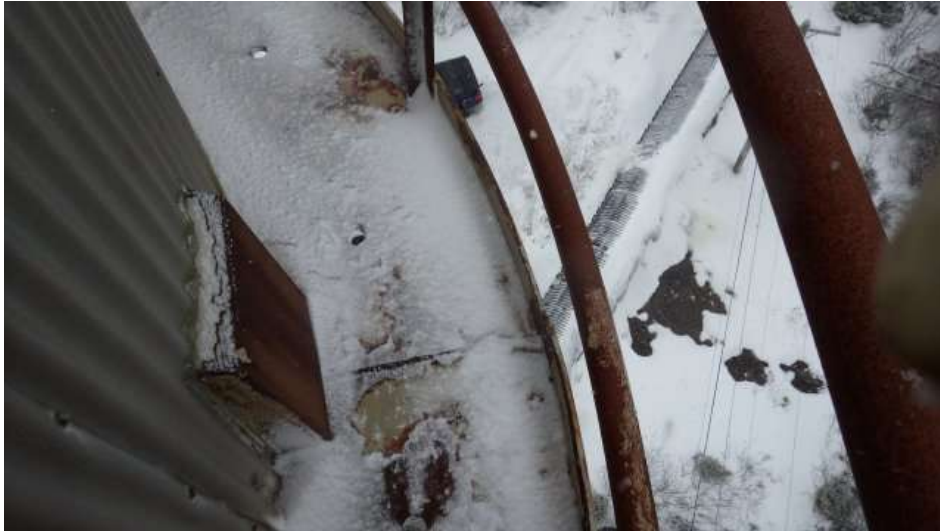
Location: Circular landing on the north side

Description: General coating breakdown and corrosion found throughout.

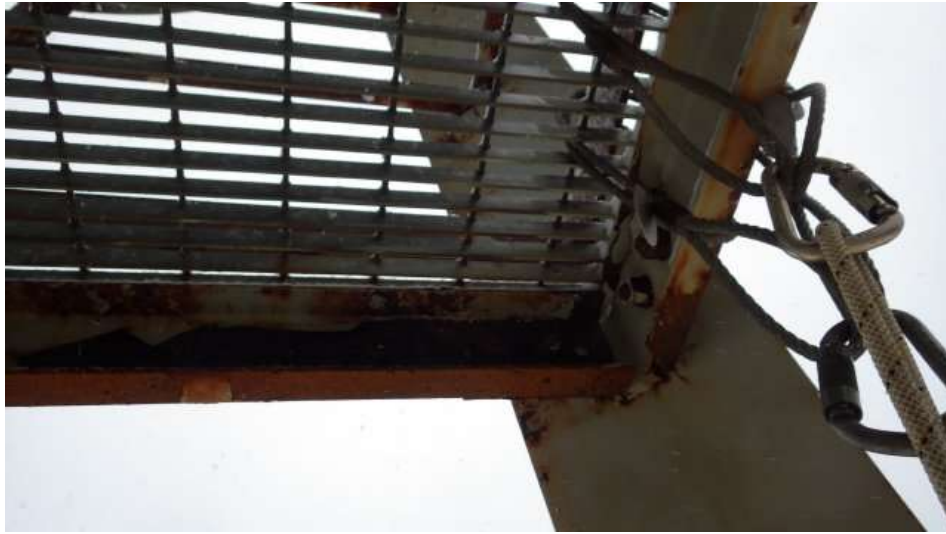
Location: Underside of the landing below the tank.

Description: Coating breakdown and corrosion on grating supports.

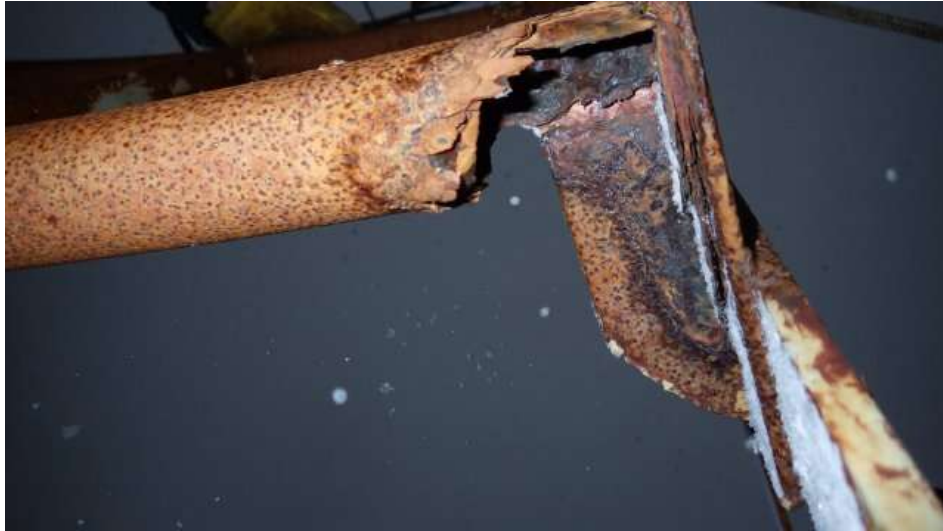
Location: Location A as seen in the previous photo.

Description: Excessive corrosion.

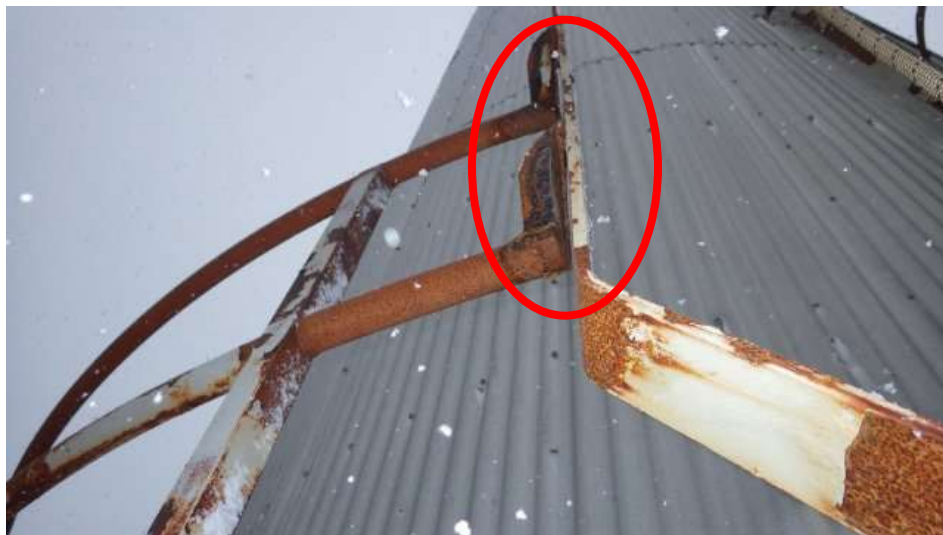
Location: Location B and C

Description: Major corrosion and scaling was found on the underside of the hand rails.

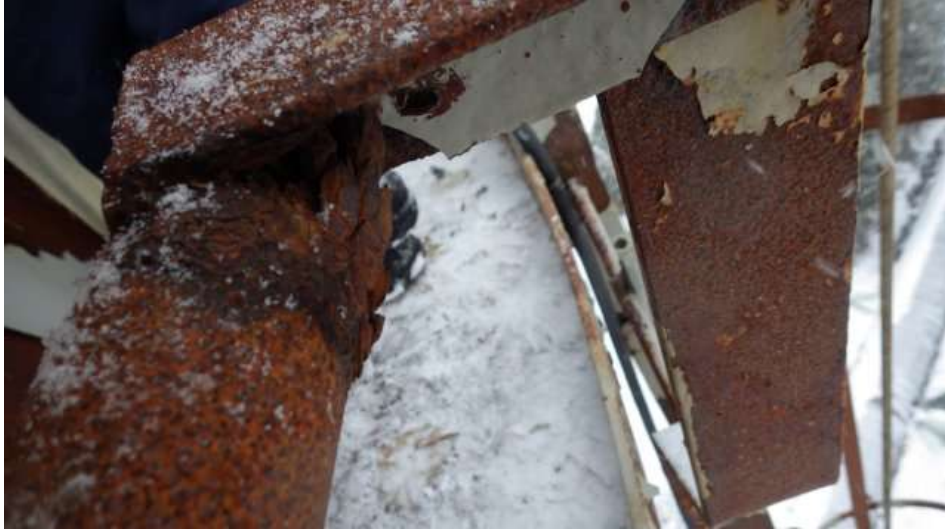
Location: Location C close up.

Description: Major corrosion and scaling found.

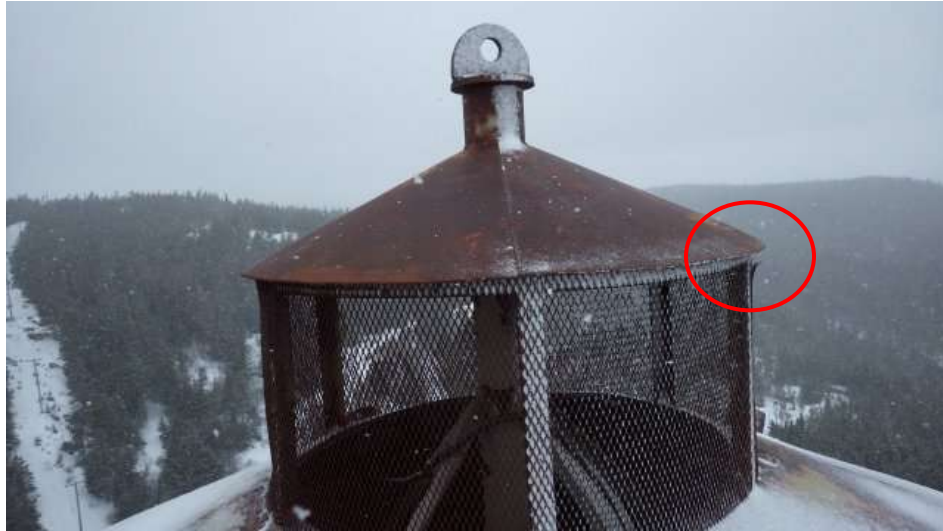
Location: Tank top rain cap

Description: Tank top rain cap, coating breakdown and minor corrosion found with a small tear in the mesh noted (circle above).

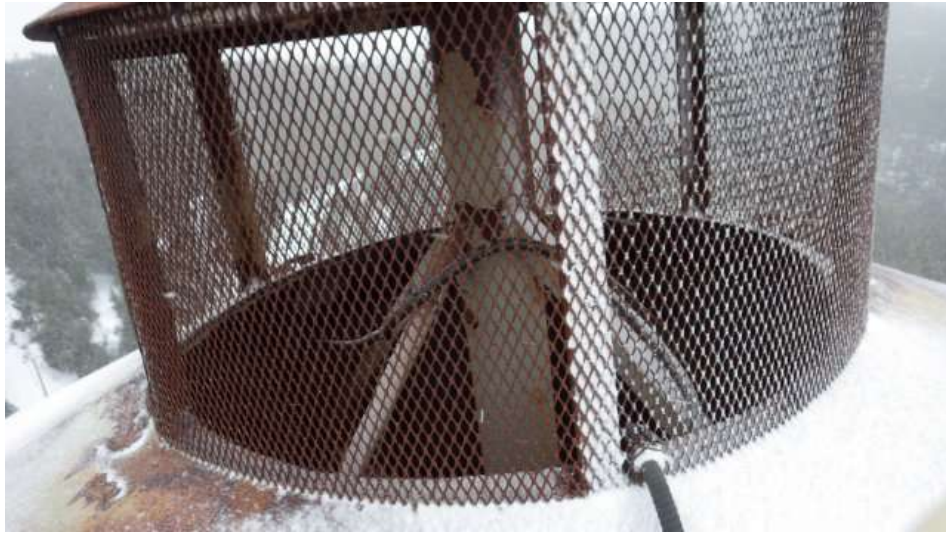
Location: Tank top inside the rain cap

Description: Coating breakdown and minor corrosion.

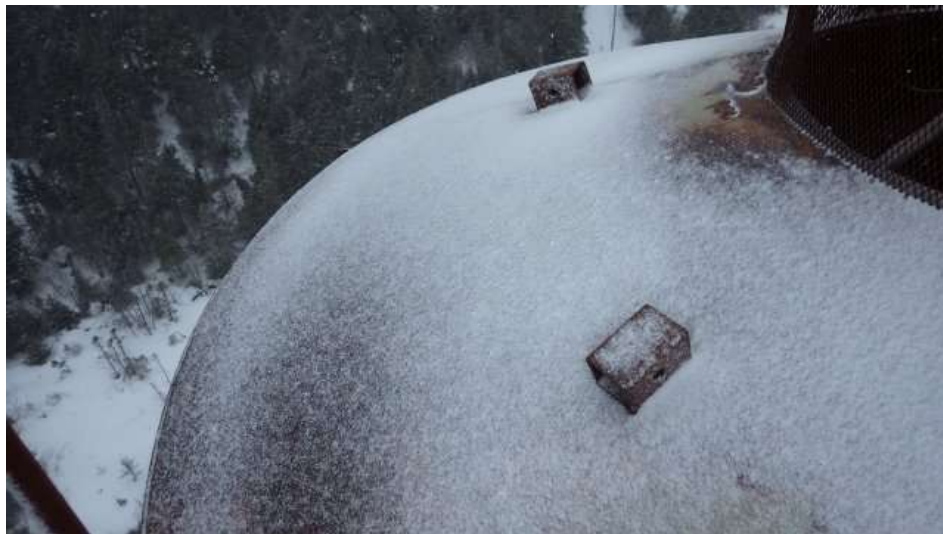
Location: Tank top west and north side

Description: Coating breakdown and minor corrosion.

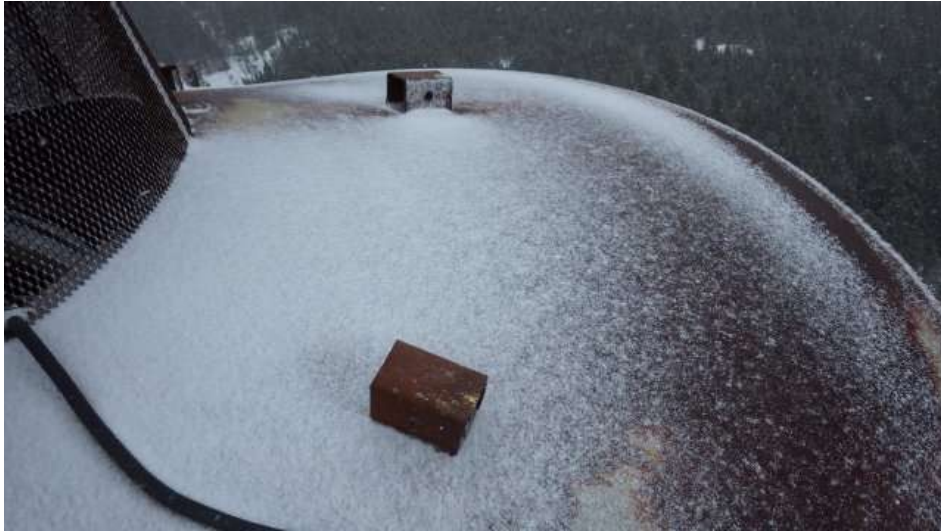
Location: Tank top east and north side

Description: Coating breakdown and minor corrosion.

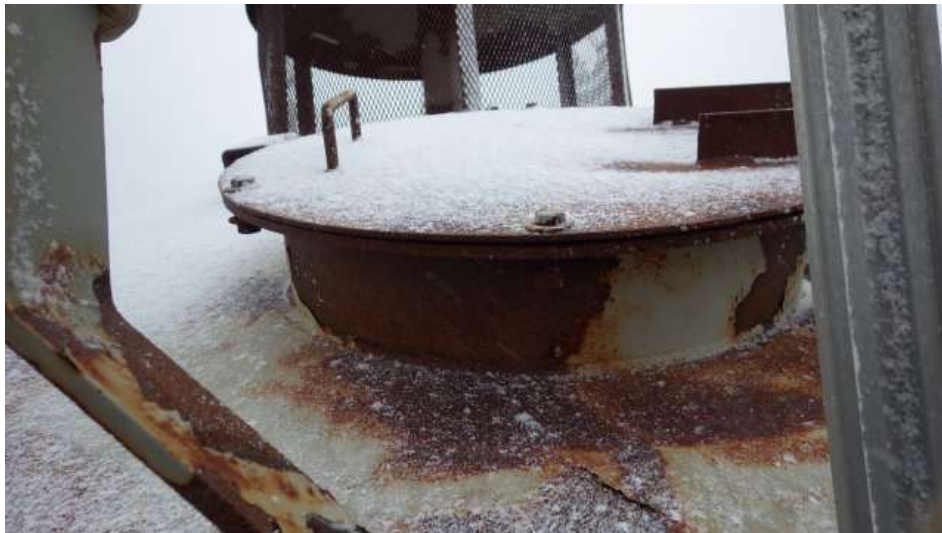
Location: Tank top south side and west side with hatch cover

Description: Coating breakdown and minor corrosion. Hatch was not opened.

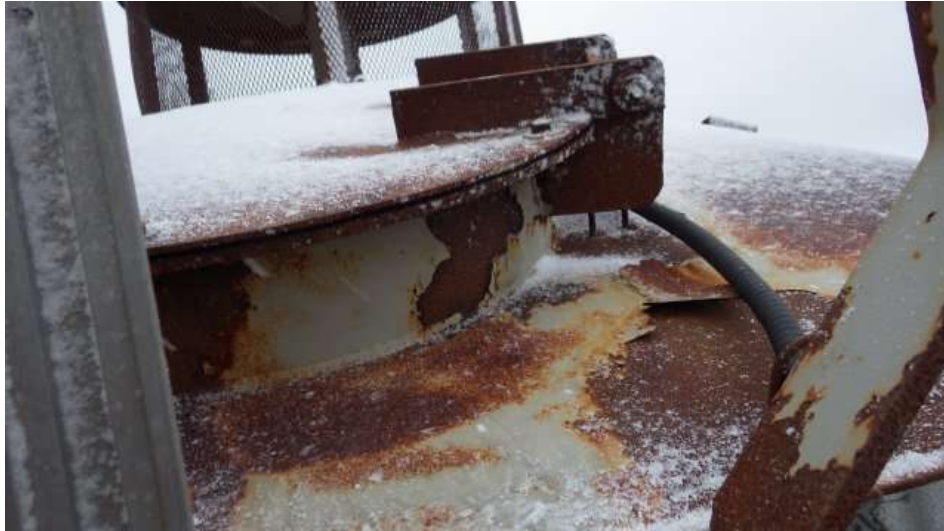
Location: Tank top south and east side with hatch cover.

Description: Coating breakdown and minor corrosion.

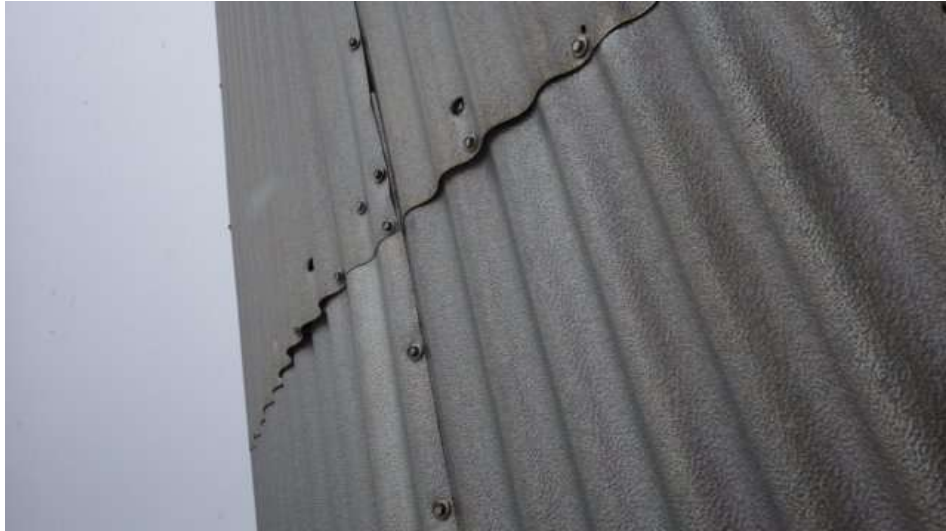
Location: Surge tank, approx. 5 metres from the tank top, left of the ladder.

Description: Two securing bolts were missing, loose cladding.

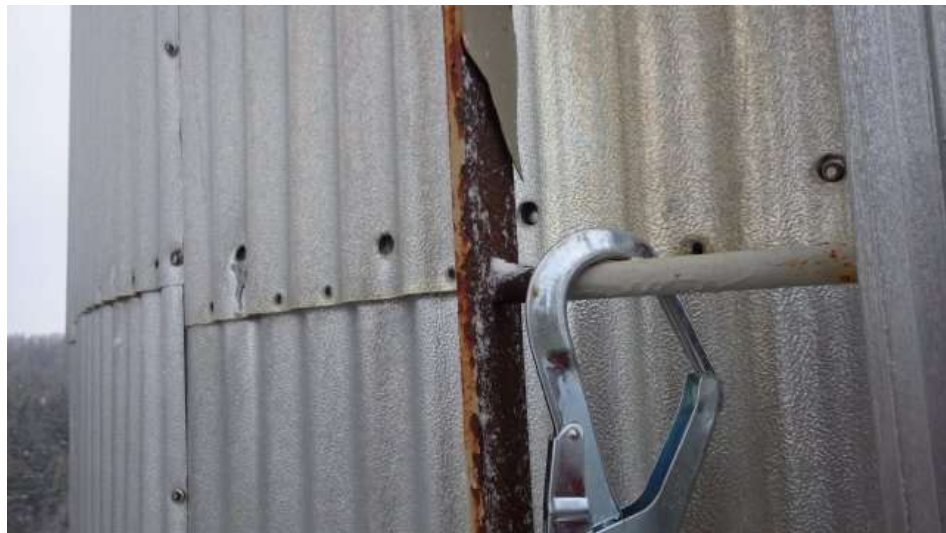
Location: Riser

Description: General photo. Good condition some water staining present.

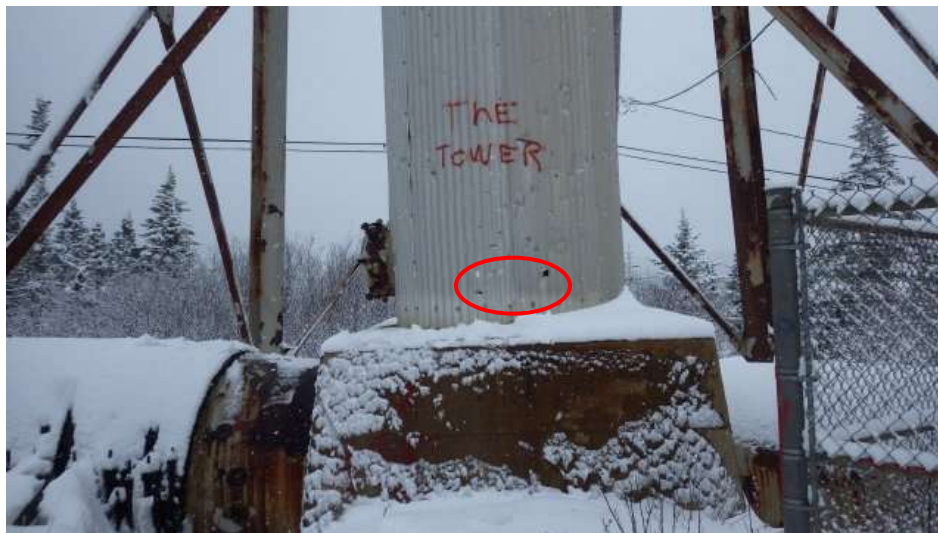
Location: Riser Base South Side

Description: General Photo, puncture holes in the cladding.

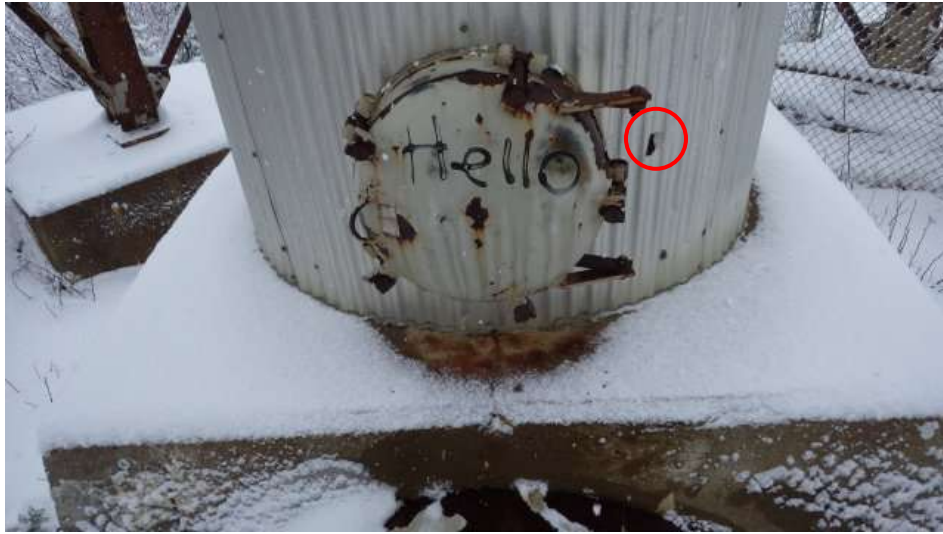
Location: Riser base west side

Description: General Photo, Puncture holes in the cladding, coating breakdown and minor corrosion on the hatch. Hatch was not opened during the inspection.

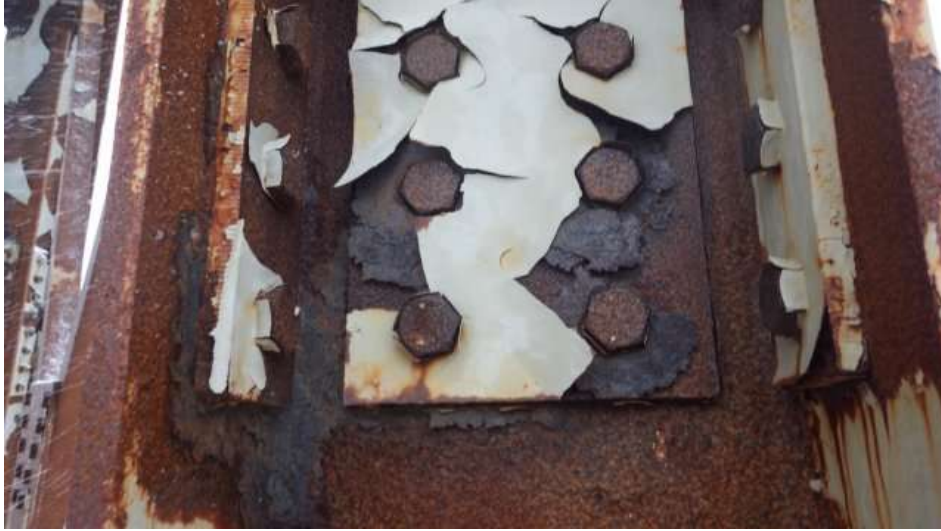
Location: Leg Connection, ladder leg

Description: Coating breakdown and moderate corrosion, scaling up to 6mm found throughout the leg connections.

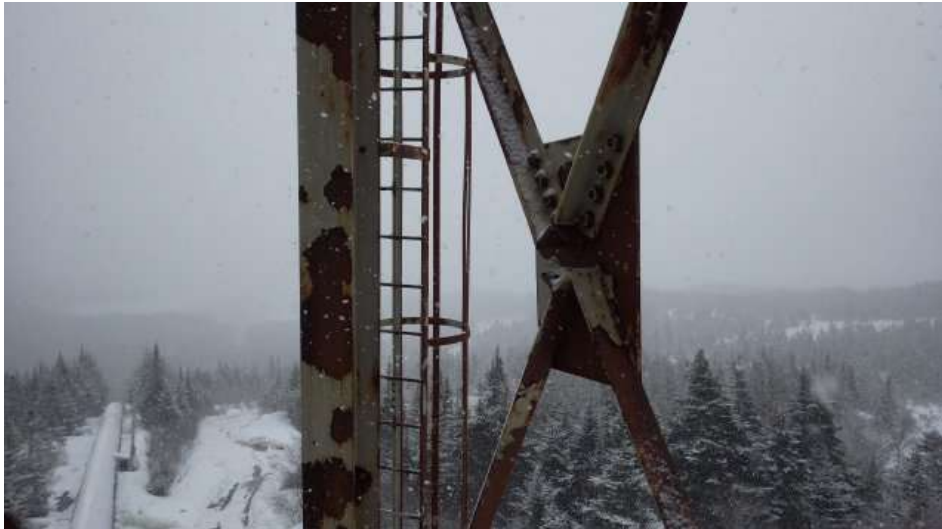
Location: Upper cross member, south side

Description: General photo, coating breakdown and corrosion found on all cross members.

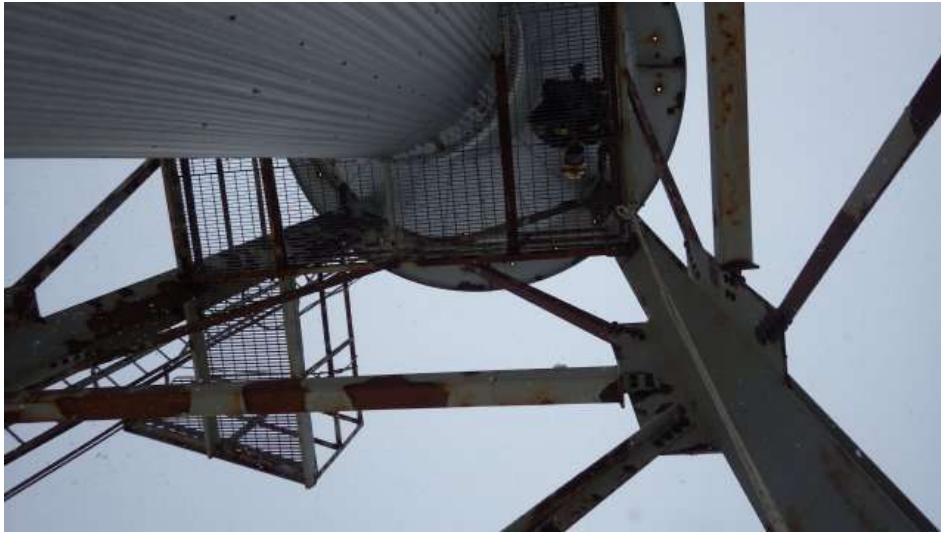
Location: Horizontal beams, south and west side, upper section.

Description: General photo, coating breakdown and corrosion found on all Beam members.

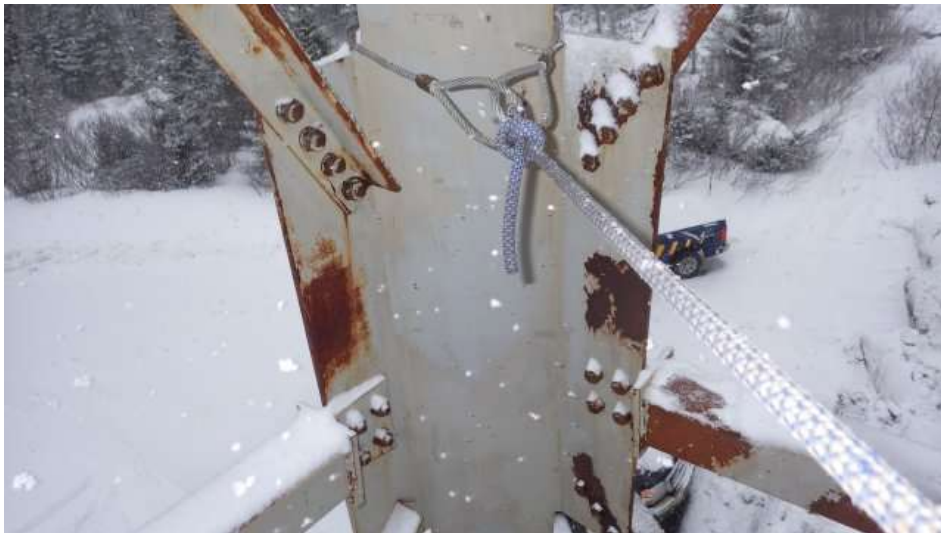
Location: Lower leg tie-in connection, south west leg.

Description: General photo, coating breakdown and corrosion found on all members.

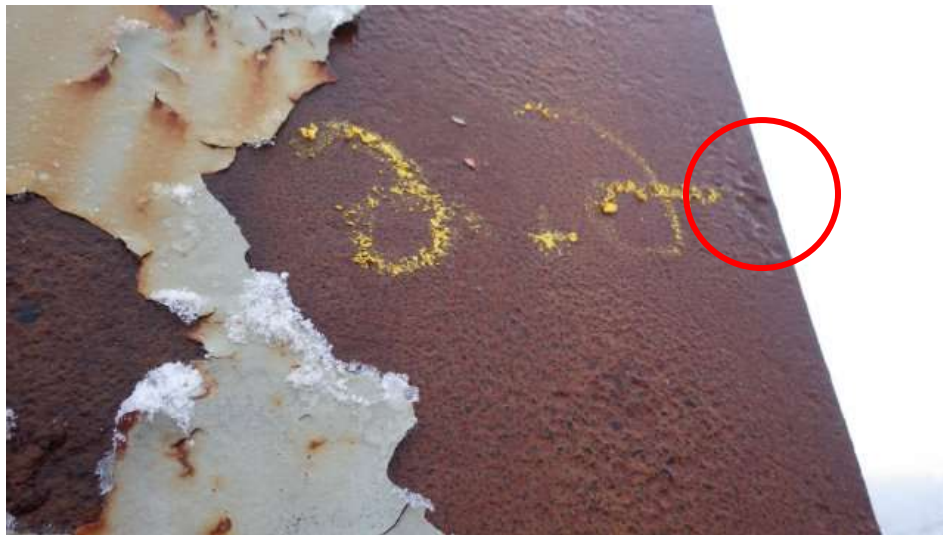
Location: Location 1

Description: Deepest pit was 2.2mm, average was 1.8mm. Area was approx. 3cm by 2cm. Approx. 2.5 metres up from the base.

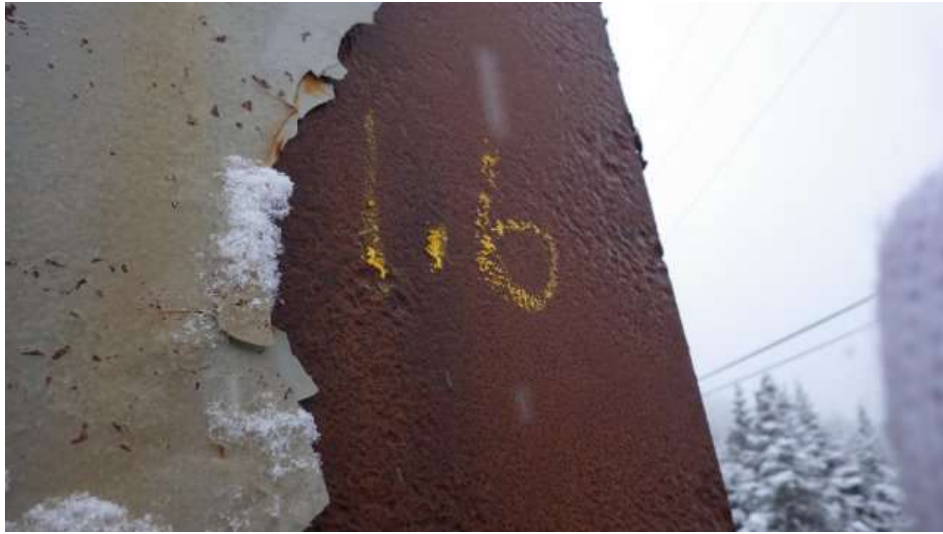
Location: Location 2

Description: Deepest pit was 1.6mm, average was 1.2mm. Area was approx. 3cm by 3cm. Approx. 2 metres up from the base.

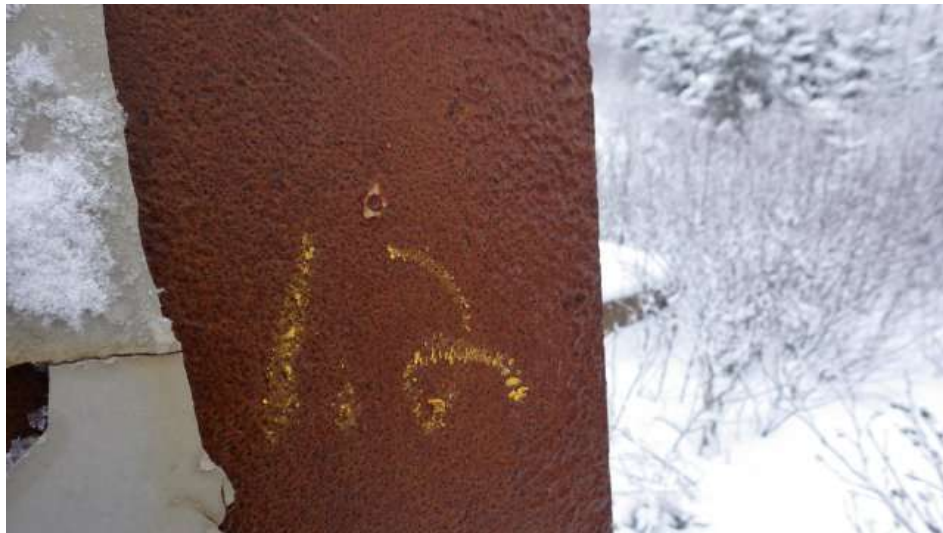
Location: Location 3

Description: Deepest pit was 1.2mm, average was 1.0mm. Area was typical for the base of the Leg. Approx. 1.5 metres up from the base.

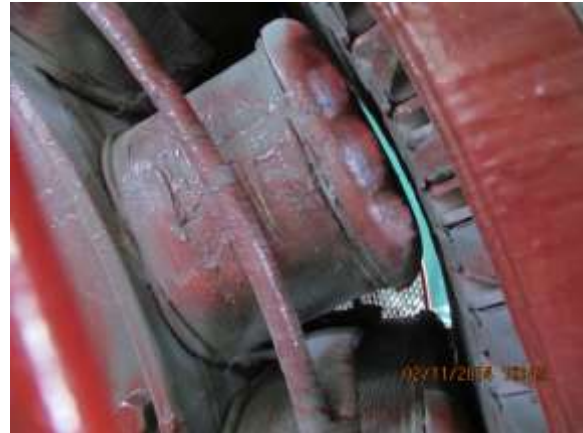
Electrical insulation of the rotor is subjected to thermal stresses due to the heat created by the normal operation of the generator. The variation of operating temperature caused by load changes and the start/stop cycling of the generator creates thermal cycling. Thermal cycling causes expansion and contraction of the copper windings relative to the insulating material creating an abrasive effect on the insulation. Visual inspection has confirmed that thermal stress on the G1 rotor has resulted in degradation of the insulating material.

Figure 1 – SCV-G1 Rotor Pole

Mechanical stresses experienced by rotor poles are high due to centrifugal forces present during normal operation. During an emergency shutdown the speed of the rotor accelerates dramatically thereby increasing the magnitude of the centrifugal force exerted on the rotor poles. As the generator ages and is affected by thermal stresses, loss of insulating material causes movement when the rotor experiences centrifugal forces during operation. Over time thermal stresses will increase the negative impact of mechanical stresses on the rotor. Mechanical stress has resulted in some weakening of the G1 rotor poles.

The condition and age of the rotor insulation necessitates the rewinding of the 16 rotor poles in 2015.

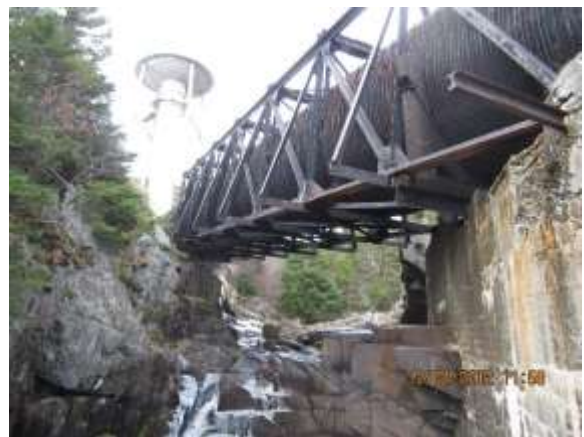
In 2012, due to severe corrosion present on the structure, the Company retained Bridger Design Associates Limited (“BDAL”) to conduct an assessment of the structure.⁵ BDAL assessed the structure and provided recommendations on required upgrading to regain the structural integrity of the truss system. Overall the structure was assessed to be in fair to poor condition with rust and paint scaling throughout. The bottom horizontal truss, penstock support bands and the concrete abutments were assessed to be poor to very poor condition.⁶

Figure 1 - Tors Cove Penstock Trestle

To ensure the continued safe and reliable operation of the Tors Cove hydroelectric facility, it is recommended that the Tors Cove penstock trestle be replaced. Alternate 3, the replacement of the trestle with a section of steel penstock is the least cost alternative to regain the structural integrity of the truss system.

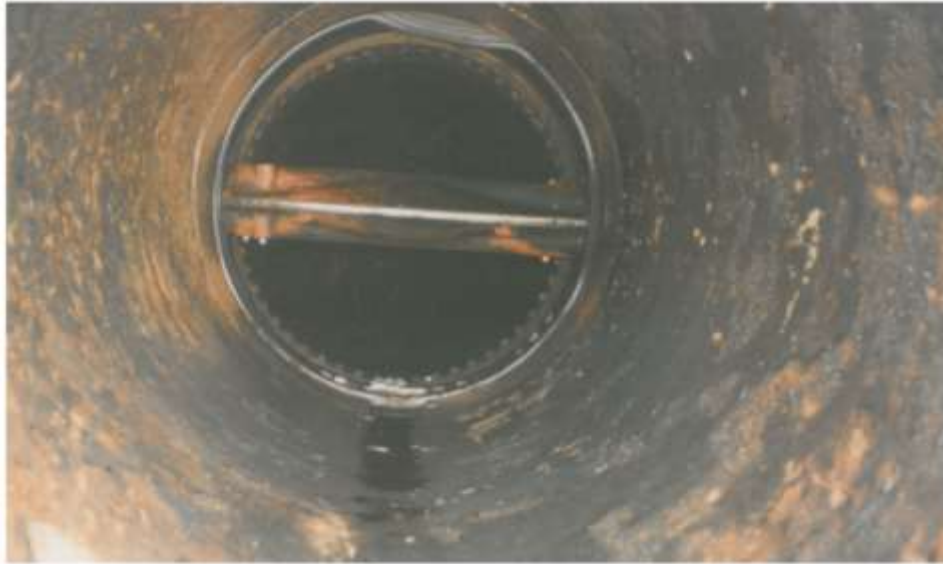
The G2 main inlet valve is a 42-inch electrically actuated butterfly valve which replaced the original manual operated butterfly valve in 1985. It is evident from the constant flow of water when the valve is in the closed position that it is not sealing properly. Furthermore there are recorded instances where the rubber seal has separated from the disc allowing a large quantity of water to flow through. (See Figure 4) Replacing the rubber seal following one of these incidents requires that the valve be removed from the pipe requiring a plant outage.

Figure 4 - Main Valve Rubber Seal Separation (Photo Taken in 1991)

The valve cannot be used safely as a point of isolation to allow for turbine inspections due to the excessive amount of leakage. After 30 years of service the valve will be replaced in 2015 with a modern butterfly valve. In addition, a dismantling joint and rearrangement of the bypass valve will be incorporated into the new design to increase maintainability of the new main inlet valve. The scroll case drain valve is also in poor condition and currently not operational. The drain valve and piping will also be replaced at the same time.

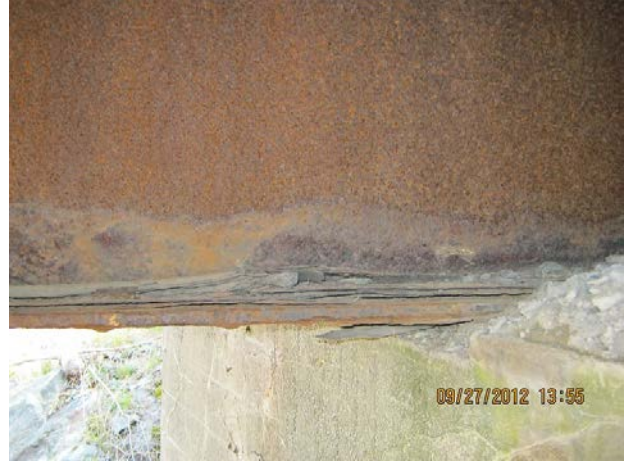
Photo No. 2.2.1.2 - Severe Scaling on Beams, Typical

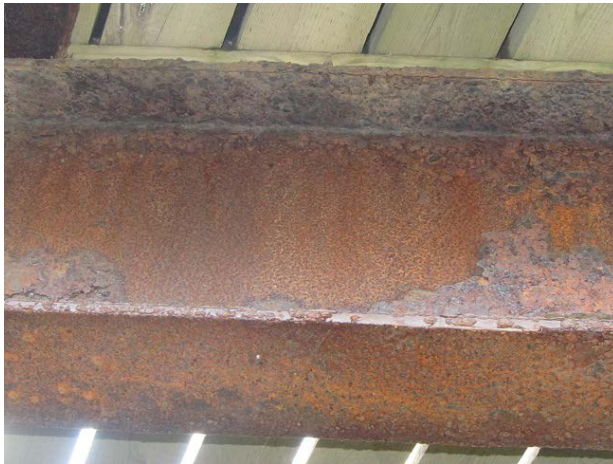
Photo No. 2.2.1.3 – Severe Rust on Beams, Typical

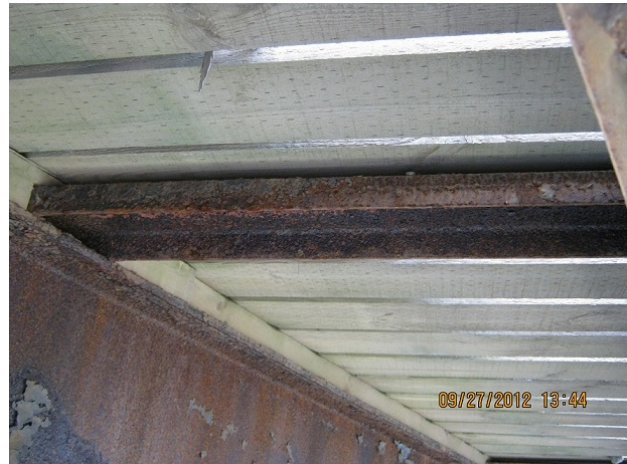
Photo No. 2.2.1.4 – Severe Rust and Scaling on Channels, Typical

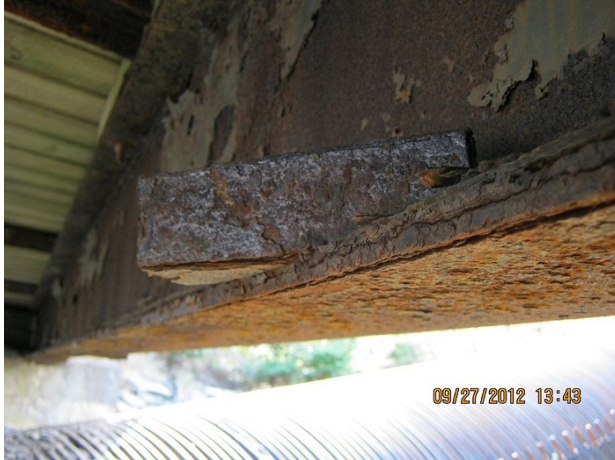
Photo No. 2.2.1.5 – Remaining Section of Steel Angle Cross-bracing, Typical

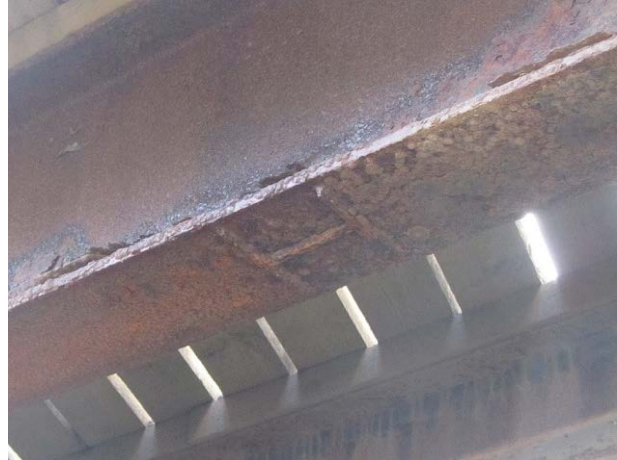
Photo No. 2.2.1.6 – Remaining Section of Steel Column, Typical

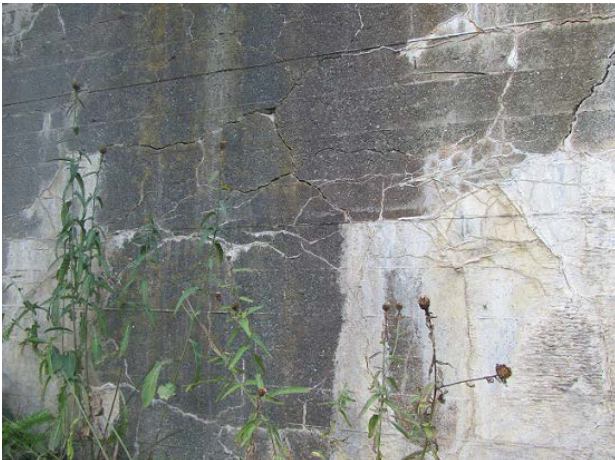
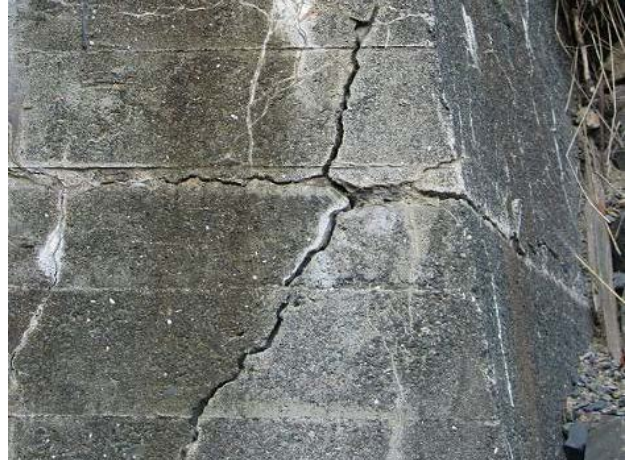
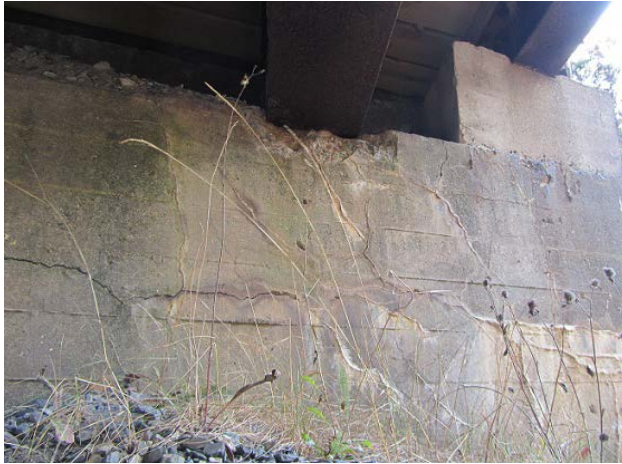
- Abutments appear to be unreinforced and in very poor condition. Each abutment has significant cracking; efflorescence is evident indicating possible Alkali-Aggregate Reactivity (AAR) and the beam seats are deteriorated under several beams (Photo No. 2.2.1.7, No. 2.2.1.8, and No. 2.2.1.9).

Photo No. 2.2.1.7 – Significant Cracks in Concrete Abutment

Photo No. 2.2.1.8 – Significant Cracks and Efflorescence, Concrete Abutment

Photo No. 2.2.1.9 – Concrete Severely Deteriorated Under Beam

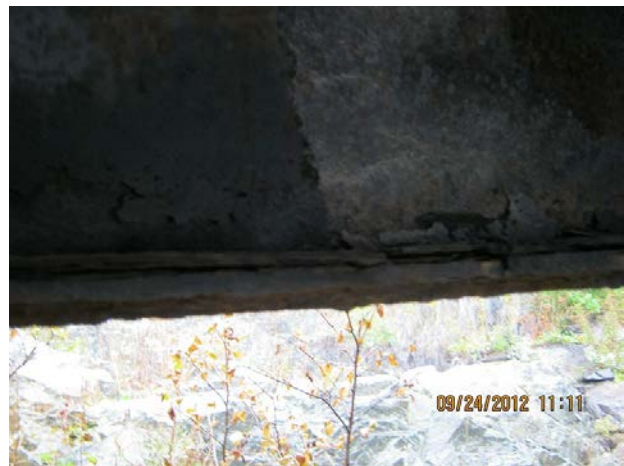
Photo No. 2.3.1.2 - Severe Scaling on Beams, Typical

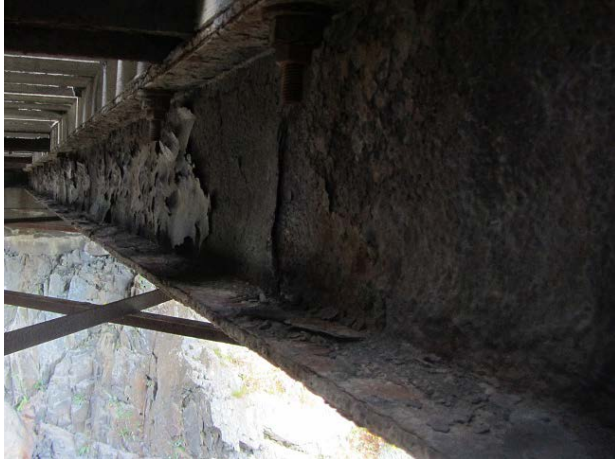
Photo No. 2.3.1.3 – Severe Rust and Scaling on Beams, Typical

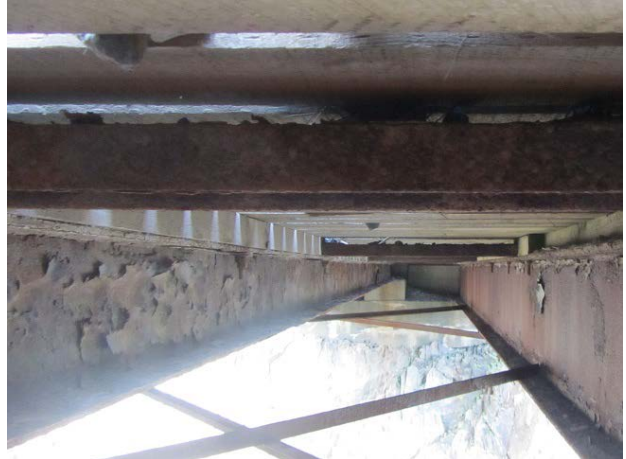
Photo No. 2.3.1.4 – Severe Rust and Scaling on Channels, Typical

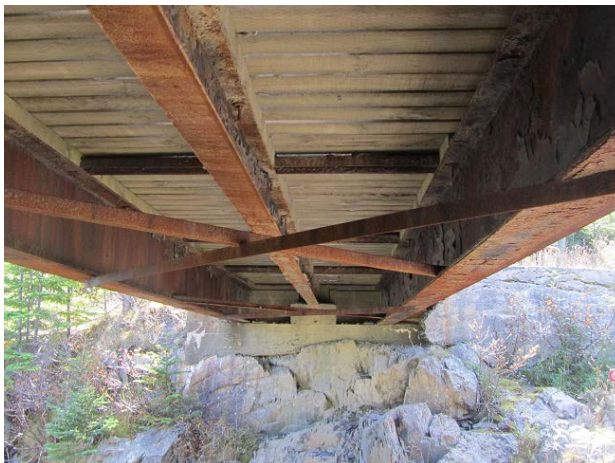
Photo No. 2.3.1.5 – Severe Rust on Angle Cross-bracing, Typical
