Re: Newfoundland Power's 2015 Capital Budget Application

**Pierre's Brook Hydro Plant
Penstock Replacement and Surge Tank Refurbishment**

June 2014

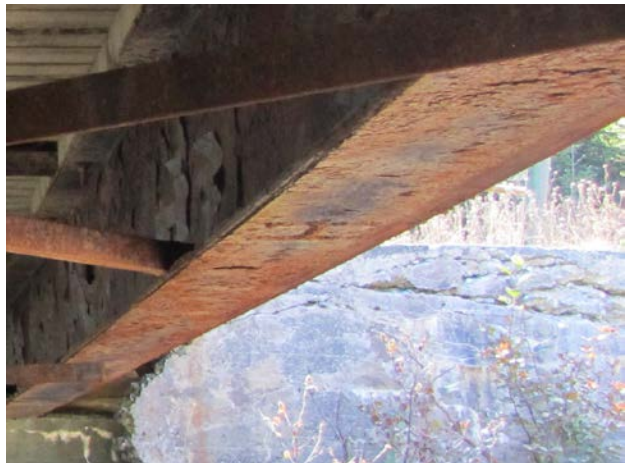
Photo No. 2.3.1.6 – Remaining Section of Steel Column, Typical

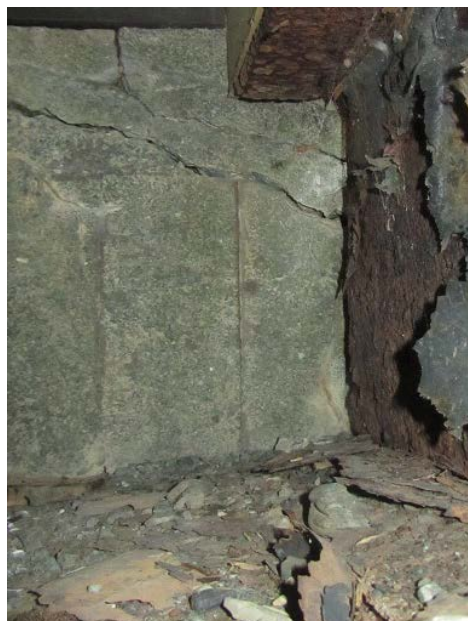
Photo No. 2.3.1.7 – Significant Cracks in Concrete Abutment

- Install new reinforced concrete abutments - both abutments on this bridge are severely cracked and deteriorated. The presence of Alkali-Aggregate Reactivity (AAR) indicates they will only continue to deteriorate.
- Further investigation should be carried out on the structural steel as this was mainly a visual inspection on the members. Moving forward with this option would require the steel members be cleaned and ultrasonic thickness measurements obtained to ensure members do not have excessive loss of section properties.
- Upgrade existing steel members - existing members would require upgrading to increase the load capacity of the existing bridge to meet the current design requirements.
- Install new guiderail/wheelguard system in accordance with the bridge code.

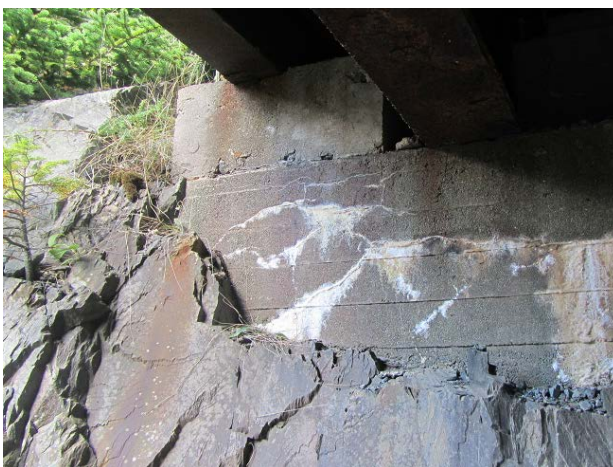
Photo No. 2.3.1.8 – Significant Cracks and Efflorescence, Concrete Abutment

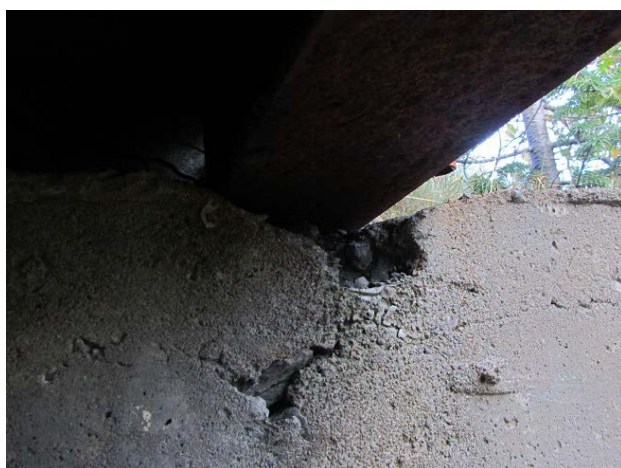
Photo No. 2.3.1.9 – Concrete Severely Deteriorated Under Beam

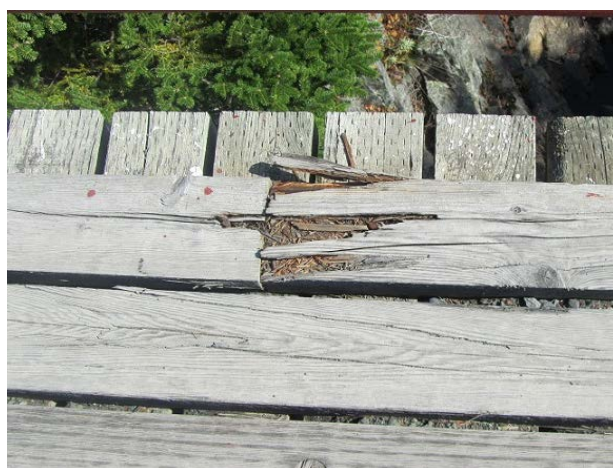
Photo No. 2.3.1.10 – Slight Rotting on Timber Raceway

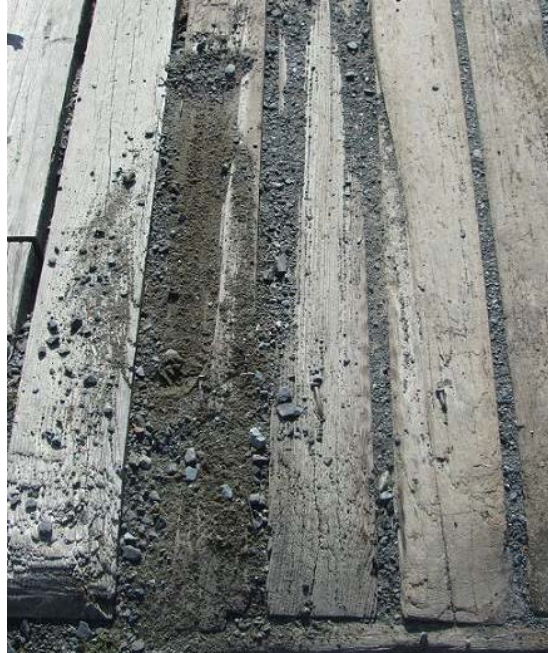
**Photo No. 2.3.1.11 – Broken Timber
Raceway Members**

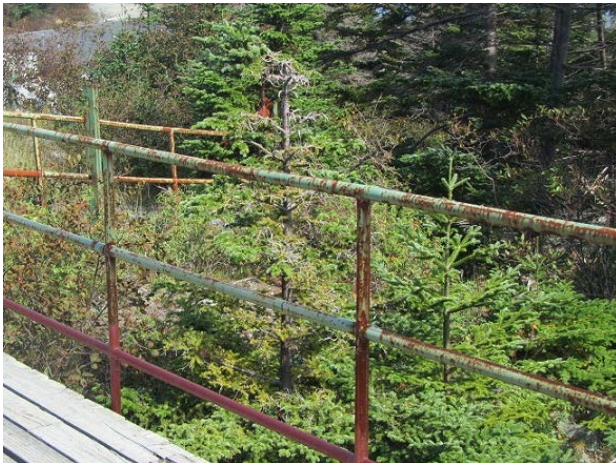
Photo No. 2.3.1.12 – Rust on Handrail

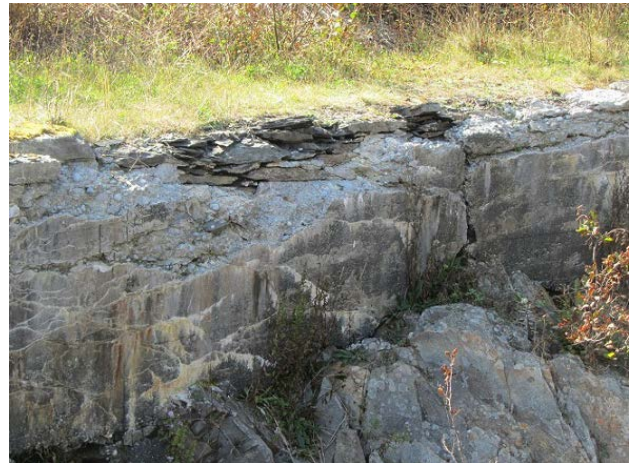
**Photo No. 2.3.1.13 – Retaining Wall
Severely Deteriorated**

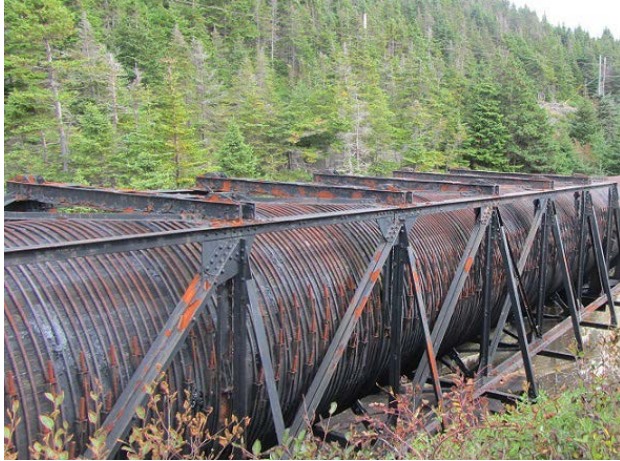
- Overall the truss is in fair to poor condition with rust and paint scaling throughout (Photo No. 2.4.1.1).
- The members and connections at the top horizontal truss have significant surface rusting with paint scaling (Photo No. 2.4.1.2 and No. 2.4.1.3).

Photo No. 2.4.1.1 – Overall Penstock Truss Structure

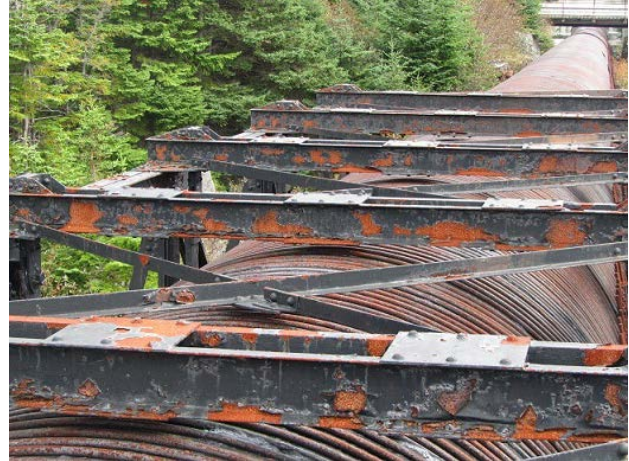
Photo No. 2.4.1.2 – Rust on Top Chord Members, Typical

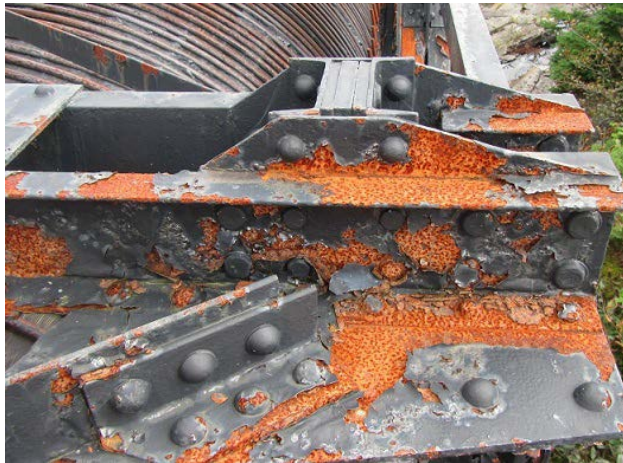
Photo No. 2.4.1.3 – Rust on Top Chord Connection, Typical

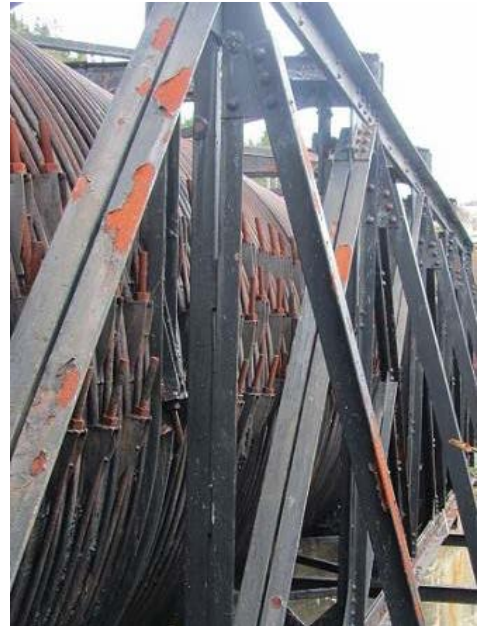
- The members along the south truss are in fair condition. Truss members and connections have surface rusting and paint scaling (Photo No. 2.4.1.4, No. 2.4.1.5, and No. 2.4.1.6).

Photo No. 2.4.1.4 – Rust on South Chord Member, Typical

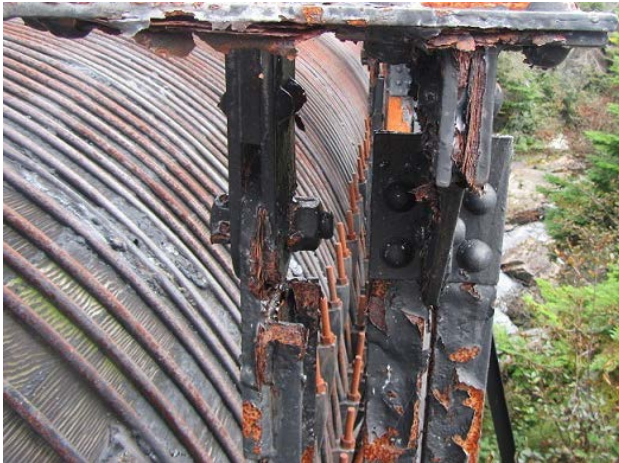
Photo No. 2.4.1.5 – Rust and Scaling on South-Top Chord Connection, Typical

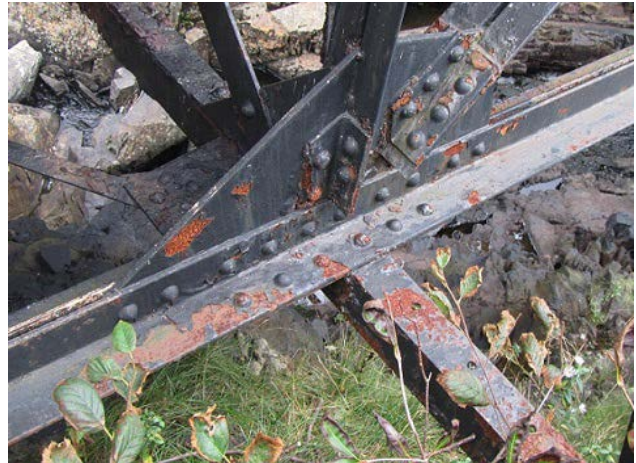
Photo No. 2.4.1.6 – Rust on South-Bottom Chord Connection, Typical

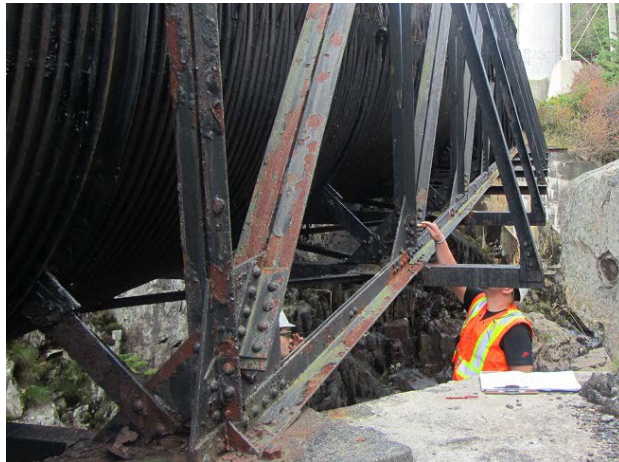
- The members along the north truss are in similar condition to the members along the south truss (Photo No. 2.4.1.7 and No. 2.4.1.8).
- The members in the bottom horizontal truss have severe rust, paint scaling and are in very poor condition. Heavy corrosion has left many of the members with a significant loss in cross-section and holes have formed in some members. The joints connecting the bottom truss to both side trusses have severe rusting and scaling (Photo 2.4.1.9, No. 2.4.1.10, No. 2.4.1.11, and 2.4.1.12).

Photo No. 2.4.1.7 – Rust on North Chord Member, Typical

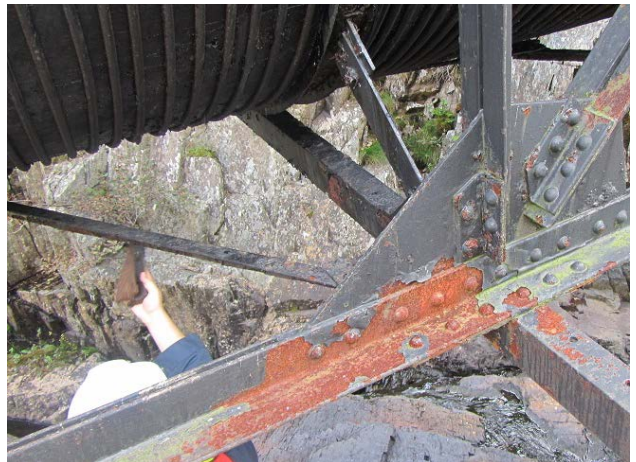
Photo No. 2.4.1.8 – Rust on North-Bottom Chord Connection, Typical

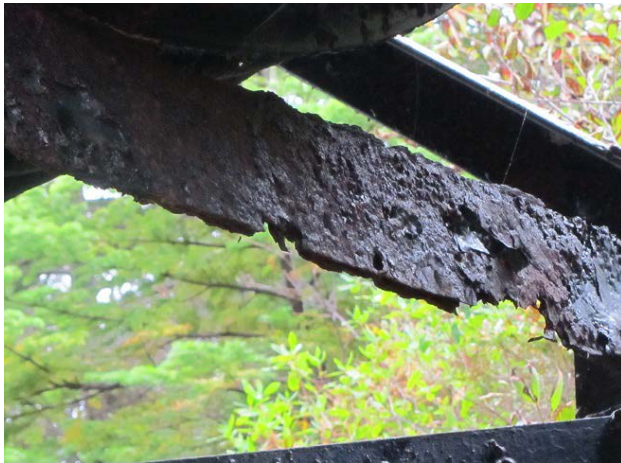
Photo No. 2.4.1.9 – Heavy Corrosion Forming Holes in Bottom Chord Member, Typical

- Remove and replace all bottom horizontal truss members - several members along the bottom horizontal truss have experienced heavy corrosion and have significant loss of section properties. Remaining members are in poor condition. In its current condition, the capacity of this horizontal truss is greatly reduced.

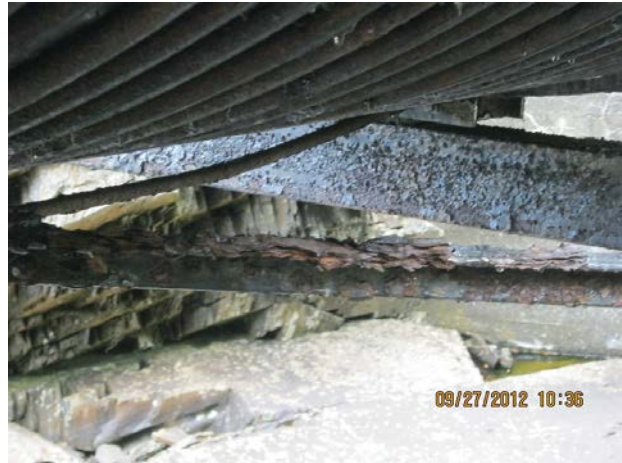
Photo No. 2.4.1.10 – Rust and Scaling on Bottom Chord Cross-bracing Member, Typical

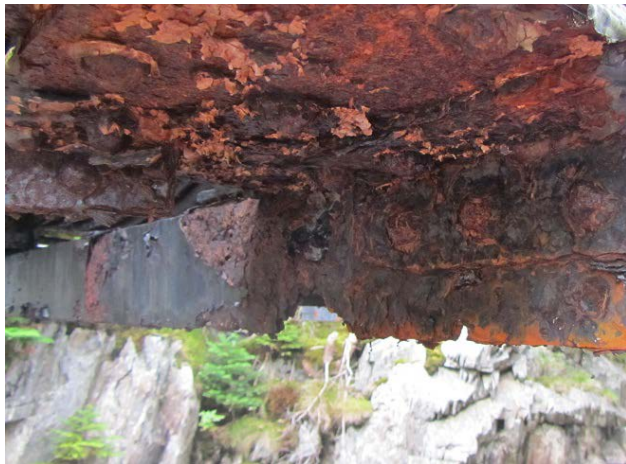
Photo No. 2.4.1.11 – Rust and Scaling on Bottom Chord Connection, Typical

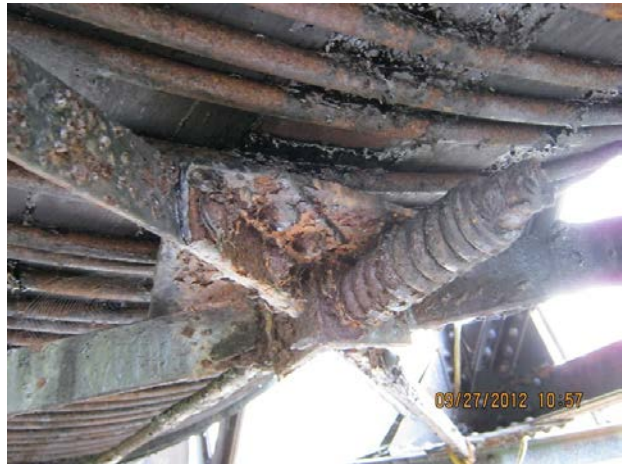
Photo No. 2.4.1.12 – Rust and Scaling on Bottom Chord Cross-bracing Connection, Typical

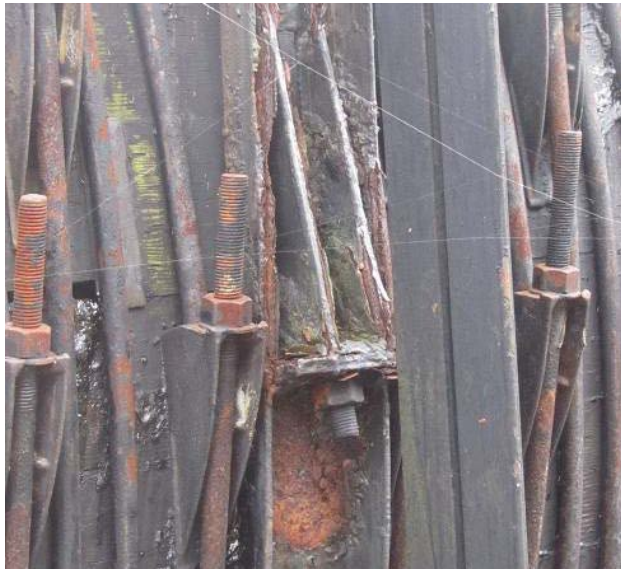
- There is a band, consisting of a bent channel, wrapping around and supporting the weight of the penstock. The channel and the members connecting this band to the truss, located at the joint between the bottom and side truss, are in poor condition with severe rust and scaling (Photo 2.4.1.13 and No. 2.4.1.14).

Photo No. 2.4.1.13 – Rust and Scaling on Penstock Support Band, Typical

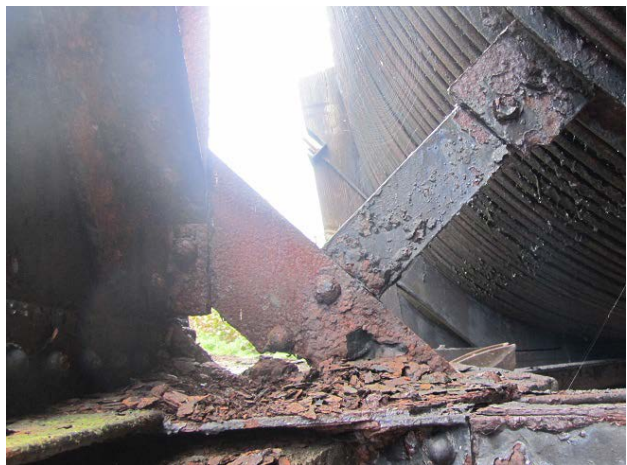
Photo No. 2.4.1.14 – Rust and Scaling on Support Band-Bottom Chord Connection Member, Typical

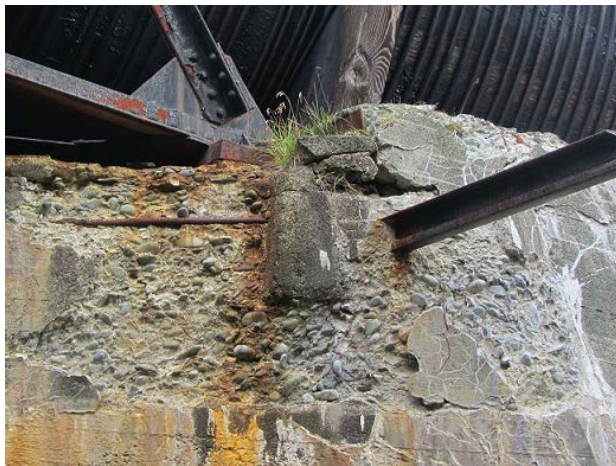
- Abutments are in poor condition with significant cracks. Efflorescence is present indicating possible Alkali-Aggregate Reactivity (AAR). The baseplates supporting trusses at the abutments have significant rust and scaling (Photo No. 2.4.1.15, No. 2.4.1.16 and No. 2.4.1.17).

Photo No. 2.4.1.15 – Severe Deterioration Below Baseplate on East Abutment

- Install new reinforced concrete abutments - both abutments on this structure are severely cracked and deteriorated. The presence of Alkali-Aggregate Reactivity (AAR) indicates they will only continue to deteriorate.

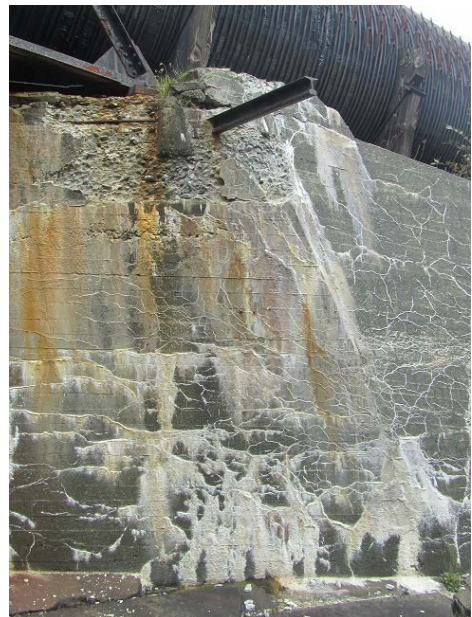
Photo No. 2.4.1.16 – Significant Cracks and Efflorescence, Concrete Abutment, Typical

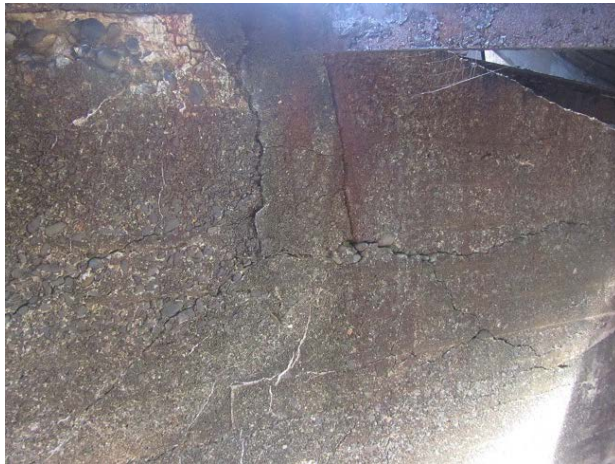
Photo No. 2.4.1.17 – Significant Cracks, Concrete Abutment, Typical

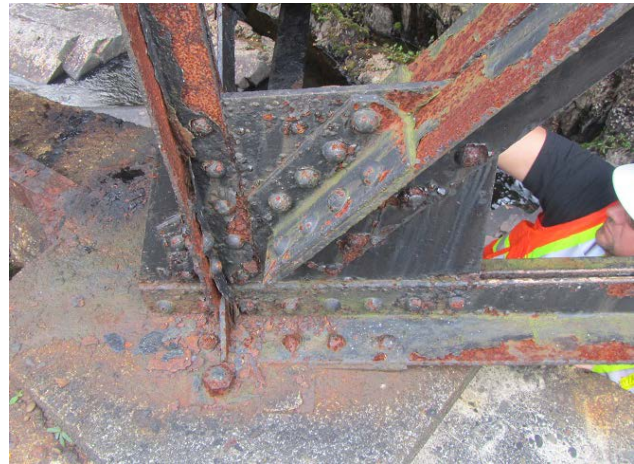
Photo No. 2.4.1.18 – Rust and Scaling on Abutment Baseplate, Typical

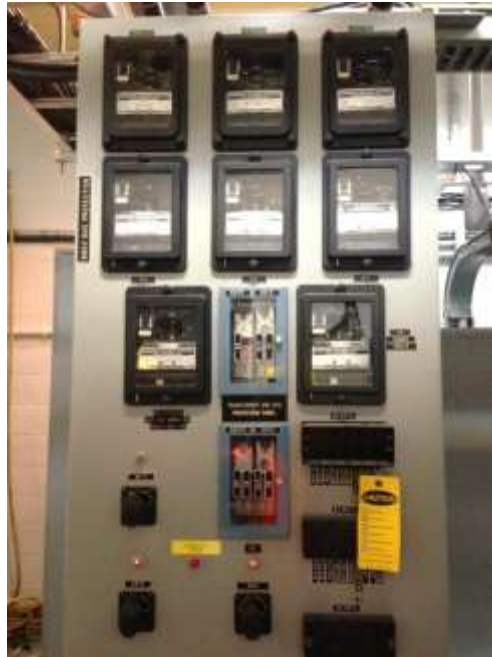
⁵ The feeder breakers are protected using vintage electromechanical relays original to the substation's 1960 construction.

66kV Bus Protection Panel (Electromechanical Relays)

The protection upgrade will also involve replacing the existing protection panels. This approach minimizes the number of active devices used to provide protection to substation assets, consolidates the control and automation architecture, and reduces ongoing maintenance. In addition, the communications package will be upgraded to enhance SCADA system remote-control and monitoring of the power system from the newly installed protection equipment.⁷ The gateway will integrate the digital protection relays for the transmission lines, distribution feeders, power transformers and the 66 kV bus into the SCADA system.

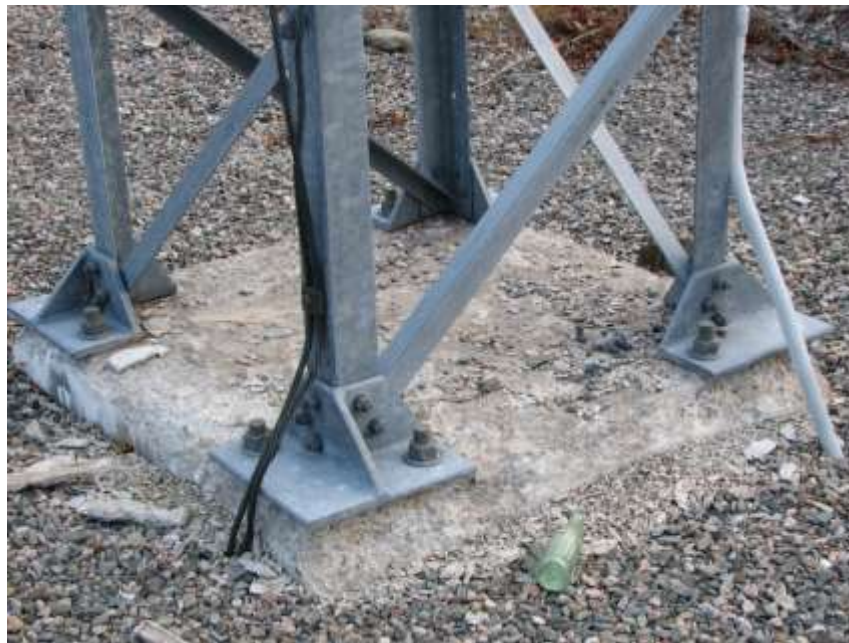
Engineering assessments determine that 138 kV and 12.5 kV steel structures, buses, and insulators are all in good condition. The 66 kV wood pole structure is in a deteriorated condition. Twisting and movement of the wood poles has resulted in misalignment of the 66 kV switches on the structure. The wood pole structure will be replaced by steel structures. The concrete foundations generally are in good condition with the exception of four 138 kV pier foundations and breaker foundations that need to be refurbished.

A 138 kV Pier Foundation that Requires Refurbishment

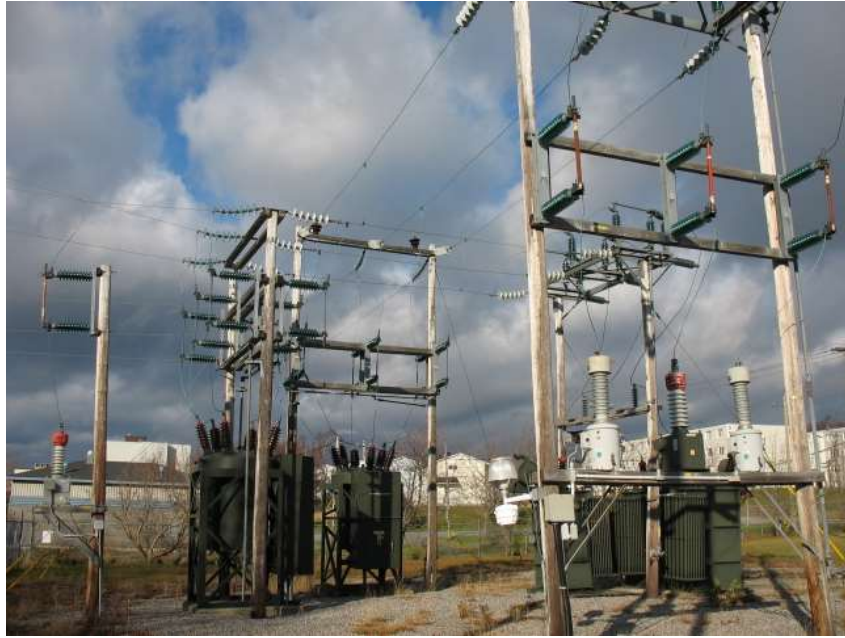
66 kV Wood Pole Structures that Requires Replacement

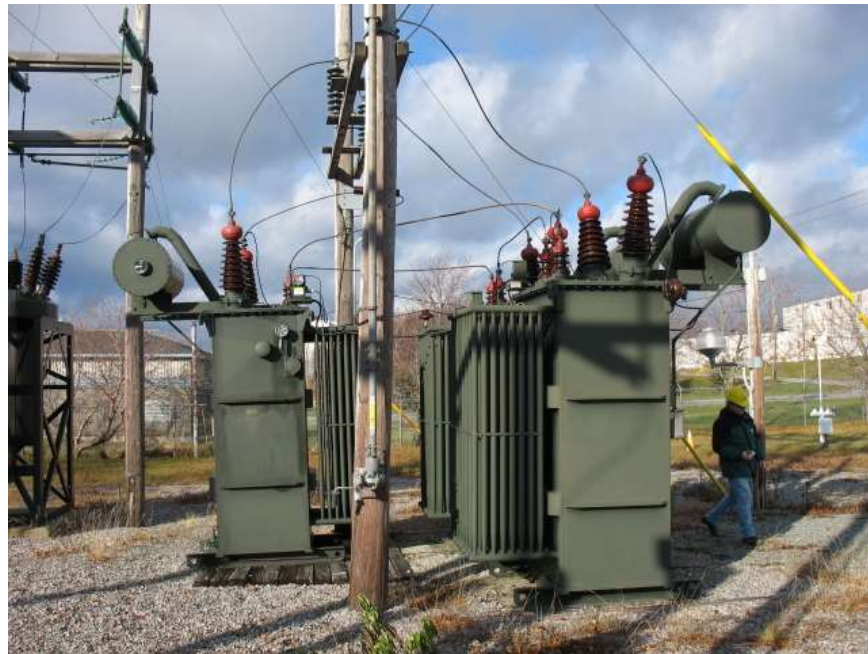
A spill containment foundation will be constructed for grounding transformers T3 to protect against environmental damage in the event of an oil spill from the units. To provide improved monitoring and protection for the grounding transformers, 3 current transformers will be installed.

Existing Grounding Transformers T3

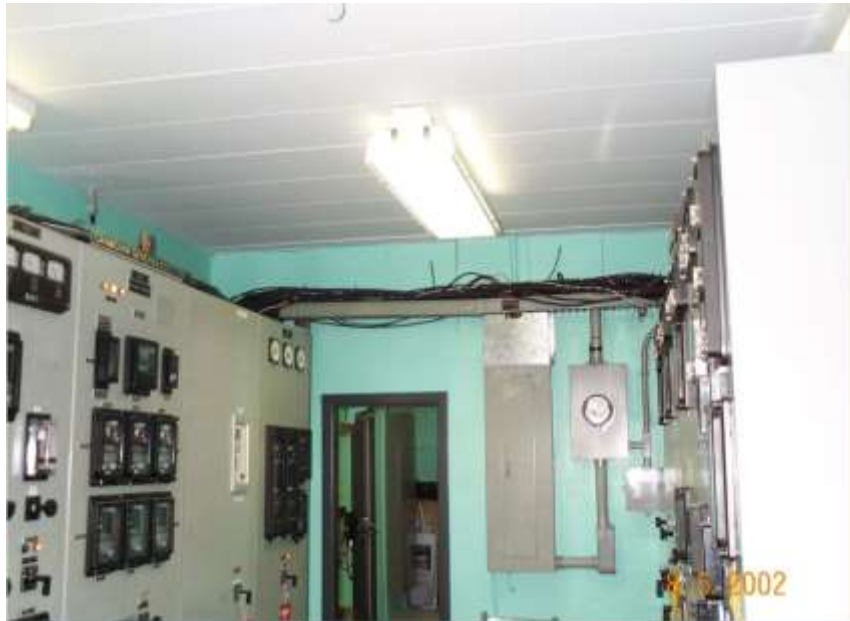
Existing Control Building with Electromechanical Relays

The existing 55 year old control building at Gander Substation cannot accommodate the new relay and communication panels required to complete the protection upgrades. The building is deteriorated and does not meet current standards.¹⁷ A new control building will be constructed adjacent to the existing building. The new building will permit installation of the protection and communications panels with minimum disruption to the existing protection scheme and impact to the integrity of the electrical system during construction.

¹⁷ There is corrosion present on both the metal roof panels and siding, the exterior walls are not insulated, and there is no cable trench extending inside the building. Overcrowding of the panels inside the building limits access to the rear of the panels where the wiring is terminated. The battery room does not meet current electrical and building codes.

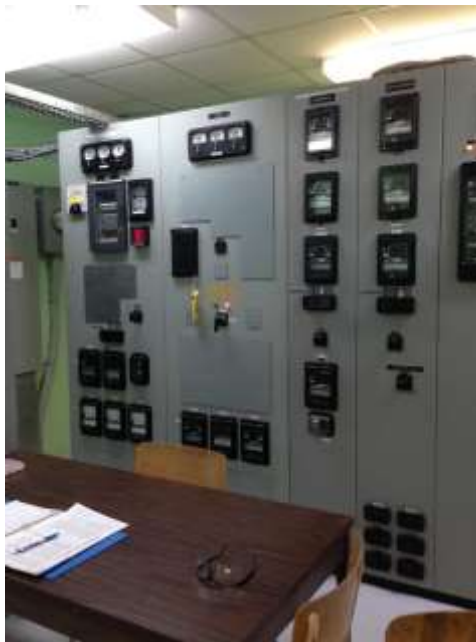
43 years old.²⁴ Electromechanical relays contain moving parts and can fail as they age, wear, and accumulate dirt and dust. The age of these relays dictate they are to be replaced.

Electromechanical Relay Panels of Transformer, Buses and 110L Protection

The protection and control of the substation will be modernized by replacing these obsolete devices with microprocessor based digital relays, reducing the total protection relay device count from 65 to 14. The protection upgrade will also involve replacing all of the existing protection panels. This approach minimizes the number of active devices used to provide protection to substation assets, consolidates the control and automation architecture, and reduces ongoing maintenance.

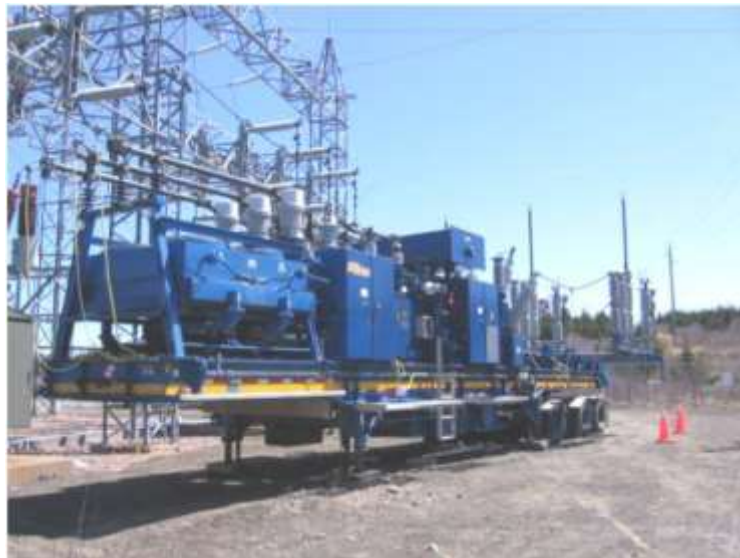
Portable substation P4 was purchased in 1993. It is used to respond to power transformer failures and for planned transformer maintenance and substation refurbishment and modernization work. P4 can provide backup for 70% of the 192 power transformers in service on Newfoundland Power's system.

Portable Substation P4

The refurbishment was scheduled to be completed in 2013. However, due to the increased use of the portable substations associated with completion of the PCB Bushing Phase-out project, the unit was unavailable for refurbishment in 2013 and 2014. The refurbishment of portable substation P4 will take place in 2015. This will be the first comprehensive refurbishment of this portable substation since its purchase in 1992 ensuring its availability into the future.

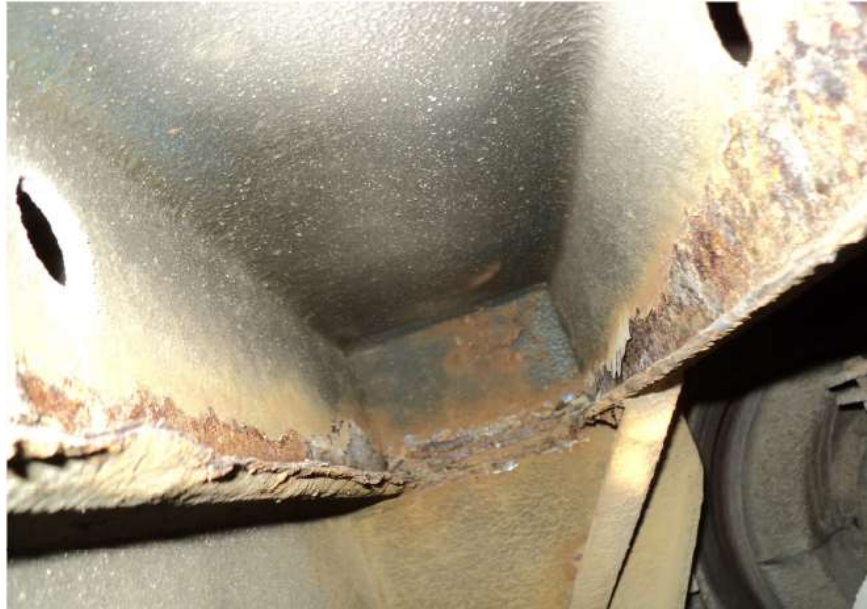
An inspection of the portable substation trailer has identified areas of excessive corrosion, deteriorated welding and stress cracks in the trailer chassis. These issues will be corrected and a rust inhibiting coating applied to the chassis and axles to inhibit further deterioration.

Corrosion on 7" C-Channel

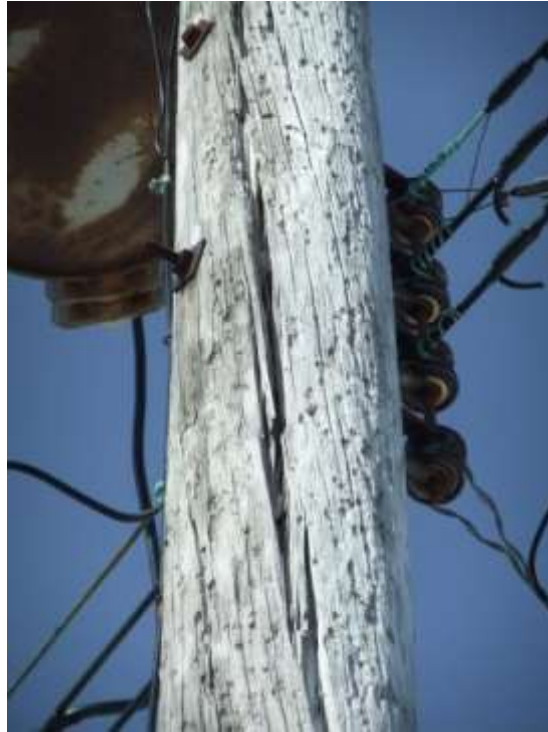
Figure 1 – Severe Checking in Pole

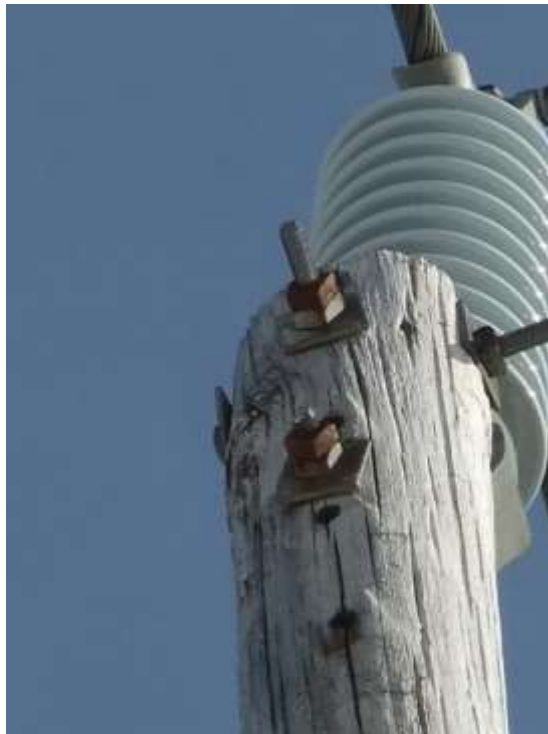
Figure 2 – Deteriorated Pole

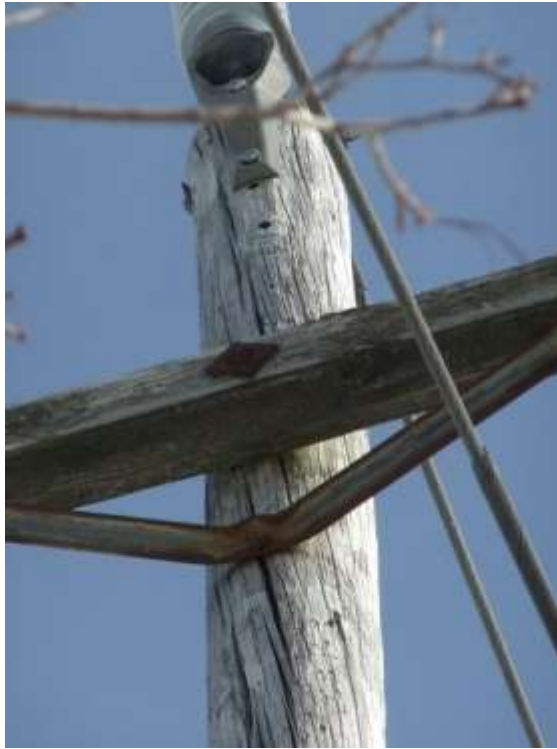
Figure 3 – Pole Checking and Deteriorated Crossarm

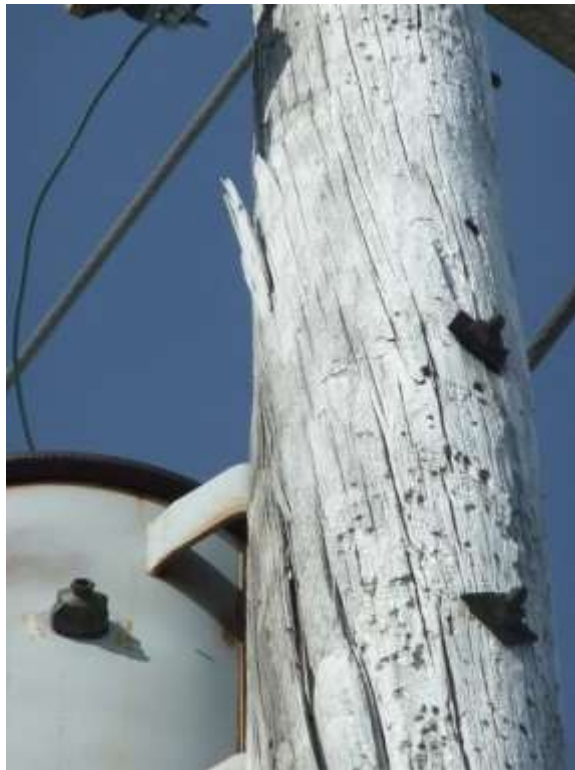
Figure 4 – Pole Shell Damage

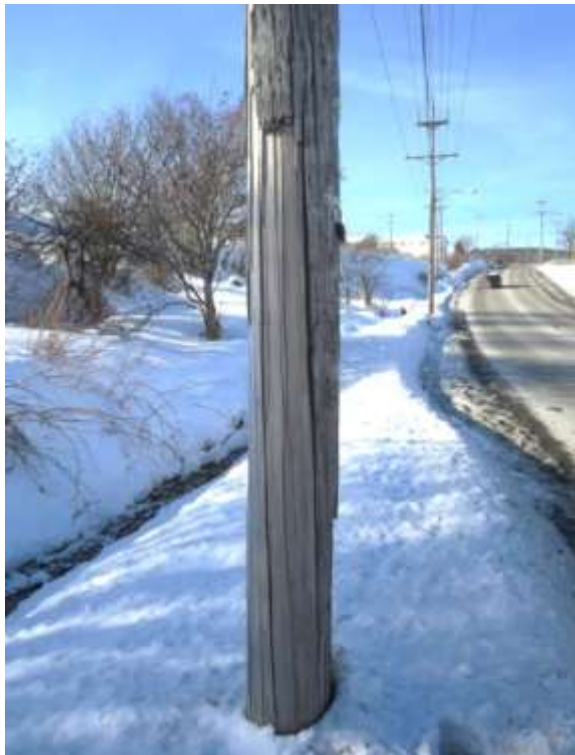
Figure 6 – Damaged Pole

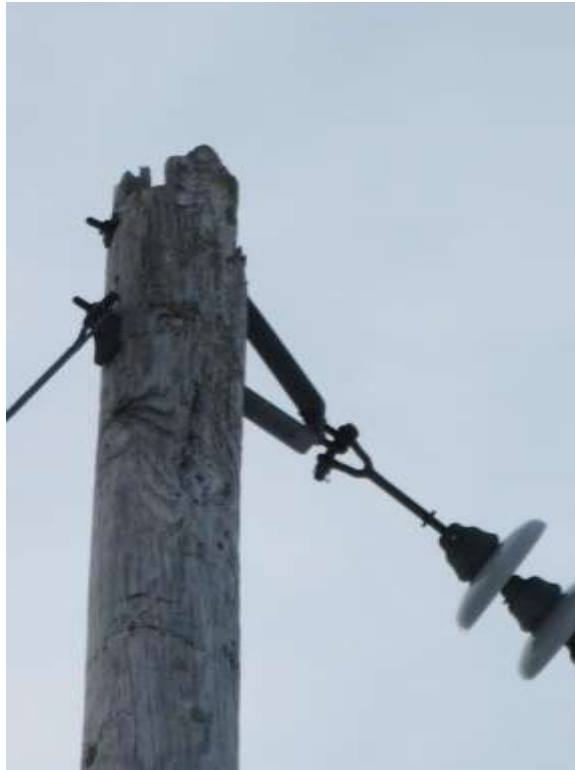
Figure 7 – Deteriorated Pole Top

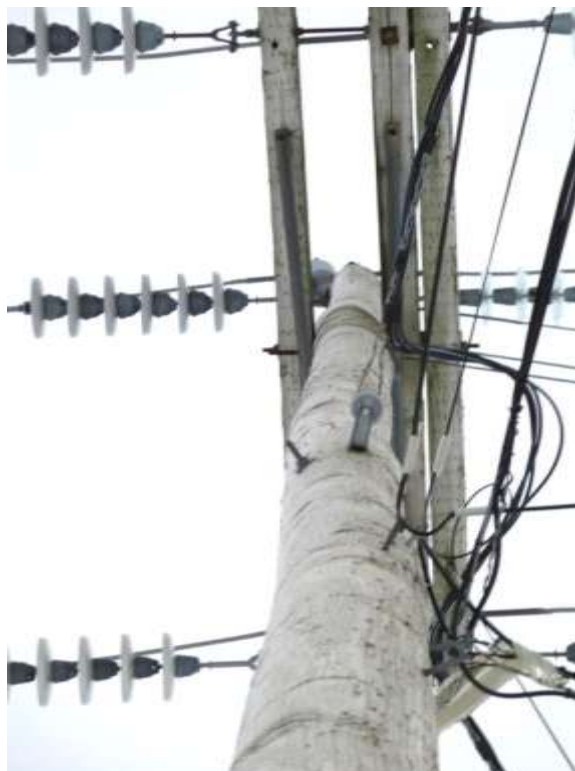
Figure 8 – Split Crossarms

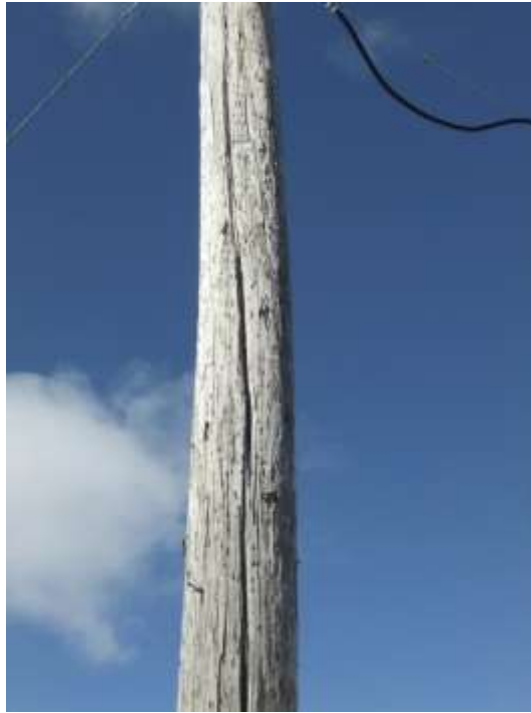
Figure 9 – Pole Checking

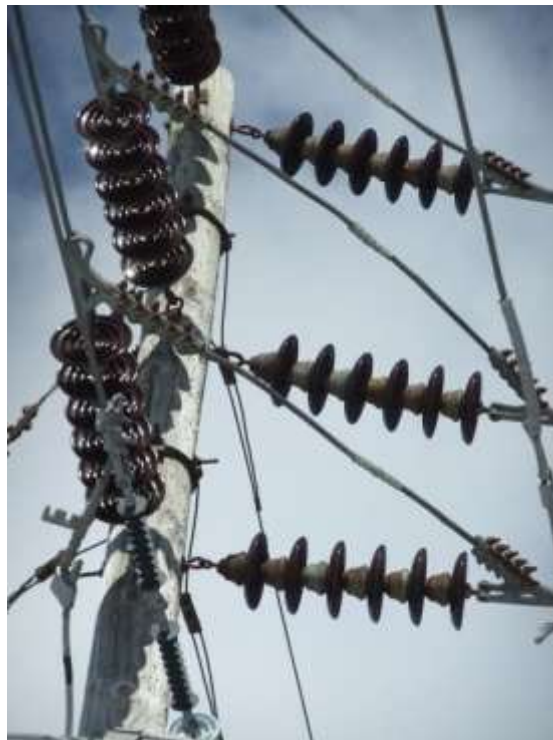
⁶ See Figure 10 of Appendix C for a photograph of these insulators.

Figure 10 – 1950's Vintage Insulators and Hardware

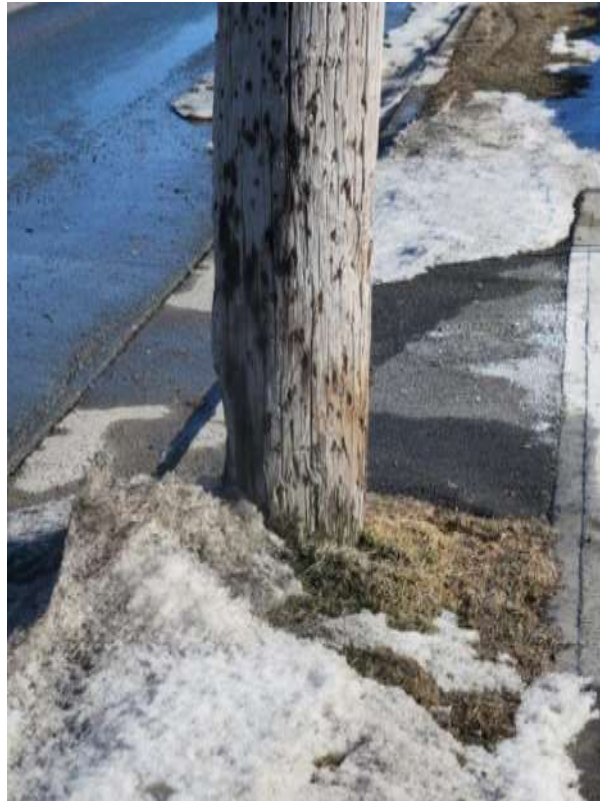
Figure 11 – Pole Damage

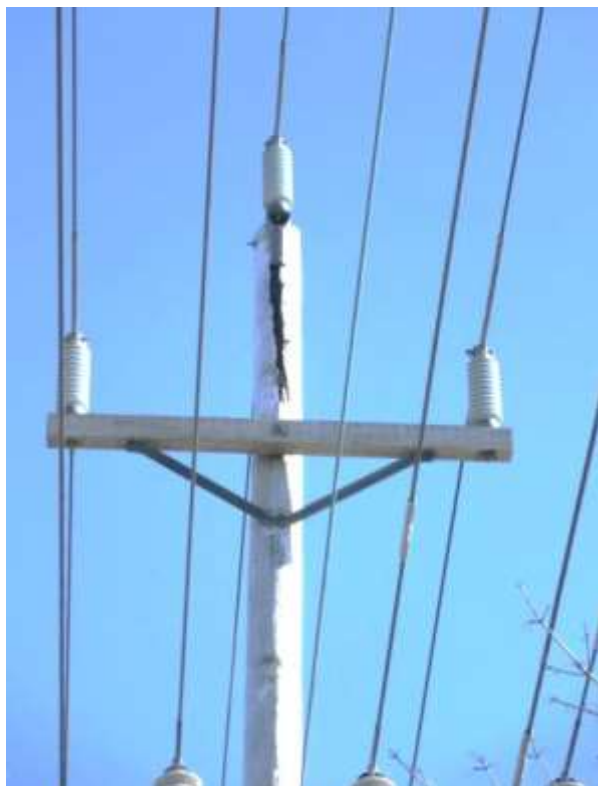
Figure 12 – Burned Pole

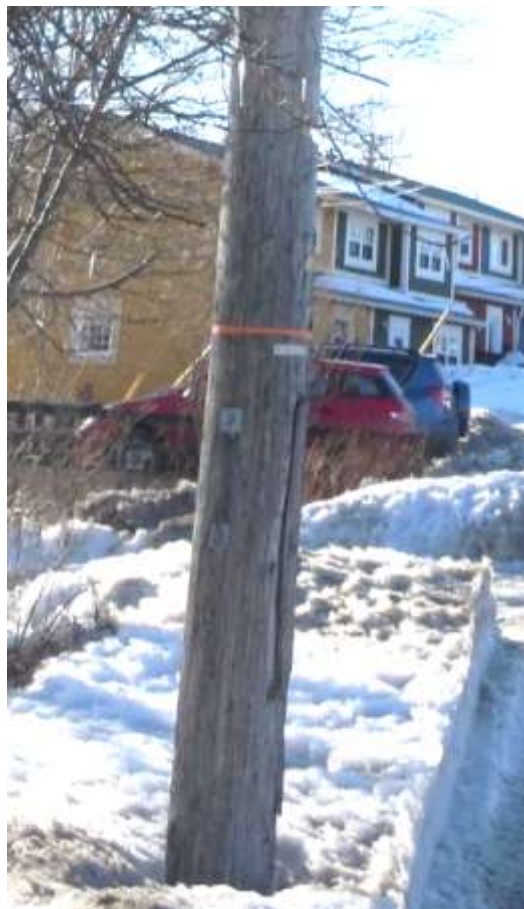
Figure 14 – Bolts Provide Temporary Repairs to Damaged Pole

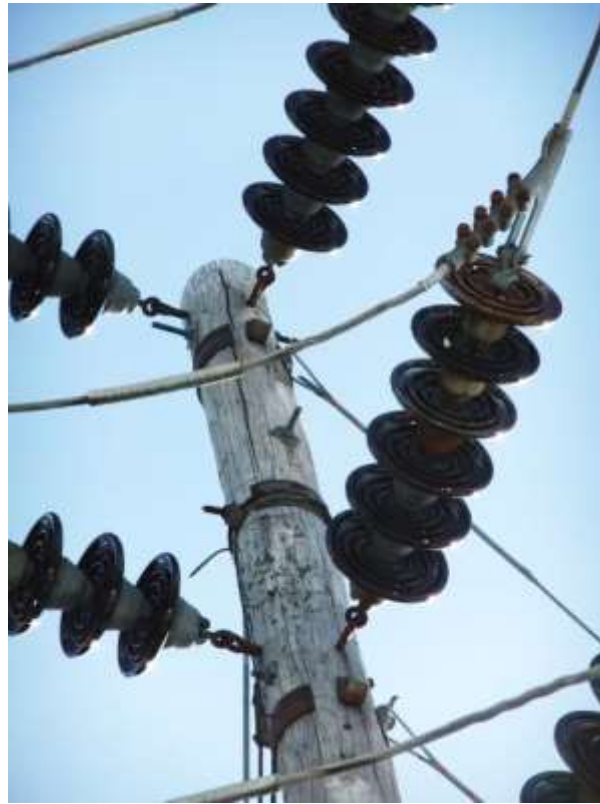
Figure 15 – Pole Checking and Original Vintage Insulators

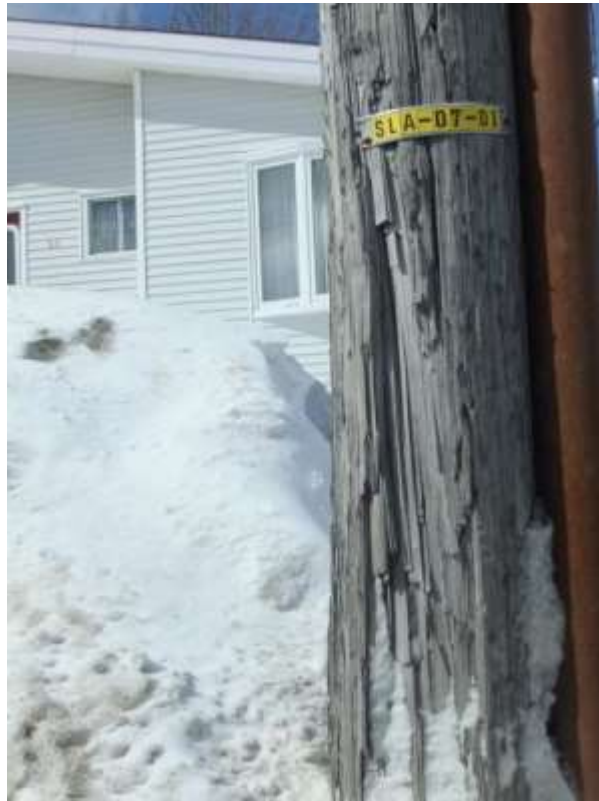
Figure 17 – Pole Damage

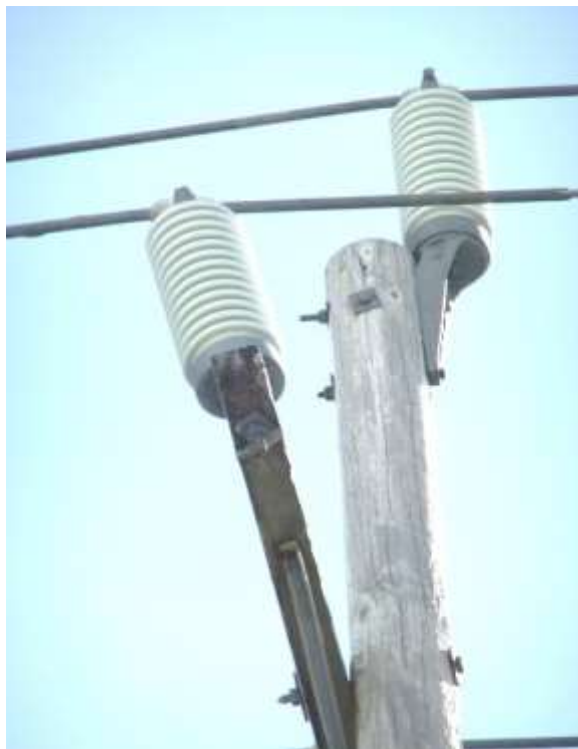
Figure 18 – Damaged Crossarm

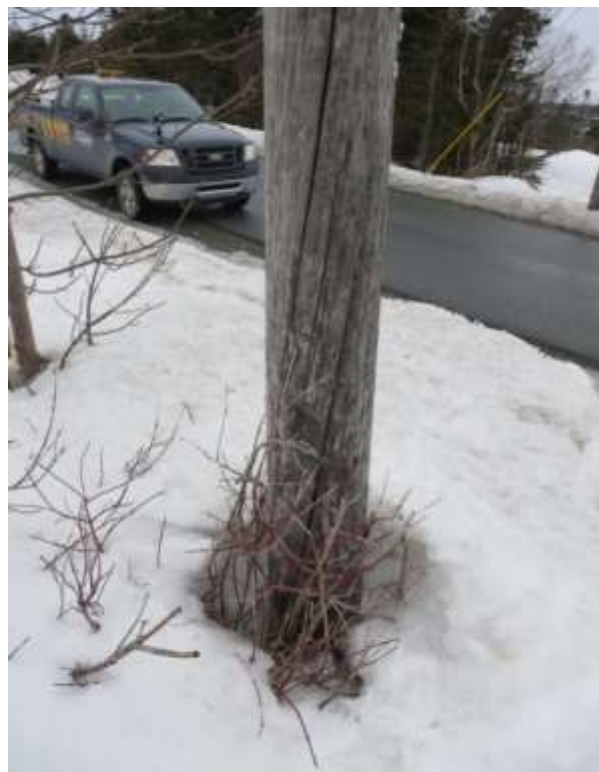
Figure 20 – Deteriorated Pole

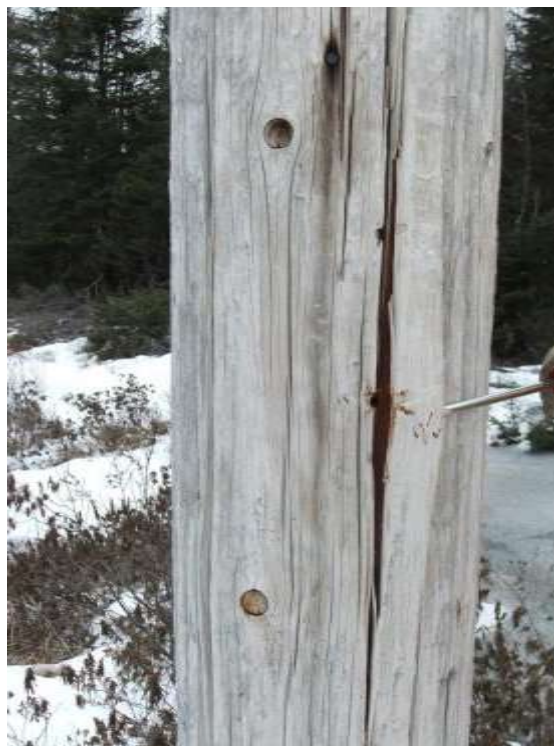
Figure 22 – Pole Shell Separation

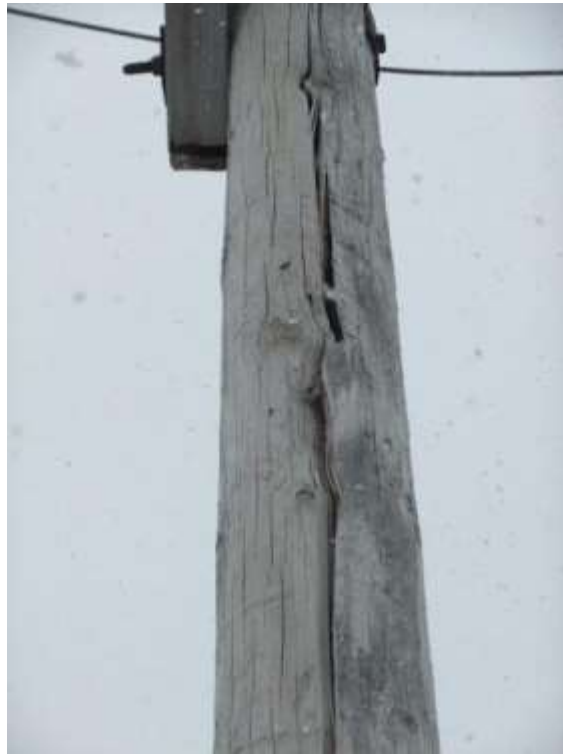
Figure 23 – Significant Pole Checking Due To Shell Separation

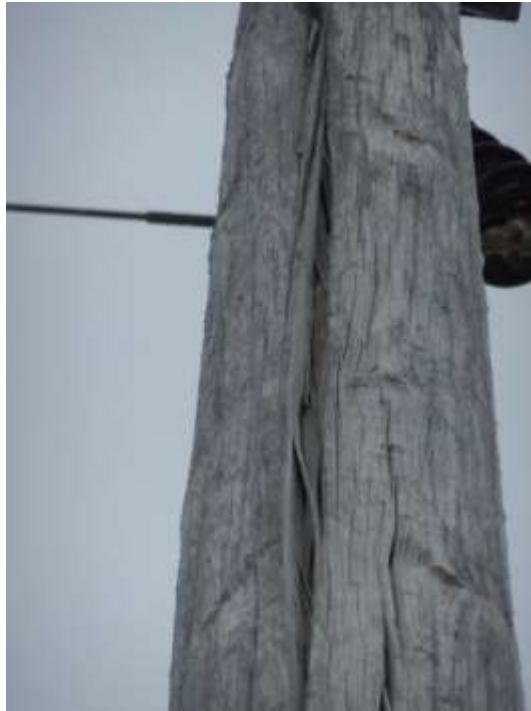
Figure 29 – Deep Checking Due to Shell Separation

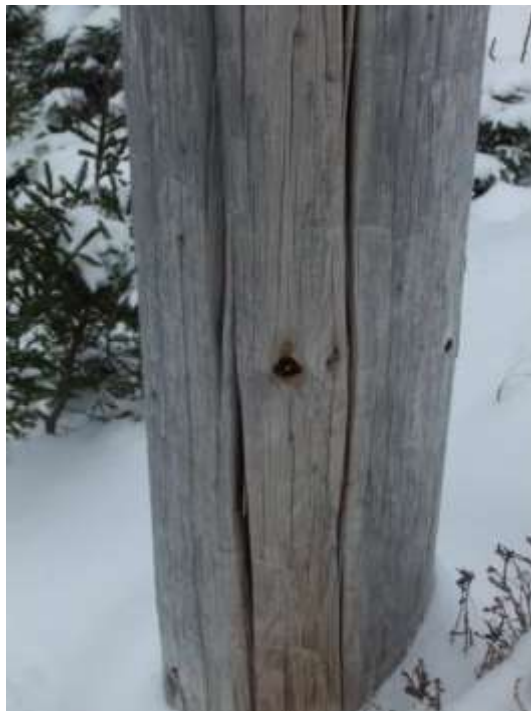
Figure 30 – Pole Shell Separation
