Re: Newfoundland Power's 2015 Capital Budget Application

**Pierre's Brook Hydro Plant
Penstock Replacement and Surge Tank Refurbishment**

June 2014

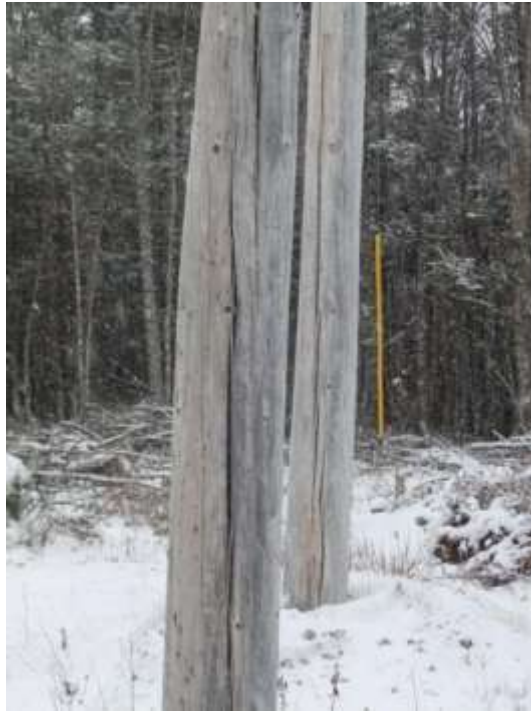
Figure 31 – Deep Pole Checking

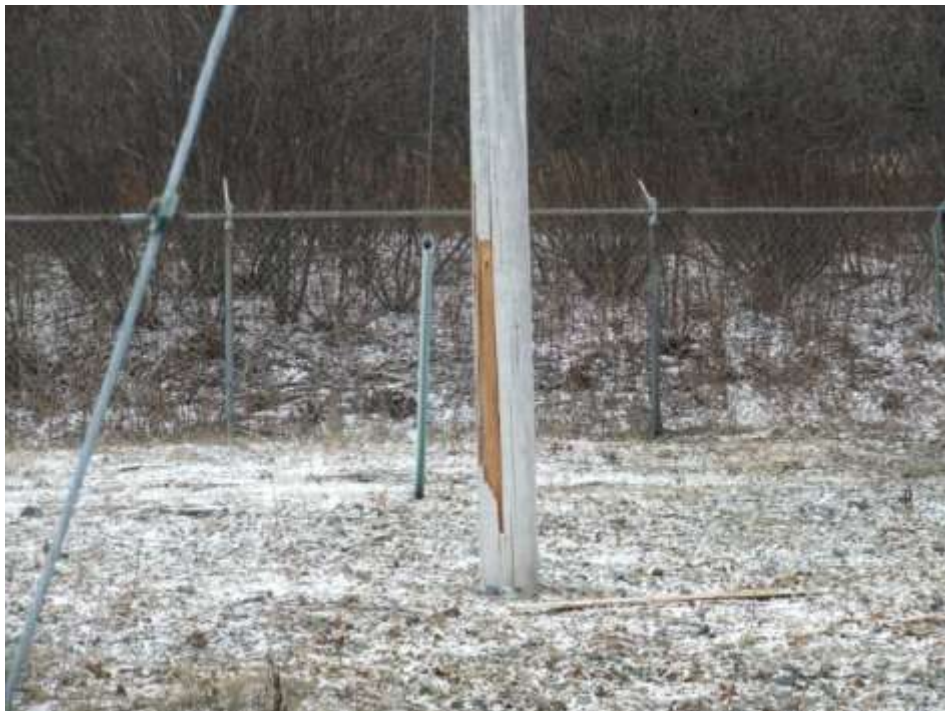
Figure 32 – Exposed Inner Wood

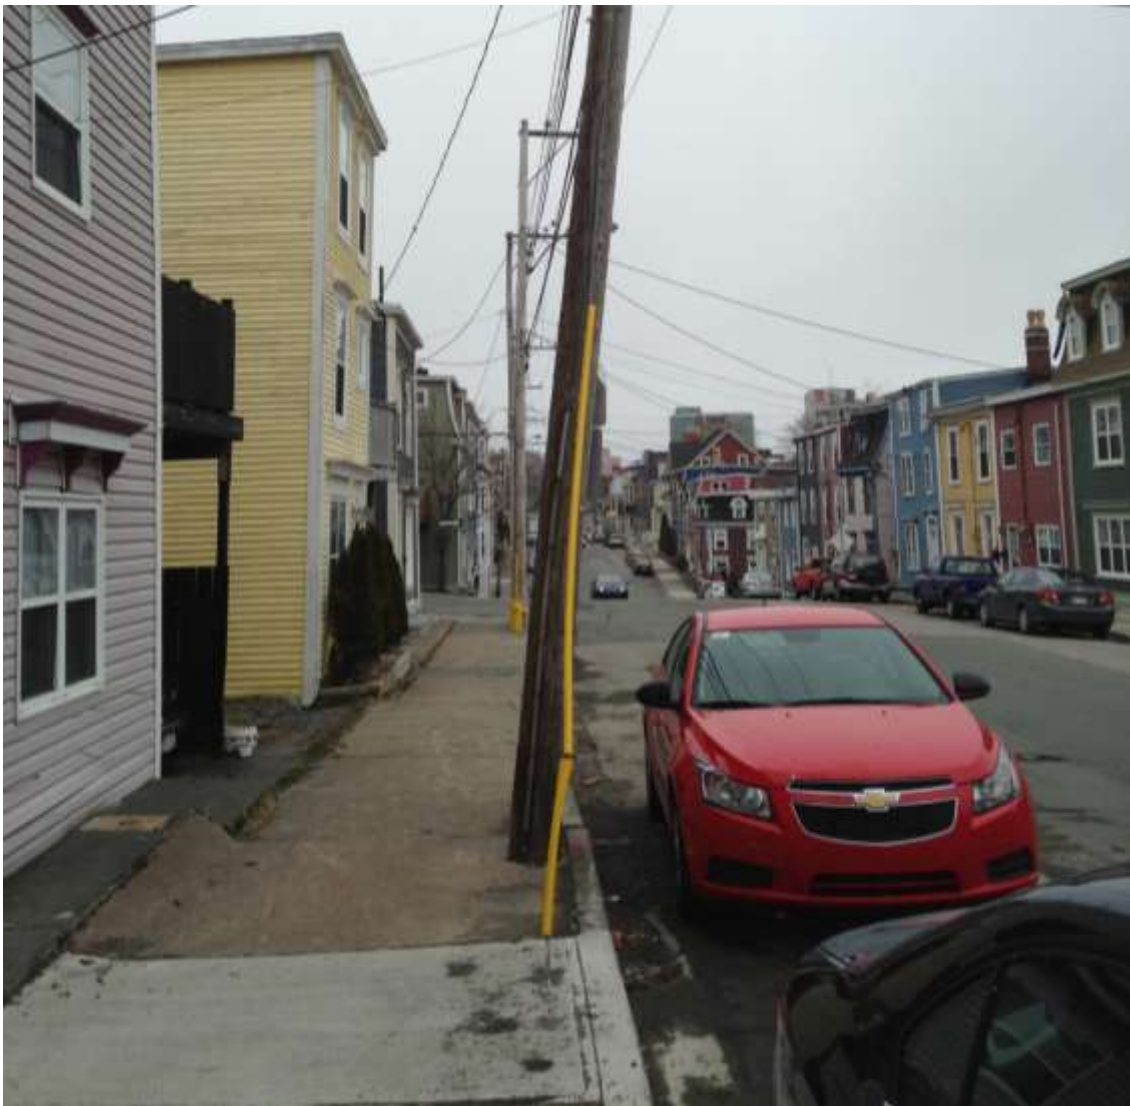
Figure 3 - Pole Leaning Towards Traffic

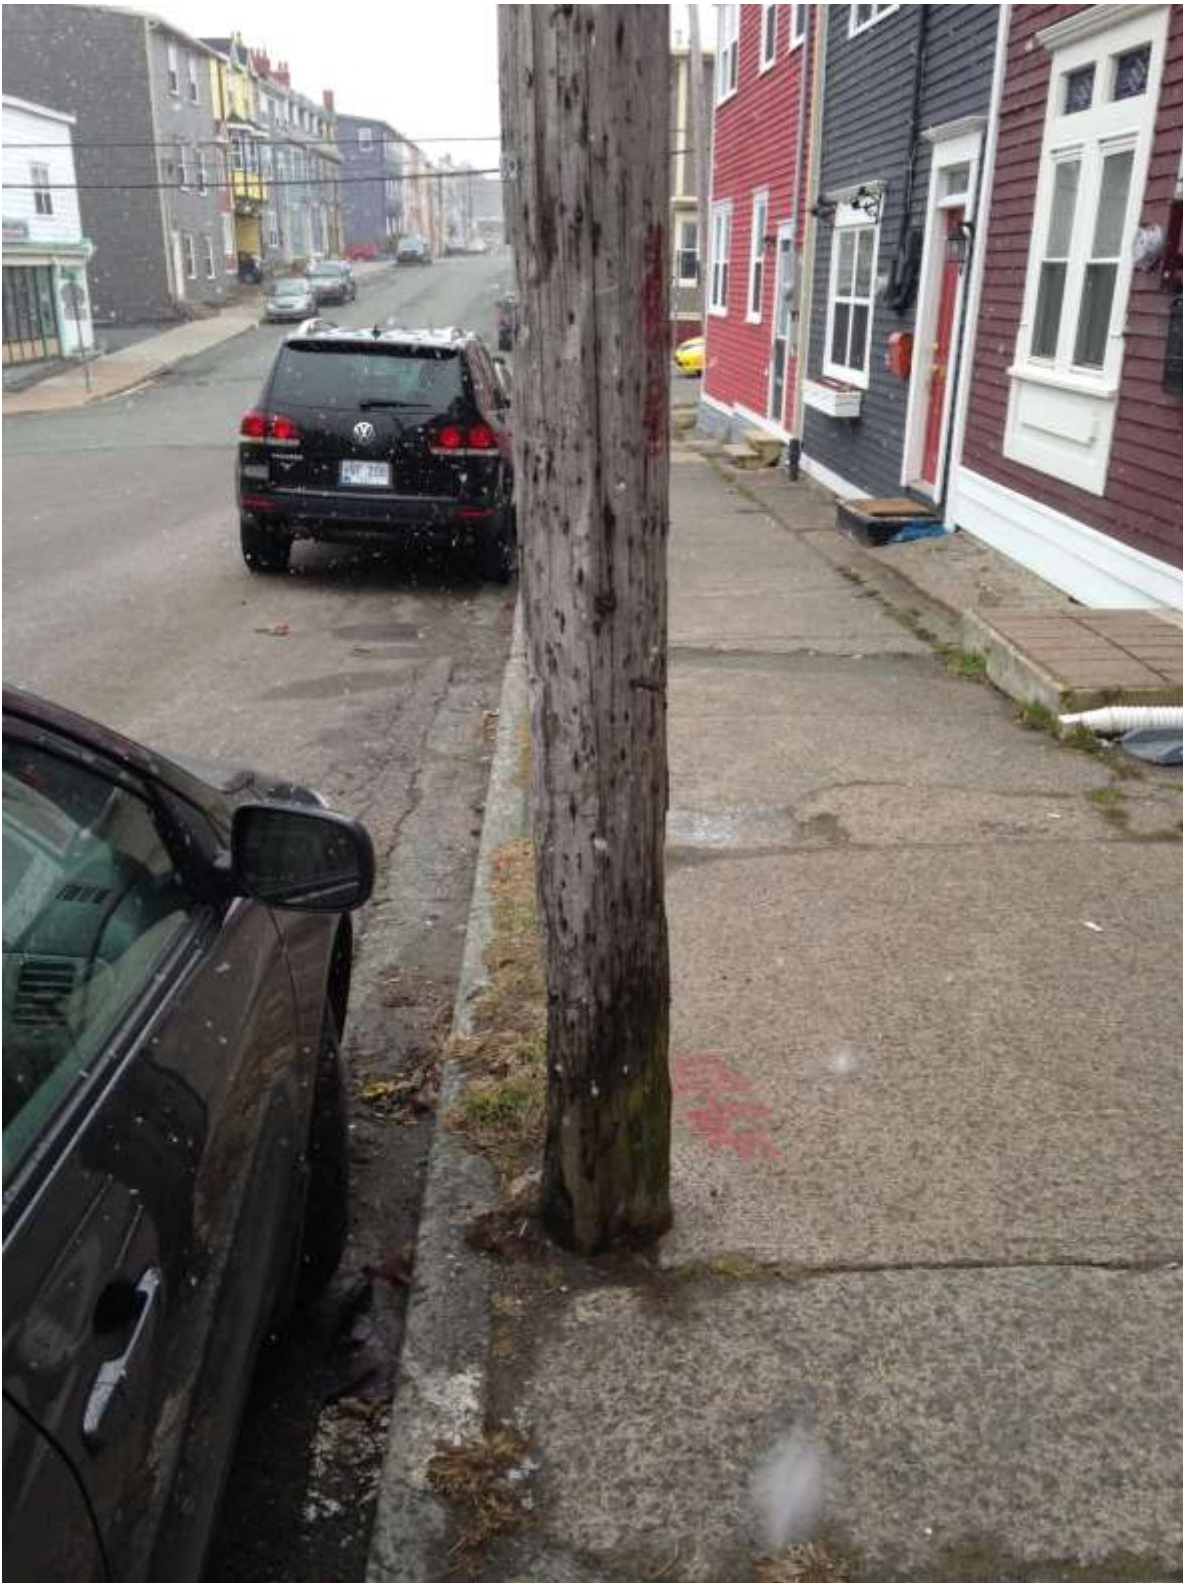
Figure 4 - Loss of Pole Diameter at Base

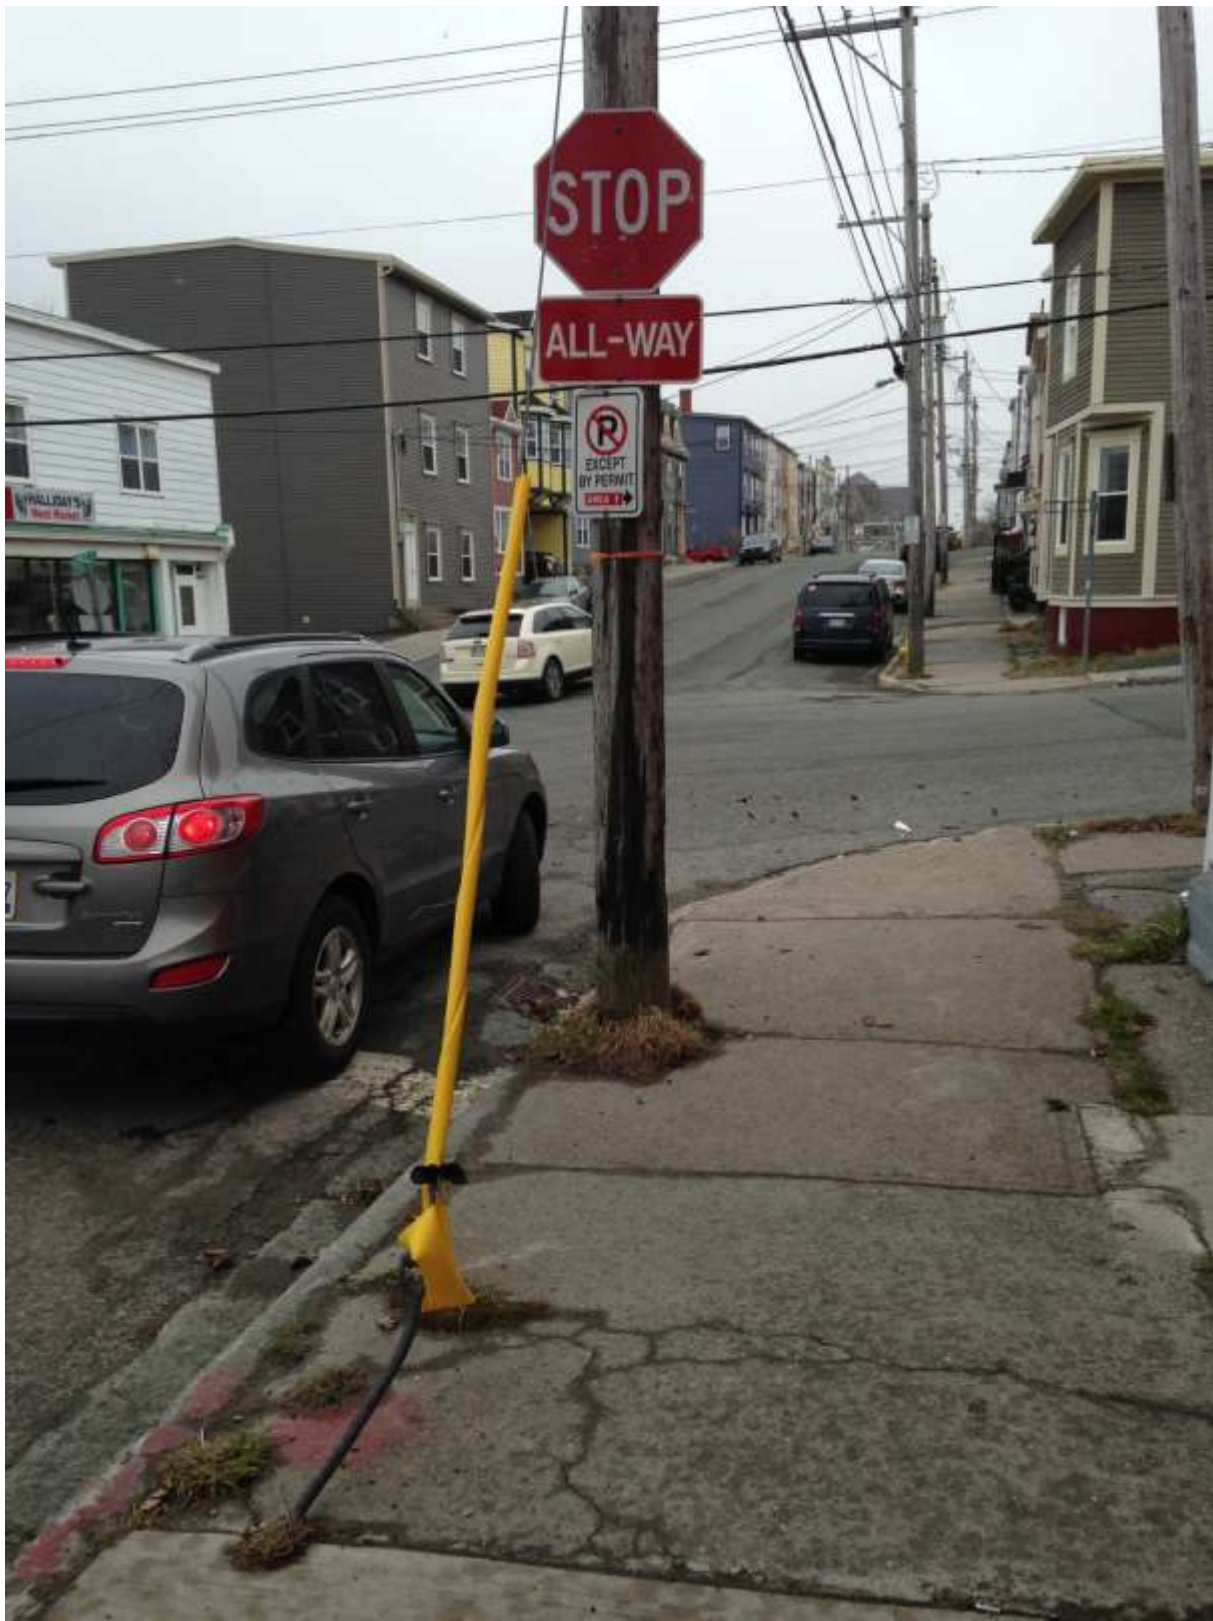
Figure 5 - Guy Bent Towards Sidewalk

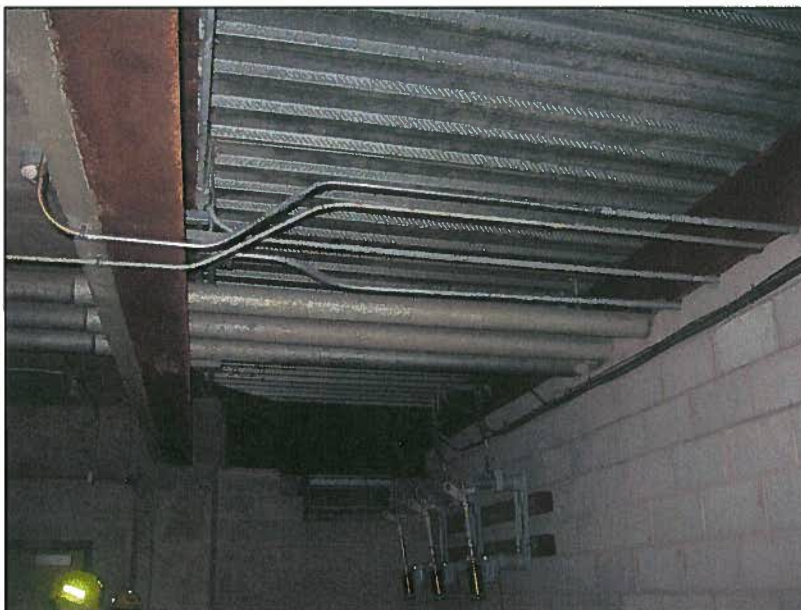
The ceiling has what appears to be a poured-in place structural concrete section. The other section of the ceiling is poured-in-place concrete on steel exposed decking supported on exposed wide flanged steel beams. There is no fireproofing on this section of the ceiling.

Picture 6: Ceiling without fireproofing

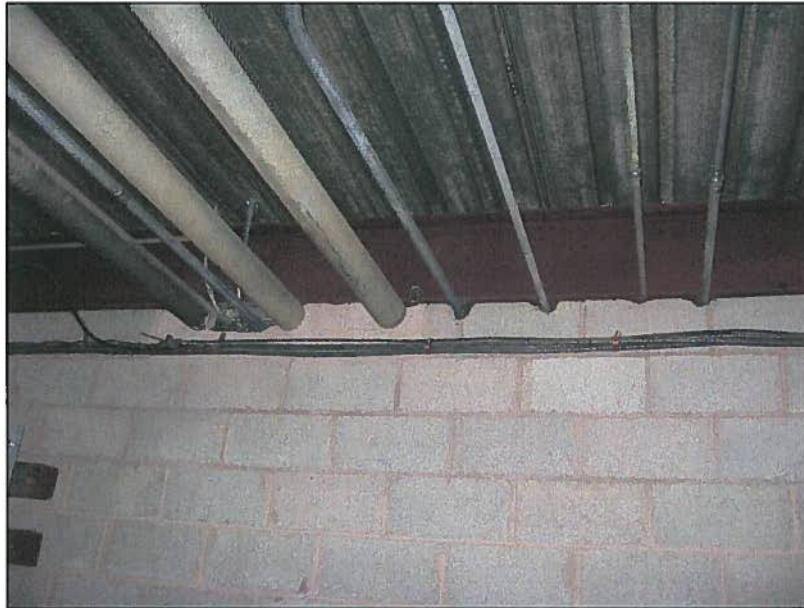
There are gaps between the masonry walls and poured-in-place concrete which occur at the penetrations of structural steel, electrical conduit and exhaust ducts. These gaps are not filled with mortar or fireproofing sealant.

Picture 7: Conduit penetrations without fireproofing sealant.

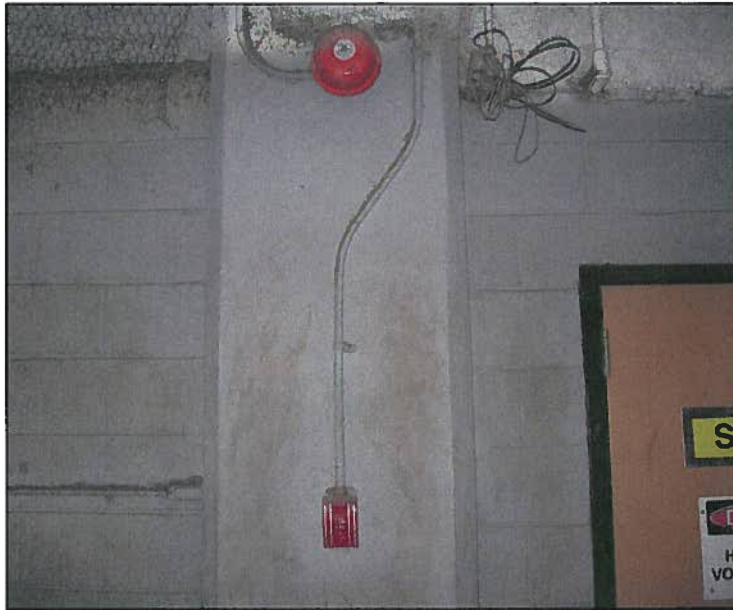
While there is one grounding type 120 V receptacle inside the vault near the double doors, it is not functional. It's supply wiring is unconnected and coiled on the other side of the wall in the parking garage.

Picture 10: Disconnected receptacle wiring

It would appear work was undertaken at some time in the past, on the vault ancillary AC electrical system but it was not completed.

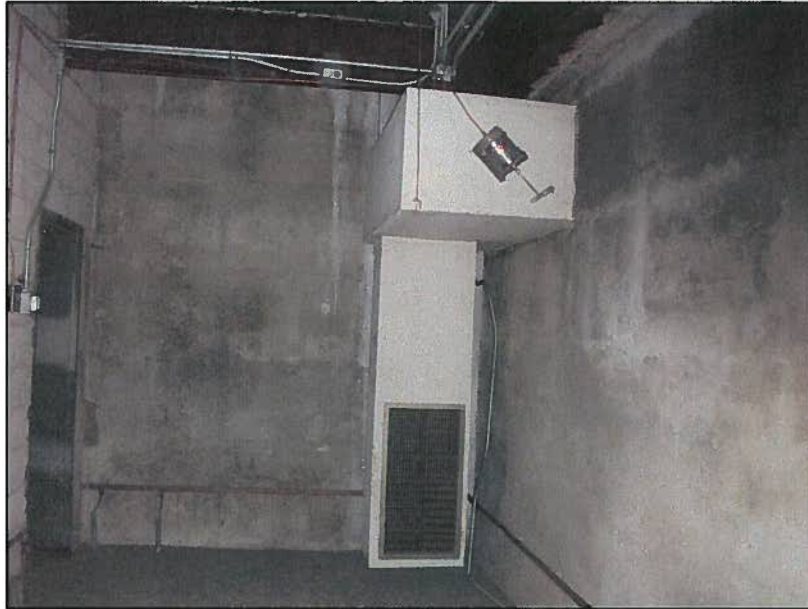
The vault ventilation system has an insulated fresh air intake located in the Ayre's Cove exterior wall. The intake has a pneumatic thermostatically controlled damper. The operation of the damper was not verified. The exhaust section of the ventilation system consists of open duct with a fire damper to the right of the double doors. The duct originating from the vault passes through the parking garage and exhausts outdoors in the receiving area off Ayre's Cove. The intake and exhaust ducting appear to be in good condition. The exhaust duct contains an axial fan but the fan motor is missing. According to the long-term building manager, the motor has been missing for his 34 year tenure. The exhaust duct is equipped with a Fire Stat. This device would deactivate the exhaust ventilation system in case of a fire. Control of the exhaust ventilation could not be traced but appears to be by an electrical thermostat in the small section of the room, near the intake thermostat.

Picture 12: Fresh air intake. Note ceiling without fireproofing.

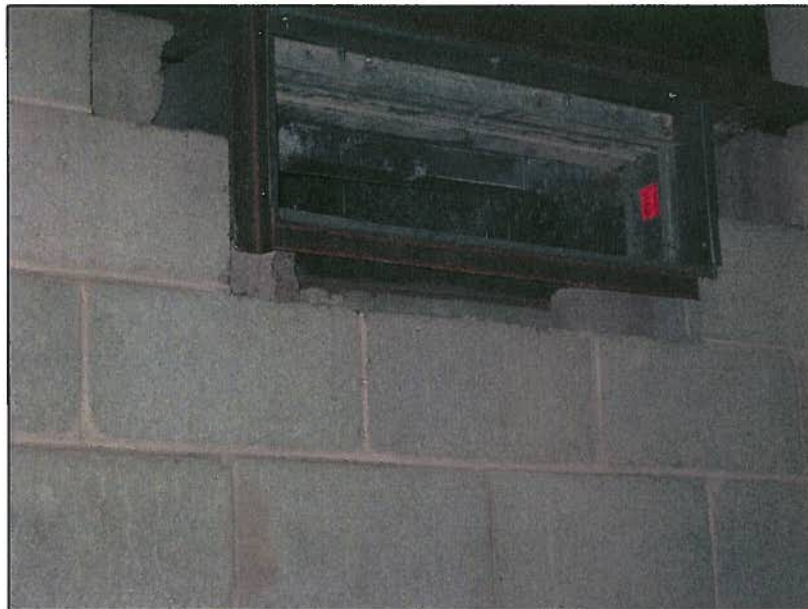
Picture 13: Exhaust ventilation duct opening. Note missing grille and grouting for fireproofing

4. NBC 3.6.2.7 Sentence 7) requires that the vault ventilation system “shall be separate from the system for the remainder of the building and be designed to automatically shut off for a fire in the vault”. Fire dampers were not found during visual inspection.

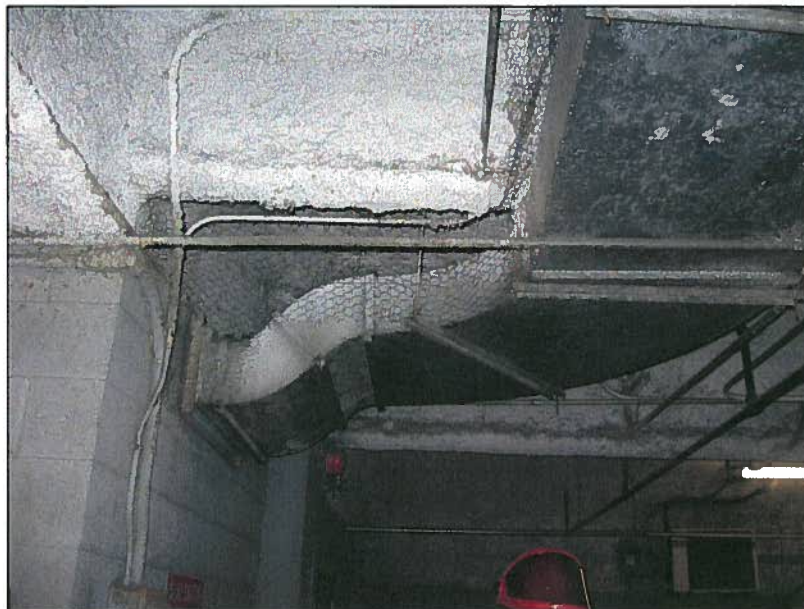
Picture 14: Ventilation exhaust duct

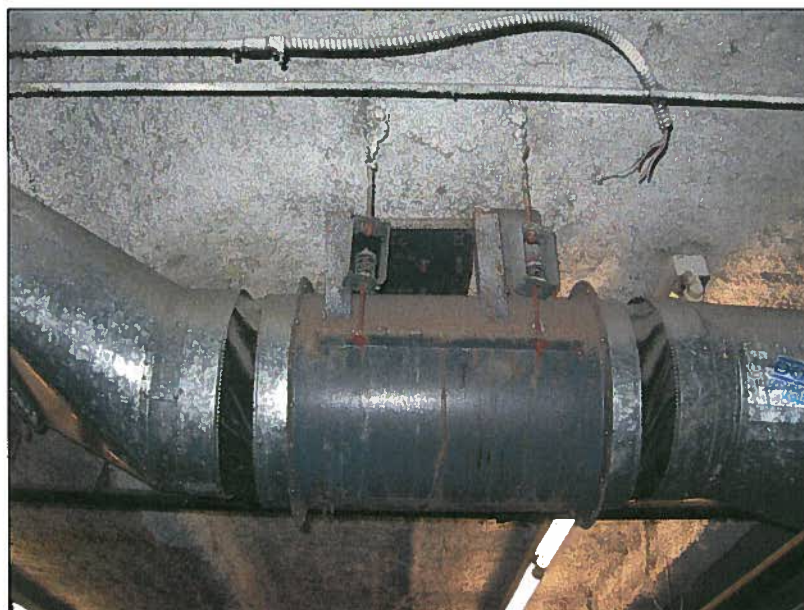
Picture 15: Exhaust ventilation axial fan with empty motor bracket. Note disconnected motor wiring.

4. NBC 3.6.2.7 Sentence 6) requires the vault shall be "provided with ventilation designed in accordance with Part 6 to prevent the ambient temperature in the vault from exceeding 40°C". It is not known if the ventilation was designed to meet this requirement. But as the system is not functional, this item has been listed as a deficiency.

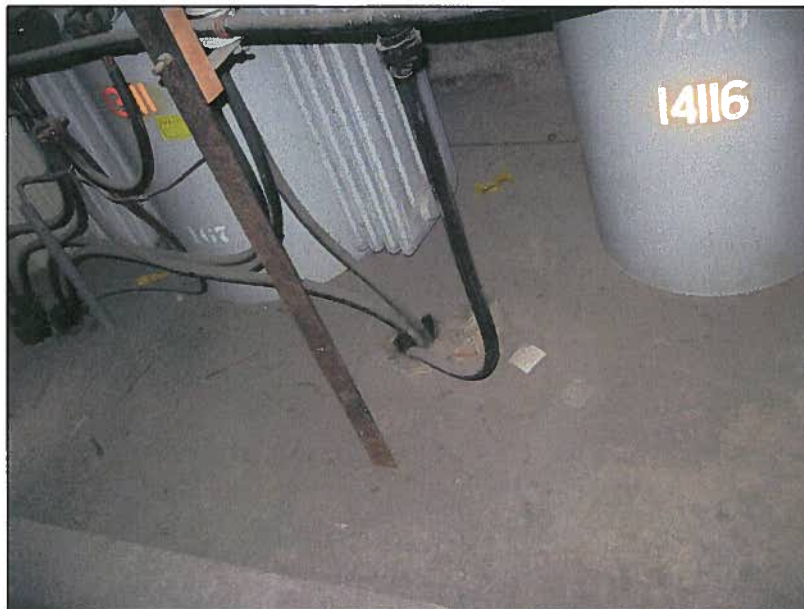
The oil spill containment around the bushing transformers consists of two vault walls, vault floor and a concrete curb, approximately 160 mm high. These components are in good condition with no signs of where possible leakage would occur. In the containment area, there are four fibre ducts. The ducts do not extend above the curb. Each duct is damaged and are effectively open at the floor level which would allow spilled oil to flow into the duct.

Picture 16: Fibre duct conduit in spill containment

5. NBC 3.6.2.7 Sentence 8) requires the vault floor to be liquid tight and surrounded by liquid tight walls. The fibre duct in spill containment area is open at floor level which could allow an oil spill to enter the duct rather than being contained. The unknown condition of the underground spill containment tank raises concern with respect to conformance with this rule.

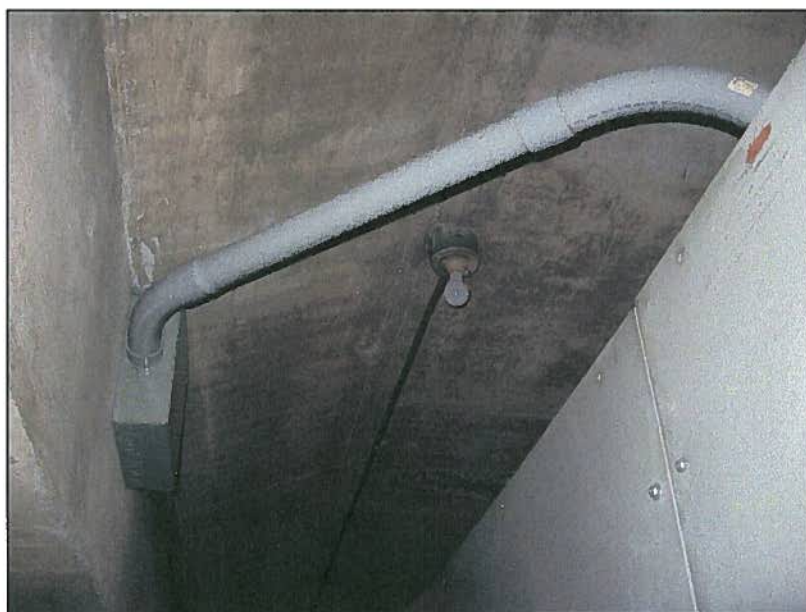
Picture 18: Fibre Optic conduit leaving switchgear.

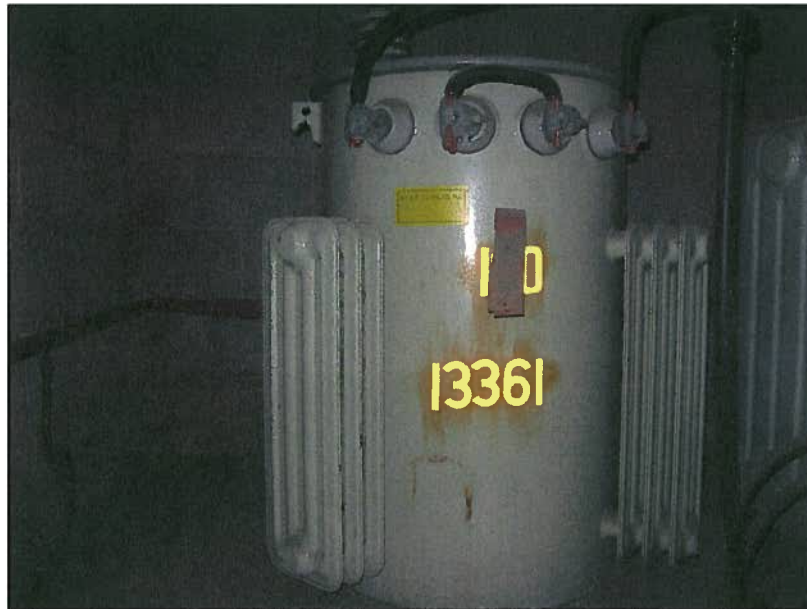
The transformers do not have H2 bushings. The two side transformers have the ground straps removed from the X2 bushing but the boss for the X2 ground strap bushing is not connected to the system neutral.

Picture 20: Left side transformer X2 ground boss.

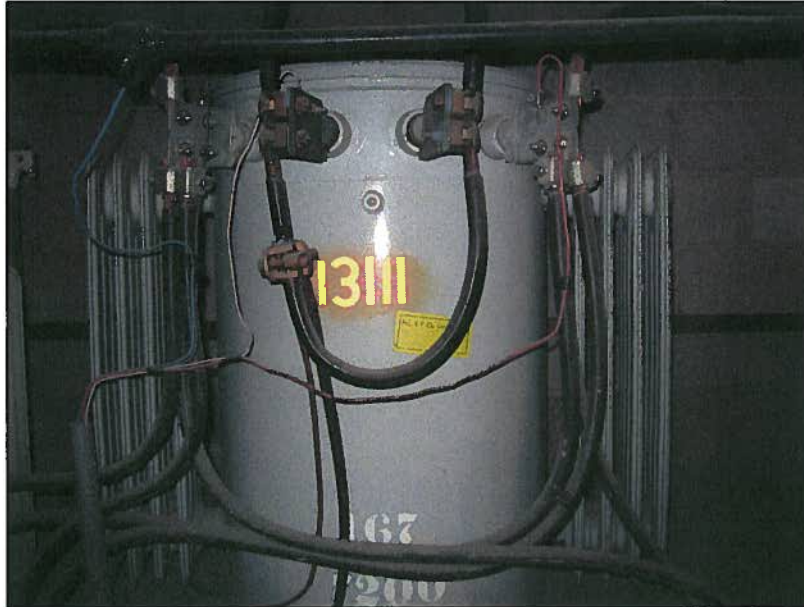
The middle transformer's secondary winding is centre tapped to ground to provide 120/240V supply. The X2 bushing of the centre transformer does not have the ground strap installed.

Picture 21: Centre transformer unconnected X2 grounding. Note #10 AWG wiring.

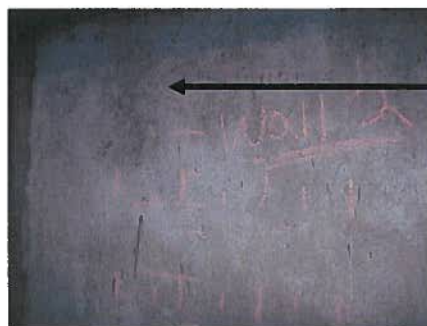
Location 2
Basement Vault
Concrete Wall 2

This is an image to the right of wall on page 1 (opposite double doors into vault and left of main support). The approximate thickness of wall is undetermined as there is no clear visible indicator of the back of the wall but the GPR signal appears to extend further than 8 inches. This is the same wall as in image on page 1 and uniformity of the structure appears to be the same so it can be assumed that this wall has the same thickness throughout its length.

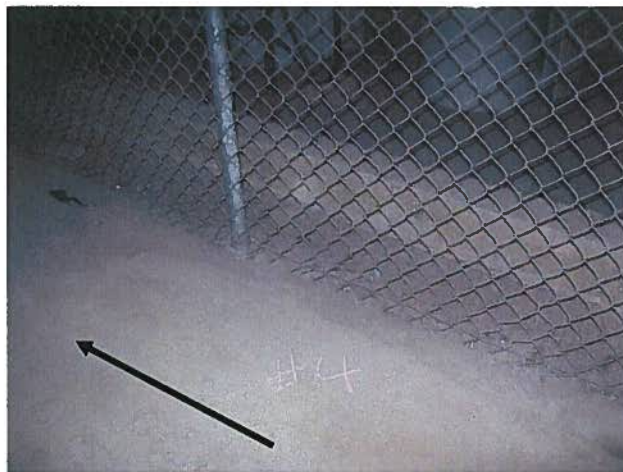
Location 4
Basement Vault
Concrete Floor 2

Image of same floor as on page 3. Image shows slab thickness at 6—7 inches. Concrete floor will always have differences in uniformity (thickness will rise and fall) across the structure.

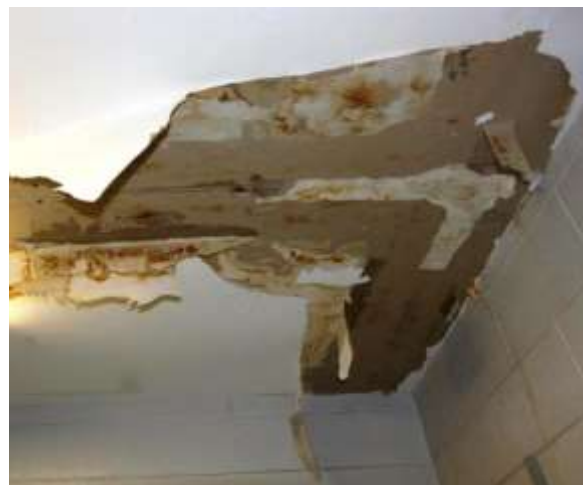
Overall, the roof at the Facility is assessed to be in good condition however localized areas of deterioration are present. Leakage has been identified in two areas; (i) at the intersection of the built-up office area roof and standing seam

Figure 1 – Damage as a Result of Roof Leakage

warehouse roof, and (ii) at the edges of the standing seam warehouse roof. Upgrades are required at this time to prevent the leaks from damaging the interior of the building.

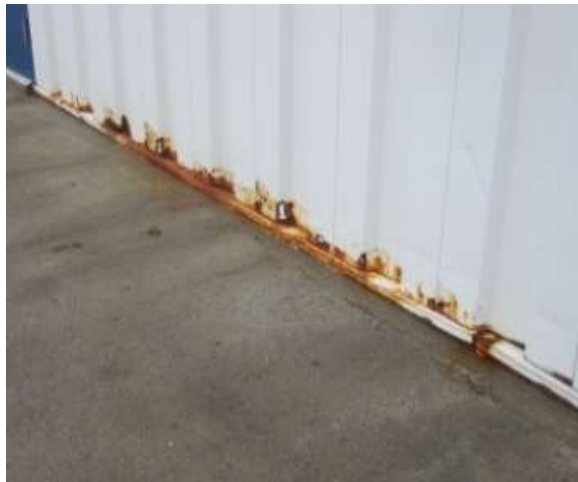
Figure 2 - Corroded Siding

The building's exterior siding is in good condition with the exception of the area near the base. The deterioration in this area is accelerated due to its exposure to de-icing salt. As shown in Figure 2 the siding at the base has corroded through and is no longer weather tight. In areas where the siding has been exposed to de-icing salt the removal and replacement of existing corroded siding is required. Siding is corroded and will be replaced on approximately 200 linear meters of the building's exterior walls.⁴

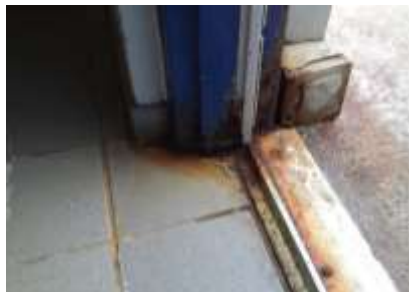
The Facility's overhead and personnel doors vary in condition. The original overhead doors in the line truck bays have been replaced due to corrosion. Overhead shipping and receiving doors are original and are in fair condition. The overhead door used by forklifts traveling to and from the storage yard is corroded and requires replacement. The Facility's personnel doors are largely original and have significant corrosion, including on the door frame, where exposed to de-icing salts. Deterioration has reached a point where visible gaps are evident between the door and frame. Replacement of 11 deteriorated personnel doors and frames is required.

Figure 3 - Corroded Door Frame

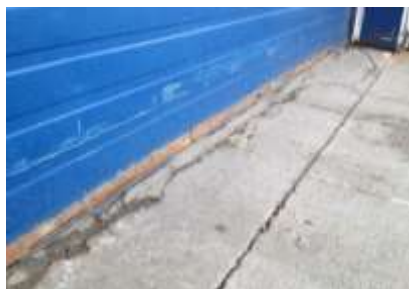
Figure 4 - Corroded Overhead Door

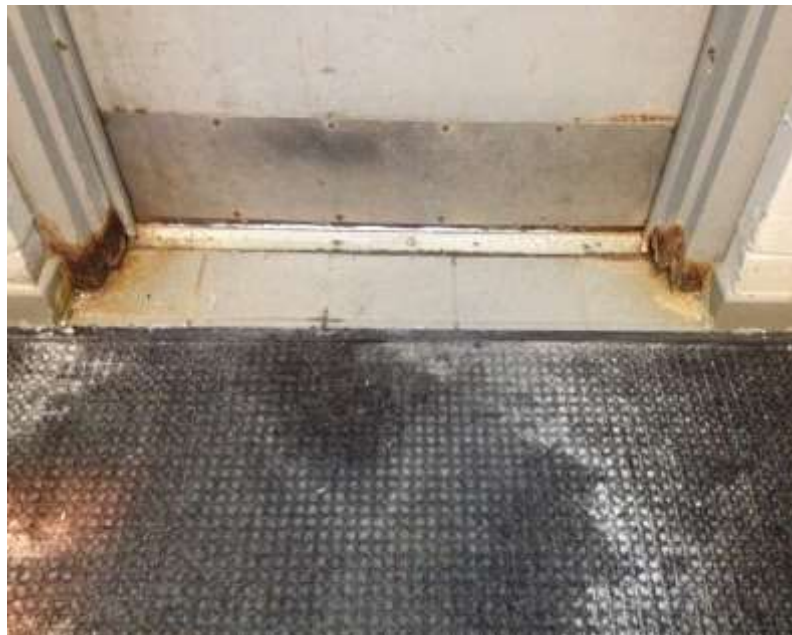
Figure 5 - Corroded Frame
(NOTE: Air gap between door and frame)

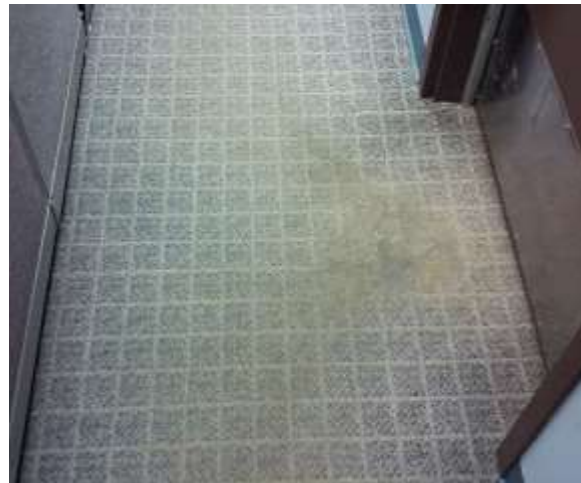
The interior finishes on the walls of the Facility consist of painted concrete block and drywall. Overall the interior finishes vary in condition from poor to good. The floor coverings are in fair to good condition with the exception of the carpet which is in poor condition. The carpet throughout the building is original to the Facility's 1988 construction, is at the end of its service life and due for replacement. Areas of deteriorated wall finishes will be refurbished along with window coverings that no longer function properly.

Figure 6 - Deteriorated Carpet

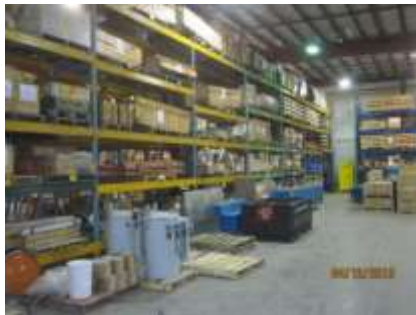
The Central Stores warehouse in the Facility is the primary materials storage facility for the Company. Exterior transformer racks were placed in service in 2008 and are in good condition. The majority of the warehouse's internal storage racks predate the original 1988 construction as they were relocated from the O'Leary Avenue warehouse.¹⁵ Overall the racking is in good condition however isolated deficiencies have been identified throughout. Typical deficiencies include damage to the support frame legs, damaged welds on cross bracing, bent cross bracing and re-welding of load bearing beams. Replacement of deteriorated sections of racking is required to ensure the continued safe operation of the warehouse.

Figure 7 - Typical Racking

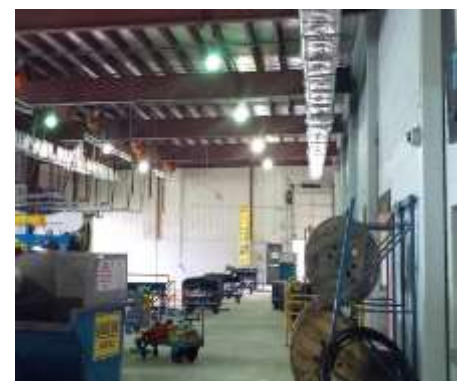
Figure 10 - Truck Bay Loading Dock

The shipping and receiving area of Central Stores utilizes dock levelers at 4 of its truck bays to allow loading and offloading of various height trucks. The dock levelers are in good condition. However the mechanical system used to adjust the height of the dock levelers has deteriorated and is in poor condition. In recent years, 2 of the 4 levelers were retrofitted, replacing the original mechanical system with hydraulic systems. The mechanical systems on the remaining two dock levellers are in poor condition and require replacement.

Warehouse improvements are required in 2015 including replacement of damaged sections of the pallet racking system along with improvements to the dock-levelers.

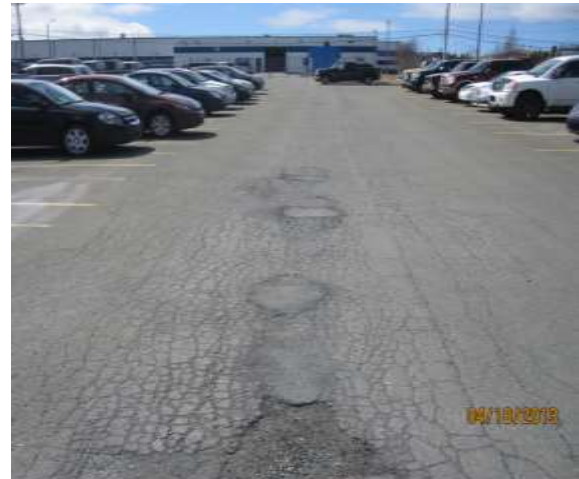
Figure 11 - Mews Place Parking Lot

The condition of the parking areas vary from poor to good. The Mew's Place parking lot is in poor condition and requires immediate resurfacing. Resurfacing of the remainder of the Facility's parking lots is anticipated within 5 and 10 years.

The Mews Place parking lot is in poor condition and resurfacing is required in 2015.²⁰ This includes addressing curb and sidewalk deficiencies as adjacent sections of pavement are replaced.

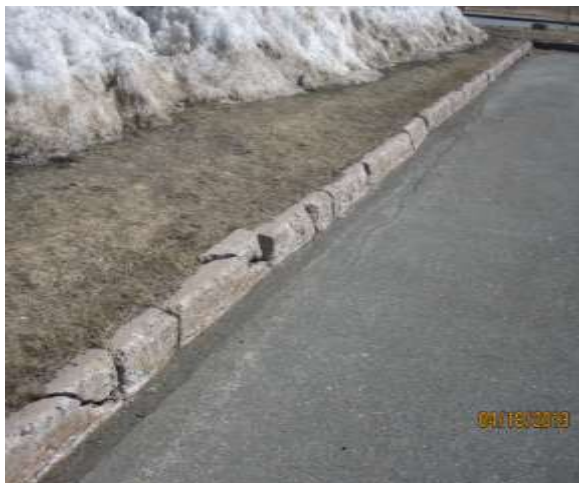
Figure 12 - Damaged Curbs

The curbs are generally in fair to good condition however there are areas in poor condition primarily as a result of snow clearing activities.¹⁷ Sidewalks are generally in good condition. Curb and sidewalk deficiencies will be addressed as adjacent pavement is replaced.

¹⁷ Figure 12 shows isolated curb damage associated with snow clearing.

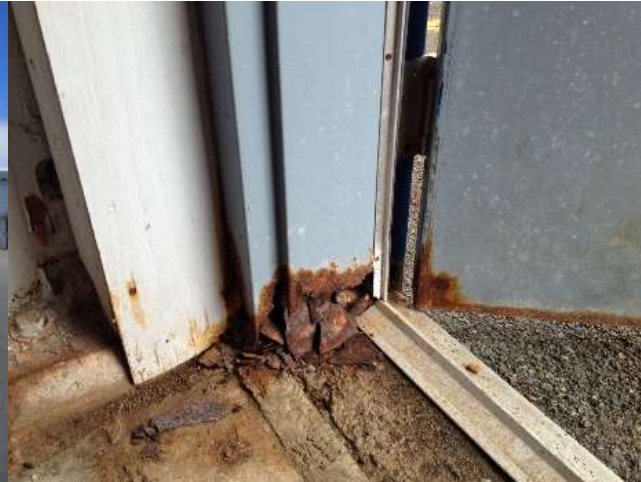
Figure 14 - Corroded Door and Frame

Like the main building, this Facility's secondary building is largely in good condition however there are isolated areas of deterioration. The personnel doors are significantly corroded and several windows are no longer properly sealed. Some leaks have been noted in isolated areas. Problem areas will be addressed as similar work is completed on the main building.

Replacement and refurbishment of deteriorated building envelope components are required at this time to ensure the building remains weather tight. Replacement of corroded personnel doors, including those in the secondary building, along with one overhead door in the warehouse is required. Replacement of corroded siding along with localized refurbishment of the roof is also required.
