1 Q. Reference: Newfoundland and Labrador Hydro's 2009 Capital Budget Application,
2 Volume II, Tab 21, *Hardwoods Gas Turbine Plant Life Extension Upgrades*.

**FINAL REPORT
CONDITION ASSESSMENT AND LIFE
CYCLE COST ANALYSIS
HARDWOODS AND STEPHENVILLE
GAS TURBINE FACILITIES**

Stantec Job #: 21061
Ref. #: 2007-35410-OQ
December 18, 2007

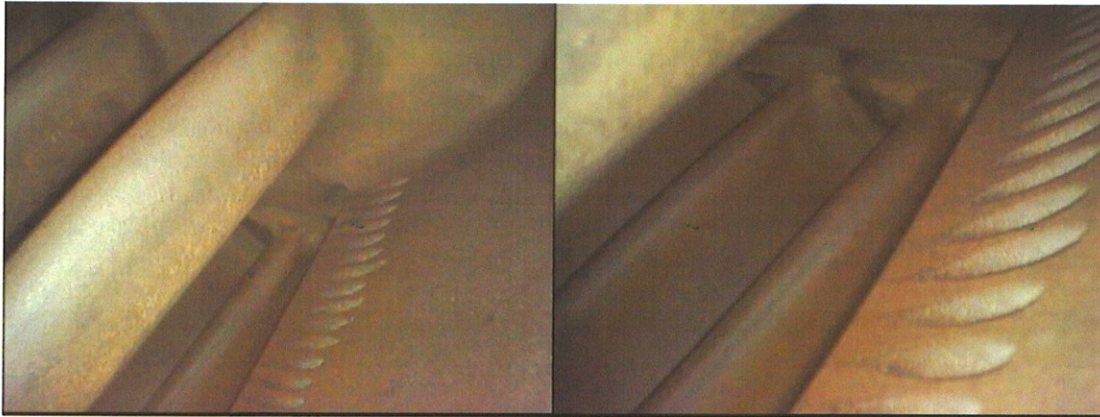
HP NGV

HP NGV trailing edge

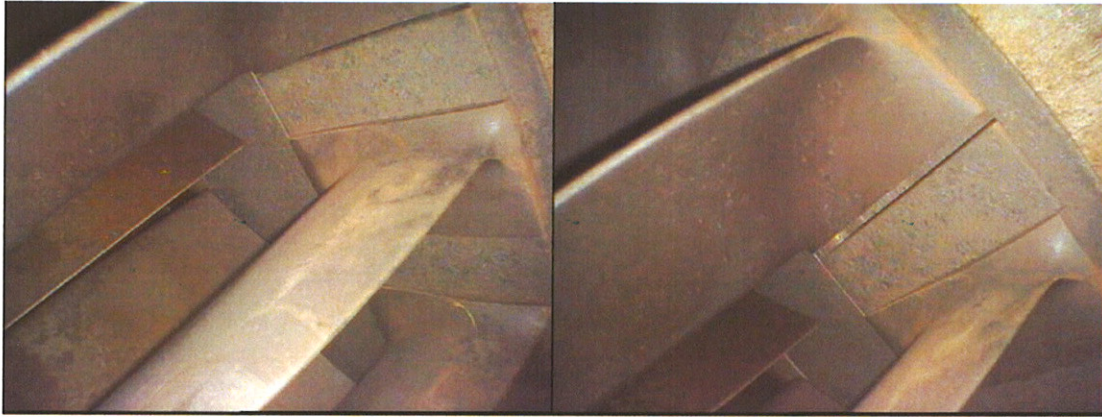
Gap growth on stator

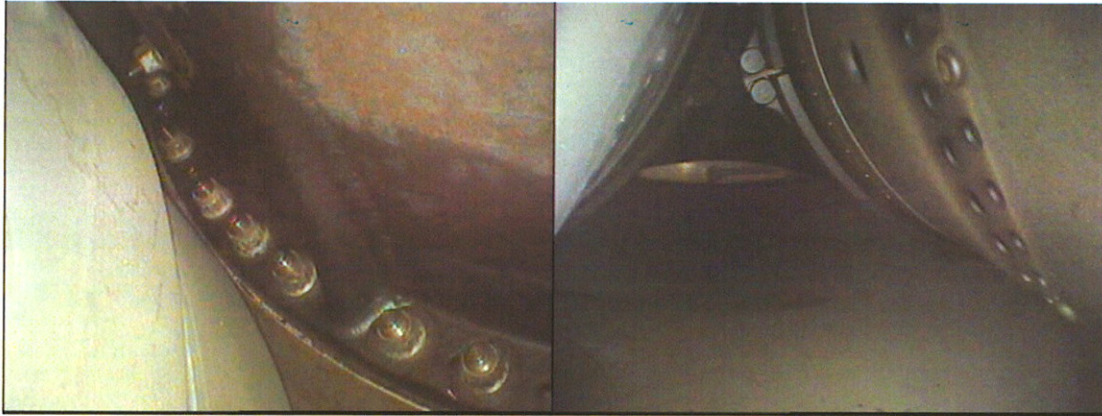
The combustion second, although heavily affected by carbon, was in good condition and should be monitored yearly through borescope.

External Combustion can and clamp

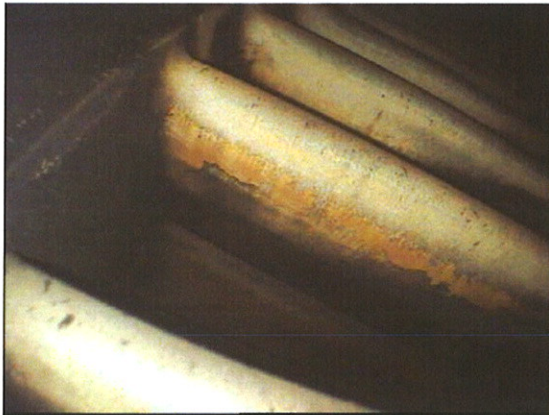
Excessive coating loss on HP NGV

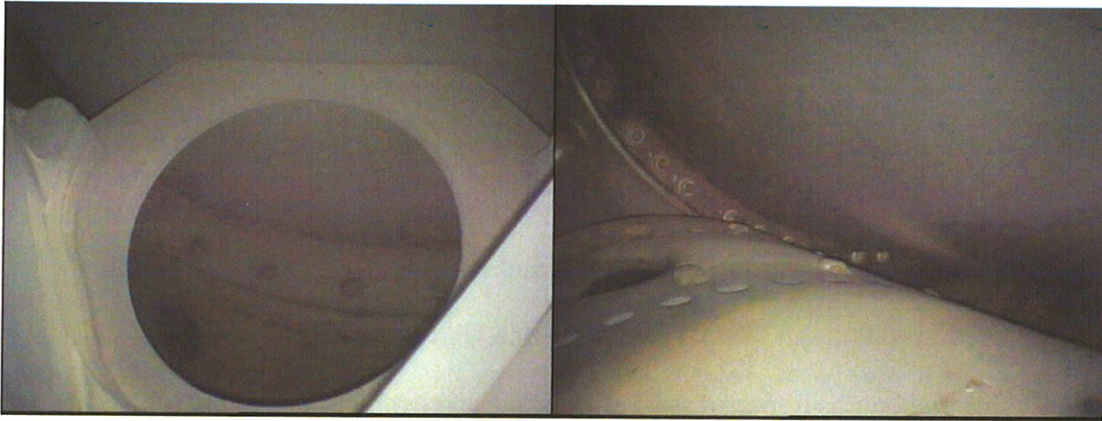
The combustion area was generally in good condition with the exception of the No5 position, which has a large crack and material loss.

External area of combustion can

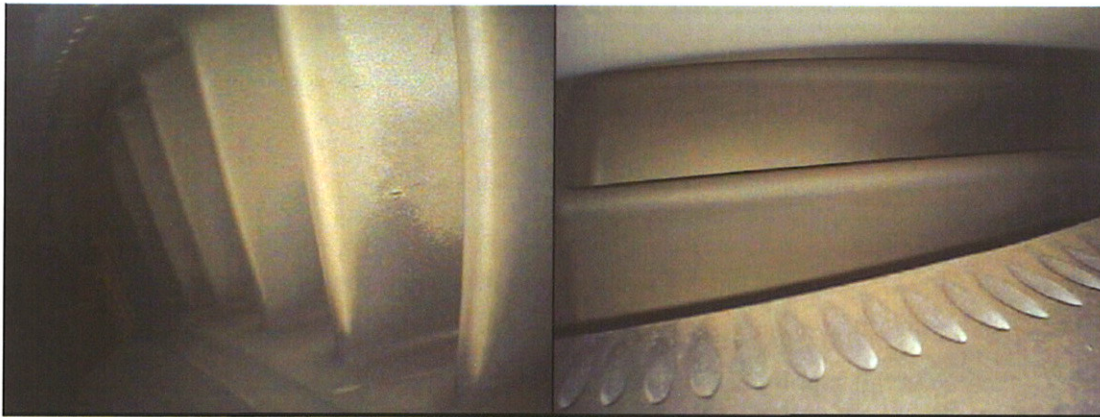
HP NGV's
