**A REPORT TO  
THE BOARD OF COMMISSIONERS OF PUBLIC UTILITIES**

## **UPGRADE UNIT 1 STACK BREECHING**

### **Holyrood Thermal Generating Station**

**Revision 1, October 26, 2010**

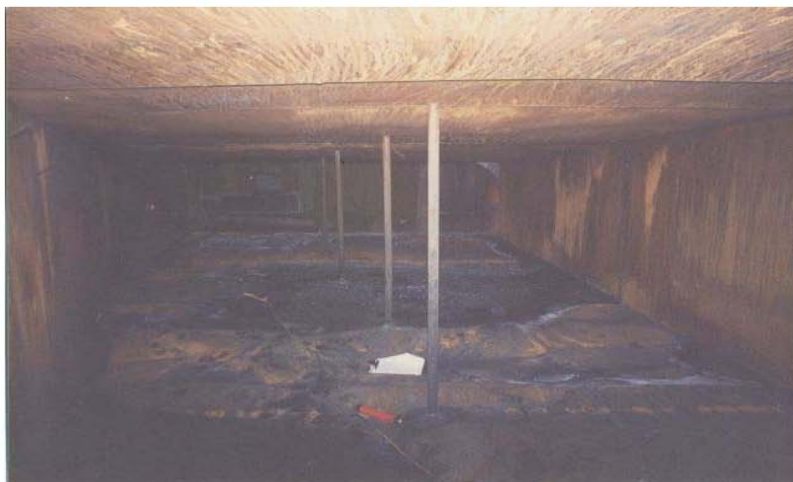
**Fig. 1: Original Breeching, floor in horizontal section – Unit 1 or 2**

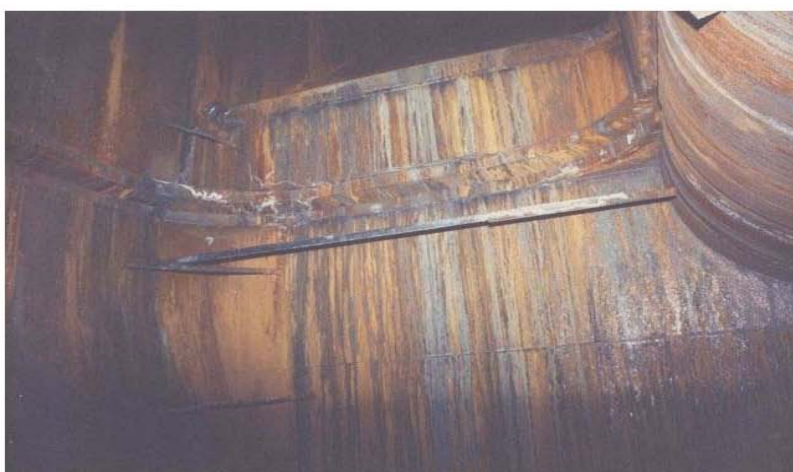
**Fig. 2: Original Breeching, pantleg inlet – Unit 1 or 2**

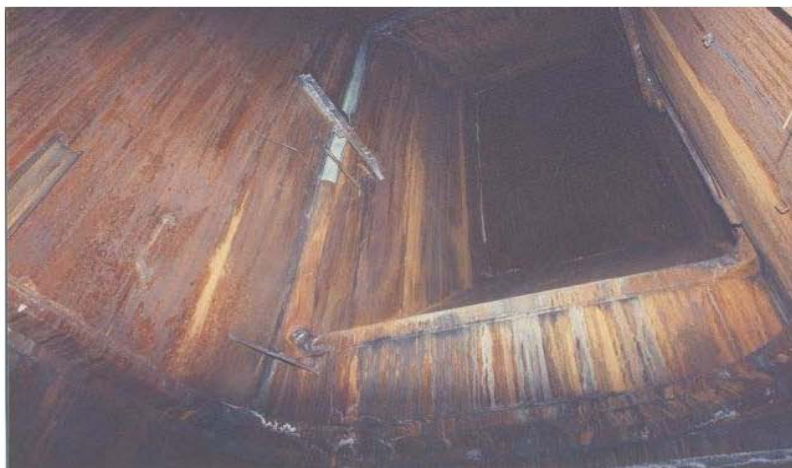
**Fig. 3: Original Breeching, sloping section – Unit 1 or 2**

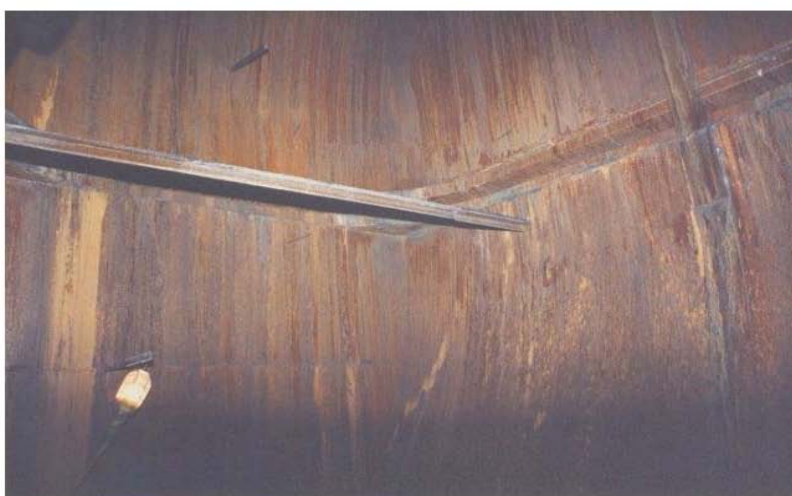
**Fig. 4: Original Breeching, bend section – Unit 1 or 2**

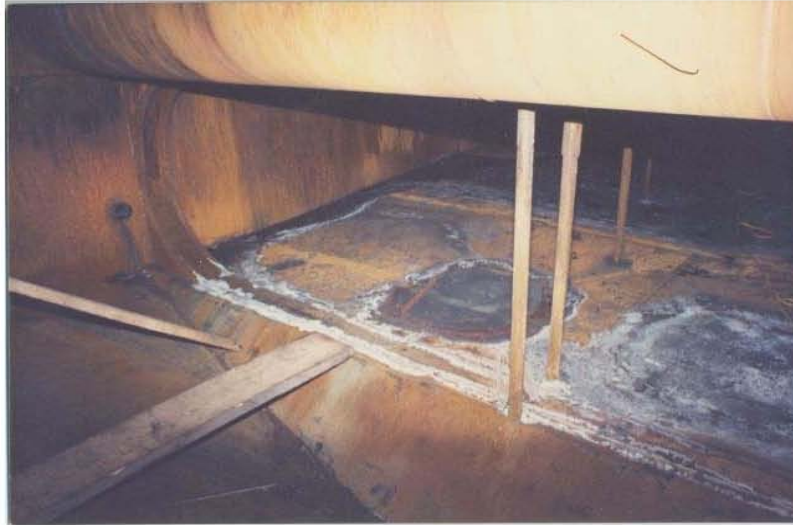
Fig. 5: Original Breeching, entrance to horizontal section (at heater) – Unit 1 or 2

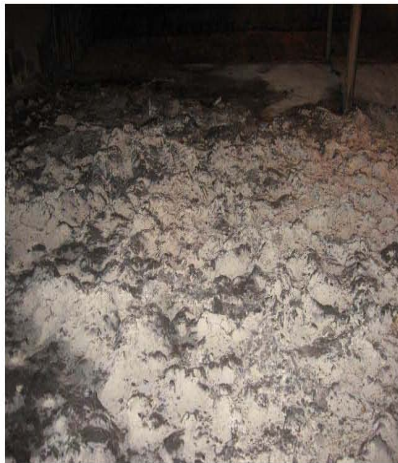
**Fig.14: Unit 1 – Ash accumulated on the floor**

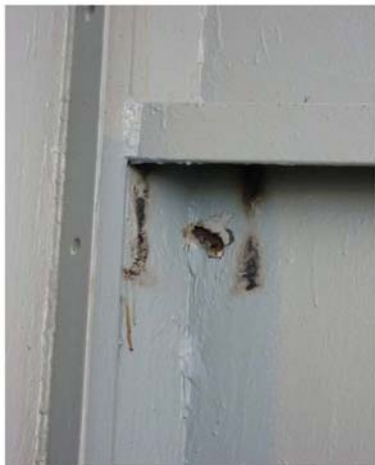
**Fig. 25: Unit 3 – Patched casing (from inside)**

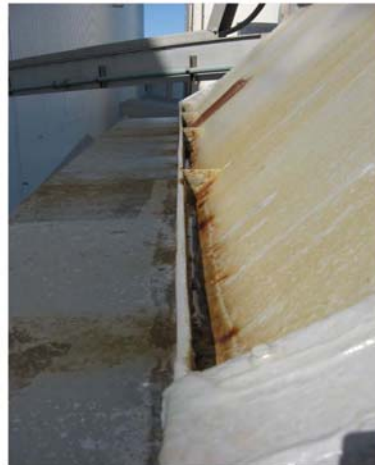
**Fig. 26: Unit 3 – Top near the stack**

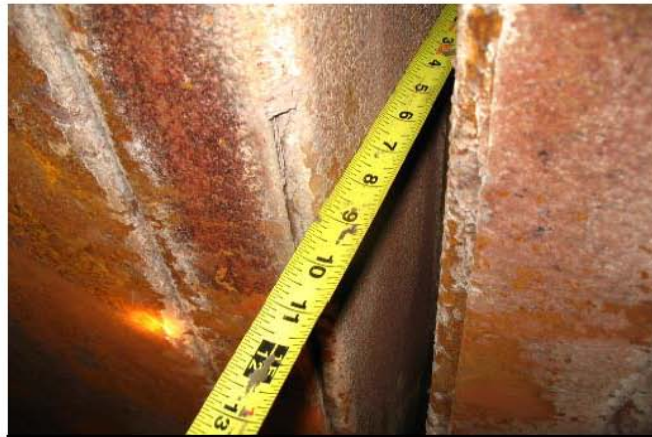
Joint 1

Fig. 30: Unit 3 – Expansion joint, hot air duct from air heater

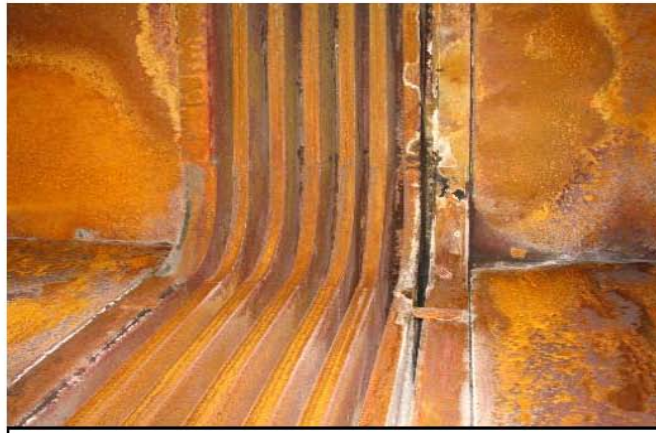
Joint 2 - corner

Fig. 31: Unit 3 – Expansion joint, hot air duct from air heater

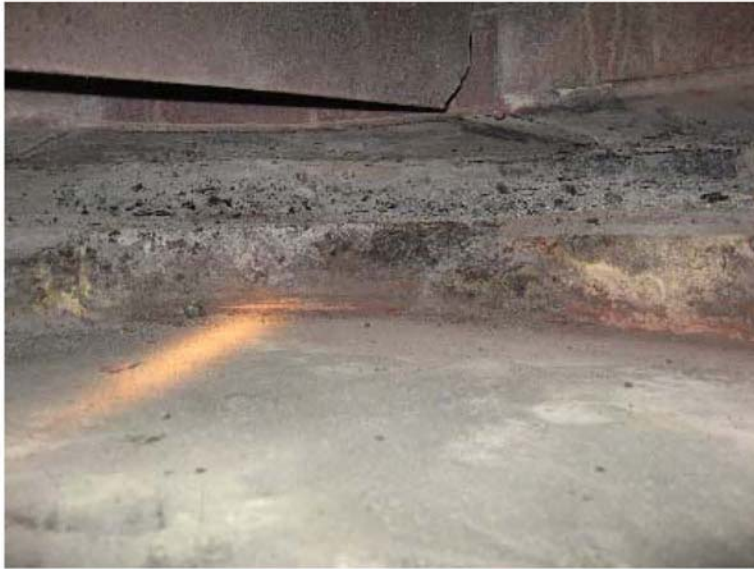
**Fig. 32: Unit 3 – Expansion joint #4, hot air duct from air heater**

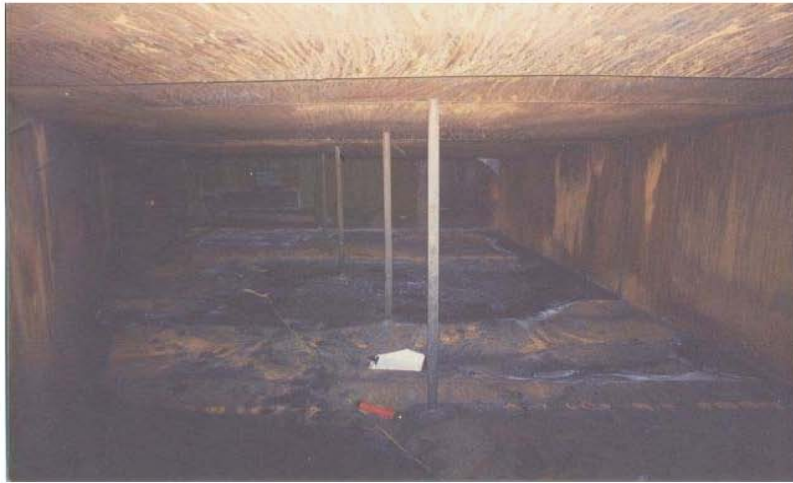
**Fig. 1: Original Breeching, floor in horizontal section – Unit 1 or 2**

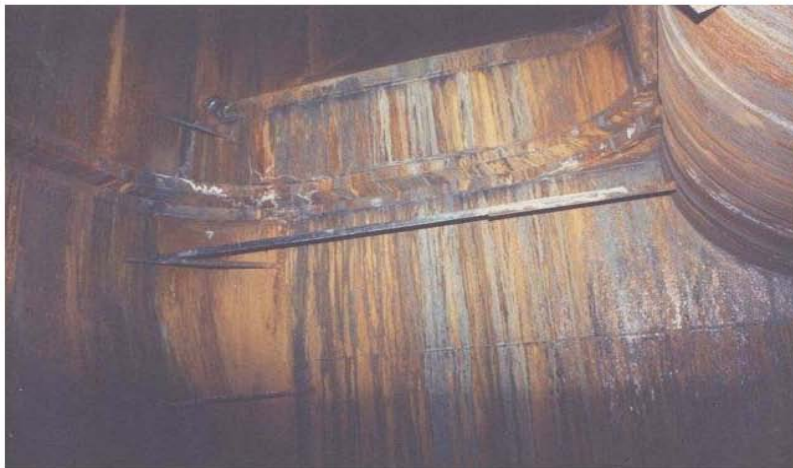
**Fig. 2: Original Breeching, pantleg inlet – Unit 1 or 2**

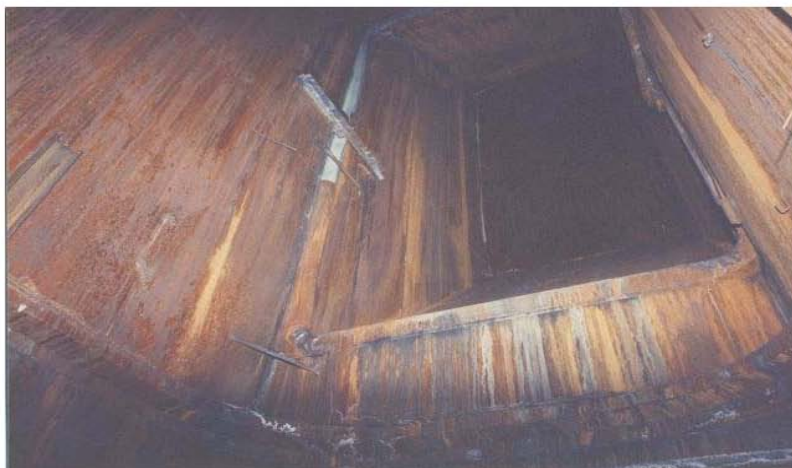
**Fig. 3: Original Breeching, sloping section – Unit 1 or 2**

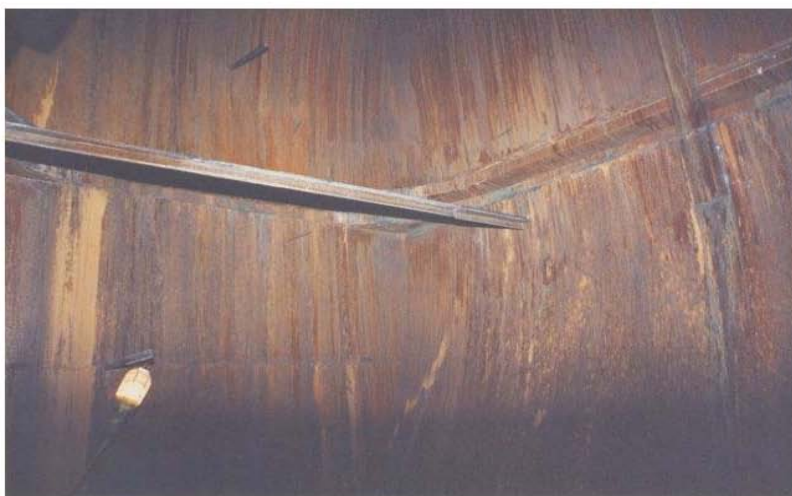
**Fig. 4: Original Breeching, bend section – Unit 1 or 2**

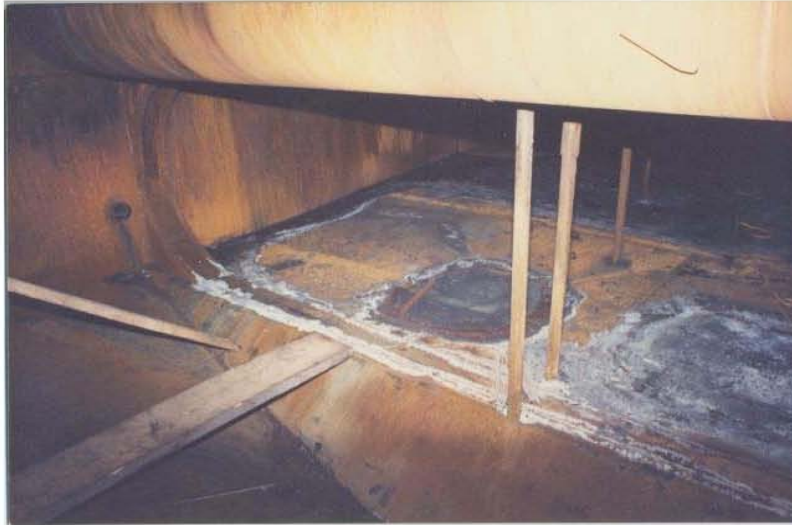
Fig. 5: Original Breeching, entrance to horizontal section (at heater) – Unit 1 or 2

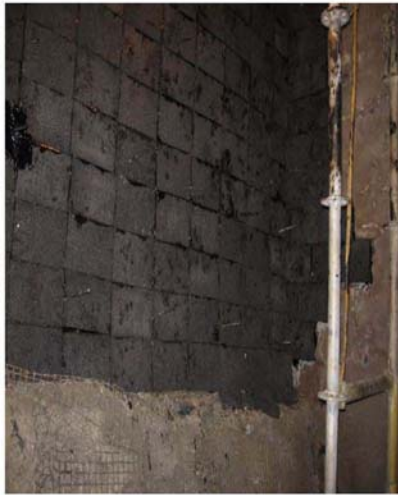
Also, failure of the internal insulation blocks is caused by the breakdown of the adhesive membrane that bonds the blocks to the breeching plate. The temperature limit of the membrane is 200 degrees Fahrenheit. This limit is exceeded by the actual flue gas outlet temperature which is approximately 311 degrees Fahrenheit when Unit 1 is operated at full load.

**Fig. 8: Unit 1 – Insulating block replacement**

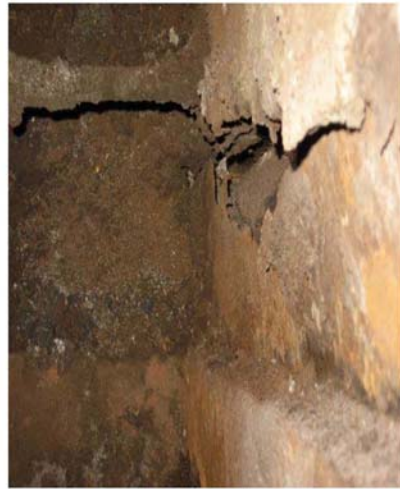
In addition, controlling outlet flue gas temperature from the air pre-heaters has contributed to deterioration of the stack breeching on Unit 1. Unit 1 utilizes steam coil air heaters (SCAH) to maintain the outlet temperature of the flue gas to a minimum requirement as it exits the air pre-heaters and enters the stack breeching. The flue gas temperature should be at least 50 degrees Fahrenheit above the sulfuric acid dew point of the gas. Sulfuric acid dew point is the temperature at which condensation occurs to cause the formation of sulfuric acid which is an extremely corrosive liquid. Sulfuric acid dew point is a function of the sulfur content in the boiler fuel oil and will increase as the fuel oil sulfur content increases. Increasing the dew point increases the likelihood of forming sulfuric acid during operation. SCAHs have been used to keep the average outlet gas temperature entering the stack breeching above the sulfuric acid dew point. However, during past operation, poor

control of the flue gas outlet temperature through the SCAHs in conjunction with burning fuel oil with a sulfur content of 2.0 to 2.5 percent has contributed to the deterioration of the breeching by allowing corrosive sulfuric acid to form inside the breeching when the gas temperature is below the acid dew point. In January of 2009, Hydro has switched to fuel oil with a sulfur content of 0.7 percent, reducing the possibility of sulfuric acid formation.

**Fig. 9: Unit 1 – Duct corroded through**

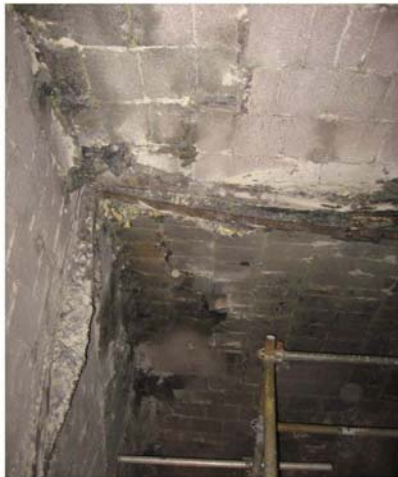
**Fig. 10: Unit 1 – Sloped section as found**

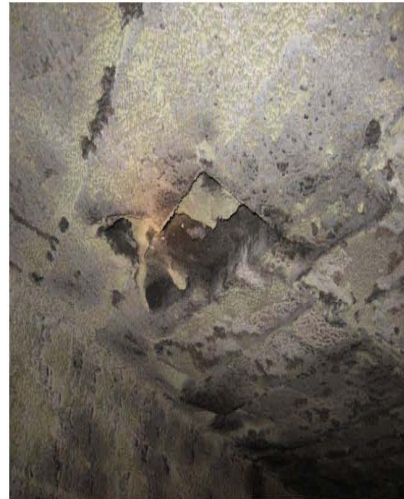
**Fig. 12: Unit 1 – Replaced blocks**

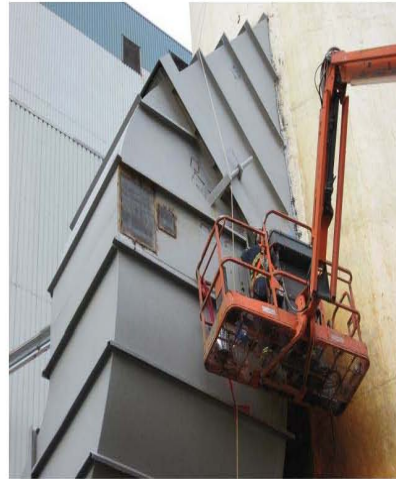
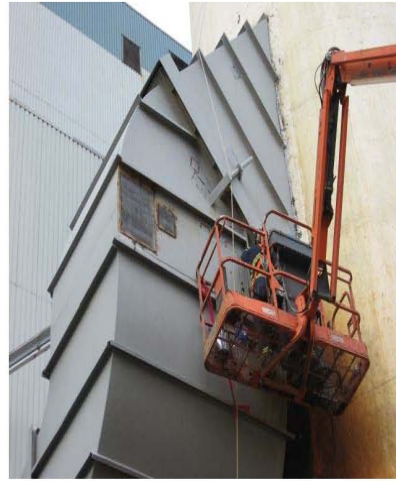
**Fig. 16: Unit 1 – External duct repairs**

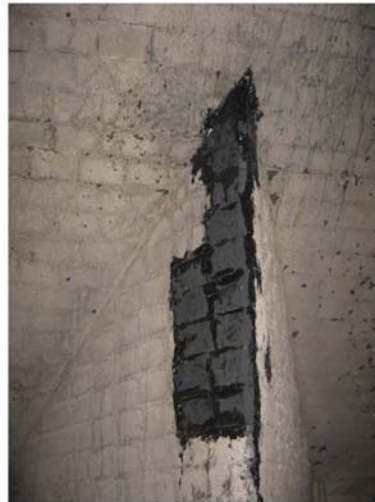
**Fig. 23: Unit 3 – Repairs 2007**

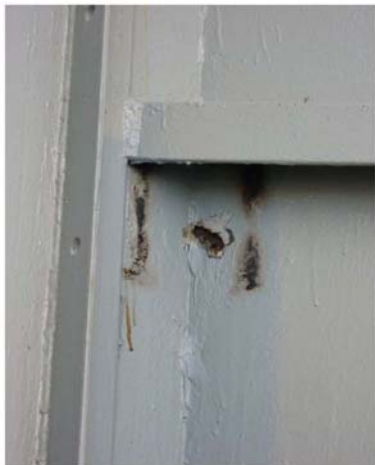
**Fig. 24: Unit 3 – Crotch repairs**

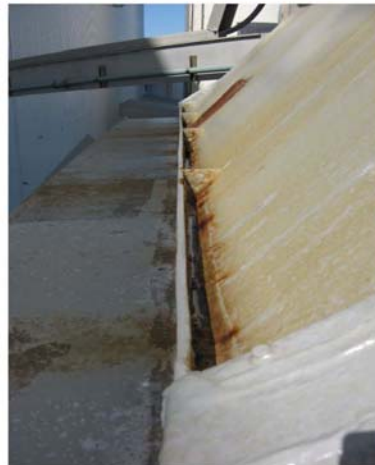
**Fig. 25: Unit 3 – Patched casing (from inside)**

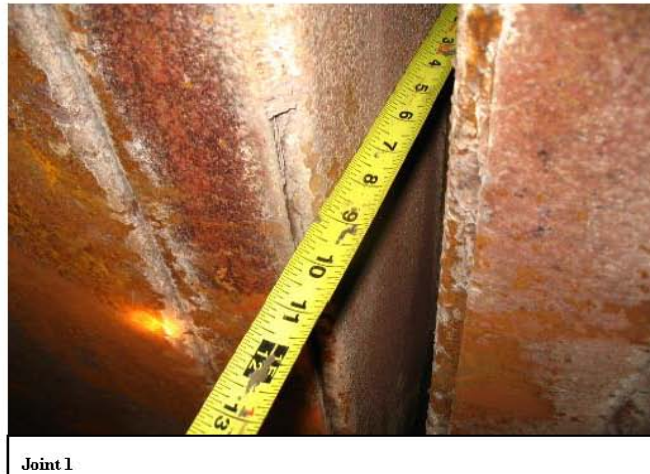
Joint 1

Fig. 30: Unit 3 – Expansion joint, hot air duct from air heater

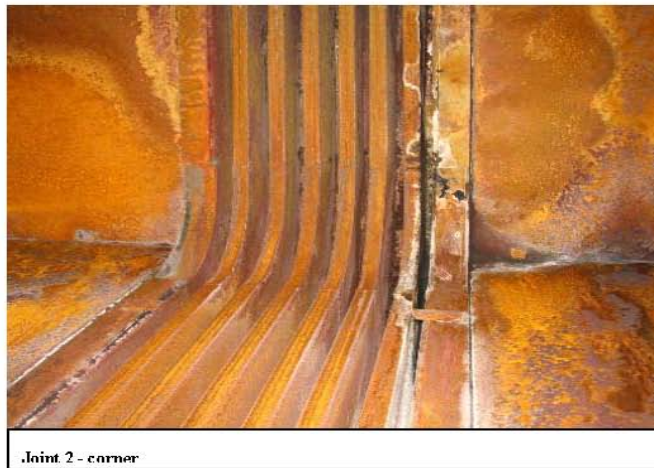
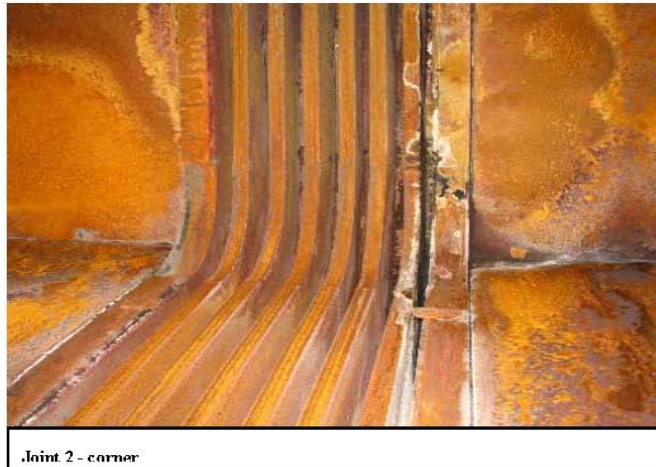
Joint 2 - corner

Fig. 31: Unit 3 – Expansion joint, hot air duct from air heater

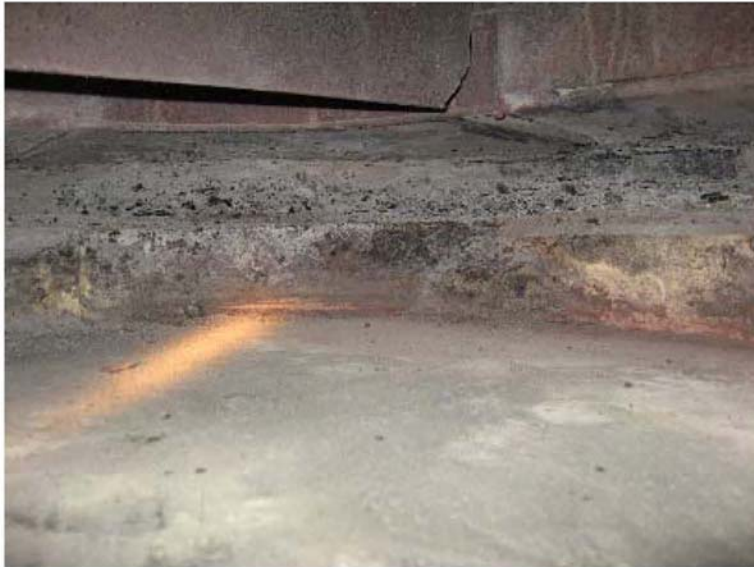
**Fig. 32: Unit 3 – Expansion joint #4, hot air duct from air heater**

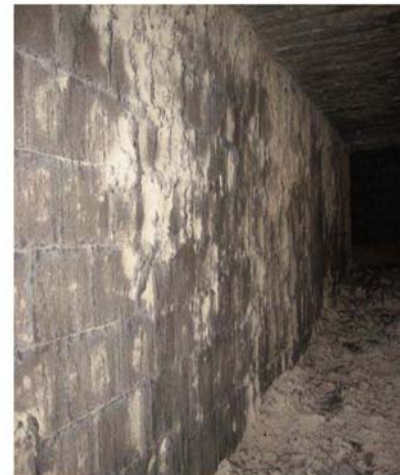
**Fig. 11: Unit 1 – Sidewall and floor**

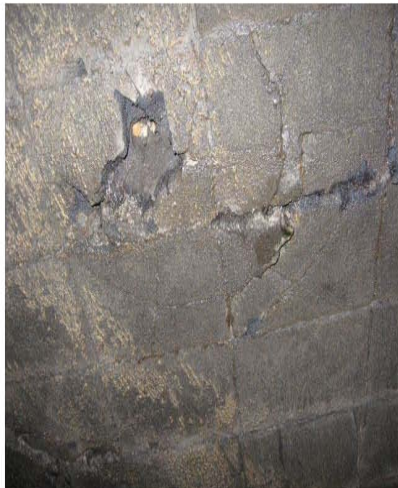
**Fig. 18: Unit 2 – Missing insulation blocks**

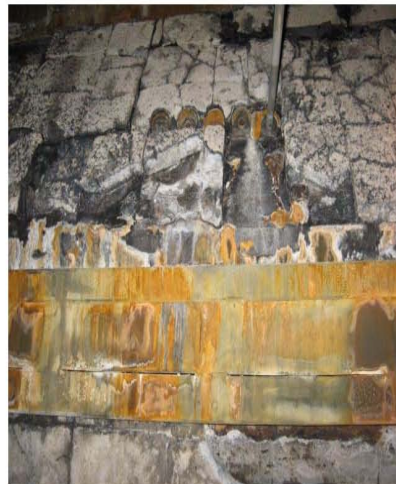
**Fig. 19: Unit 2 – Missing insulation blocks**

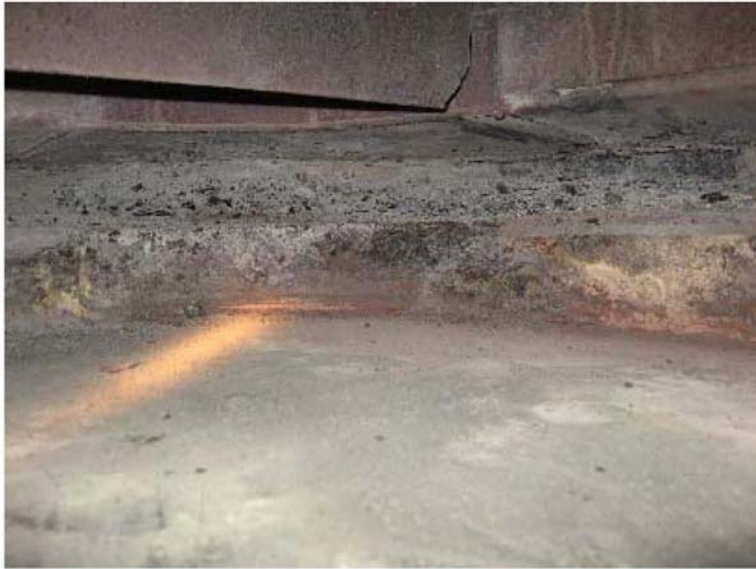
**Fig. 32: Unit 3 – Expansion joint #4, hot air duct from air heater**
