1    Q.    **Re: Project B-12 Upgrade Unit 2 Stack Breeching**

**Condition Assessment of Stack Breeching**

**Holyrood G.S.**

**Alstom Canada Inc.**

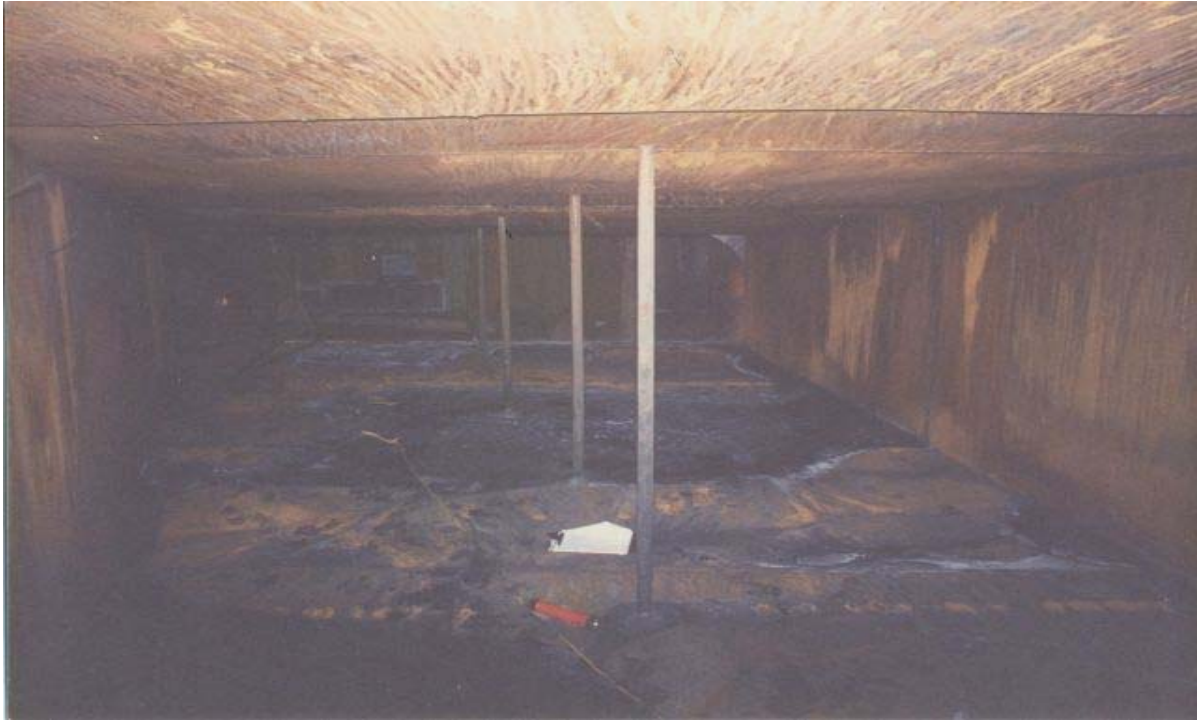
**Fig. 1: Original Breeching, floor in horizontal section – Unit 1 or 2**

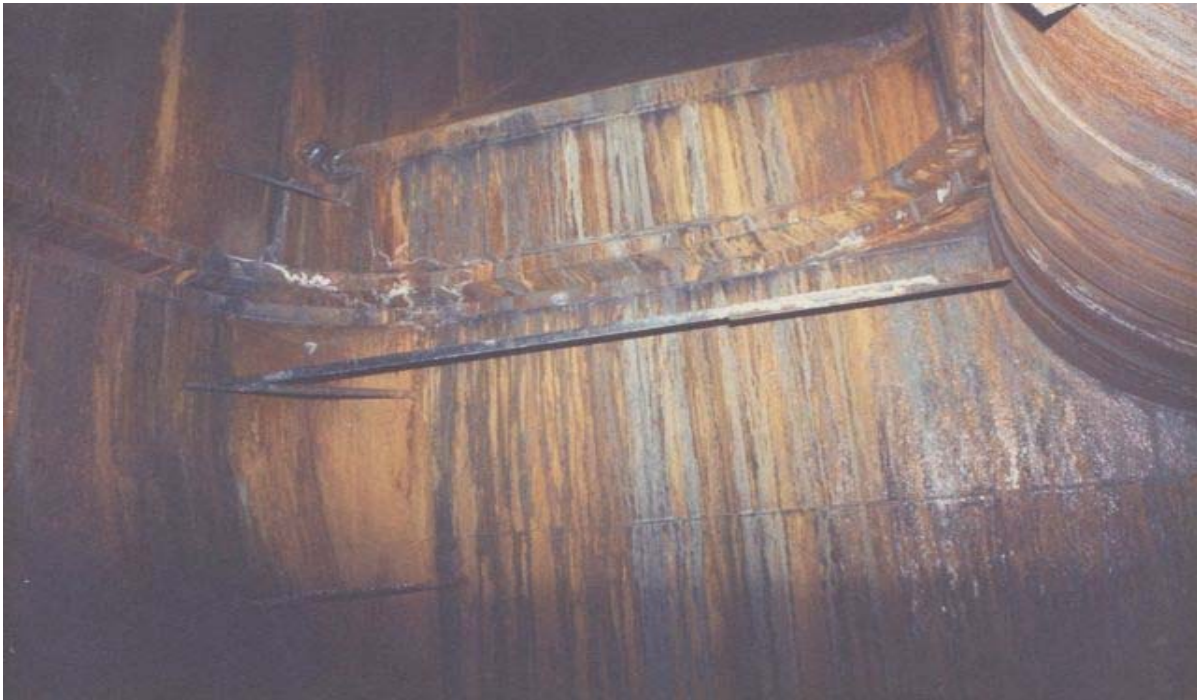
**Fig. 2: Original Breeching, pantleg inlet – Unit 1 or 2**

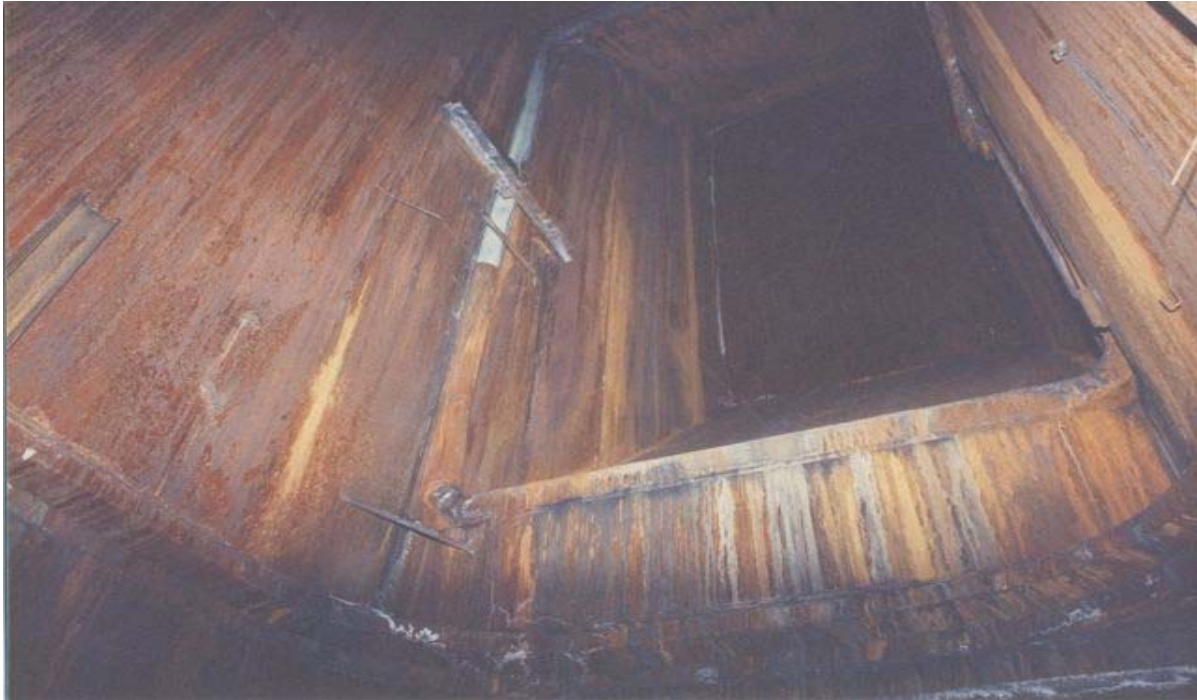
**Fig. 3: Original Breeching, sloping section – Unit 1 or 2**

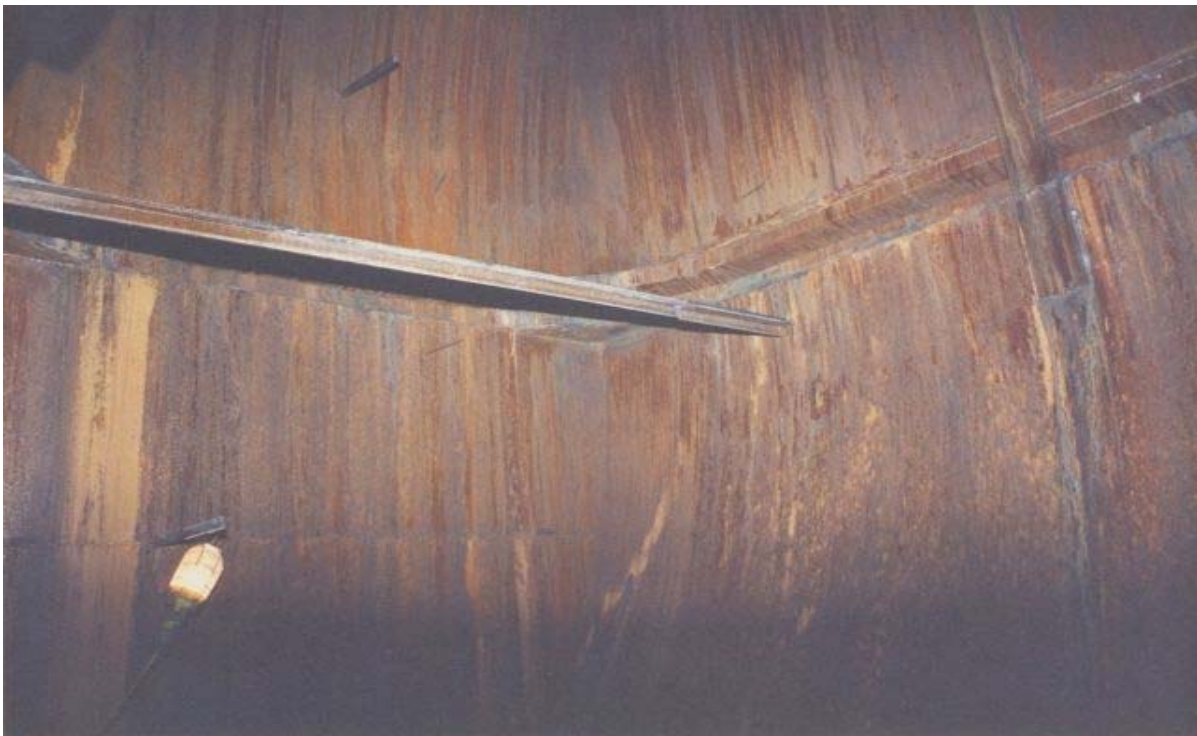
**Fig. 4: Original Breeching, bend section – Unit 1 or 2**

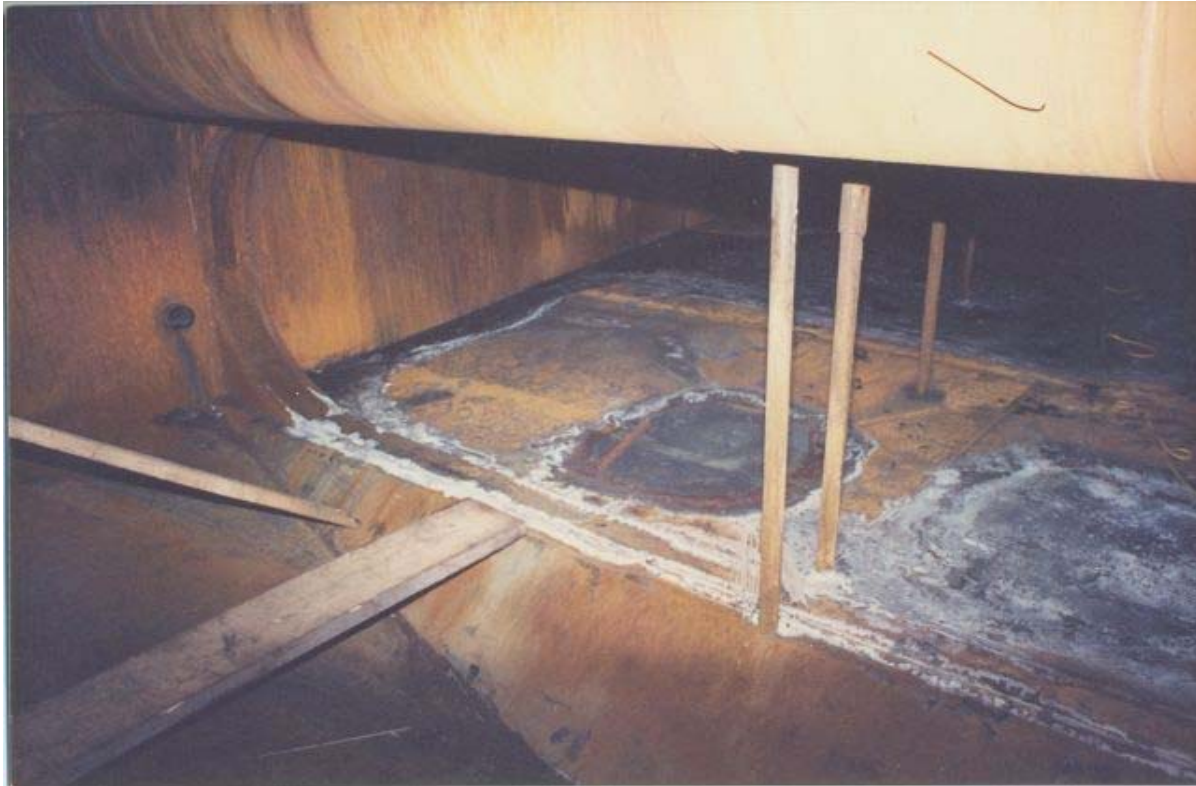
**Fig. 5: Original Breeching, entrance to horizontal section (at heater) – Unit 1 or 2**

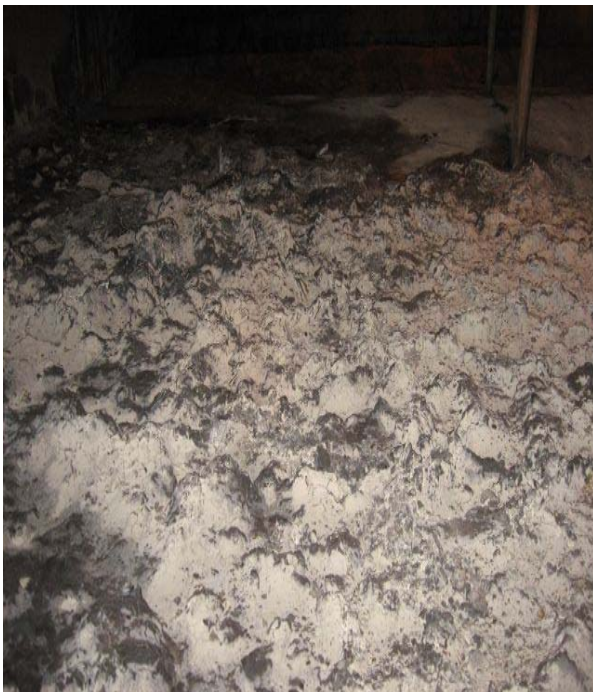
**Fig.14: Unit 1 – Ash accumulated on the floor**

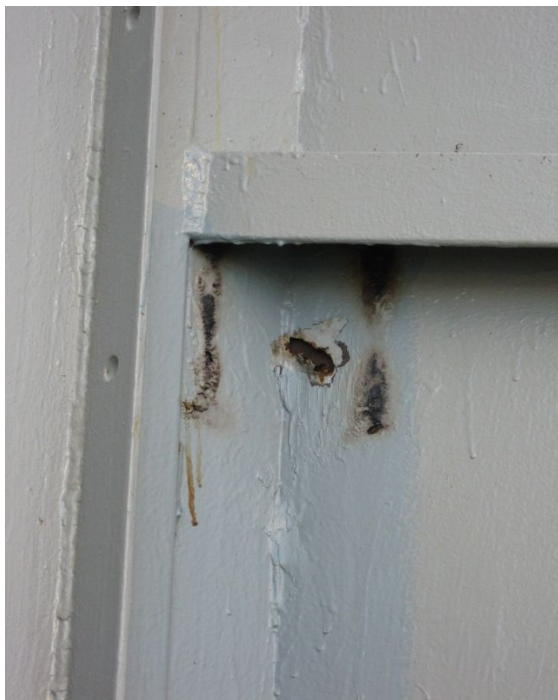
**Fig. 25: Unit 3 – Patched casing (from inside)**

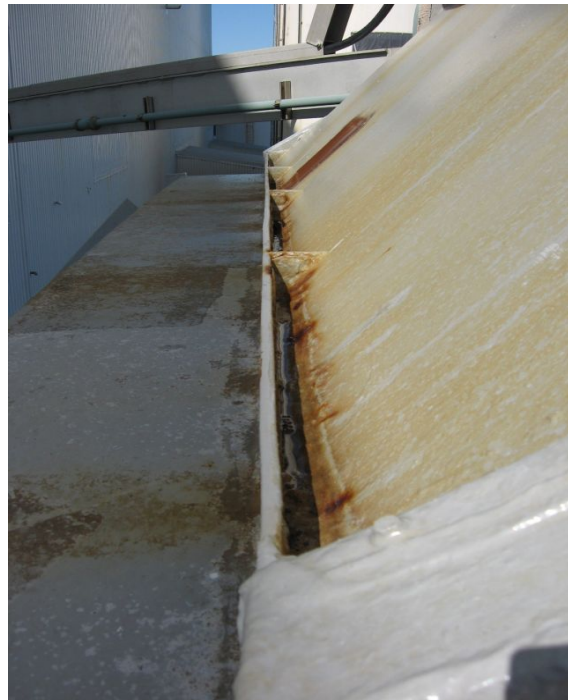
**Fig. 26: Unit 3 – Top near the stack**

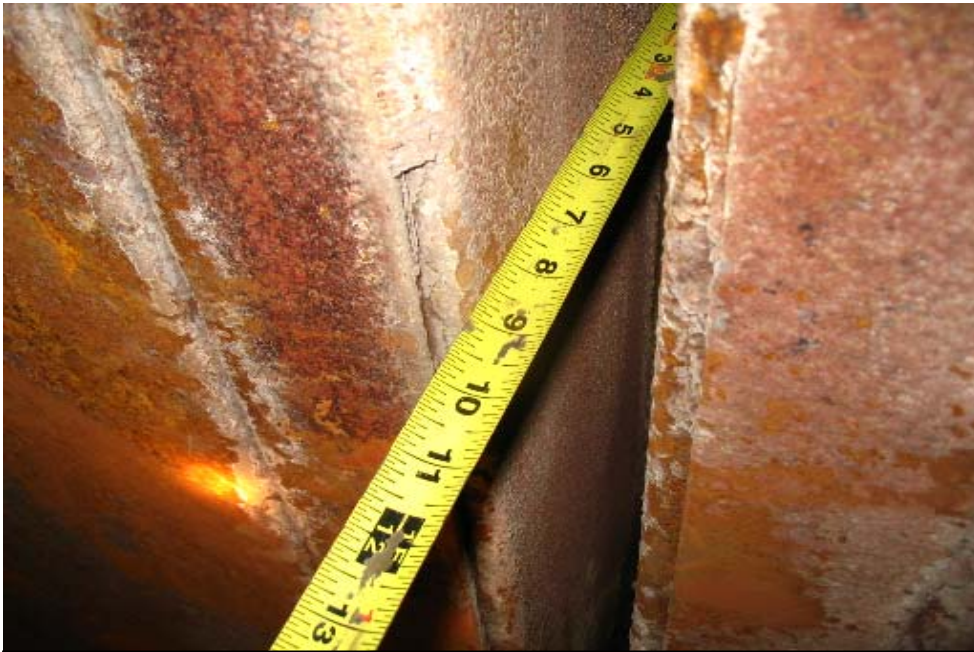
.Joint 1

**Fig. 30: Unit 3 – Expansion joint, hot air duct from air heater**

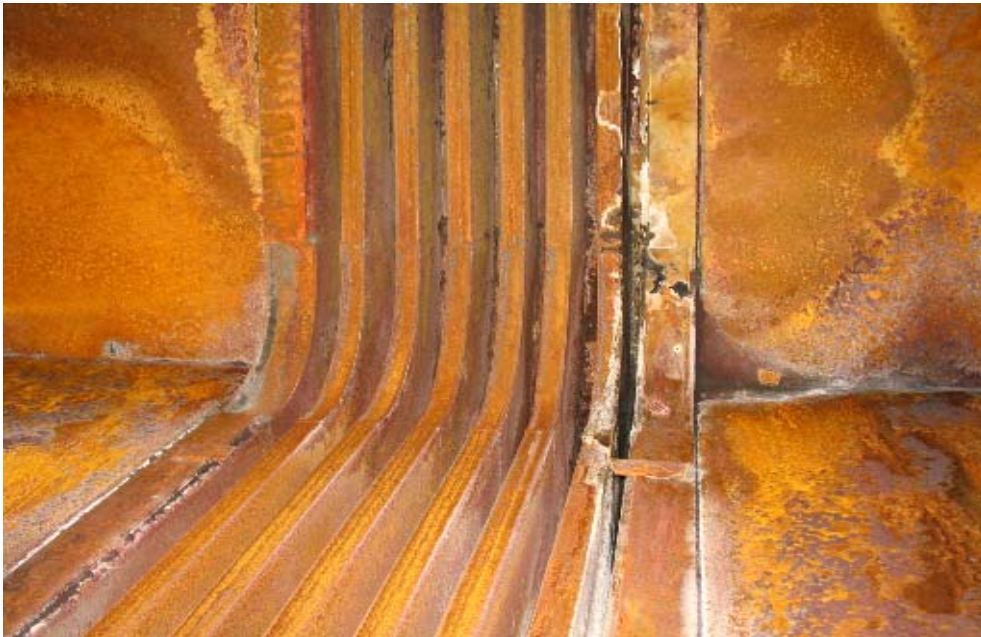
.Joint 2 - corner

**Fig. 31: Unit 3 – Expansion joint, hot air duct from air heater**

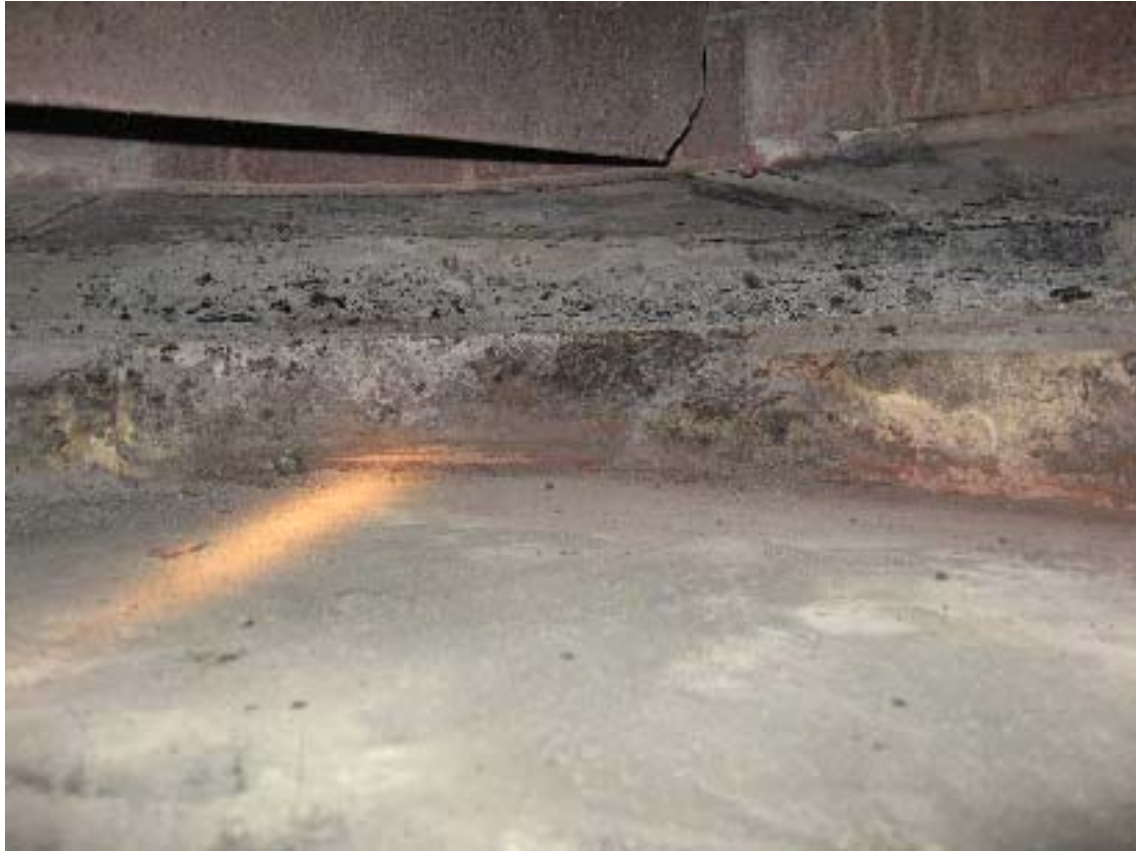
**Fig. 32: Unit 3 – Expansion joint #4, hot air duct from air heater**

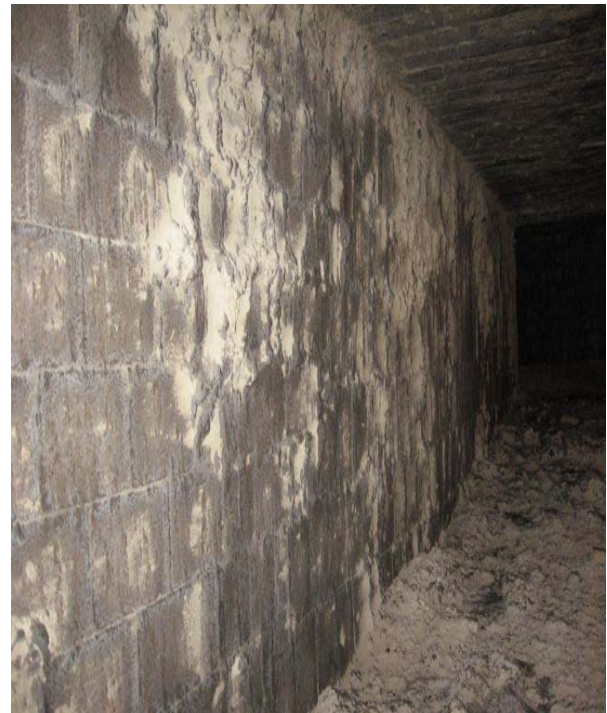
**Fig. 11: Unit 1 – Sidewall and floor**

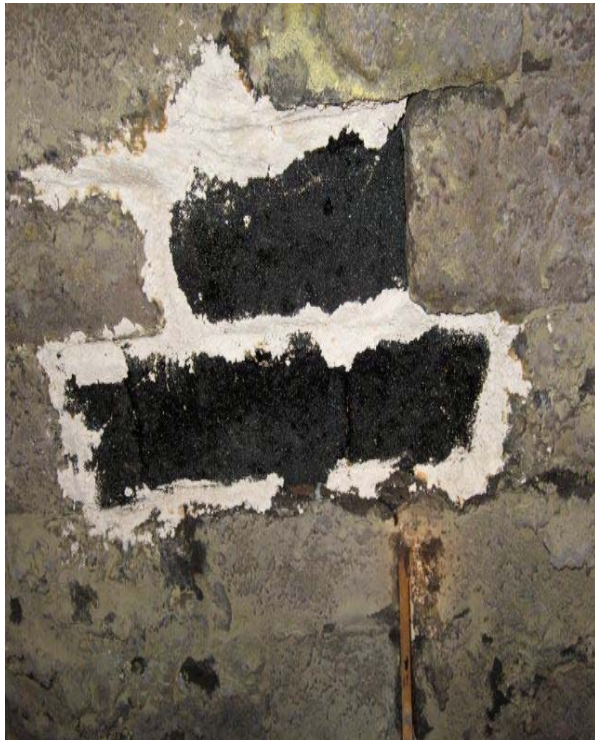
**Fig. 12: Unit 1 – Replaced blocks**

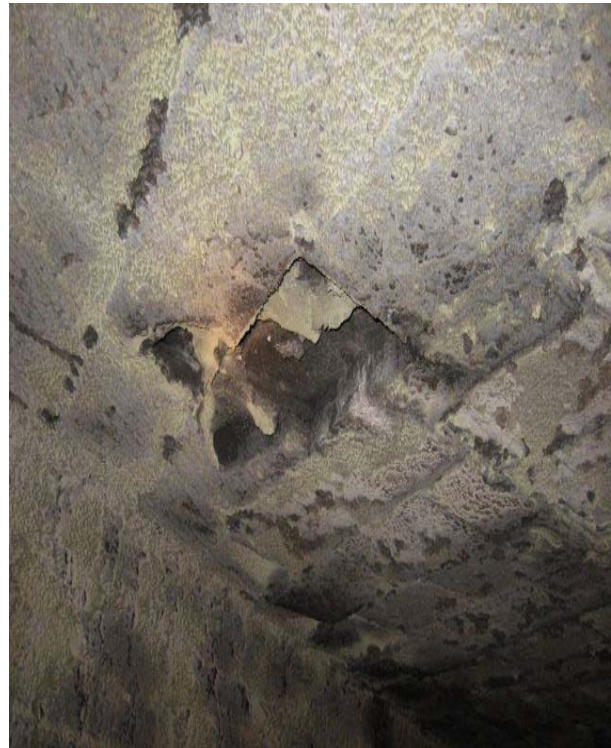
**Fig. 13: Unit 1 – Missing block overhead**

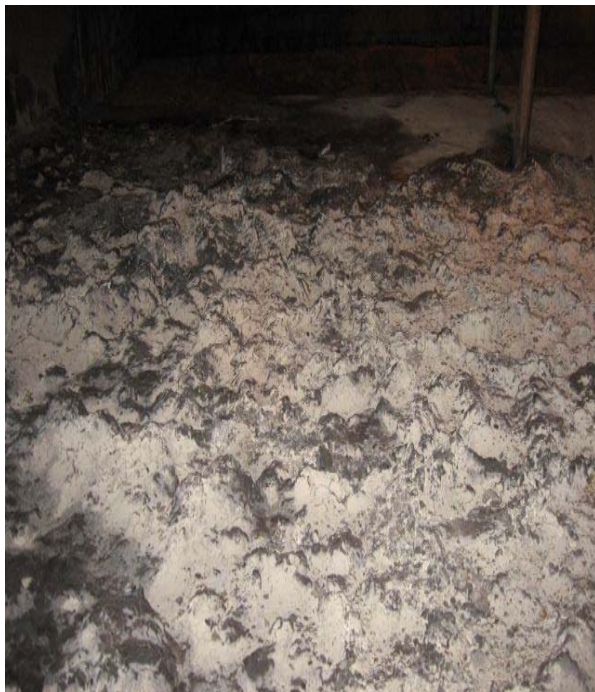
**Fig.14: Unit 1 – Ash accumulated on the floor**

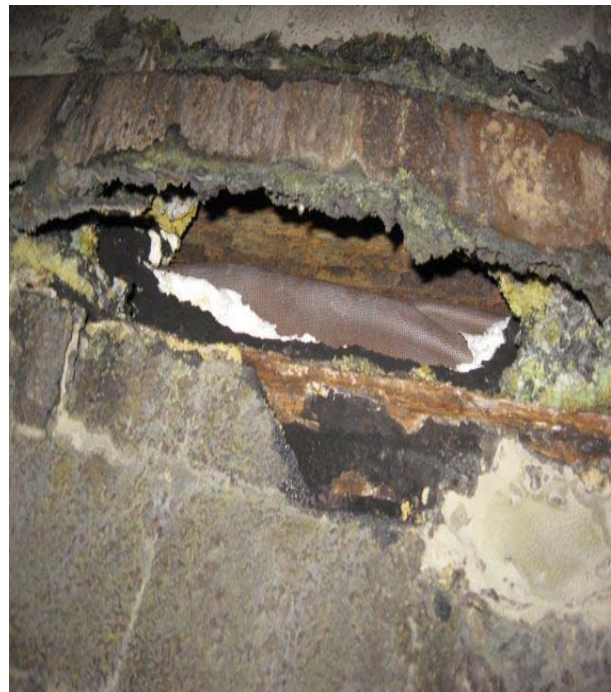
**Fig. 15: Unit 1 – Damaged expansion joint**

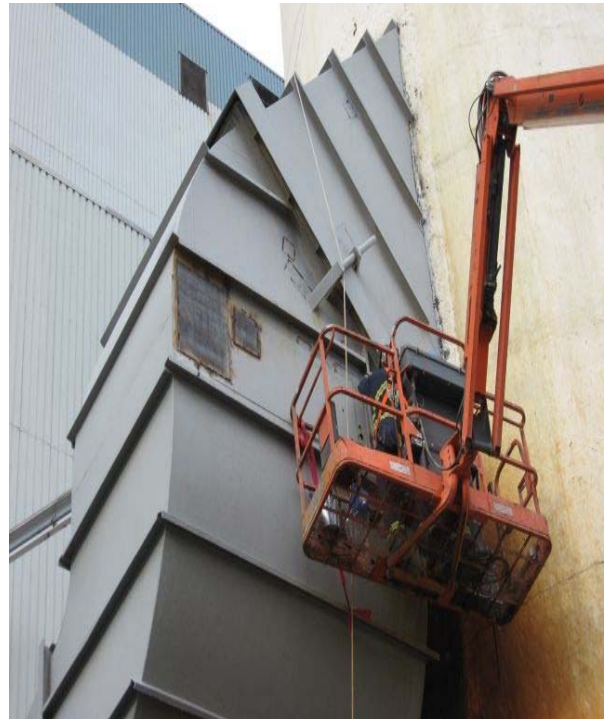
**Fig. 17: Unit 1 – External duct repairs**

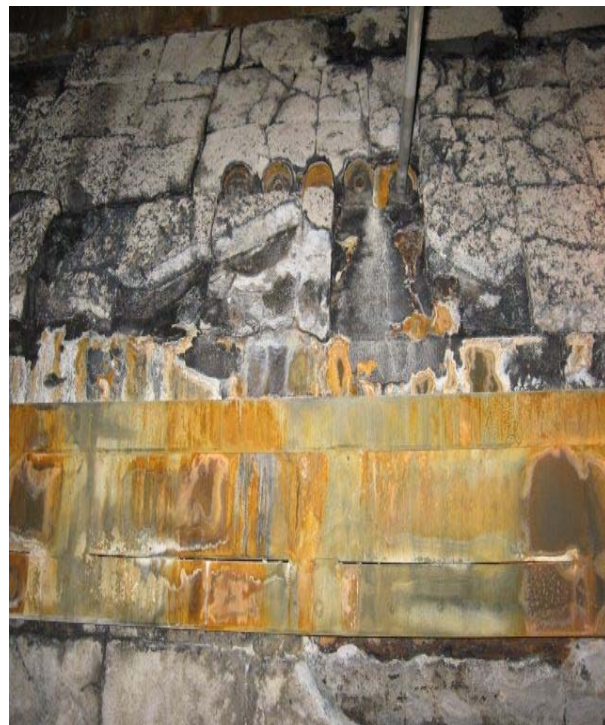
**Fig. 19: Unit 2 – Missing insulation blocks**

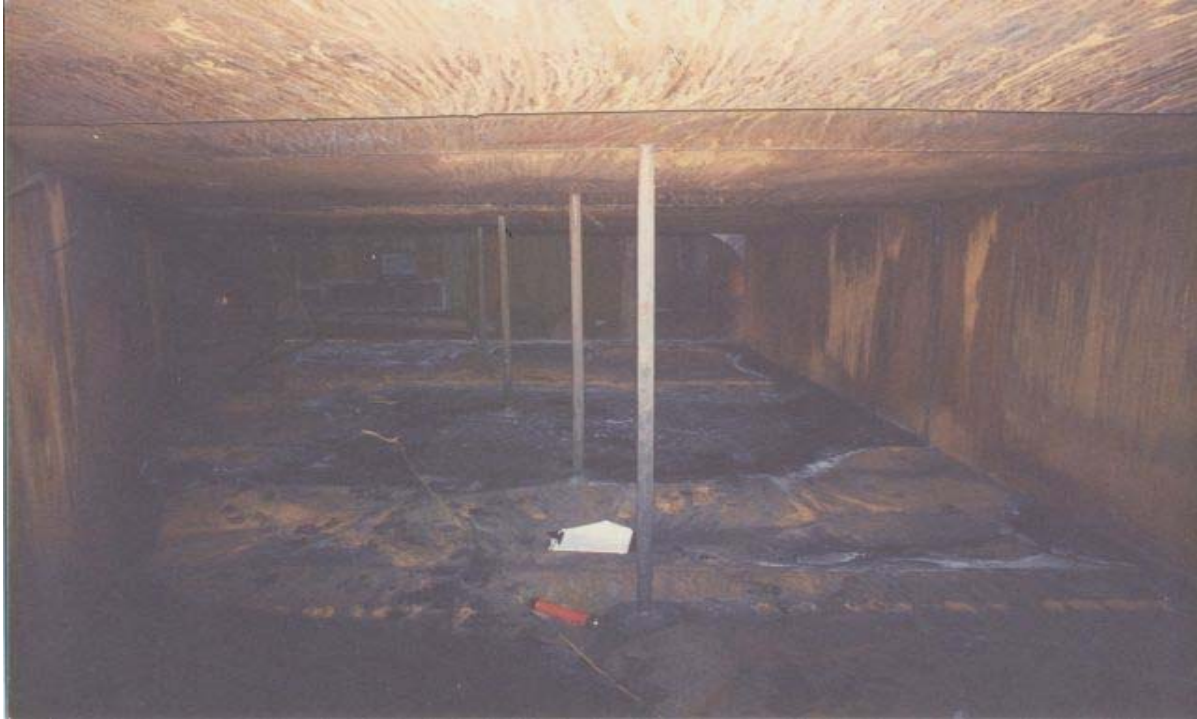
**Fig. 1: Original Breeching, floor in horizontal section – Unit 1 or 2**

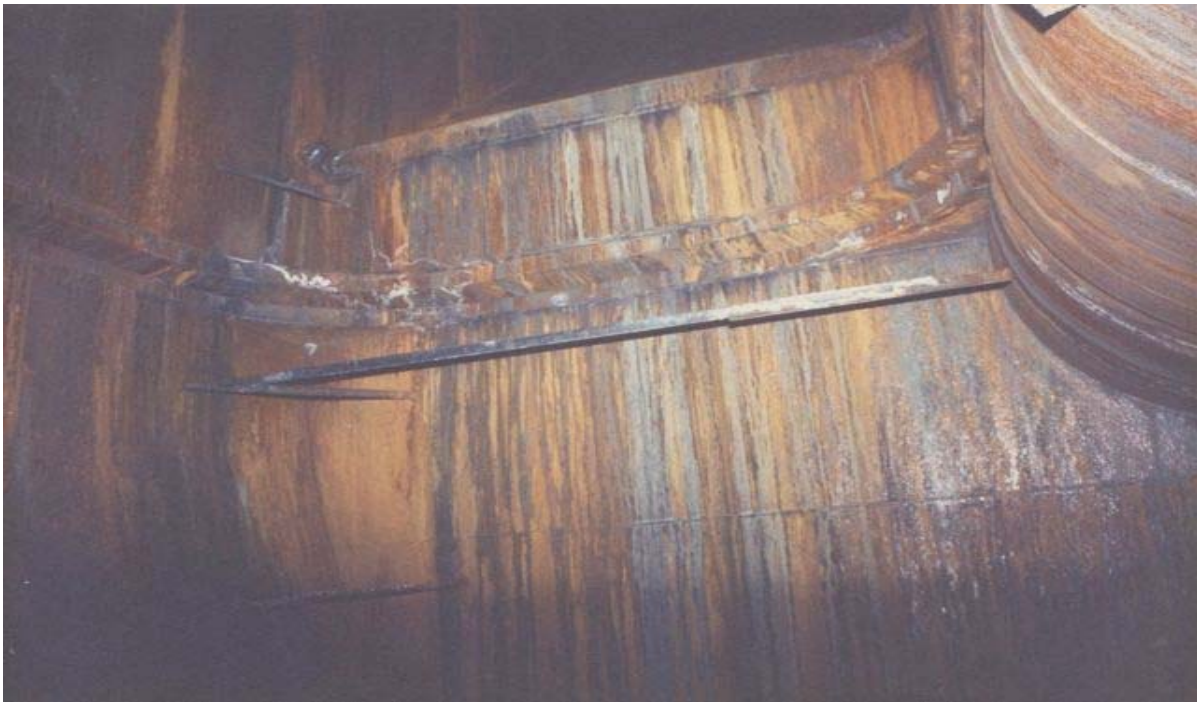
**Fig. 2: Original Breeching, pantleg inlet – Unit 1 or 2**

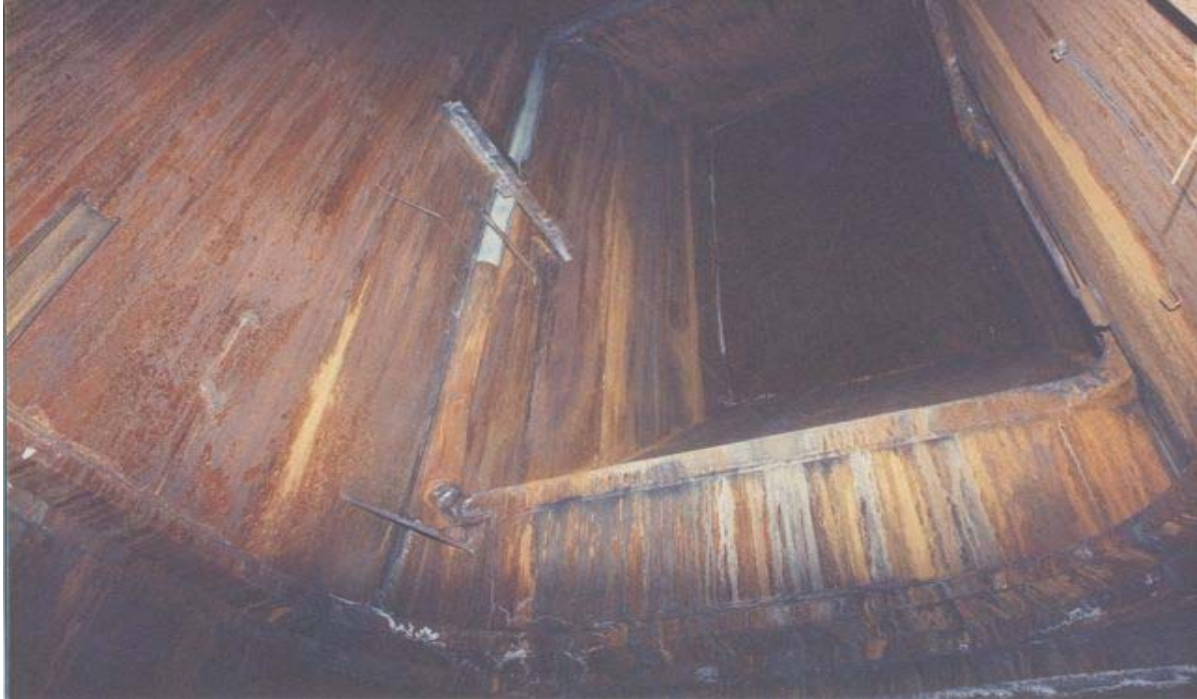
**Fig. 3: Original Breeching, sloping section – Unit 1 or 2**

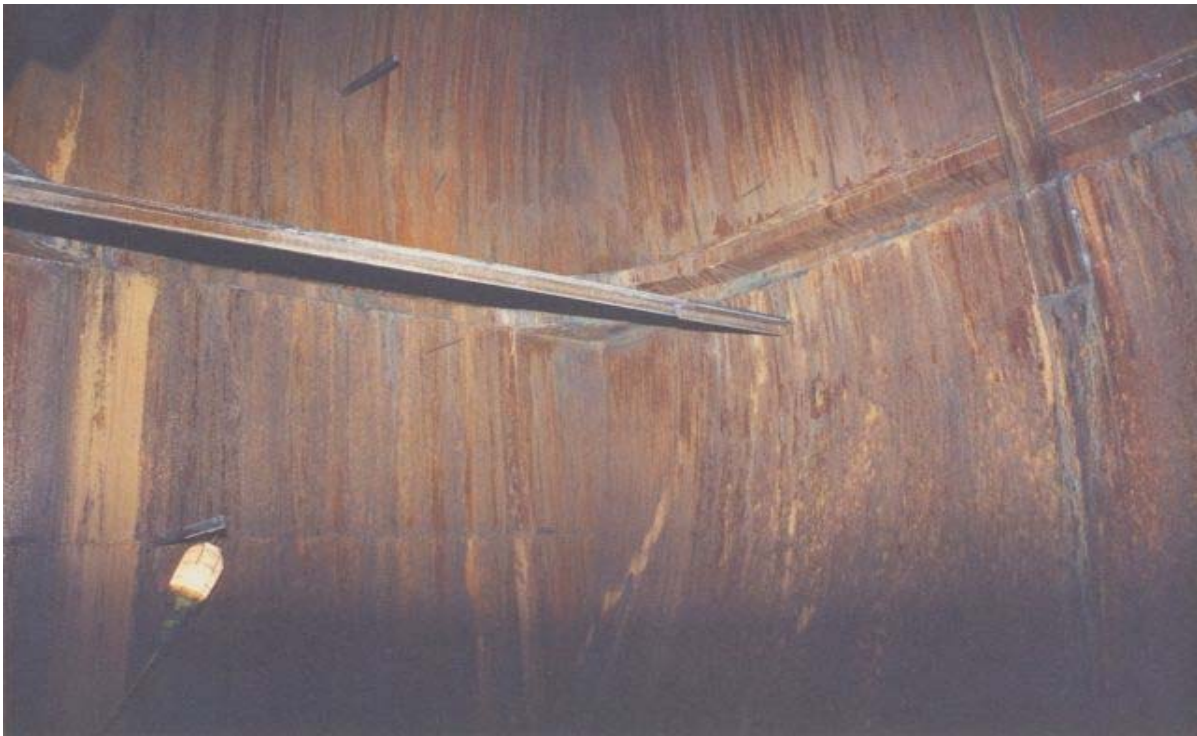
**Fig. 4: Original Breeching, bend section – Unit 1 or 2**

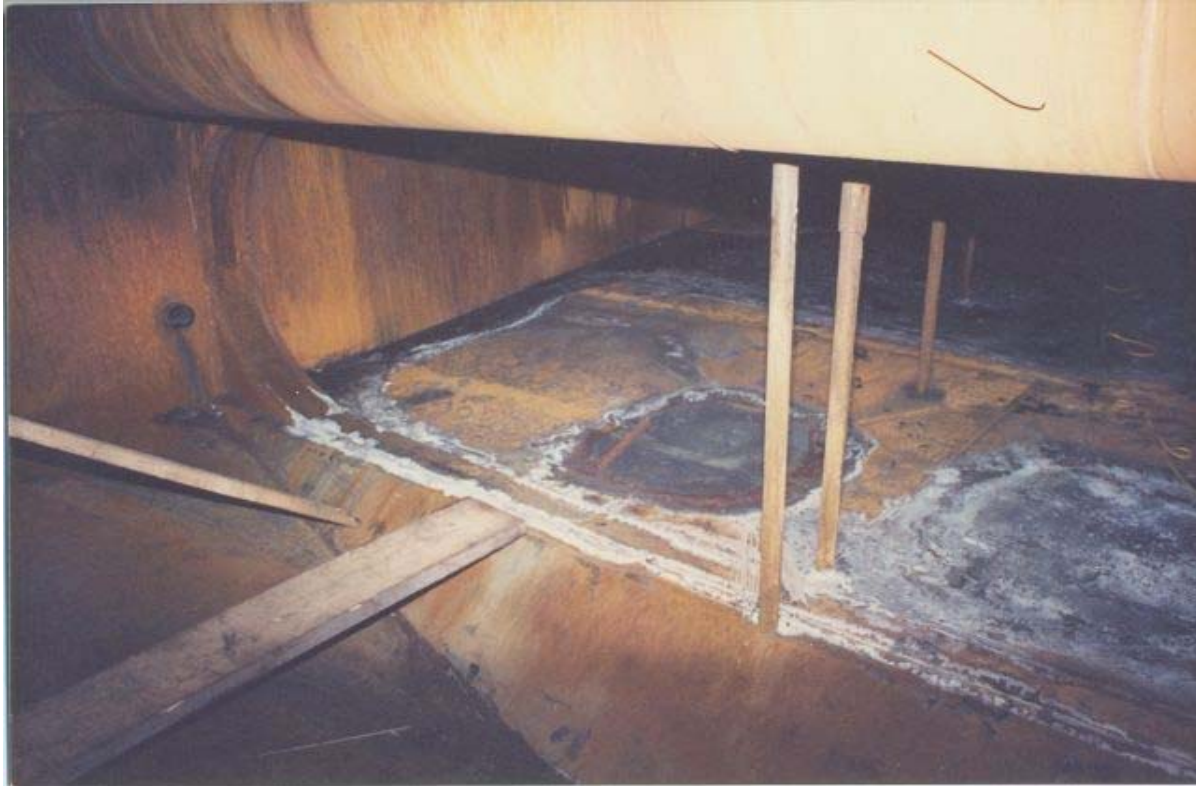
**Fig. 5: Original Breeching, entrance to horizontal section (at heater) – Unit 1 or 2**

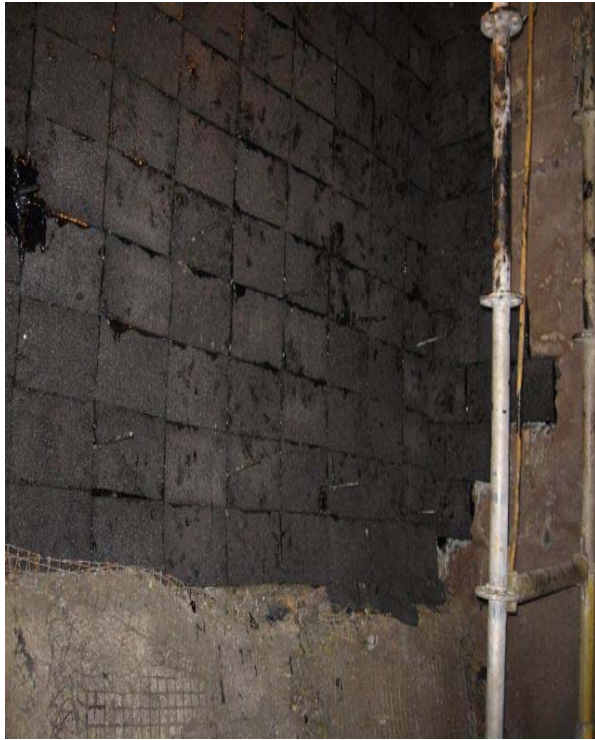
**Fig. 8: Unit 1 – Insulating block replacement**

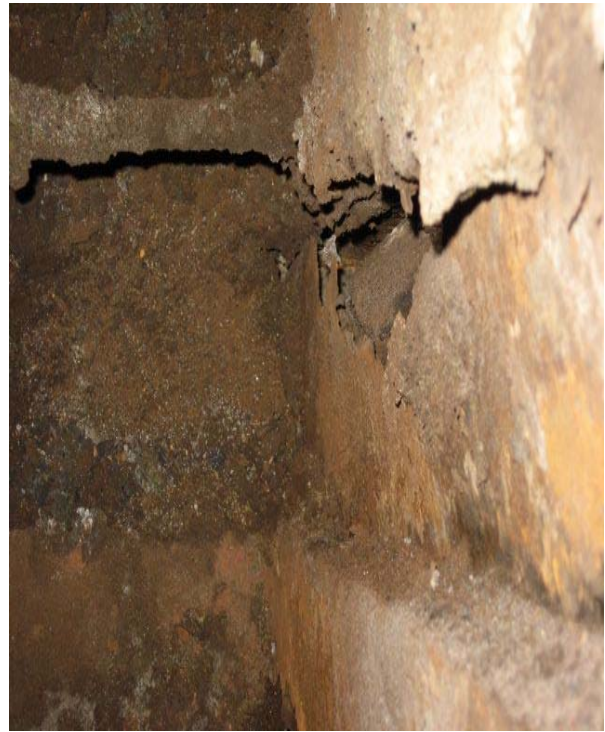
**Fig. 9: Unit 1 – Duct corroded through**

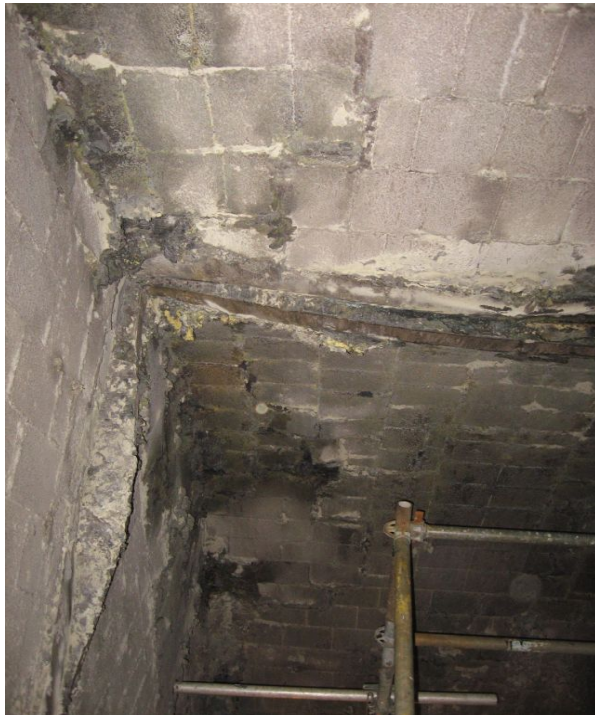
**Fig. 10: Unit 1 – Sloped section as found**

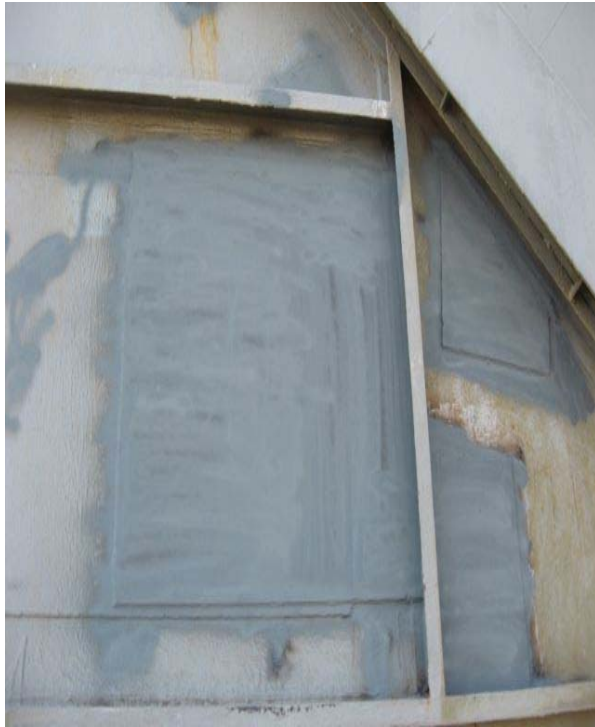
**Fig. 15: Unit 1 – Damaged expansion joint**

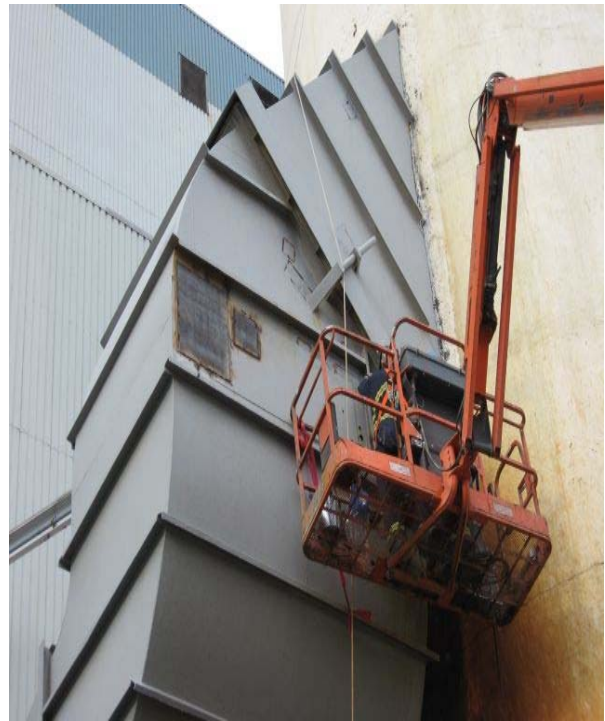
**Fig. 16: Unit 1 – External duct repairs**

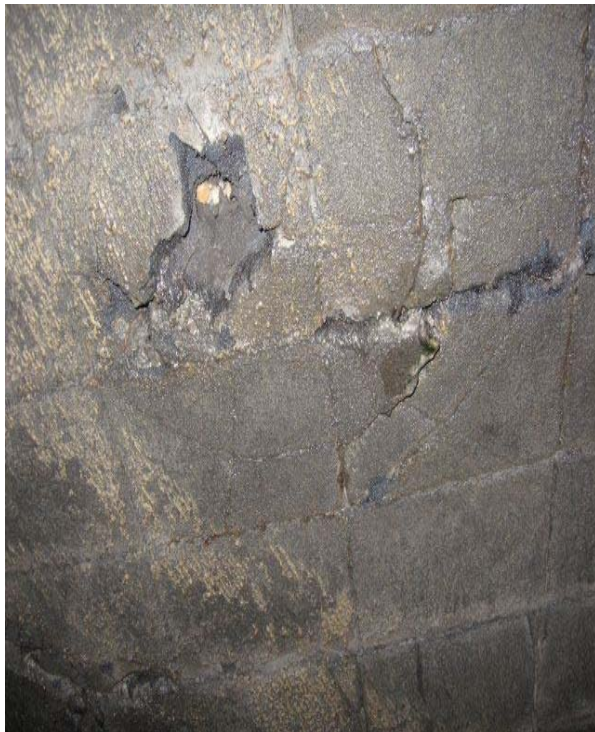
**Fig. 17: Unit 1 – External duct repairs**

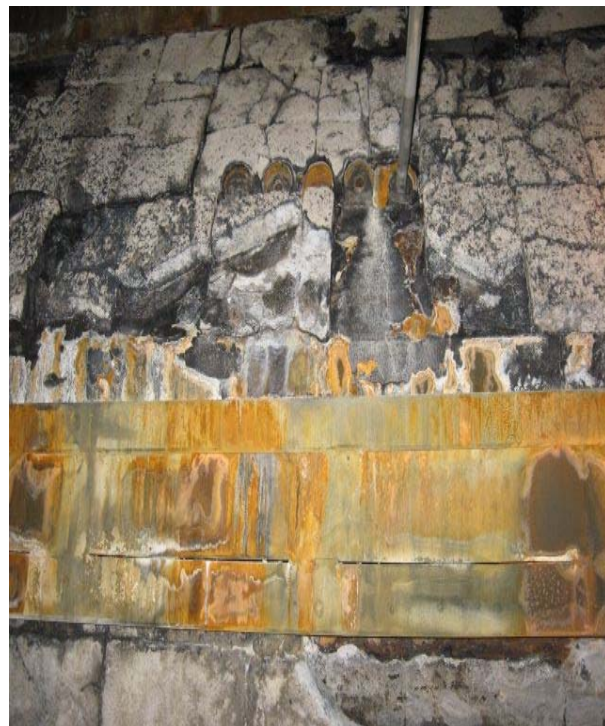
**Fig. 18: Unit 2 – Missing insulation blocks**

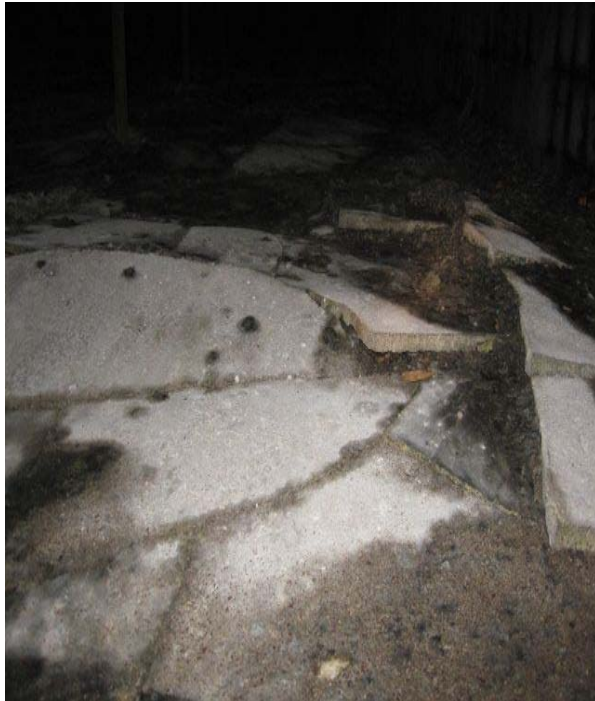
**Fig. 19: Unit 2 – Missing insulation blocks**

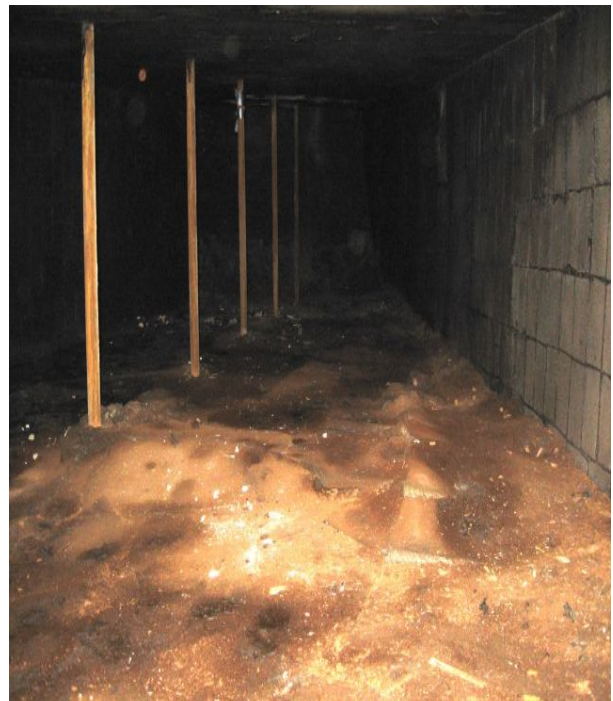
**Fig. 20: Unit 2 – Cracked cement floor**

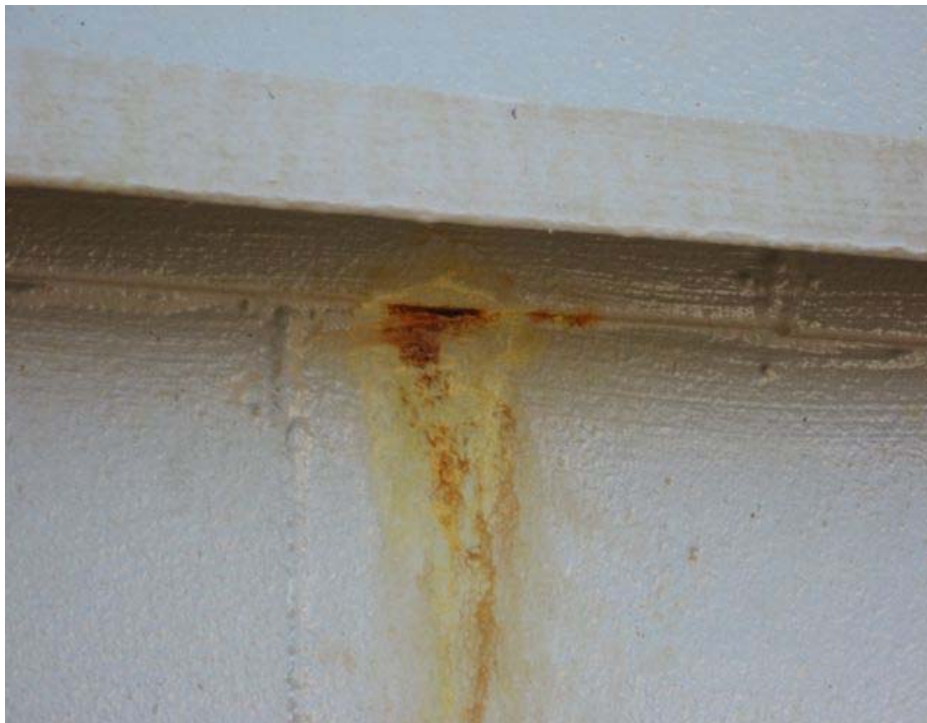
**Fig. 21: Unit 2 – Cracked cement floor**

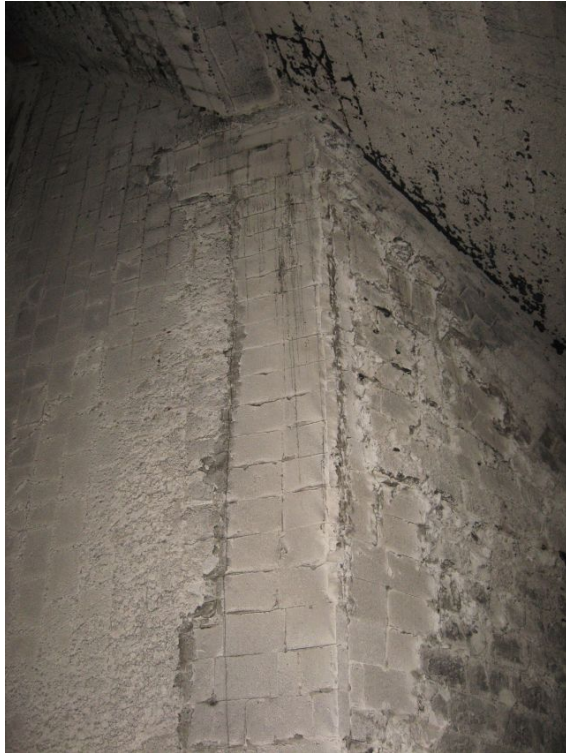
**Fig.22: Unit 2 – External coating break down**

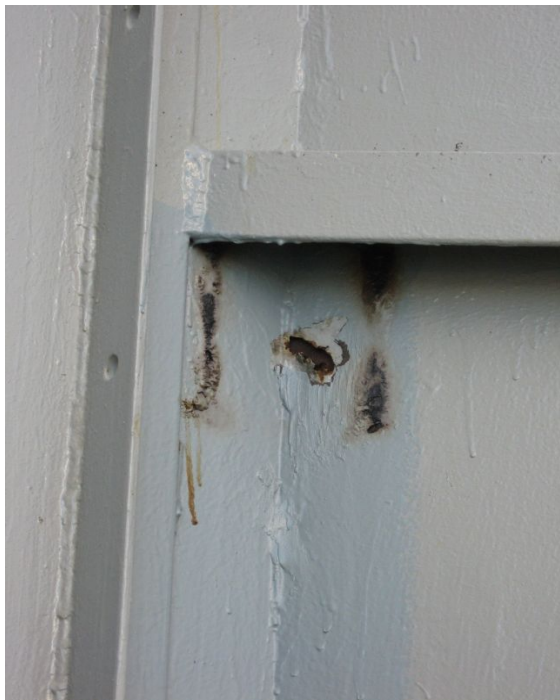
**Fig. 24: Unit 3 – Crotch repairs**

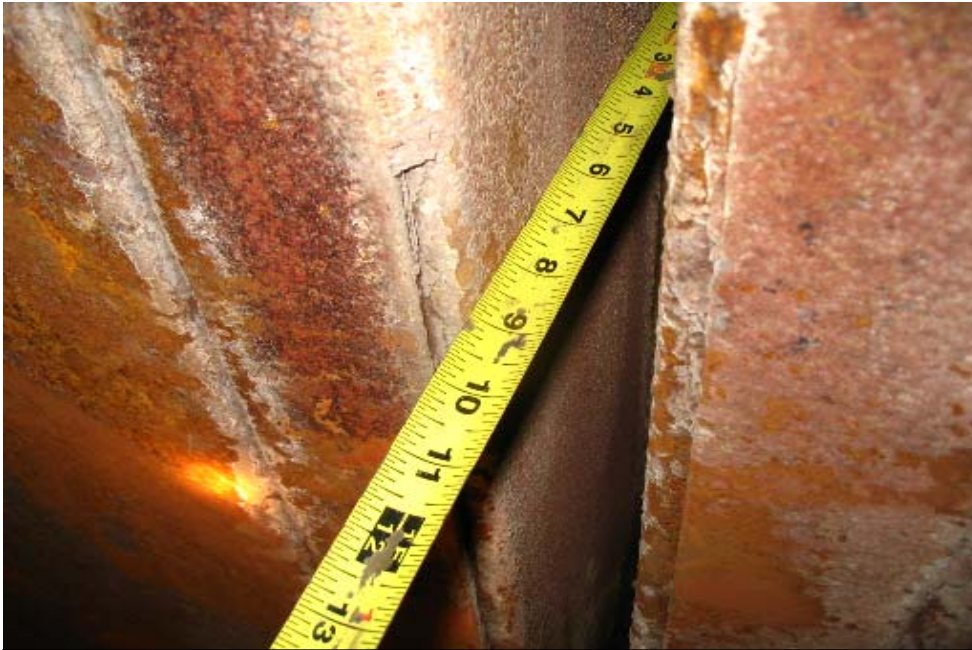
.Joint 1

**Fig. 30: Unit 3 – Expansion joint, hot air duct from air heater**

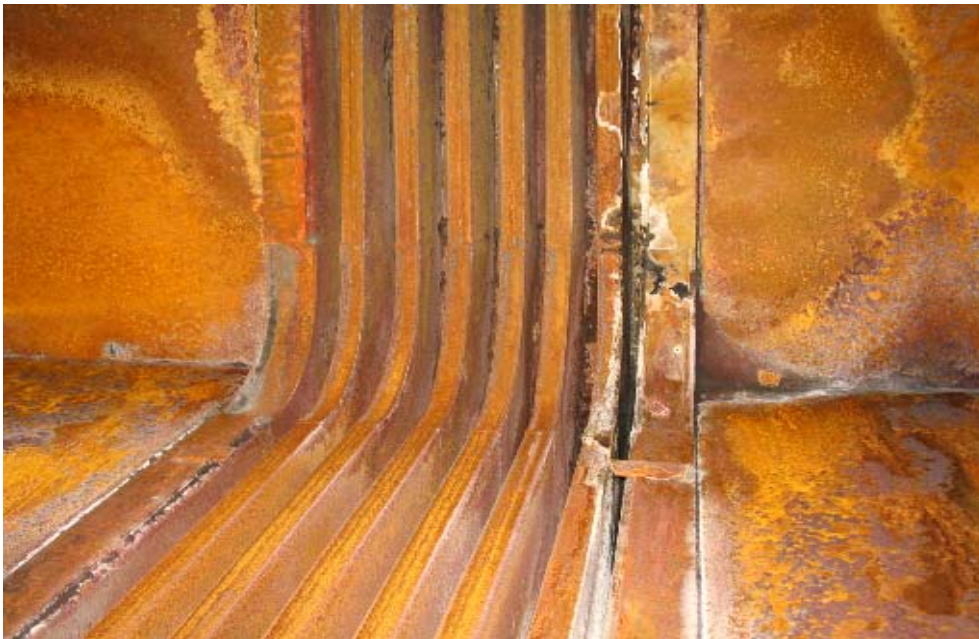
.Joint 2 - corner

**Fig. 31: Unit 3 – Expansion joint, hot air duct from air heater**
