1    Q.    **Re: Project B-12 Upgrade Unit 2 Stack Breeching**

**Condition Assessment of Stack Breeching**

**Holyrood G.S.**

**Alstom Canada Inc.**

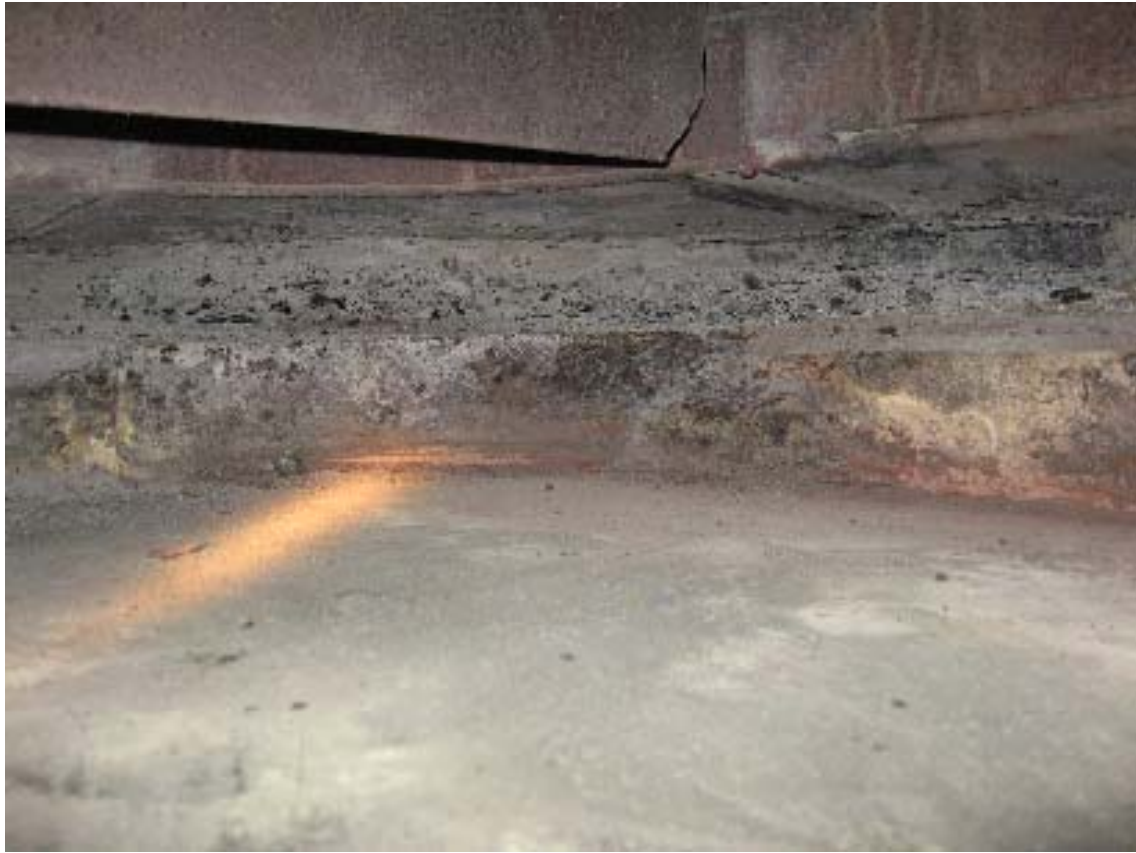
**Fig. 32: Unit 3 – Expansion joint #4, hot air duct from air heater**
