1 **Q. Please describe how transmission line equipment repairs are prioritized and state**
2 **the time limits for each prioritization.**

Appendix C
Photographs of Transmission Lines
12L, 13L, 18L, 35L and 68L

**2013 Transmission Line Rebuild
June 2012**

**2010 Transmission Line Rebuild
June 2009**

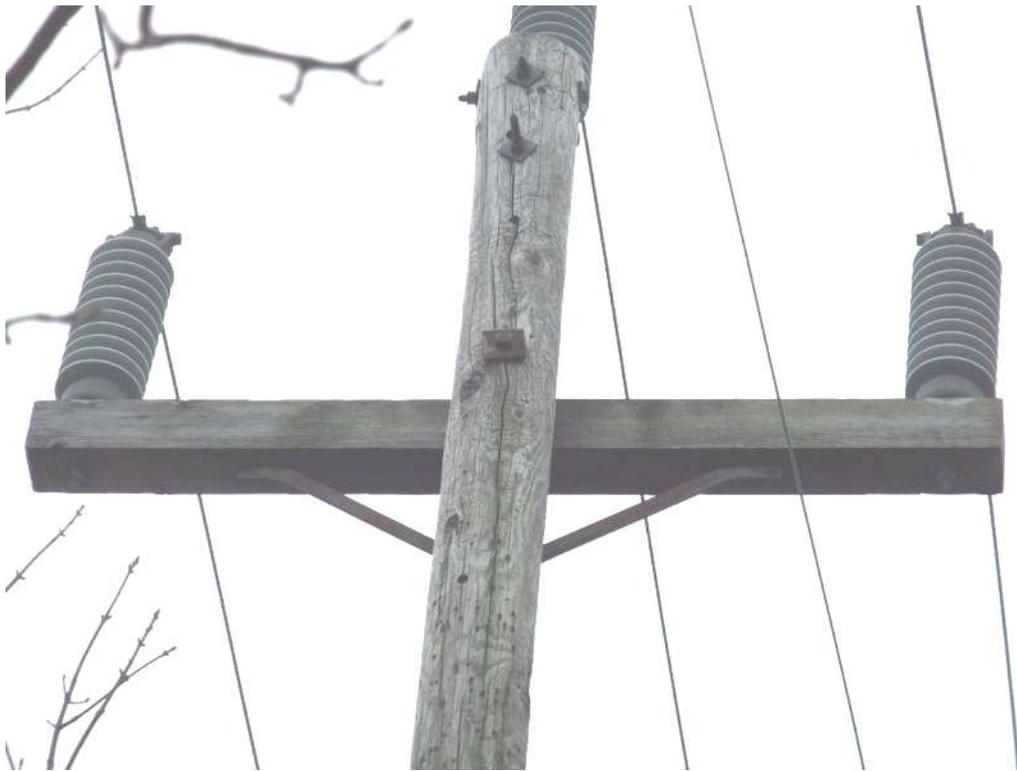
Figure 1 – 12L - Pole showing checking around bolts

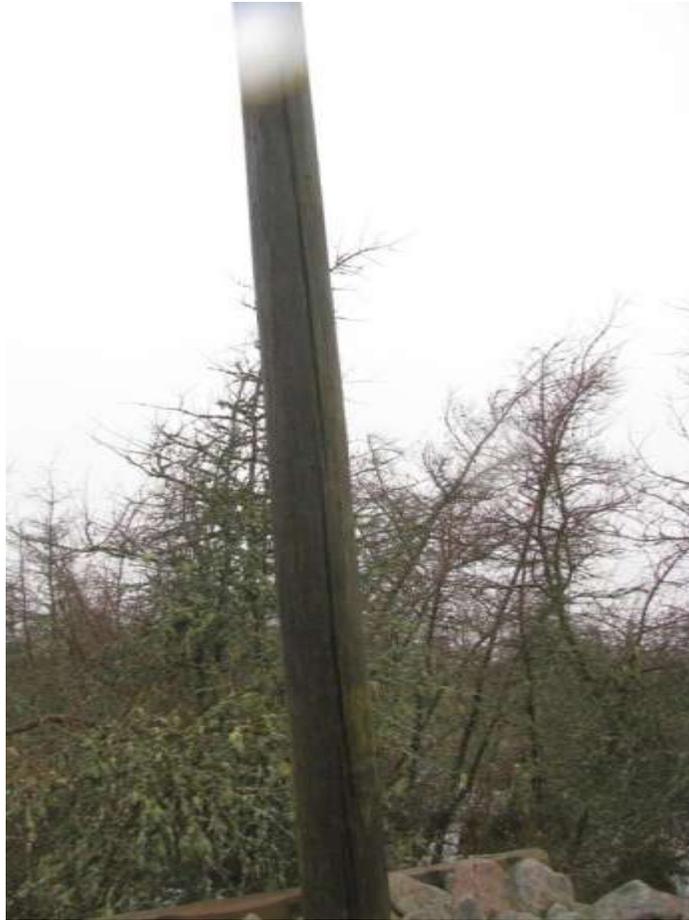
Figure 11 – 18L - Pole with severe checks

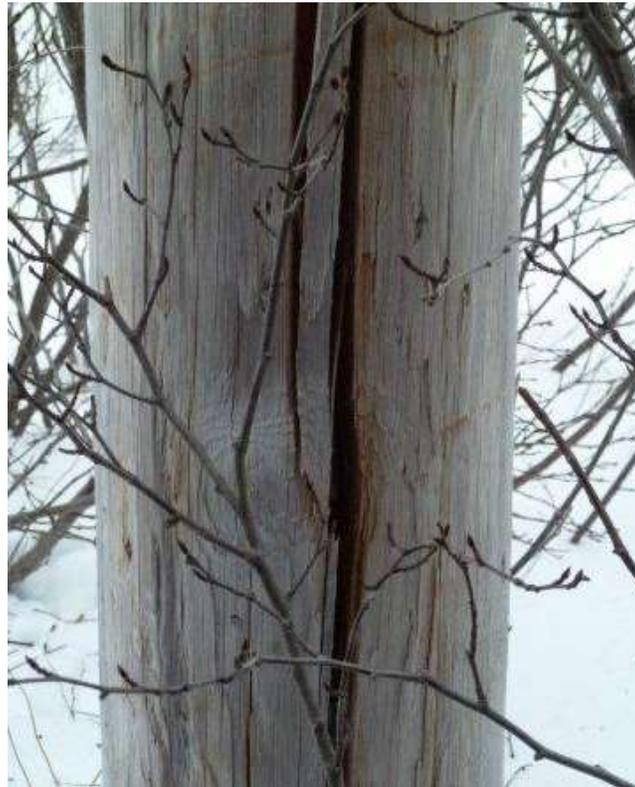
Figure 18 – 68L - Deep check in pole

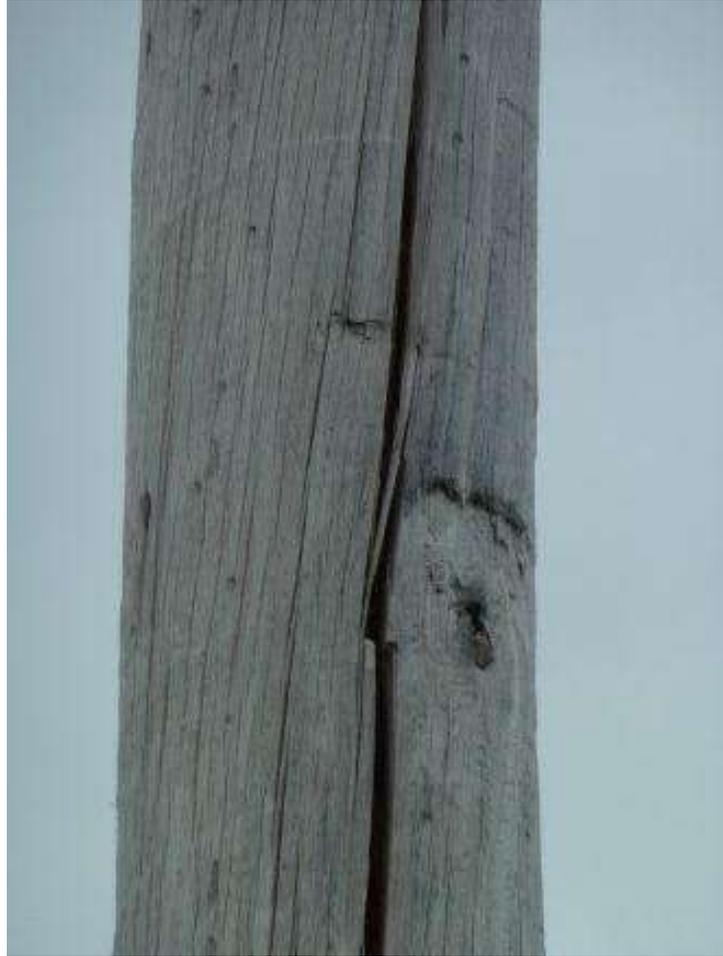
Figure 19 – 68L - Pole showing shell separation

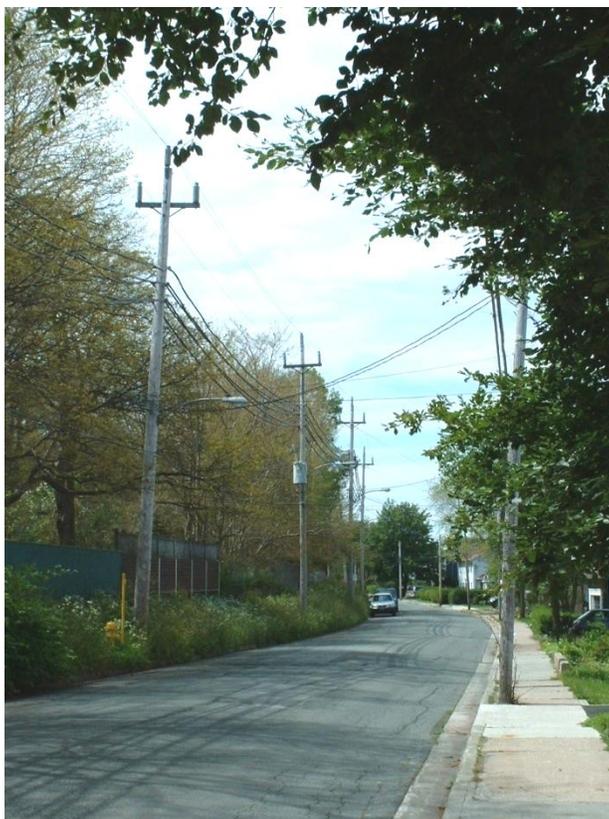
Figure 10 – 12L – Distribution aerial cable arrangement (2)

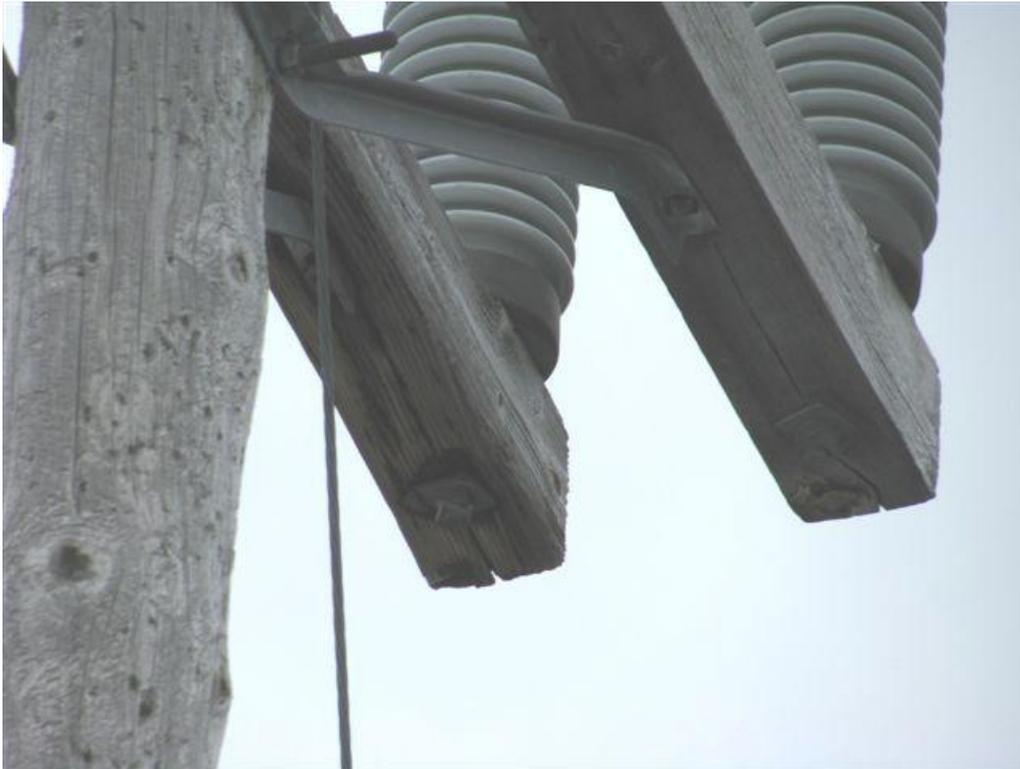
Figure 1 – Split Crossarm 110L

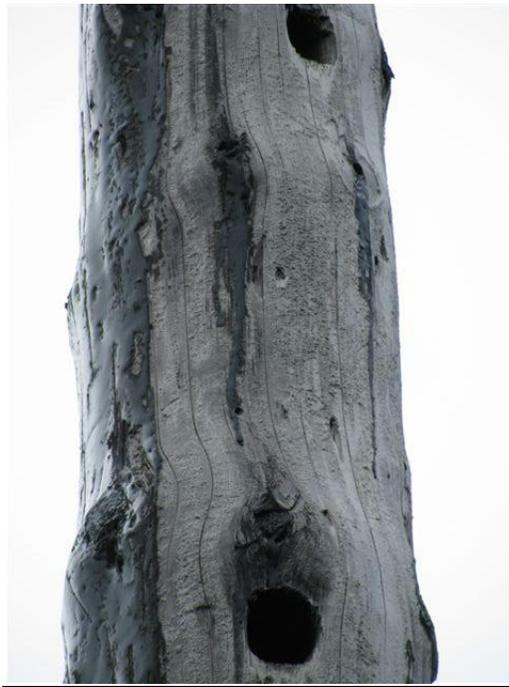
Figure 4 – Woodpecker Holes 110L

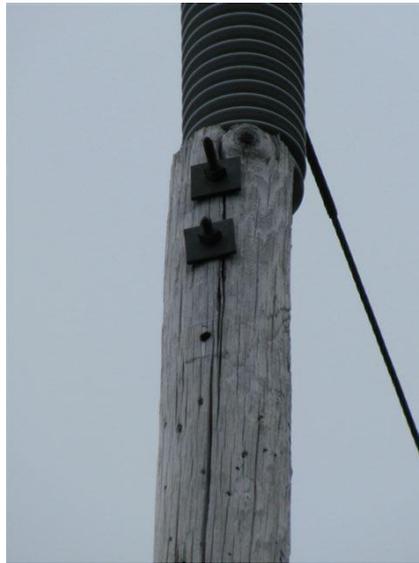
Figure 5 – Split Pole Top 110L

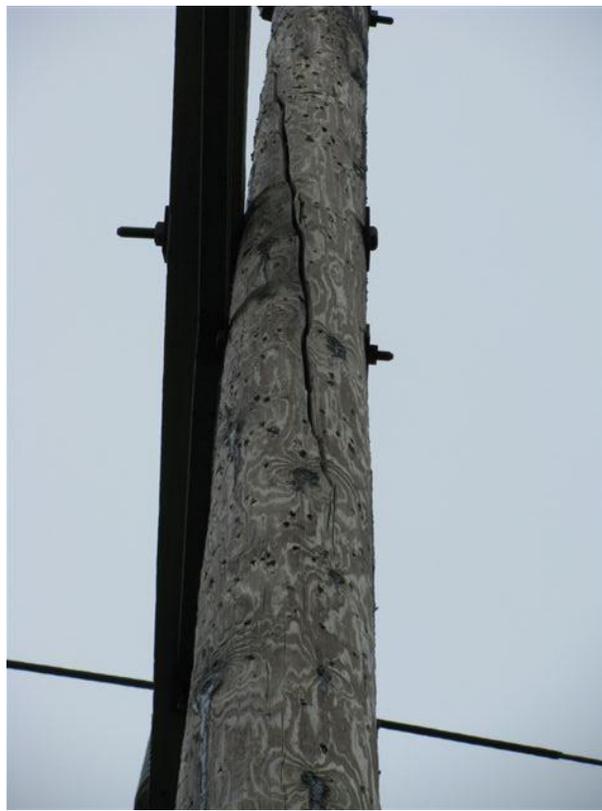
Figure 6 – Split Pole 110L

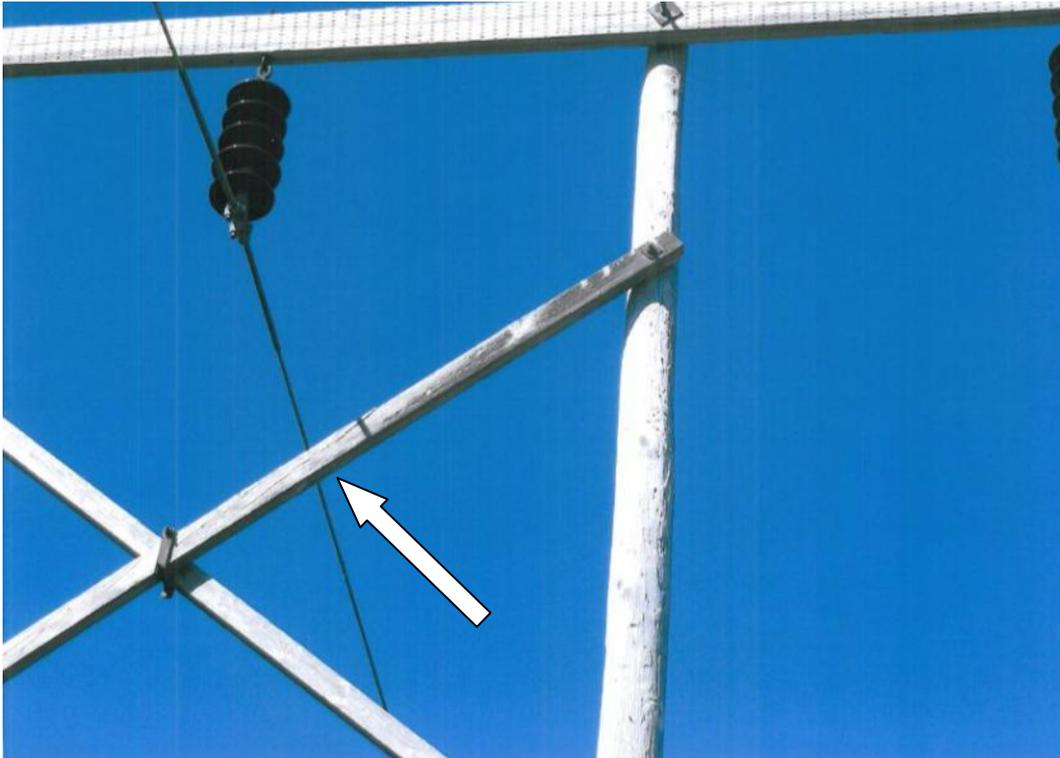
Figure 7 – Split Crossbrace 21L

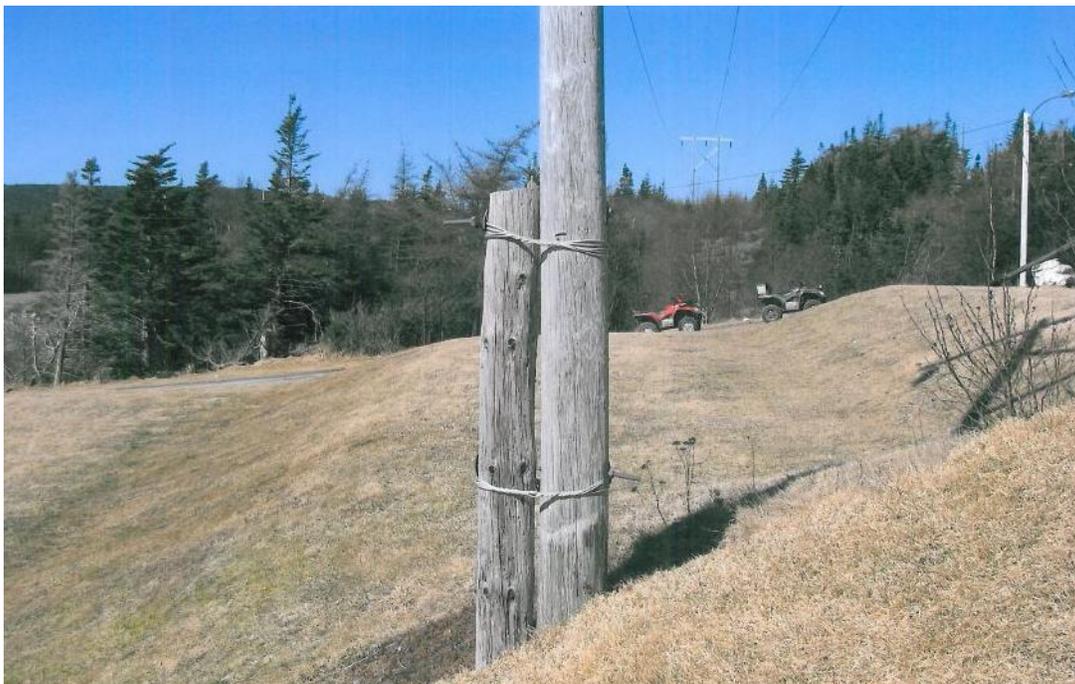
Figure 8 – Pole requiring temporary support 21L

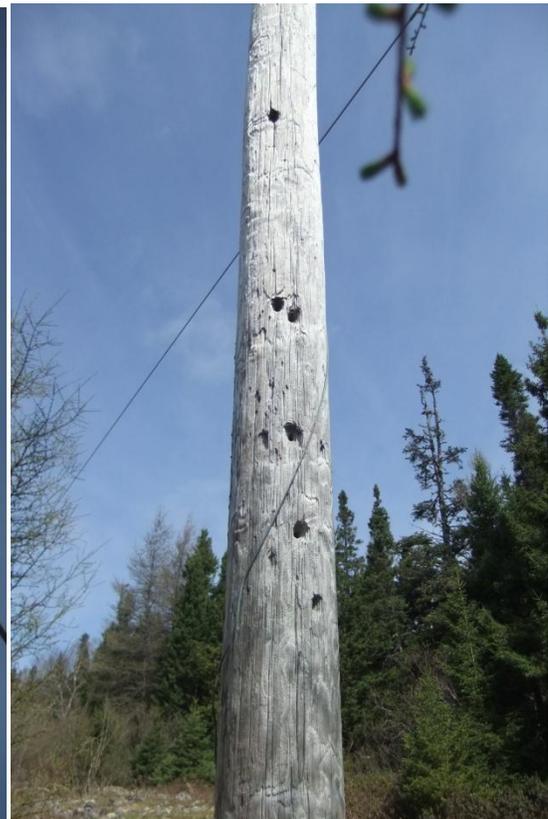
Figure 15 – Woodpecker Holes 124L

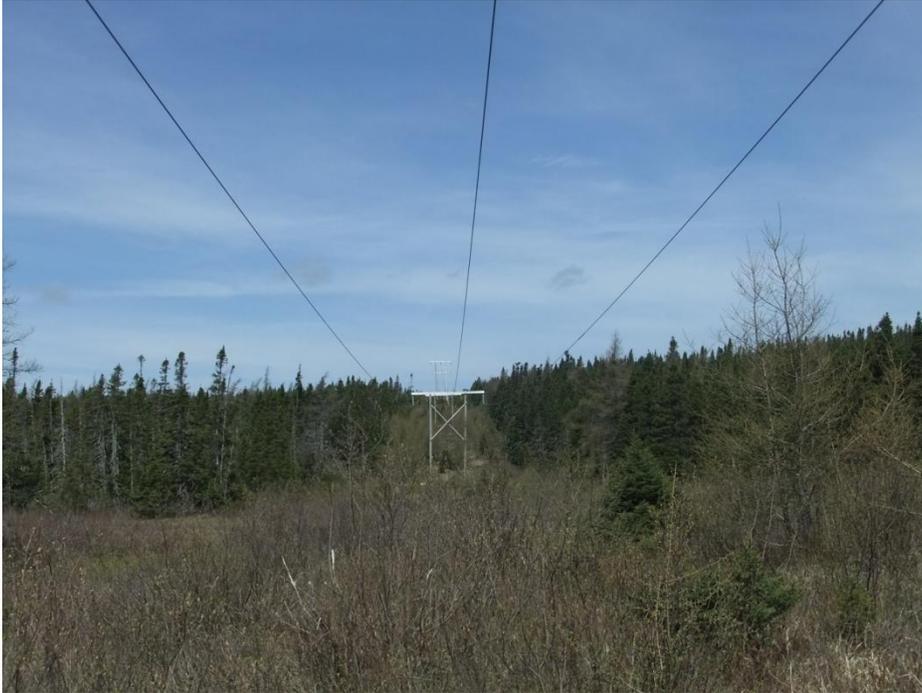
Figure 19 – Location with Reduced Ground Clearance 124L

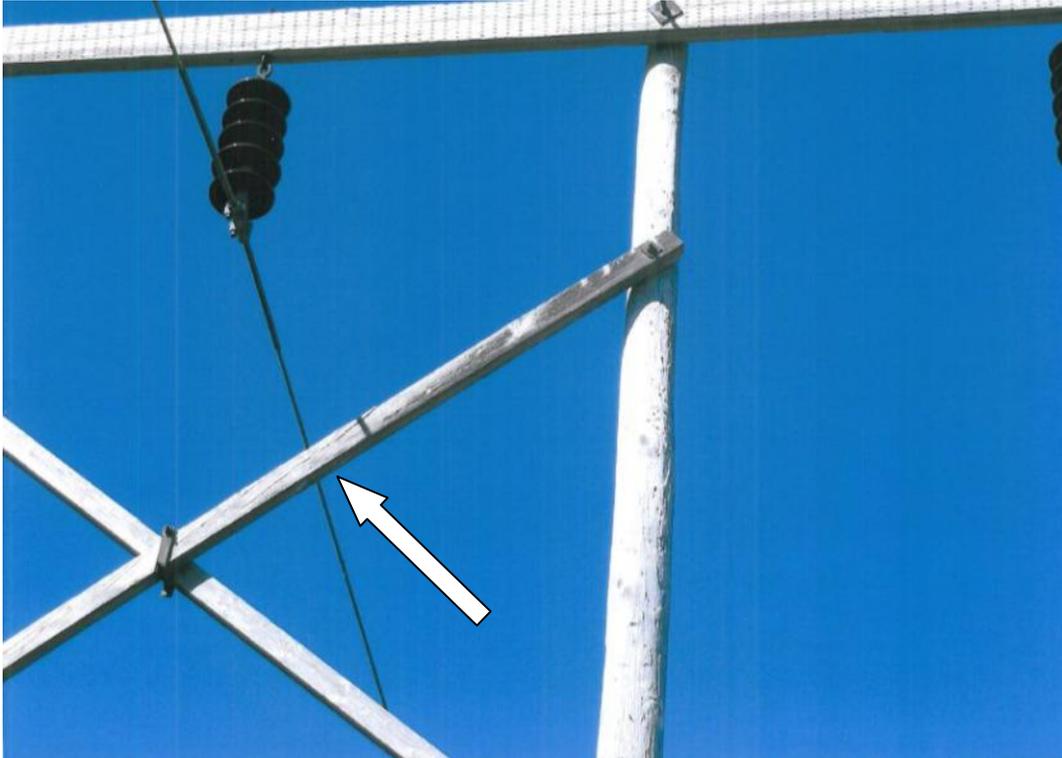
Figure 5 – Split crossbrace 21L

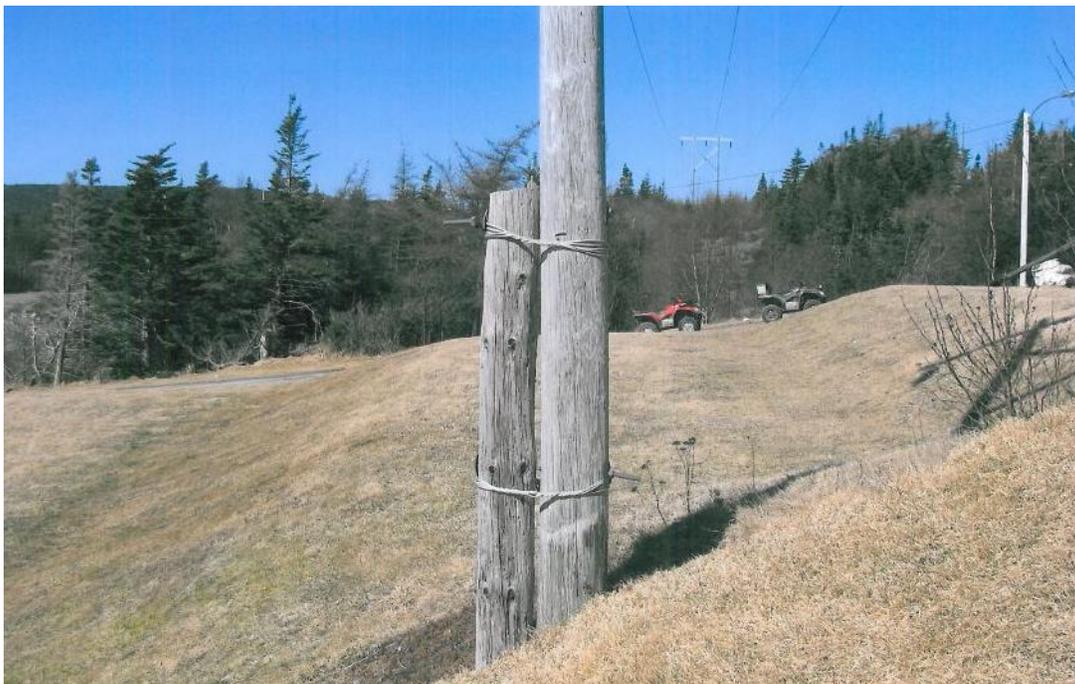
Figure 6 – Pole requiring temporary support 21L
