# Re: *Reliability and Resource Adequacy Study Review* – Labrador-Island Link Failure Investigation Reports

# Failure Investigation Report – L3501/2 Tower and Conductor Damage

Failure Investigation Report – L3501/2 Tower	R	evision R1		
Icing Event January 2021 in Labrador	Date:	Revision R1     :   28-May-2021     :   ii		
Nalcor Doc. No. ILK-EG-ED-6200-TL-RP-0001-01	Page:	ii

# FAILURE ANALYSIS OF ELECTRODE CROSS ARM IN LABRADOR ISLAND TRANSMISSION LINK (LITL)

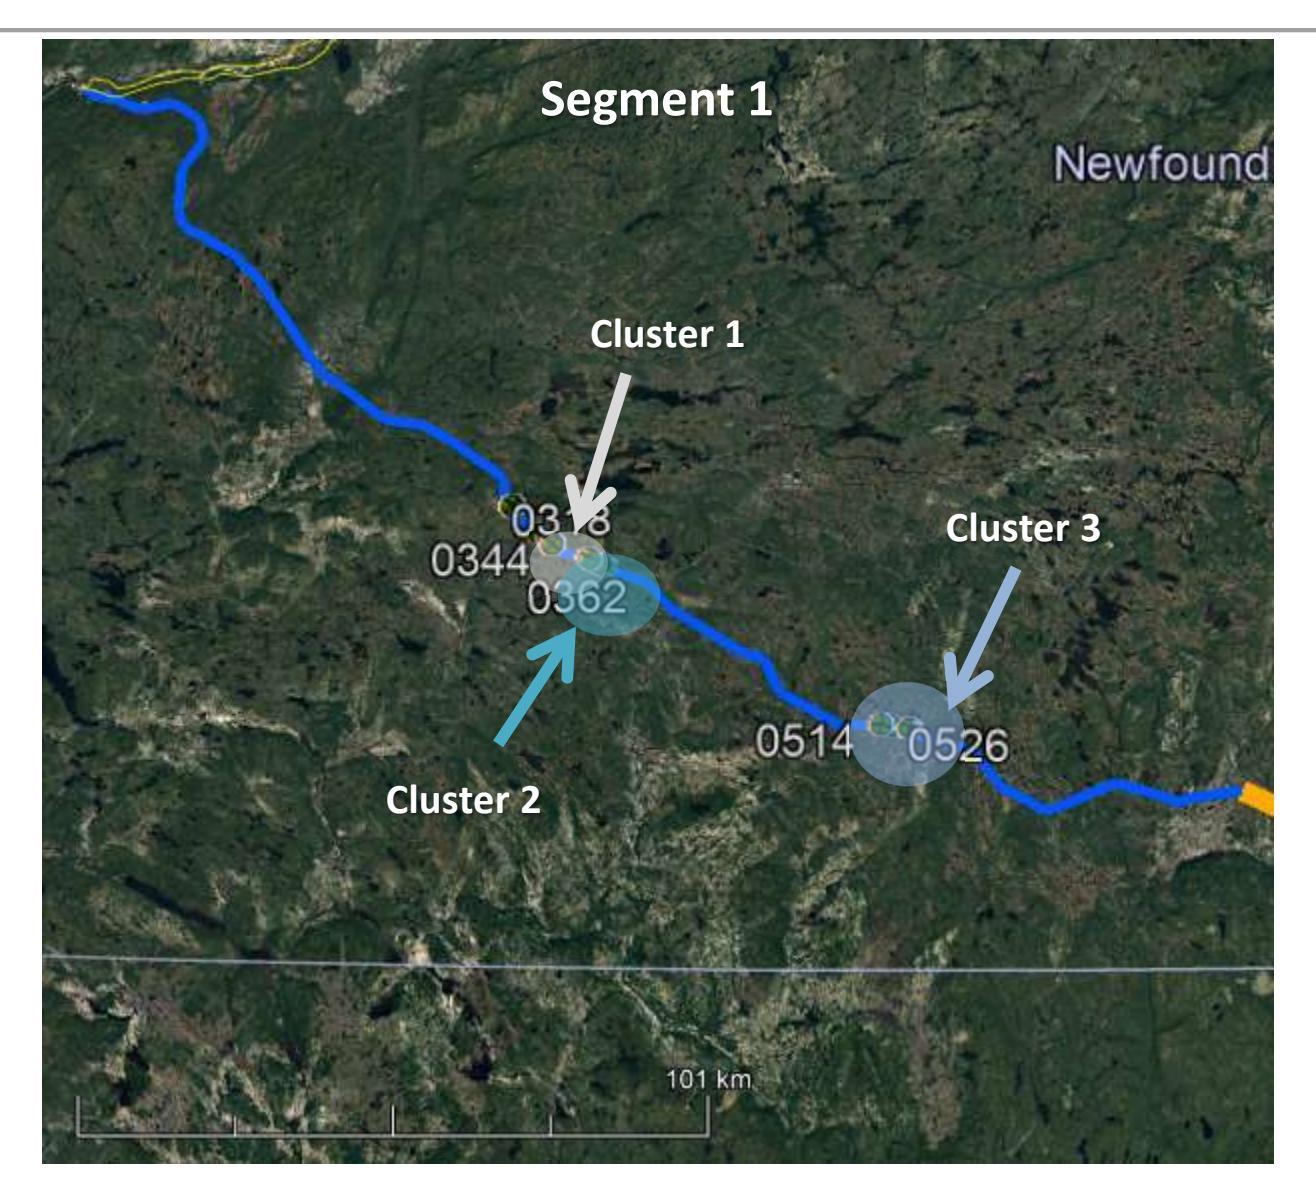
Figure 3 – Segment 1 Showing All Damages (Note: Scale of 101 km)

For the purpose of this report, the damages can be broken down into three separate clusters (as labeled in Table 2 - L3501/2 Damages from 2021 Ice Storm).

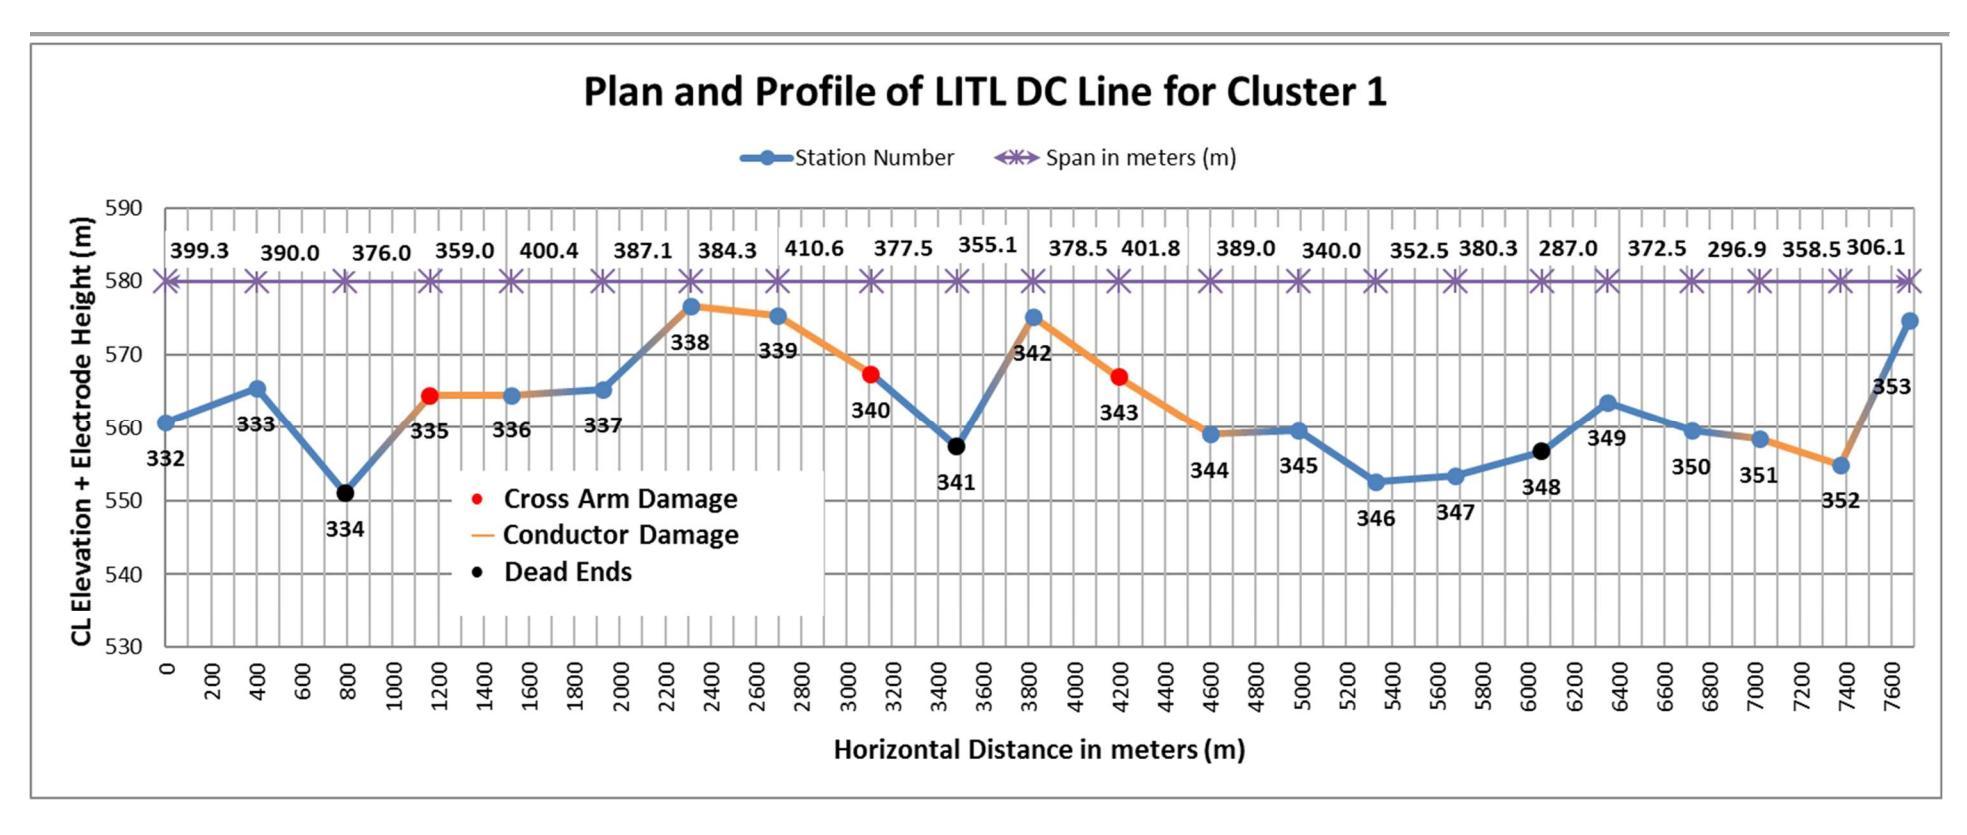
Figure 6 – Station 332 to 347 (Cluster 1)

To better understand the positioning of the tower locations that sustained damage within each cluster, the clusters have been plotted with their tower elevations and span length. The span length is the horizontal distance in meters (m) between the centreline of two adjacent towers. Tower locations with damaged cross arms are shown in red, while lines shown in orange represent damaged conductors.

All the failures and damage identified followed a similar pattern throughout the clusters. The failure to the conductor consisted of longitudinal (along the line direction) slippage of the conductor within the suspension clamps and longitudinal

bending of the electrode cross arms. The below charts also indicate a similarity with failure locations with respect to longer span locations and spans with large elevation differences.

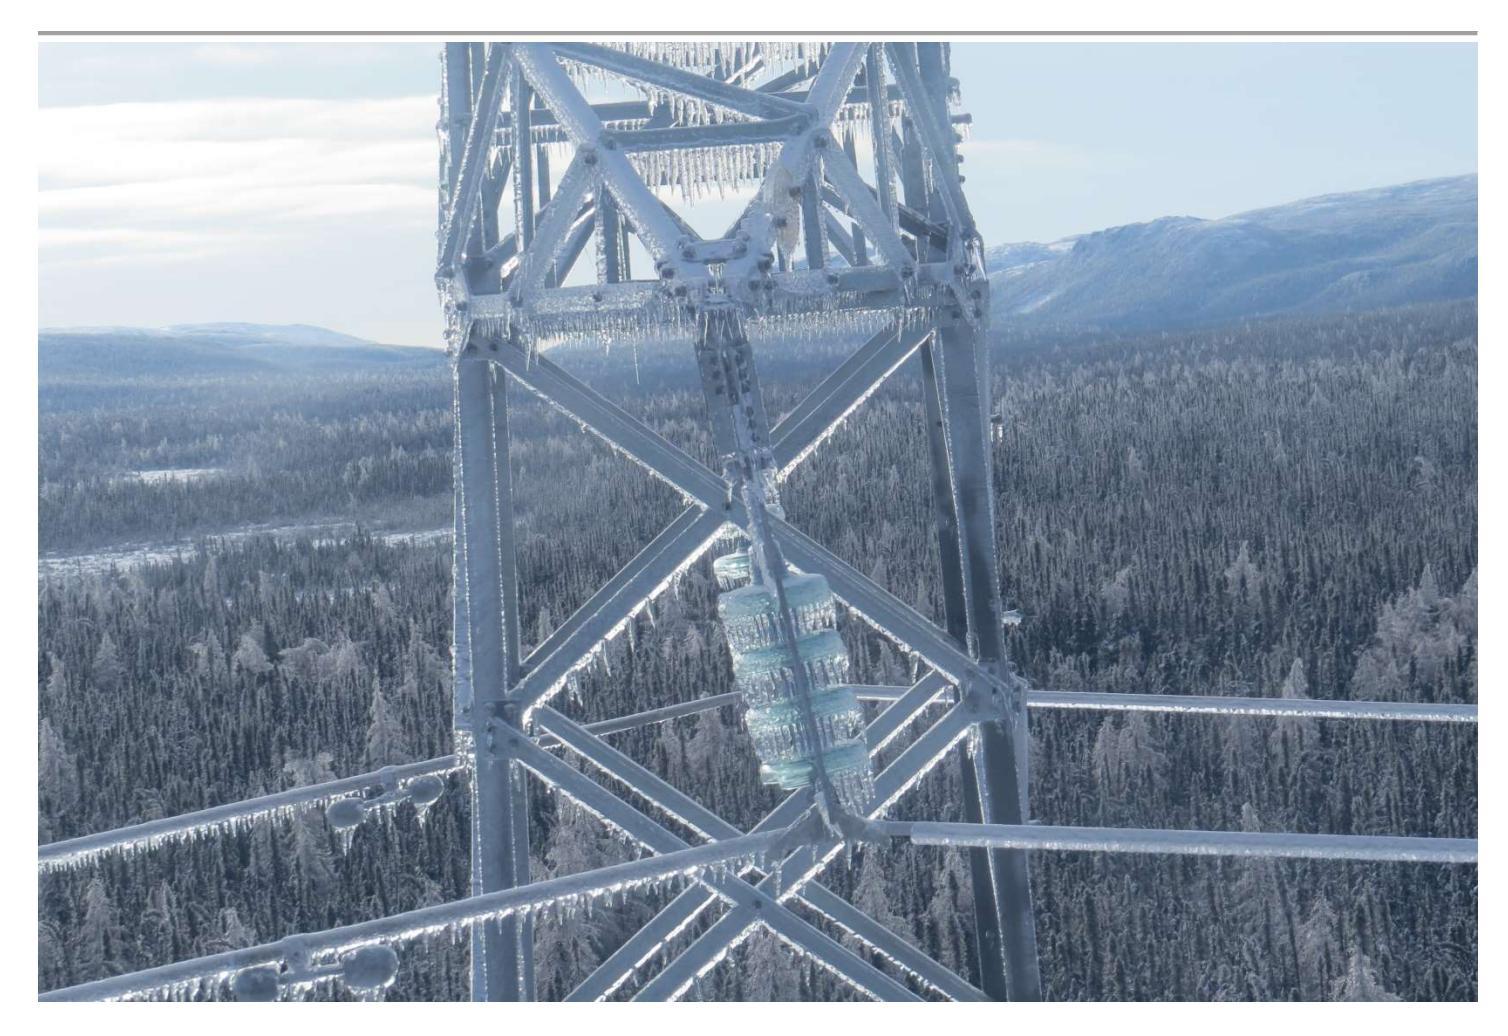
Photo 7 – IMG\_2643 (2021.01.15) – Glaze Ice

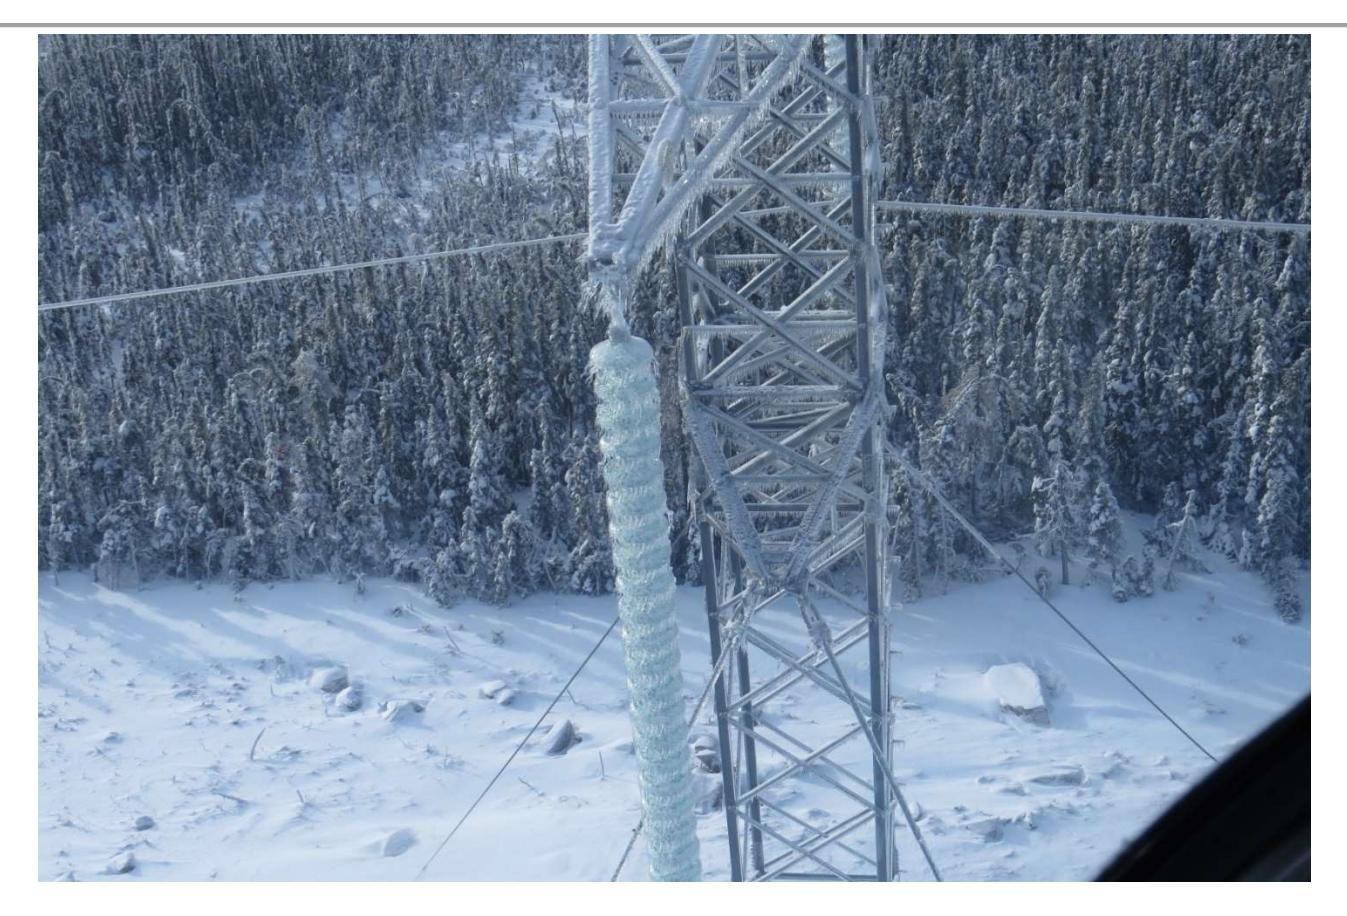
Photo 8 – Pole Insulator Glaze Icing – IMG\_2652 (2021.01.15)

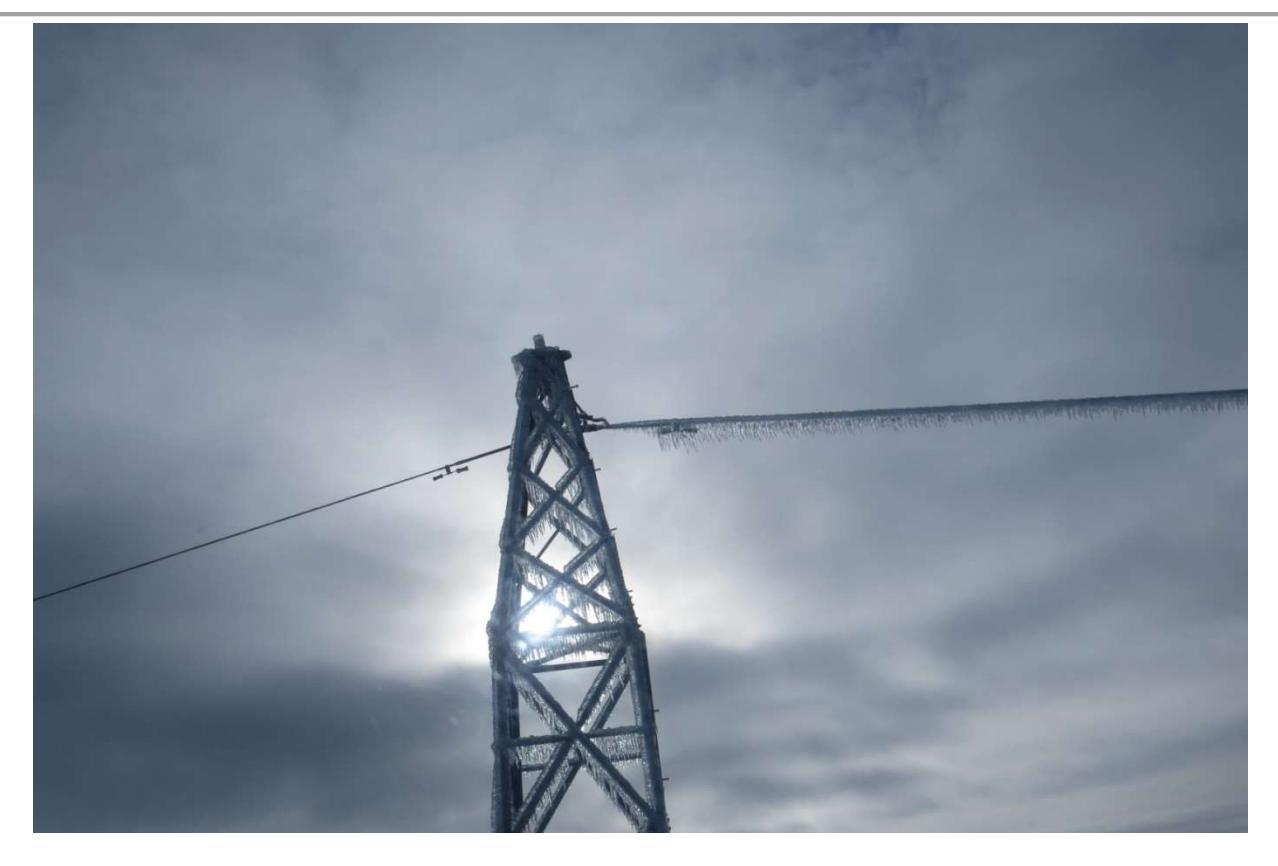
Photo 9 – Evidence Uneven Ice Shedding on OPGW – IMG\_2663 (2021.01.15)

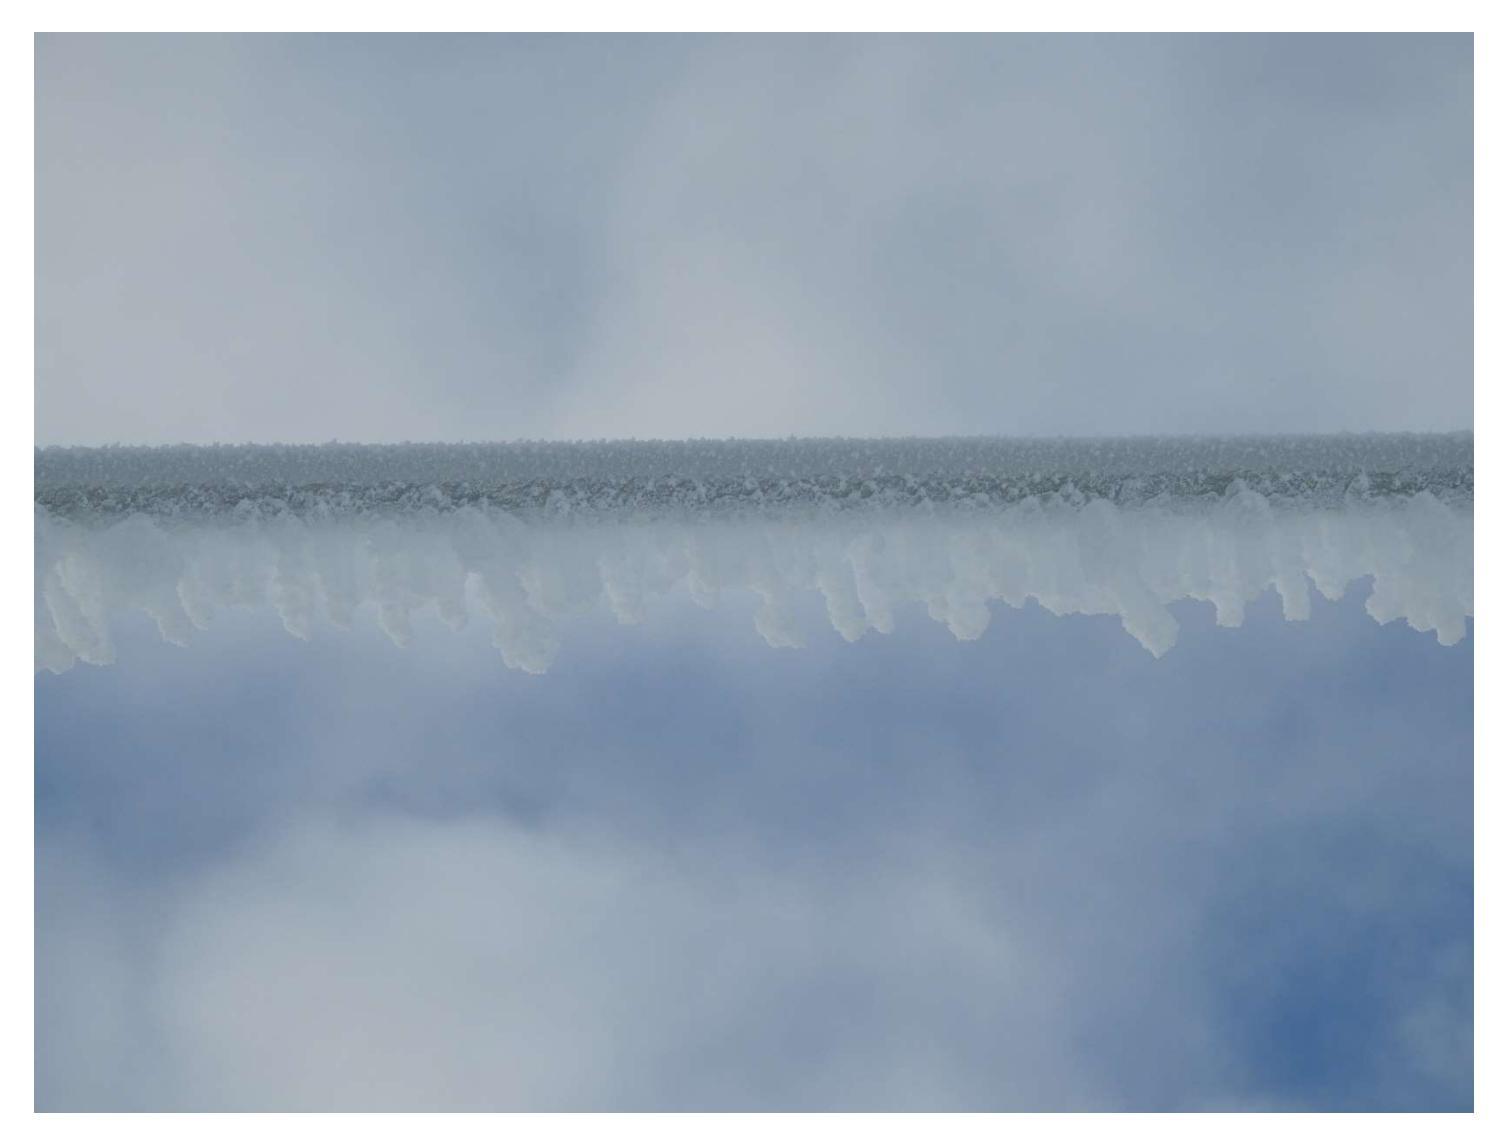
Photo 14 – Irregular Ice Accumulation – DSCN6473 (2021.01.14)

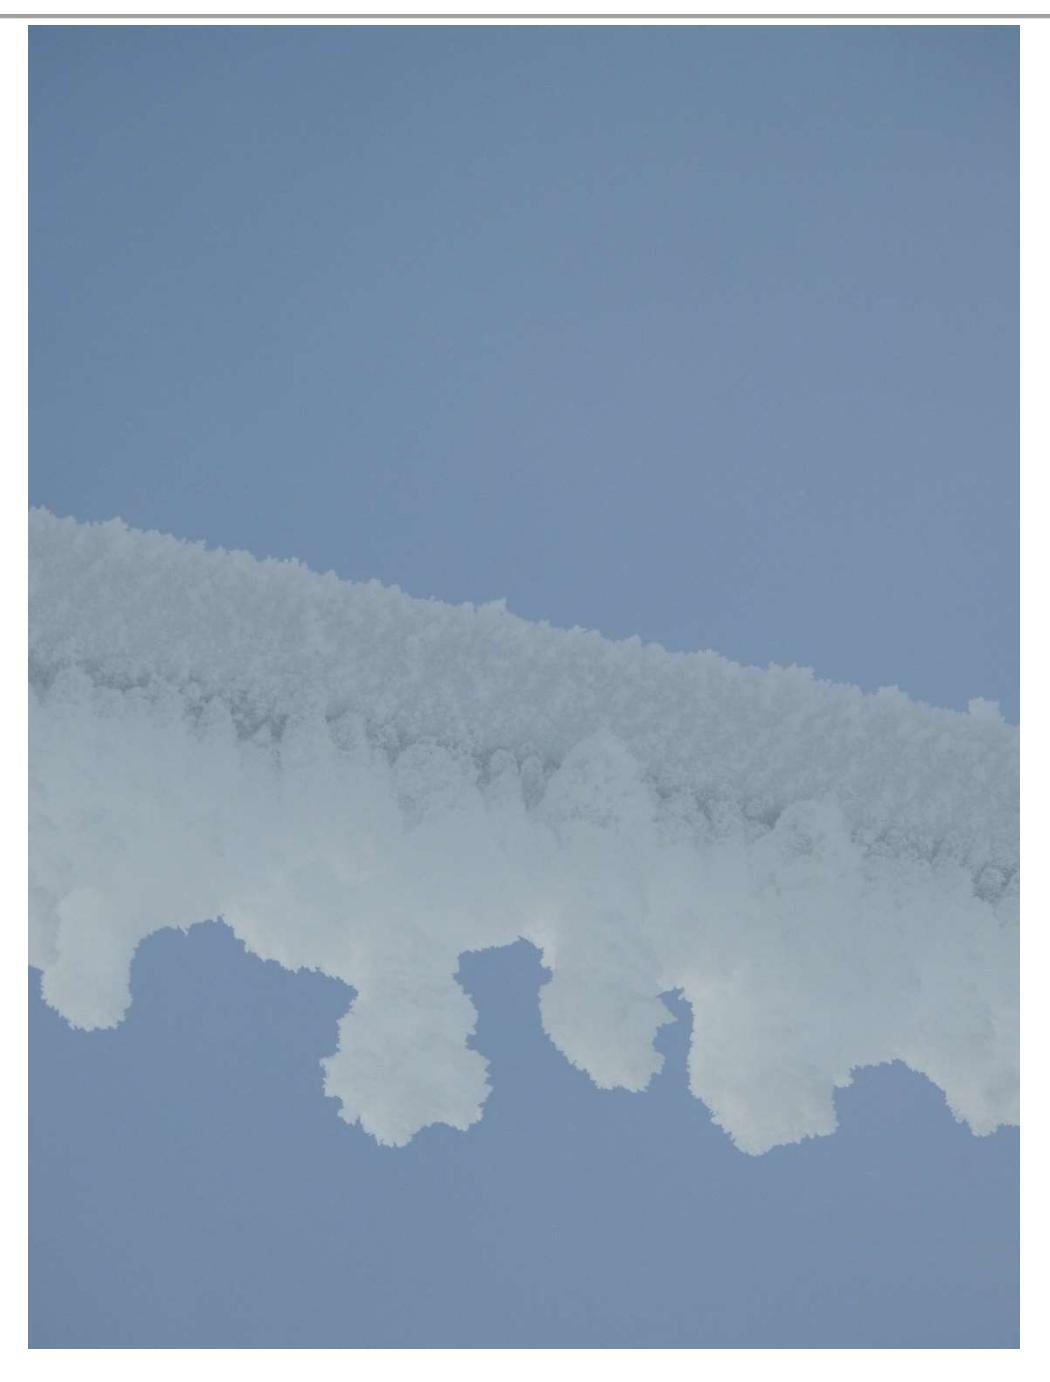
Photo 15 – Irregular Ice Accumulation – DSCN6477 (2021.01.14)

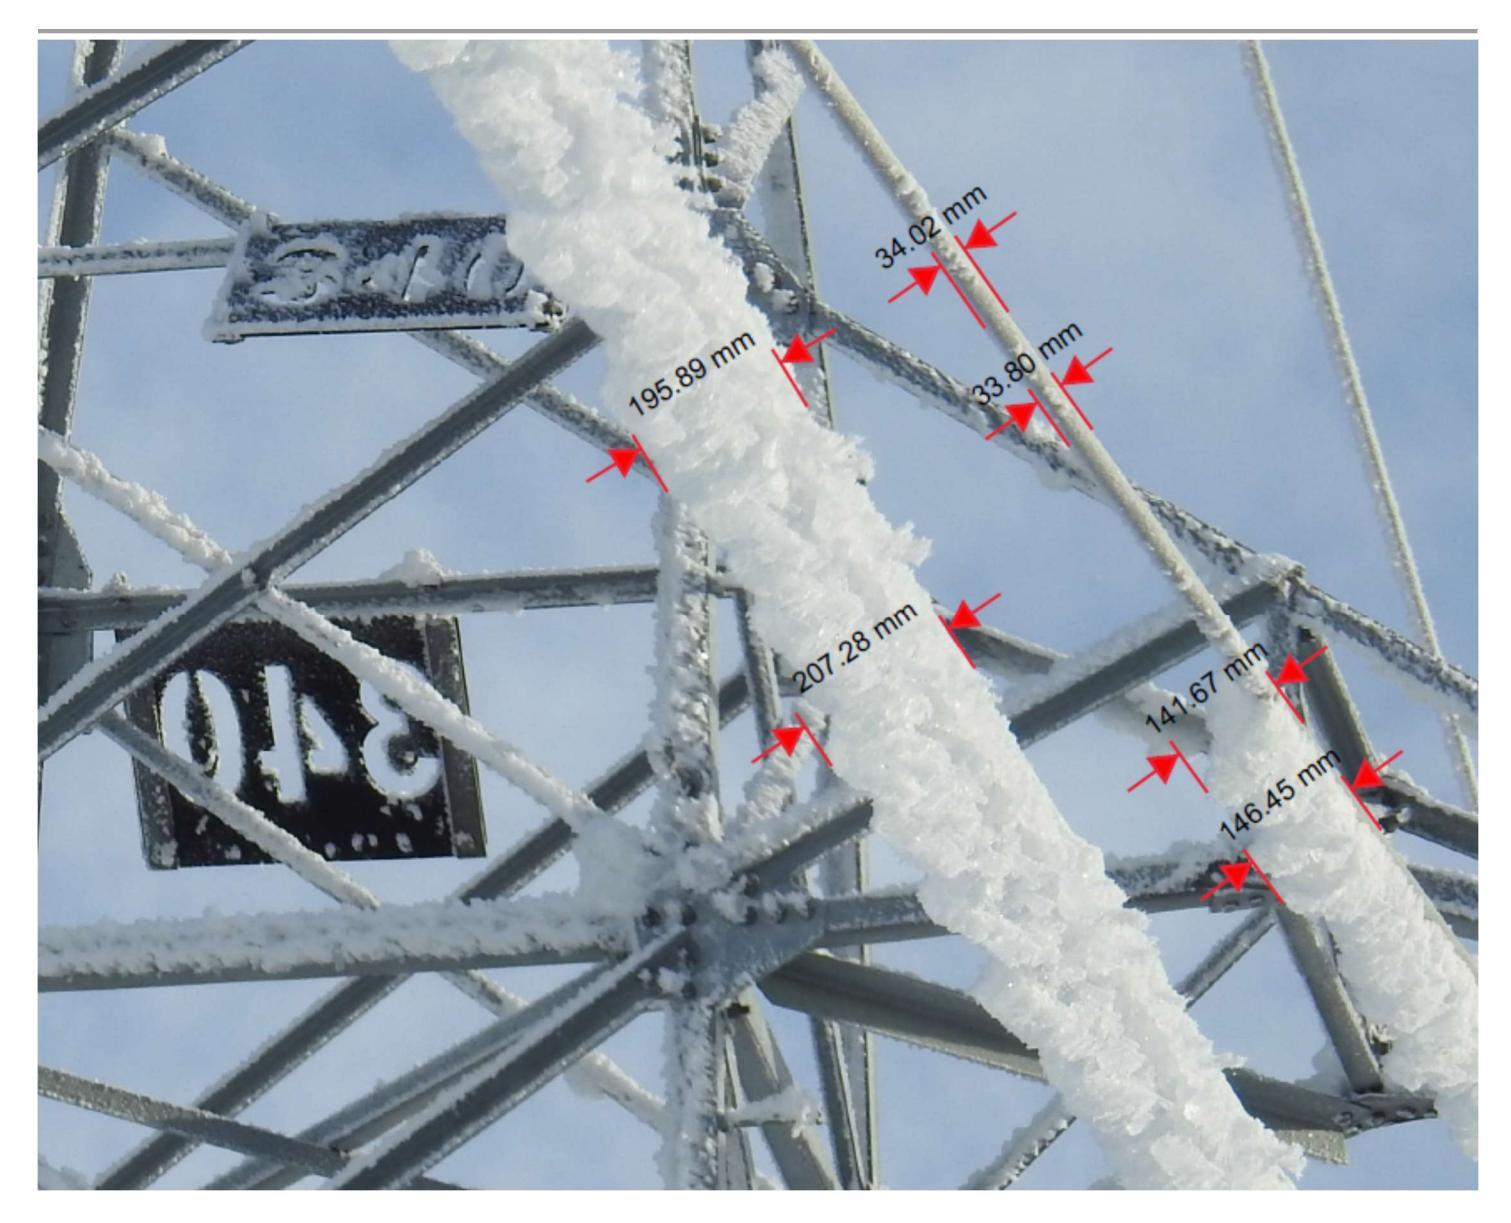
Figure 11 – Ice Thickness Estimation on Str. 340 (DSCN6402 2021.01.11)

In the following photo, the lower (larger) conductor is the pole conductor and the conductor measuring 34mm is the electrode line conductor.

Source Picture	Tower #	Conductor	Conductor Diameter (mm)	Total Diameter (mm)	Radial Ice (mm)
DSCN6402	340	Electrode	33.9	146.45	56.3
DSCN6402	340	Pole	57	207.28	75.1
525 OPGW	525	OPGW	14.5	142	63.8
DSCN6489	526	Pole	57	186.48	64.7
DSCN6494	527	Electrode	33.9	194.27	80.2
DSCN6501	528	OPGW	14.5	119	52.3
DSCN6506	529	OPGW	14.5	161.72	73.6
DSCN6511	530	OPGW	14.5	126.11	55.8
DSCN6515	531	OPGW	14.5	132.74	59.1
DSCN6515	531	OPGW	14.5	223.54	104.5

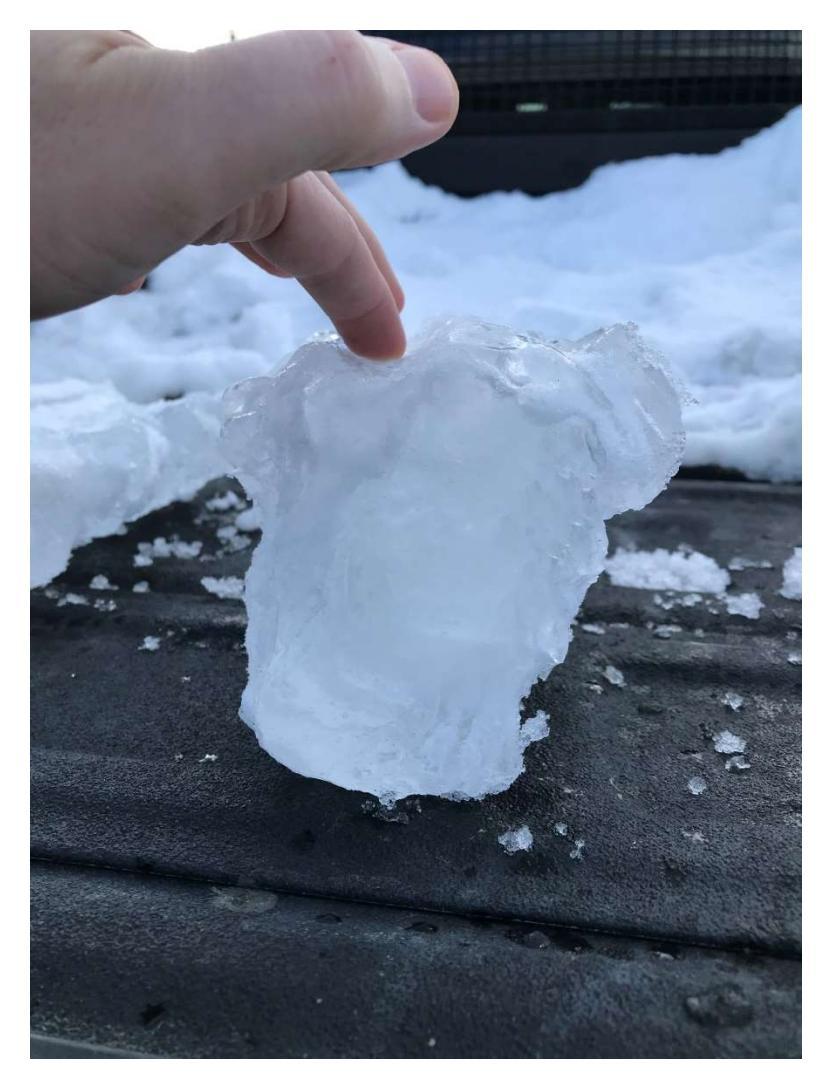
Note that the ice measurements vary from span to span and wire to wire.

Photo 16 – Fallen Ice from Conductor, Str. 340 (2021.01.18)

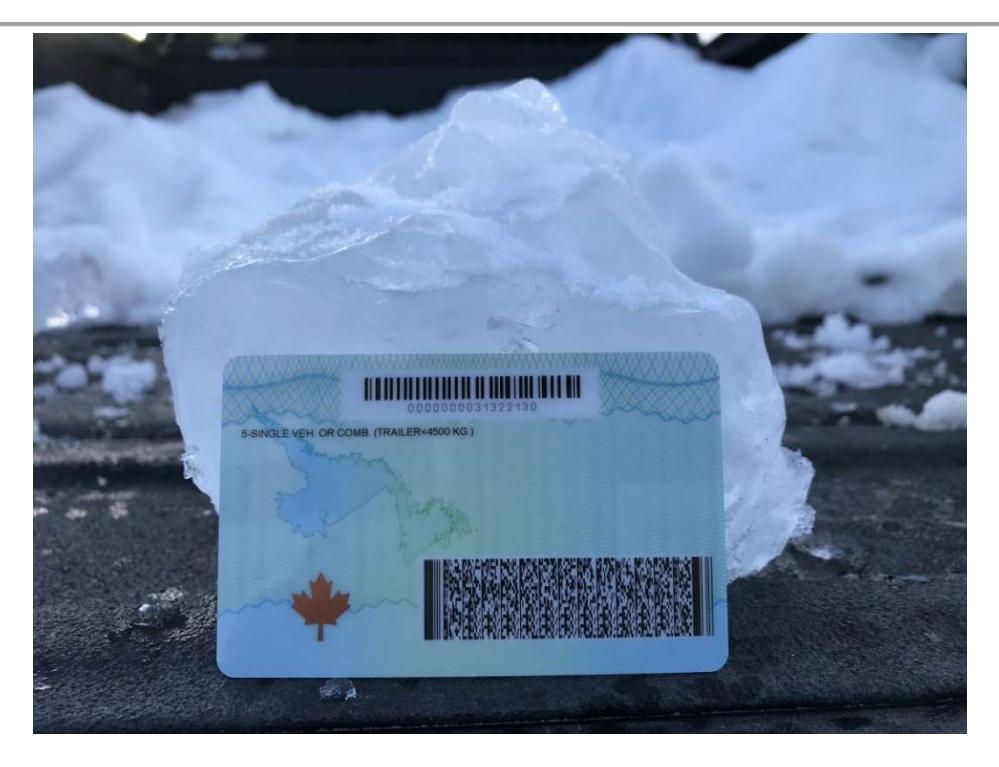
Photo 17 – Fallen Ice from Conductor, Str. 340 (2021.01.18)

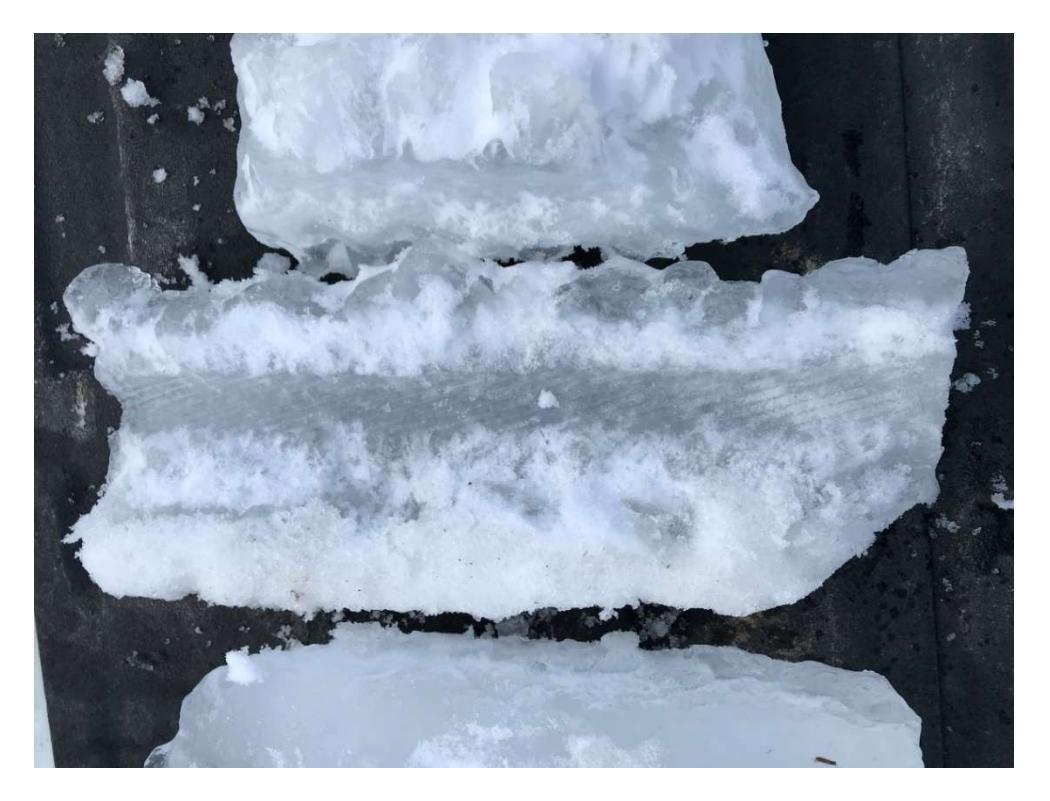
Photo 18 – Fallen Ice from Conductor, Str. 340 (2021.01.18)

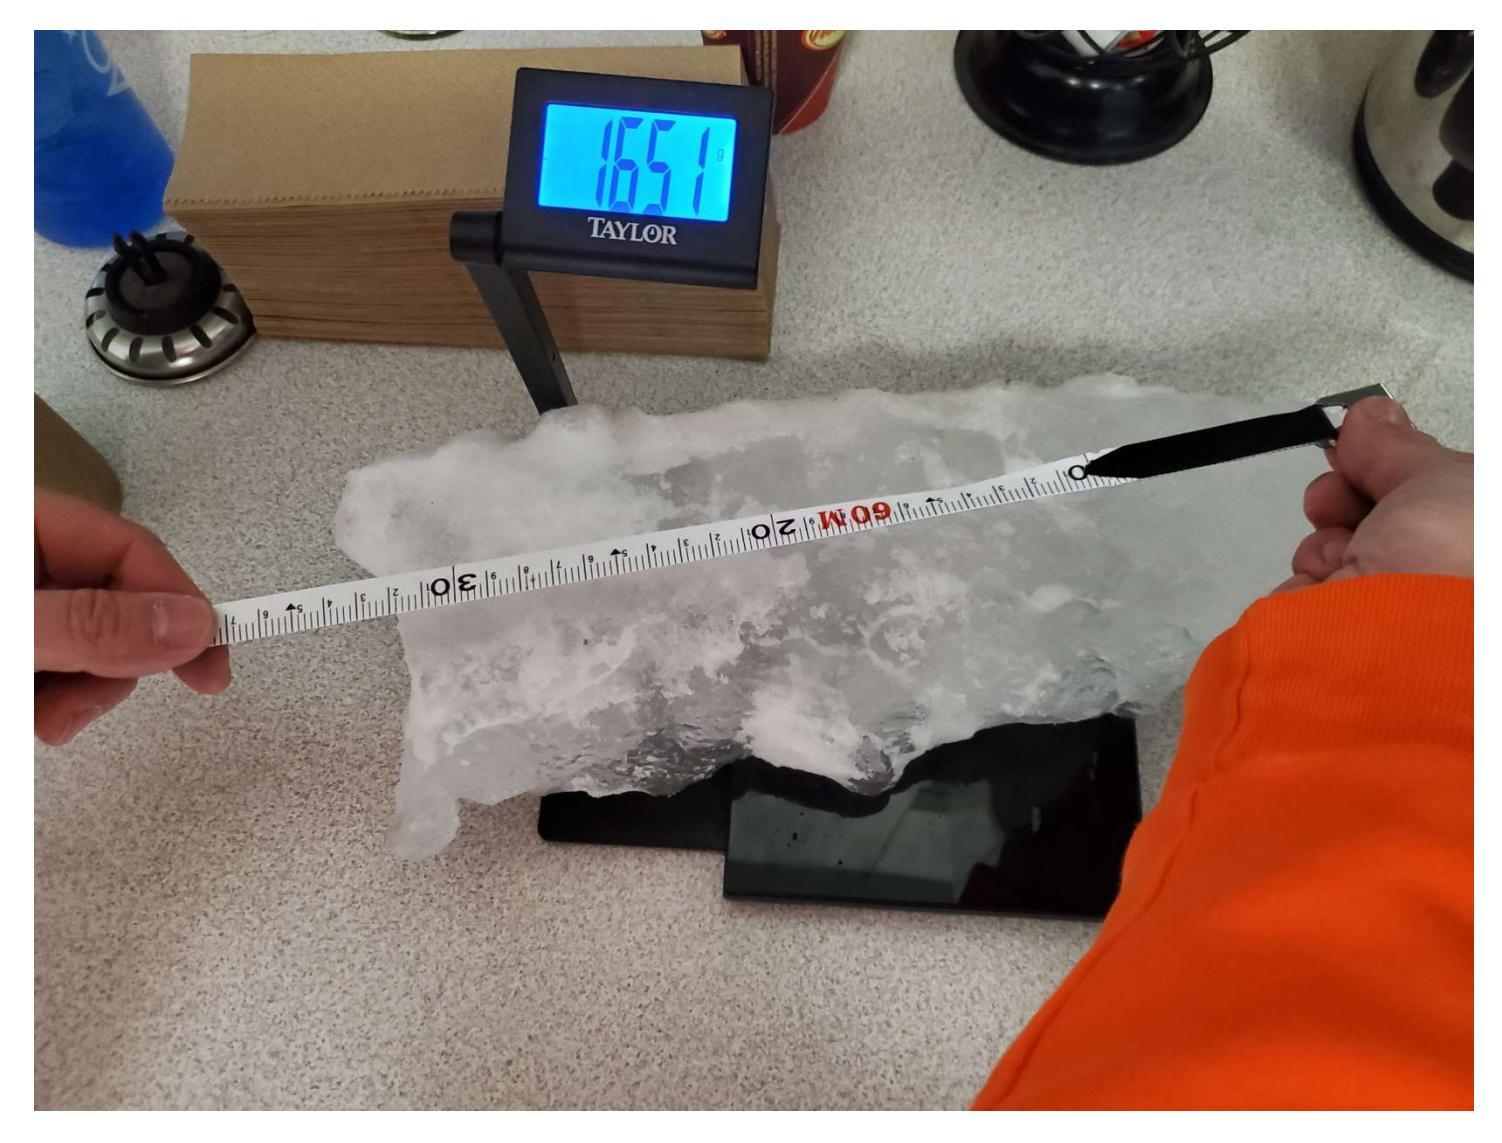
The following ice sample was collected from the Structures in the 340's structure location (Cluster 1). The sample weighs 1,651 grams and measures approximately 320 mm long (in direction of line) and 160 mm wide.

Photo 19 – Ice Sample Weight and Length Measurement from 340's

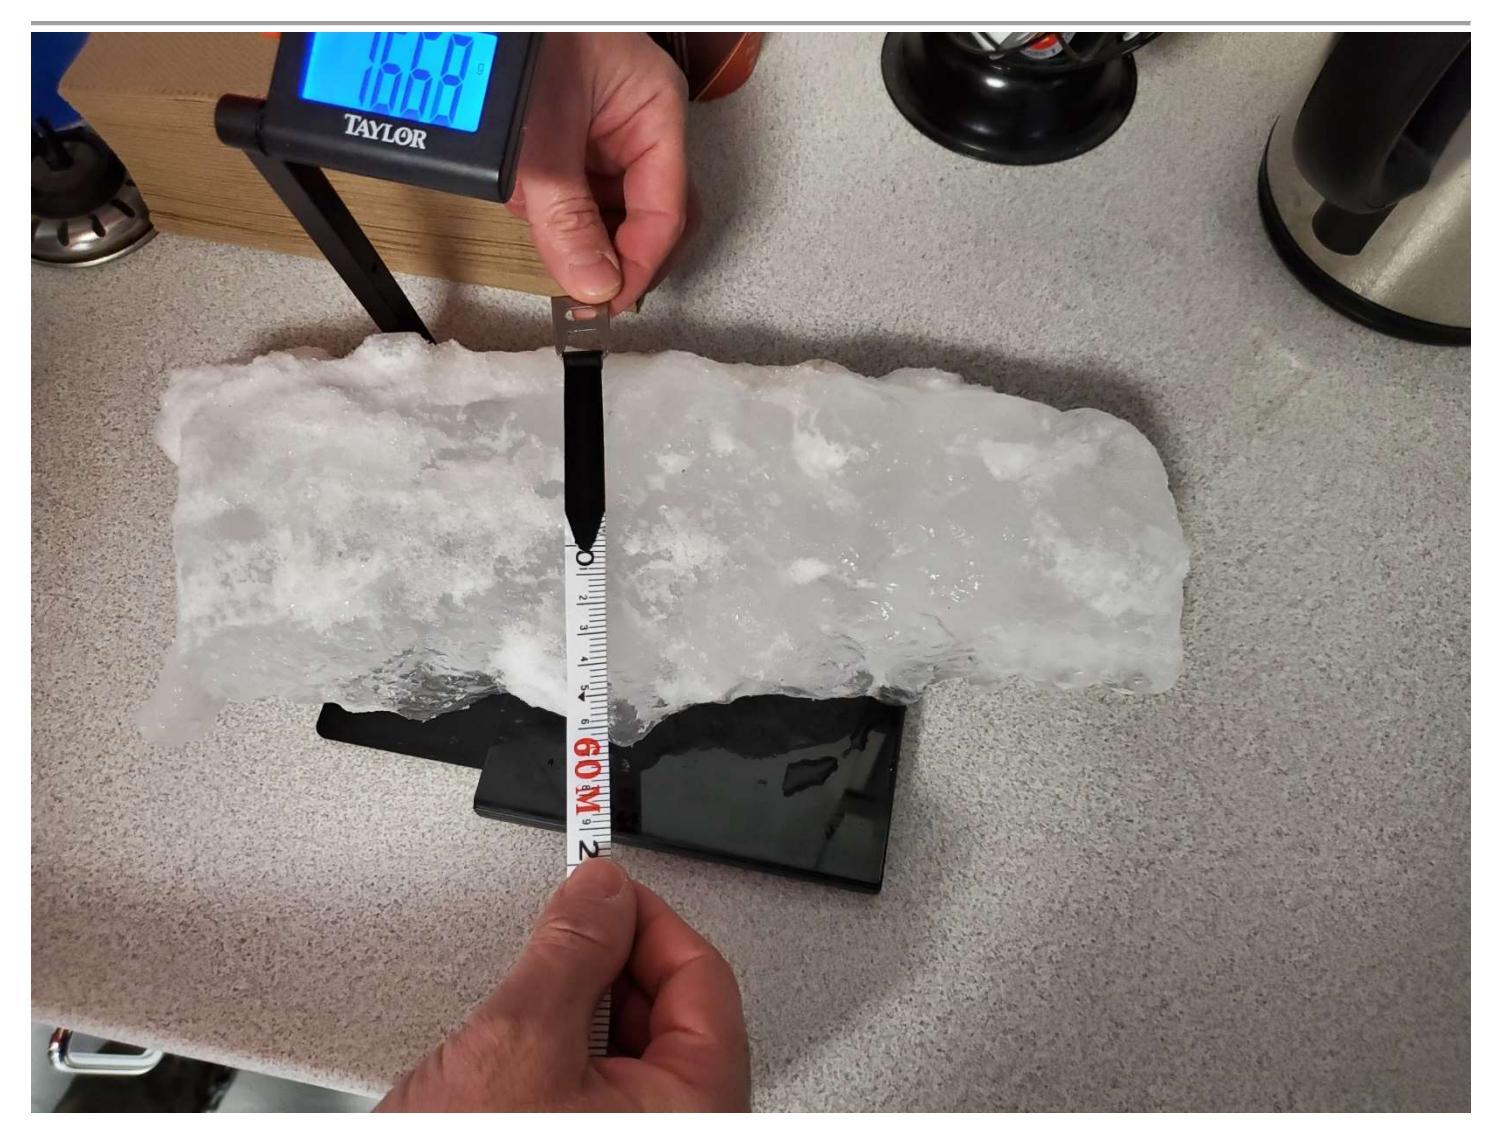
Photo 20 – Ice Sample Weight and Width Measurement from 340's

The ice samples that were measured and weighed were calculated to have a unit weights ranging from 5.1 to 10.6 kg/m. Note that the ice samples do not represent the total cross section of ice that was present on the line. The 10.6 kg/m sample, for example was estimate to represent approximately 80% of the total cross section. The total estimate unit weight of ice on the line based on this sample is therefore 13.3 kg/m.

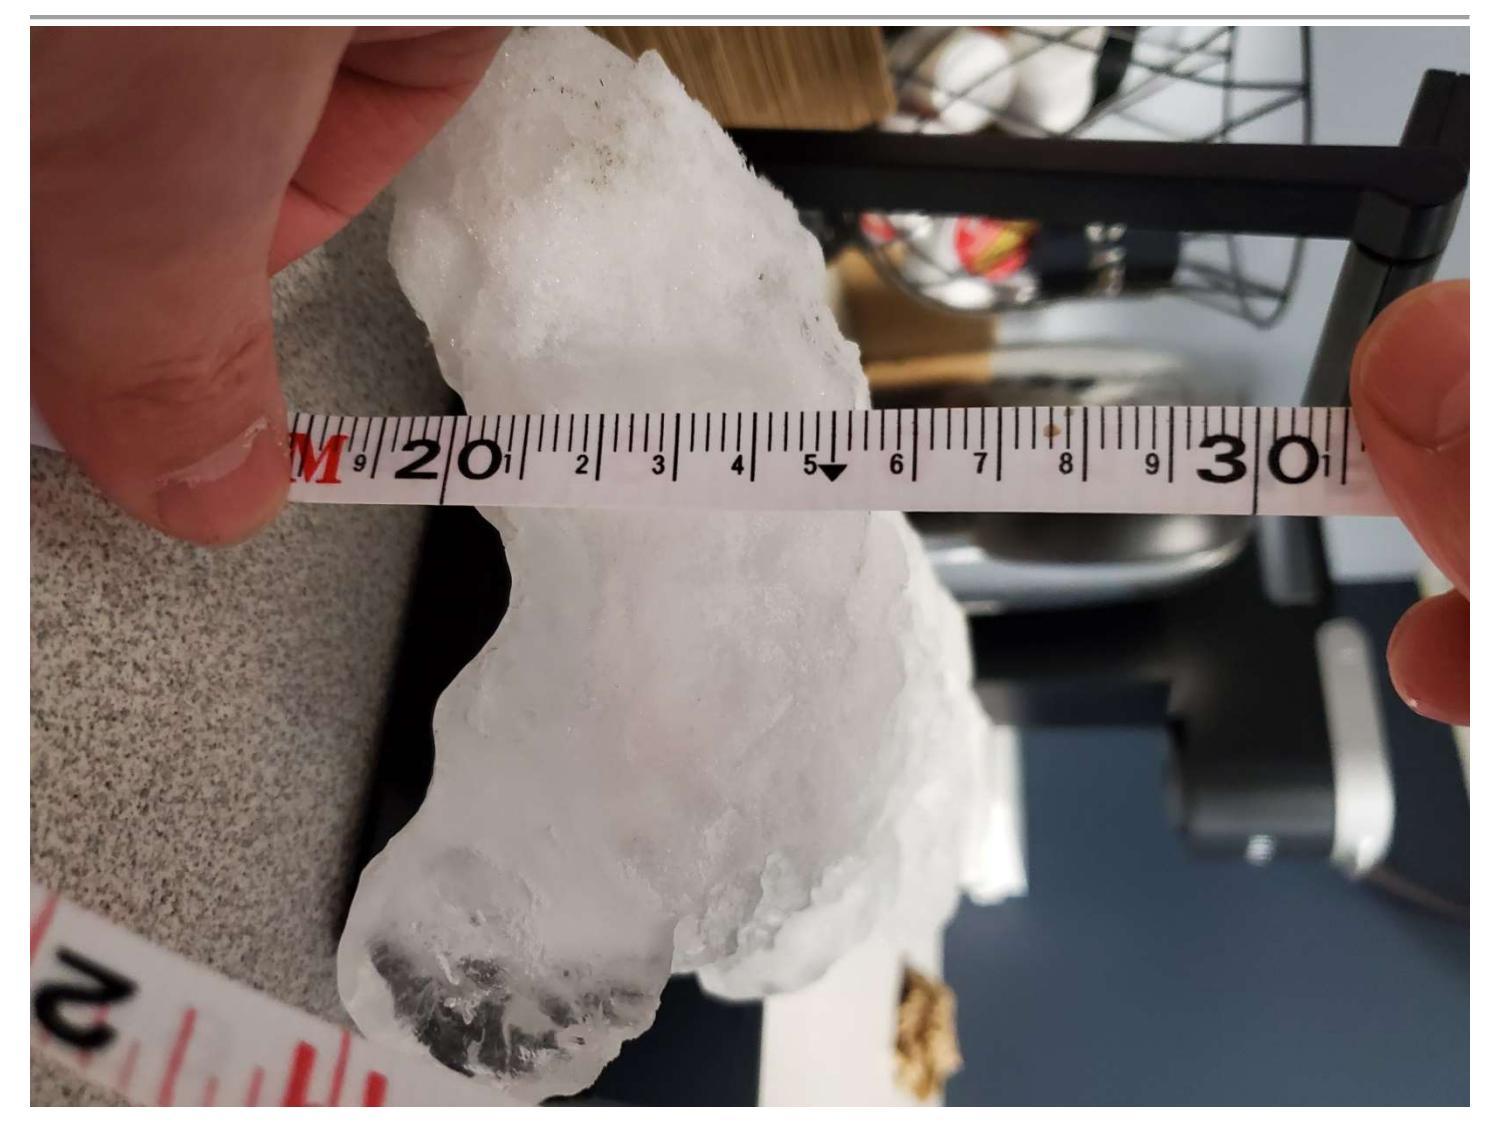
Photo 21 – Ice Sample Measurement from Edge of Conductor from the 340's

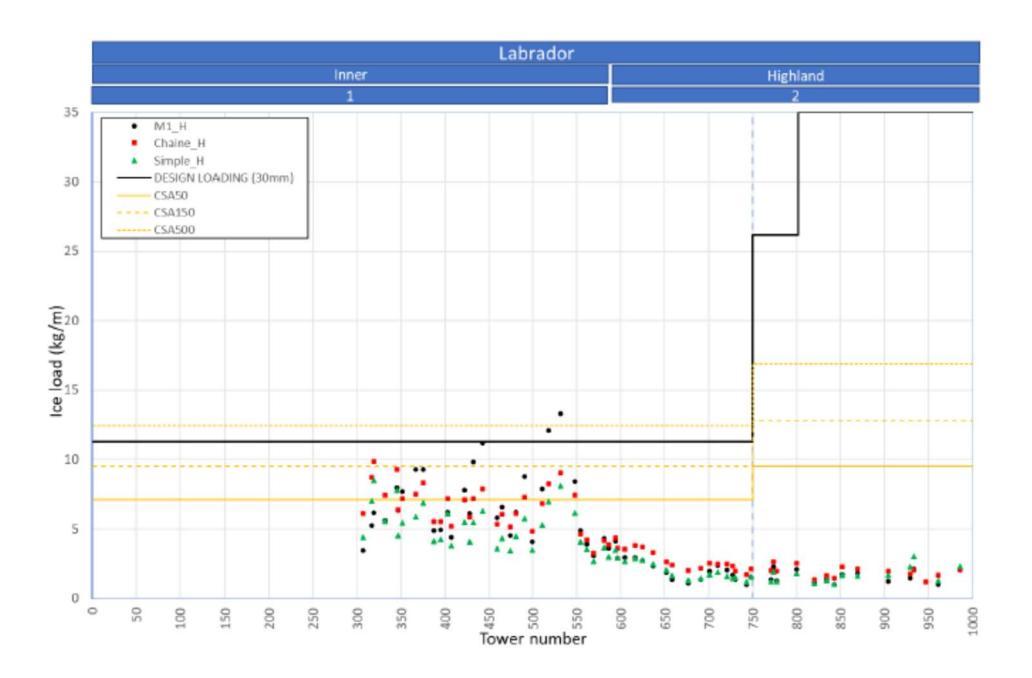
Figure 24 shows the total ice load from the January icing event compared to the design load, and CSA return period loads. In some cases the ice load from the storm was more than the design load.

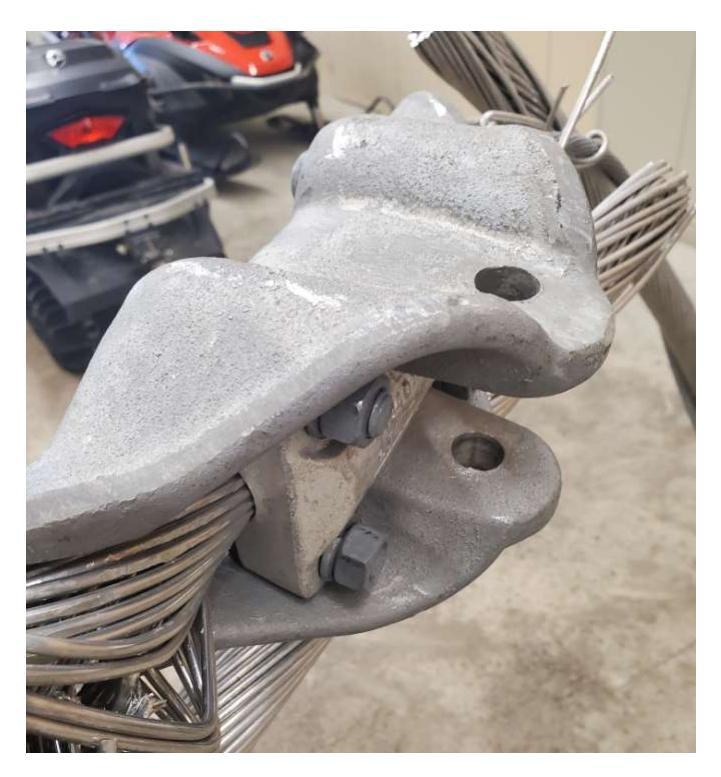
Visual inspections of the suspension clamps did show differential torques were applied to the four bolts that were used to hold the suspension clamp in place on the conductor. However, it was not clear if some of the bolts were loosened during the repairs that took place in January and February 2021.

It should be noted that these clamps, if improperly or unevenly torqued, can lose a significant amount of their slippage strength capacity. It has been noted that the use of lockwashers is not considered an affective means of preventing bolts from backing off and are no longer used by many utilities for this reason. See Appendix C "Conductor Failures – LITL".

Figures 25 – Suspension Clamp and Failed Conductor Location

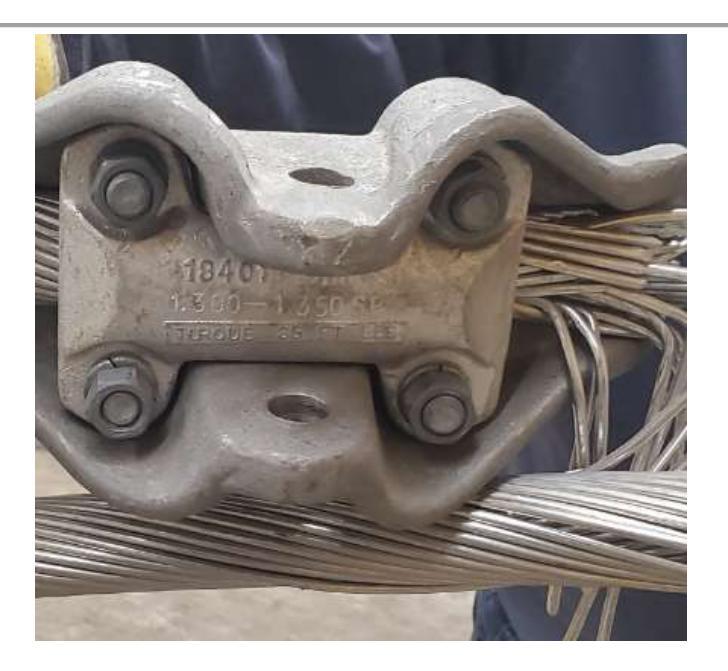
Figures 26 – Suspension Clamp and Failed Conductor Location (2)
