# Re: *Reliability and Resource Adequacy Study Review* – Labrador-Island Link Failure Investigation Reports

# Failure Investigation Report – L3501/2 Tower and Conductor Damage

Failure Investigation Report – L3501/2 Tower	R	evision R1		
Icing Event January 2021 in Labrador	Date:	Revision R1     :   28-May-2021     :   ii		
Nalcor Doc. No. ILK-EG-ED-6200-TL-RP-0001-01	Page:	ii

# FAILURE ANALYSIS OF ELECTRODE CROSS ARM IN LABRADOR ISLAND TRANSMISSION LINK (LITL)

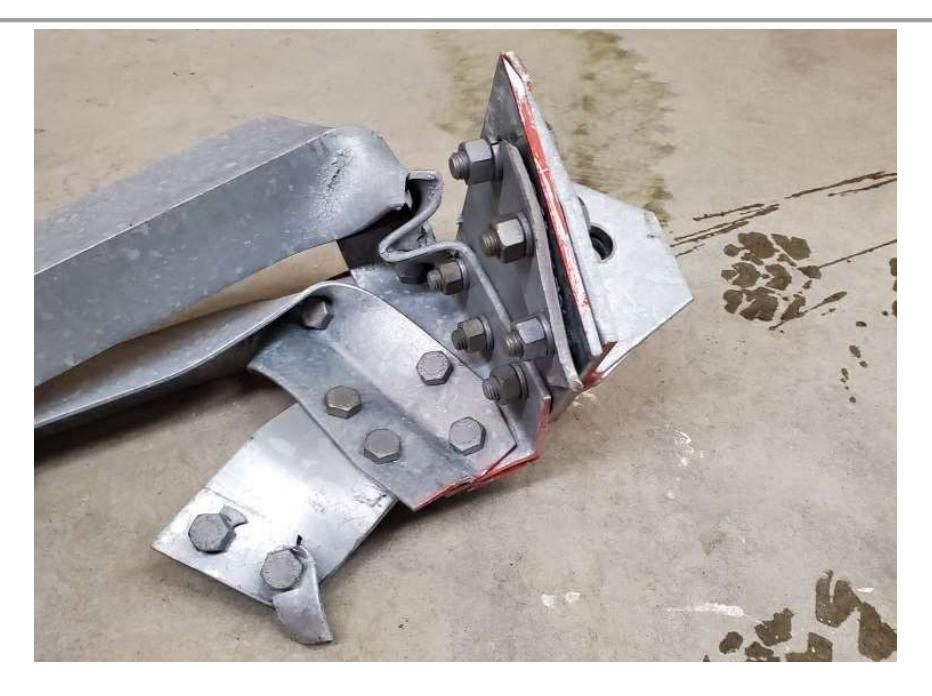
Figure 27 – Str. 340 Damaged Members from Cross Arm

Test results from Kinectrics on the cross arm indicate there were no issues with the material specification. Hardness, charpy impact, and chemical analysis results are all acceptable. The failure analysis concluded that the failure occurred at the location of the bolt holes, and was a ductile failure indicating an overloading event. There were no signs of fatigue or other insidious failure mechanisms.

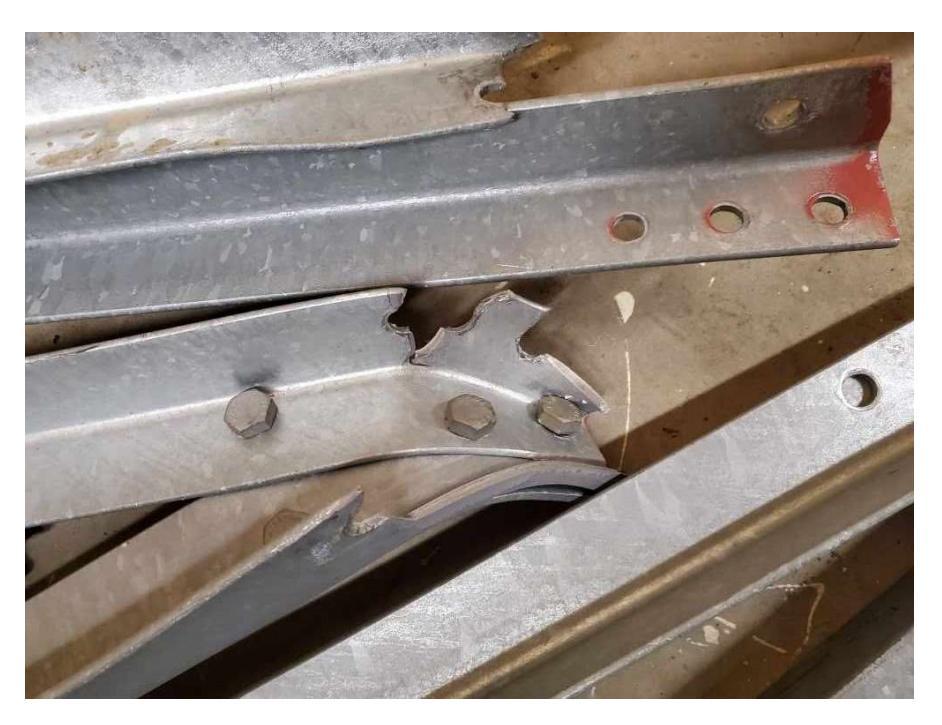
Figure 28 – Str. 340 Damaged Members from Cross Arm

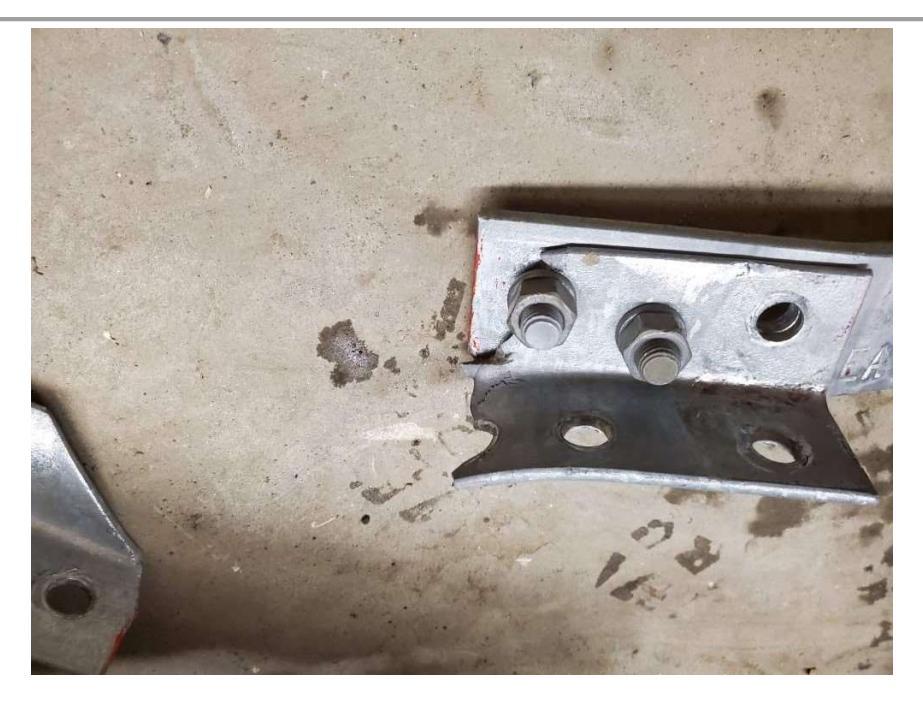
Figure 29 – Str. 340 Damaged Members from Cross Arm

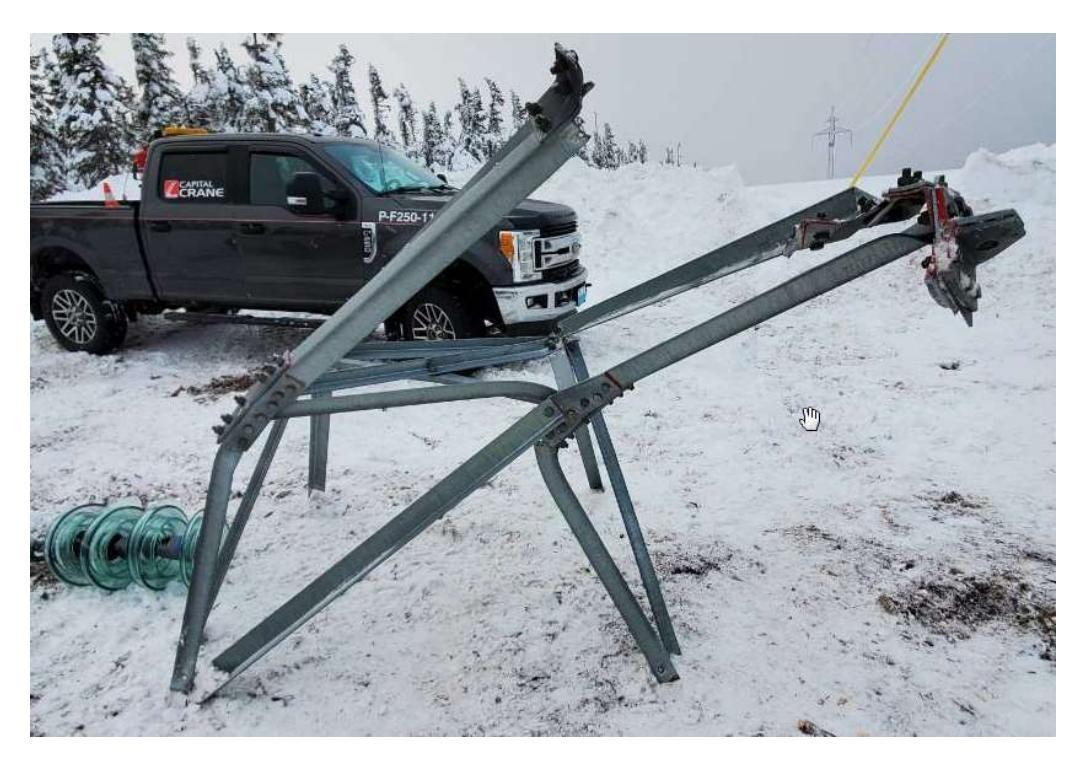
Figure 30 – Damaged Cross Arm from Str. 364

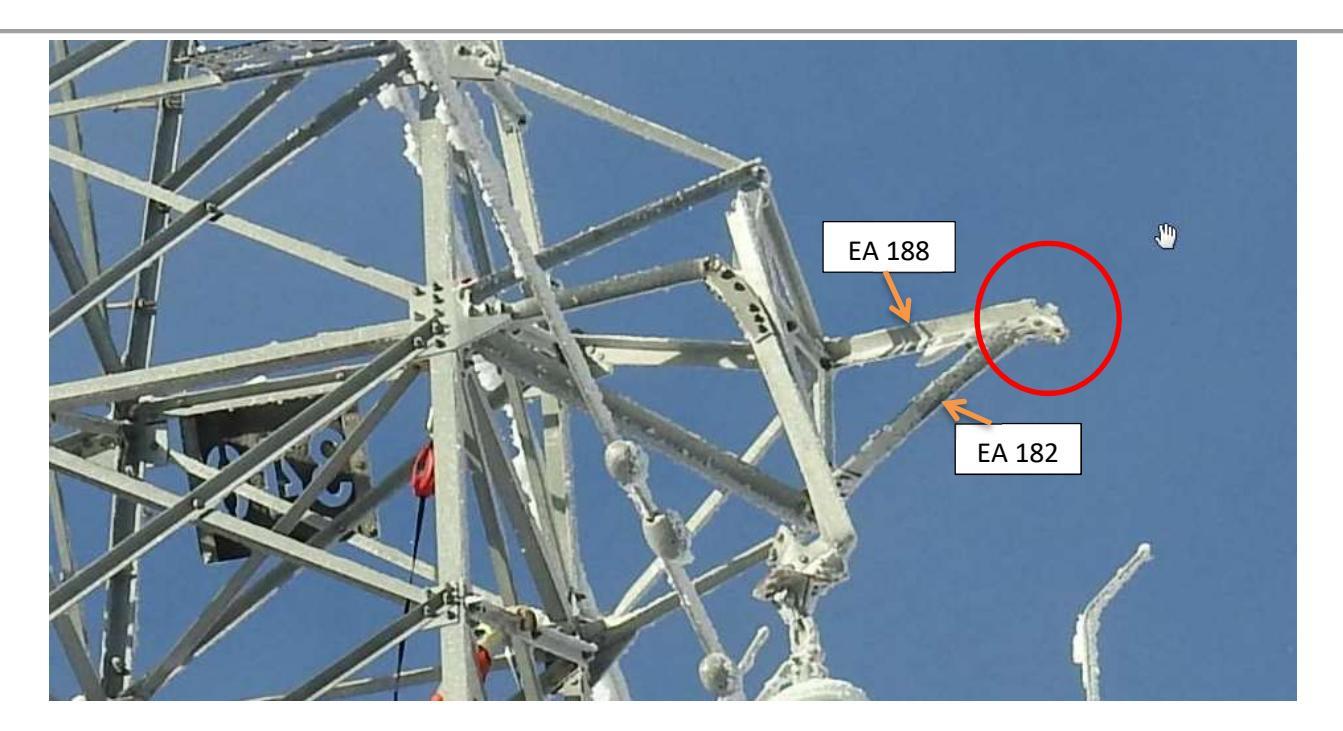
- 1. The cleat that the insulator string attaches to (consists of two angles, EA 186 and EA 187);
- 2. The two members that are located on the lower portion of the cross arm (EA 182/183); and
- 3. The two members on the upper portion of the electrode cross arm (EA 188/189).

Figure 32 – Str. 340

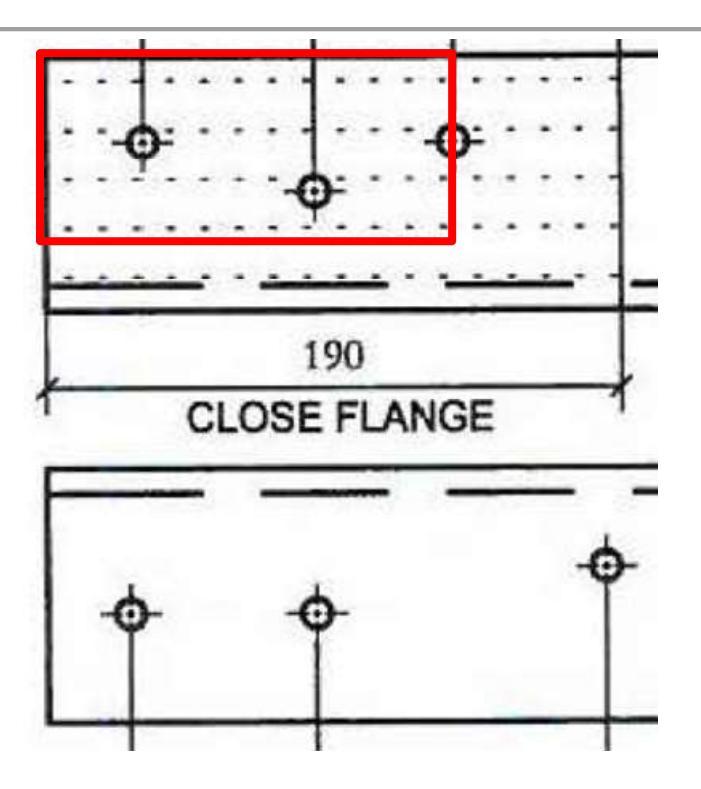
Figure 34 – Member 182 Failure Path on Str. 340

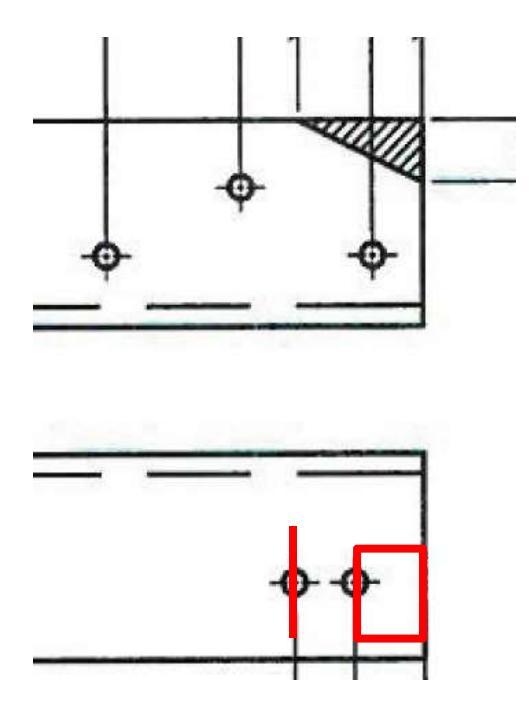
Figure 35 – Member 188 Failure Path on Str. 340

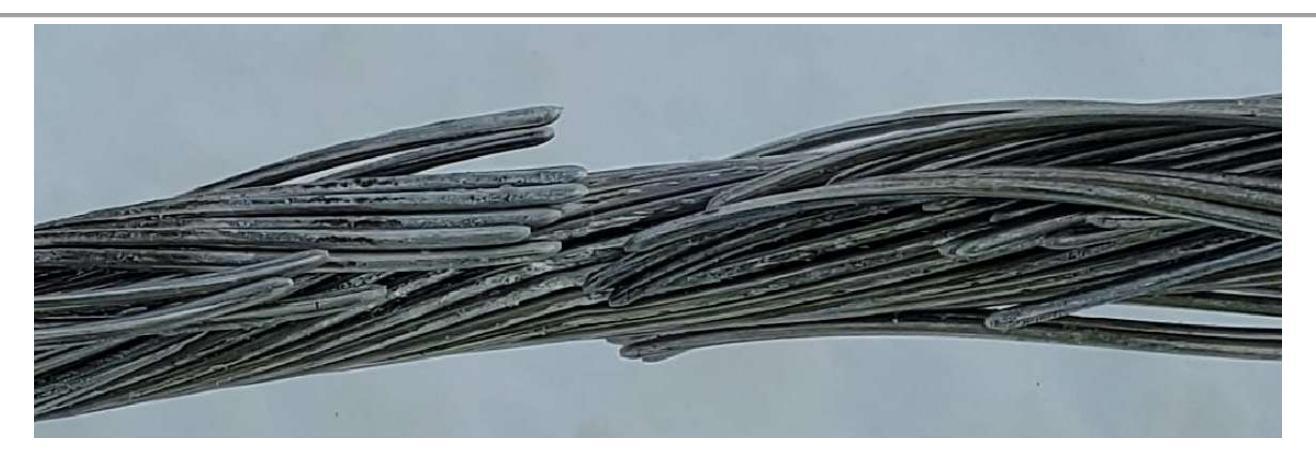
- Multiple broken strands close to the suspension clamps;
- Complete removal of sections of the aluminum close to the suspension clamps;
- Indentations on the top aluminum layer close to the suspension clamps;
- Complete failure of the conductor (all strands broken);
- Conductor strands have broken in two modes, i.e. tensile and fatigue or shock loading;
- Conductor strands show signs of excessive rubbing/fretting; and
- Second layer aluminum strands have fatigue or shock loading type failures.

Figure 38 – Damaged EL1 Conductor at Str. 343

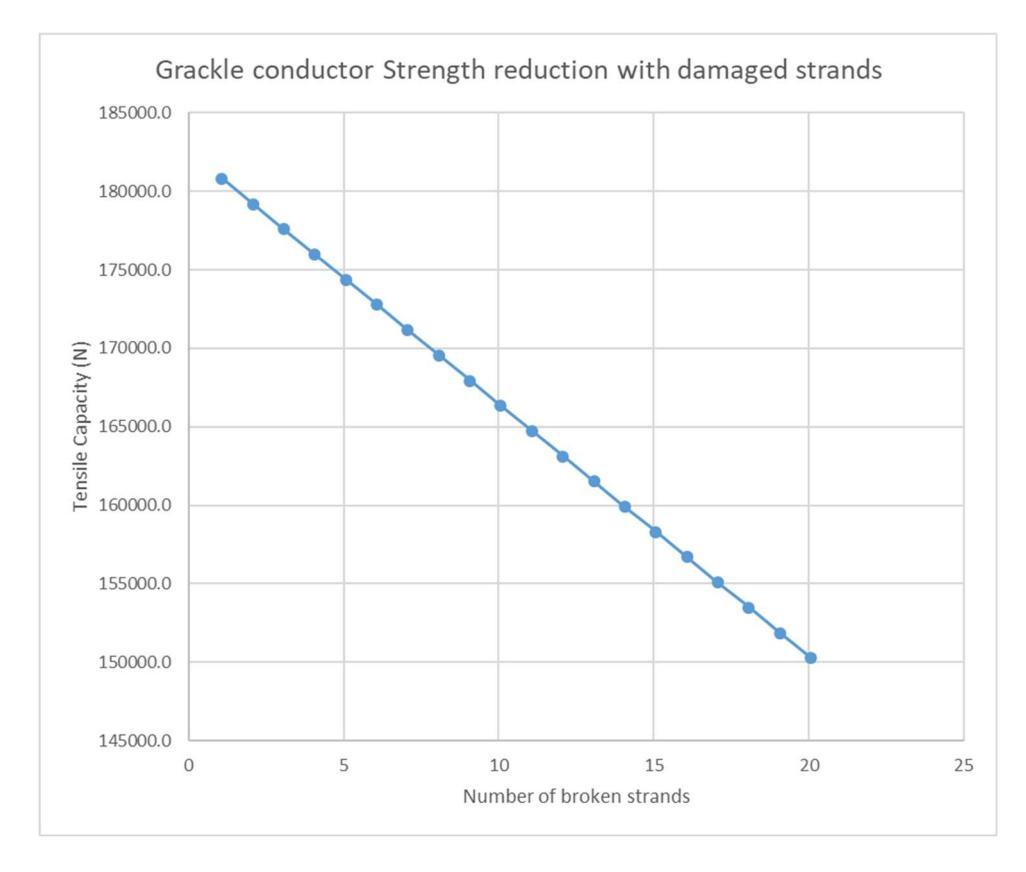
Further indication of this theory was presented upon the analysis of the reduction in tensile capacity of the conductor. One broken conductor on EL2 at structure 526 showed only 10 visible broken strands prior to its breakage. With 10 broken strands the conductor tensile capacity would still be approximately 166 kN. See Figure 39.

Figure 39 – Electrode Conductor Strength Reduction with Damaged Strands

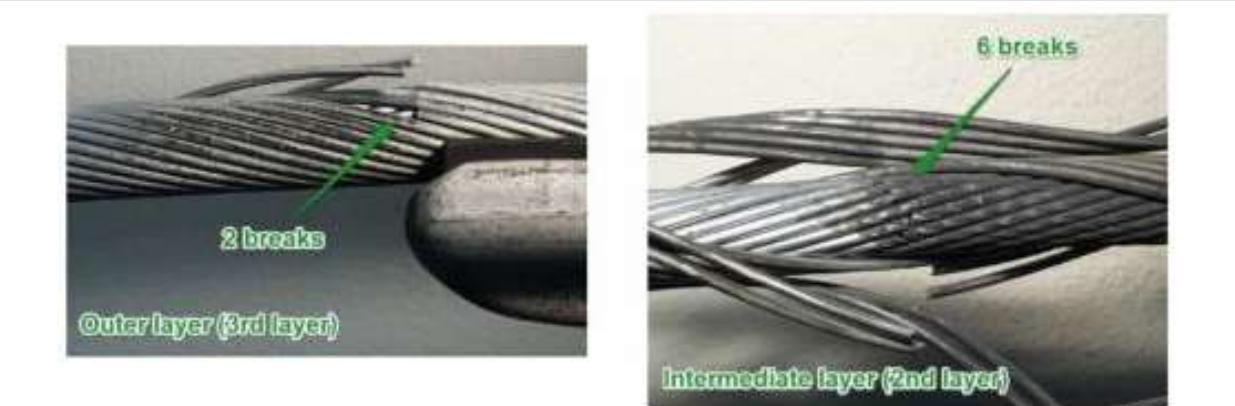
During vibration or galloping, the 1st and 2nd layer (inner layers) of aluminum tend to have the worst damage as the strands experience fretting from the strands above and below it. The outer layer of aluminum on the Electrode Line ACSR conductor has fretting only due to abrasion from the strands below, hence shows less damage. Figure 41 shows examples of damage on inner layers that are not visible under the outer strands. These are example only and not samples from L3501/2.

Figure 41 – Example Inner Aluminum Strand Damage (not L3501/2)

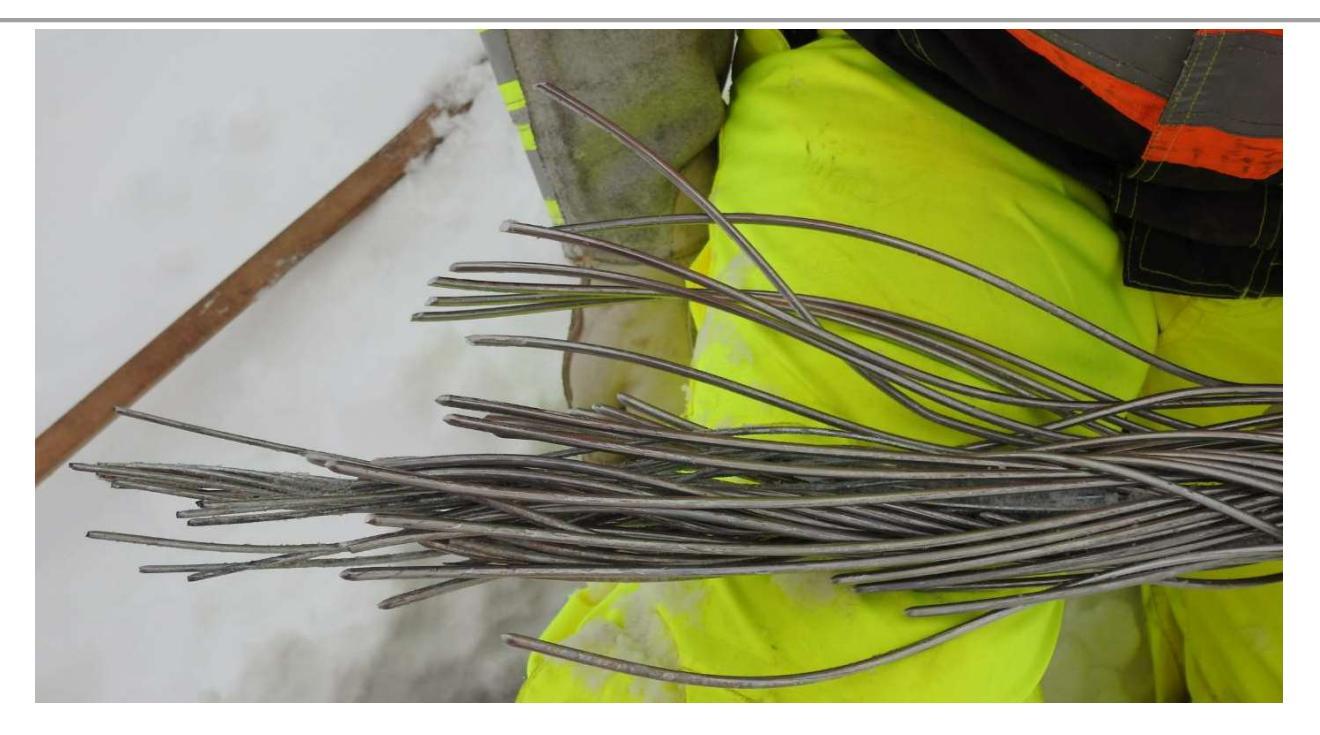
Figures 42 and 43 show the damage strands from the Broken EL2 conductor at Str. 526. There are indications from inspection of both fatigue and fracture failures to inner and outer strands.

Figure 43 – Failed EL2 Conductor at Str. 526 (2)

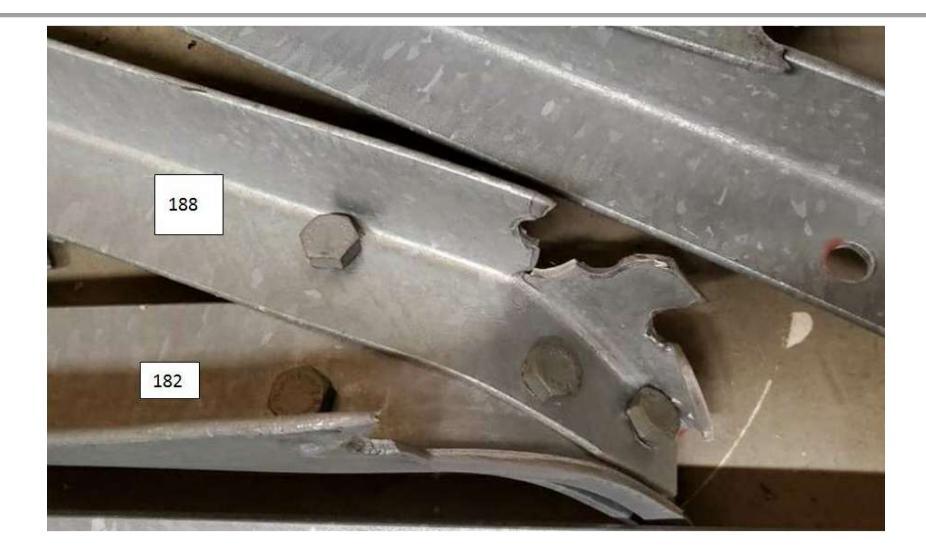
In each cross arm failure, member 188/189 suffered block shear tear out failure such as the one shown below on member 188 on Str. 340.

Figure 44 – Block Tear Out on Member 188 from Str. 340

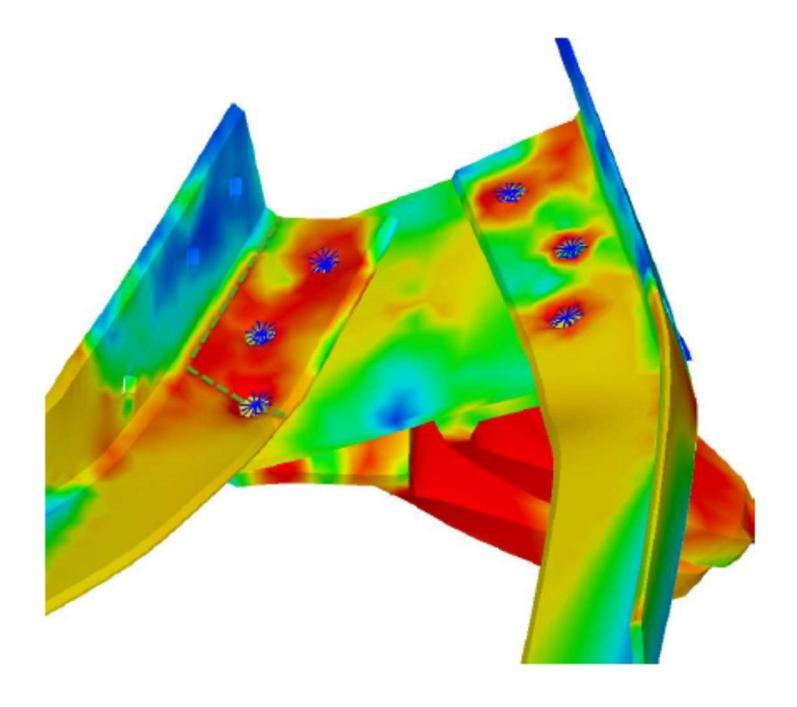
EFLA has modeled the cross arm in a finite element model to better understand the failure. The model replicated the failure observed in the field with a rupture failure at the bolt holes at the end of the angles on the electrode cross arm.

Figure 47 – Block Tear out Failure Path on FEM

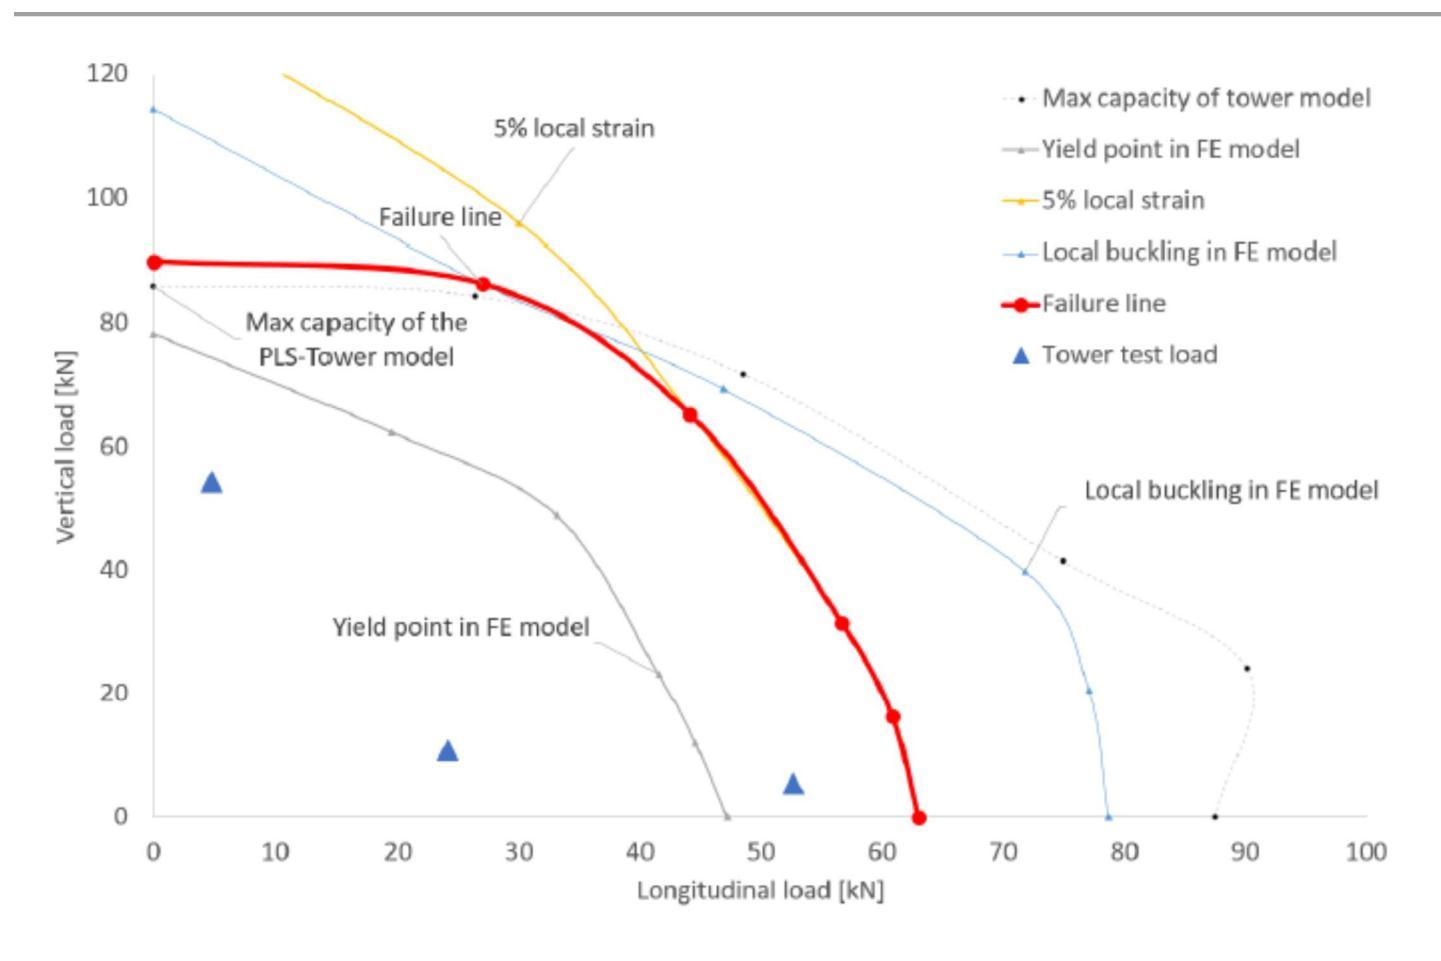
The figure below shows the failure envelop for the vertical and longitudinal loads. The failure envelop for the FEM model is shown in red based on the local strain and local buckling. It should be noted that the PLS-TOWER model under estimates the vertical and over estimates the longitudinal capacity according to the FEM. Also note that the maximum vertical design load on the electrode cross arm is 64.9 kN (under maximum ice) and the maximum longitudinal design load is 52.7 kN (under broken conductor condition), both which are within the failure limits based on the FEM. The arm design is consistent with the requirements under the design loadings and loading seen during the icing event could exceed this capacity. The failure pattern seen in cross arms are consistent with the loading seen.

Note that a longitudinal load of 65 kN will cause failure in the cross arm according to the FEM. This is approximately the slip strength capacity of the suspension clamp were we are also seeing failures. A combination of the vertical and longitudinal load caused by unbalanced icing would fall outside the failure limits of the chart. For example, the unbalanced ice load case 75 mm of radial ice with 28/70% of ice thickness on the ahead/back span for str. 525 has a 62 kN longitudinal load and a 41 kN vertical load. The FEM plot suggests this will result in a failure of the cross arm. See Appendix F for complete report "Failure Analysis of Electrode Cross Arm in Labrador-Island Transmission Link (LITL)".

Figure 48 – Failure Envelope for the Cross Arm

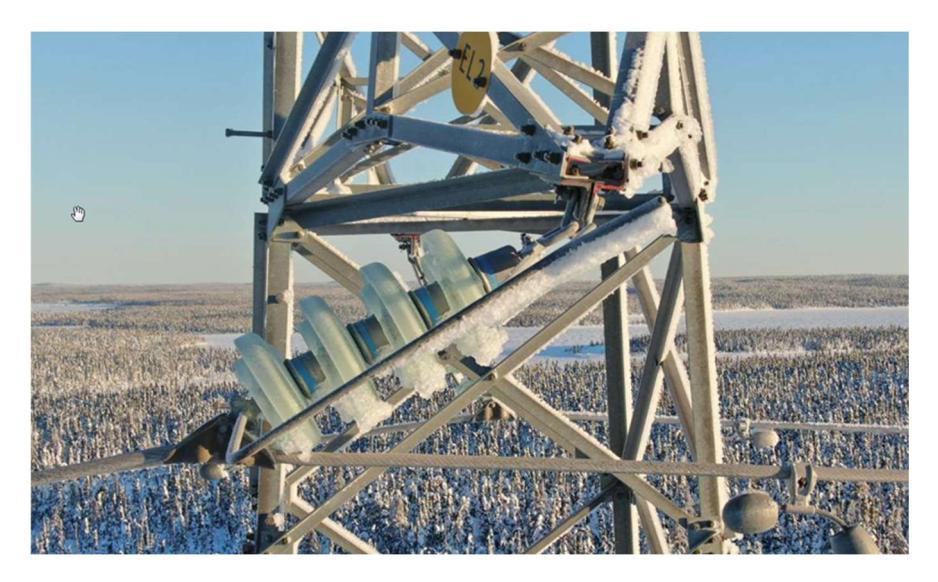
Due to the short length of the electrode insulator assembly, and the large insulator swing due to unbalanced ice, it was observed that the insulator can contact the conductor. See Photo 22. It was calculated that this switch can be created by a difference of approximately a 4.5 kg/m ice load on adjacent spans. See Appendix C for more details.

Photo 22 – Insulators on Electrode Assembly Contacting the Conductor

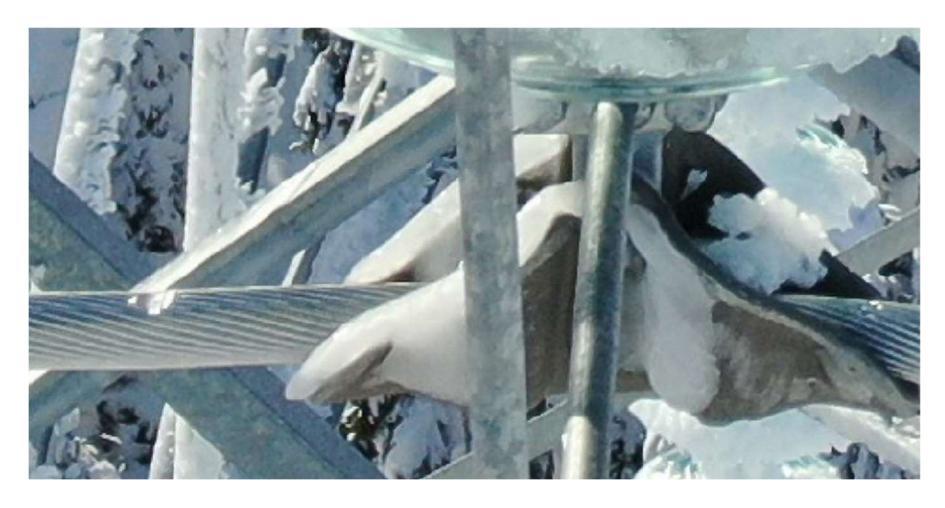
There have been dents observed in the conductor near the insulator assembly. These dents are likely due the insulator contact. The hardness of the glass is greater than the hardness of the conductor. The denting could be a contributing factor to the conductor damage.

Photo 23 – Dent in the conductor near the tangent assembly

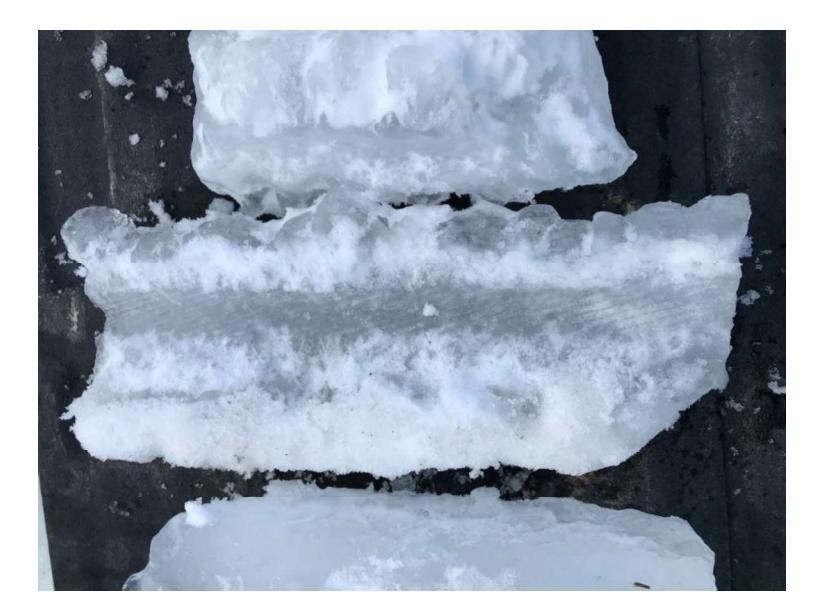
Few icing samples were measured and weighted by Nalcor. The ice samples measured and weighed were calculated to have unit weights ranging from 5.1 to 10.6 kg/m. Note that the ice samples do not represent the total cross-section of ice that was present on the line. For example, the 10.6 kg/m sample was estimated to represent approximately 80% of the total cross-section. The total estimated unit weight of ice on the line based on this sample is 13.3 kg/m (at tower 340).

FIGURE 2 Ice falling from the conductor at tower 340, date 2021-01-18

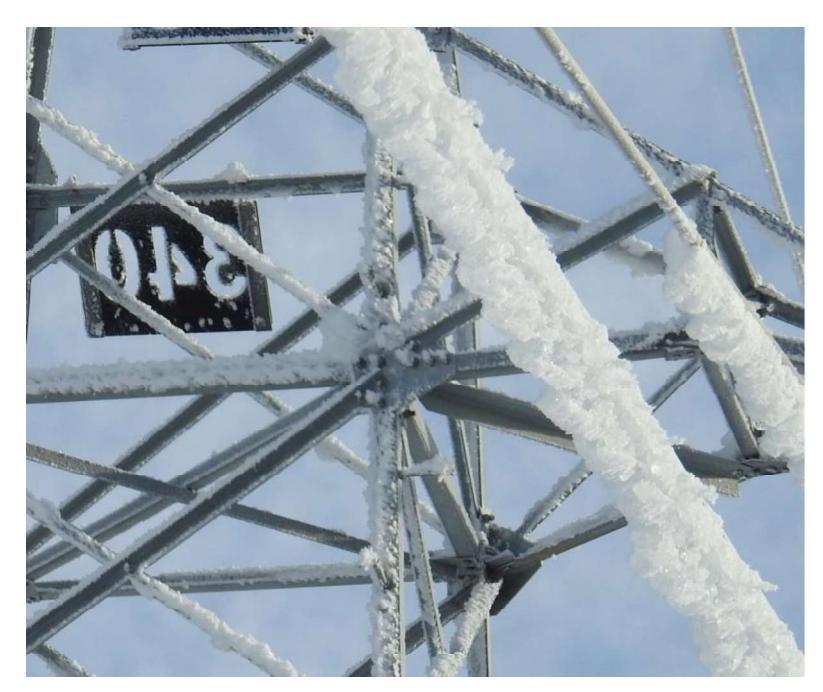
The icing appearance varied along the line. In some areas, it was with a white appearance quite dense, see Figure 3. It was mixed with rime in some areas, see Figure 5, and in others, it was a clear glaze with icicles; see Figure 4.

FIGURE 3 Icing at tower 340, date 2021-01-15

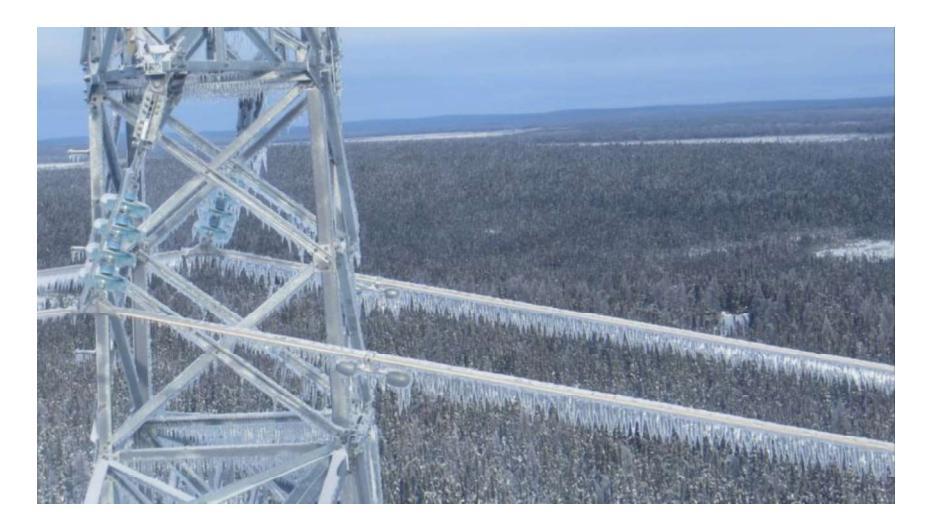
FIGURE 4 Glaze icing with icicles. Date 2021-01-15.

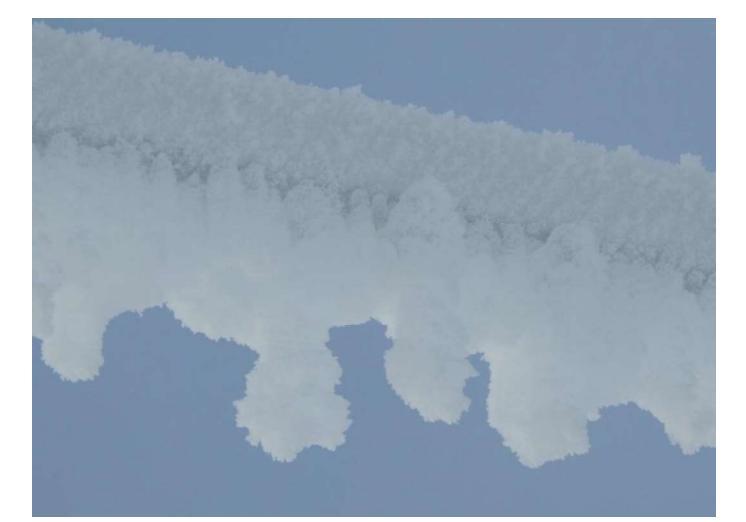
FIGURE 6 Rime icing onto glaze icing

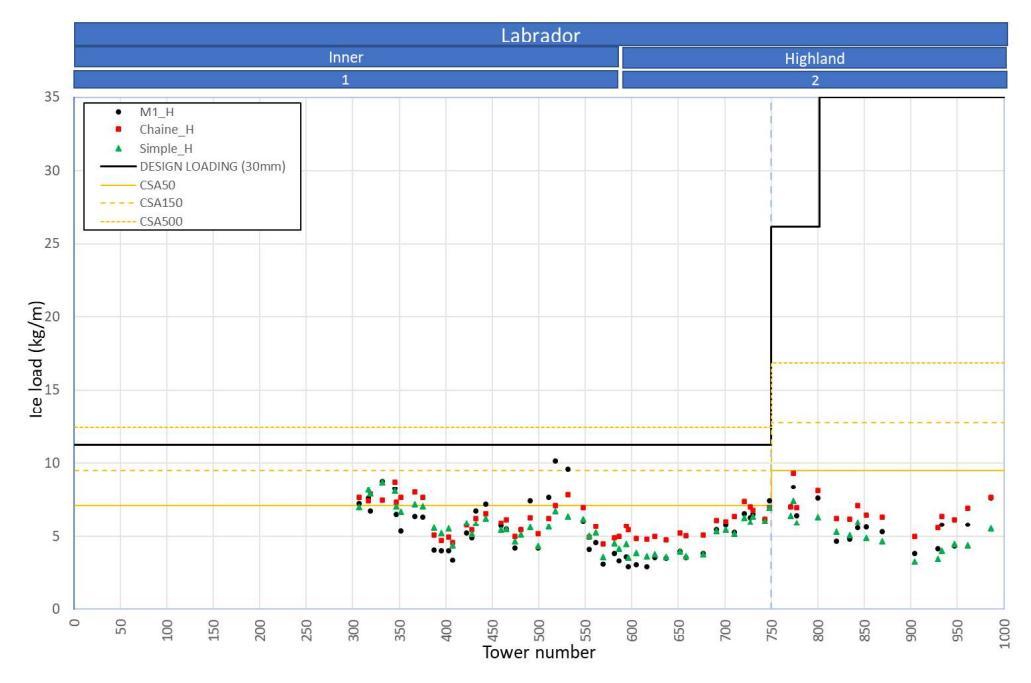
Figure 10 shows the estimated 50 years icing value at different tower sites and a comparison to the design ice load and proposed glaze ice loading in the CSA standard. The solid black line represents design loading used in the LITL (converted to 30 mm conductor) and the orange lines show proposed loading in the CSA standard. The results show that there is a consistency in the icing prediction between tower sites. The Chainé model predicts the highest icing in most cases. The M1\_H model predicts higher loading in few instances, e.g., towers 518 and 531, partly because rime icing and wet-snow icing are included. Generally, the predicted ice values are well within the design loading. Predicted icing is above the 50-years proposal in the CSA standard in some towers, and the M1\_H model is above the 150-years proposal in two cases.

FIGURE 10 Prediction of 50 years icing of the three icing models (30mm conductor). The black line represents the design loading in the LITL.

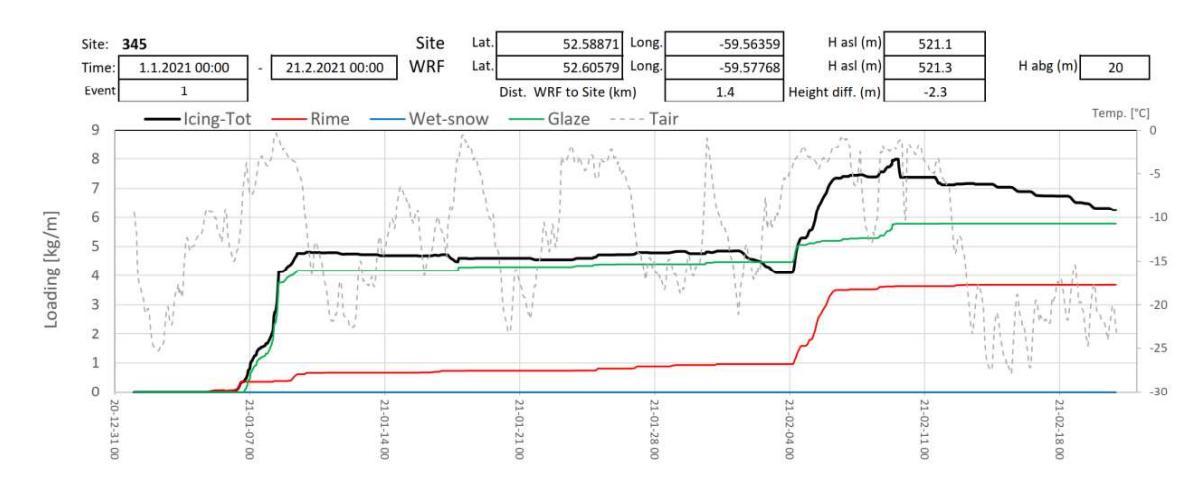
Figures 14 to 17show examples of accumulation in WRF points close to tower sites 345, 367, 443 and 531. Glaze icing is dominant in all cases, although rime icing is also present. Peak icing is evaluated as 13.3 kg/m at site 531. Total accumulation ("Icing-Tot") is the total icing at each time considering ice removal, while lines for each icing type are without ice removal and show the total accumulated ice. Ice removal in this event is a mixture of sublimation melting and ice shedding in the end.

FIGURE 14 M1\_H model, icing prediction at tower site 345 in the period of 01.Jan.-21.Feb. 2012. The larger part of accumulation is due to freezing rain, but rime icing is also present. Temperature varies but does not exceed 0°C in the period.

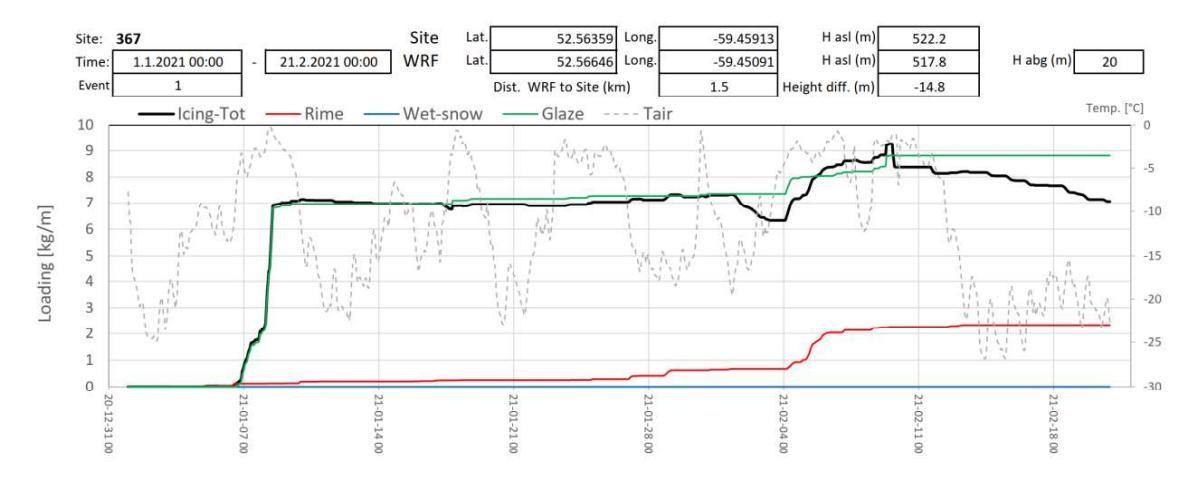
**FIGURE 15** M1\_H model, icing prediction at tower site 367 in the period of 01.Jan.-21.Feb. 2012. The larger part of the accumulation is due to freezing rain, but some rime icing is also present. Temperature varies but does not exceed 0°C in the period.

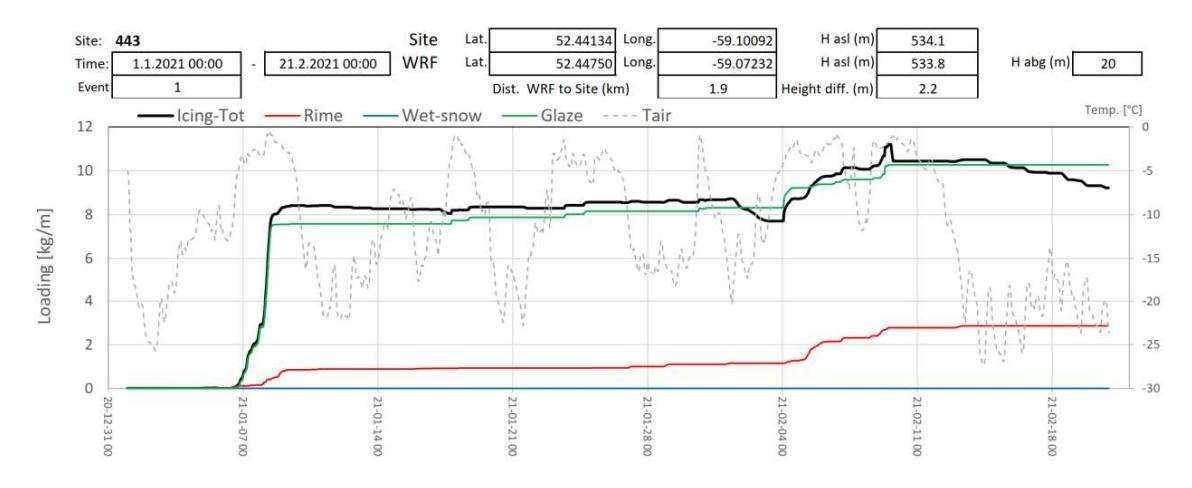
FIGURE 16 M1\_H model, icing prediction at tower site 443 in the period of 01.Jan.-21.Feb. 2012. The larger part of accumulation is due to freezing rain, but rime icing is also present. Temperature varies but does not exceed 0°C in the period.

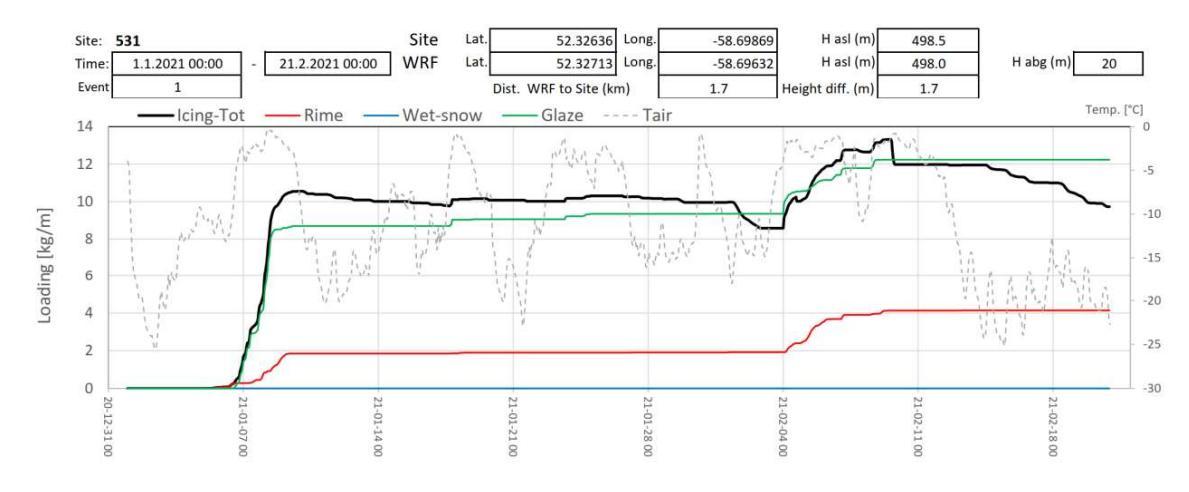
FIGURE 17 M1\_H model, icing prediction at tower site 531 in the period of 01.Jan.-21.Feb. 2012. The larger part of accumulation is due to freezing rain, but rime icing is also present. Temperature varies but does not exceed 0°C in the period.

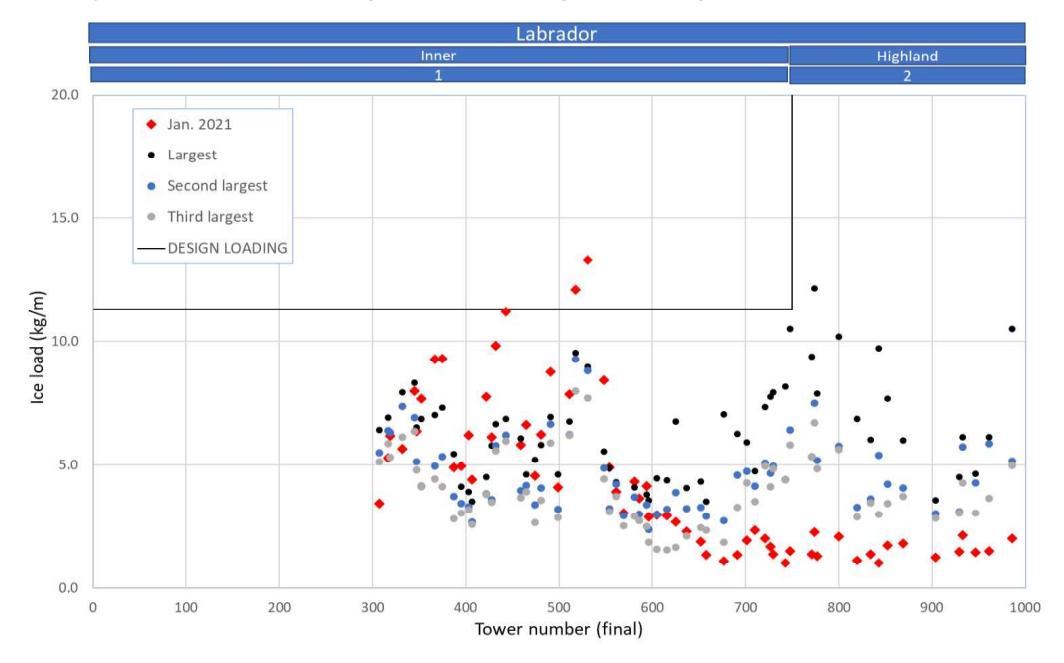
Figure 20 shows the three largest events at each site in 1979-2019 compared to the January icing event. The January event 2021 is exceeding the historical highest loading in areas between towers 360-531.

FIGURE 20 Comparison of January ice storm to the three largest icing events in 1979-2019 in the M1H model.

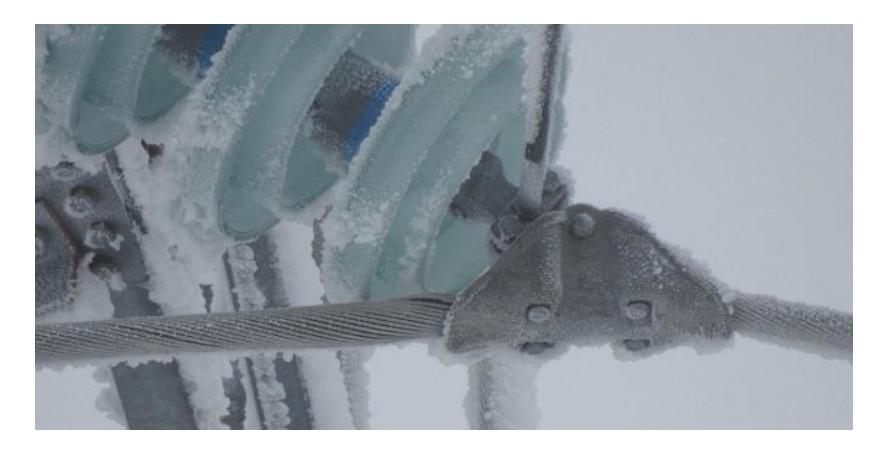
FIGURE 6 Maximum Insulator longitudinal swing

The photo in **FIGURE 6** below shows the electrode insulator at tower 527 in contact with the conductor. The insulator glass has a higher Mohrs hardness than that of the conductor and hence can damage the conductor strands.

- 3. A very low unbalanced load of 4 kg/m can cause the electrode insulator glass disk to rub against the electrode conductor and damage the strands. The loading required is well within the design loads of 10 kg/m. Nalcor must investigate the possibility of increasing the distance between the conductor clamp and the insulator closest to the conductor so that the string can accommodate greater longitudinal swing than 55 degrees and not damage the conductor.

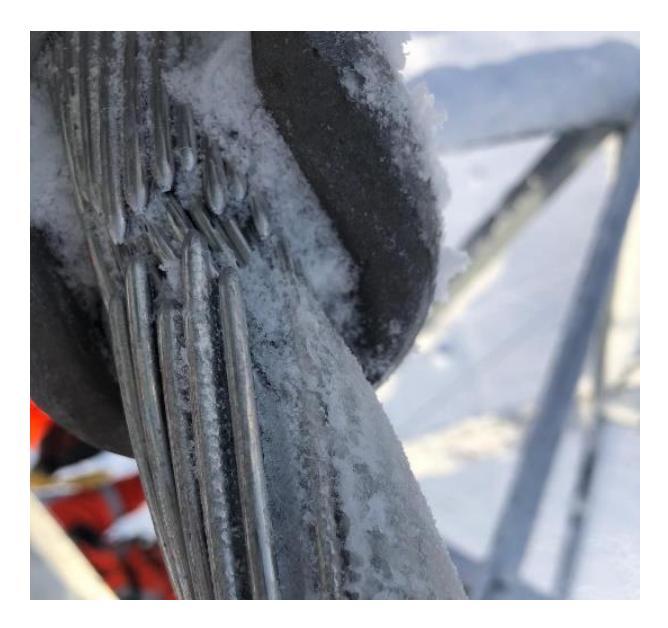
The aluminium strands shown in **FIGURE 9** failed in tensile mode as indicated by the cone shaped ends of the broken strands. This failure is possible if the insulator swing is great enough to result in the insulator rubbing against the aluminium conductor strands. The glass disk has a higher hardness than that of the aluminium strands and hence would cut into the aluminium with movement of the conductor or insulator. The cutting action would reduce the area of the aluminium thereby reducing its tensile capacity. The increase in ice load coupled with the decrease in temperature and subsequent increase in tension in the aluminium strands will then result in the tensile failure of the strands.

FIGURE 9 Conductor damage: Tensile failure of strands

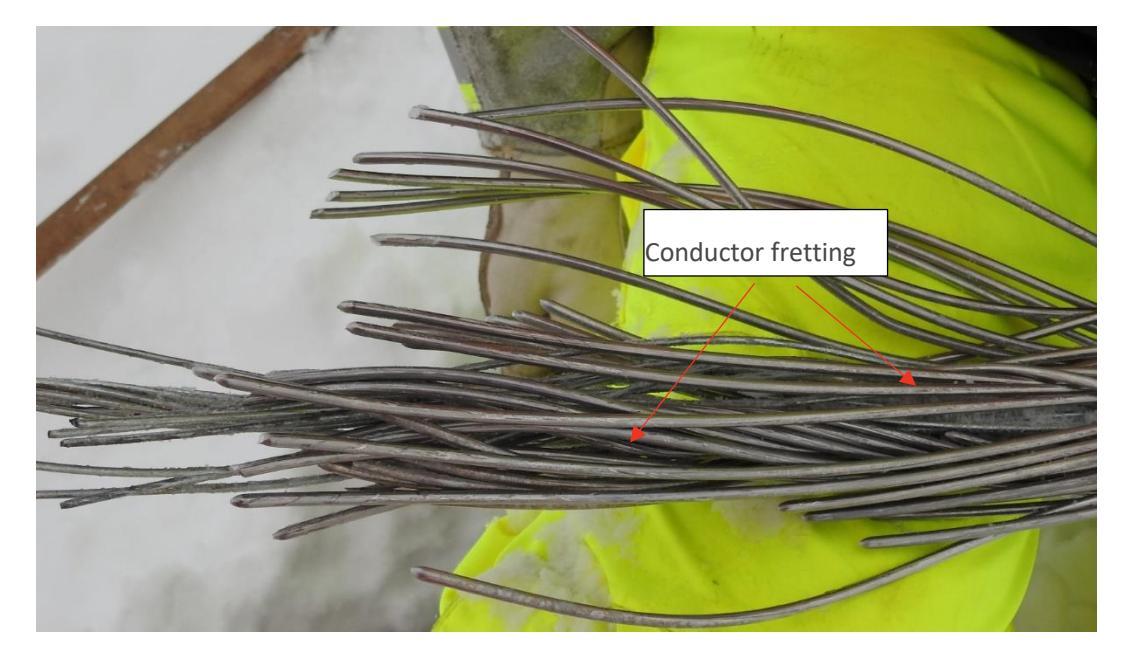
**FIGURE 10** and **FIGURE 11** show the damaged electrode 2 conductor removed from Tower 526. The strands in the second layer of aluminium in **FIGURE 10** show fretting which is a sign of movement between the strands possibly created by conductor galloping, aeolian vibration or large amplitude oscillations.

When the conductor failed (broke), the load on the conductor was estimated at 11 kg/m based on the ice sample taken from site. A uniform load of 11 kg/m applied to all spans in the tension section between towers 523 and 541, gives an electrode conductor tension of 140 kN or 72% of the conductor RTS (rated tensile strength). The same ice load applied as an unbalanced load will give a lower conductor tension due to suspension insulator movement and lower overall ice loads being applied.

The workmen indicated that they saw 10 broken strands on the conductor. This would reduce the tensile capacity of the conductor from 194 to 170 kN, see **FIGURE 3**. This is still sufficient to carry the ice load calculated above with a 20% margin of safety. The stress in the aluminium strands would be approximately 125 N/mm<sup>2</sup> according to **FIGURE 2**, well below the maximum stress level. The shift of load from the steel core to the aluminium strands is difficult to calculate, however the increase according to **FIGURE 5** seems to be in the order of magnitude of 10% from 0 °C to minus 20 °C. This implies that the conductor should not have failed under these loads.

FIGURE 10 Conductor damage from tower 526: Fretting marks visible

It is important to conduct metallurgical tests on the conductor as soon as possible to establish the failure mechanism. It is also suggested to cut open and inspect the conductor sections that have been removed from the line. The sections close to the old suspension clamp positions should be inspected to check for fatigue failures in the conductor.

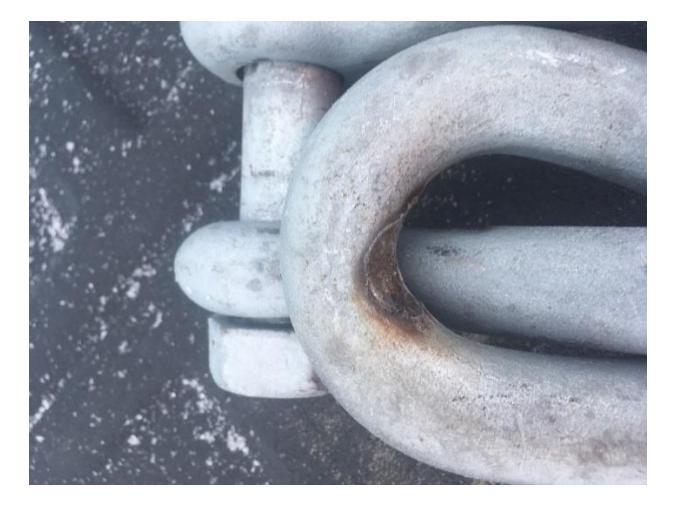
The hardware from tower 1209 shows signs of wear possibly resulting from galloping of the conductors.

FIGURE 13 Hardware from tower 1209 showing signs of wear

While galloping may not have been occurring when the conductor failed, conductor galloping could have damaged strands in the first and second layer of aluminium which resulted in the premature failure of the conductor at tower 526. No detailed images of the hardware from tower 526 were available.
