# Re: *Reliability and Resource Adequacy Study Review* – Labrador-Island Link Failure Investigation Reports

# Failure Investigation Report – L3501/2 Tower and Conductor Damage

Failure Investigation Report – L3501/2 Tower	R	evision R1		
Icing Event January 2021 in Labrador	Date:	Revision R1     :   28-May-2021     :   ii		
Nalcor Doc. No. ILK-EG-ED-6200-TL-RP-0001-01	Page:	ii

# FAILURE ANALYSIS OF ELECTRODE CROSS ARM IN LABRADOR ISLAND TRANSMISSION LINK (LITL)

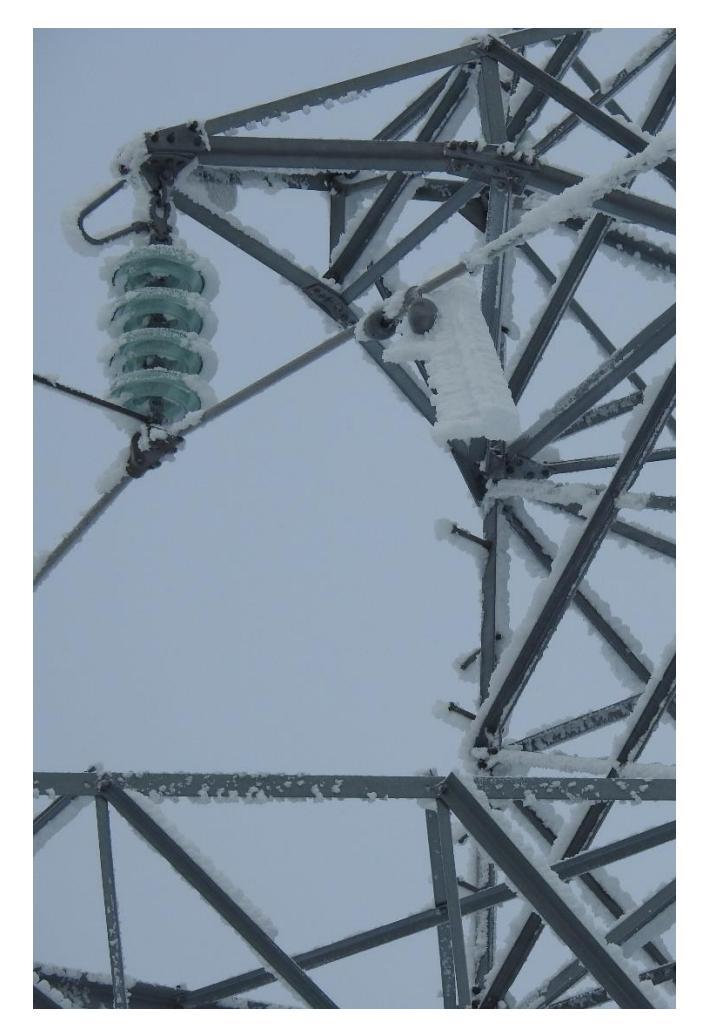
The dampers on EL 1 and EL 2 at towers 526 (see Figure 16) and 527 (see Figure 17 and Figure 18) show signs of fatigue similar to that shown in Figure 14. Some of the dampers however seem intact. Damaged dampers will significantly reduce the span damping and has the potential of resulting in fatigue failure of the conductor close to the attachment points at the hardware.

FIGURE 16 Tower 526 – EL2, prior to failure

2. Nalcor should investigate alternatives for the damping system and seek a solution that is more robust against conductor galloping, such as the Bretelle dampers used in Norway and Iceland, shown in the images below. The Helix damper is also an option for lines experiencing conductor galloping.

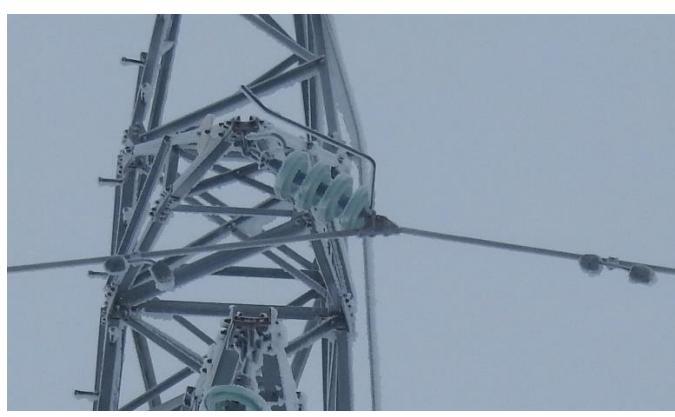
FIGURE 18 Tower 527 – After EL2 failure at Tower 526

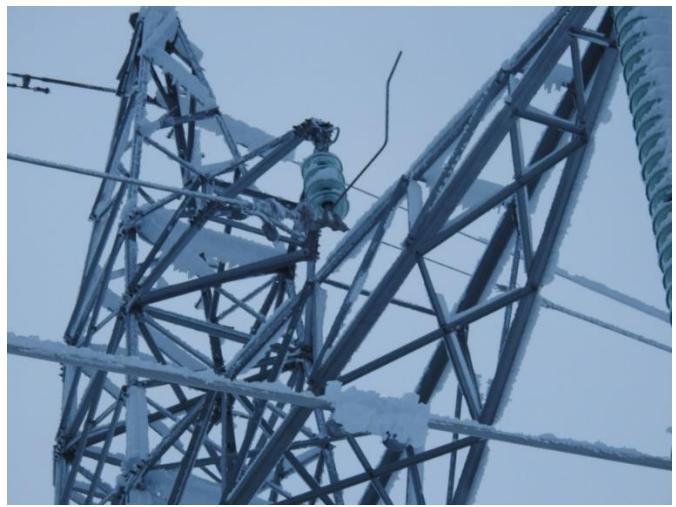
FIGURE 19 Tower 360 – Dampers showing signs of fatigue

6. The vibration damper failures could be attributed to ice shedding, galloping or fatigue due to aeolian vibration. Should the metallurgy tests indicate that fatigue is the cause of failure, then it is suggested that the damper study be redone. The level of conductor self-damping, turbulence and radial ice on the conductors must be considered in the design of the damping system. From the documentation provided, it seems that ice has not been considered in the design of the aeolian vibration damping system.

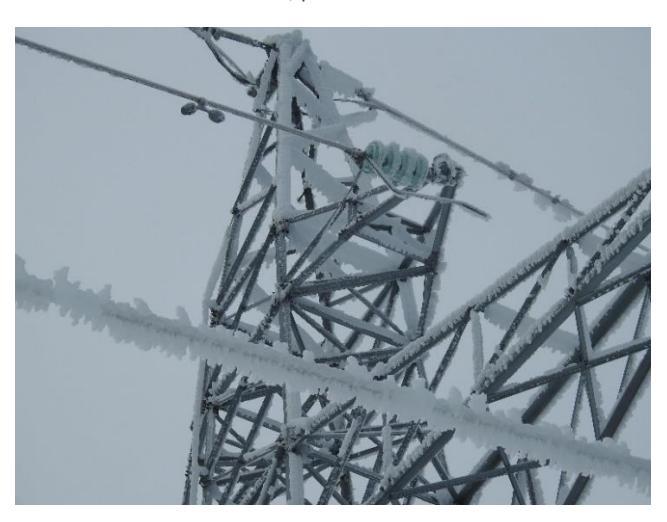
FIGURE 17 Tower 527 EL 1 – Prior to EL2 failure at Tower 526

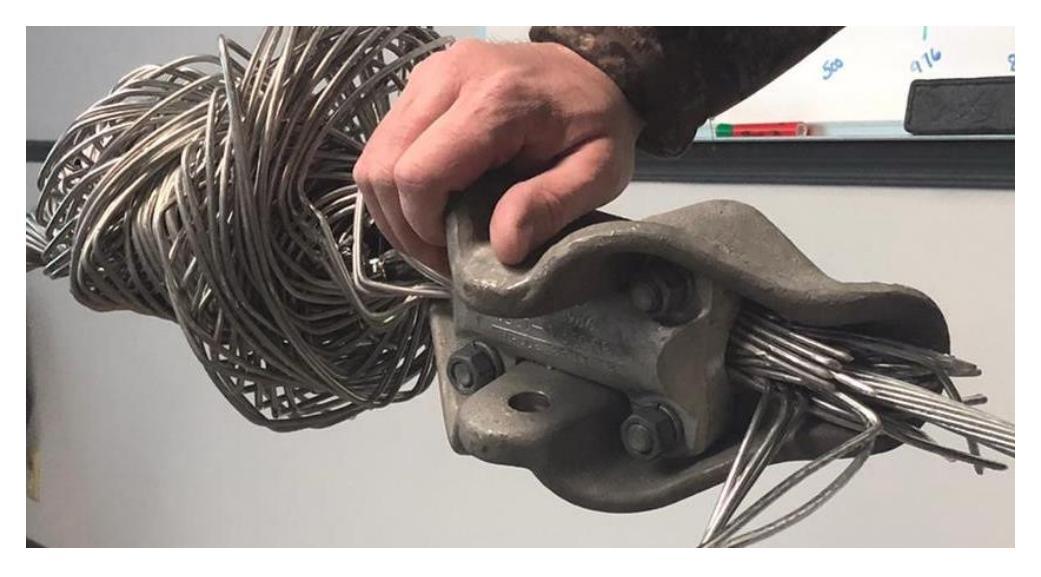
It is possible that vibration has been causing the nuts to loosen and hence allow for slippage of the conductor in the clamp. The clamp shown in Figure 20 has bolts torqued to different levels as evidenced by the varying number of threads protruding from the nuts. The loose nuts could have resulted from:

- Excessive vibration (aeolian or galloping)
- Poor installation practice
- They were loosened by the workmen when the clamps were removed from the line

Further investigation is required to ascertain the cause of the conductor slippage in the clamps.

FIGURE 20 Conductor damage and slippage in clamp.

- 4. The hardware used to support the electrode conductor is a normal bolted clamp without armor rods. The clamp uses spring lock washers to secure the bolt and nuts which are commonly considered as unreliable. More work must be done to investigate if the clamp arrangement was vibration tested and if the slip load tests were completed. The impact of correct torqueing procedure must be assessed in relation to the slip load capability of the clamps.

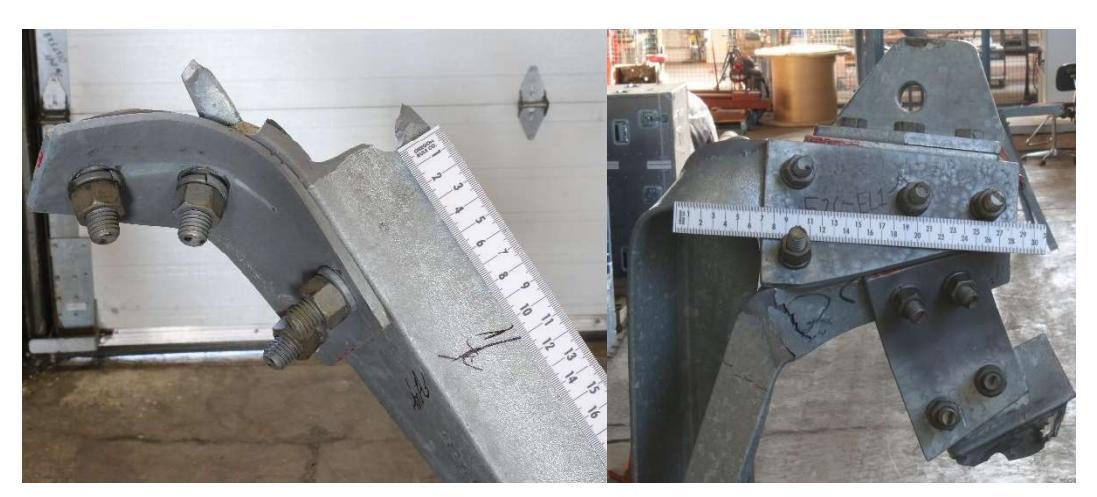
Figure 3: Damage to Cross Arm 526-EL1

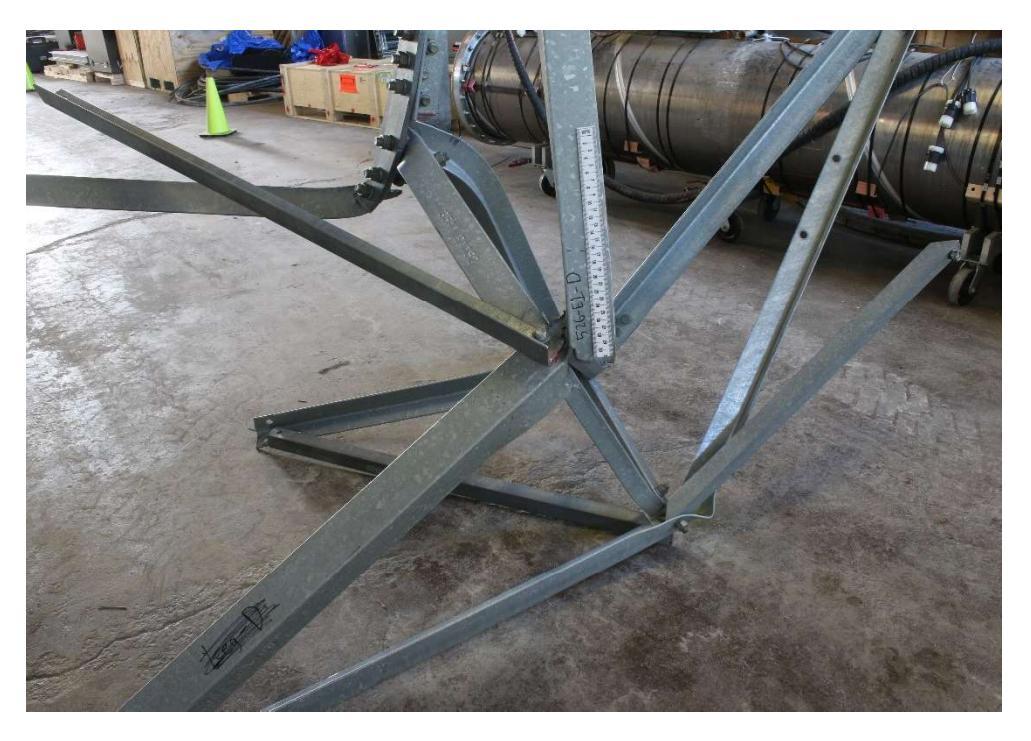
Figure 4: Damage to Cross Arm 526-EL1

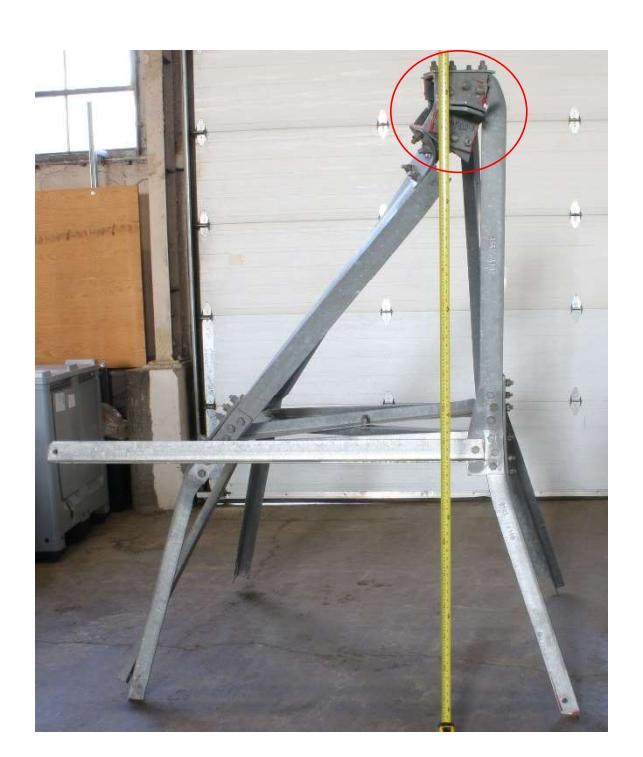
Figure 6: Cross Arm 343-EL2 As-Received

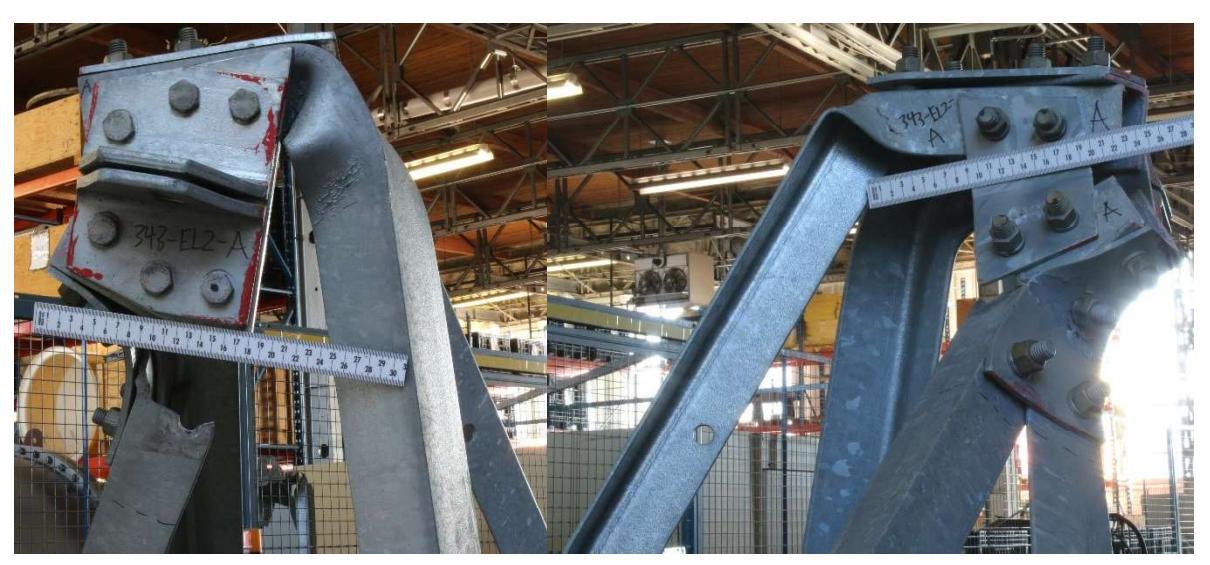
Figure 7: Damage to Cross Arm 343-EL2

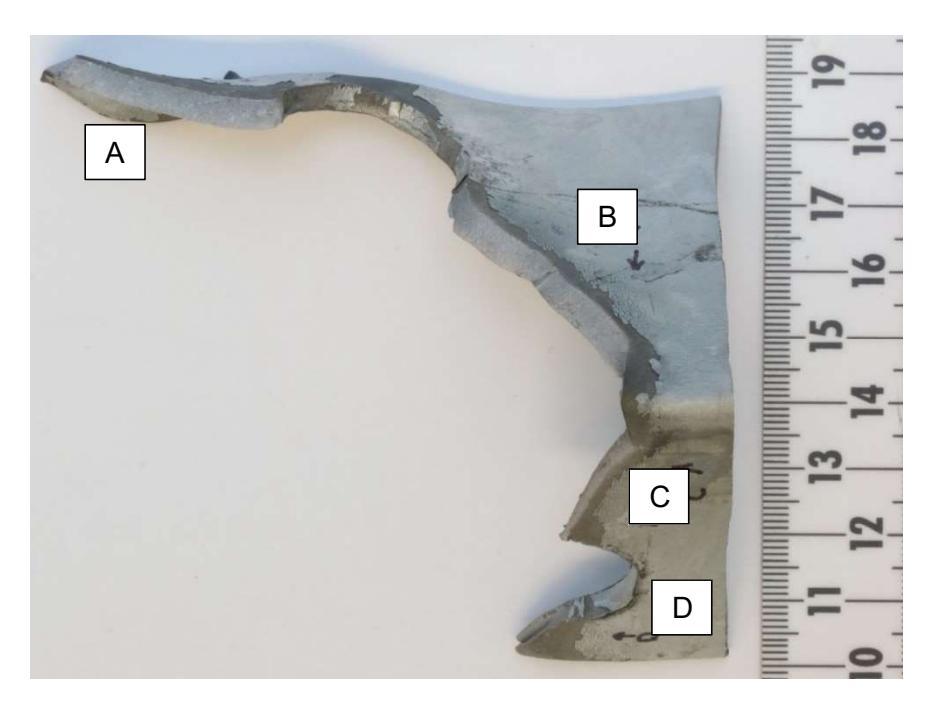
Figure 11: Cross Arm 526-El1 Fracture Face F1 Post-Cleaning

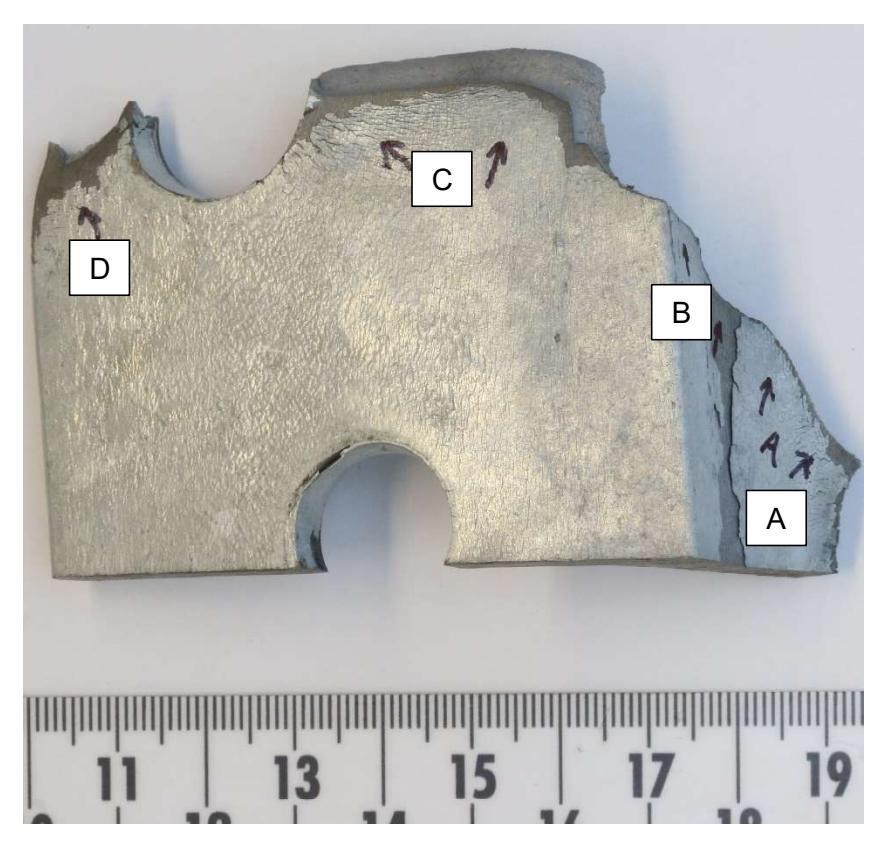
Figure 12: Cross Arm 343-EL2 Fracture Face D1 Post-Cleaning

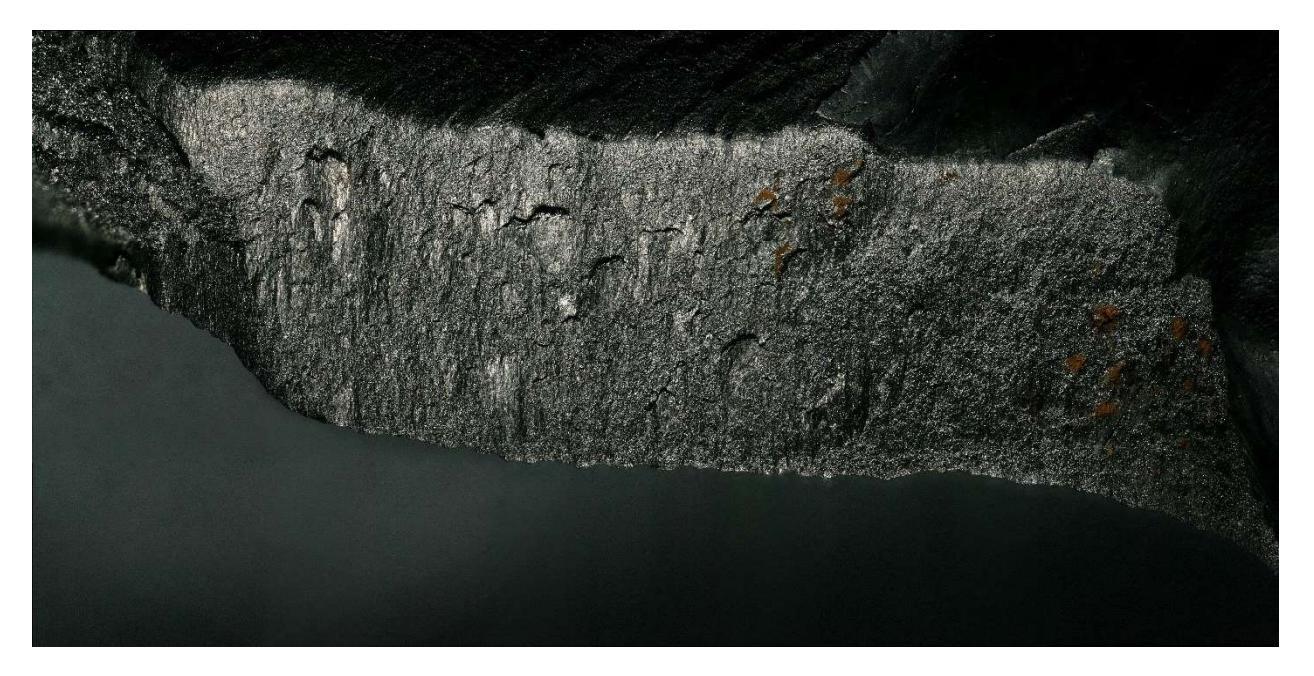
Figure 21: Cross Arm 343-EL2 Fracture Face Segment A

Representative SEM micrographs from each fracture face segment are presented in Figure 25 to Figure 28. Fracture Segments A, C, and D had a regular dimple morphology, which is characteristic of a tensile loading induced ductile fracture. Fracture Segment B (Figure 26) had regions of quasi-cleavage morphology (moderately ductile fracture) and dimple morphology. Based on these observations, tensile overload leading to ductile and quasi-cleavage fracture was the likely cause of the cross arm failure.

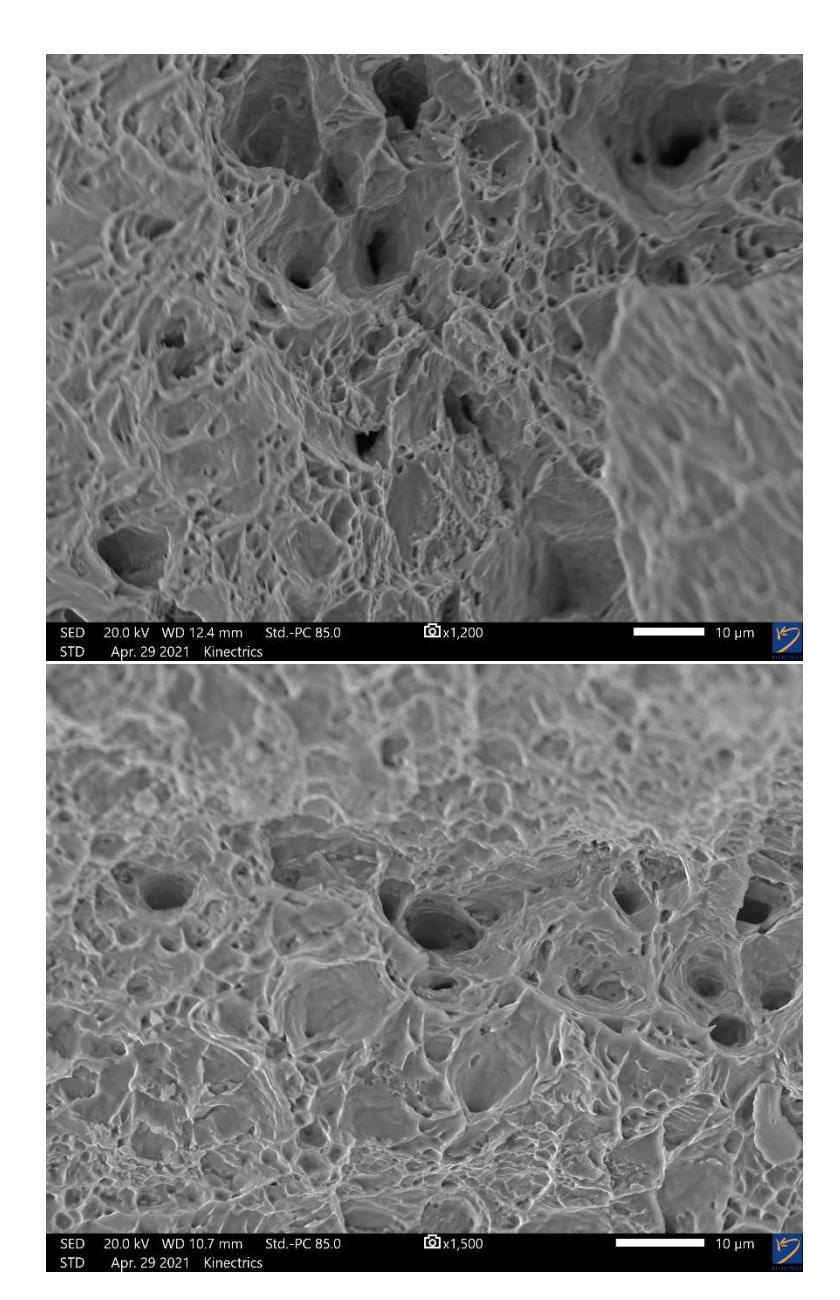
Figure 27: Cross Arm 343-EL2 Fracture Face Segment C SEM Micrograph showing dimple morphology

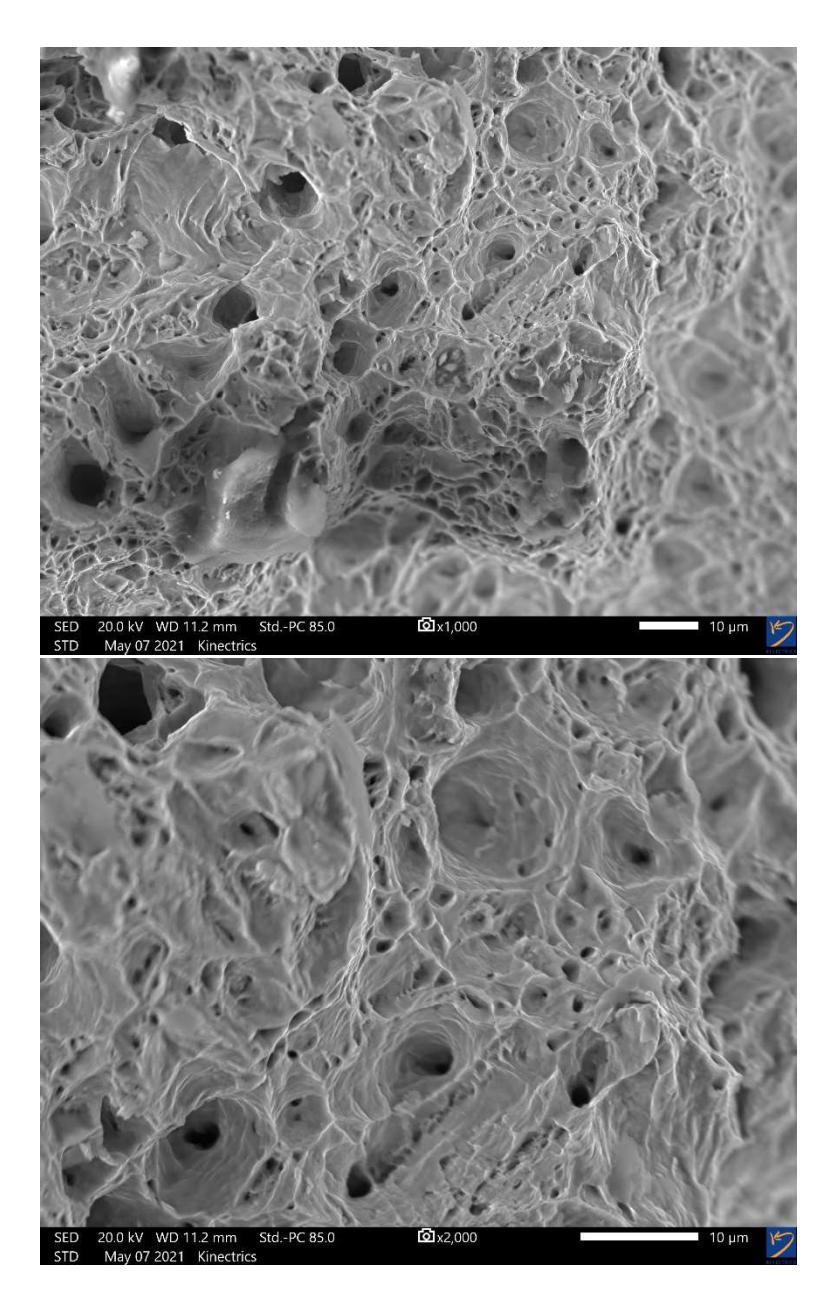
Figure 28: Cross Arm 343-EL2 Fracture Face Segment D SEM Micrograph showing dimple morphology

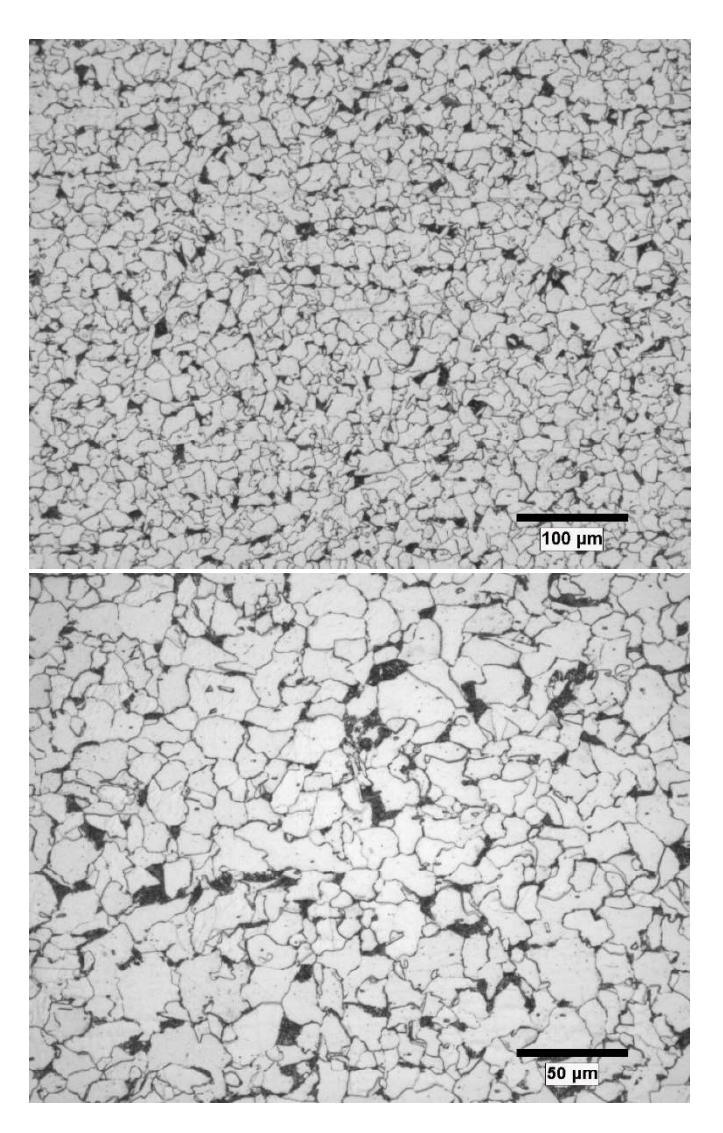
Figure 29: Representative Microstructure of Steel from Cross Arm 526-EL1

Optical metallography was performed on prepared (polished and micro-etched) metallurgical cross-sections from the three cross arms to examine the microstructure of the HSLA steel. Figure 29 to Figure 31 show the representative microstructure observed in the steel from each cross arm. The microstructures are similar in appearance, possessing a ferrite-pearlite structure characteristic of a HSLA in the normalized condition. There were no signs of deleterious features in the microstructures.

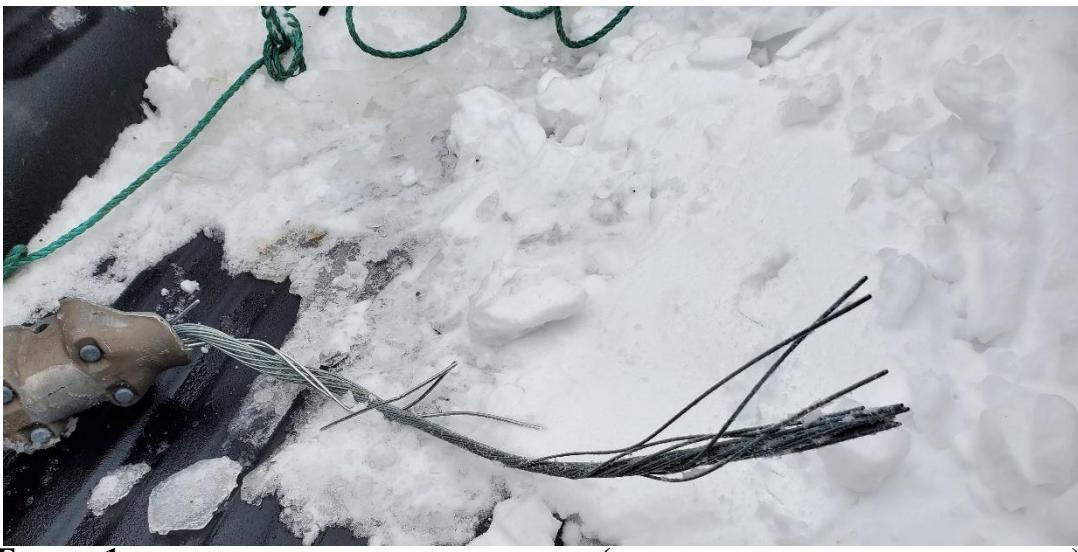
We received two broken conductors, two conductor sections with multiple broken strands, and one new conductor section. We were informed that the broken conductor sections were found on the ground after a heavy weather condition creating excessive ice built up on the conductors. Figure 1, Figure 2, and Figure 3 show there of the broken wires received. Client requested us to examine the broken conductors and determine the root cause.

FIGURE 1. ONE OF THE BROKEN CONDUCTORS (PICTURE PROVIDED BY THE CLIENT)

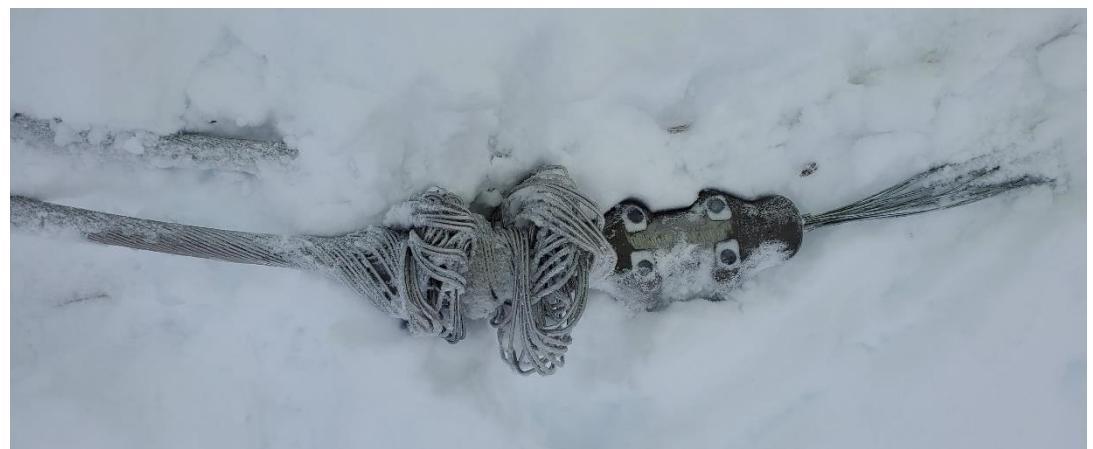
FIGURE 2. ANOTHER BROKEN CONDUCTOR (PICTURE PROVIDED BY THE CLIENT)

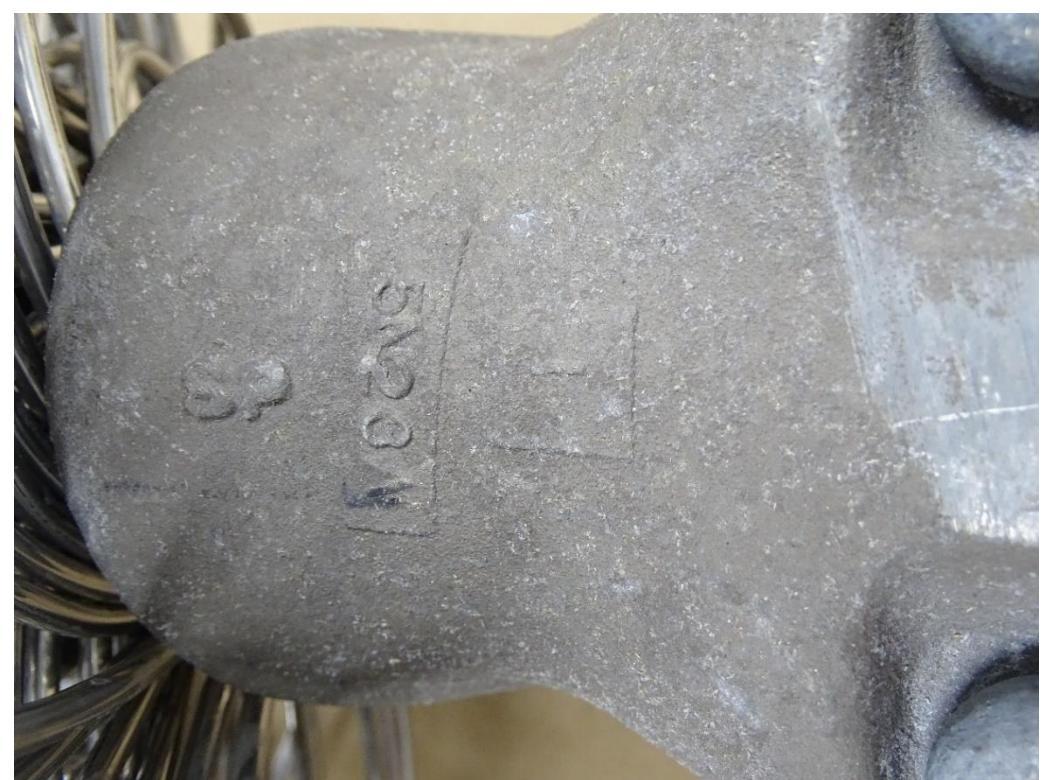
FIGURE 7: MARKINGS ON THE FRONT FACE OF THE CLAMP, CUT END OF CONDUCTOR

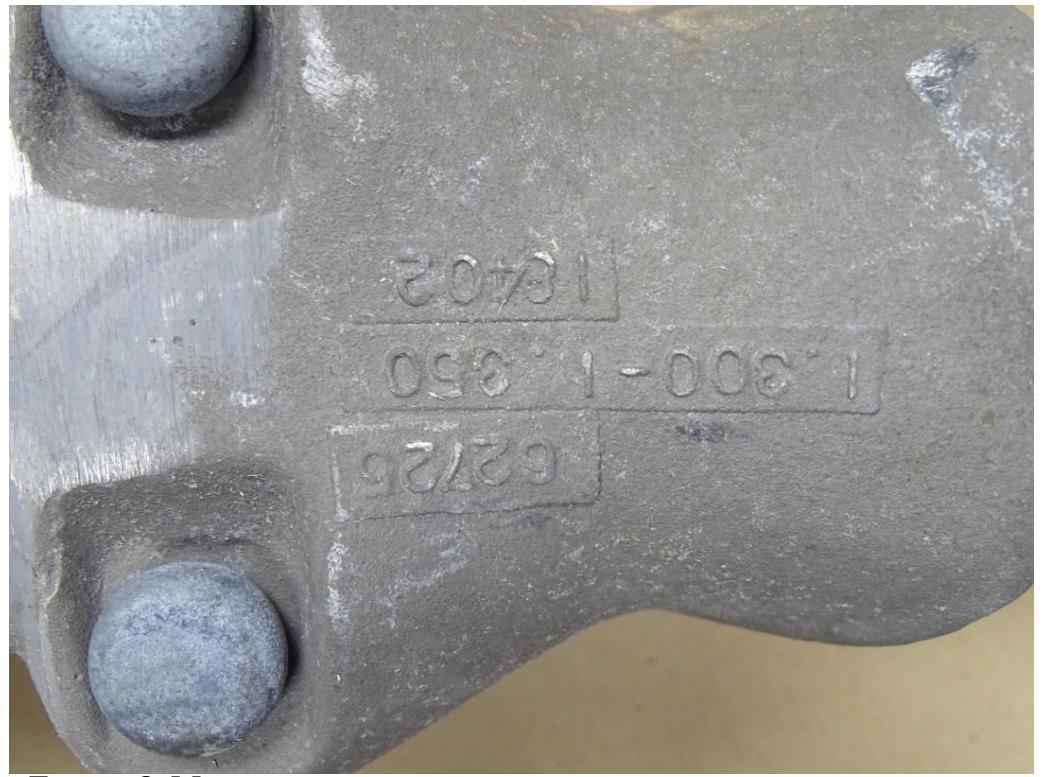
FIGURE 8: MARKINGS ON THE FRONT FACE OF THE CLAMP, BROKEN END OF THE CONDUCTOR

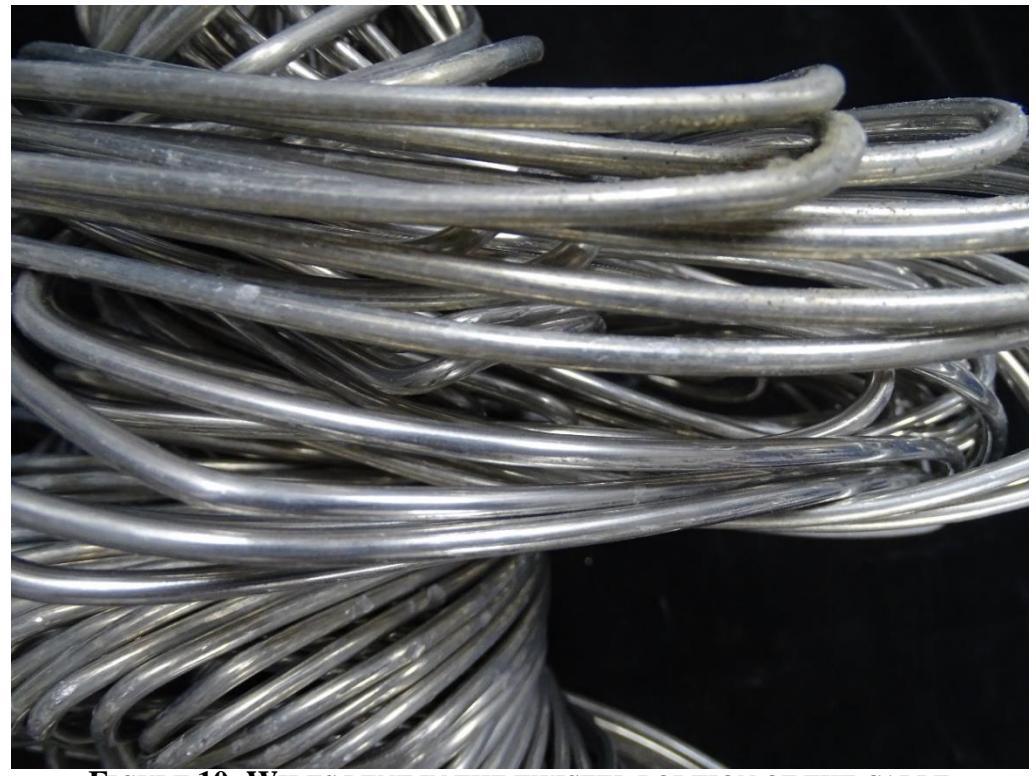
FIGURE 10: WIRES BENT IN THE TWISTED PORTION OF THE CABLE

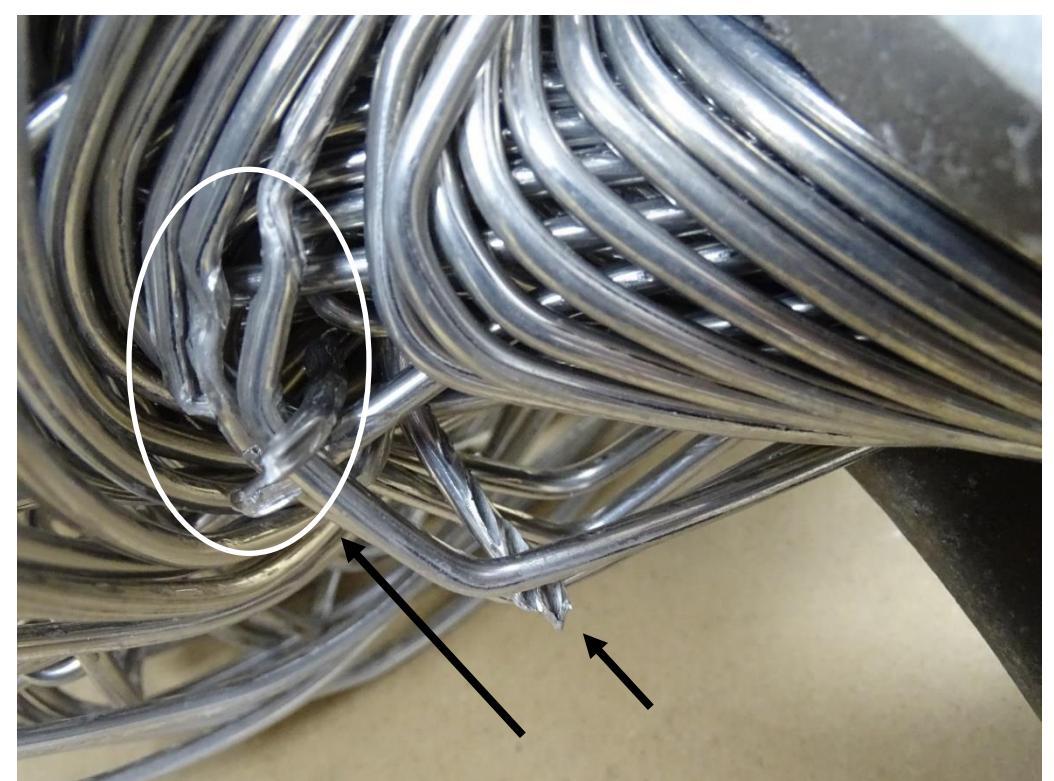
FIGURE 11: TWISTED PORTION OF THE CABLE, SOME OF THE WIRES WERE BADLY DAMAGED

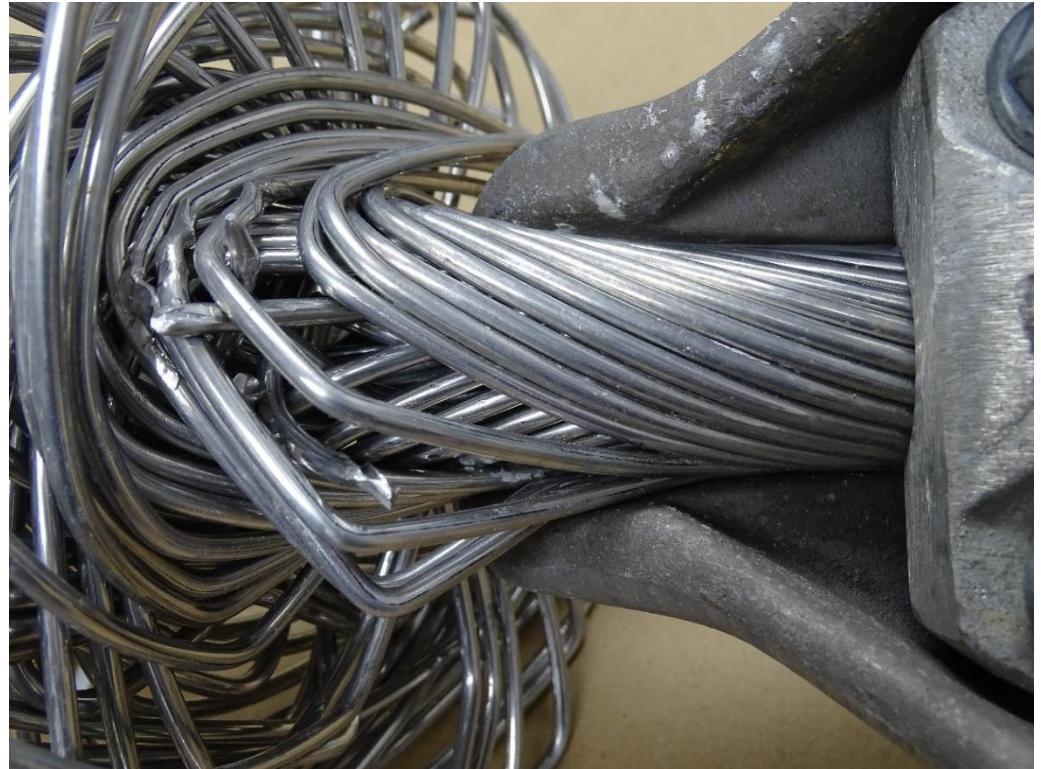
FIGURE 12: INTACT CABLE JUST OUT OF THE CLAMP

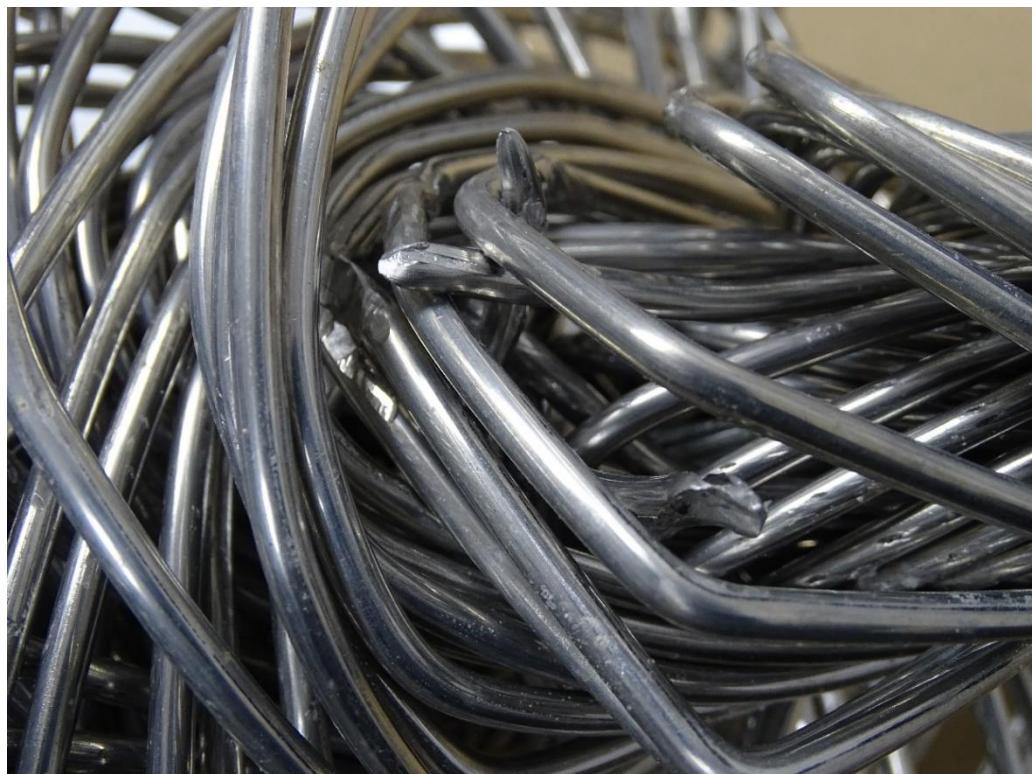
FIGURE 13: SOME BROKEN ALUMINUM WIRES ON THE TWISTED SIDE, SAMPLE #1

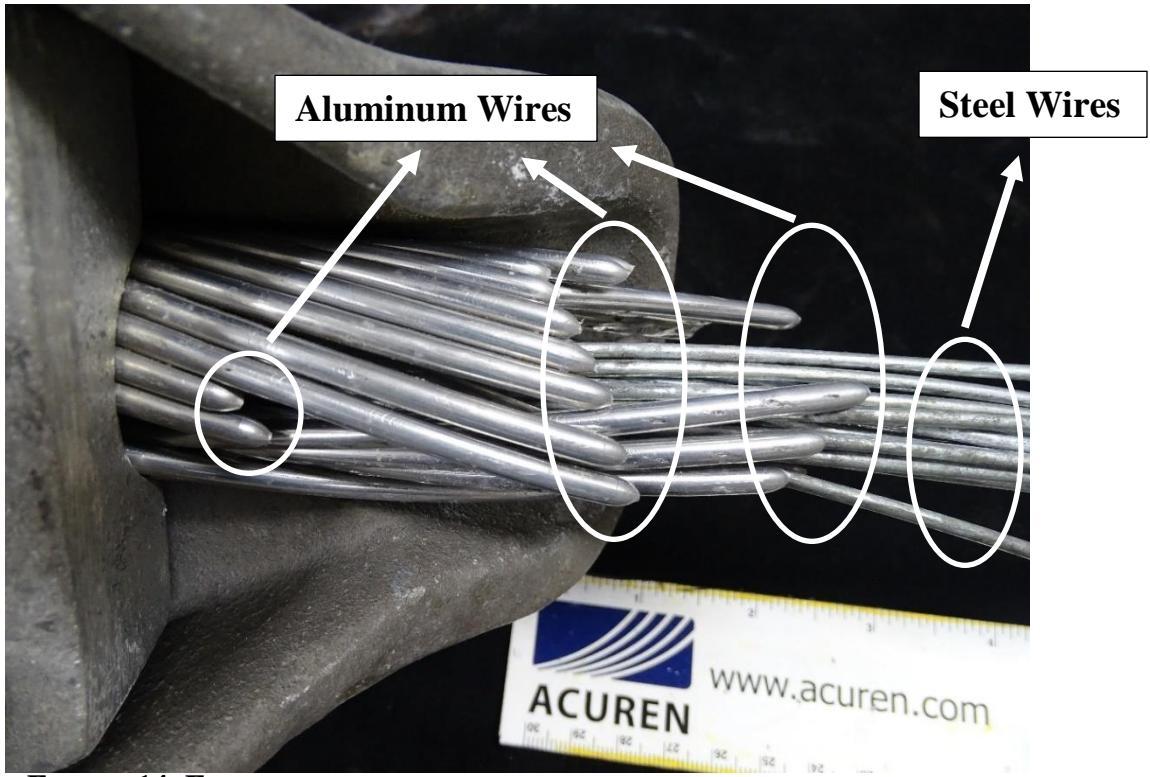
FIGURE 14: FRACTURED ALUMINUM WIRES IN THE VICINITY OF THE CLAMP

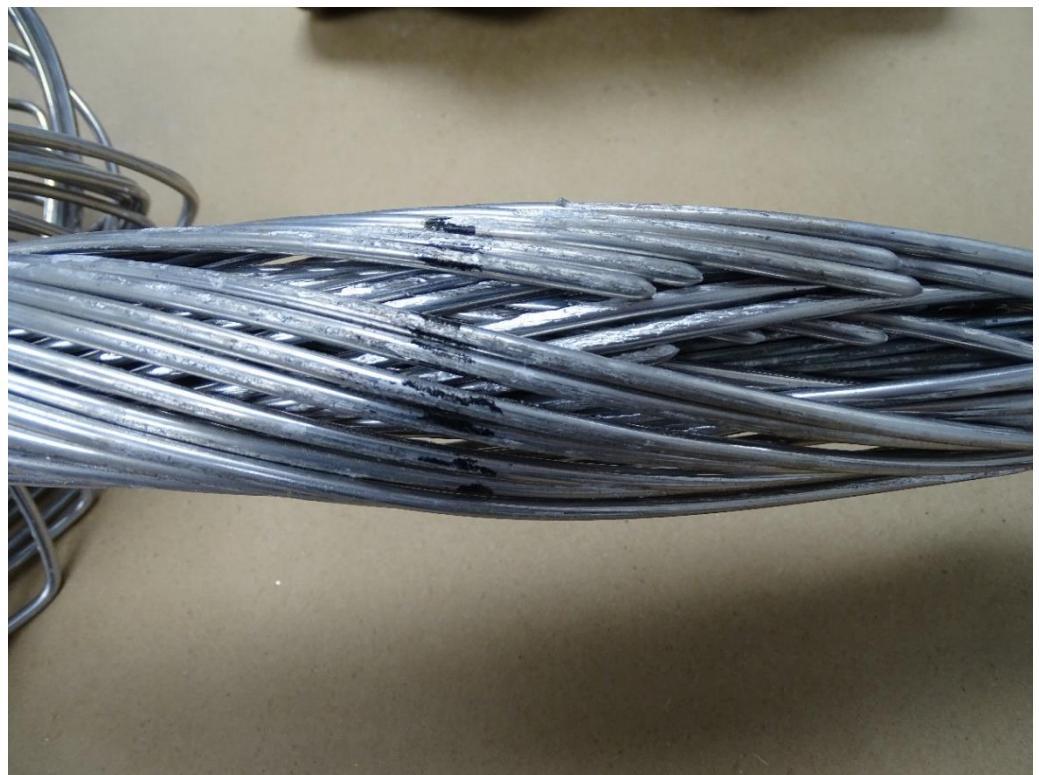
FIGURE 15: WIRES OF THE CABLE IN THE CLAMPED REGION. PHOTO TAKEN AFTER REMOVING THE CLAMP

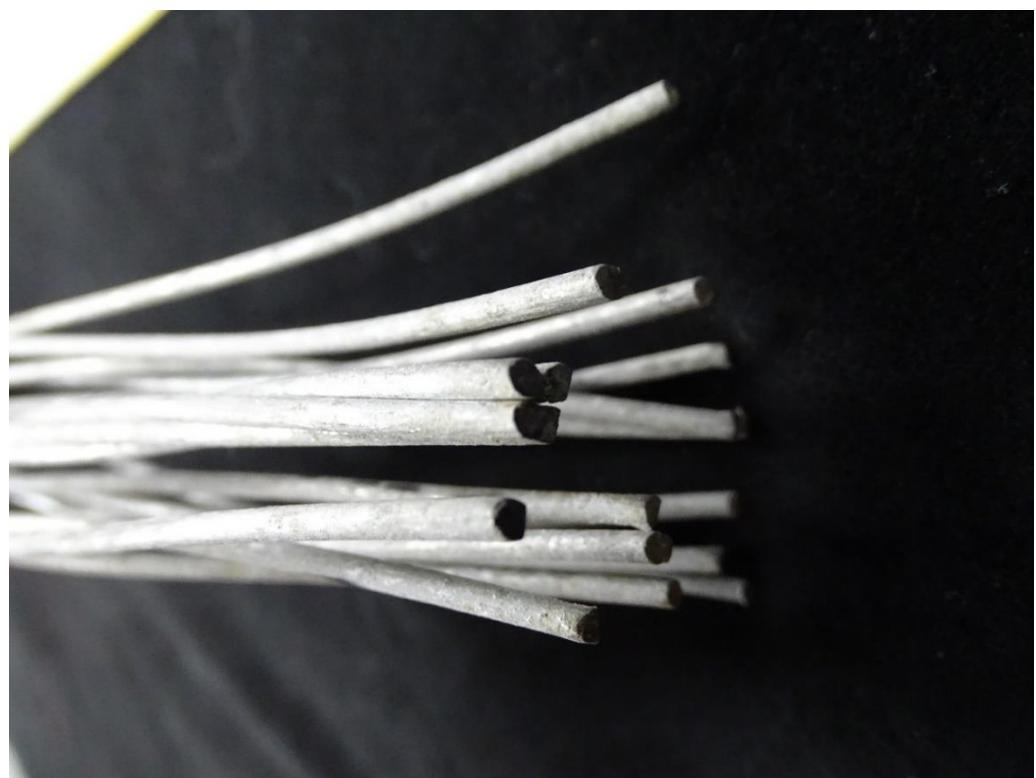
FIGURE 16: SOME OF THE BROKEN ALUMINUM WIRES IN THE CLAMPED REGION, PHOTO TAKEN AFTER REMOVING THE CLAMP

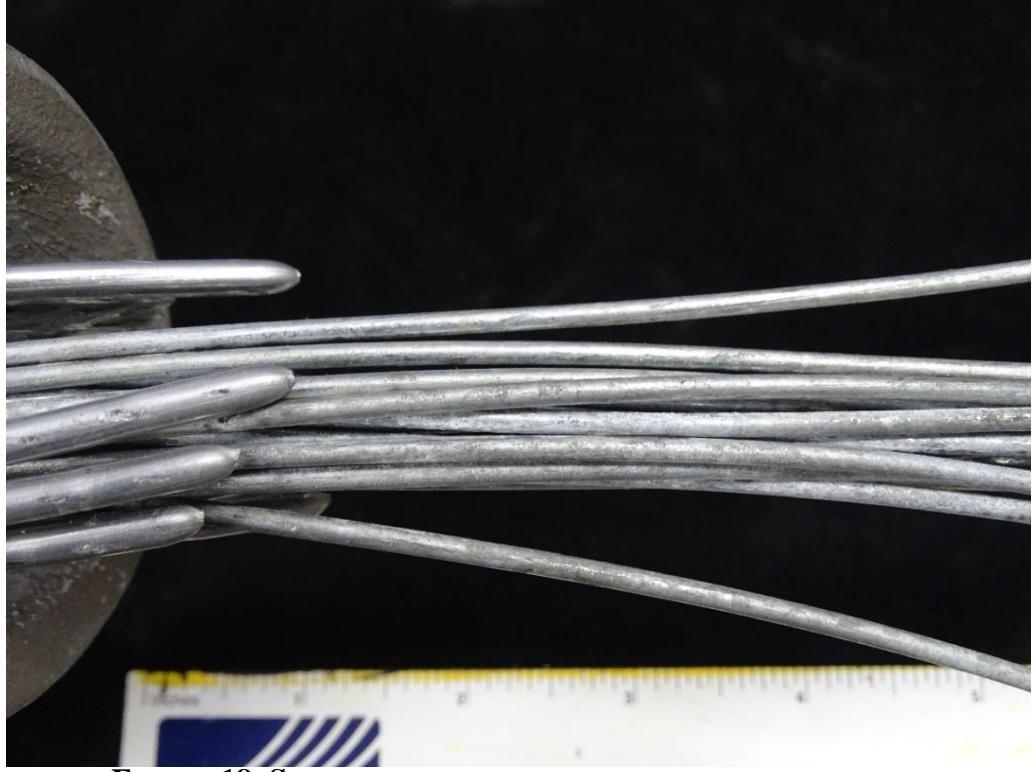
FIGURE 17: BROKEN STEEL WIRES

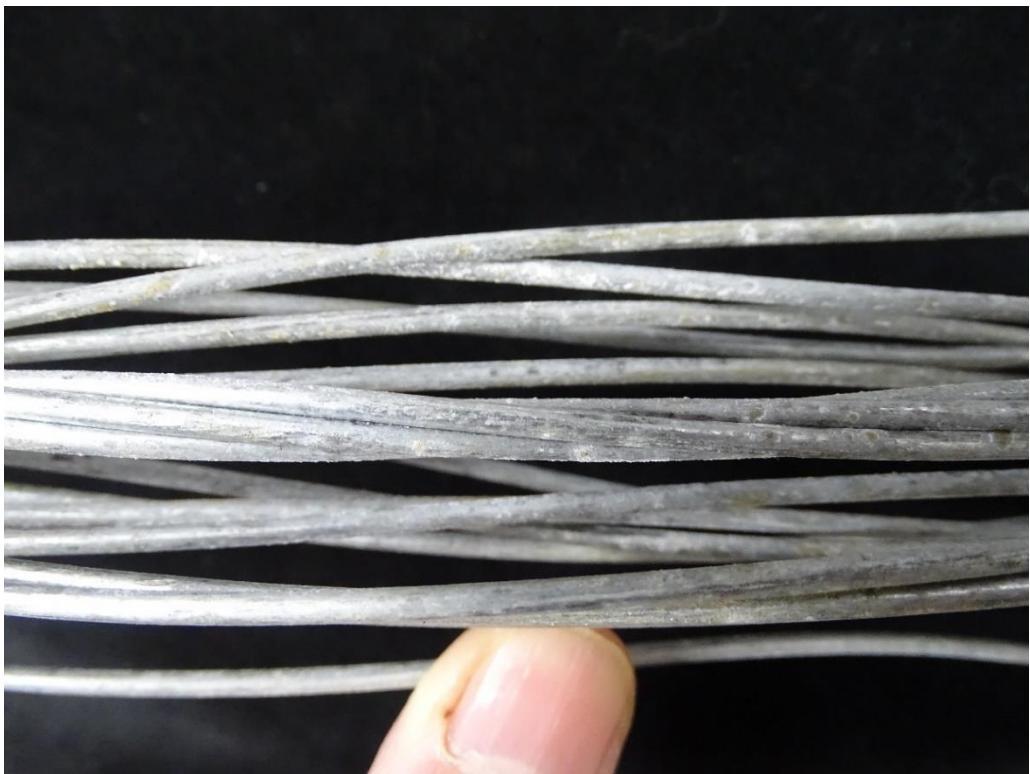
FIGURE 18: STEEL WIRES IN THE VICINITY OF THE CLAMP END

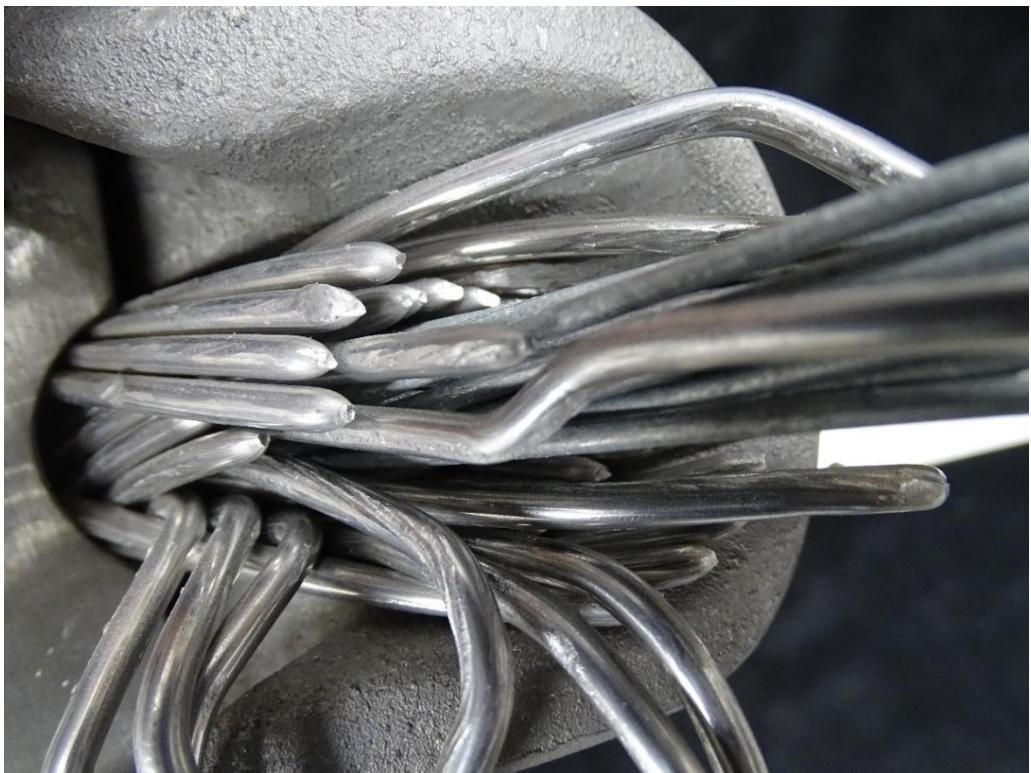
FIGURE 22: ALL THE WIRES BROKEN IN ONE END OF THE CLAMP, SAMPLE #2
