# Re: *Reliability and Resource Adequacy Study Review* – Labrador-Island Link Failure Investigation Reports

# Failure Investigation Report – L3501/2 Tower and Conductor Damage

Failure Investigation Report – L3501/2 Tower	R	evision R1		
Icing Event January 2021 in Labrador	Date:	Revision R1     :   28-May-2021     :   ii		
Nalcor Doc. No. ILK-EG-ED-6200-TL-RP-0001-01	Page:	ii

# FAILURE ANALYSIS OF ELECTRODE CROSS ARM IN LABRADOR ISLAND TRANSMISSION LINK (LITL)

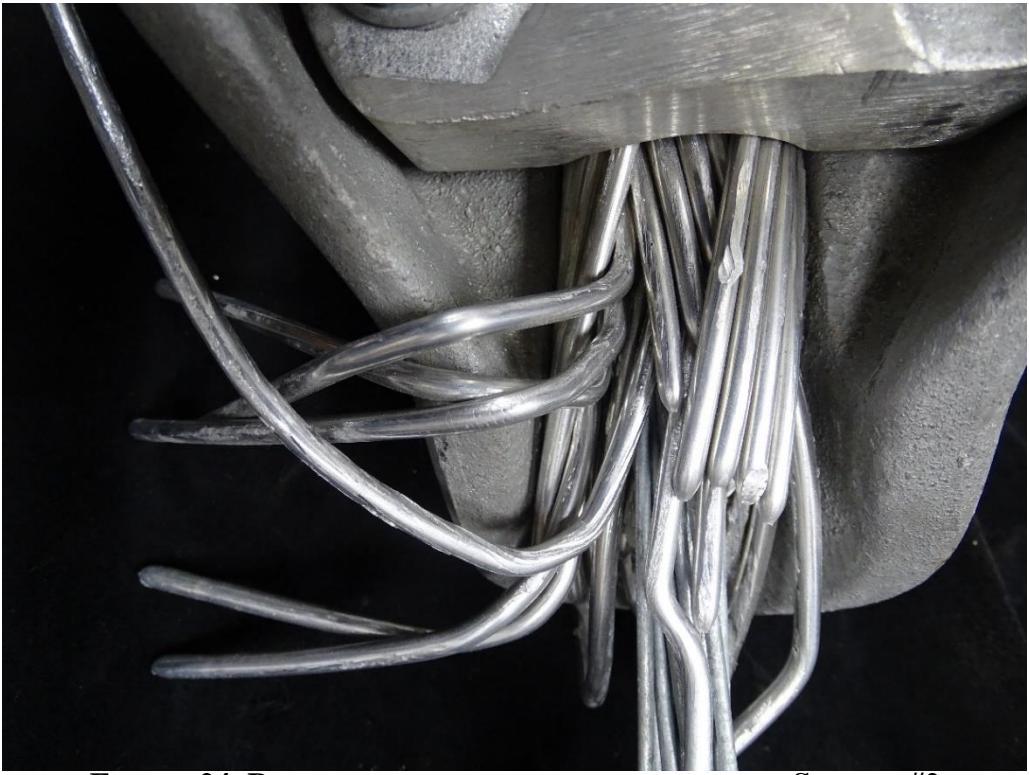
FIGURE 23: BROKEN ALUMINUM WIRES, SAMPLE #2

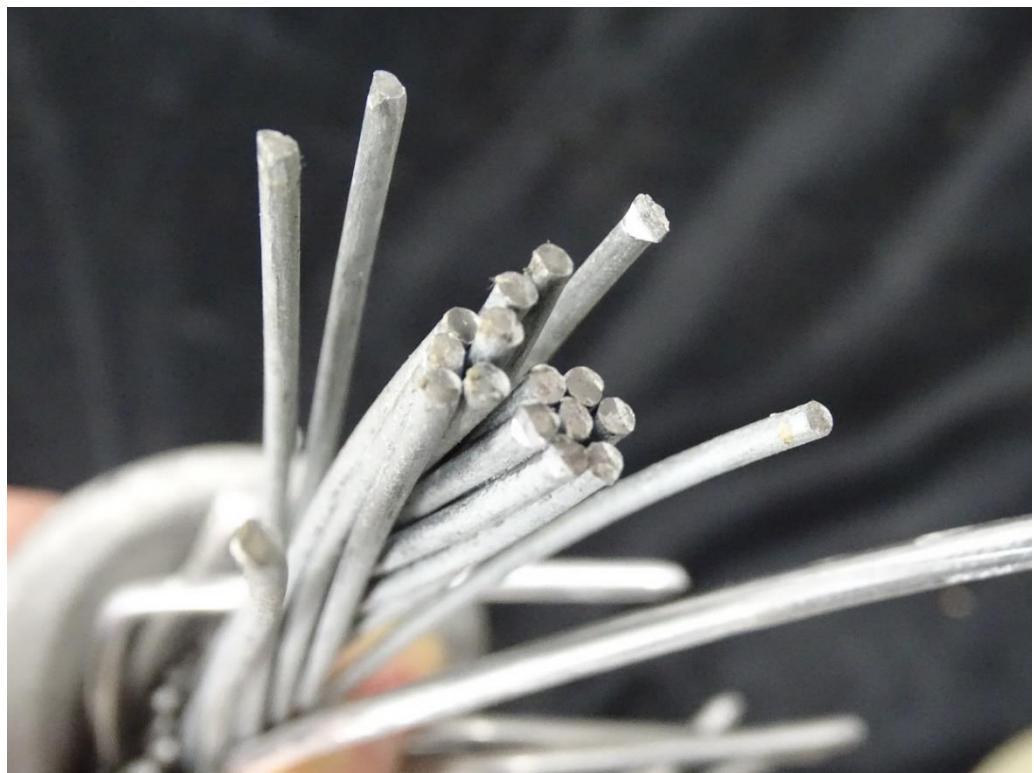
FIGURE 24: BROKEN ALUMINUM WIRES, OTHER SIDE, SAMPLE #2

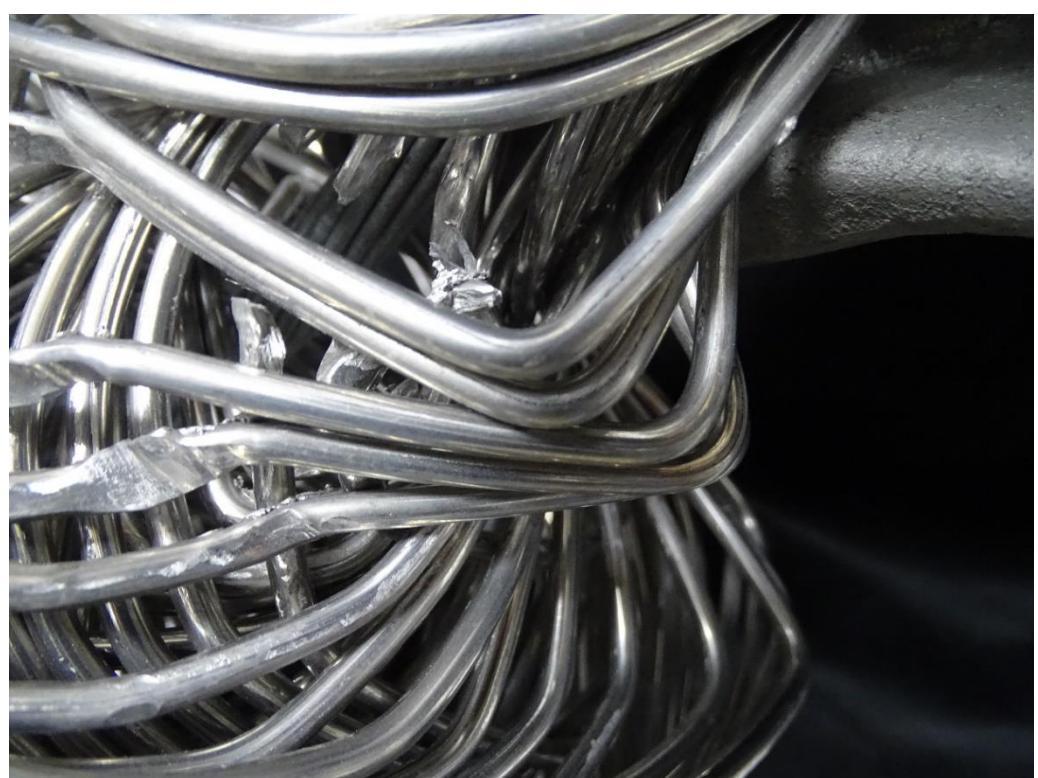
FIGURE 26: TWISTED WIRES, SAMPLE #2

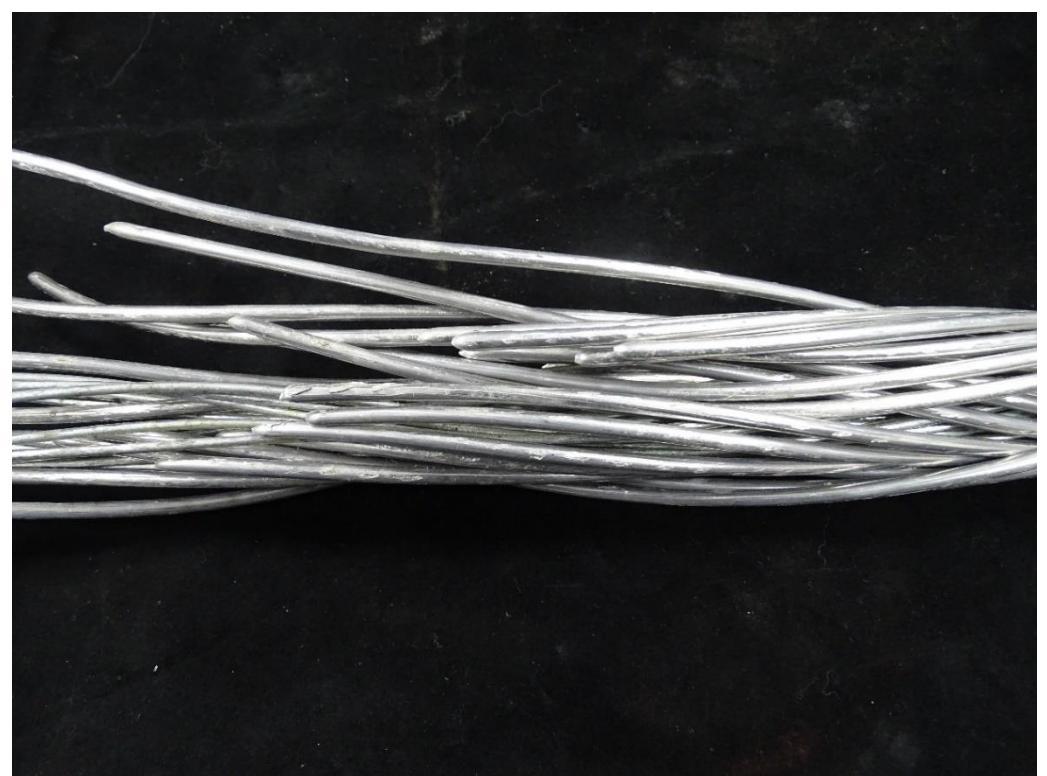
FIGURE 28: SAMPLE #3 AND SAMPLE #4

- i. Figure 28 shows sample #3 section of conductor. The conductor cable was identical to the other two cables examined. This sample did not have a clamp (Client informed us that this sample might have been broken completely and fell to the ground. However, our observations suggest some of those may have also been cut).

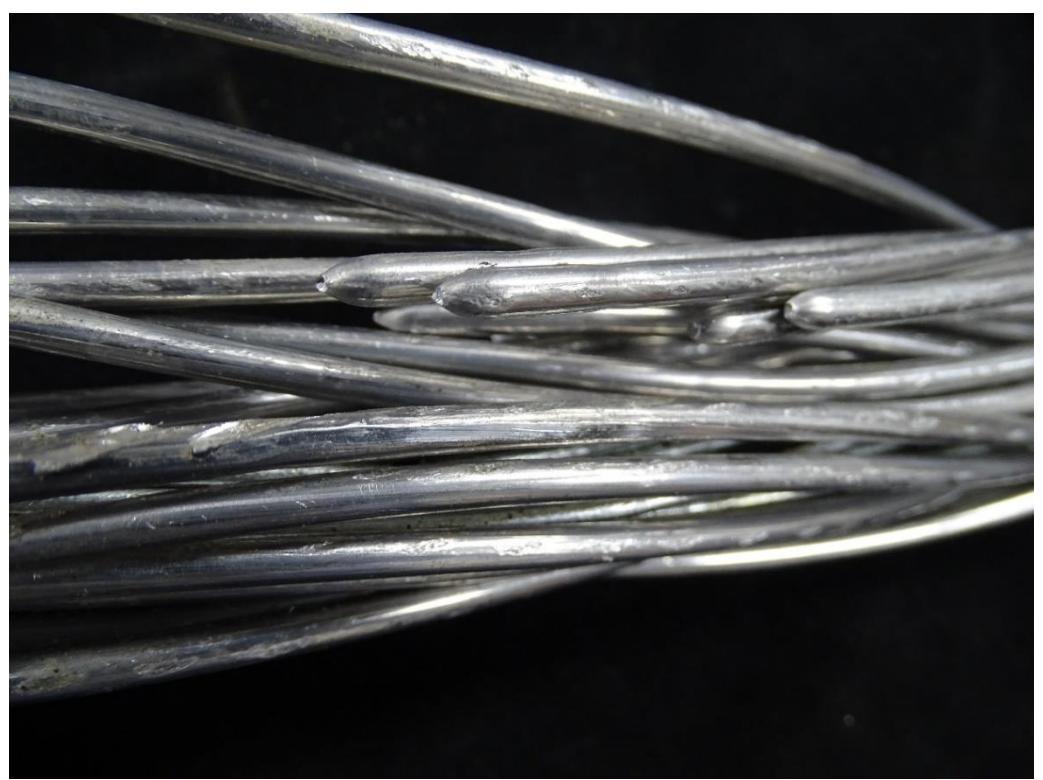
- ii. The broken aluminum wires fracture surfaces, were similar to those of the wires of cables Sample #1 and Sample #2. Local plastic deformation in the vicinity of the fracture surface of aluminum wires was evident, Figure 29. Figure 30 shows close view of the fractured aluminum wires. Some of the wires were damaged.

FIGURE 29: BROKEN ALUMINUM WIRES OF SAMPLE #3

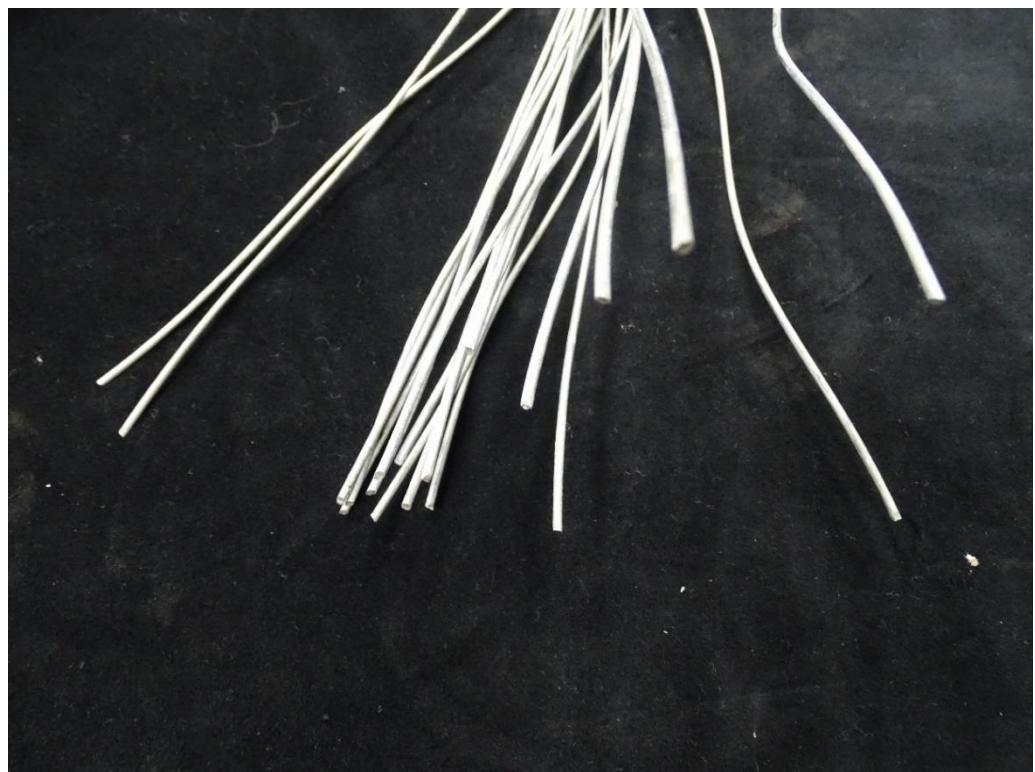
FIGURE 30: FRACTURED ALUMINUM WIRES, SAMPLE #3

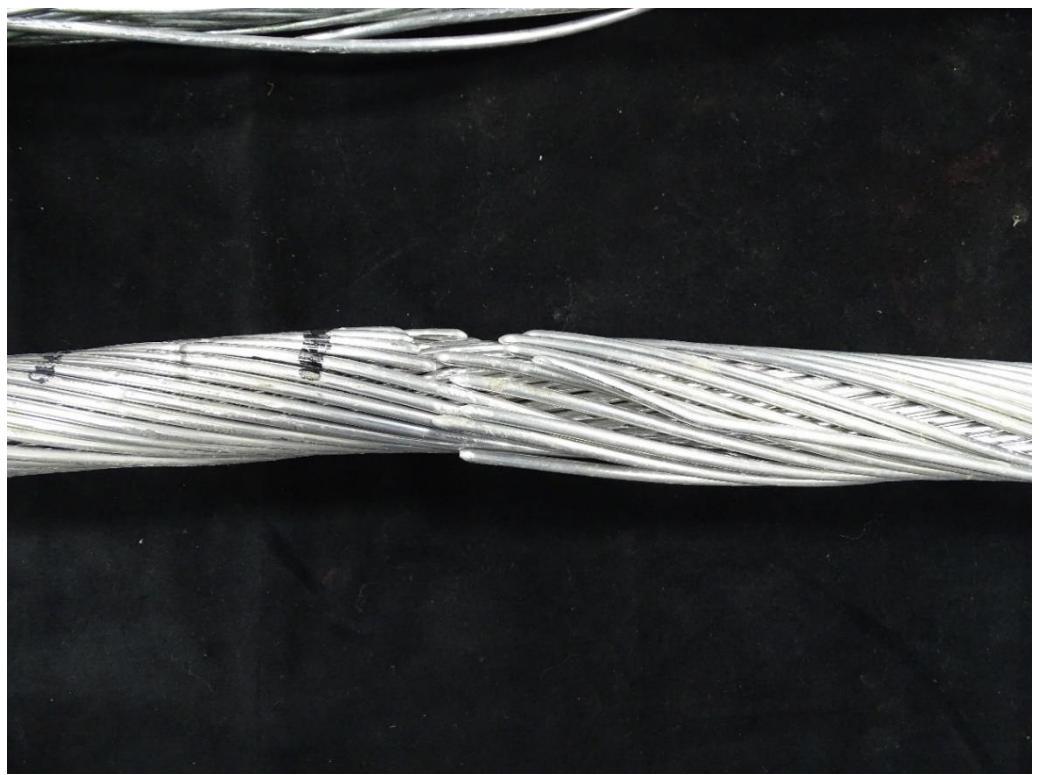
- iii. Fracture surfaces of the steel core wires were mostly flat, crack propagated perpendicular to the longitudinal direction of the wires. Some of the wires showed wedges adjacent to the fracture surface. Those wires with wedges possibly the ones that were cut. Steel wires were dull gray in colour. Figure 31 shows the steel wires.

FIGURE 31: FRACTURED STEEL WIRES, SAMPLE #3

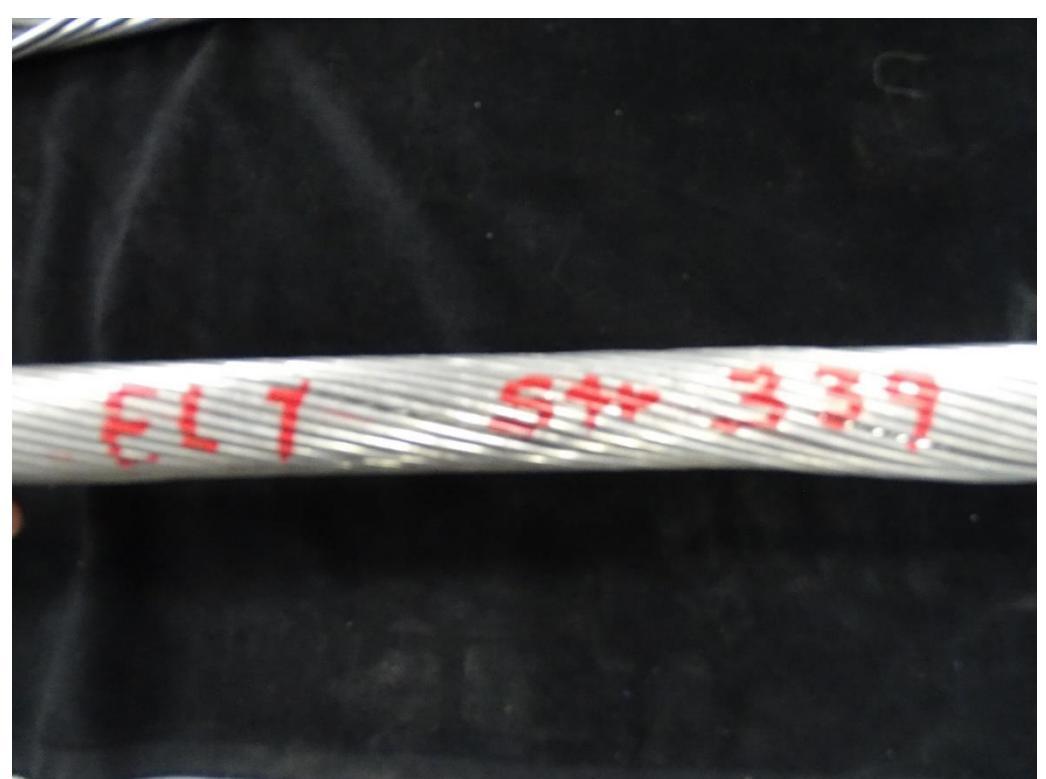
- i. Figure 28 shows Sample #4. Sample #4 showed some broken aluminum wires at the area marked in Figure 32, however, there was no complete separation. It was marked by the client with a red marker as "LTT str 339", Figure 33 (client informed us that this sample was from structure 339).
- ii. 12 of the 24 outer layer aluminum wires were broken. Figure 34 shows ten of these broken aluminum wires. These ten wires showed necking in the vicinity of the fracture surface.

FIGURE 32: FRACTURED ALUMINUM WIRES, SAMPLE #4

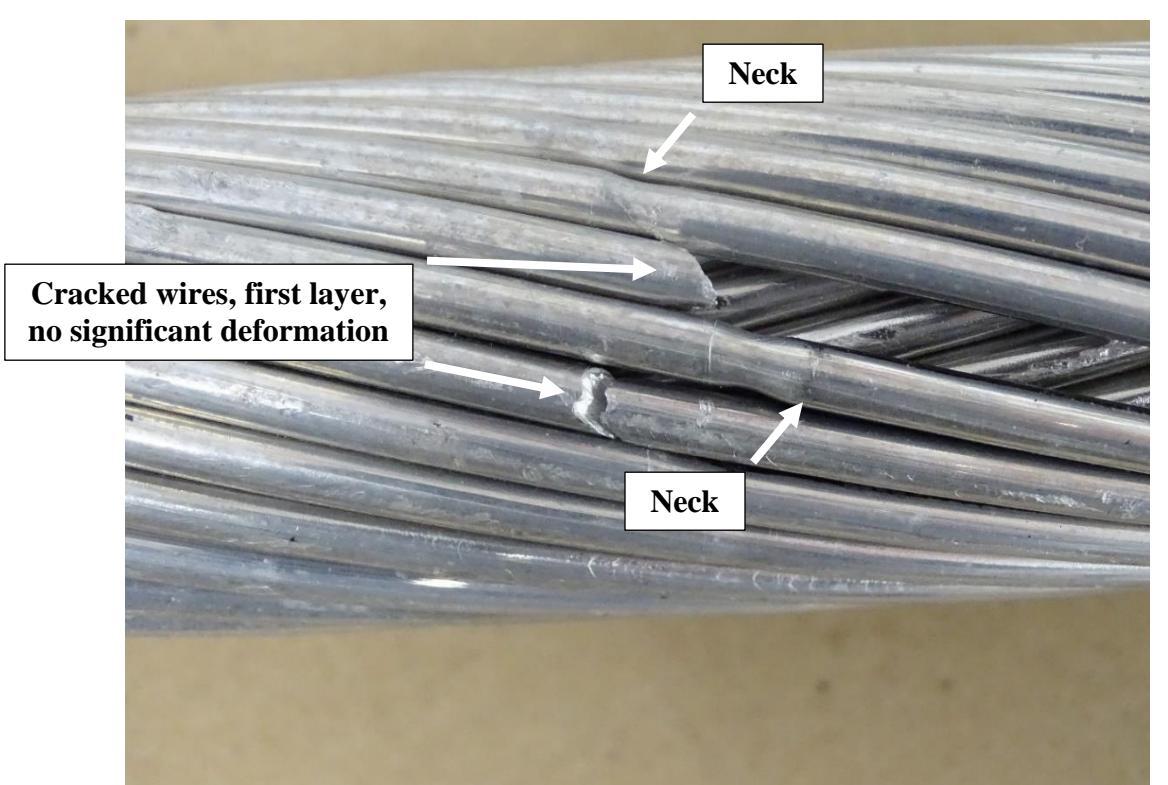
- iii. Ten of these wires were together in one area. We arbitrarily marked that as 4-8 o'clock region.
- iv. The other two wires were also in the same region, however, several inches away from the others. These two were did not show visible necking while the other ten wires did. Two wires adjacent to those two broken wires showed necking yet no separation, Figure 35.
- v. We observed two of the aluminum wires on the second layer with necking. None of the wires were broken on the second layer.

FIGURE 34: BROKEN WIRES OF THE FIRST LAYER AND NECKING OF WIRES ON THE SECOND LAYER, SAMPLE #4

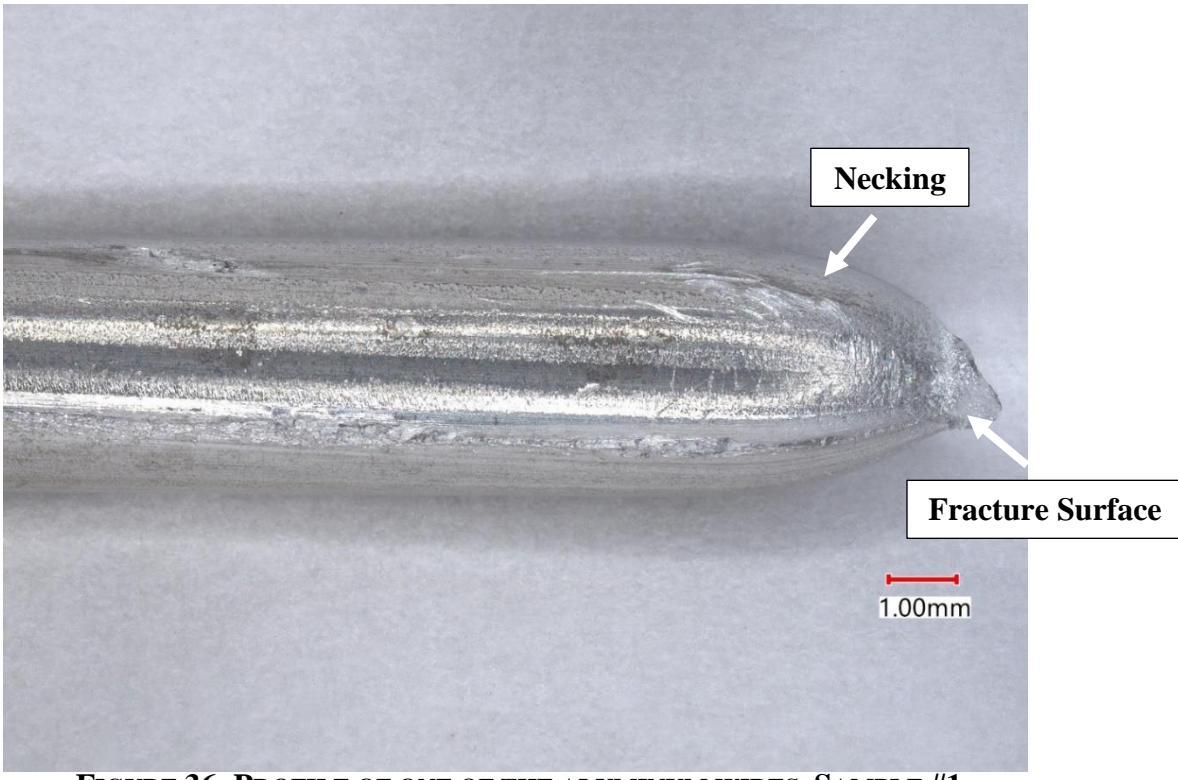
- i. Figure 36 and Figure 37 shows the profile of two aluminium wires broken in the field.
- ii. Aluminum wire surfaces were generally clean and free from corrosion/oxidation products.

FIGURE 36: PROFILE OF ONE OF THE ALUMINUM WIRES, SAMPLE #1

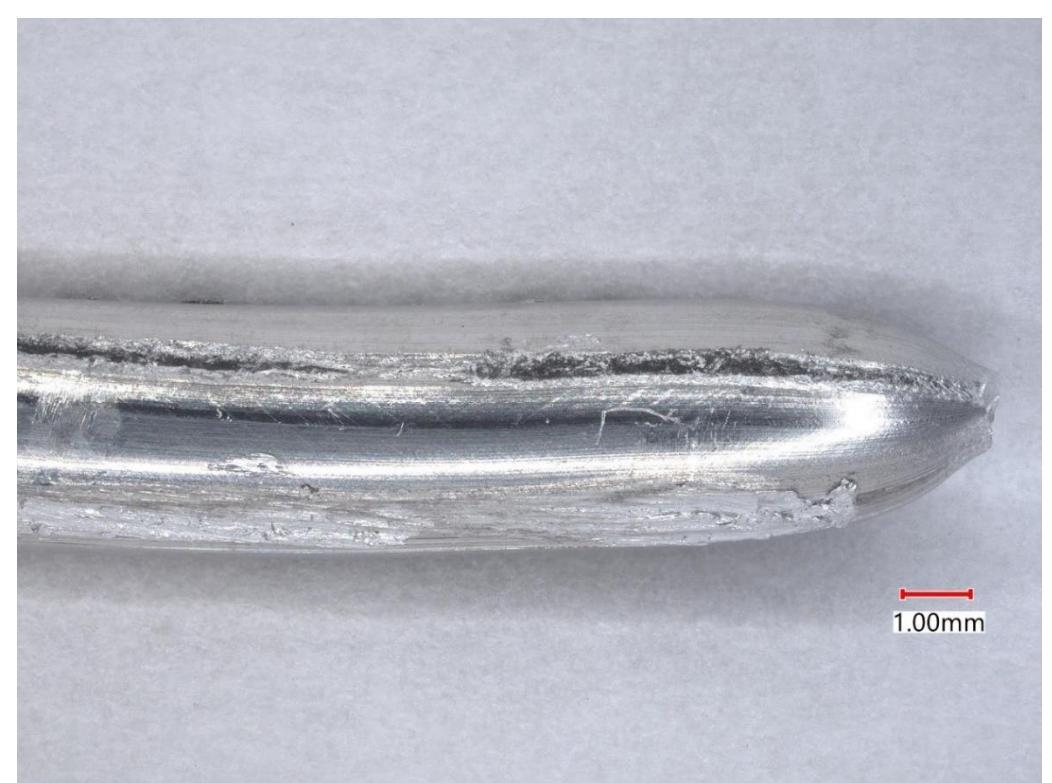
FIGURE 37: PROFILE OF ANOTHER ALUMINUM WIRE, SAMPLE #1

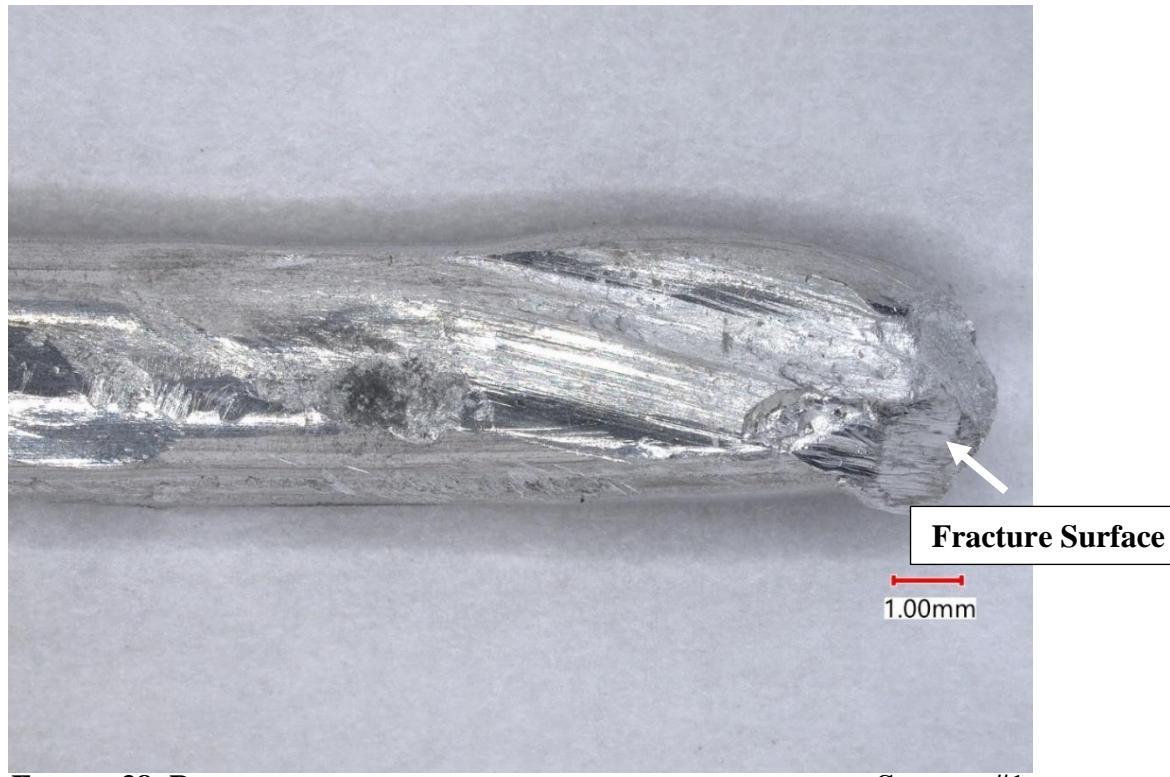
- iii. Aluminum wires showed some scratches that formed during the incident.
- iv. Aluminum wires showed necking adjacent to the fracture surface.
- v. Figure 38 shows profile of an aluminium wire with heavy deformation on the side surface. Observations made indicated that such deformation formed during the incident

- vi. Heavy deformation on the side surface of the wires formed as a result of wires rubbing each other during the incident.
- vii. Aluminum wires showed heavy localized deformation in the vicinity of the fracture, finally causing fracture in that area.

- viii. Final fracture surface was very small, in other words, reduction in area of the aluminium wires was extremely high.
- ix. Low reduction in area on the wire in Figure 38 is due to heavy deformation and surface damage formed during the incident.

FIGURE 38: PROFILE OF A HEAVILY DEFORMED ALUMINUM WIRE, SAMPLE #1

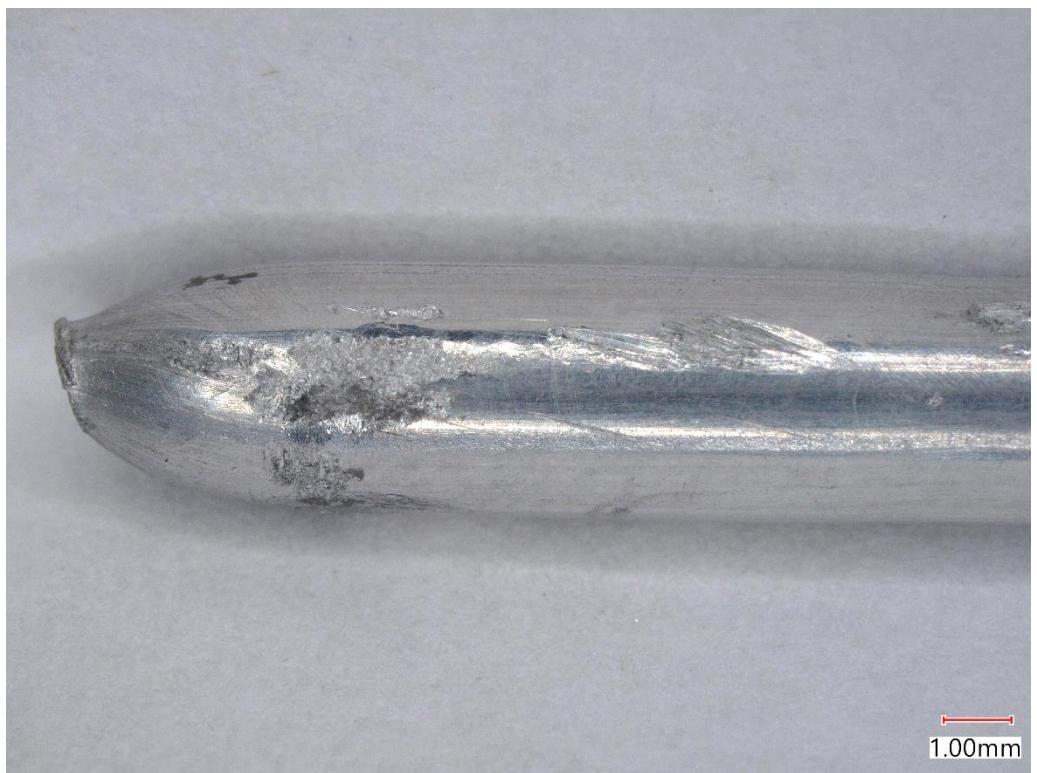
- x. Figure 39 shows profile of an aluminium wire from Sample #2. Similar observations were made on aluminium wires from Sample #2.
- xi. Figure 40 shows profile of an aluminium wire from Sample #3. Similar observations were made on aluminium wires from Sample #3.

FIGURE 39: PROFILE OF A BROKEN ALUMINUM WIRE, SAMPLE #2

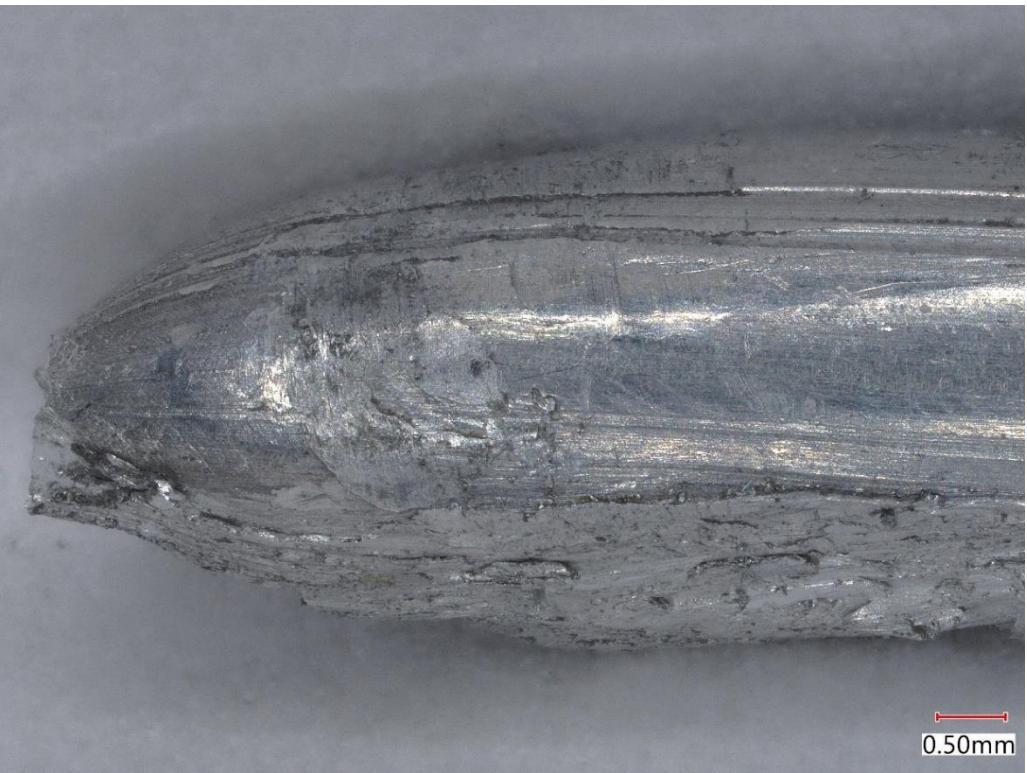
FIGURE 40: PROFILE OF A BROKEN ALUMINUM WIRE, SAMPLE #3

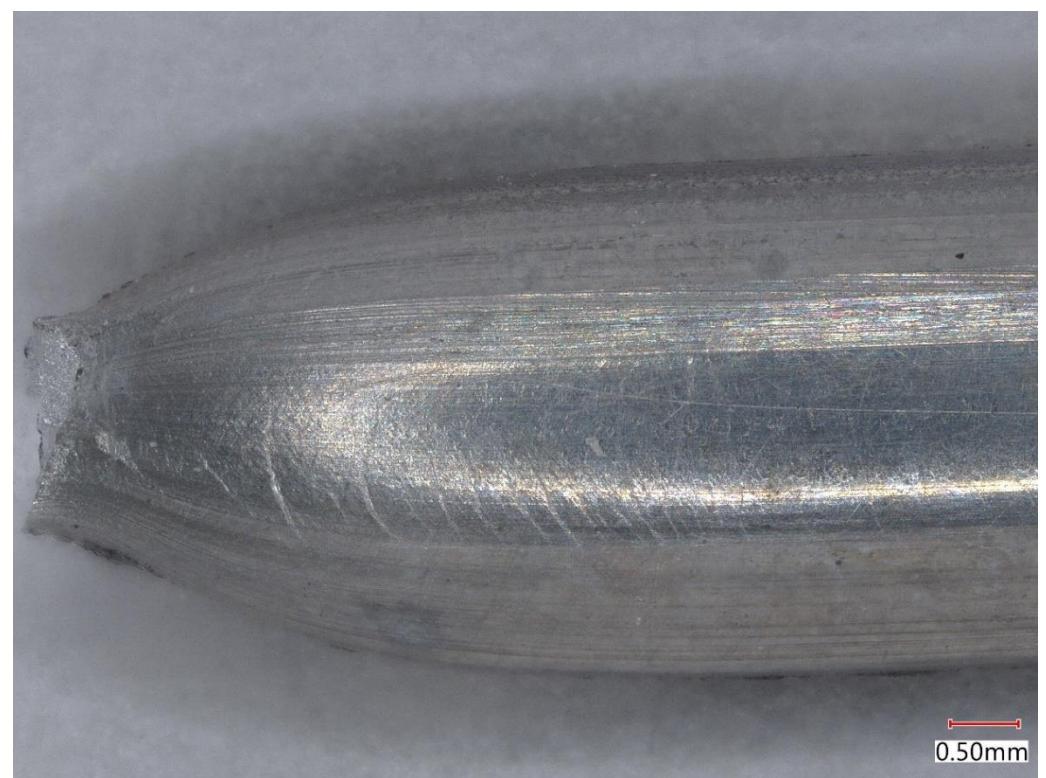
- xii. Figure 41 shows profile of an aluminium wire from Sample #4. Similar observations were made on aluminium wires from Sample #4.
- xiii. Figure 42 shows one of the aluminium wires which did not show any localized necking in the vicinity of the fracture. This is due to damage and stress state created on this aluminium wire during the incident.

FIGURE 41: PROFILE OF A BROKEN WIRE, SAMPLE #4

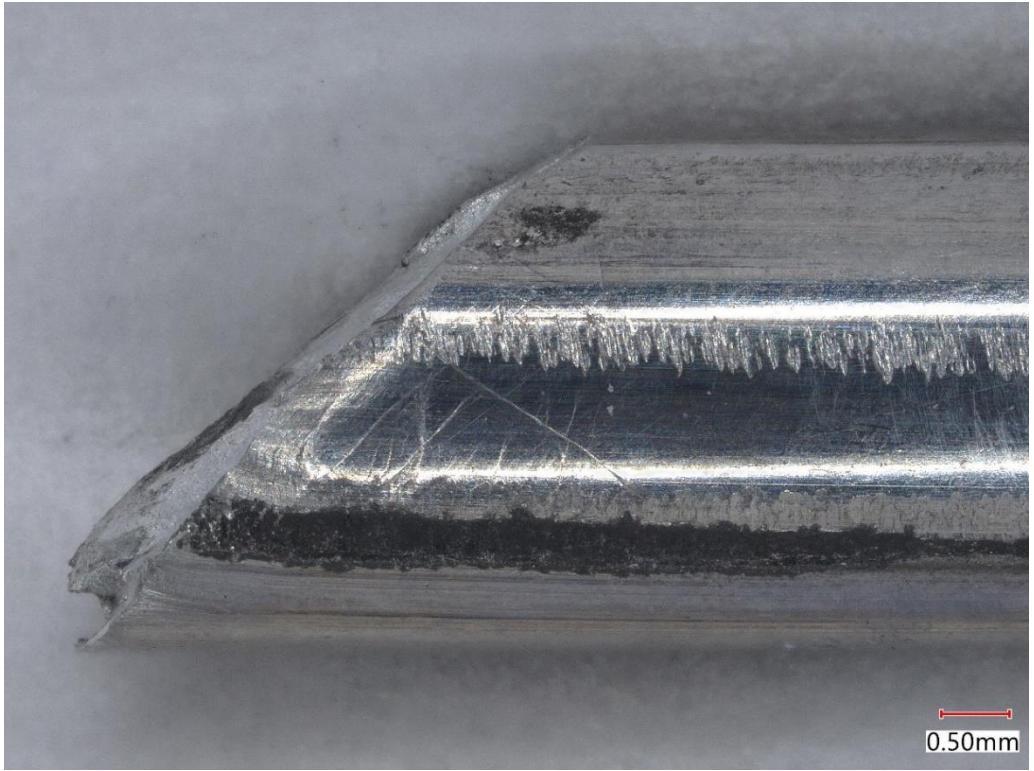
FIGURE 42: BROKEN ALUMINUM WIRE THAT SHOWED NO LOCAL DEFORMATION (NECKING) IN THE VICINITY OF THE FRACTURE SURFACE, SAMPLE #4

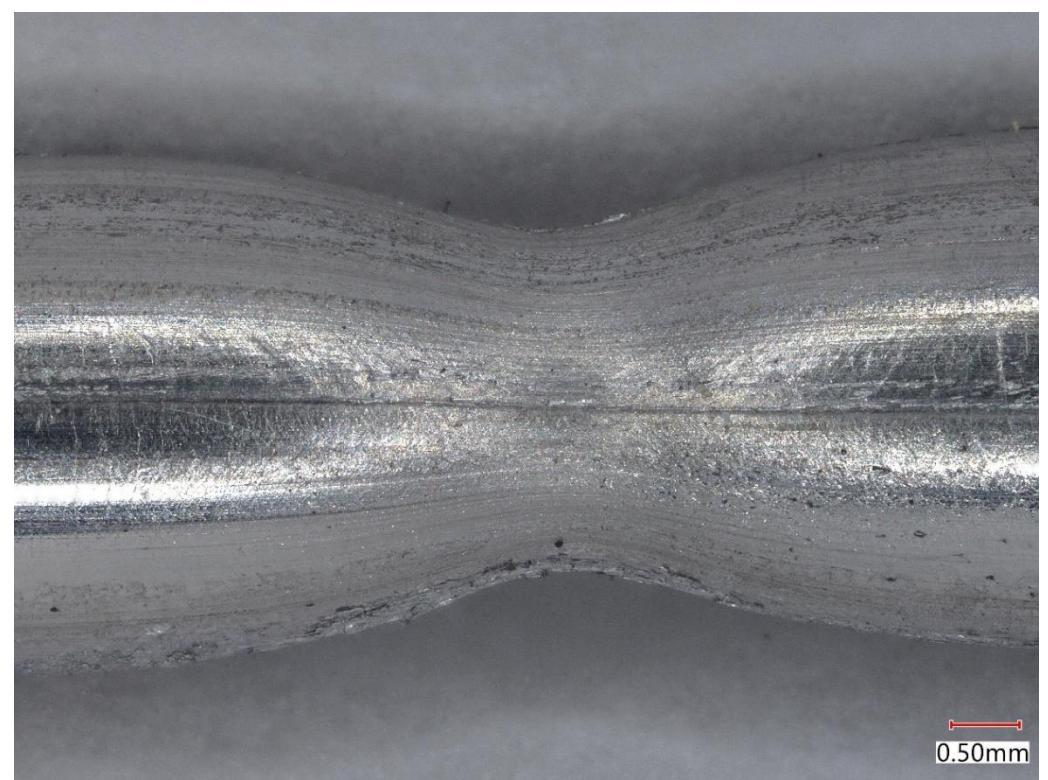
- xiv. Figure 43 and Figure 44 shows two of the wires necked but did not develop a fracture. Similar observations were made on some of the wires of the second layer.

FIGURE 43: ONE OF THE ALUMINUM WIRES THAT NECKED BUT DID NOT CRACK, FIRST LAYER OF ALUMINUM WIRES ON THE CABLE, SAMPLE #4

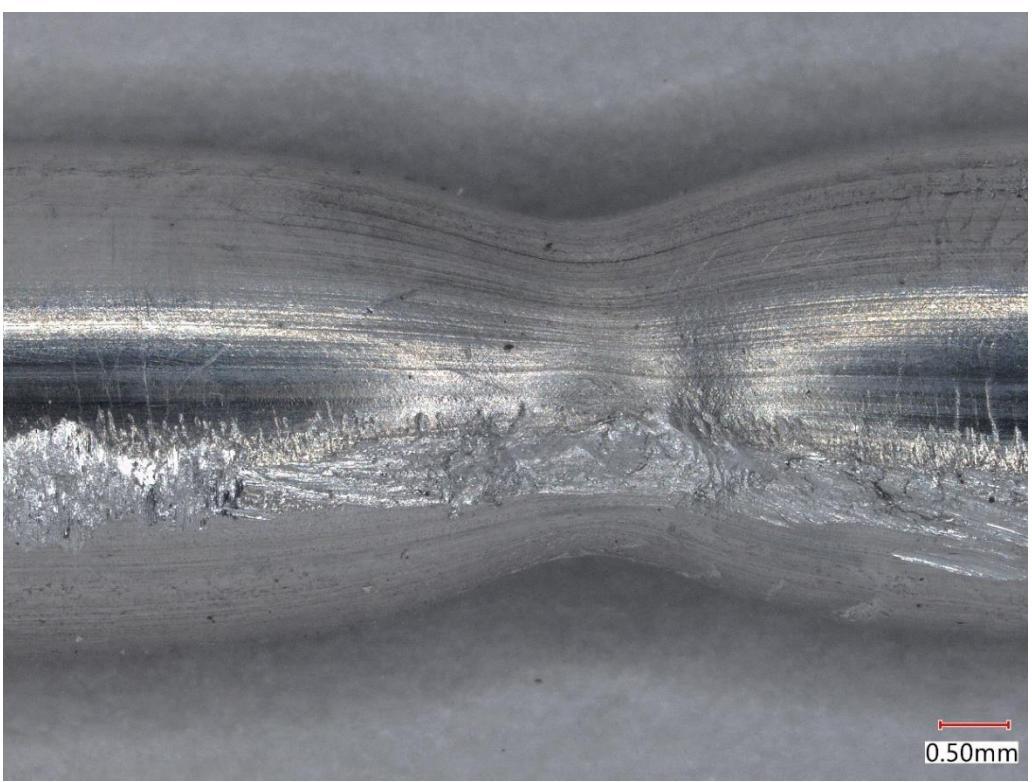
FIGURE 44: SAME AS FIGURE 43, THIS WIRE ALSO HAS SURFACE SCRATCH MARKS

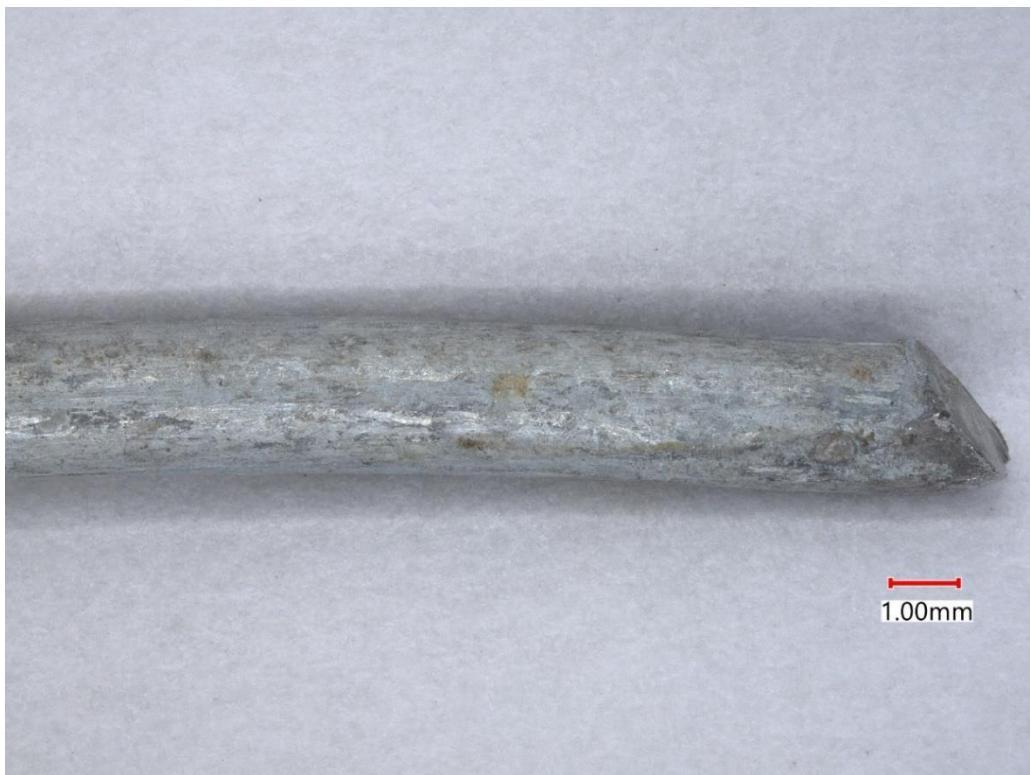
- xv. Figure 45Figure 44 shows the broken steel wires from Sample #1. Wire end surface was about 45° to the longitudinal direction of the wire.
- xvi. Surface of the steel wires were zinc coated and some white powdery corrosion products and some brown patches of a substance (possibly foreign material or rust) were observed, Figure 45 and Figure 46.

FIGURE 45: ONE OF THE BROKEN STEEL WIRES, SAMPLE #1 (THIS WIRE WAS POSSIBLY CUT)

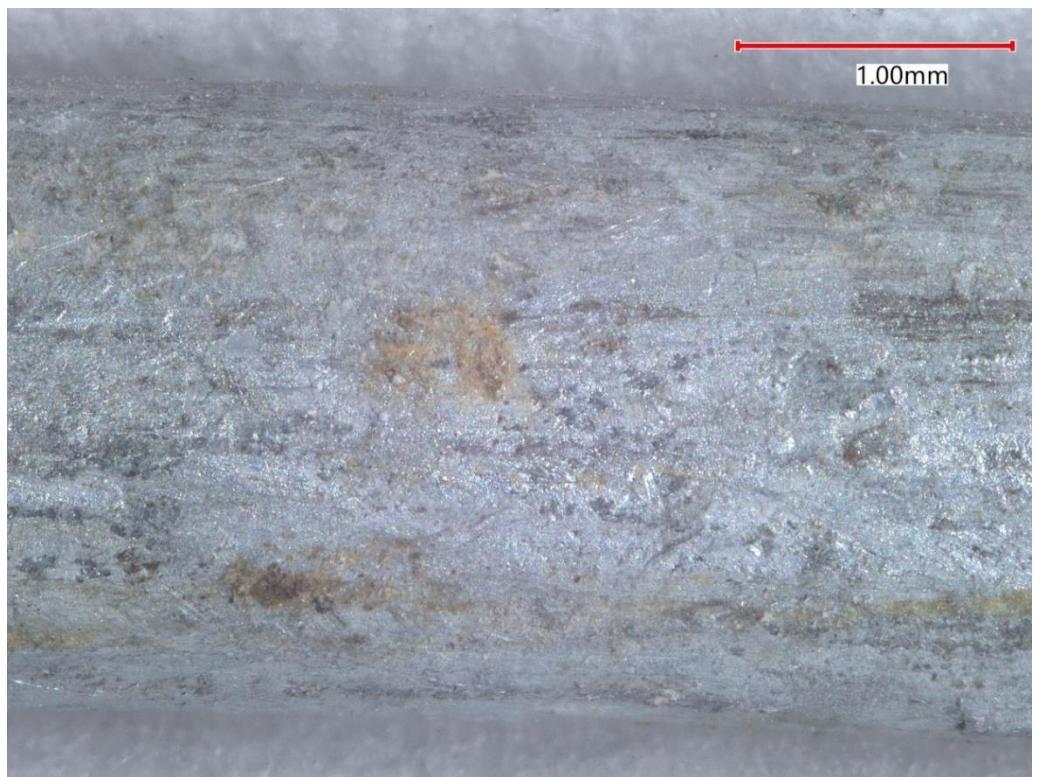
FIGURE 46: CLOSE VIEW OF STEEL WIRE SURFACE, SAMPLE #1

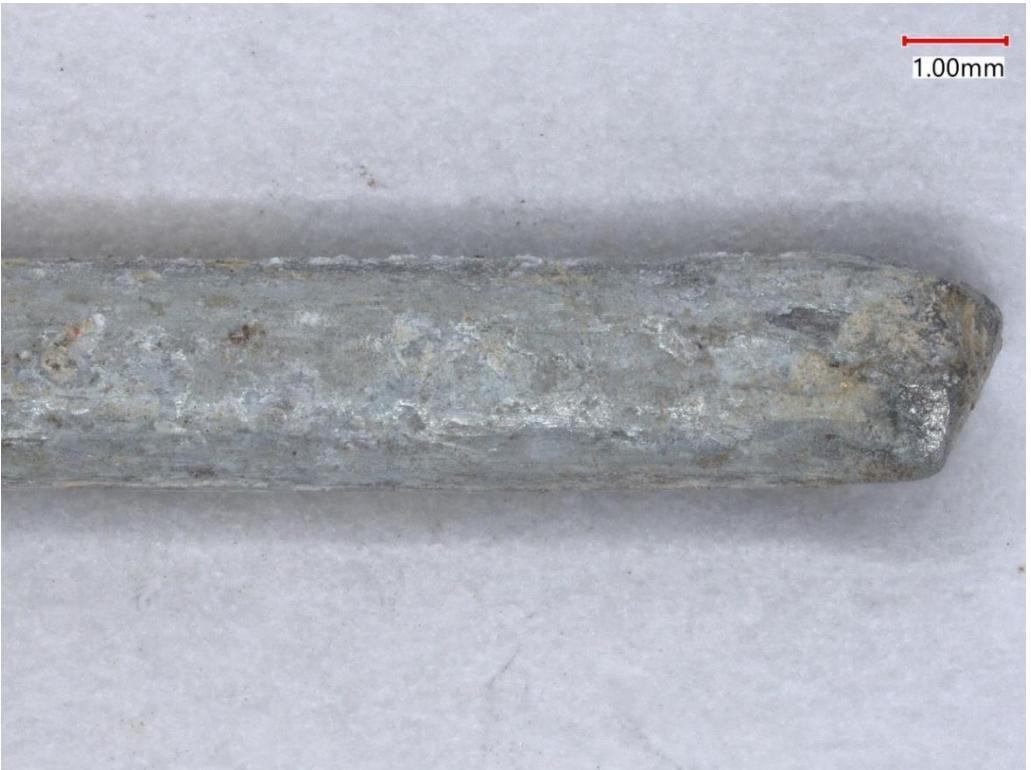
- xvii. Figure 47 shows another steel wire from Sample #1. This wire also showed some brown patches of rust or foreign material and white powdery corrosion products, Figure 48.

FIGURE 47: ANOTHER STEEL WIRE FROM SAMPLE #1 (THIS WIRE WAS POSSIBLY CUT)

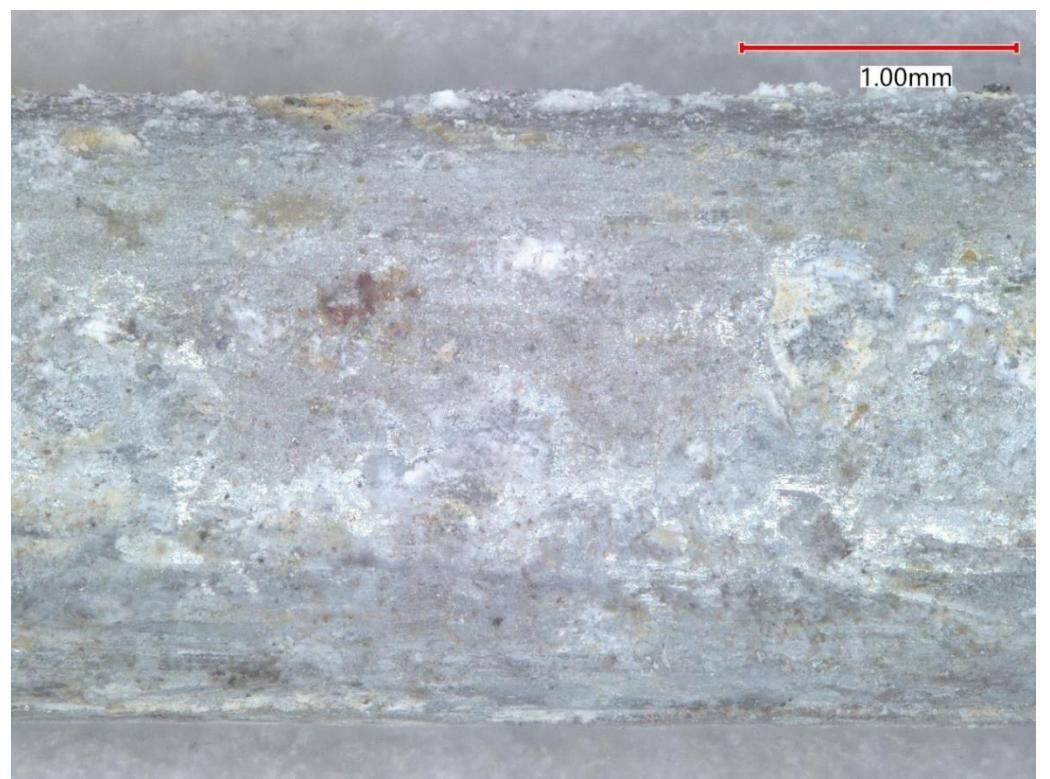
FIGURE 48: CLOSE VIEW OF THE SIDE SURFACE OF THE SECOND STEEL WIRE, SAMPLE #1

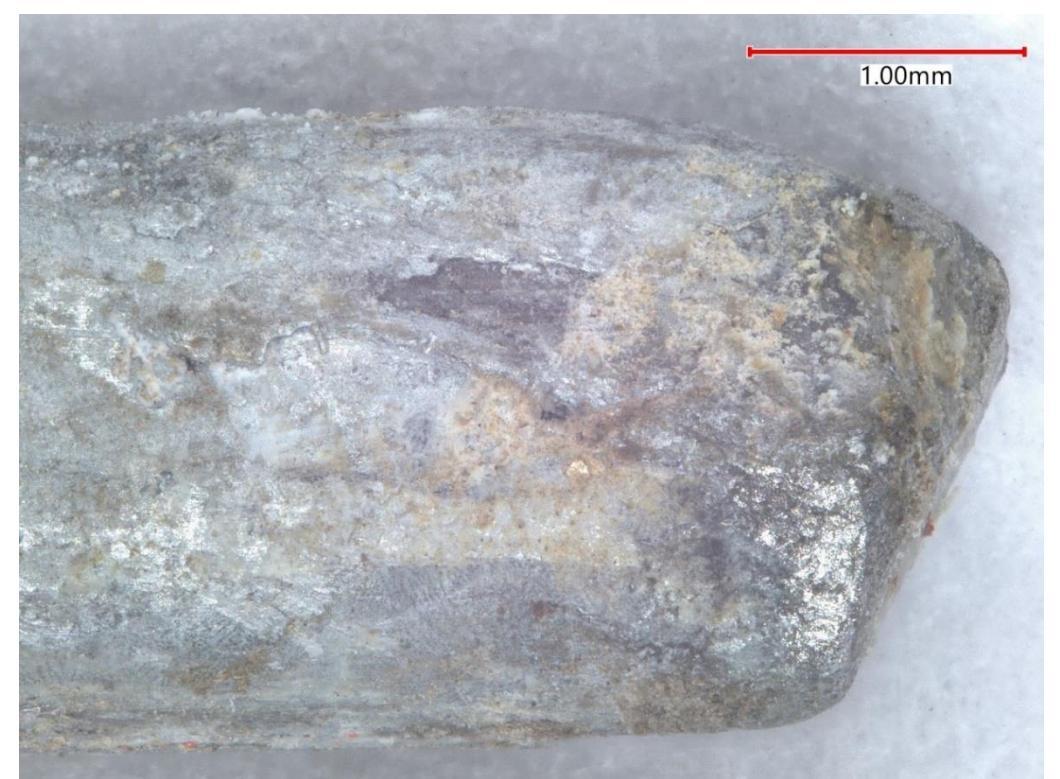
- xviii. Second steel wire showed a wedged fracture surface. Wedging on both sides was evident,
   Figure 49 (this wire was possibly cut).
  - xix. Figure 50 shows a wire end surface from Sample #2. Figure 51 shows the fracture surface of a broken steel wire removed from Sam Sample #3.

FIGURE 49: WEDGE FRACTURE SURFACE, STEEL WIRE #2, SAMPLE #1 (THIS WIRE WAS POSSIBLY CUT)

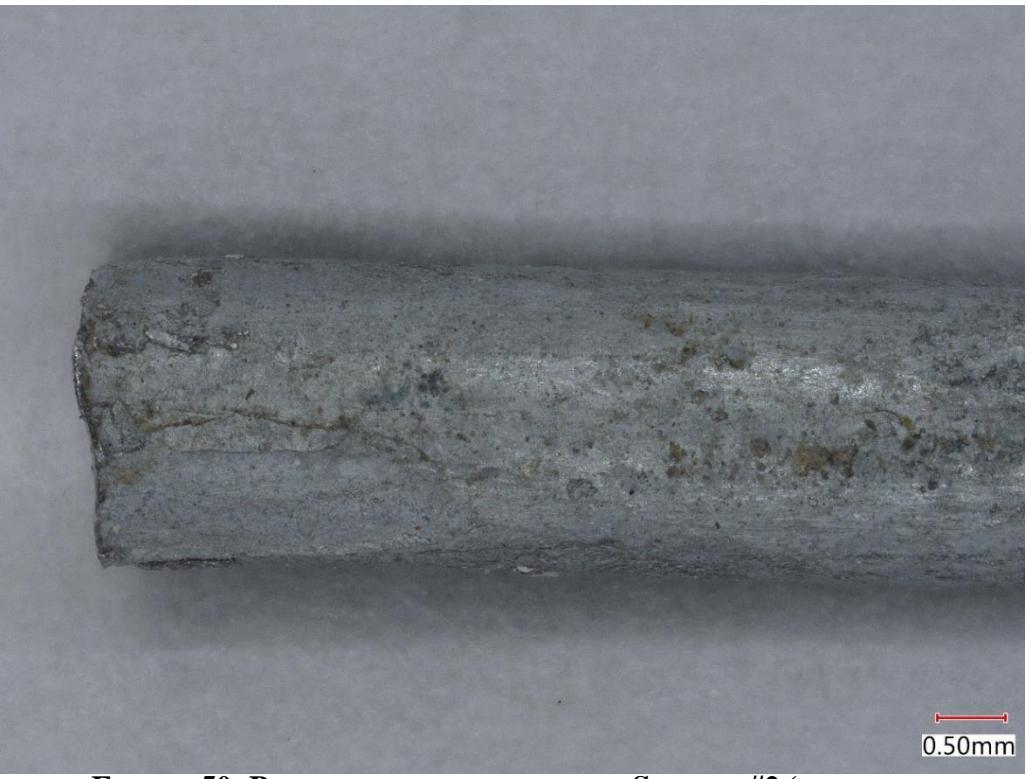
- xx. Wire end surface of steel wire from Sample #2 was normal to the longitudinal direction of the wire. Fracture surface of steel wire from Sample #3 was slightly at an angle.
- xxi. No steel samples were removed from Sample #4 as there were no broken steel wires.
- xxii. Figure 52 and Figure 53 show the fracture surface of aluminium wires from Sample #3 and Sample #4, respectively. High percentage of reduction of area for both wires was evident.
- xxiii. Figure 54 shows wire end surface of a steel wire from Sample #3. Corrosion/oxidation products on the surface were evident. We also observed a wedge on one side.

FIGURE 50: BROKEN STEEL WIRES FROM SAMPLE #2 (THIS WIRE WAS POSSIBLY CUT)

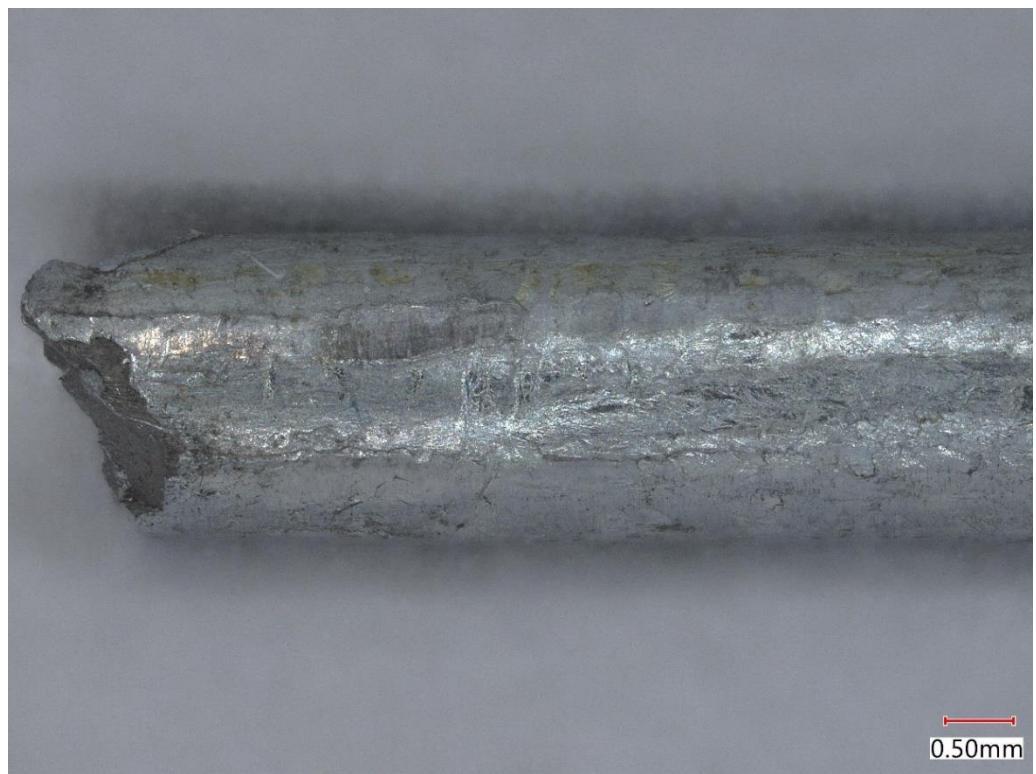
FIGURE 51: BROKEN STEEL WIRE FROM SAMPLE #3
