# Re: *Reliability and Resource Adequacy Study Review* – Labrador-Island Link Failure Investigation Reports

# Failure Investigation Report – L3501/2 Tower and Conductor Damage

Failure Investigation Report – L3501/2 Tower	R	evision R1		
Icing Event January 2021 in Labrador	Date:	Revision R1     :   28-May-2021     :   ii		
Nalcor Doc. No. ILK-EG-ED-6200-TL-RP-0001-01	Page:	ii

# FAILURE ANALYSIS OF ELECTRODE CROSS ARM IN LABRADOR ISLAND TRANSMISSION LINK (LITL)

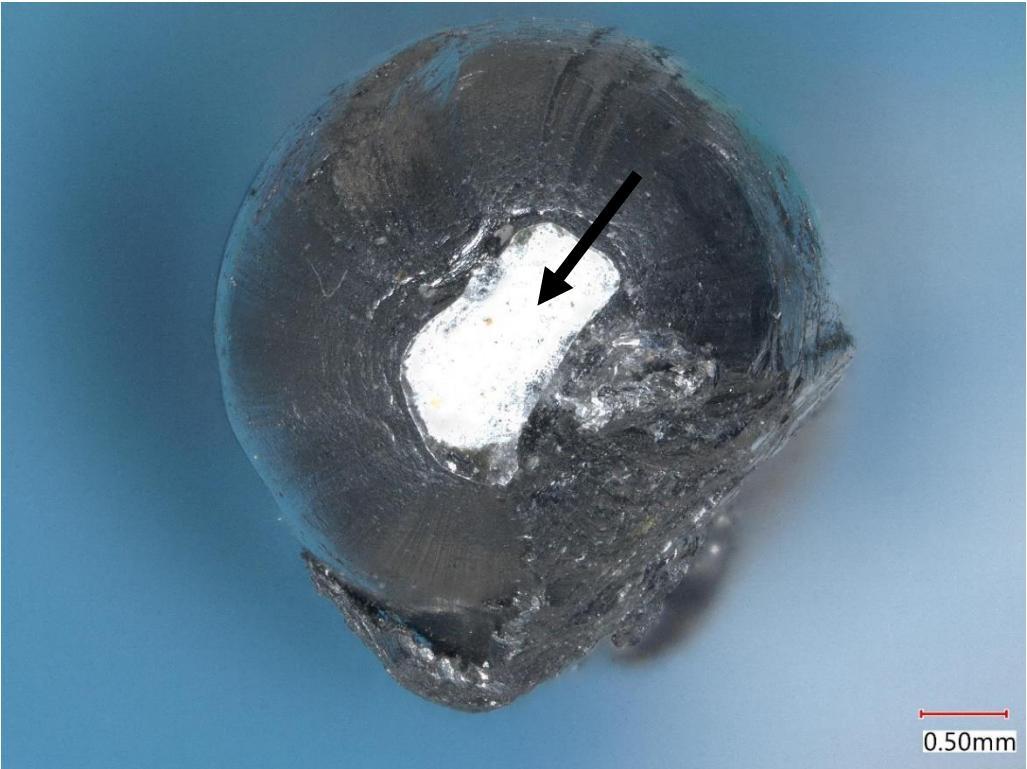
- xx. Wire end surface of steel wire from Sample #2 was normal to the longitudinal direction of the wire. Fracture surface of steel wire from Sample #3 was slightly at an angle.
- xxi. No steel samples were removed from Sample #4 as there were no broken steel wires.
- xxii. Figure 52 and Figure 53 show the fracture surface of aluminium wires from Sample #3 and Sample #4, respectively. High percentage of reduction of area for both wires was evident.
- xxiii. Figure 54 shows wire end surface of a steel wire from Sample #3. Corrosion/oxidation products on the surface were evident. We also observed a wedge on one side.

FIGURE 52: FRACTURE SURFACE OF AN ALUMINUM WIRE, SAMPLE #3

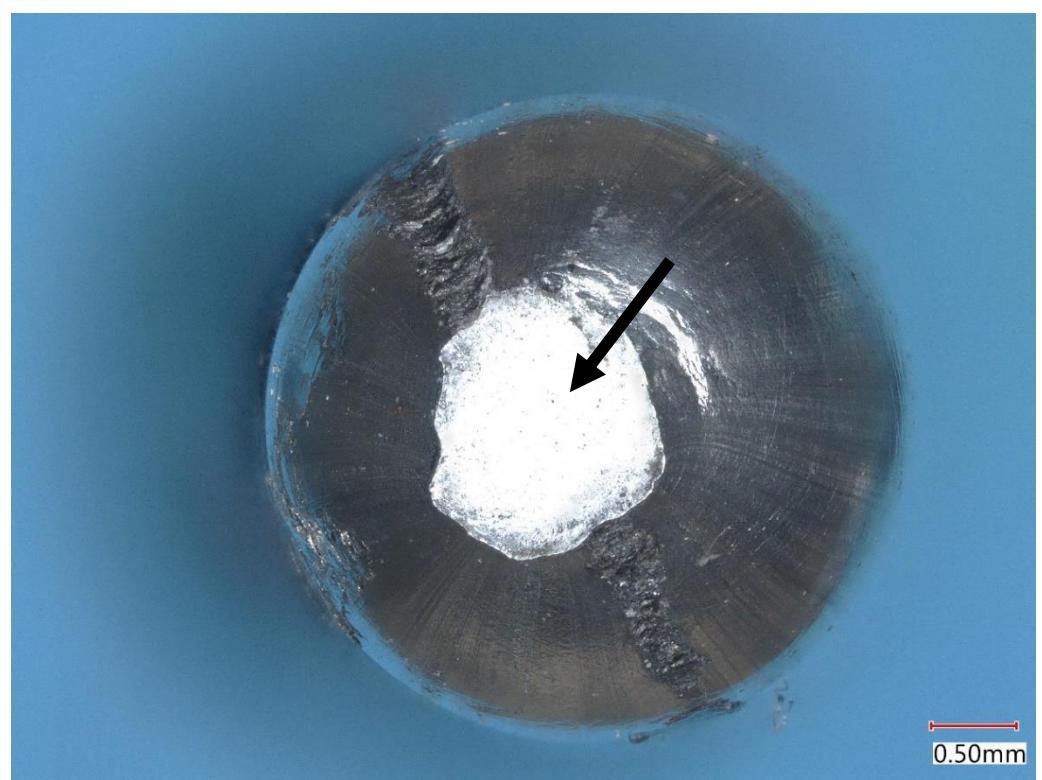
FIGURE 53: FRACTURE SURFACE OF AN ALUMINUM WIRE, SAMPLE #4

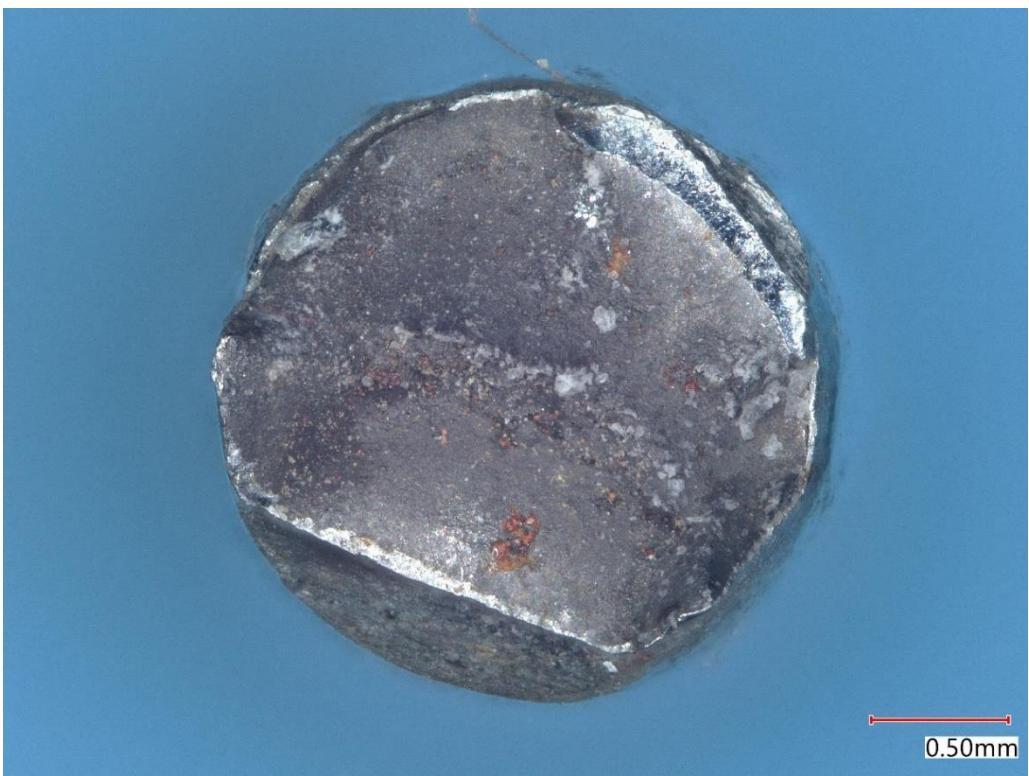
FIGURE 54: FRACTURE SURFACE OF A STEEL WIRE FROM SAMPLE #3 (THIS WIRE WAS POSSIBLY CUT)

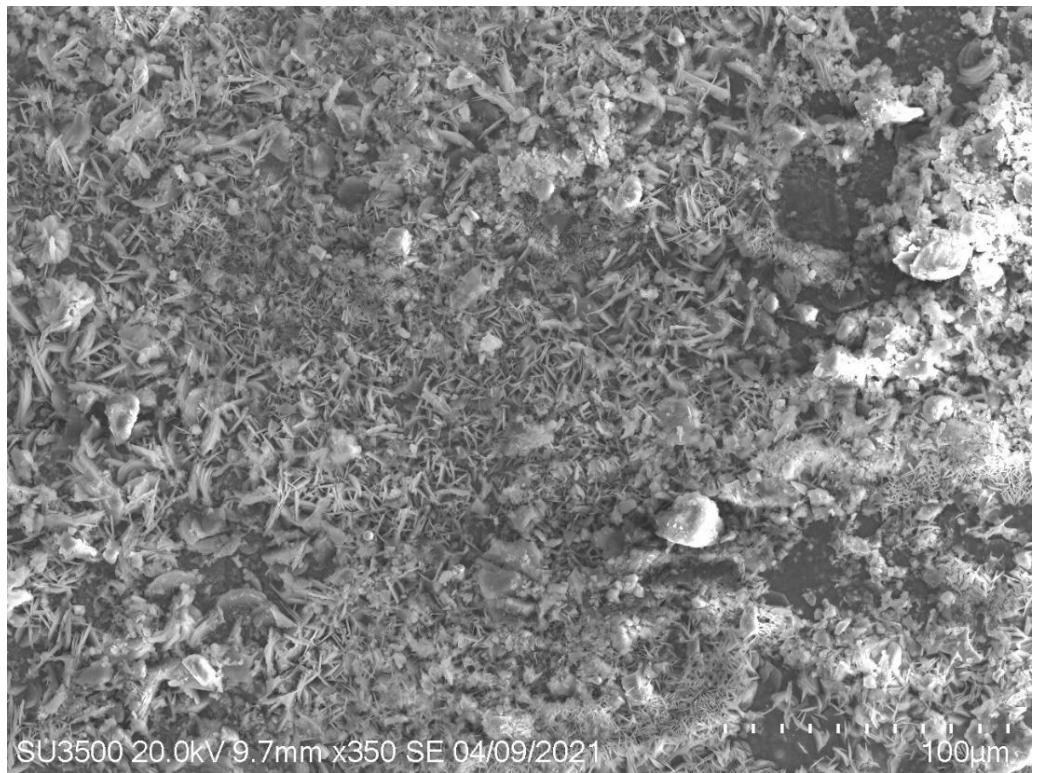
- ii. As it was observed during the low magnification examination, the surface of the steel wires contained corrosion/oxidation products. Figure 57 shows the corrosion/oxidation products on the side surface of steel wire #1 (of Sample #1). Figure 58 and Figure 59 shows EDS analysis results of the compounds on the surface. Results show that they mostly contained zinc (possibly in the form of zinc oxides), oxygen (O), sodium (Na), chlorine (Cl), silicon (Si), aluminium (Al), sulphur (S) and iron (Fe). Results indicate mostly Zn, Na and Cl were involved. Some iron and aluminium compounds were also there.

FIGURE 57: CLOSE VIEW OF OXIDATION/CORROSION PRODUCTS ON THE SIDE SURFACE OF STEEL WIRE #1, SAMPLE #1

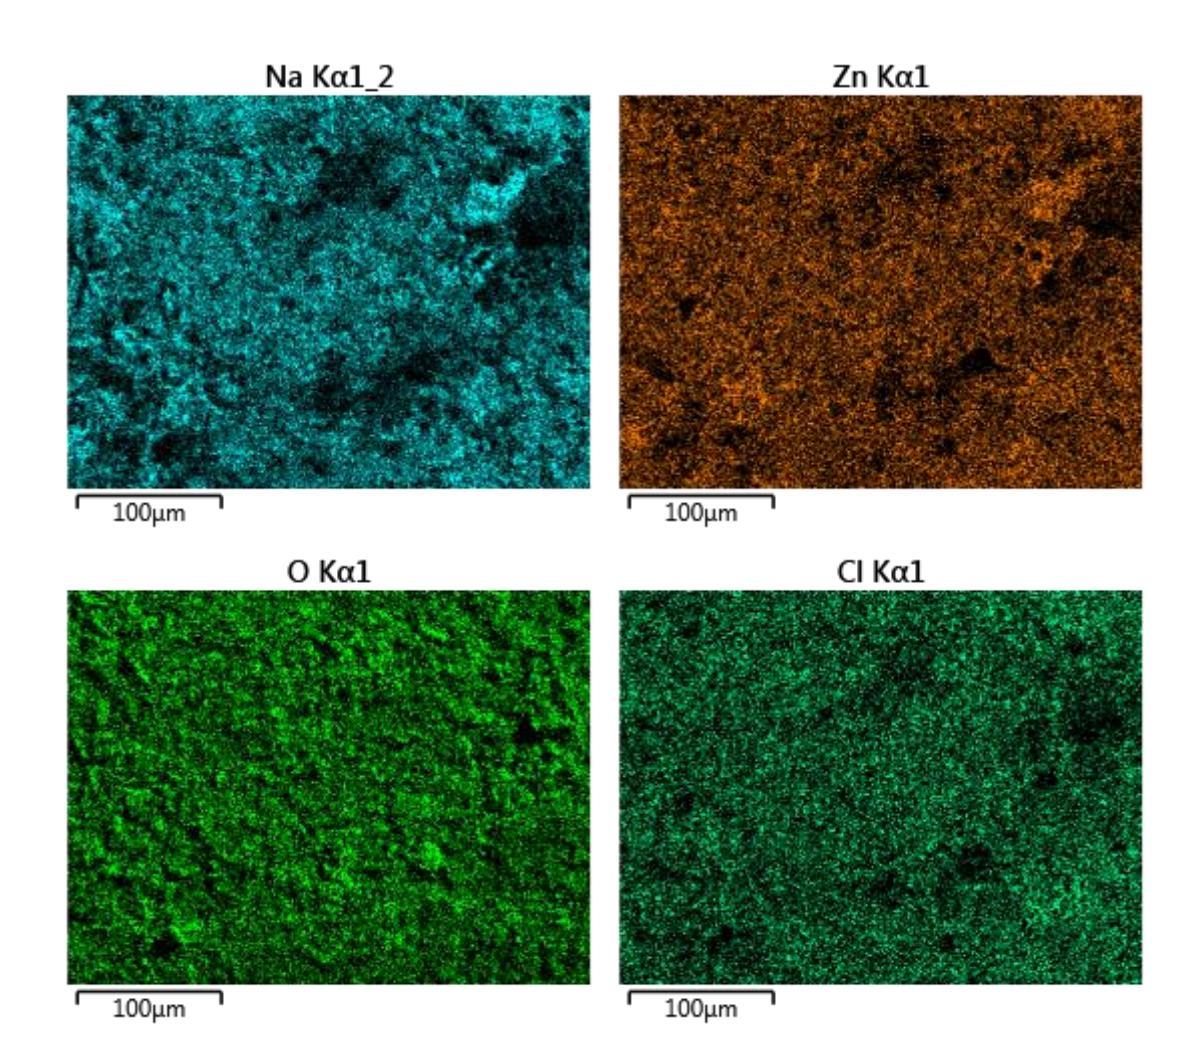
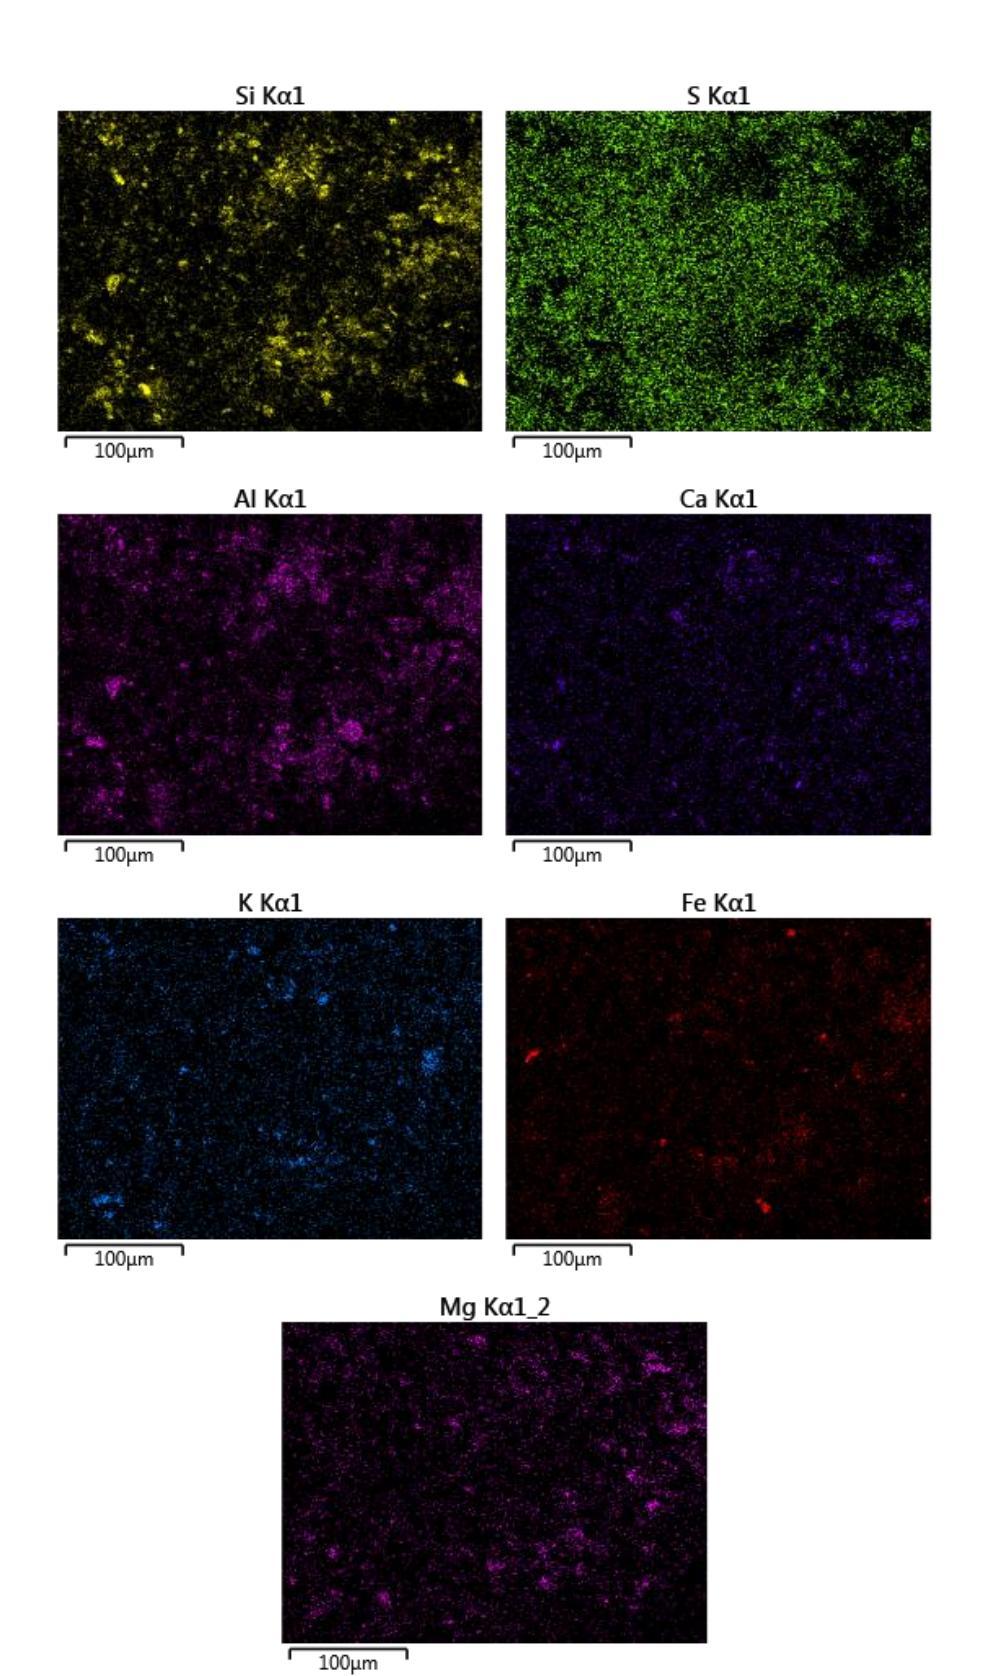
FIGURE 58: EDS MAP OF CORROSION PRODUCTS, STEEL WIRE #1, SAMPLE #1

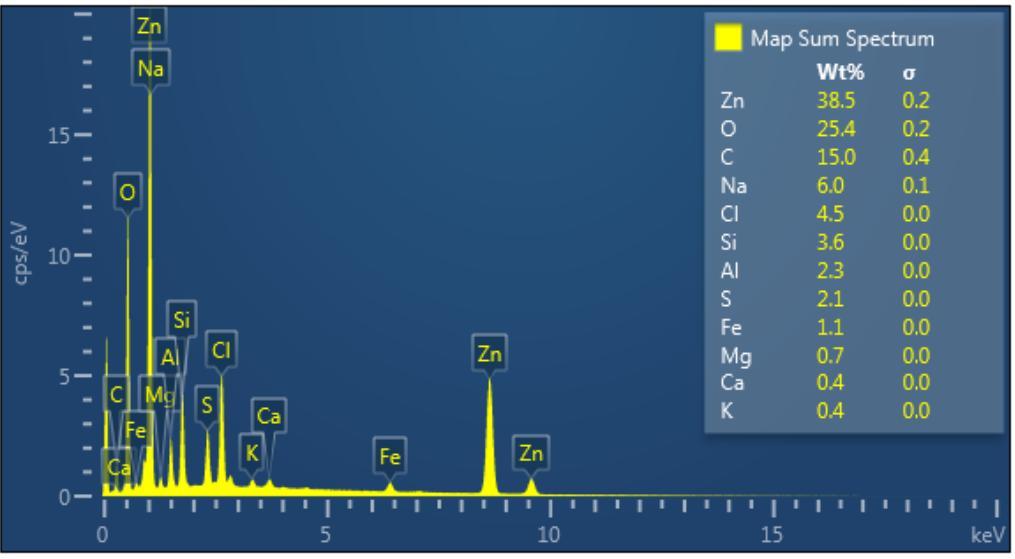
FIGURE 59: EDS (POINT) ANALYSIS RESULTS OF THE CORROSION PRODUCTS, STEEL WIRE #1, SAMPLE #1

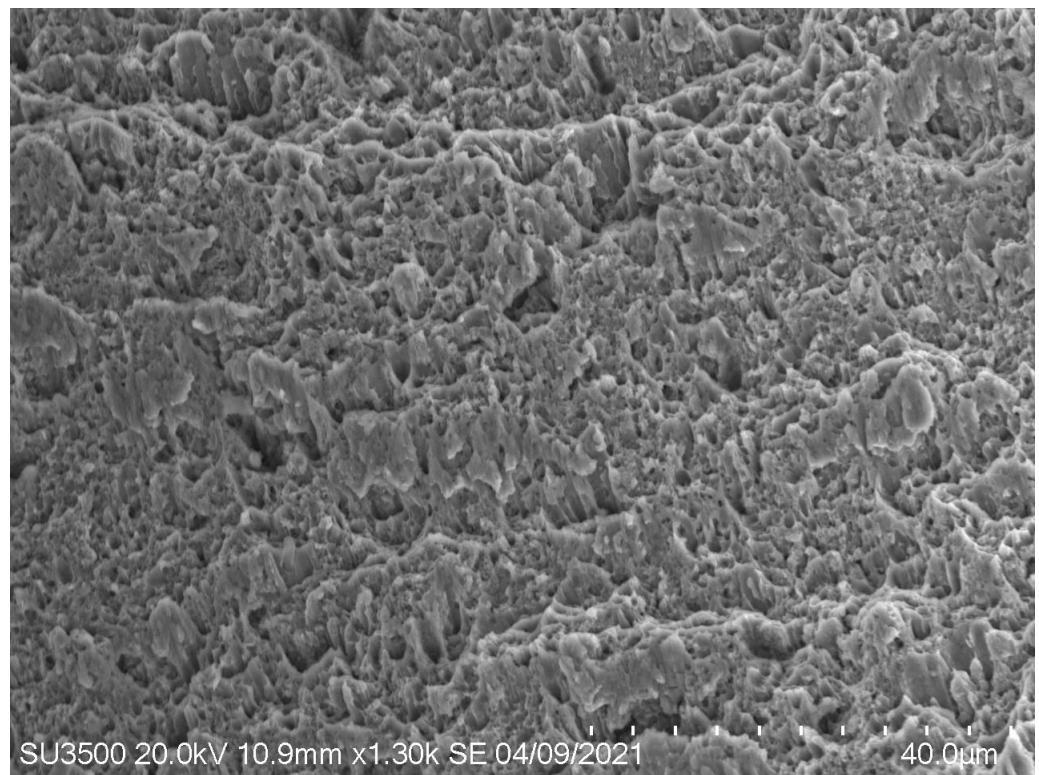
- We cleaned Steel wire #1 and #2 from Sample #1 in 5% Alconox at 70°C for 30 minutes.
  Figure 60 and Figure 61 show the fracture surfaces after cleaning. Fracture surface of each wire showed very small dimples, resolvable at high magnifications. Some areas showed shear dimples, possibly due to cutting of those samples. Figure 62, Figure 63 and Figure 64 show dimples observed on Steel wire #1 of Sample #1 at various magnifications. Appearance of the dimples suggested steel wires were cold drawn prior to manufacturing conductors. Figure 65 shows the dimples observed on Steel wire #2, Sample #1.

FIGURE 62: DIMPLES COVERING THE FRACTURE SURFACE OF STEEL WIRE #1, SAMPLE #1

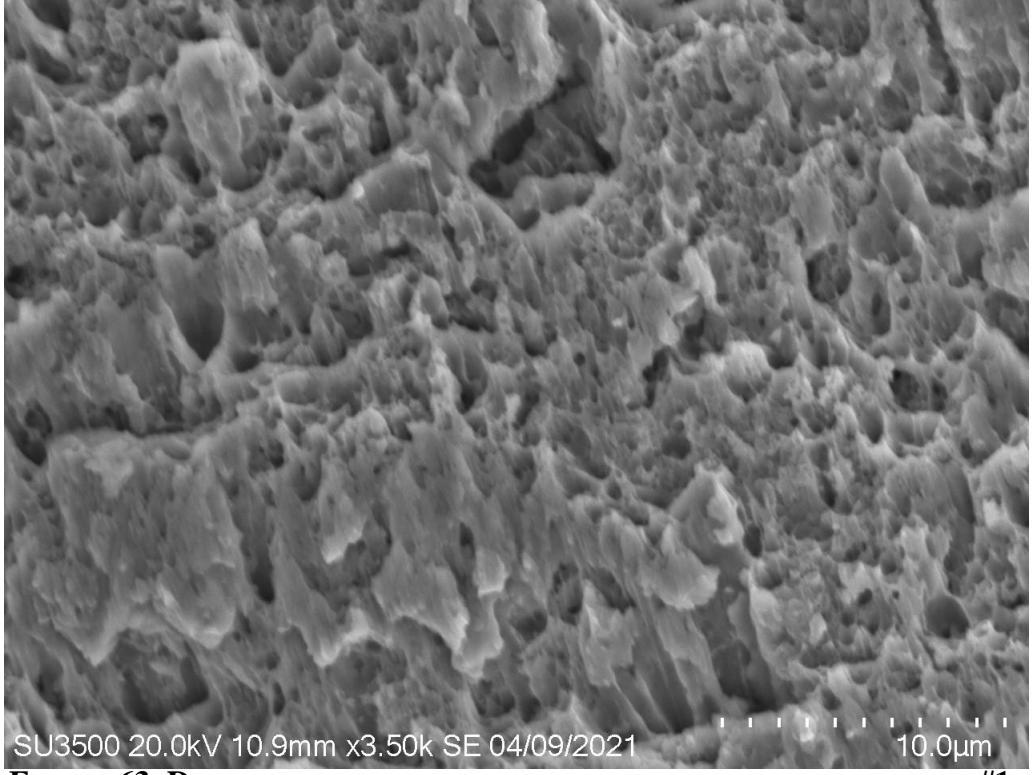
FIGURE 63: DIMPLES COVERING THE FRACTURE SURFACE OF STEEL WIRE #1, SAMPLE #1 AT HIGHER MAGNIFICATION

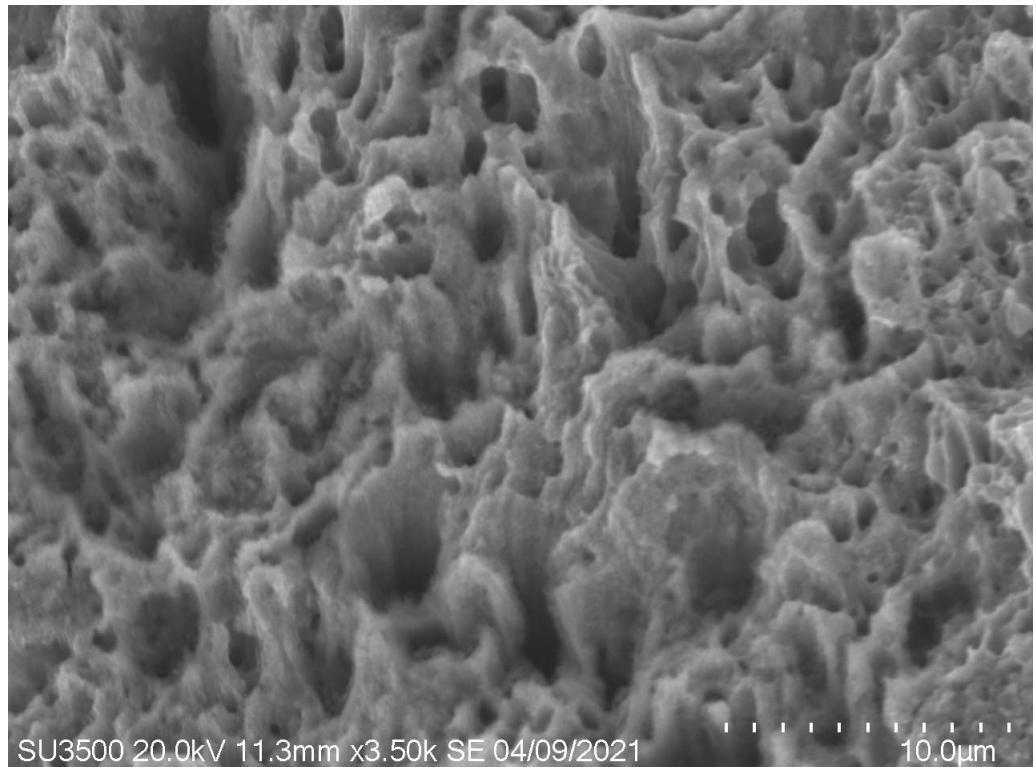
FIGURE 64: ANOTHER AREA OF THE FRACTURE SURFACE, STEEL WIRE #1, SAMPLE #1 AT HIGH MAGNIFICATION

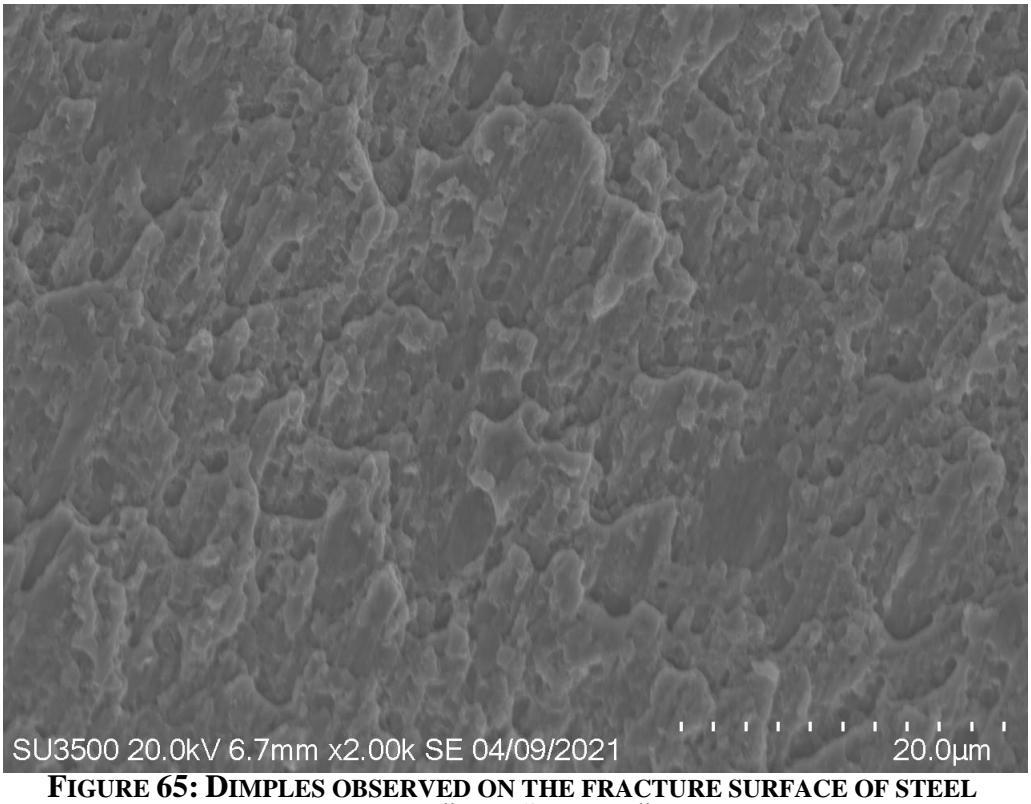
FIGURE 65: DIMPLES OBSERVED ON THE FRACTURE SURFACE OF STEEL WIRE #2 OF SAMPLE #1

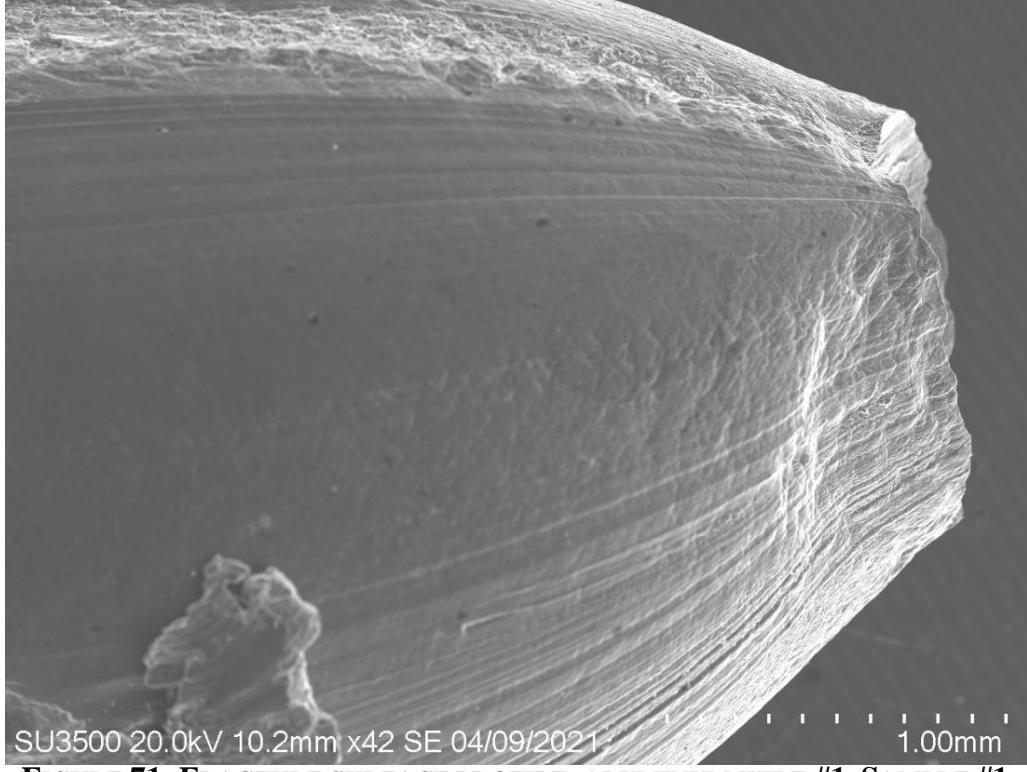
- vi. Figure 71 and Figure 72 show the profile and top of the fracture surface of aluminium wire #1, Sample #1. Significant necking was evident on the aluminium wire in the area adjacent to the fracture surface, Figure 71 and Figure 72. Reduction in area of the fracture surface was also very high, Figure 72. Dimples on the fracture surface could readily be observed at low magnifications. Dimples covering the entire fracture surface of the aluminium wires is the proof that the wire was overloaded during the incident, Figure 73.

FIGURE 71: FRACTURE SURFACE PROFILE, ALUMINUM WIRE #1, SAMPLE #1

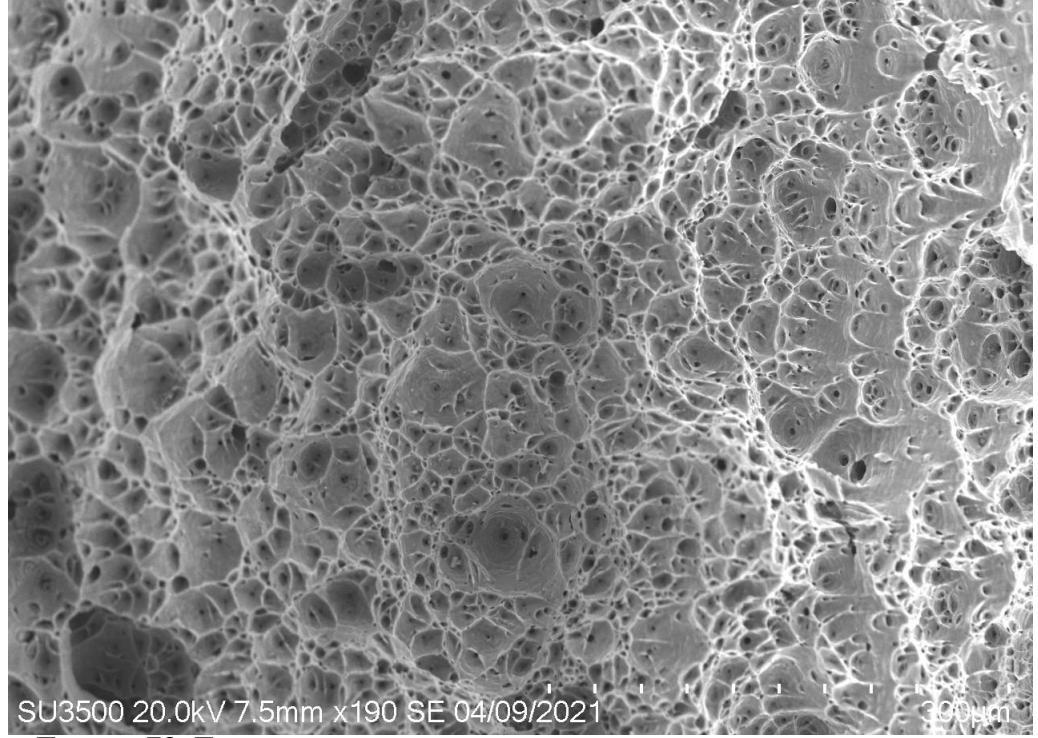
FIGURE 73: FINLEY DEVELOPED DIMPLES ON THE FRACTURE SURFACE OF ALUMINUM WIRE #1, SAMPLE #1

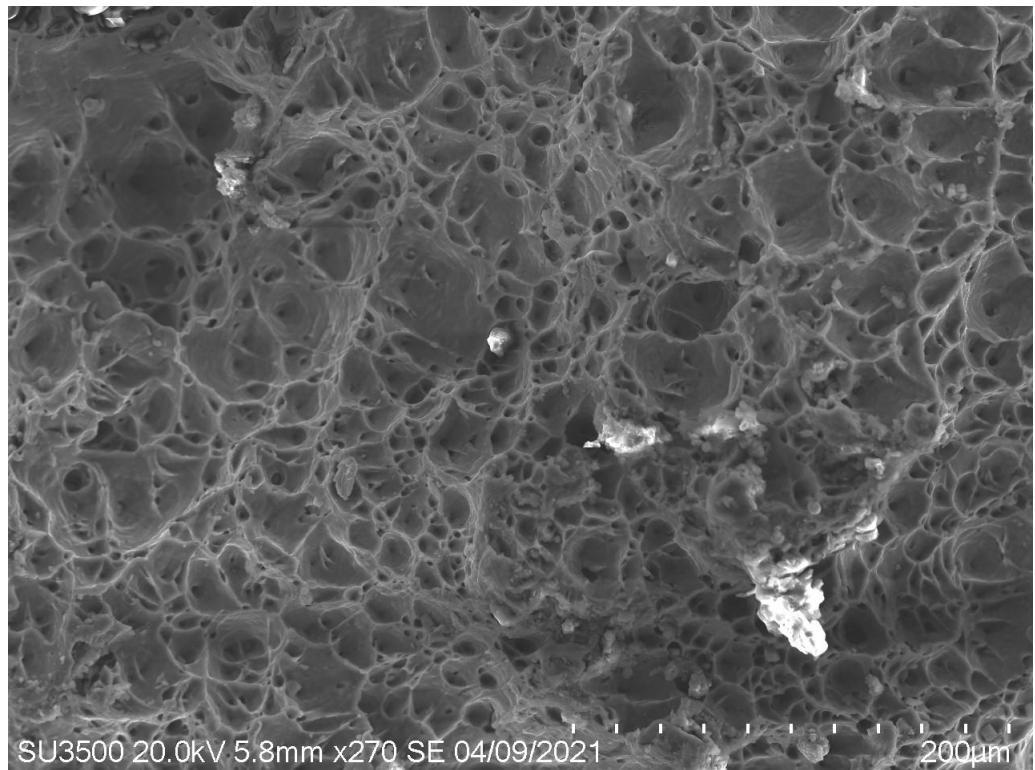
- vii. Figure 74 and Figure 75 show the profile of the fracture surface of aluminium wire #2 from Sample #1. Significant necking was evident on the aluminium wire in the area adjacent to the fracture surface, Figure 74 and Figure 75. Reduction in area of the fracture surface was also very high, Figure 76. Dimples on the fracture surface could readily be observed at low magnification. Dimples covering the entire fracture surface of the aluminium wires is the proof that the wire was overloaded during the incident.

SU3500 20.0kV 5.8mm x270 SE 04/09/2021 FIGURE 76: FINLEY DEVELOPED DIMPLES ON THE FRACTURE SURFACE OF ALUMINUM WIRE #2, SAMPLE #1

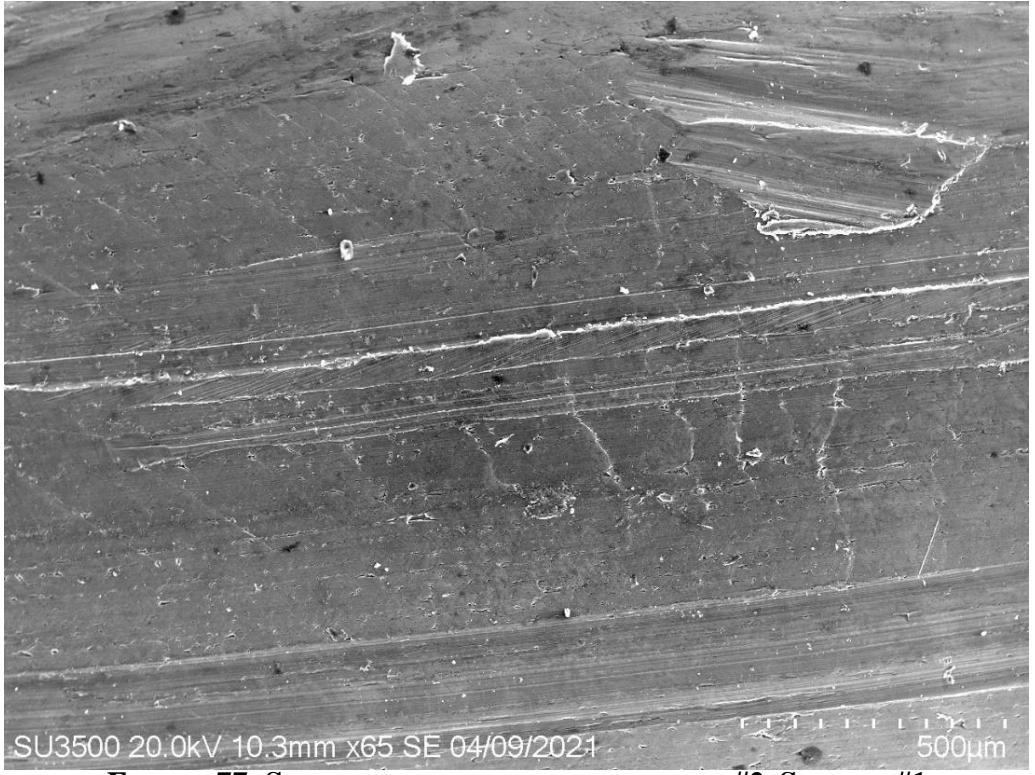
- viii. Figure 77 shows the side view of aluminium wire #2 of Sample #1. Rubbing and scratch marks as a result of relative motion of the wires of the cable were evident.

FIGURE 77: SIDE SURFACE OF ALUMINUM WIRE #2, SAMPLE #1

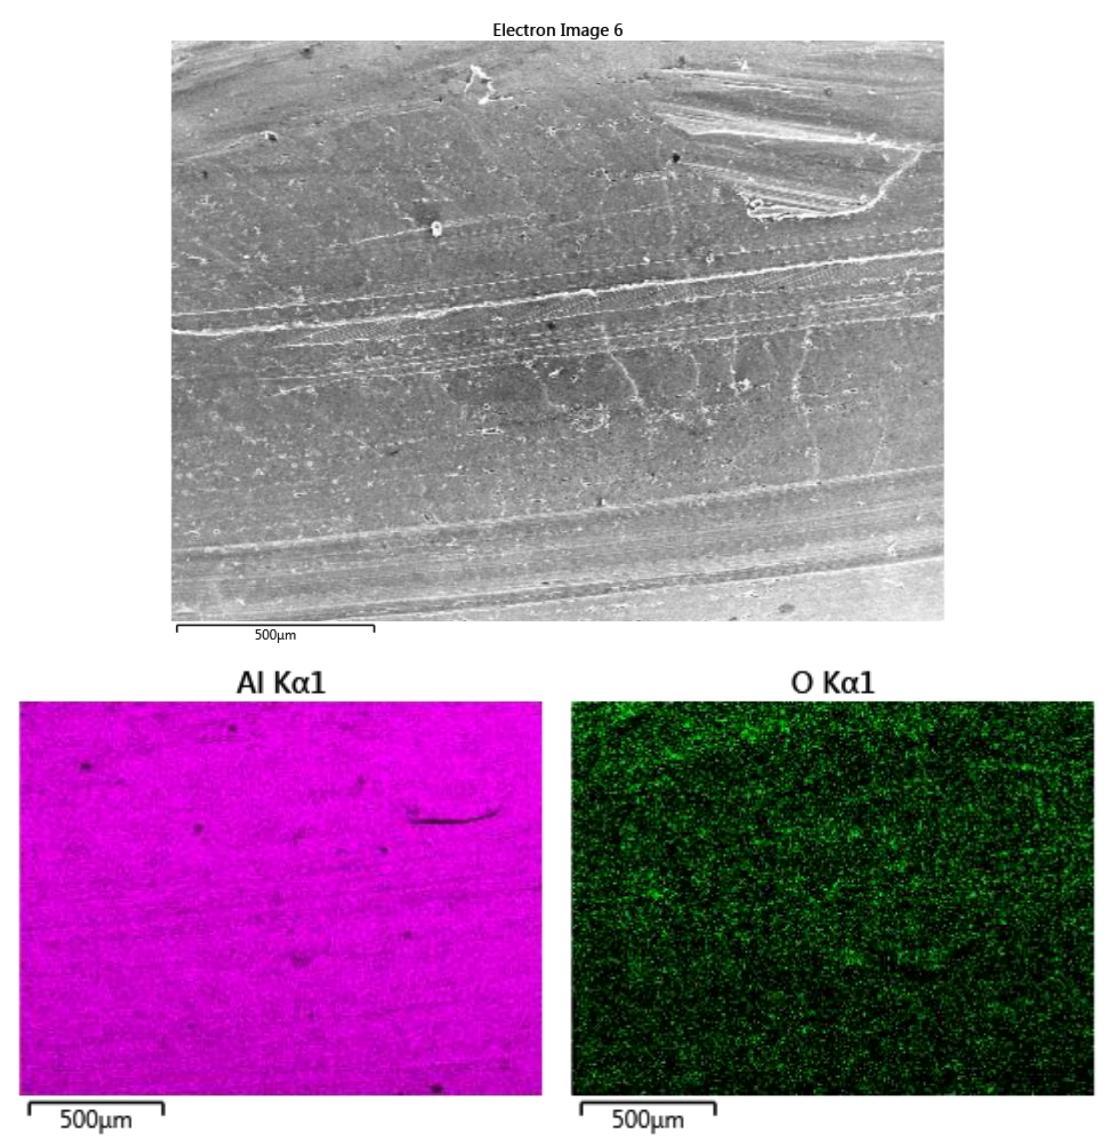
- ix. We performed EDS analysis on the side surface of the aluminum wire (wire #2, Sample #1). Results are presented in Figure 78 and Figure 79. Results show presence of only aluminium oxide on the surface.

FIGURE 78: EDS MAP OF THE AREA IN FIGURE 76, WIRE #2, SAMPLE #1

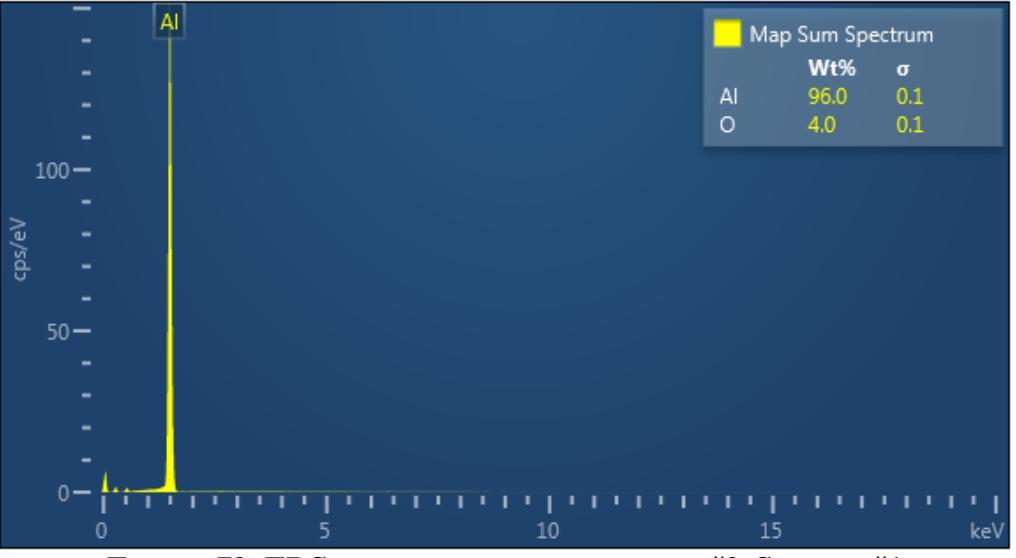
FIGURE 79: EDS ANALYSIS RESULTS OF WIRE #2, SAMPLE #1

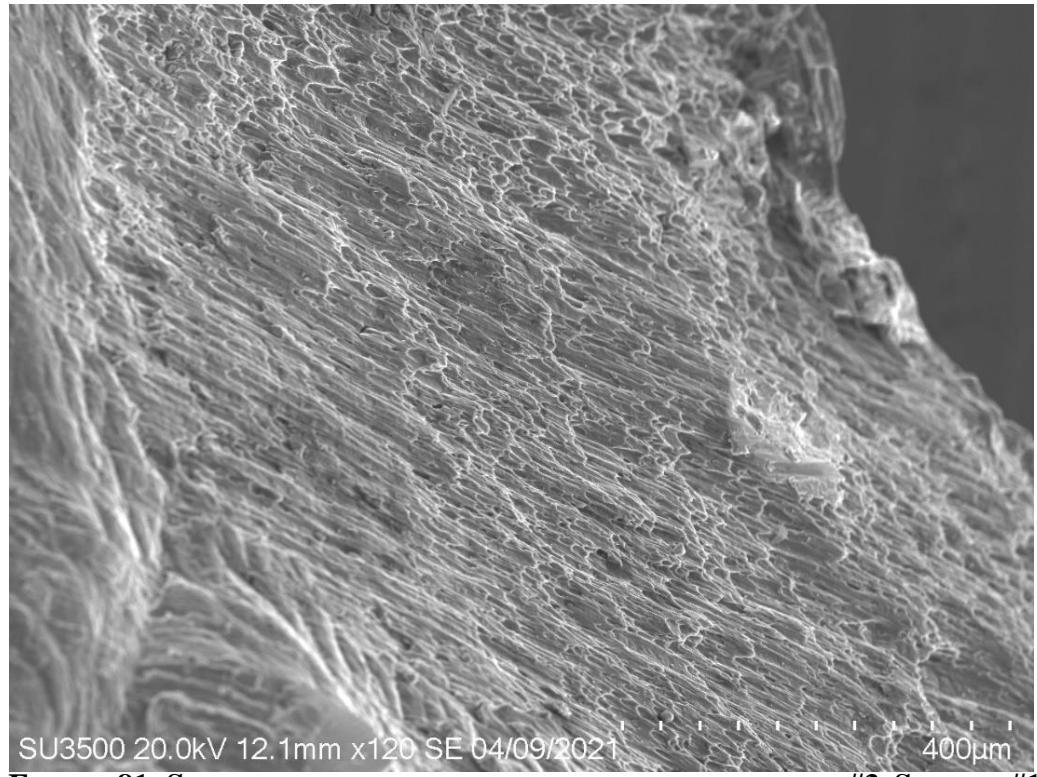
- x. Figure 80 shows the fracture surface of aluminium wire #3 of Sample #1. Figure 81 shows shear dimples on the fracture surface of the wire.
- xi. Figure 82 show aluminium wire #1 of Sample #4. This wire was one of those that broke with necking. Appearance of the fracture surface is very similar to those observed on Sample #1. Fracture surface was covered with readily observable dimples, Figure 83.

FIGURE 81: SHEAR DIMPLES ON THE FRACTURE SURFACE, WIRE #3, SAMPLE #1

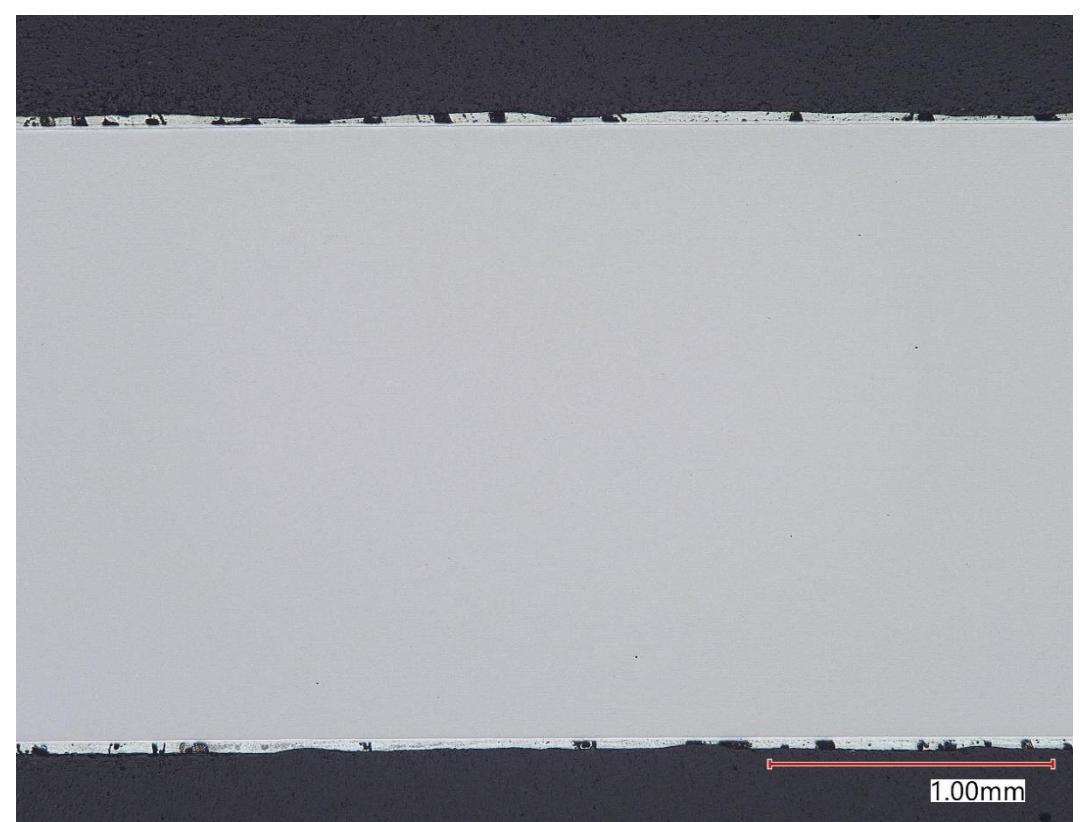
We have removed the steel wires with fracture surfaces from Sample #1,2 and 3. The steel wires were mounted in Bakelite, ground and polished in accordance with ASTM E3-11. Figure 86 and Figure 87 showed profiles of steel wires from sample #1. Wires were coated and coating appeared to have two layers, Figure 88. Coating appeared to be peeled off in some areas at low magnification, Figure 86 and Figure 87. However, examination at higher magnification revealed that these areas were stained during metallographic preparation, Figure 89 and Figure 90. It also showed some particles embedded in the coating, Figure87. We have performed EDS analysis on the coating, Figure 91. Mapping revealed zinc and sodium indicating that it was zinc coated (galvanized). Further tests on the galvanized layer revealed that the appearance on two layers were false (possibly small amount of concentration difference of sodium) and all the galvanized layer was homogeneous in zinc content, Figure 92. It is also indicated from the figure that the top layer contained some imperfections, while the bottom portion was pure galvanized layer. Figure 93 shows the elemental analysis of the galvanized layer.

FIGURE 86. PROFILE OF STEEL WIRE #1, SAMPLE #1, AS-POLISHED

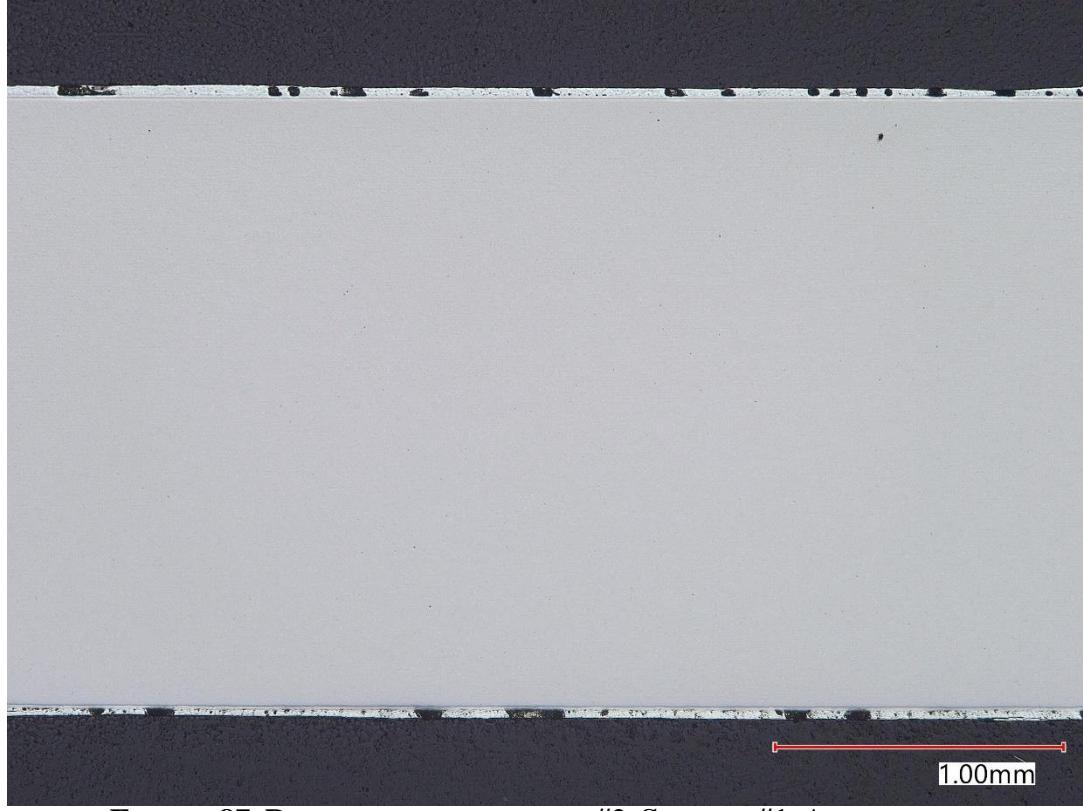
FIGURE 87. PROFILE OF STEEL WIRE #2, SAMPLE #1, AS-POLISHED

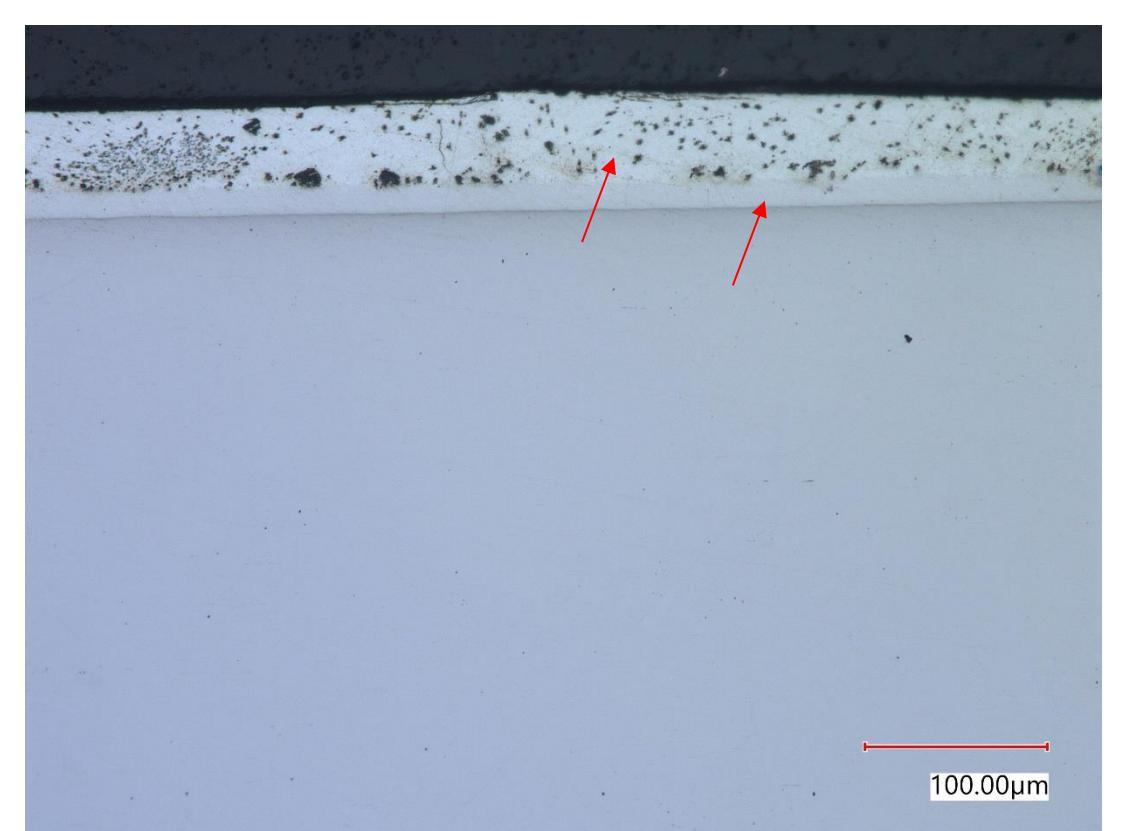
FIGURE 88. CLOSE VIEW OF COATING ON STEEL WIRE. STEEL WIRE #1 SAMPLE #3, AS-POLISHED

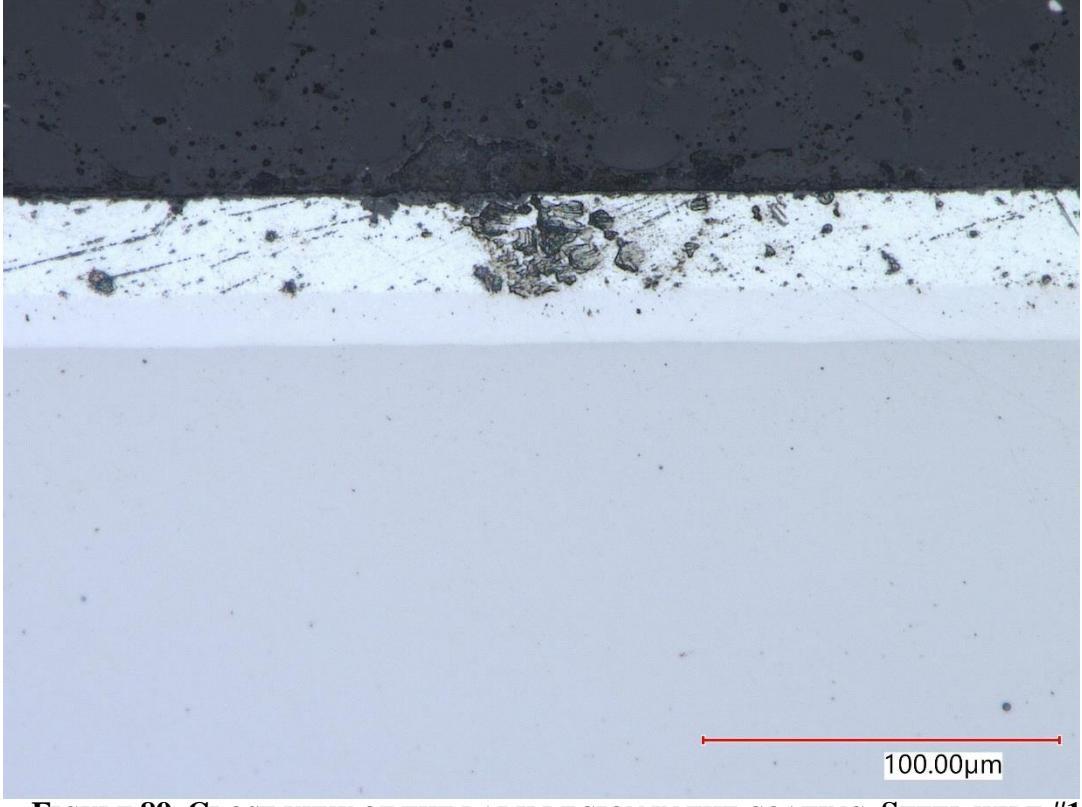
FIGURE 89. CLOSE VIEW OF THE DARK REGION IN THE COATING. STEEL WIRE #1 SAMPLE #1, AS-POLISHED

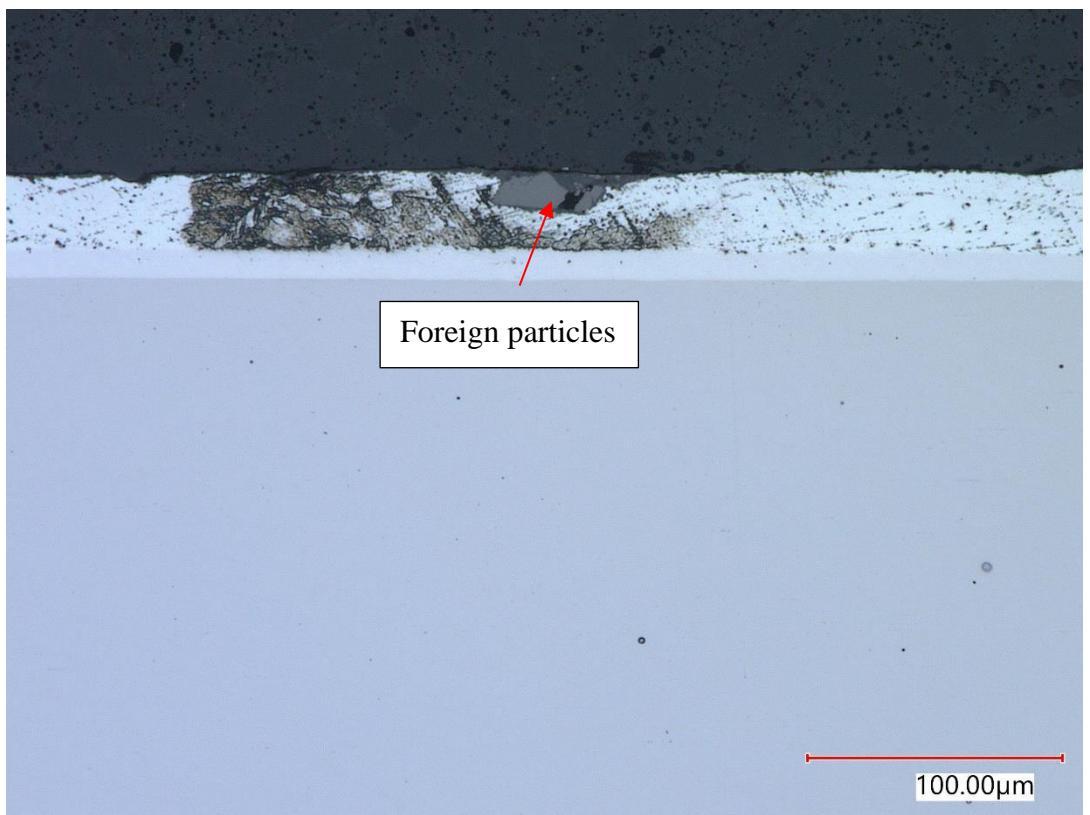
FIGURE 90. CLOSE VIEW OF THE DARK REGION IN THE COATING. STEEL WIRE #1 SAMPLE #2, AS-POLISHED
