# Re: *Reliability and Resource Adequacy Study Review* – Labrador-Island Link Failure Investigation Reports

# Failure Investigation Report – L3501/2 Tower and Conductor Damage

Failure Investigation Report – L3501/2 Tower	R	evision R1		
Icing Event January 2021 in Labrador	Date:	Revision R1     :   28-May-2021     :   ii		
Nalcor Doc. No. ILK-EG-ED-6200-TL-RP-0001-01	Page:	ii

# FAILURE ANALYSIS OF ELECTRODE CROSS ARM IN LABRADOR ISLAND TRANSMISSION LINK (LITL)

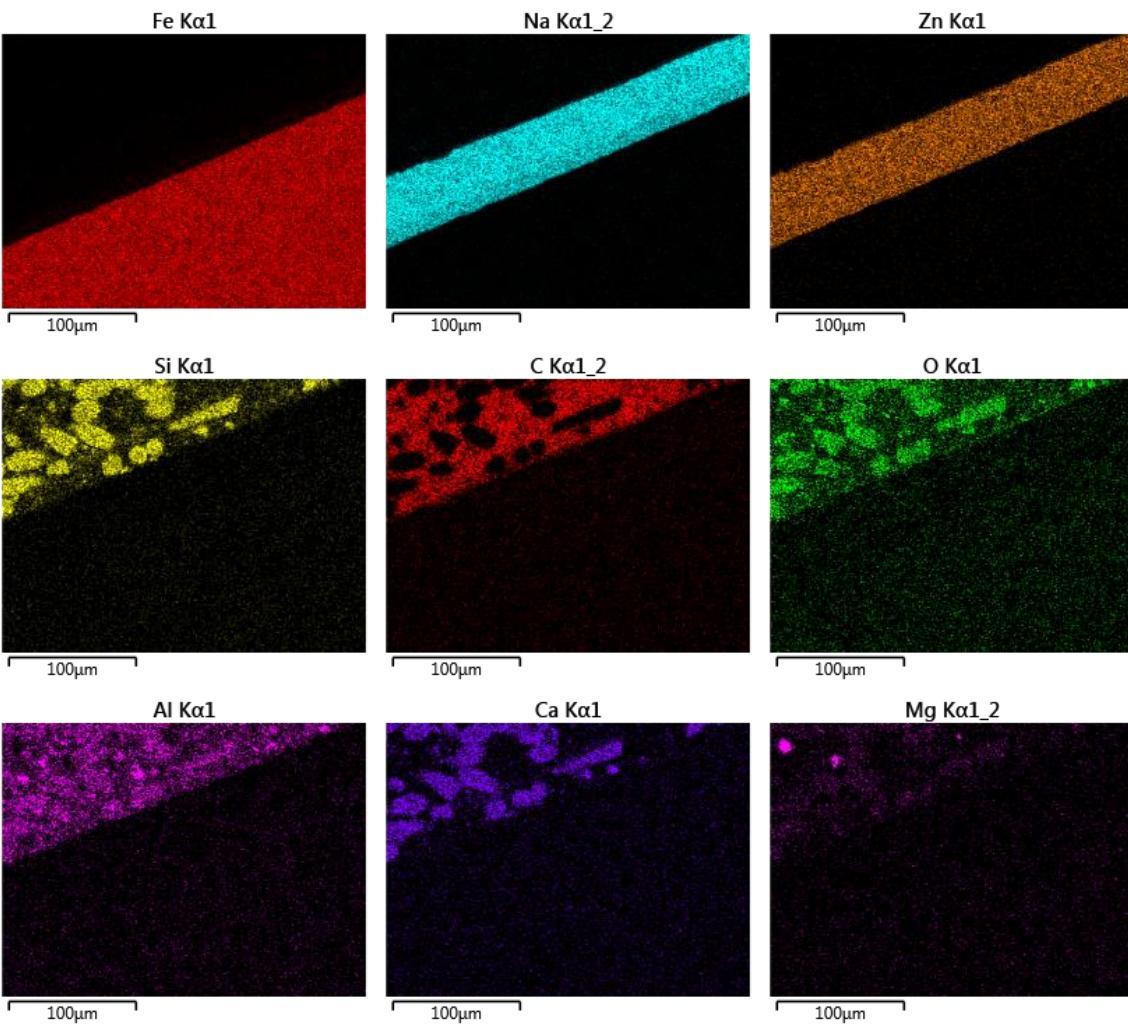
FIGURE 91. EDS MAPPING OF THE COATING

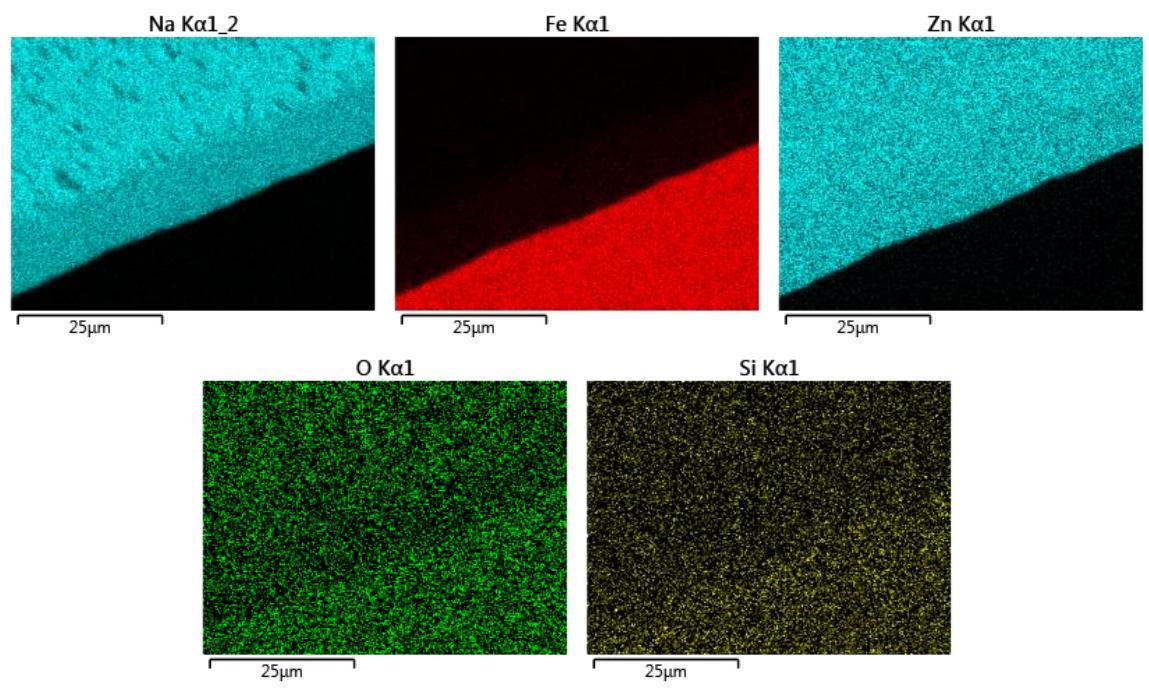
FIGURE 92. EDS MAPPING ON THE APPARENT BOTTOM LAYER OF THE COATING

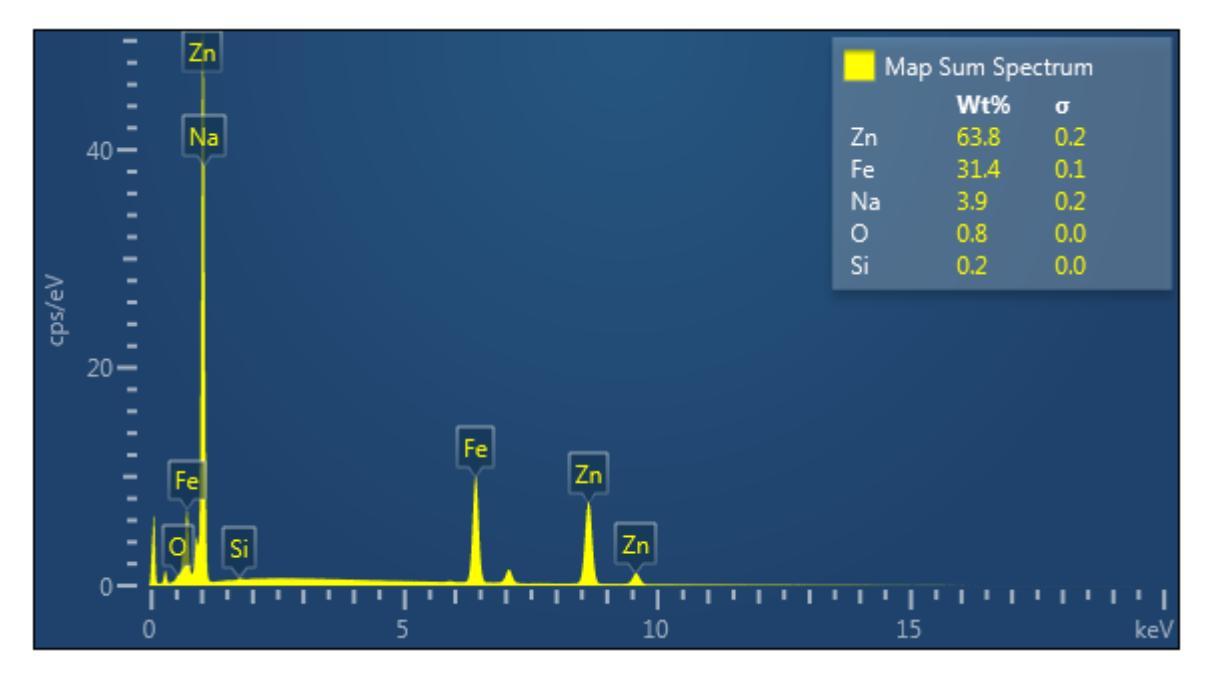
We have removed the steel wires with fracture surfaces from Sample #1,2 and 3. The steel wires were mounted in Bakelite, ground and polished in accordance with ASTM E3-11. Figure 86 and Figure 87 showed profiles of steel wires from sample #1. Wires were coated and coating appeared to have two layers, Figure 88. Coating appeared to be peeled off in some areas at low magnification, Figure 86 and Figure 87. However, examination at higher magnification revealed that these areas were stained during metallographic preparation, Figure 89 and Figure 90. It also showed some particles embedded in the coating, Figure87. We have performed EDS analysis on the coating, Figure 91. Mapping revealed zinc and sodium indicating that it was zinc coated (galvanized). Further tests on the galvanized layer revealed that the appearance on two layers were false (possibly small amount of concentration difference of sodium) and all the galvanized layer was homogeneous in zinc content, Figure 92. It is also indicated from the figure that the top layer contained some imperfections, while the bottom portion was pure galvanized layer. Figure 93 shows the elemental analysis of the galvanized layer.

FIGURE 93. POINT EDS RESULTS OF THE GALVANIZED LAYER

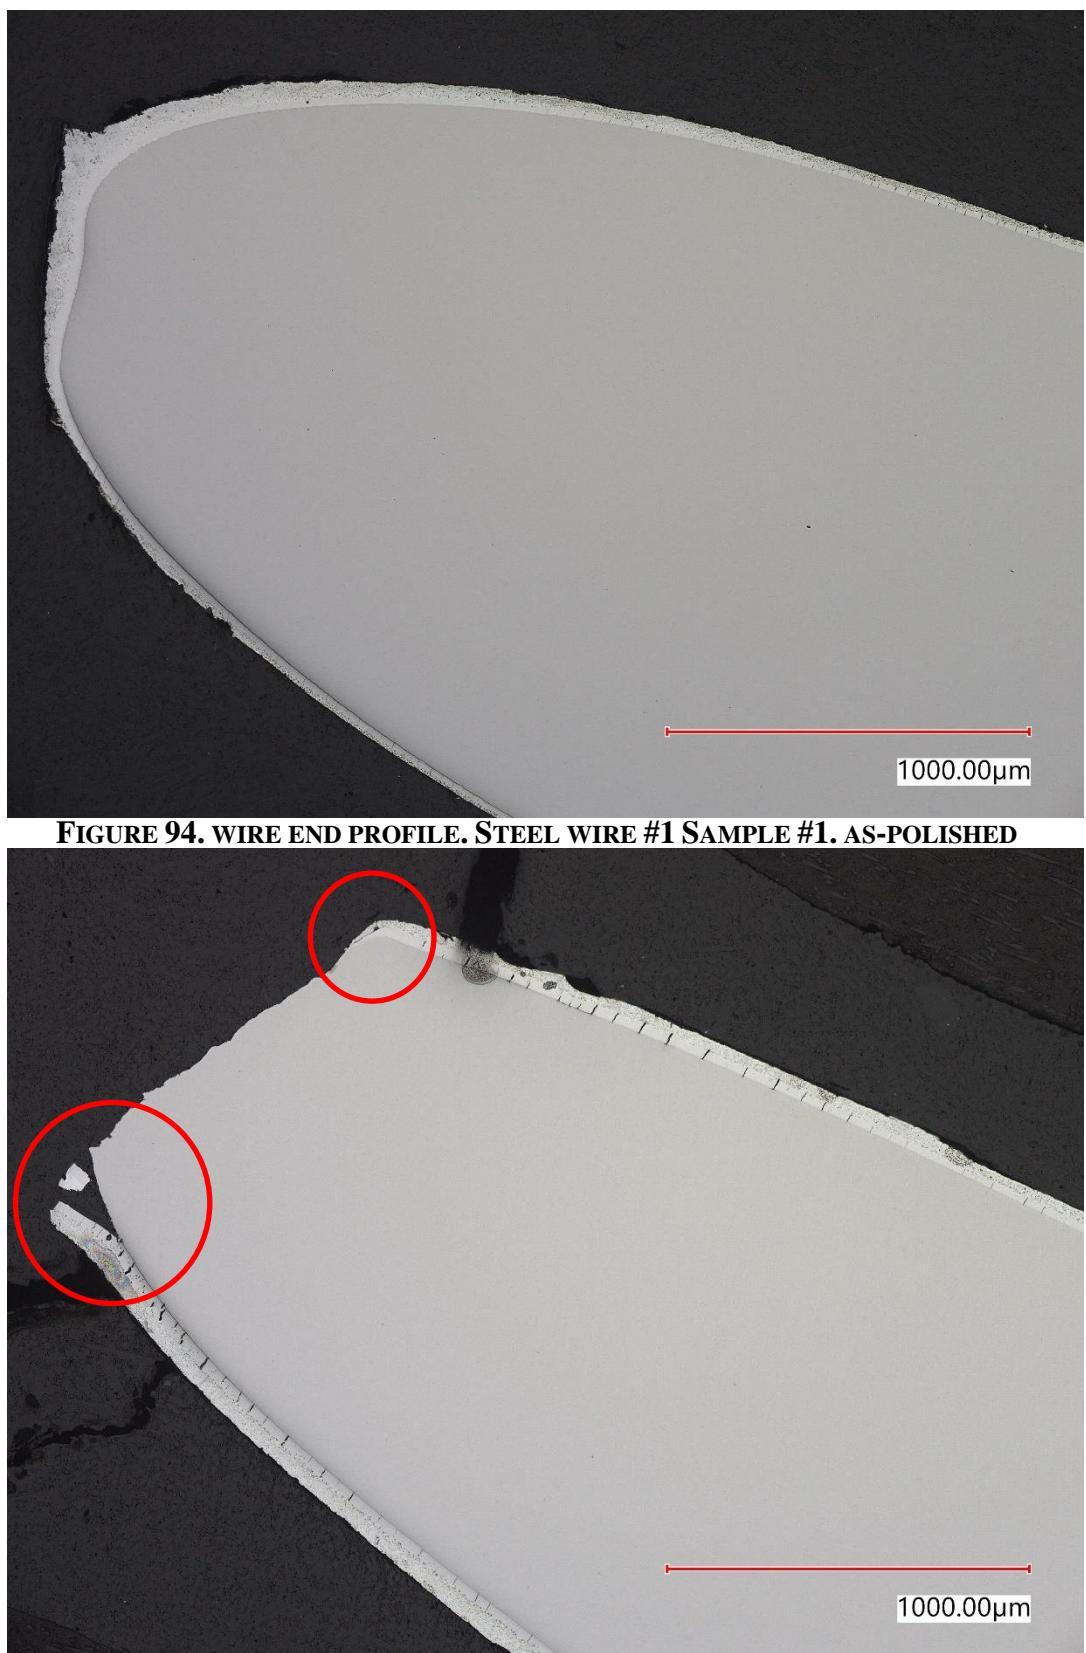
Figure 94 through Figure 98 show the wire end (cut) or fracture profiles. Figure 97 shows a wire end that was deformed during cutting and covered by smeared zinc coating. Figure 99 shows close view of the corner of the fracture surface initiated in Figure 95.

Profiles of the undamaged fracture surface were generally flat and had no discernible necking. Close view of the profile revealed relatively rough, transgranular crack propagation, Figure 100. We observed numerous cracks in the galvanize layer in the vicinity of the fracture surface, Figure 95.

FIGURE 95. FRACTURE PROFILE. STEEL WIRE #2 SAMPLE #1. AS-POLISHED

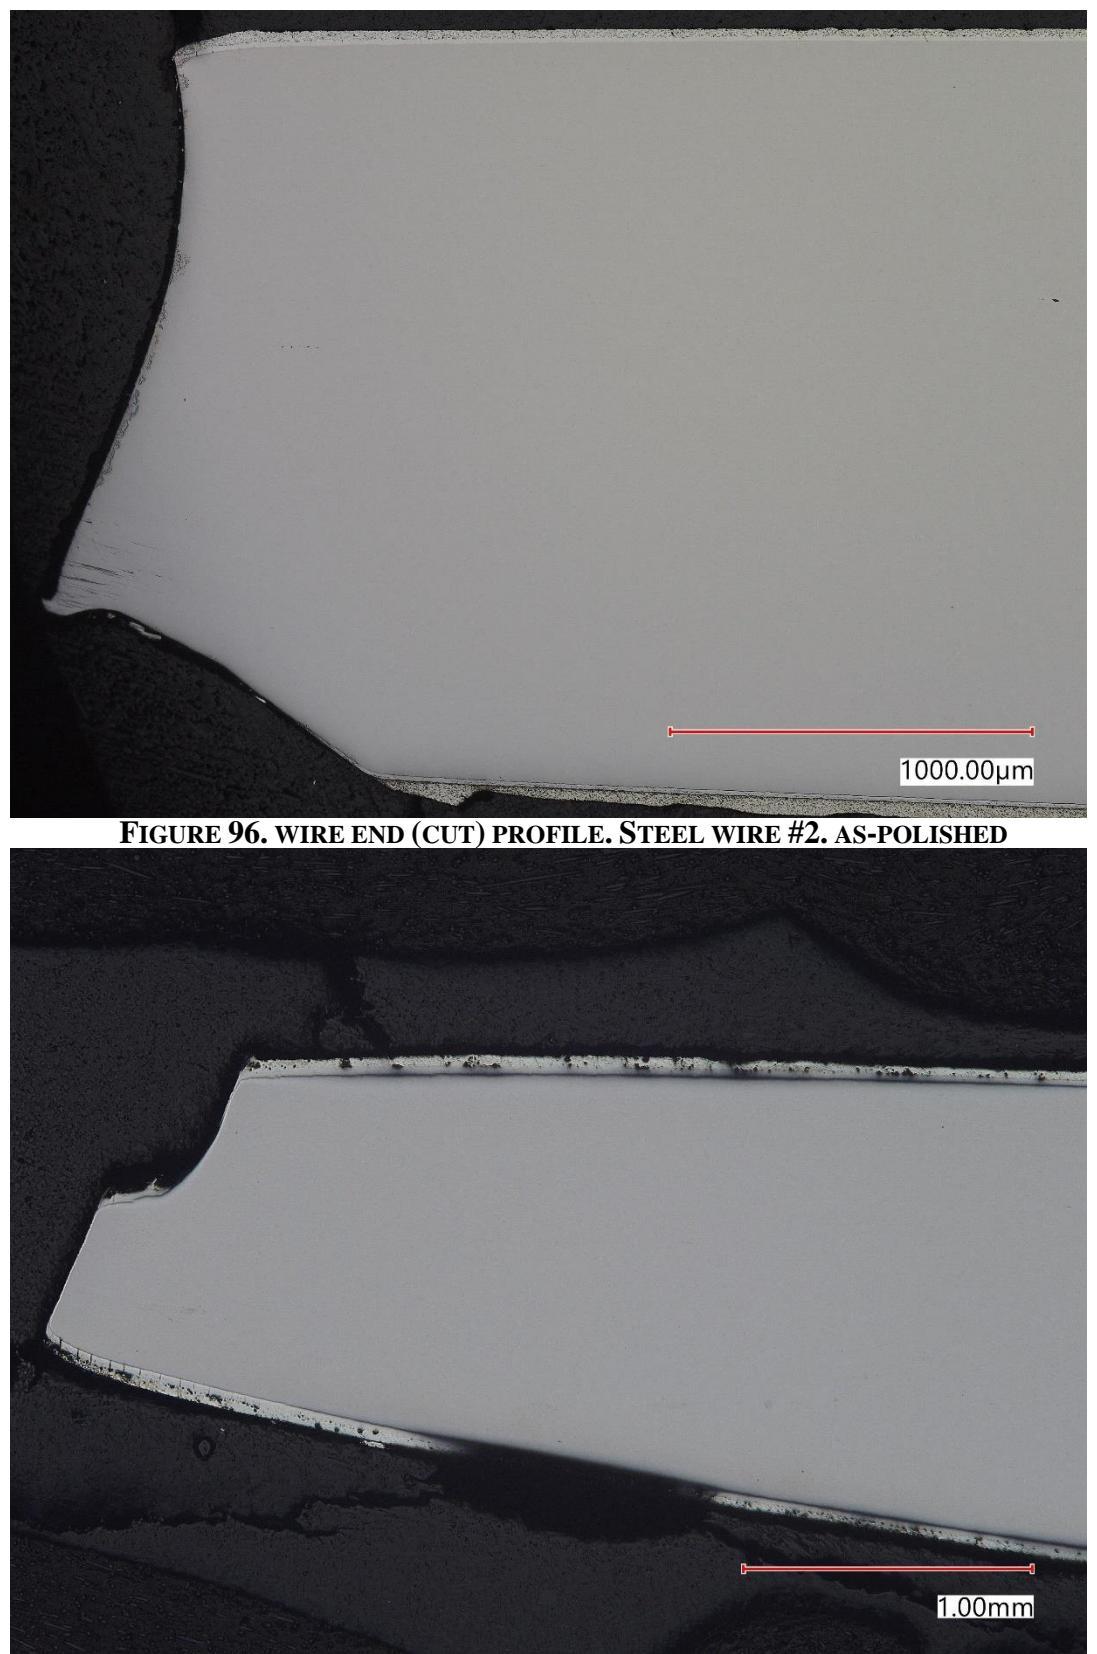
FIGURE 97. WIRE END (CUT) PROFILE. STEEL WIRE #2 SAMPLE #3. AS-POLISHED

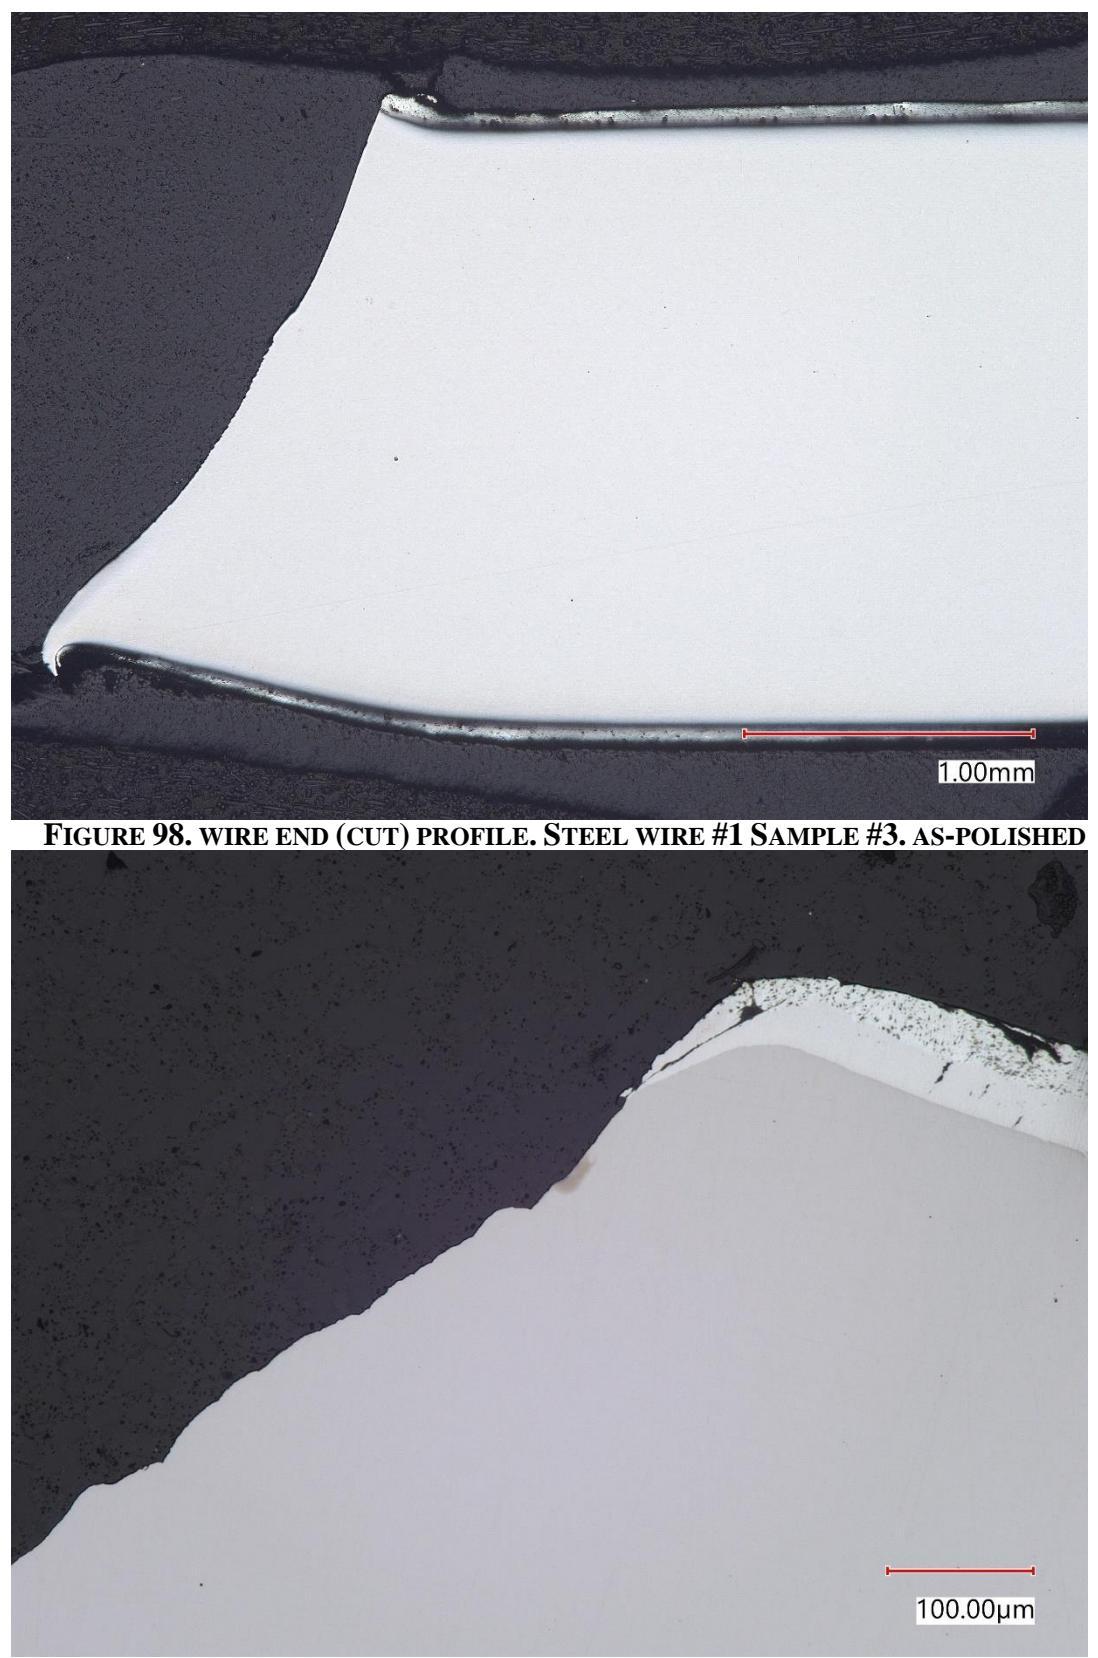
FIGURE 99. TOP CORNER OF THE FRACTURED WIRE END SURFACE DEPICTED IN FIGURE 95, STEEL WIRE #2 SAMPLE #1 AS-POLISHED

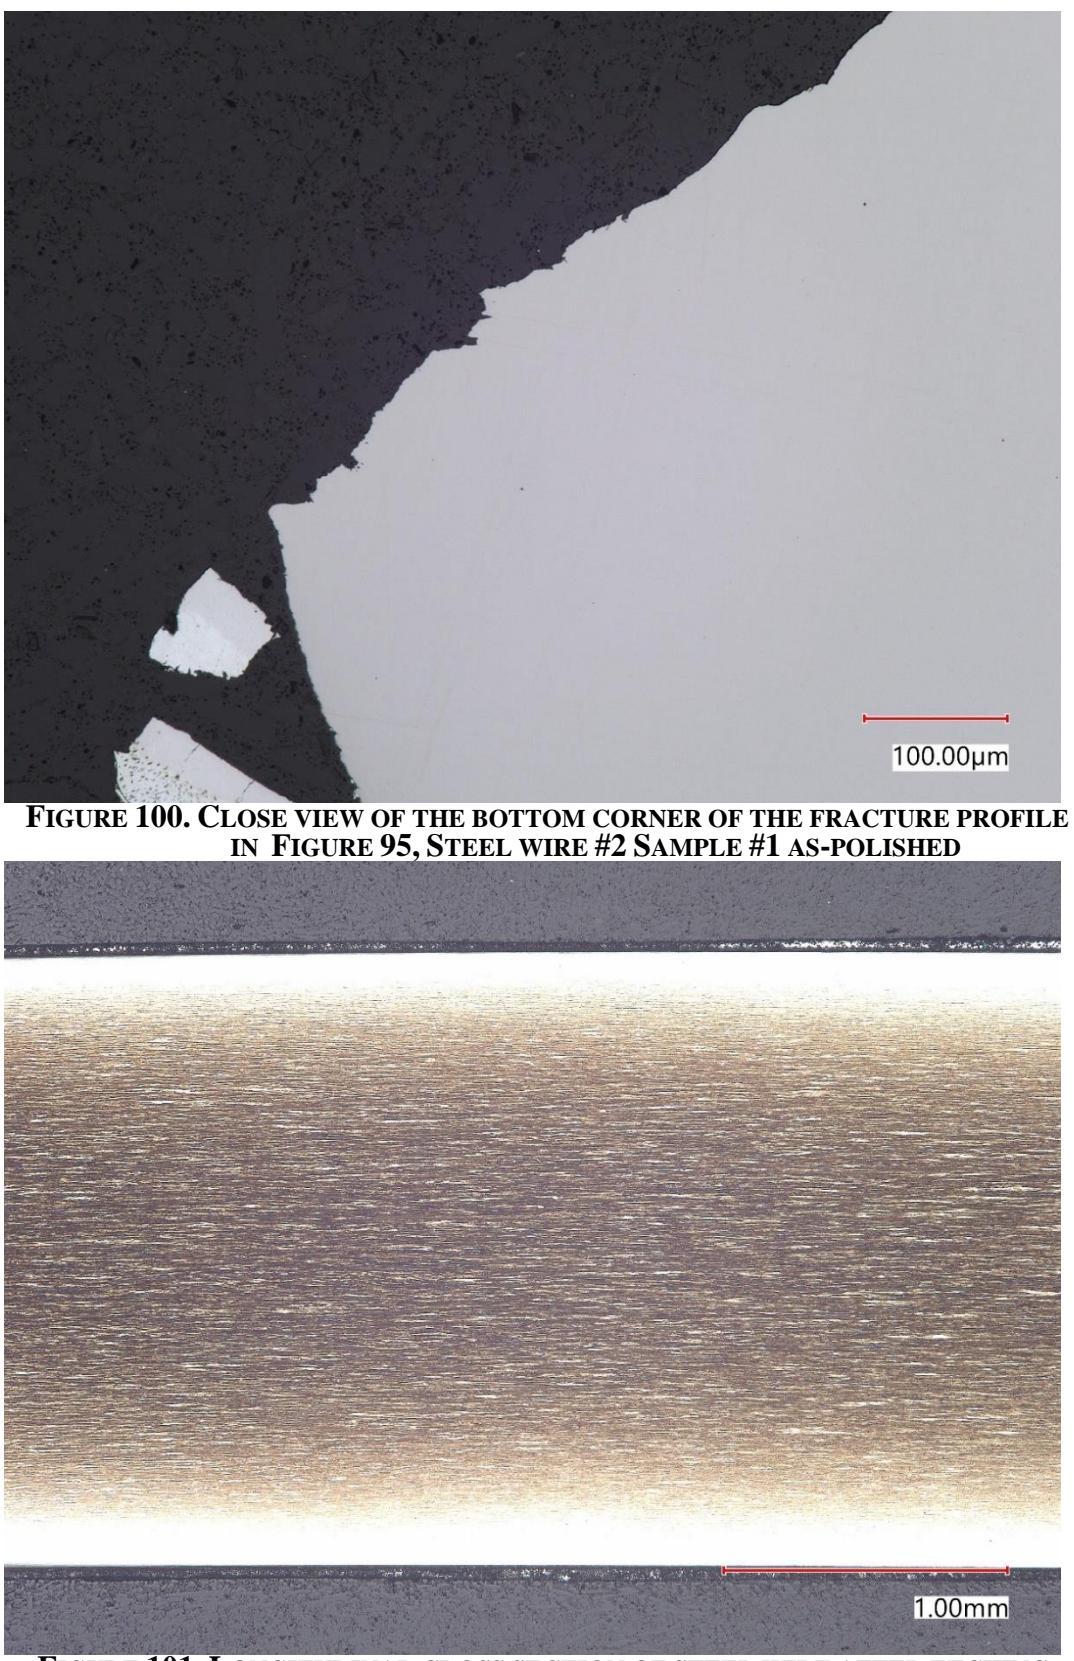
The steel samples were etched with 2% nital to reveal the microstructure. Figure 101 shows a typical cross section of a steel wire. The steel wires showed a completely deformed grain structure, heavily elongated in the longitudinal direction of the wire, Figure 102 and Figure 103. Figure 104 and Figure 105 show a couple of wire end (cut end) profiles after etching. Flow lines show the wires deformed during cutting. Figure 106 and Figure 107 show close view of the top corner of the wire end profile depicted in Figure 105. Flatness of the fracture profile at that corner and abrupt change of flow line direction is the evidence of cutting at that corner, Figure 107. It should be noted that the areas beneath galvanized layers did not etch. This is a common behaviour of materials due to presence of zinc in the vicinity.

FIGURE 101. LONGITUDINAL CROSS SECTION OF STEEL WIRE AFTER ETCHING. STEEL WIRE #1 SAMPLE #3, AFTER ETCHING

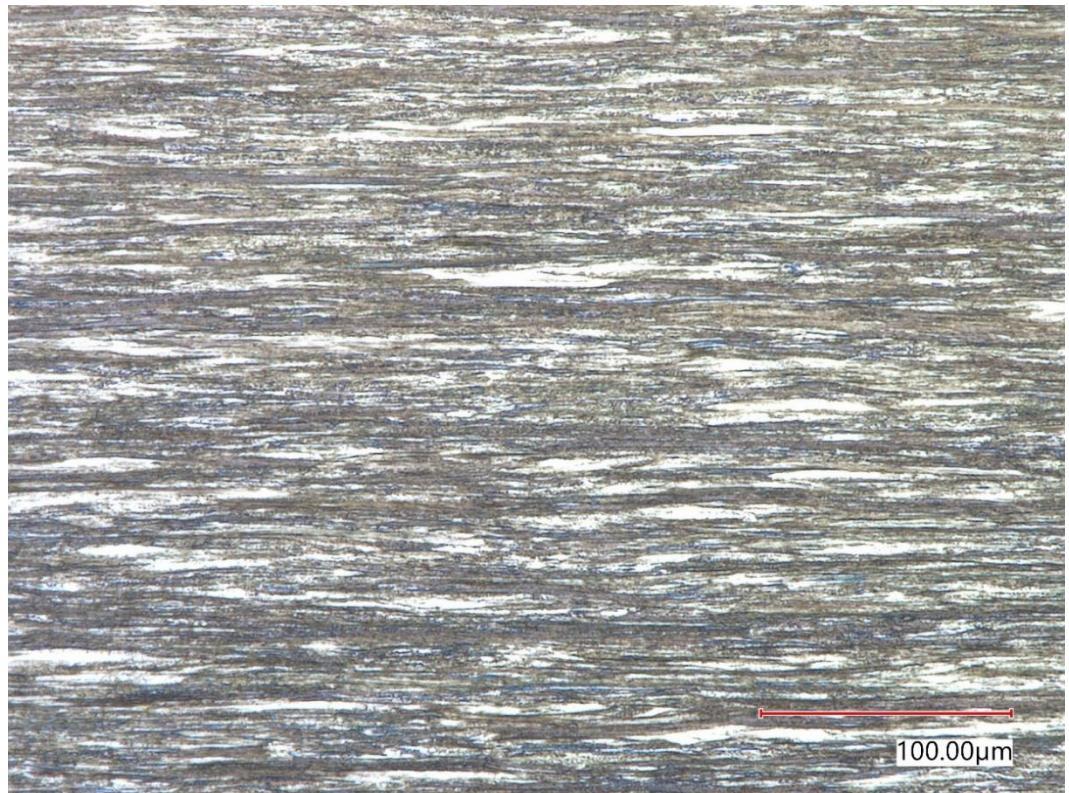
FIGURE 102. COLD WORKED STRUCTURE OF STEEL WIRE. STEEL WIRE #1 SAMPLE #3, AFTER ETCHING

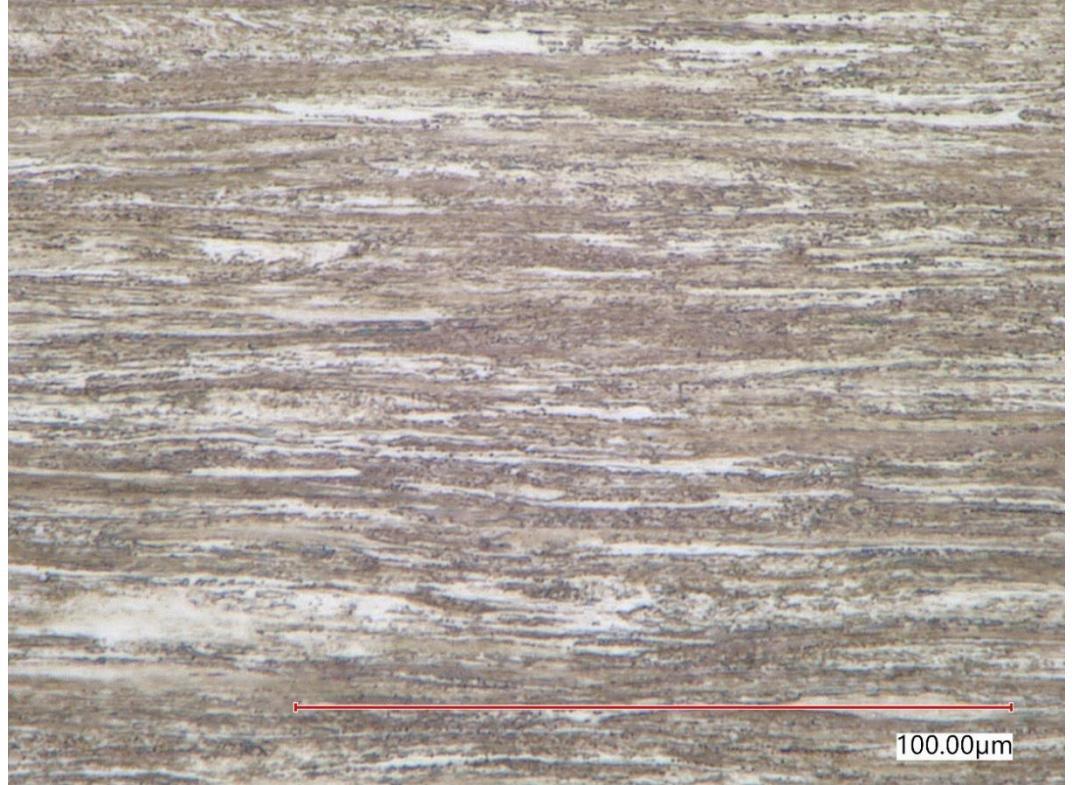
FIGURE 103. CLOSE VIEW OF THE STEEL MICROSTRUCTURE, STEEL WIRE #1 SAMPLE #3, AFTER ETCHING

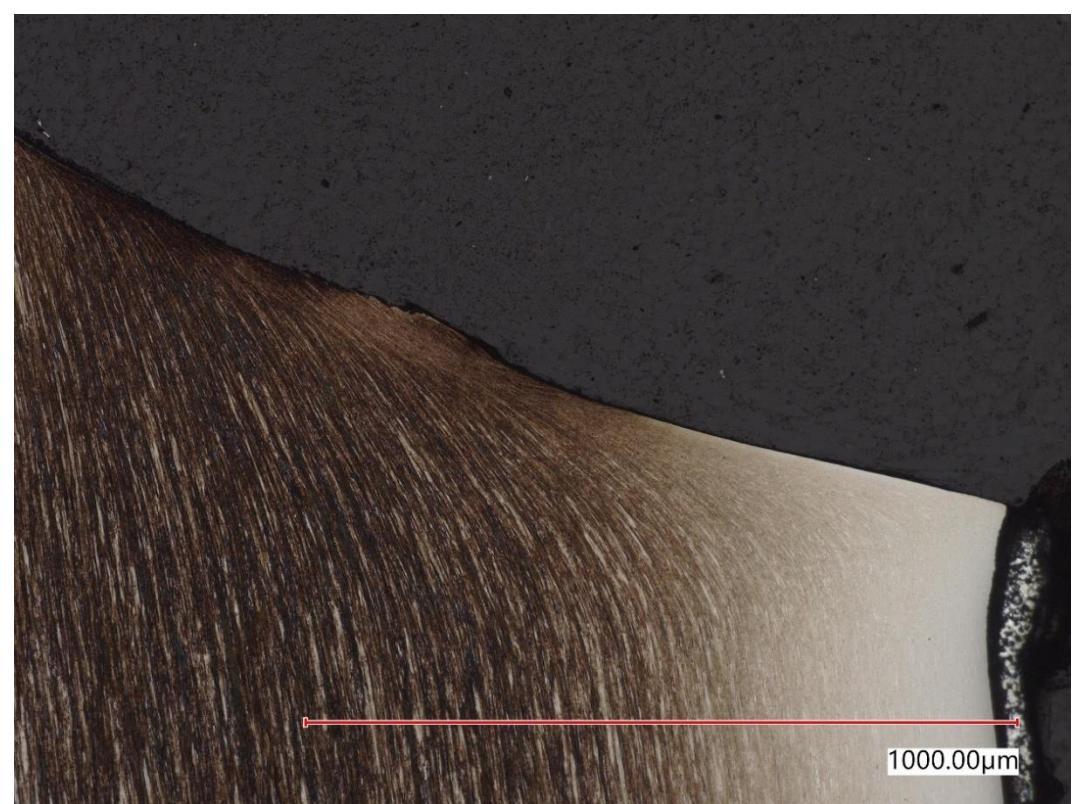
FIGURE 106. CLOSE VIEW OF THE TOP CORNER OF THE WIRE END PROFILE IN FIGURE 136, STEEL WIRE #1 SAMPLE #3

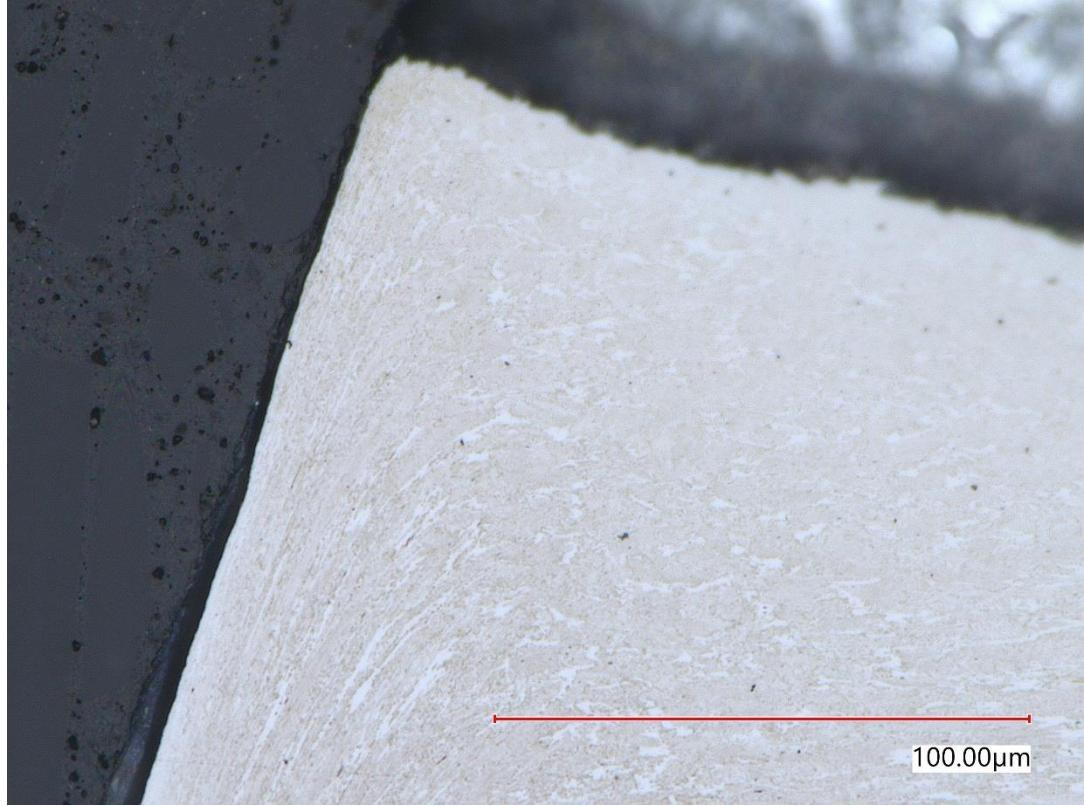
FIGURE 107. MICROSTRUCTURE AT THE AREAS OF THE CUT PROFILE IN FIGURE 106, STEEL WIRE #1 SAMPLE #3

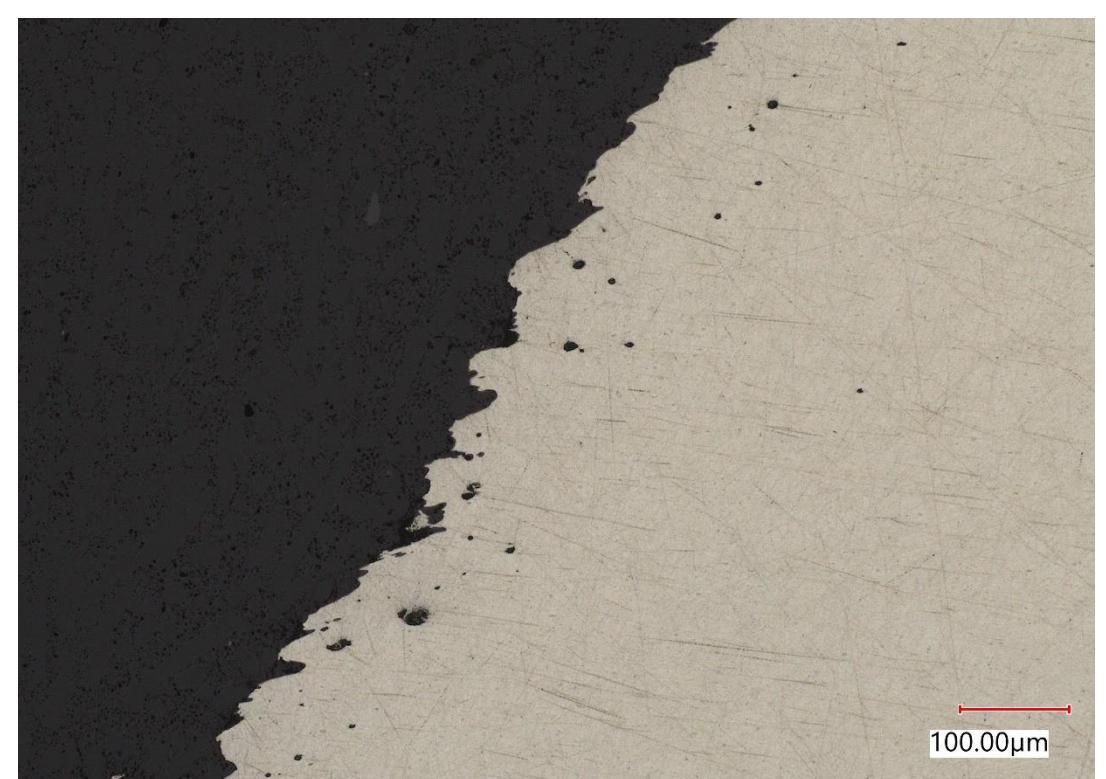
Figure 108 and Figure 109 show fracture profiles of two aluminium wires. Local deformation in the vicinity of the fracture and high local reduction of area are evident.

FIGURE 108. CRACK PROFILE, ALUMINUM WIRE, AS-POLISHED, ALUMINUM WIRE #1 SAMPLE #2

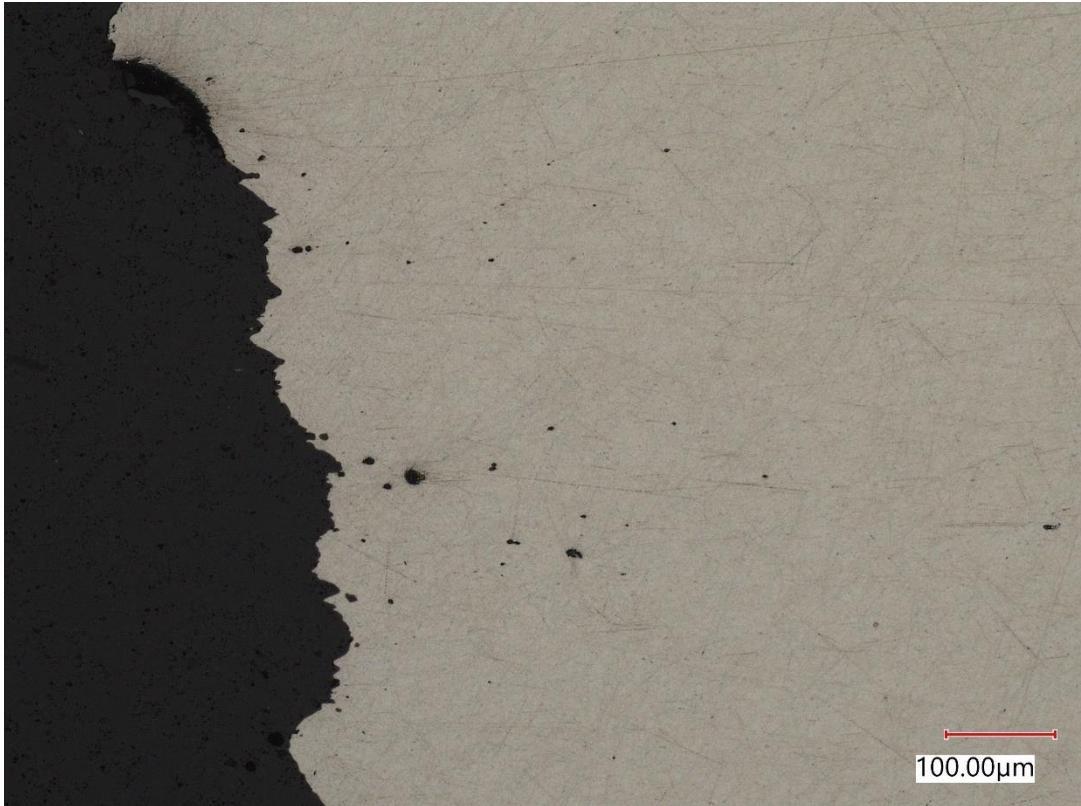
FIGURE 109. CRACK PROFILE, ALUMINUM WIRE, AS-POLISHED, ALUMINUM WIRE #1 SAMPLE #4

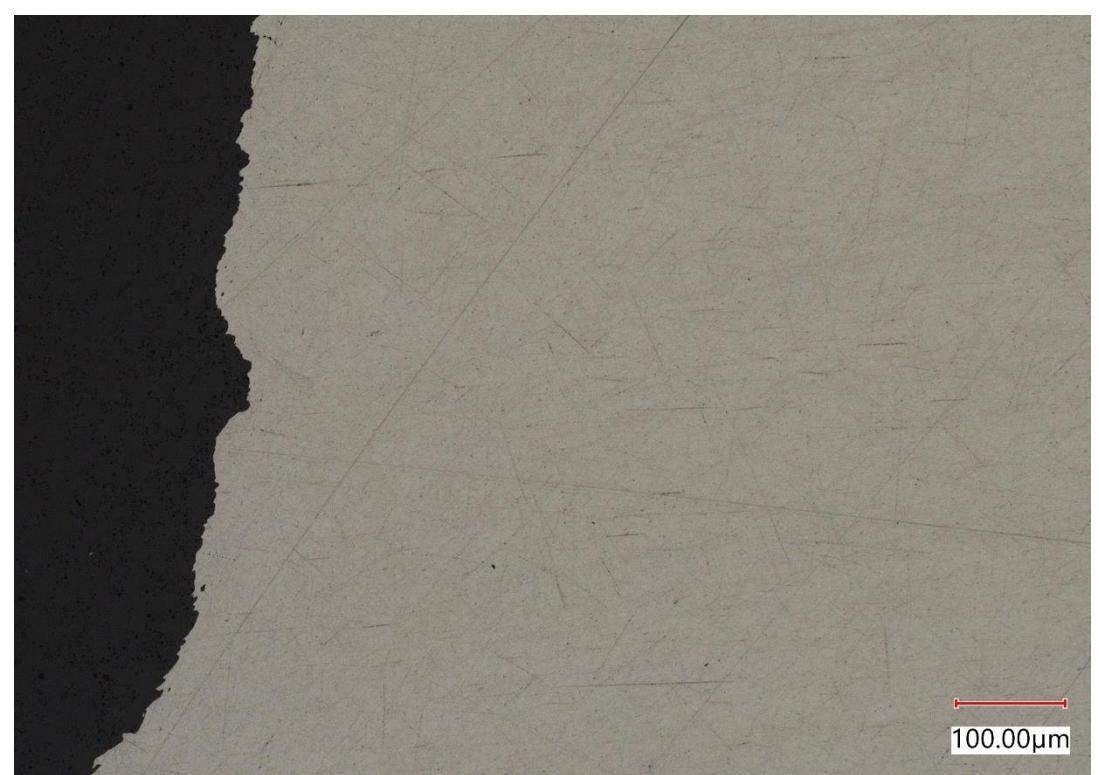
Figure 110 shows a very flat and smooth profile. The sample were etched with Keller's reagent after the examination in the as-polished condition. Figure 111 and Figure 112 show the profiles of two wires. Flow lines in the longitudinal direction of the wires were evident. Figure 113 show profile of the wire with damage during cutting. Figure 114 shows the structure at a higher magnification. Flow lines were evident; however, grain boundaries could not be observed. Appearance of the structure suggested that the etchant also attacked the deformed material created during grinding of the samples showing dotted straight lies.

FIGURE 110. CRACK PROFILE, ALUMINUM WIRE, AS-POLISHED, ALUMINUM WIRE #4 SAMPLE #2

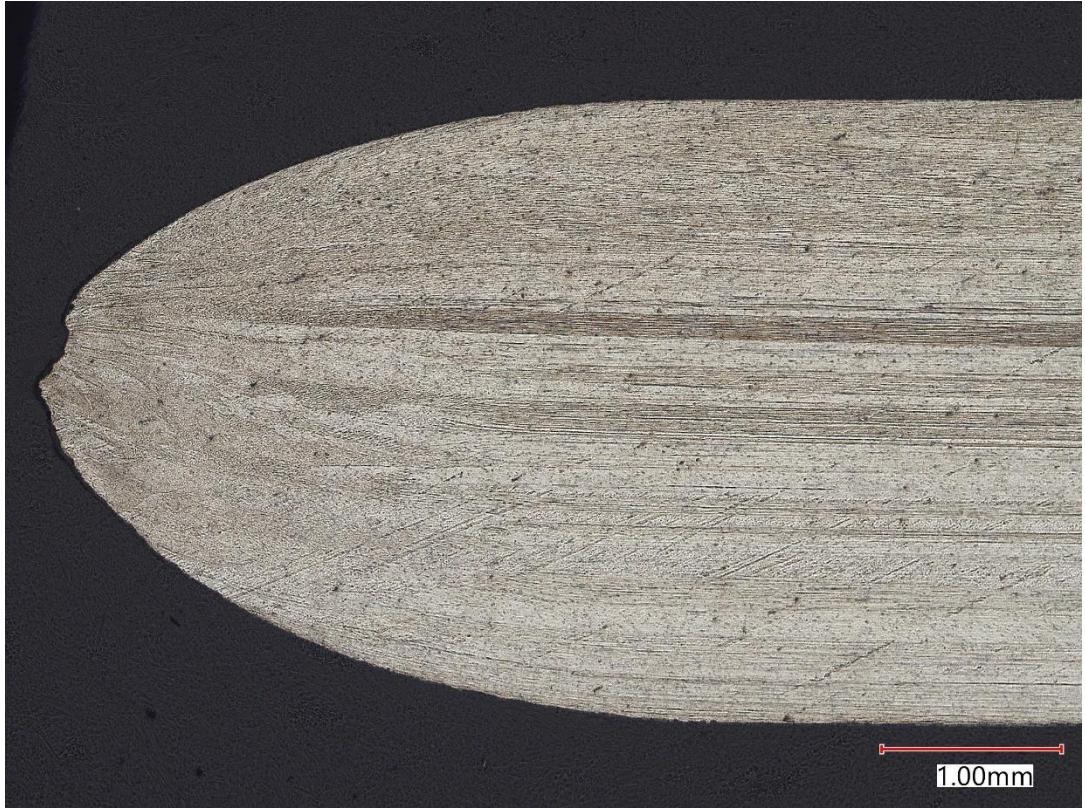
FIGURE 111. ALUMINUM WIRE #1 SAMPLE #1, AFTER ETCHING

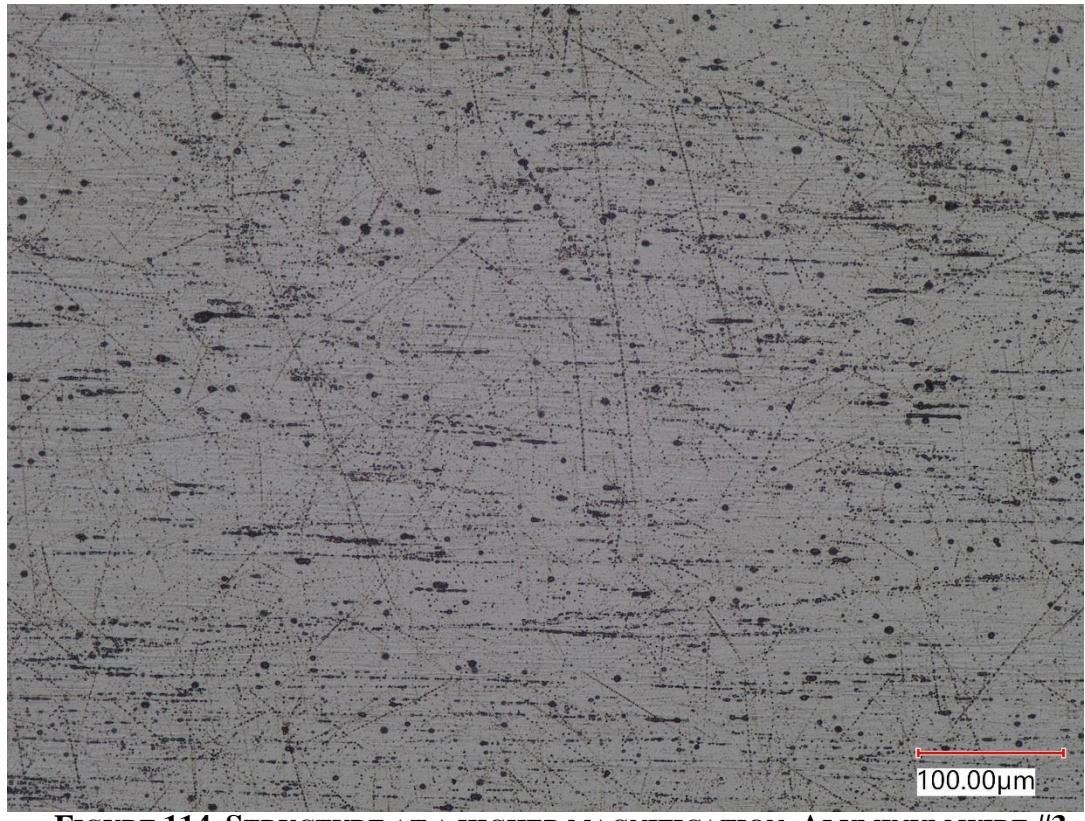
FIGURE 114. STRUCTURE AT A HIGHER MAGNIFICATION, ALUMINUM WIRE #3 SAMPLE #1, AFTER ETCHING

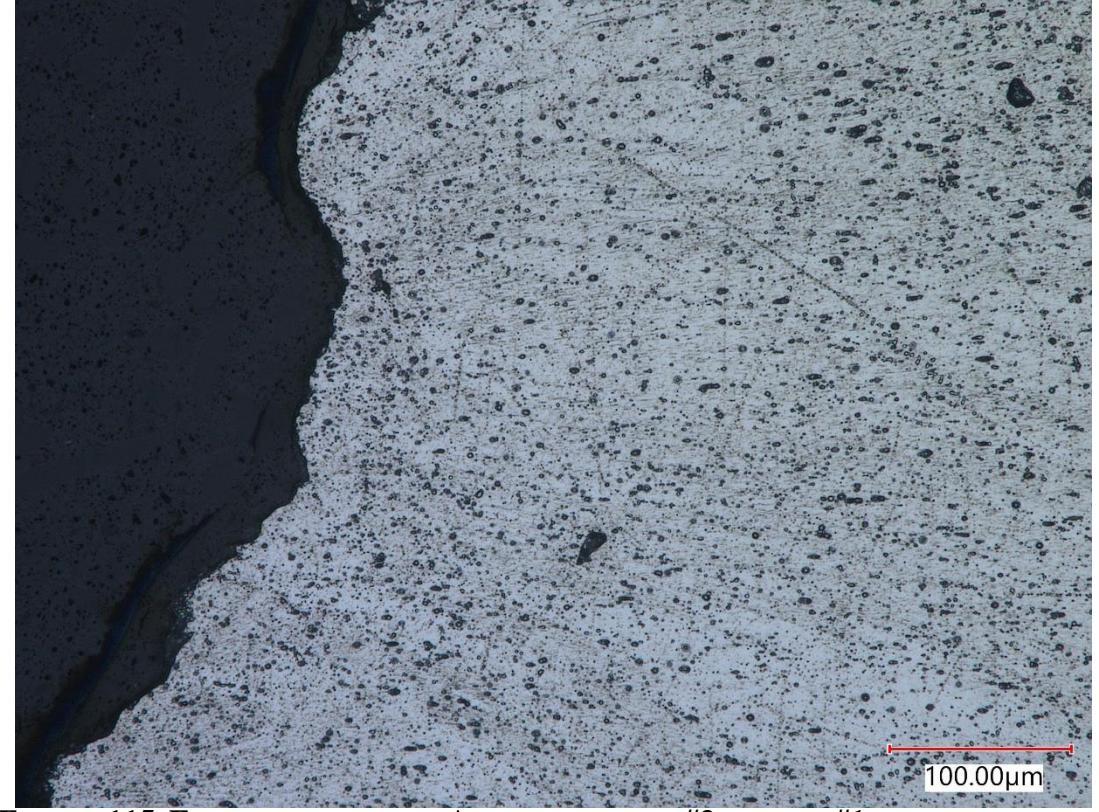
Figure 115, Figure 116 and Figure 117 show the close view of the fracture profiles. It was evident that the fracture was ductile transgranular.

FIGURE 115. FRACTURE PROFILE, ALUMINUM WIRE #3 SAMPLE #1, AFTER ETCHING

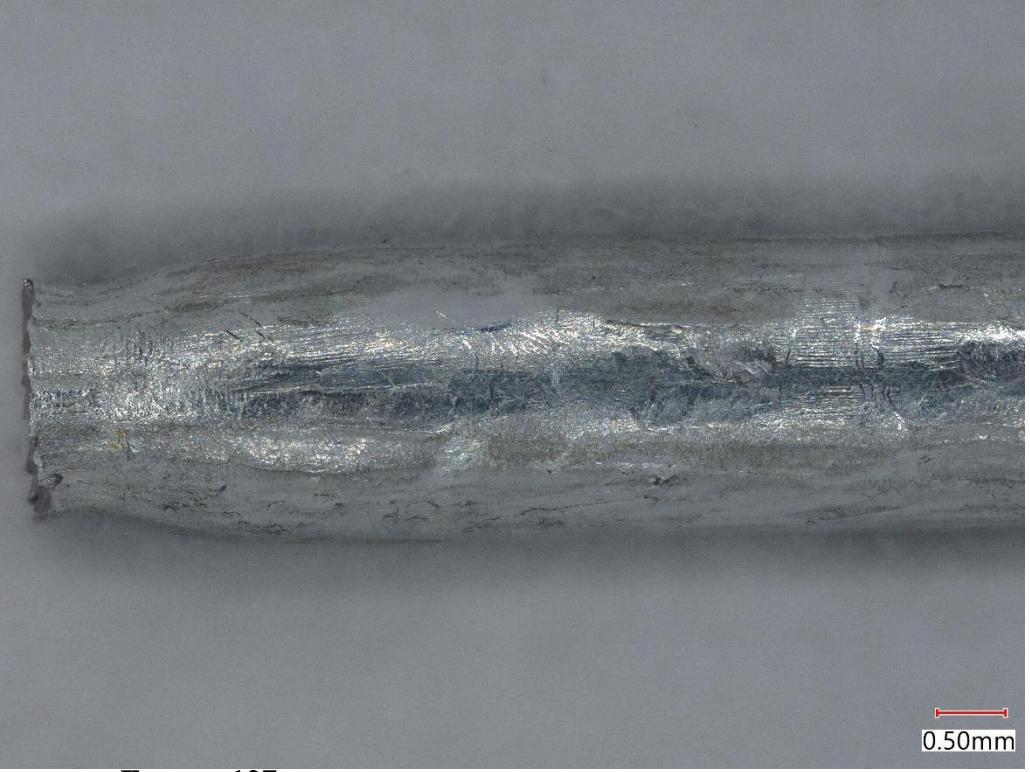
- i) Figure 127 shows the fracture profile of the steel wire tested. The wire tested showed some necking (see reduction in area in Table 1) which was not visible to the naked eye, nor at low magnification.
- ii) Figure 128 shows one of the fracture surfaces. It was typical cup-and-cone fracture.
- iii) We examined the fracture surface by means of SEM. Figure 129 shows the fracture surface.
- iv) We observed zinc layer on the outer surface, Figure 130.
- v) Area with the shear fractures showed shear dimples, Figure 131.
- vi) Central, flat region of the fracture surface showed dimples, Figure 132 and Figure 133
- vii) Observations made indicate that the tensile test sample fractured in a ductile manner. Dimples are a result of ductile transgranular cracking.

FIGURE 127: STEEL WIRE PROFILE AFTER TENSILE TESTING

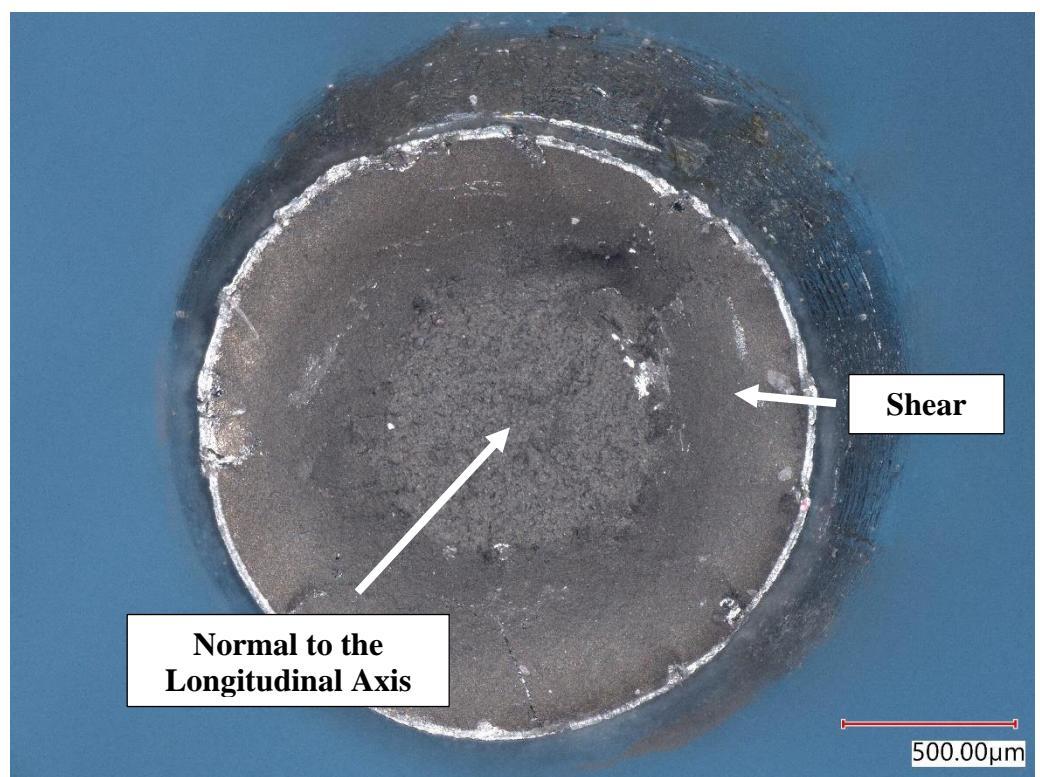
FIGURE 128: FRACTURE SURFACE OF THE TENSILE TESTED SAMPLE. STEEL WIRE

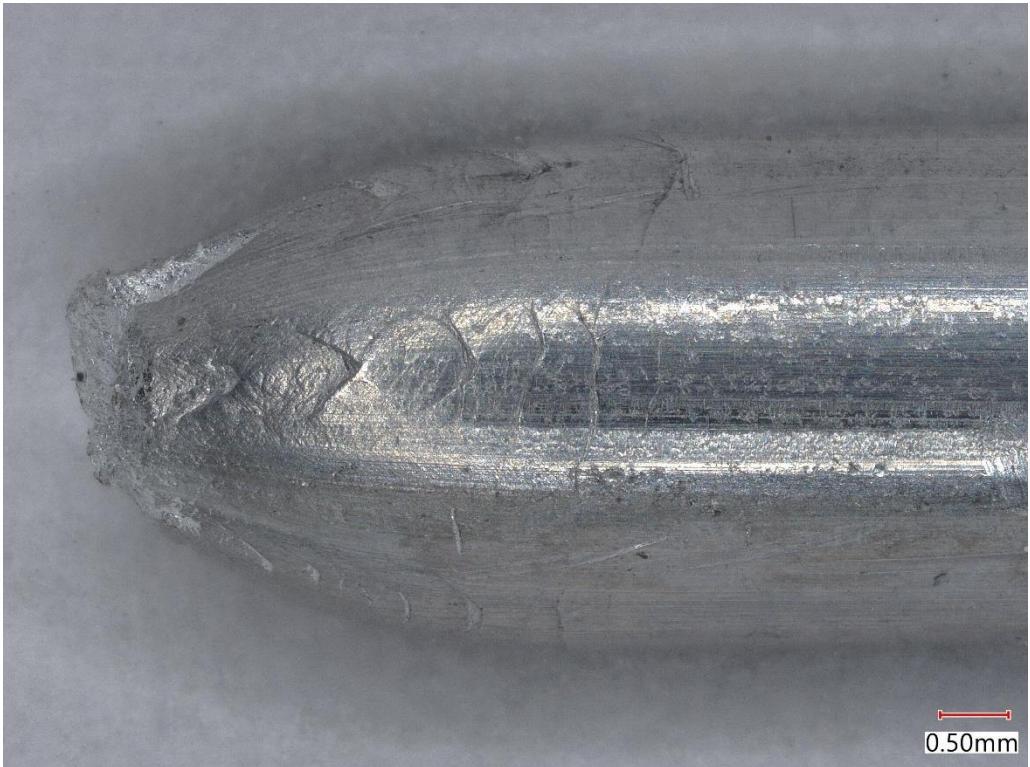
- viii) Figure 134 shows the profile of the tensile tested aluminum wire. Some slip lines at 45° to the axis of the wire were evident in the vicinity of the necked region, Figure 134 and Figure 135. Figure 136 shows the fracture surface. Necking and high percentage of reduction in area were observed.
- ix) Figure 137 shows the fracture surface of the aluminum wire under the SEM. Dimples are almost visible at low magnification.
- x) Figure 138 shows the dimples covering the fracture surface of the tensile tested aluminum wire. Dimples are visible at very low magnification.

FIGURE 134: PROFILE OF THE TENSILE TESTED ALUMINUM WIRE
