# Re: *Reliability and Resource Adequacy Study Review* – Labrador-Island Link Failure Investigation Reports

# Failure Investigation Report – L3501/2 Tower and Conductor Damage

Failure Investigation Report – L3501/2 Tower	R	evision R1		
Icing Event January 2021 in Labrador	Date:	Revision R1     :   28-May-2021     :   ii		
Nalcor Doc. No. ILK-EG-ED-6200-TL-RP-0001-01	Page:	ii

# FAILURE ANALYSIS OF ELECTRODE CROSS ARM IN LABRADOR ISLAND TRANSMISSION LINK (LITL)

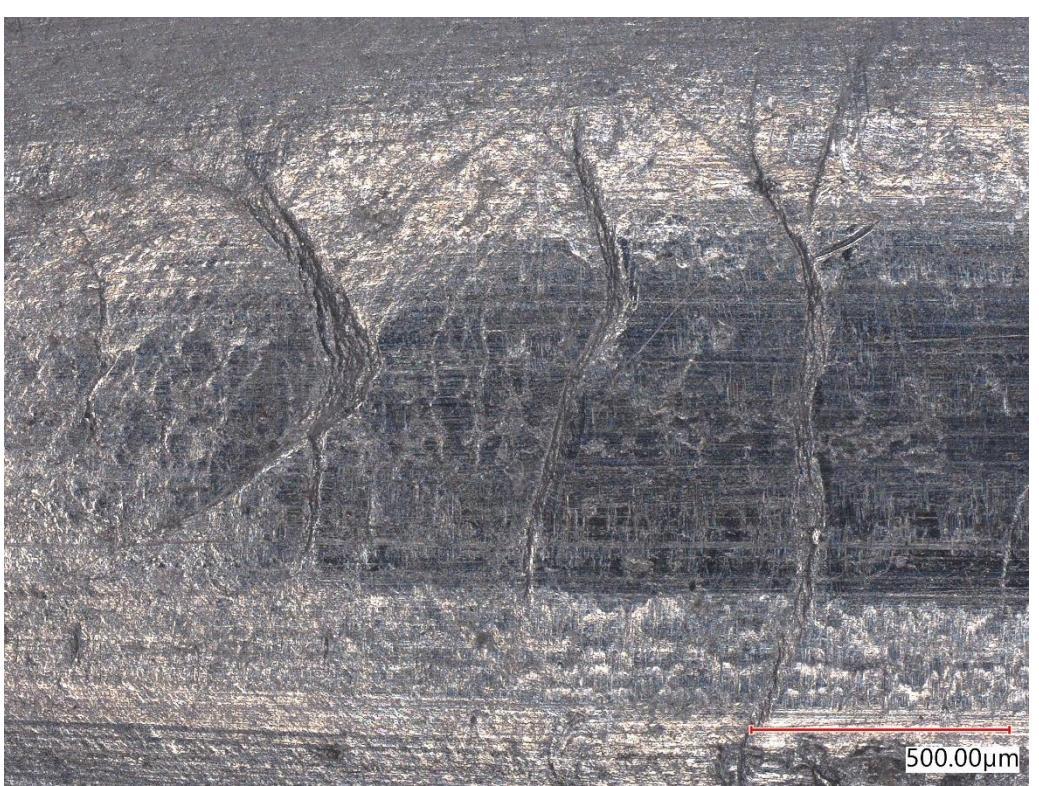
- viii) Figure 134 shows the profile of the tensile tested aluminum wire. Some slip lines at 45° to the axis of the wire were evident in the vicinity of the necked region, Figure 134 and Figure 135. Figure 136 shows the fracture surface. Necking and high percentage of reduction in area were observed.
- ix) Figure 137 shows the fracture surface of the aluminum wire under the SEM. Dimples are almost visible at low magnification.
- x) Figure 138 shows the dimples covering the fracture surface of the tensile tested aluminum wire. Dimples are visible at very low magnification.

FIGURE 135: CENTER VIEW OF THE SIDE SURFACE. TENSILE TESTED ALUMINUM WIRE

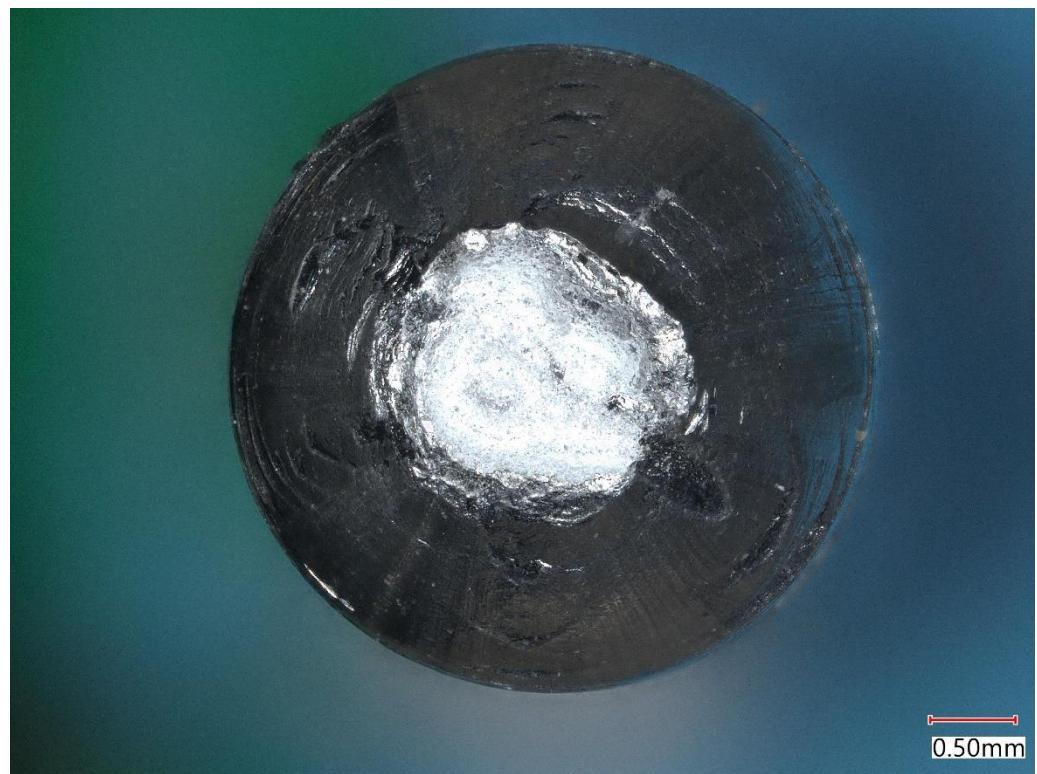
FIGURE 136: FRACTURE SURFACE OF THE TENSILE TESTED ALUMINUM WIRE

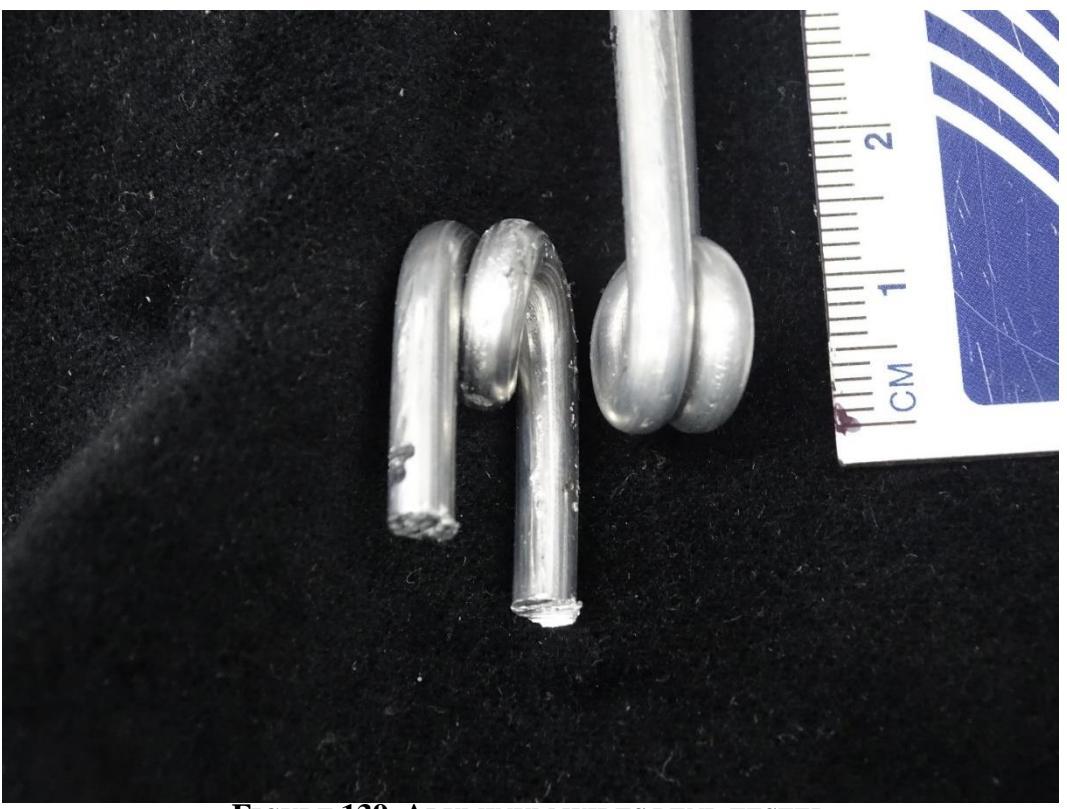
Two aluminium wire section removed from the new coil and from sample #3 were subjected to bending test in accordance with ASTM B230/B230M-07 (reapproved 2016) Section 8. Figure 139, Figure 140 and Figure 141 show the wires looped around its own diameter. No fracture on the aluminium wires occurred.

FIGURE 139. ALUMINUM WIRES BEND TESTED

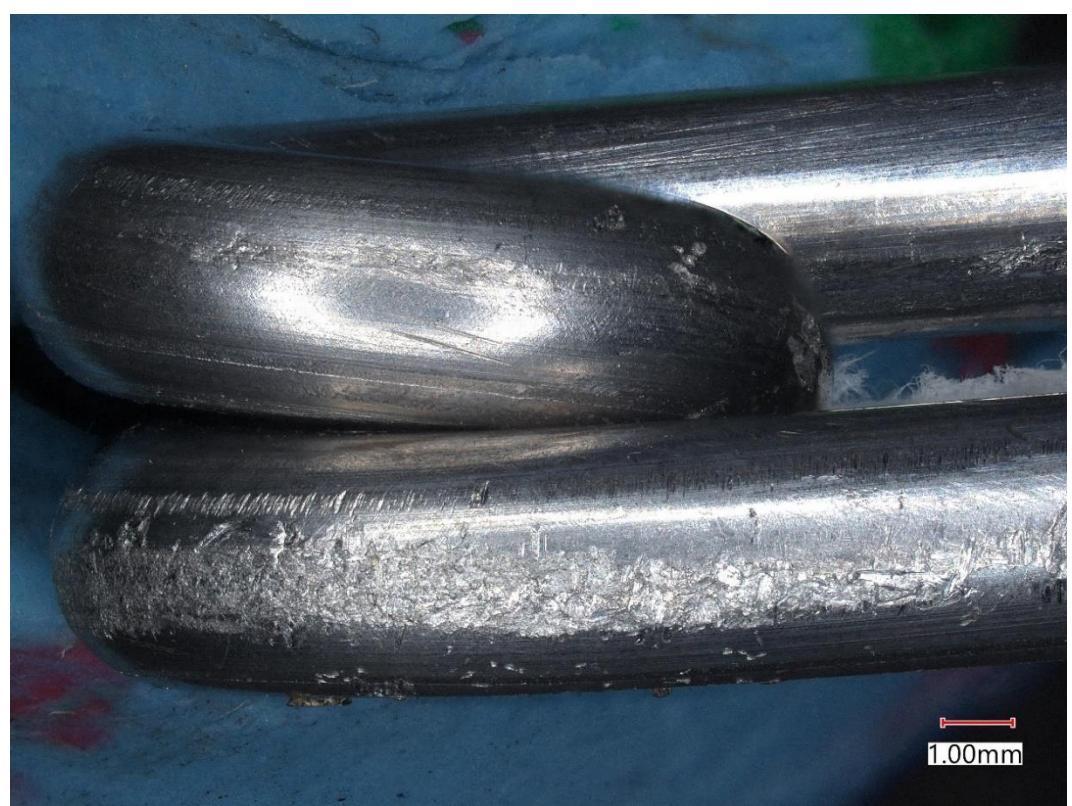
FIGURE 140. CLOSE VIEW OF ONE OF THE BEND SAMPLES. AL WIRE, DAMAGE OBSERVED ON THE WIRE WAS PRESENT PRIOR TO TESTING

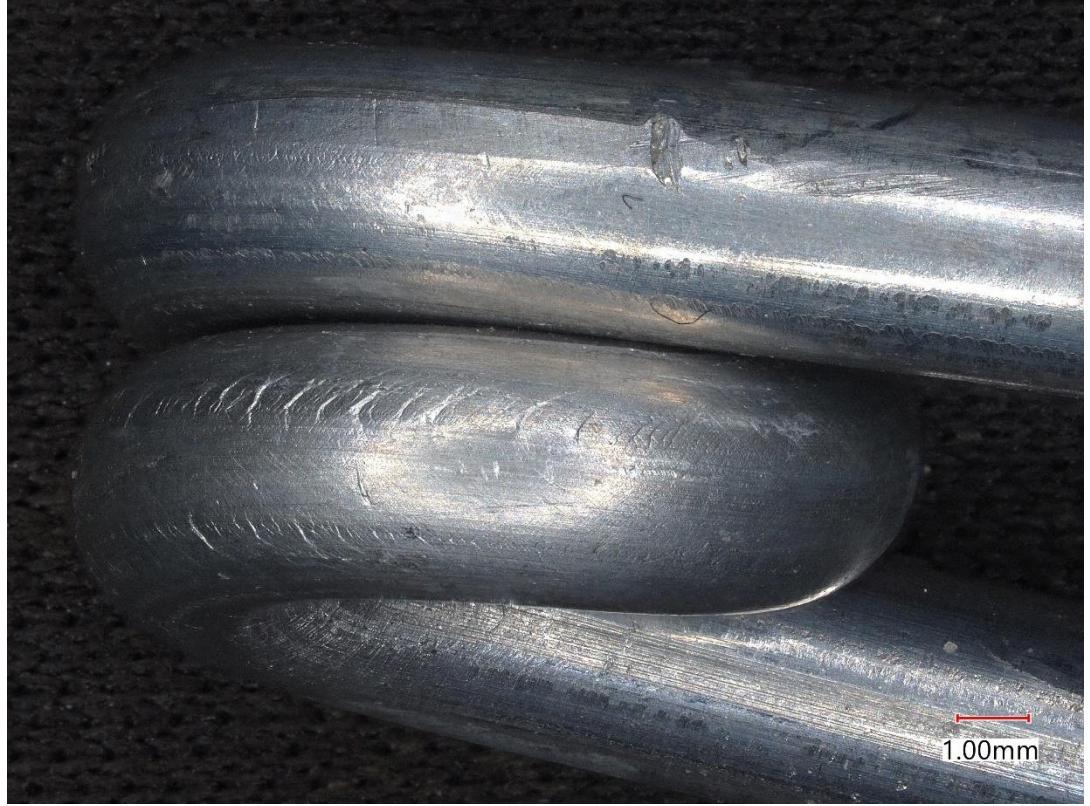
FIGURE 141. CLOSE VIEW OF THE SECOND ALUMINUM WIRE

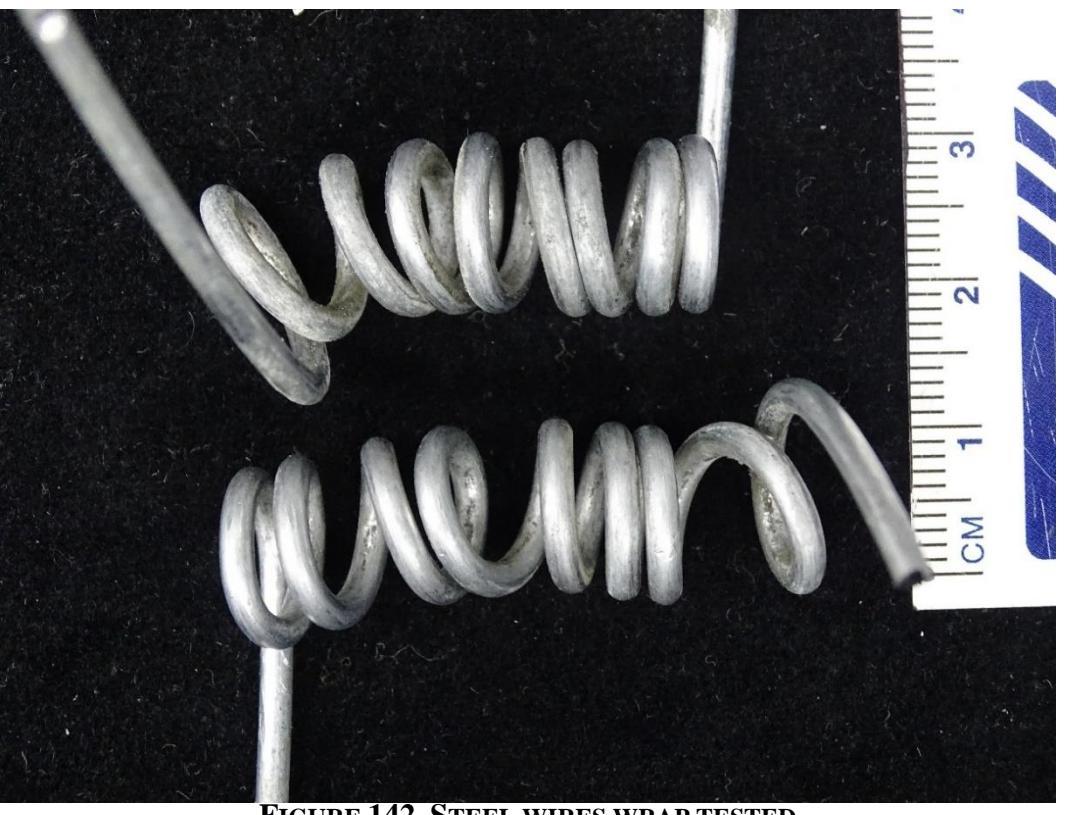
Two steel wires removed from the new cable were wrapped eight times around a cylindrical mandrel three times the diameter of the wires in accordance with ASTM B498/B498M-19 Section 9 and ASTM B606/B606M-19 Section 8. Figure 142 and Figure 143 show the wires wrapped. No cracks or fracture occurred on the loops of the wires.

FIGURE 142. STEEL WIRES WRAP TESTED

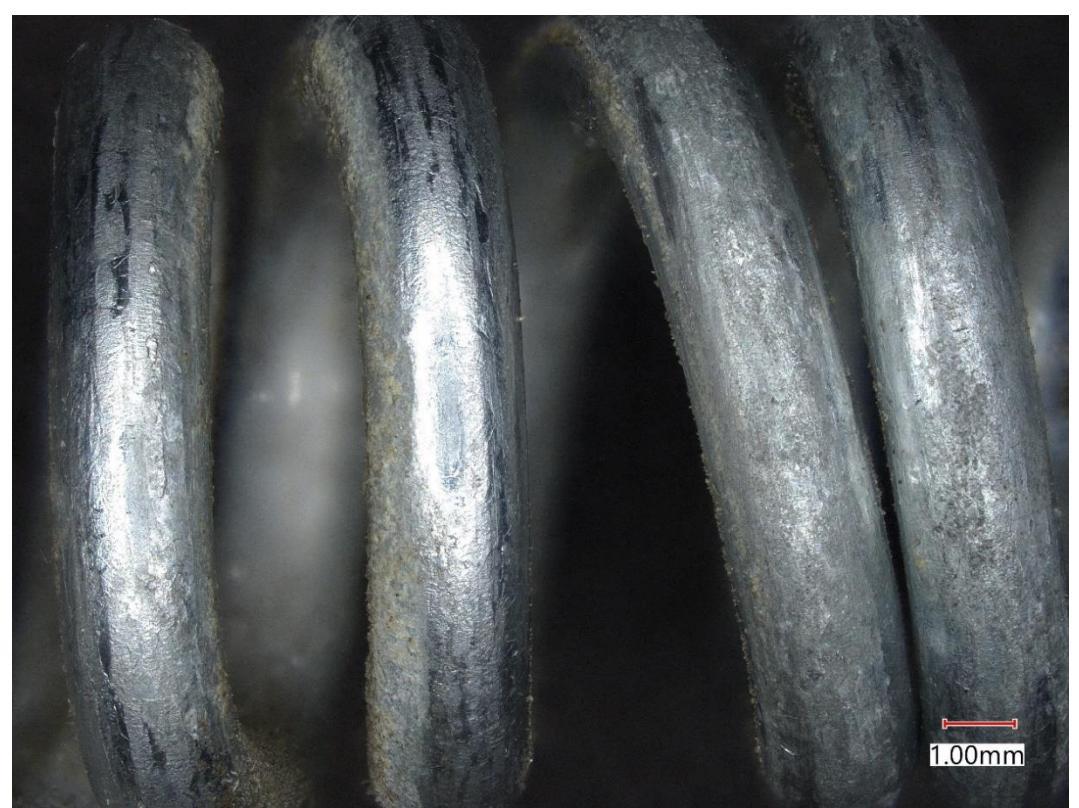
FIGURE 143. CLOSE VIEW OF FOUR OF THE LOOPS. NO CRACKS OR FRACTURE.

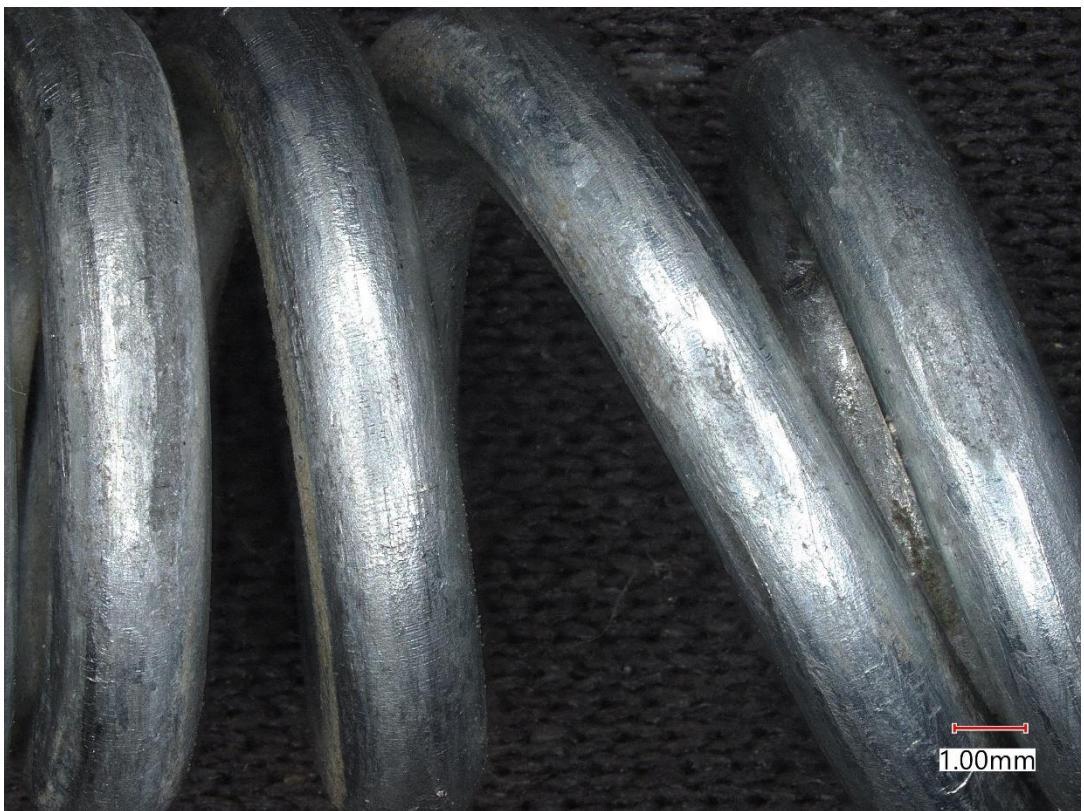
Two steel wires removed from the new cable were wrapped eight times around a cylindrical mandrel three times the diameter of the wires in accordance with ASTM B498/B498M-19 Section 9 and ASTM B606/B606M-19 Section 8. No zinc layer flaked off from the steel wire tested, Figure 144.

FIGURE 144. CLOSE VIEW OF FOUR OF THE LOOPS. NO FLAKING OF THE ZINC COATING

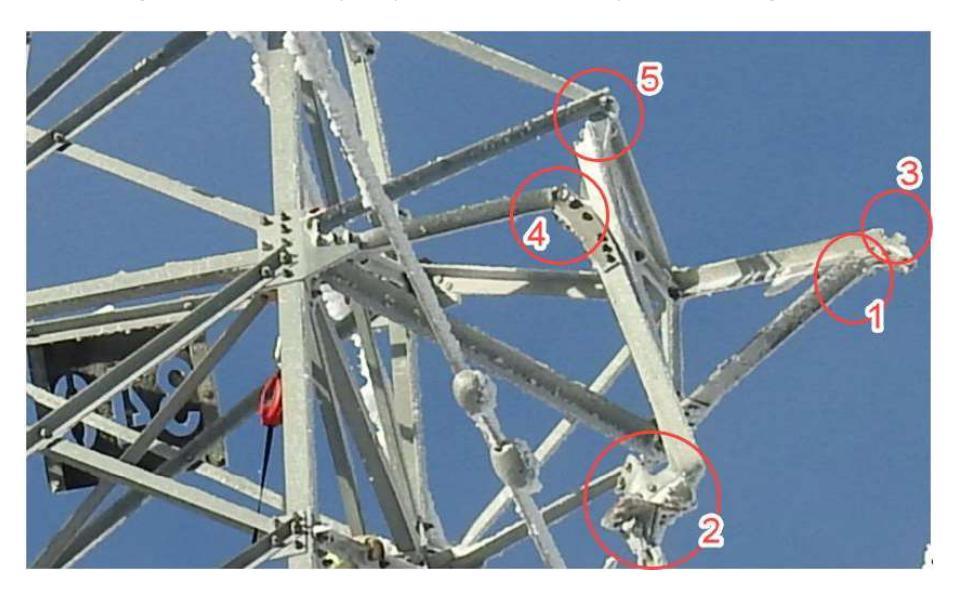
Figure 2 shows the failure of electrode cross-arm in tower 340. At least five failures can be identified. The first failure is believed to be a block-shear failure through one bolt hole and then along the L-profile radius, see Fig. 5. Failure "2" is partly a local failure of L-profile; see Fig.4.

FIGURE 2 Failure in tower 340. At least 5 failures can be seen. It is believed that the first failure is where "1" is located. The next failure might be at "2" and the third at "3".

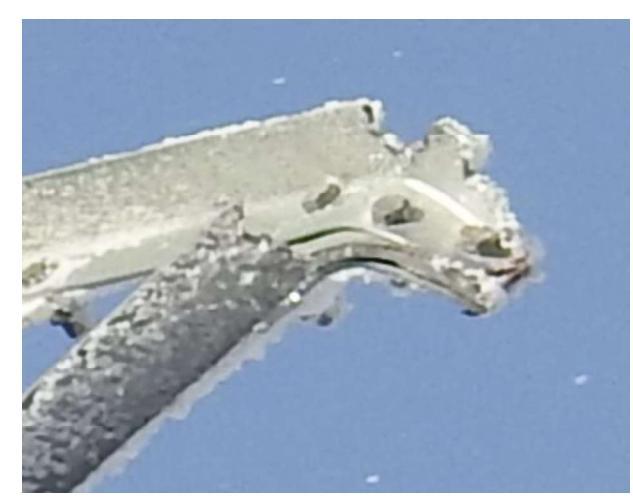
FIGURE 3

Failure location "1" and "3". Failure "1" is block shear failure through one bolt hole.

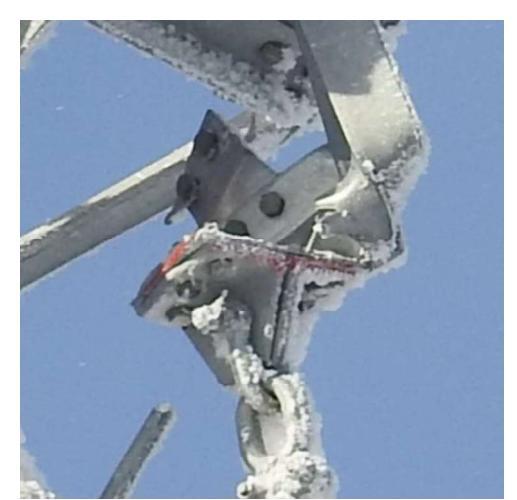
FIGURE 4 Failure location "2". Bolts are intact.

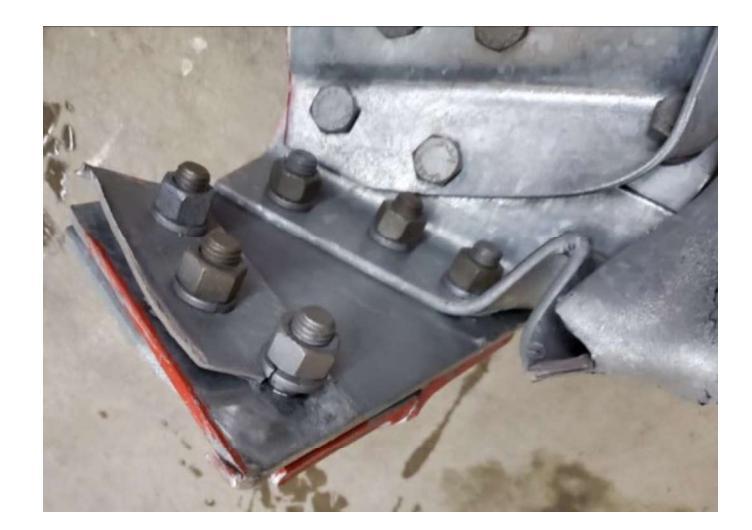
FIGURE 5 Examples of failure mechanisms. Block-shear failure of leg profile to the left and local buckling of the flange on the right

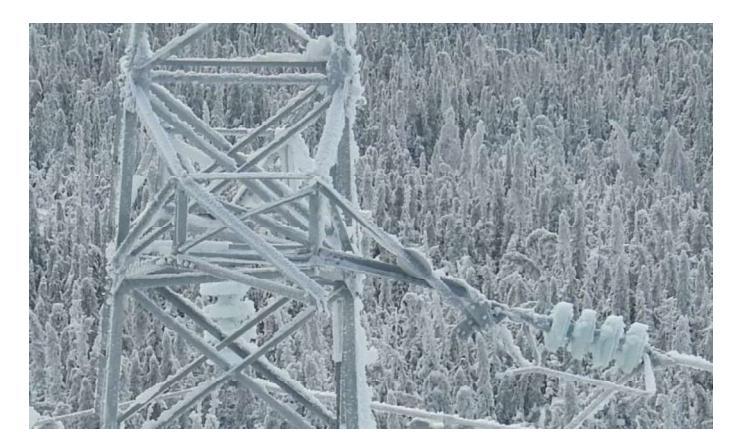
FIGURE 6

Examples of failure mechanisms, tower 330?

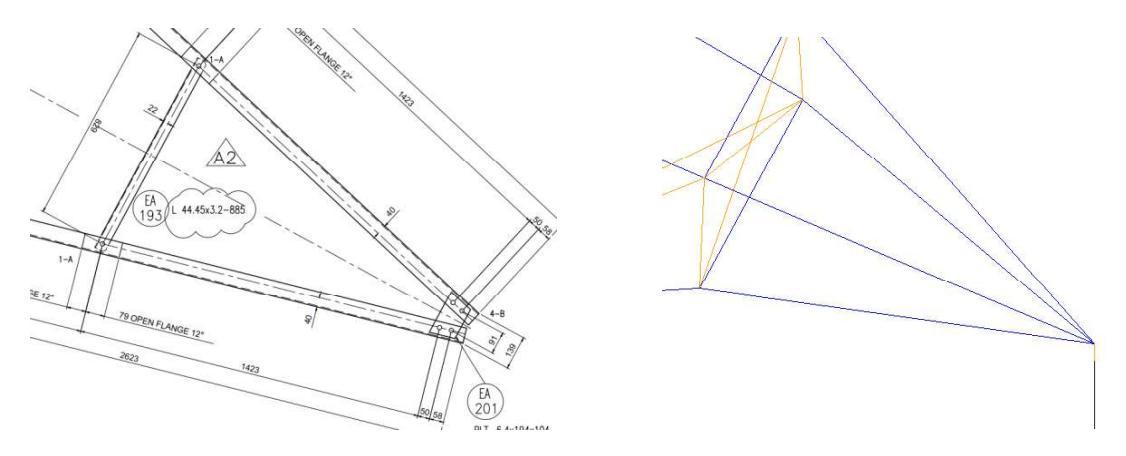
At the tip of the cross arm, the main members are connected to a single point in the PLS-Tower model. In reality, there is a spacing of about 130 mm between the main members at the end. This can have a large influence on the force distribution in the members in the case of longitudinal force and may lead to some overestimation of the capacity.

FIGURE 9 Geometry of the tip does not model the separation of members at the tip in the PLS-Tower model

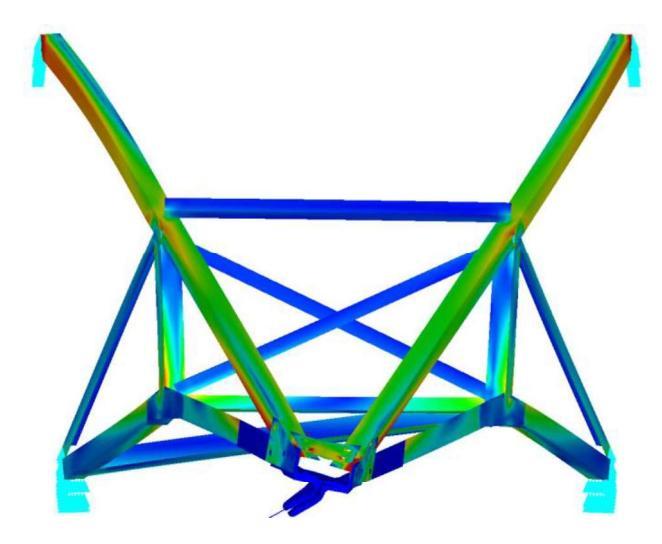
It was clear early in the process that the model accurately captures the local effect of the torsion on the tip of the cross arm. Both the stress distribution and deformed shape show similarities with the failure mechanisms documented on site. Figures 21 and 22 show the deformed shape of the tower and how the attachment cleat deforms. Figure 23 shows how well the program can replicate the local buckling of the flange. Figure 24 shows a high-stress level where the block-shear rupture has taken place in the failed cross-arms.

FIGURE 21 Deformed shape of the tower model scaled 5 times at 67 kN longitudinal load

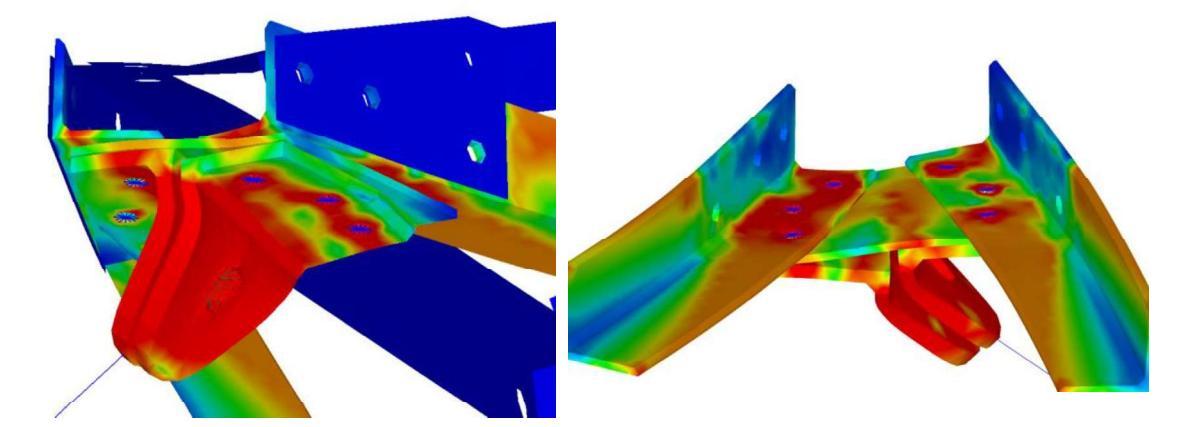
FIGURE 22 Deformed shape (scaled 5 times) and stress distribution at failure in longitudinal load 67 kN – scale set to 450 MPa

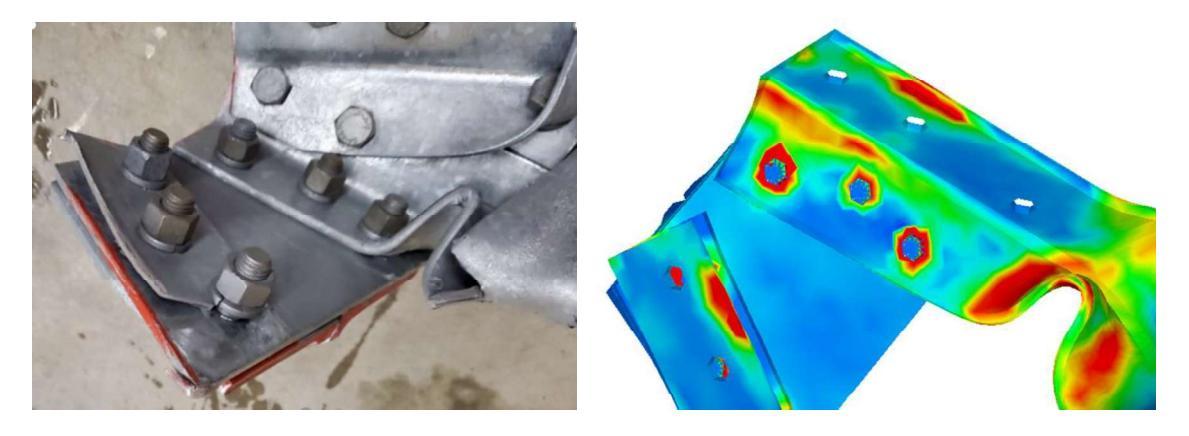
FIGURE 23 Comparison of failure mechanisms, local buckling of the flange, longitudinal load ~80 kN, Deformations NOT scaled.

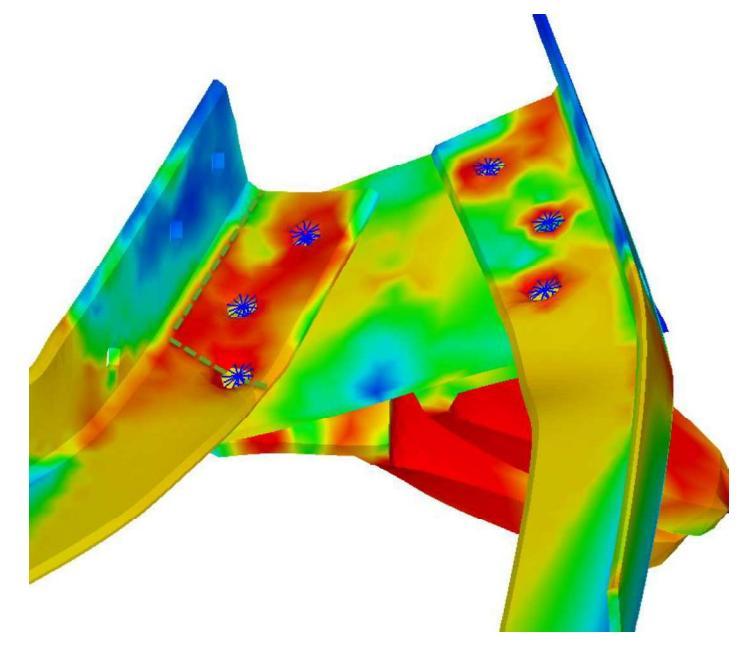
FIGURE 24 Signs of block tear in the model. Longitudinal load 67 kN

Failure of the cross arm in FE-analysis is taken as the lower value of (i) the load at which local buckling occurs or (ii) the load at which 5% strain occurs. The analysis suggests that block-shear rupture (see example in Figure 24) will be the dominating failure mode when the load is predominantly longitudinal. But when the load is primarily vertical, the failure will be due to buckling or connection rupture.

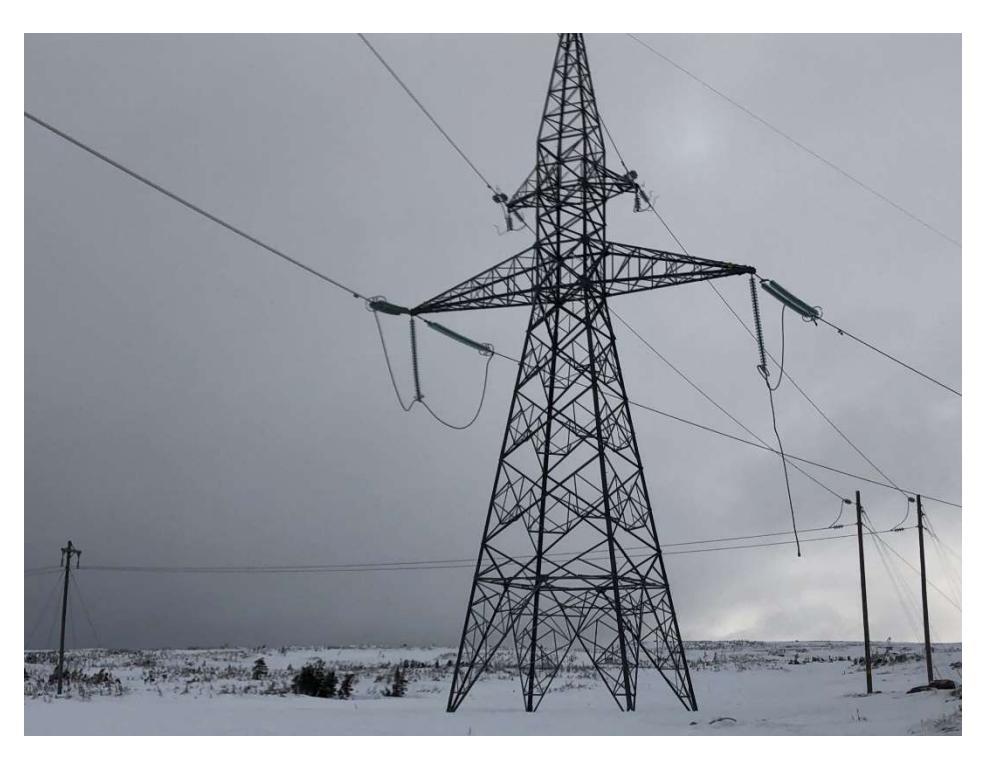
Figure 6 – Structure 1229 Pole Conductor Assembly Failure

On the February 4, 2021 a failure was discovered at dead end structure 1229 during a line patrol with the back span pole 2 conductor on the ground. Further investigation showed that the failure occurred on the turnbuckle of the dead end assembly.

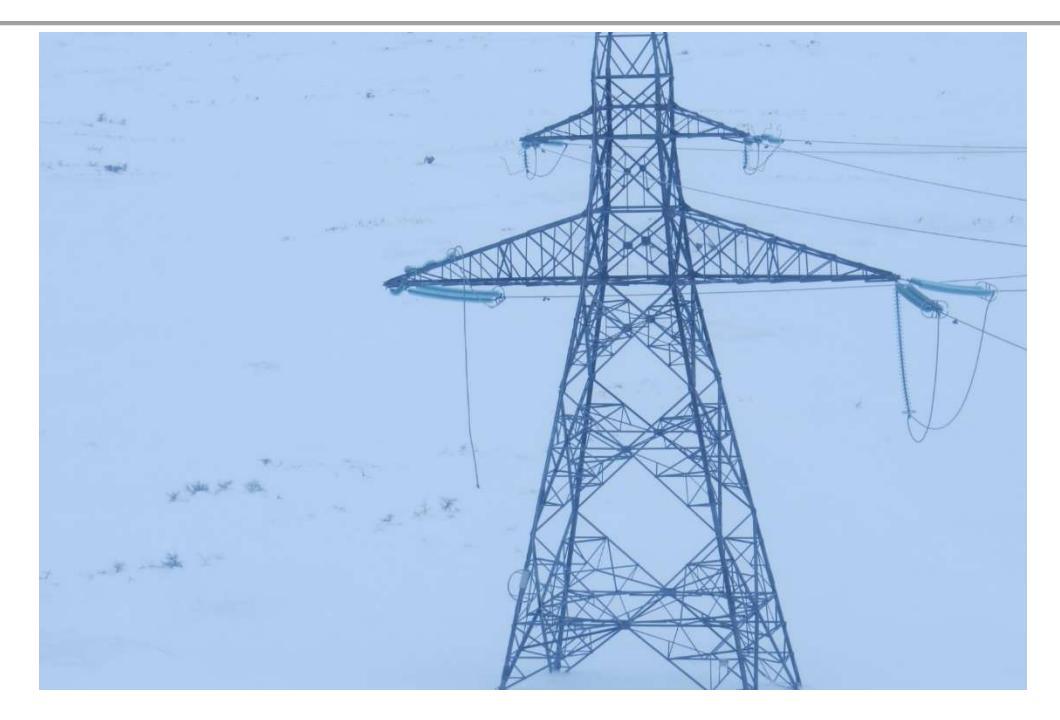
Figure 7 – Structure 1209 Pole Conductor Assembly Failures

On the February 12, 2021 an additional failure was discovered at dead end structure 1209 with the ahead span of pole 2 conductor on the ground. Upon inspection it was noted that the failure was similar to the 1229 failure and occurred on the turnbuckle of the dead end assembly.

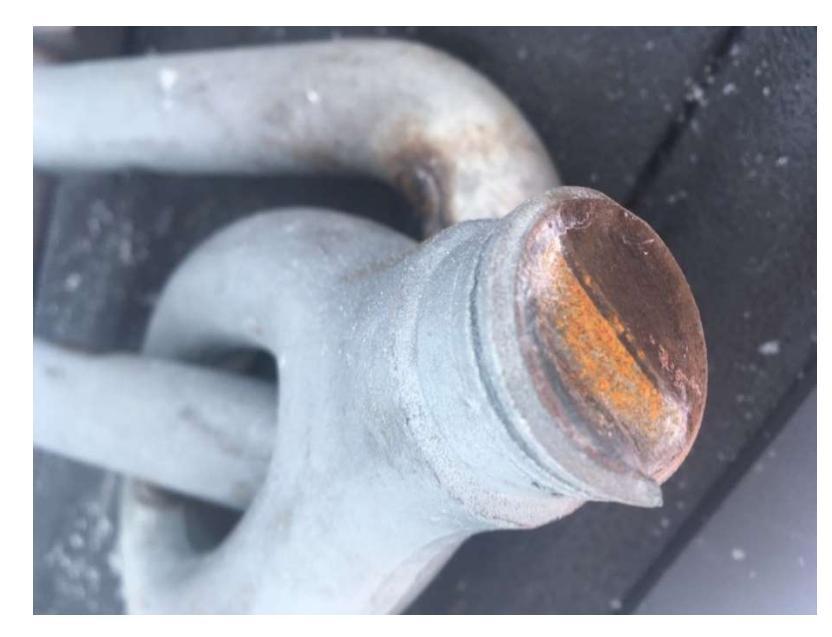
Figure 8 – Fracture Surface of Str. 1229 Turnbuckle

The turnbuckles at both structures failed at the threaded section just under the eye closest to the tower. Both failures were similar and were noted to be a clean break with no necking or bending, see Figures 8 and 9.

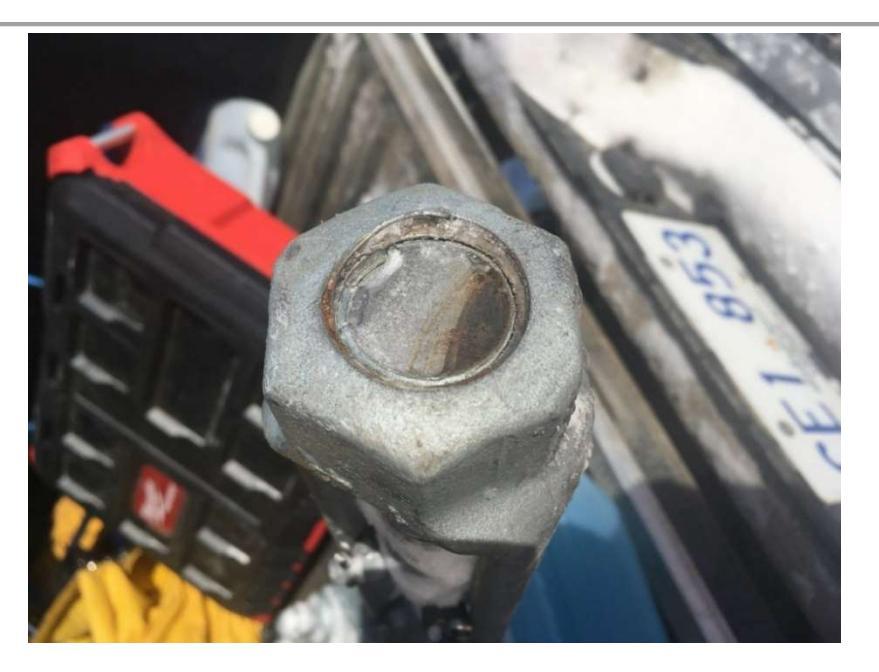
Figure 9 – Fractured Surface of Str. 1209 Turnbuckle

Analysis of the failure surface determined that the turnbuckle fractured due to fatigue crack initiation, which propagated under combination of cyclic reverse bending and cyclic tension-tension loads that were induced by motion of the assembly. The most likely cause of significate movement of a dead end assembly on a transmission line is galloping.

There is evidence the fatigue cracking was initiated by over torqueing of the turnbuckle. This over torqueing could have occurred during installation, or movement of the turnbuckle while in service. Deviations from the installation procedure were evident on the turnbuckle which may have contributed to the failure. The first deviation was that the eyes of the end-pull were not in the same orientation relative to each other. The second deviation was that two locking bolts were used on each of the end-pull, which restrain any rotation motions of the end-pulls relative to the turnbuckle body. These two deviations did not directly stress the turnbuckle. However, orientation misalignment promoted wear damage on the end-pull and the additional lock bolt prevented the turnbuckle self-balance. This could intensify the cyclic loads on the turnbuckle. See Appendix B for complete report "Failure Analysis of a Turnbuckle".

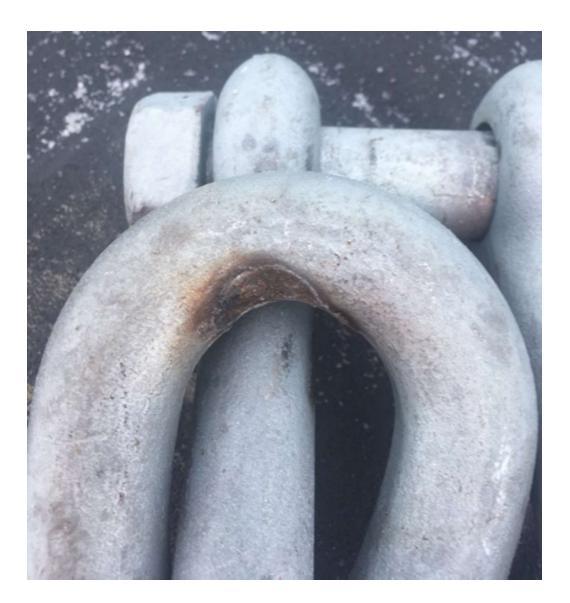
Figure 10 – Wear on Turnbuckle Str. 1229

All other components of the failed dead end assemblies were inspected for damage. There was noticeable wear on the shackle that connects to the turnbuckle and on the turnbuckle eye, see Figure 10 and 11. There was no other damage observed on other hardware or insulators.

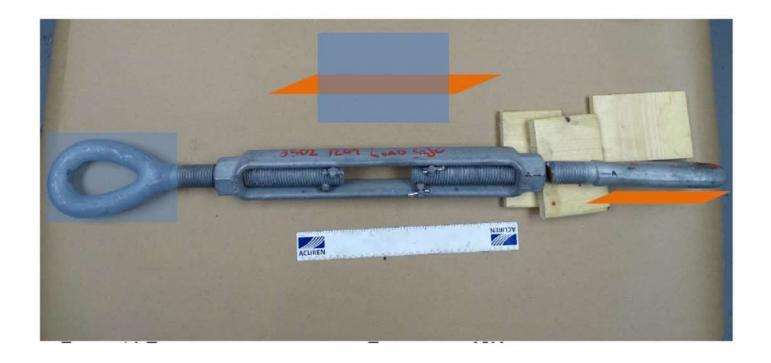
Figure 14 – Turnbuckle 1209 Failed State

It was noted that the failed turnbuckle at 1209 was installed so the two eyes were not in the same plan. This is not in accordance with the installation manual that states, "The eyes of the end fitting should be in the same orientation relative to each other."

It was also noted that the failed turnbuckle at 1209 had two locking bolts on each side. Both the drawing and installation manual from the supplier indicate there should only be one locking bolt on each side of the turnbuckle. See Figure 14 showing the orientation of the eyes and the four locking bolts.

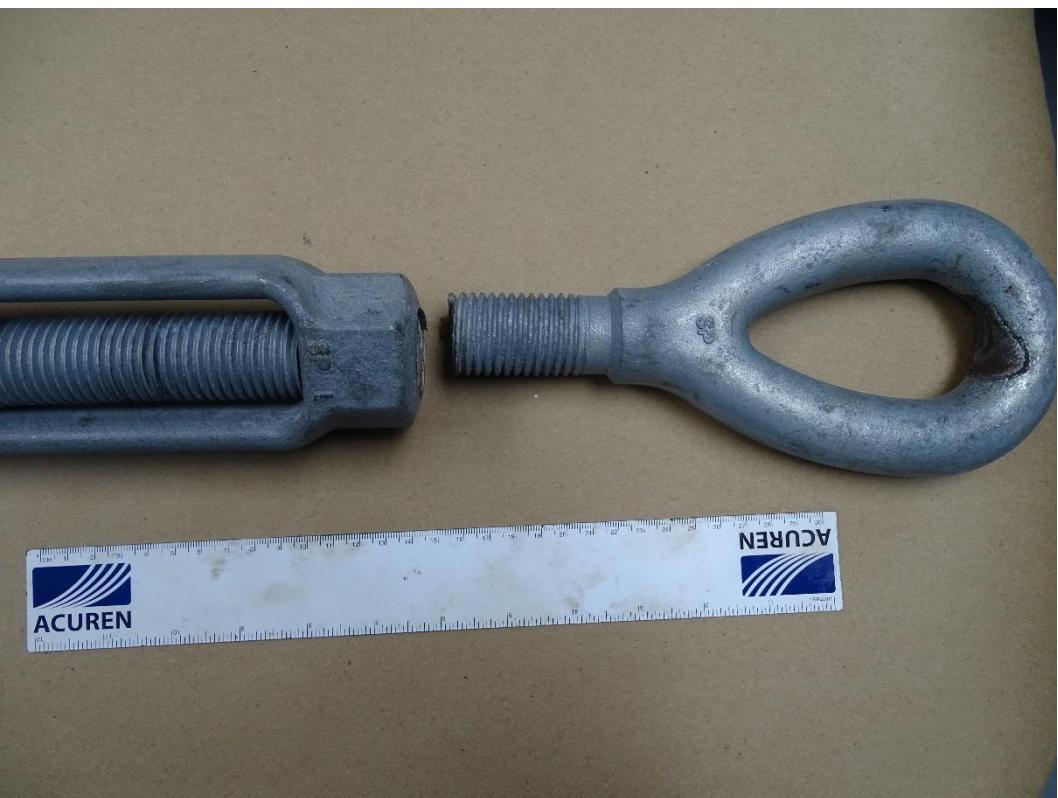
FIGURE 6. TURNBUCKLE 3502 LOCATION OF FRACTUR

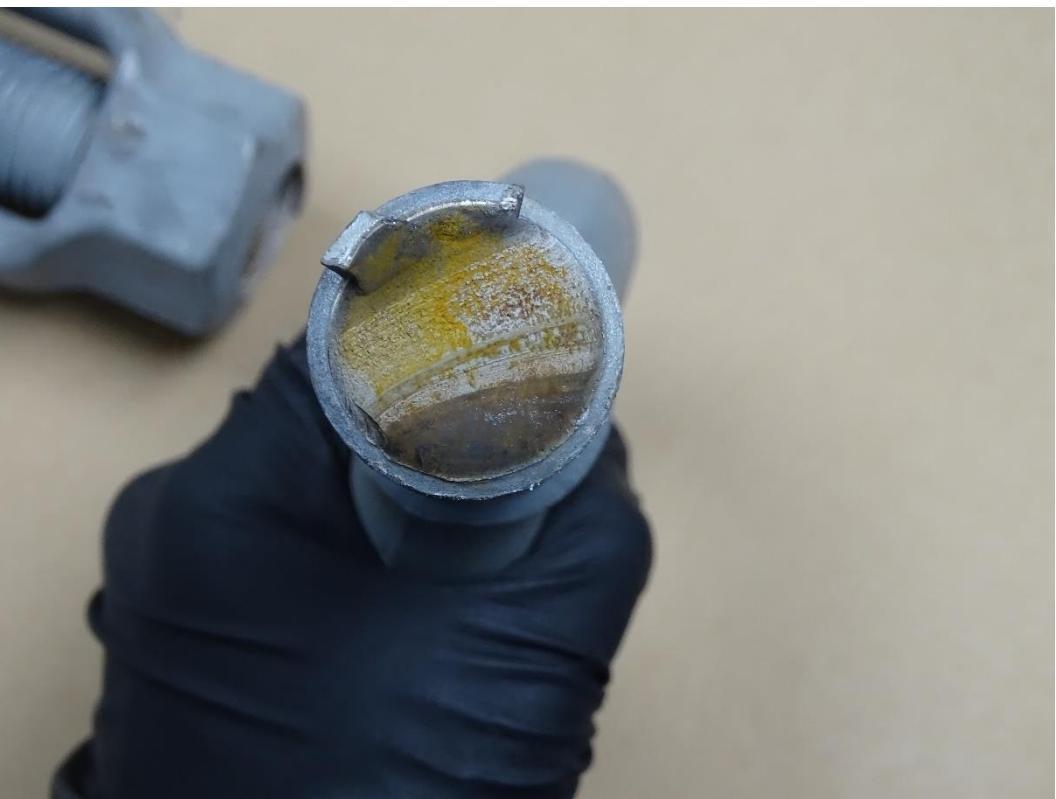
FIGURE 7. TURNBUCKLE 3502 FRACTURE SURFACE, HEAD SIDE

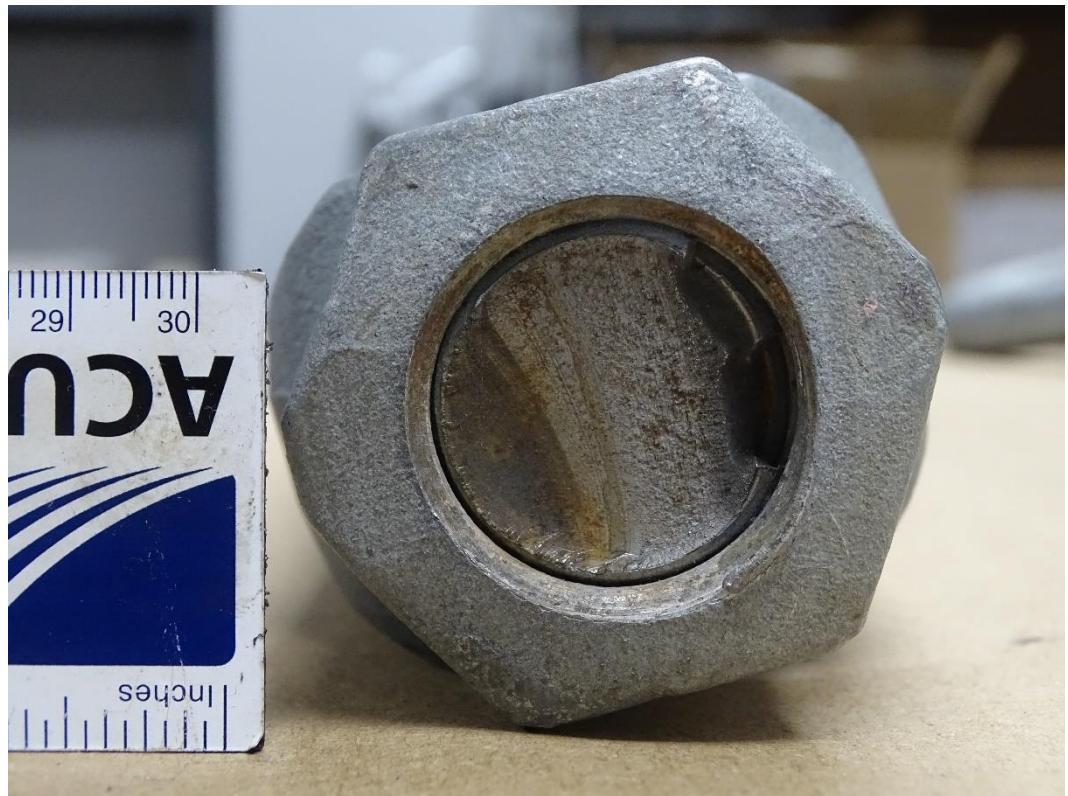
FIGURE 8. TURNBUCKLE 3502 FRACTURE SURFACE, BODY SIDE

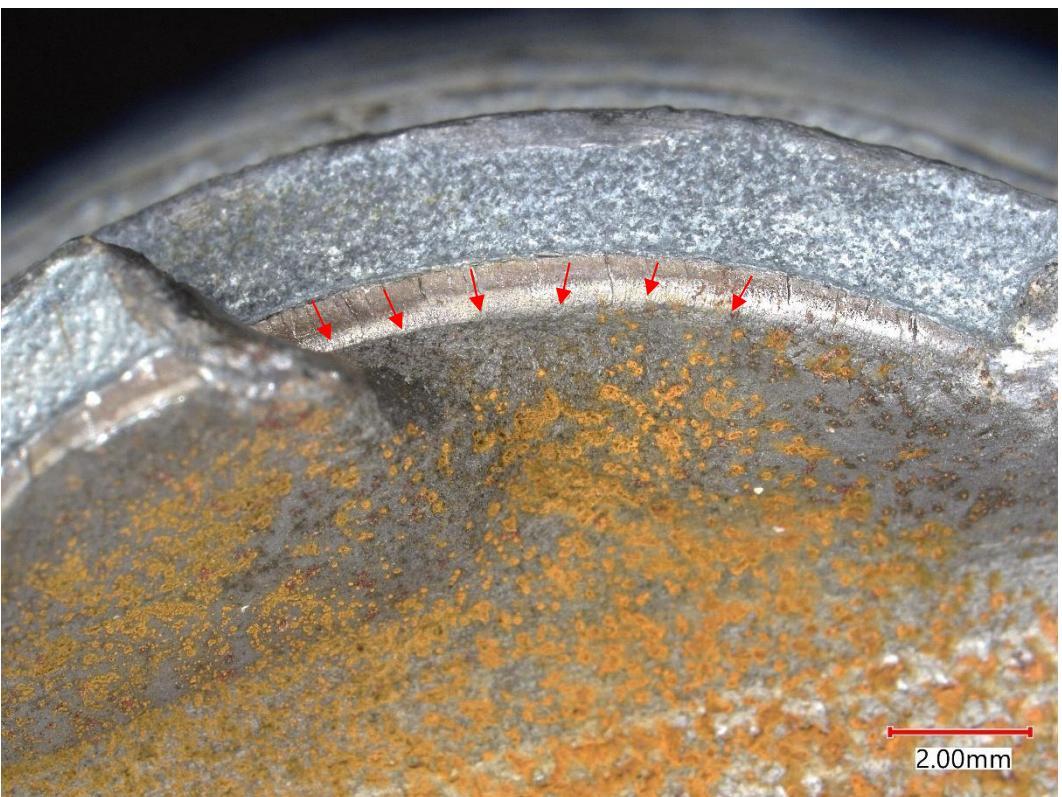
FIGURE 11. BEACH MARK NEAR FINAL FRACTURE END, BEFORE CLEANING

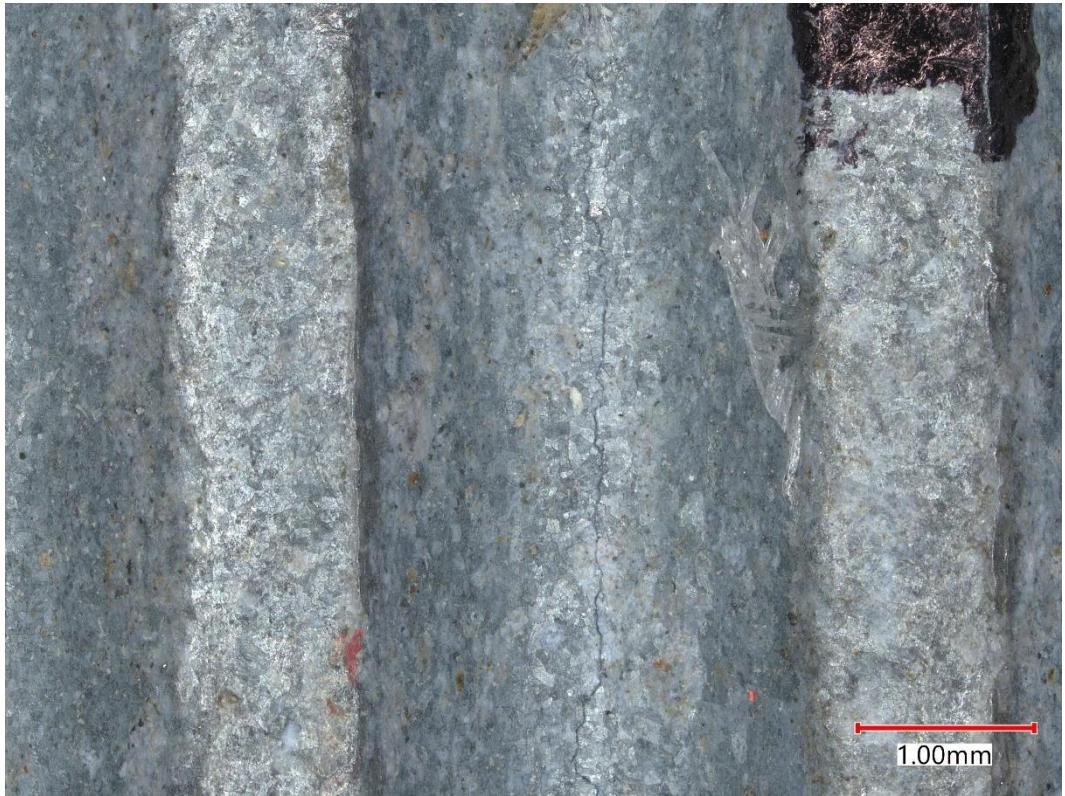
FIGURE 14. CRACKS ON GALVANIZED LAYER AT THREAD ROOT

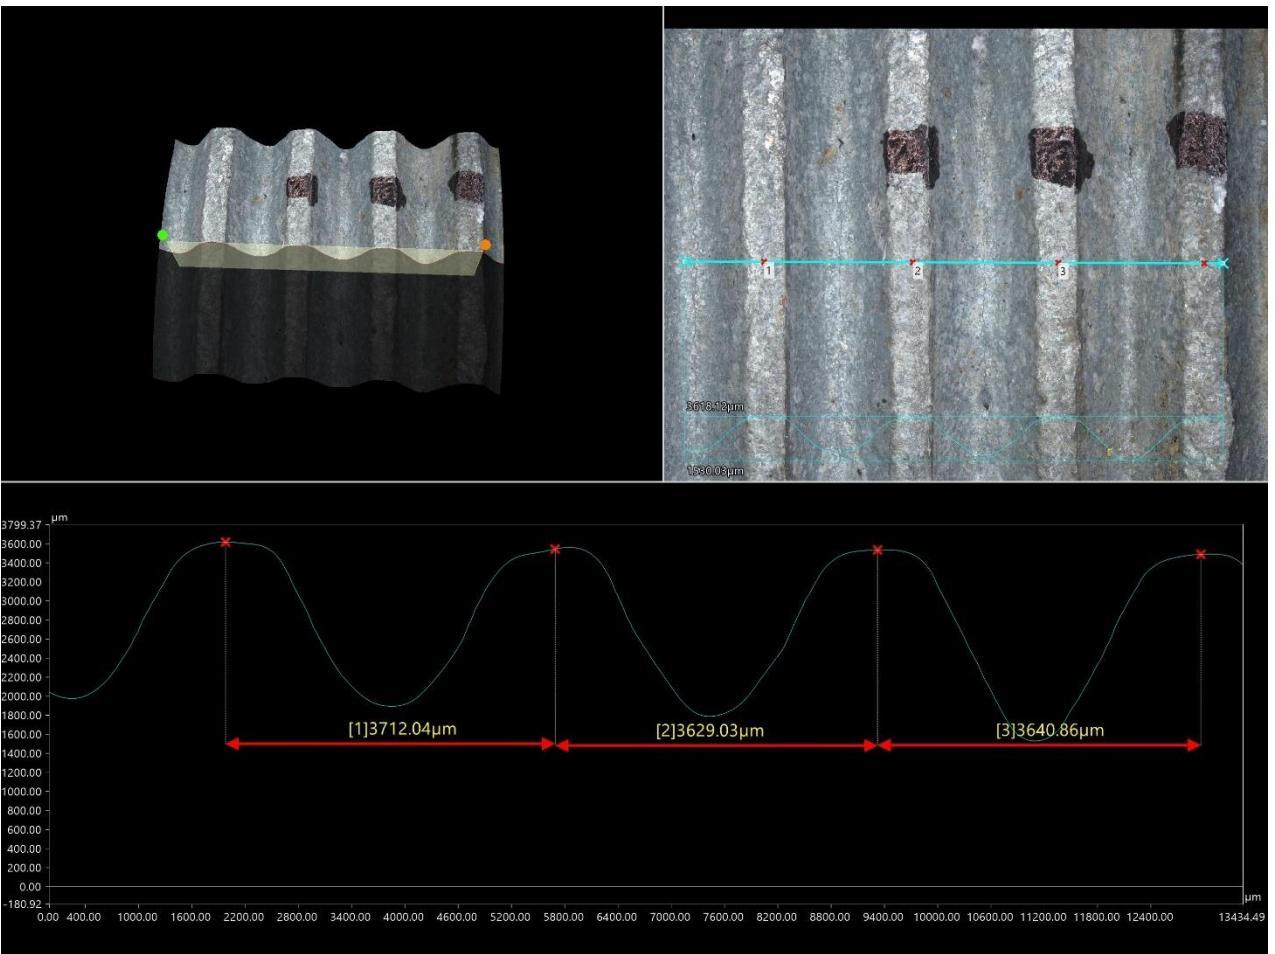
### FIGURE 15. NO OBVIOUS ELONGATION

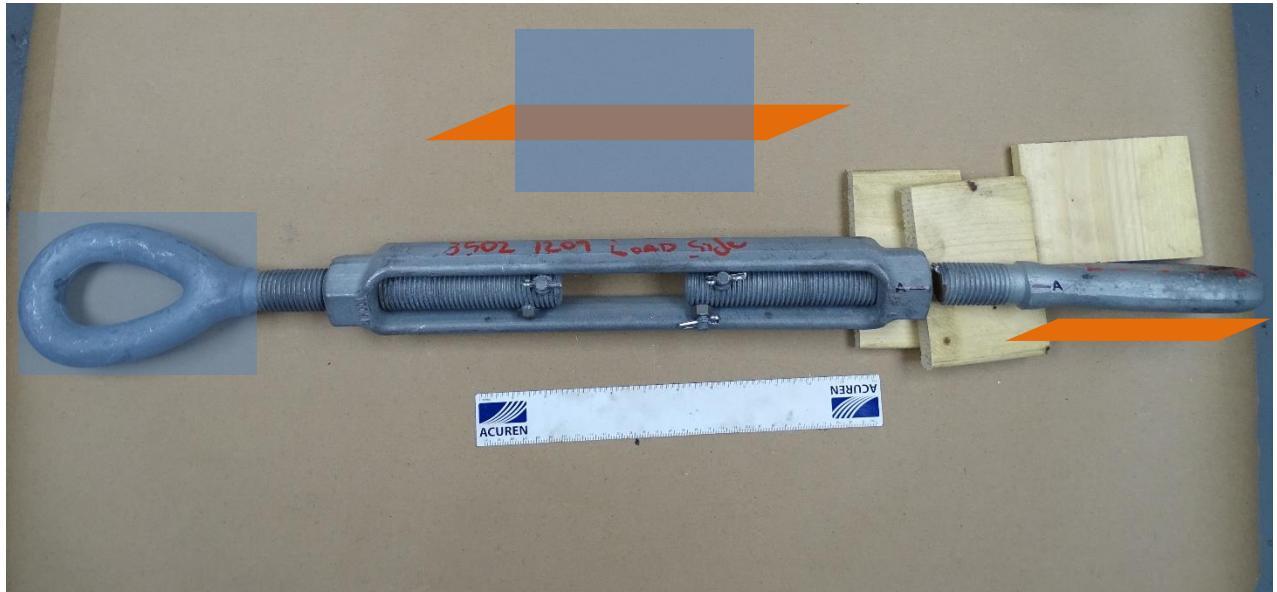
FIGURE 16. THE PLANES OF END-PULLS OF TURNBUCKLE 3502 WERE PERPENDICULAR
