# Re: *Reliability and Resource Adequacy Study Review* – Labrador-Island Link Failure Investigation Reports

# Failure Investigation Report – L3501/2 Tower and Conductor Damage

Failure Investigation Report – L3501/2 Tower	R	evision R1		
Icing Event January 2021 in Labrador	Date:	Revision R1     :   28-May-2021     :   ii		
Nalcor Doc. No. ILK-EG-ED-6200-TL-RP-0001-01	Page:	ii

# FAILURE ANALYSIS OF ELECTRODE CROSS ARM IN LABRADOR ISLAND TRANSMISSION LINK (LITL)

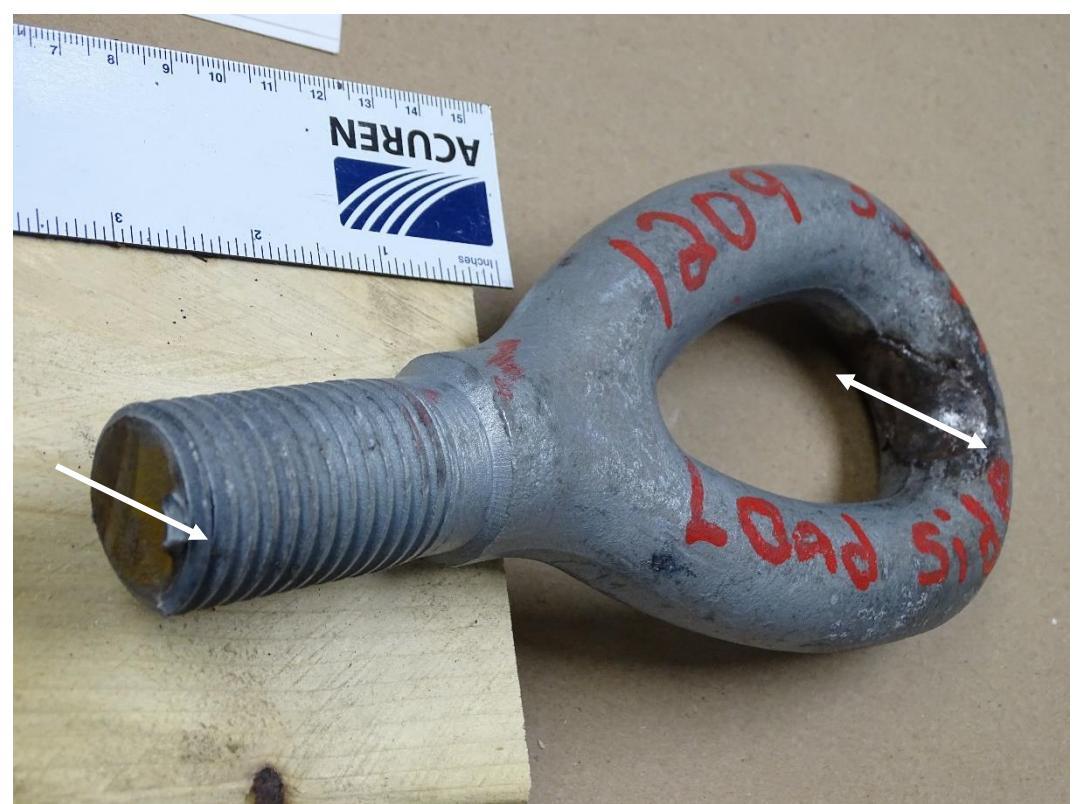
FIGURE 18. DIRECTION OF WEARING MARKS APPEARS TO ALIGN WITH CRACK PROPAGATION DIRECTION

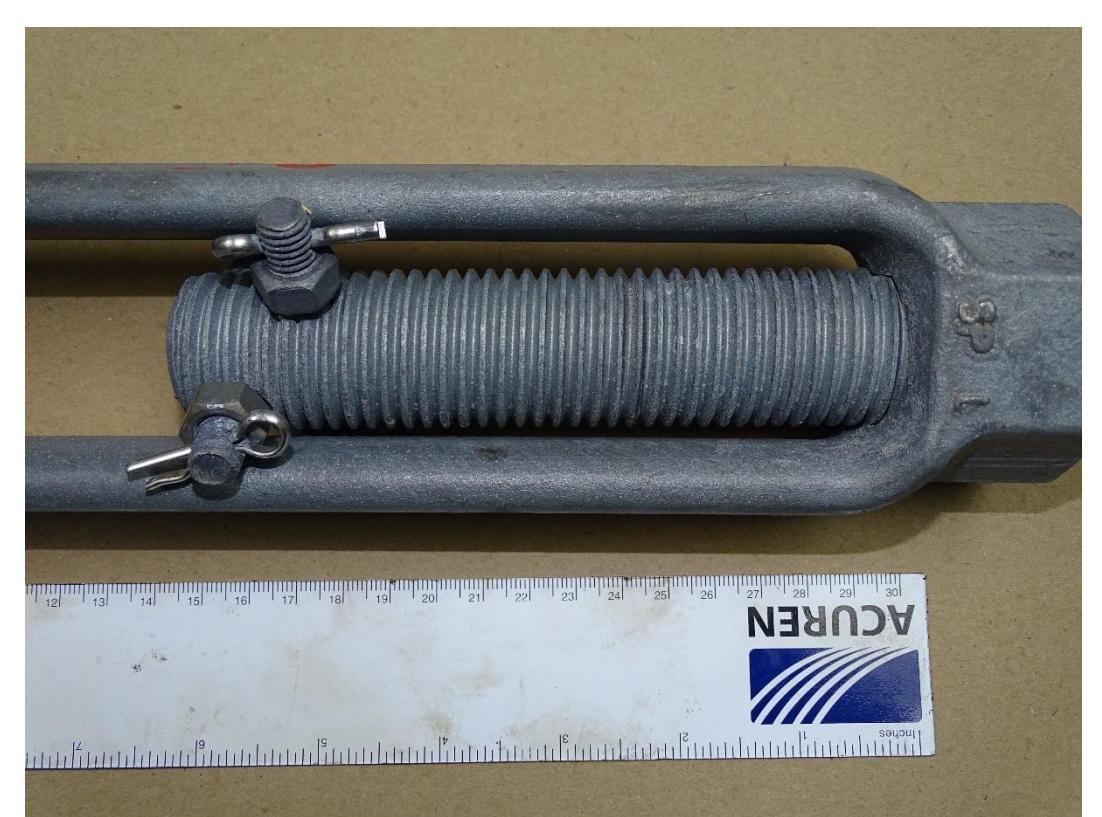
FIGURE 19. TURNBUCKLE 3502 FRACTURED AT LEFT HANDED SIDE

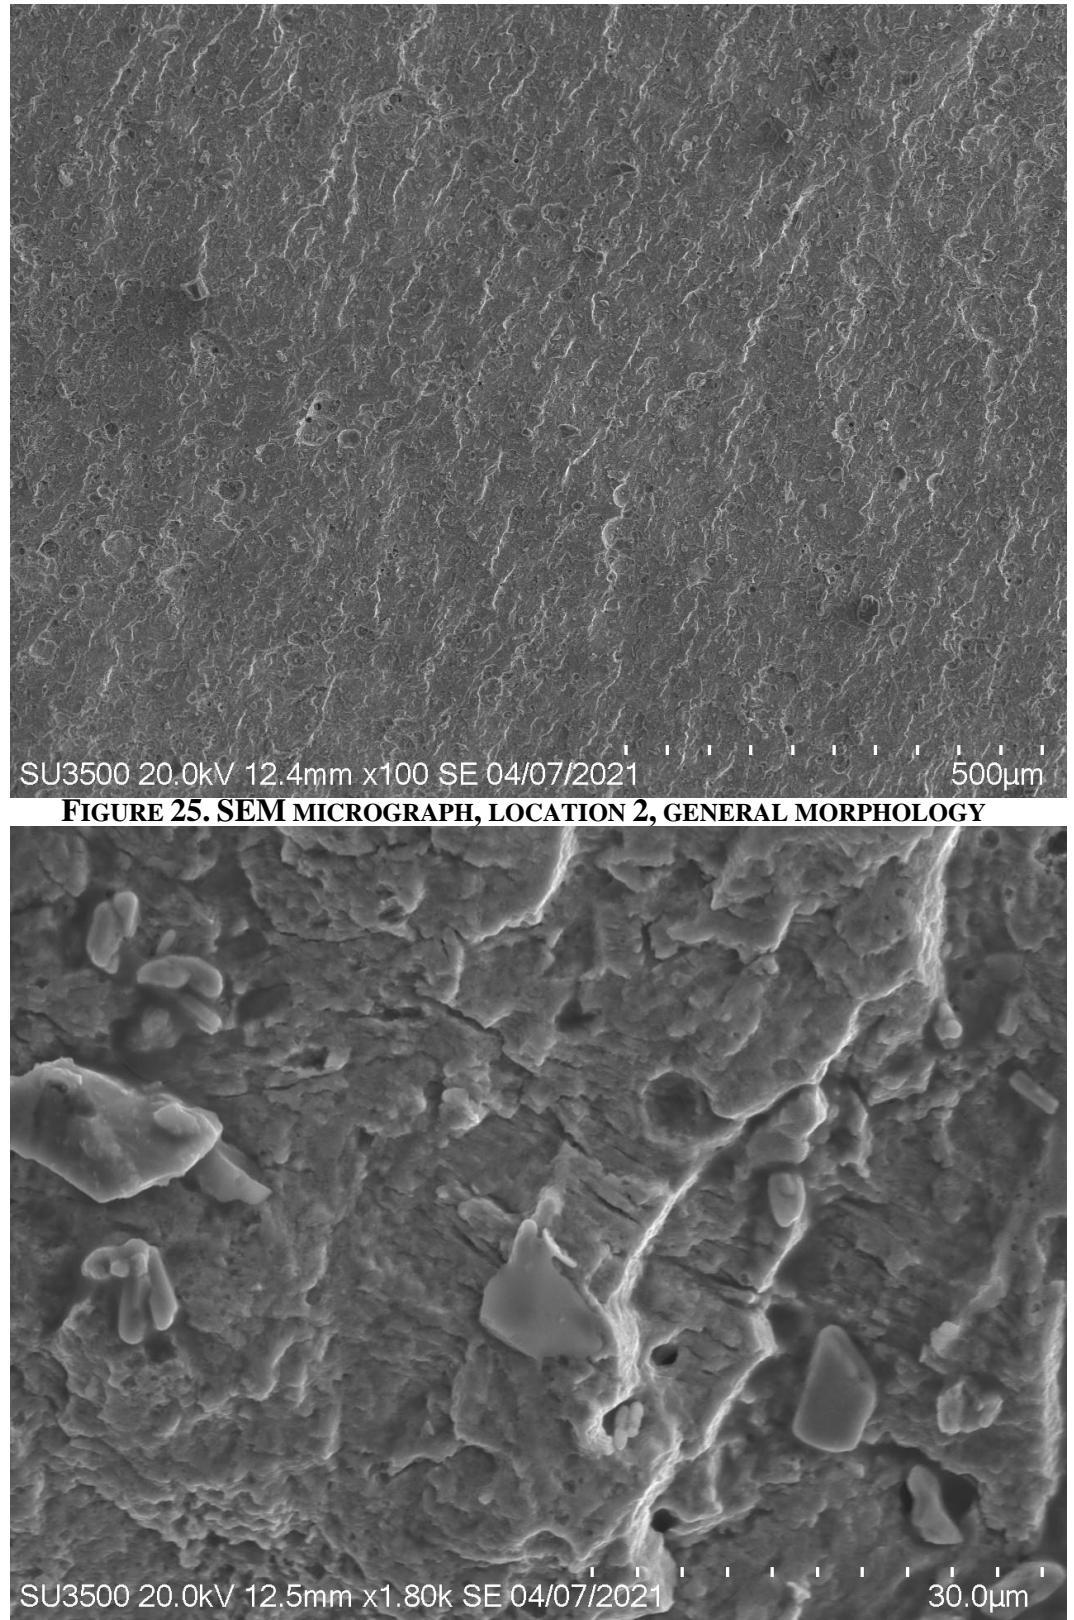
FIGURE 26. SEM MICROGRAPH, LOCATION 2, STRIATIONS

The general fracture surface morphology appeared identical near the crack initiation site (Figure 24) and in the majority of the fracture surface (Figure 25 and Figure 27). At higher magnifications, striations<sup>6</sup> were observed (Figure 26 and Figure 28), which indicates fatigue crack propagation.

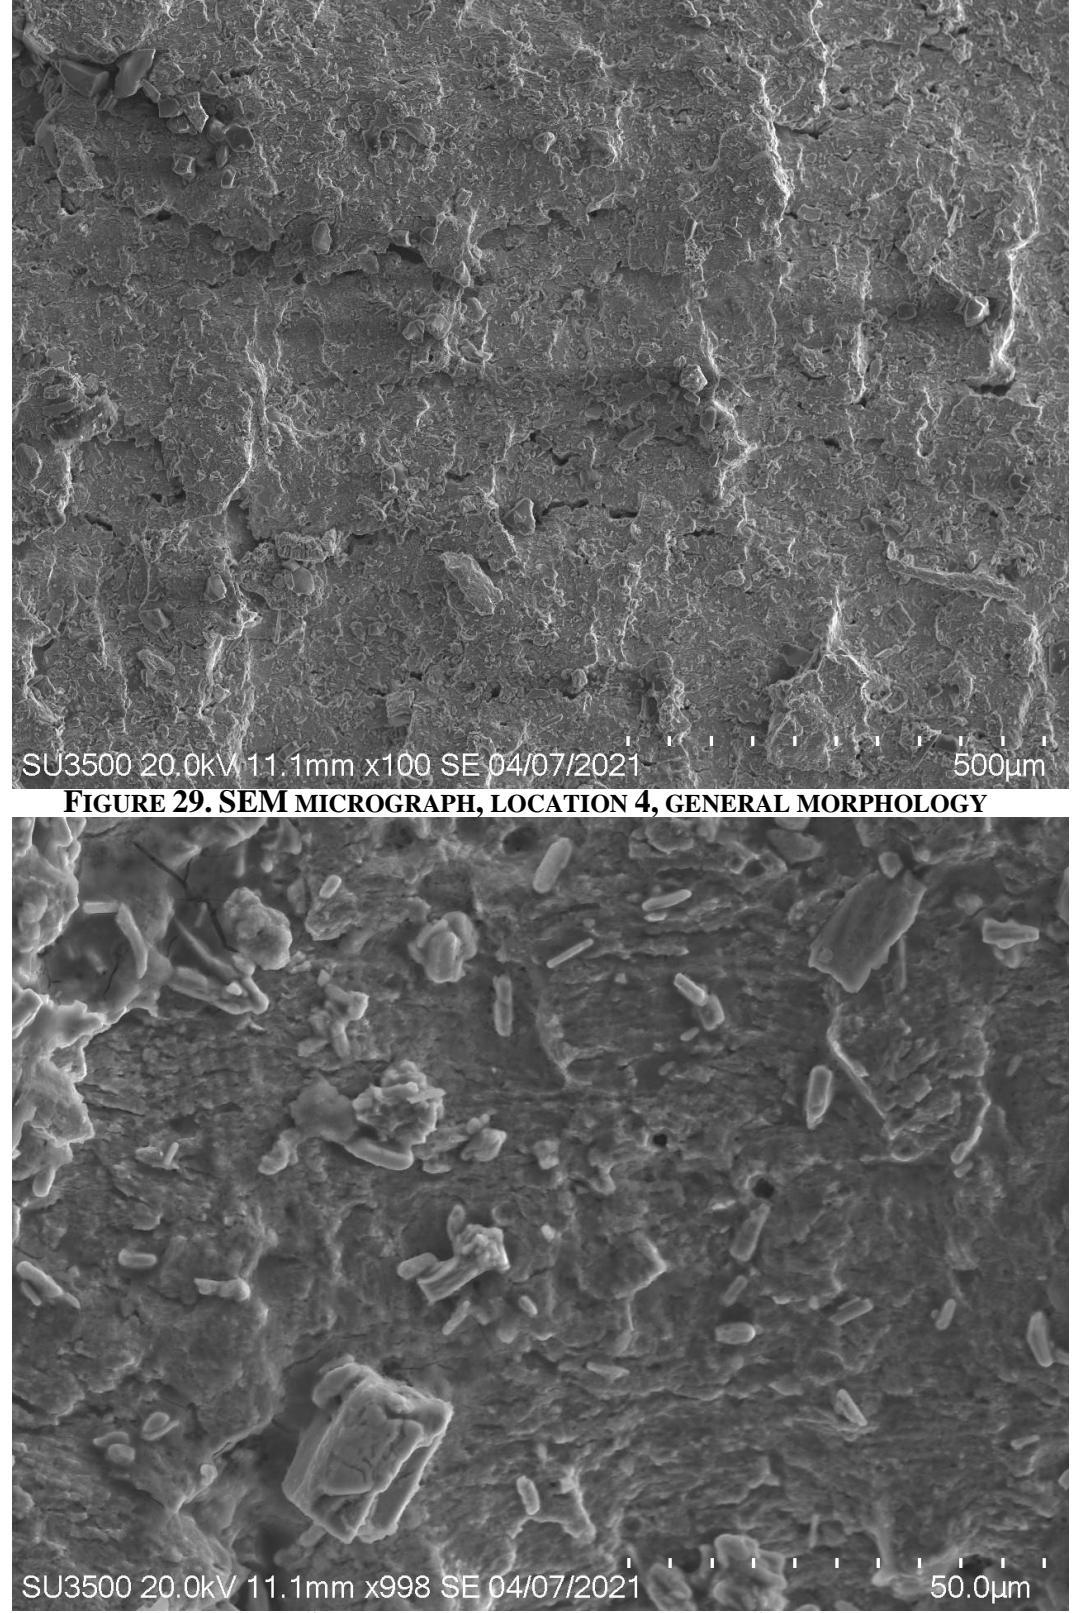
FIGURE 30. SEM MICROGRAPH, LOCATION 4, STRIATIONS

The fracture surface morphology became rougher when moving closer towards the final fracture zone (Figure 29). Fissures were evident at low magnifications and striations with larger spacing were observed at higher magnifications (Figure 30). It indicates stresses on the end-pull increased as the intact cross section area decreased due to fatigue crack propagation.

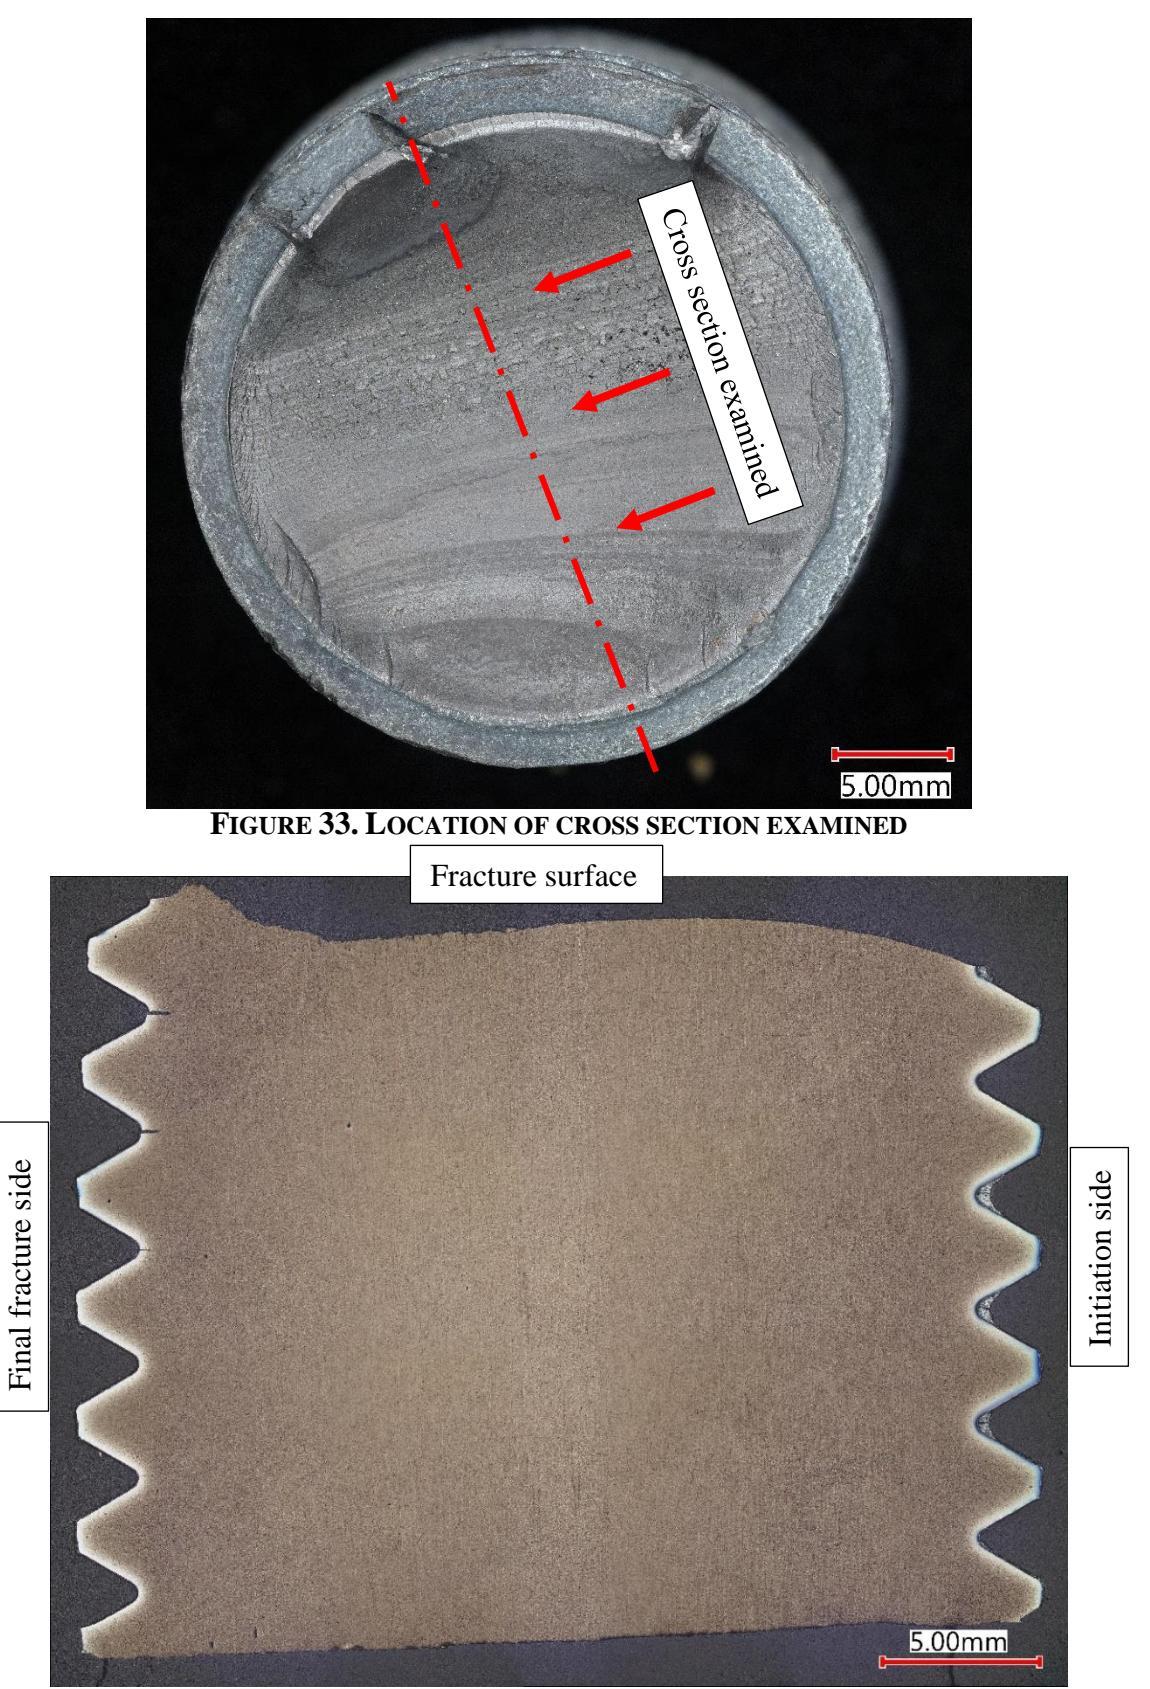
FIGURE 34. METALLOGRAPHIC SAMPLE, ETCHED CONDITION

A sample was removed from the fractured eye end-pull for metallographic examination of the longitudinal cross section (Figure 33). The samples were mounted in Bakelite, ground and polished in accordance with ASTM E3-11. After examination in the as-polished condition, we etched the sample using 2% nital in accordance with ASTM E407-07(2015)E1 to reveal their microstructure (Figure 34). The end-pull showed tempered martensitic microstructure in the entire cross section examined (Figure 35), which indicates the end-pull was through hardened. A layer of the base metal near thread surface appeared in white colour in etched condition because the zinc coating was preferentially etched by the etchant, leaving the adjacent base metal only lightly etched.

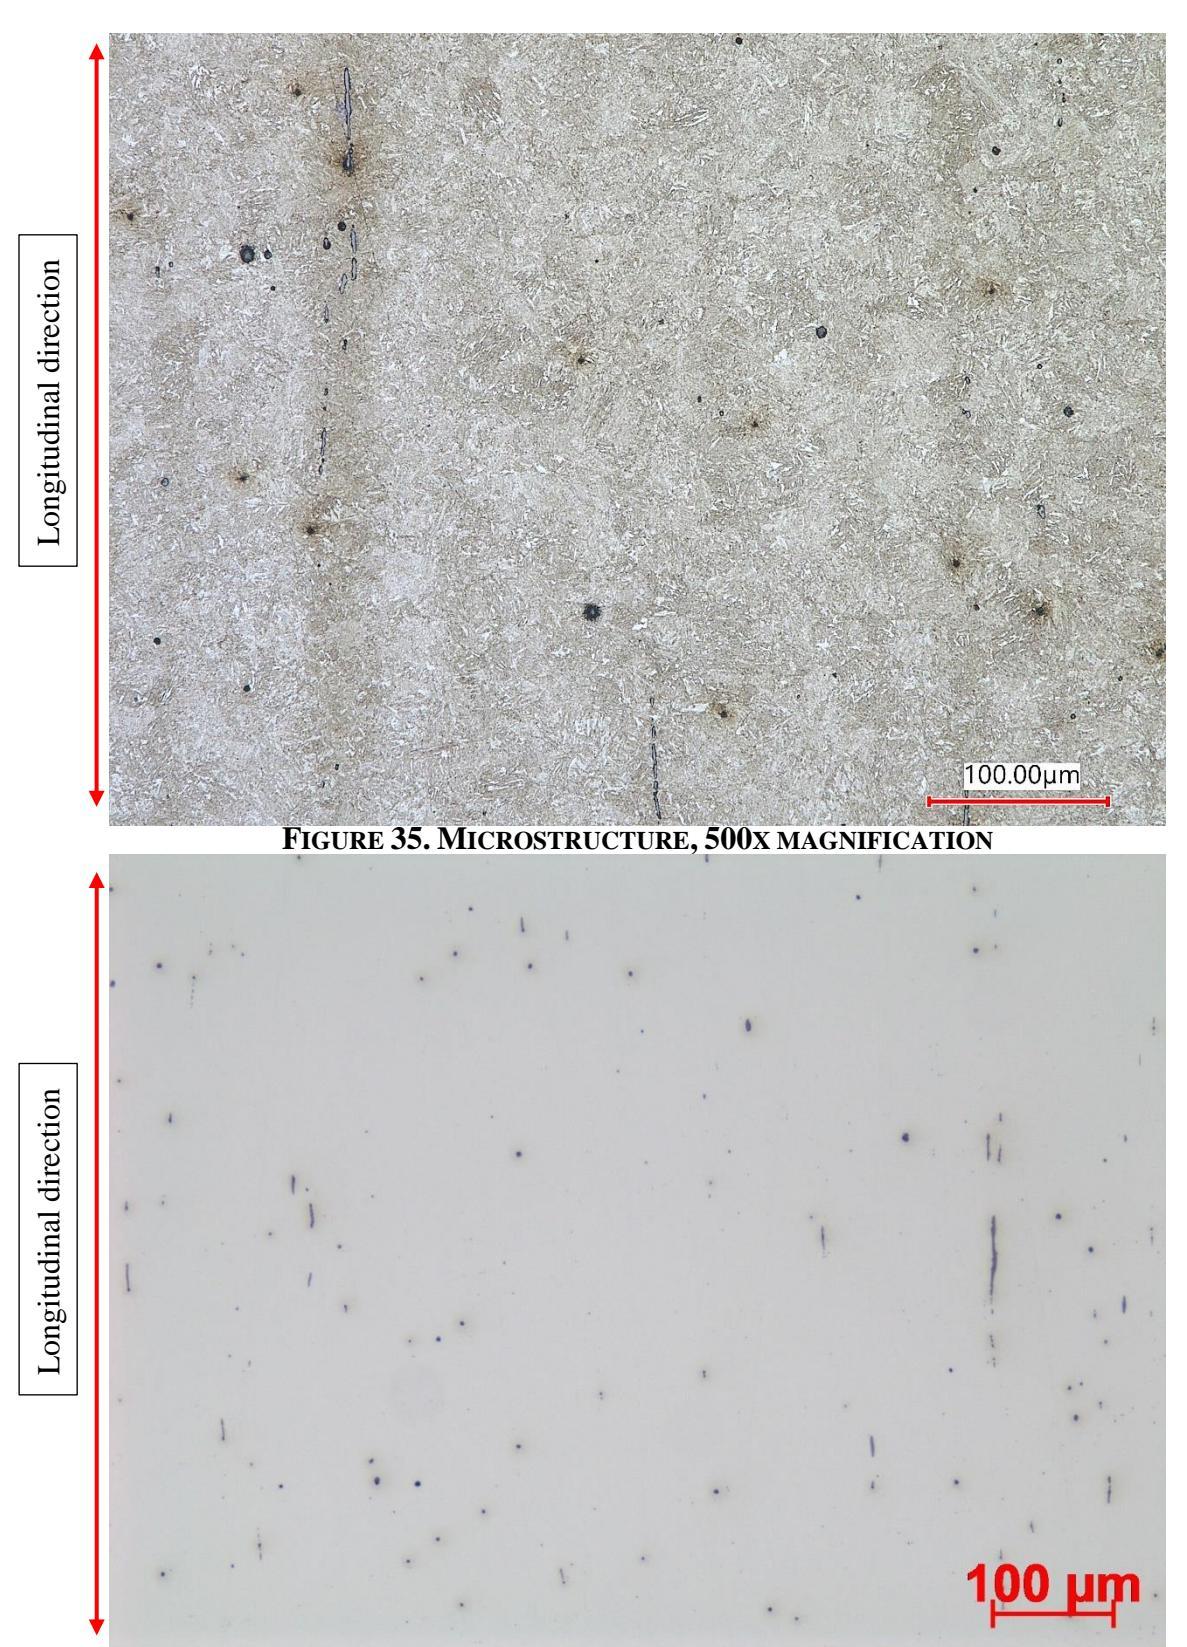
FIGURE 36. INCLUSIONS

The metallographic was subjected to inclusion rating as per ASTM E45-18, Method A (Worth Field). For this purpose, the sample was examined in as-polished condition under light microscope at 100X magnification. The sample's surface was checked to find the worth fields. The image displayed (Figure 36) was compared with the Plate 1A to determine inclusions' severity level. Results of evaluation are presented in Table 2.

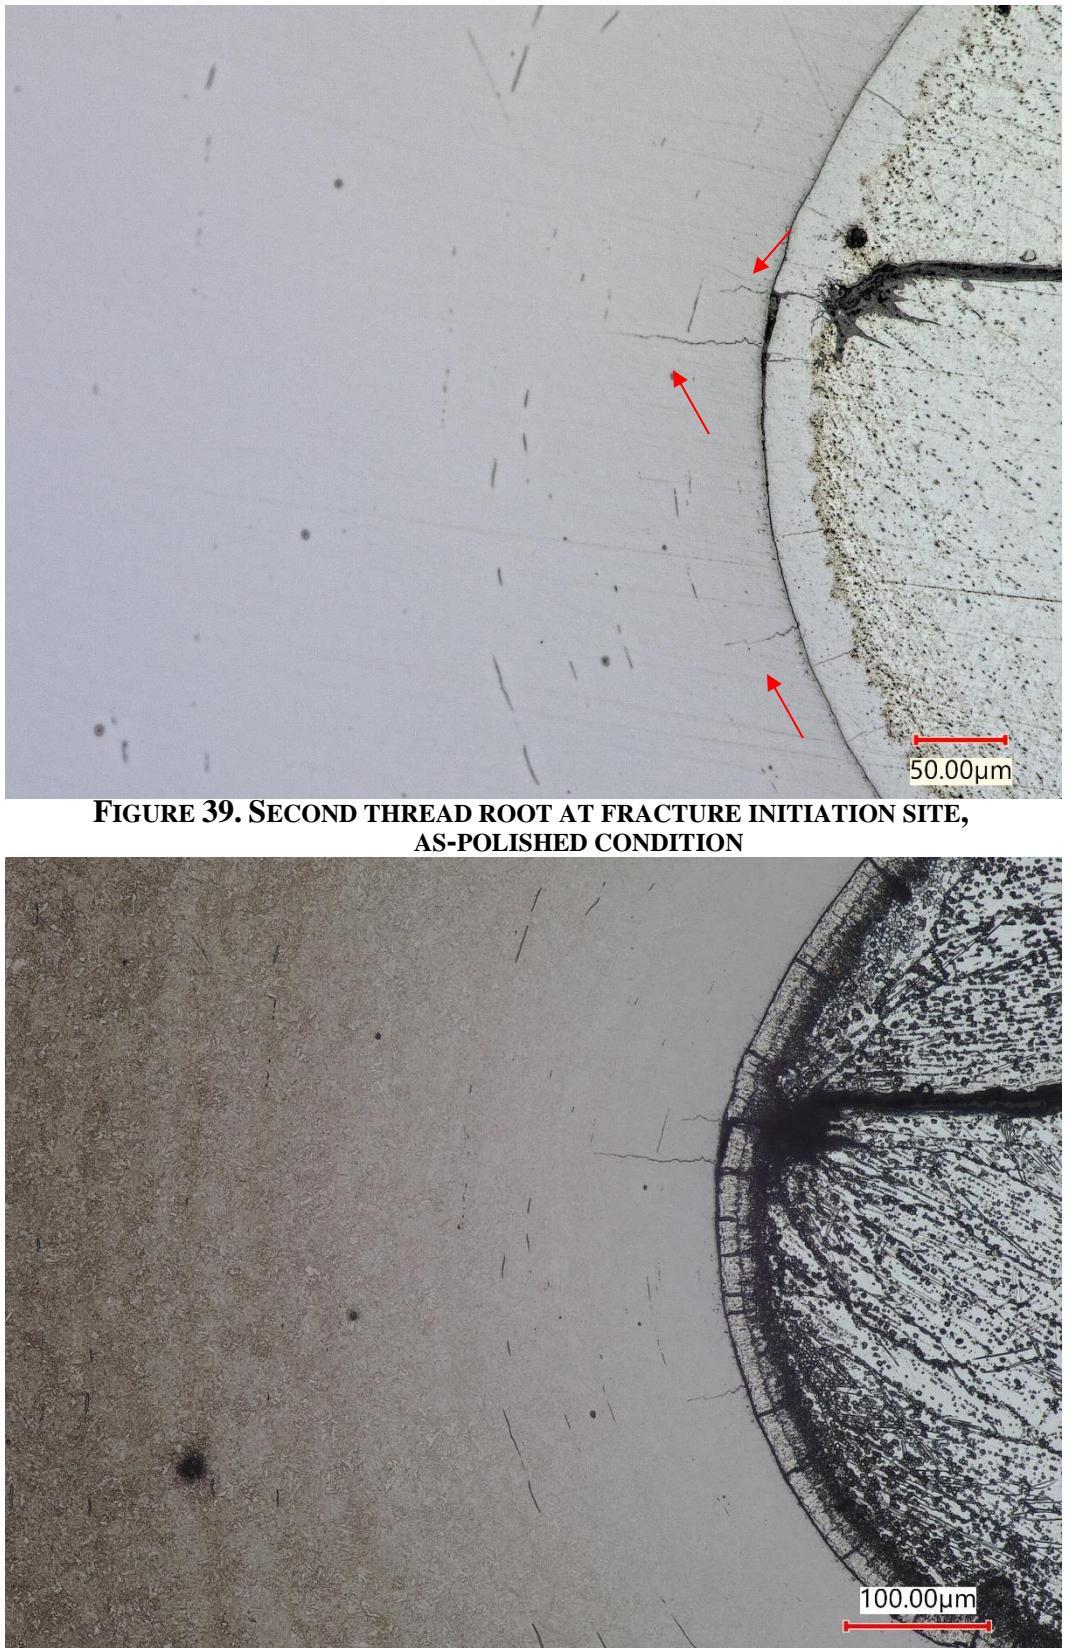
FIGURE 40. SECOND THREAD ROOT AT FRACTURE INITIATION SITE, ETCHED CONDITION

Same type of cracks were observed at all the thread root in the sample examined on the initiation side (Figure 39, Figure 40, Figure 41 and Figure 42), indicating fatigue crack initiation on these thread roots. Similarly, cracks were observed at all the thread root in on the final fracture side (Figure 43 to Figure 46). The cracks were more open at the first and second thread root adjacent to the fracture surface (Figure 43 and Figure 44), which was a result of the jerk during final fracture. Cracks away from the fracture surface show identical features as the cracks on the fracture initiation side, indicating they are fatigue cracks.

The head side of the fractured end-pull was sectioned longitudinally, polished and etched with 10% ammonium persulfate to reveal the material flow line (Figure 47). The flow lines follow the curvature of the end-pull, indicating that the end-pull was forged. The flow lines also follows the curvature of the threads(Figure 40, Figure 42, Figure 44 and Figure 46), indicating the threads were rolled.
