2020 Capital Budget Application Hydraulic Generation Refurbishment and Modernization (2020–2021)

July 2019

A report to the Board of Commissioners of Public Utilities

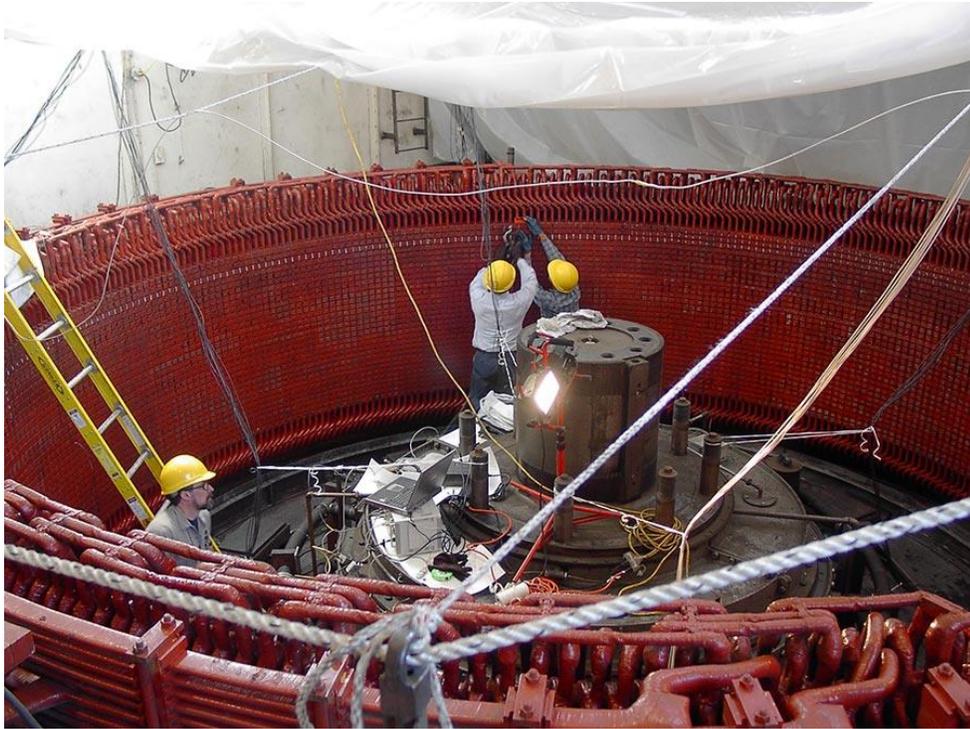
Figure 2: Stator Windings - Top View

24 PDA tests determine the thermal degradation of stator insulation. In March 2019, Bay d’Espoir Unit 5
25 stator windings have shown Qm values² around the 90th percentile (508 mV) of 13.8 kV air cooled
26 generator. Qm values above the 90th percentile indicates an increased likelihood of reaching unreliable
27 operating limits based on the Institute of Electrical and Electronics Engineers (“IEEE”) objective methods
28 to interpret Partial Discharge Data on rotating machine stator windings.

1 This testing shows Bay d’Espoir Unit 5 stator winding insulation cannot stay in service for the next six
2 years without a rewind. If the insulation degradation continues beyond this critical condition, there is a
3 heightened likelihood of failure, which would halt unit production. A stator failure would result in the unit
4 being unavailable for up to at least 24 months to complete repairs.

20 This project is required to maintain the reliability of Hydro’s hydraulic generating Unit 5 stator by
21 improving data availability for air gap and PDA unit condition assessments. It can verify that the unit is
22 operating within limits set by the manufacturers, and by trending the data Hydro can initiate proactive
23 maintenance to deal with incipient failures. Installing the PDA and air gap equipment during the
24 refurbishment of the stator eliminates the need for another unit outage to install that equipment.

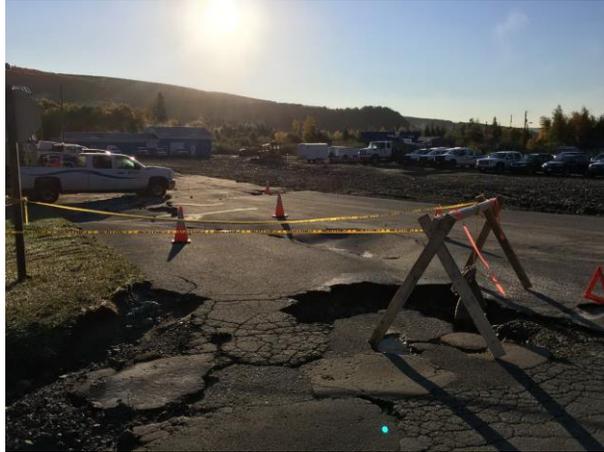
- 2 Since Hurricane Matthew, there has been several occasions when flooding occurred that damaged the
3 crossing and impeded flow of traffic to and from Powerhouse 1 and 2. Figures 24 to 29 illustrate damage
4 after Hurricane Matthew as well as damage incurred during weather events since.

Figure 25: Post Hurricane Matthew Damage to Surrounding Infrastructure after Bear Brook Crossing Failure

17 The project will be executed in 2020, with estimated costs of \$435,300. Table 26 contains the budget
18 breakdown.
19
20 This project will include replacement of the existing culverts with a bridge reused from the construction
21 of TL 267, as shown in Figures 33 and 34.

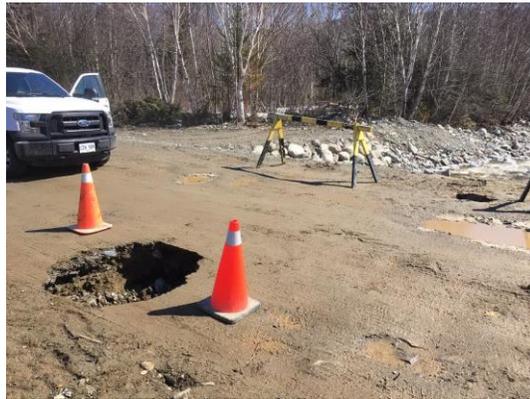
Figure 26: April 2017 - Post Weather Event - Sink Hole

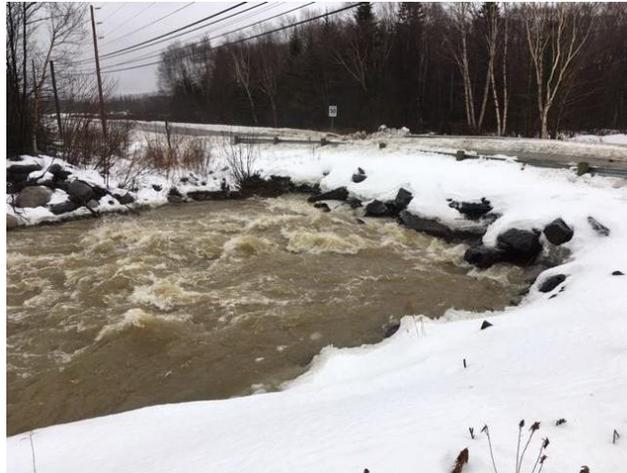
Figure 28: January 2019 - Rain Event - Culverts Fully Submersed

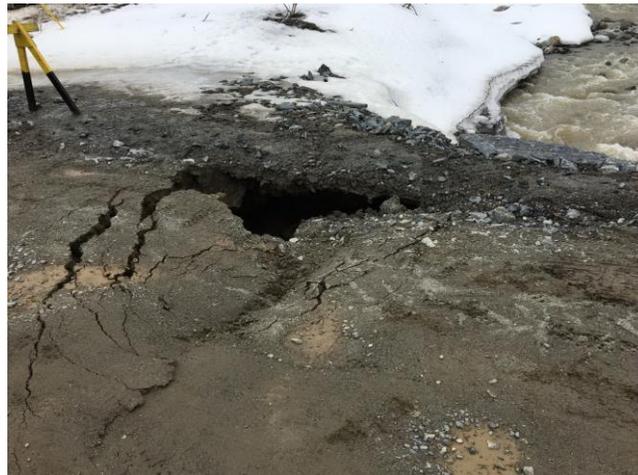
Figure 29: January 2019 Rain Event - Sinkhole

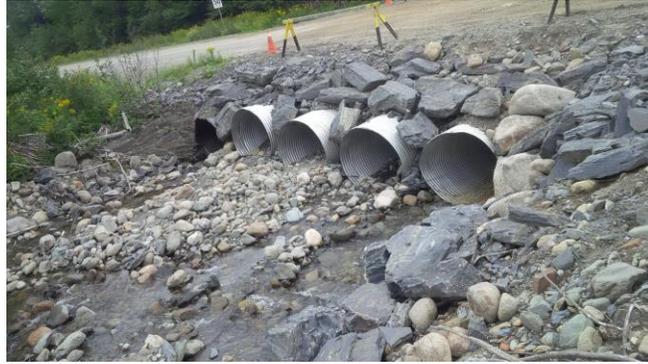
Figure 30: Bear Brook Crossing (August 2017)

- 1 Figures 30 through 32 illustrate that debris is still building up by the culverts. While the culverts are
- 2 designed to pass water freely, Bear Brook runs through a densely populated forested area and the
- 3 waterway consists of loose rocks and debris such as trees, branches, sediment, rocks, etc. which can
- 4 become dislodged when water flow increases. This debris then travels downstream creating blockages
- 5 in and around the culverts.

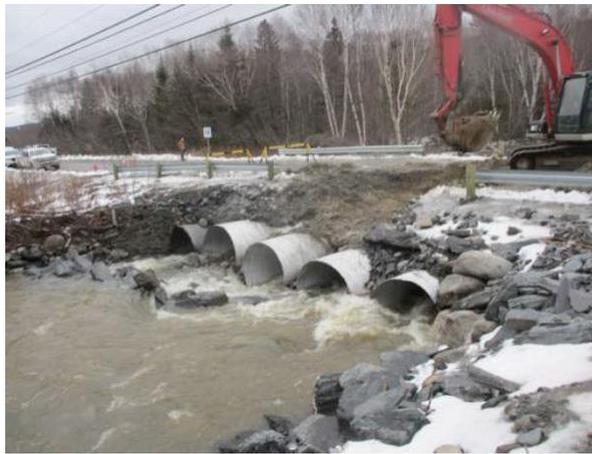
Figure 31: Bear Brook Crossing During Rain Storm (February 2018)

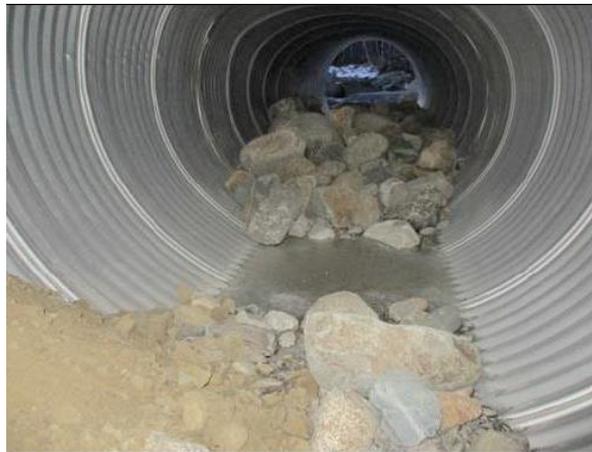
Figure 32: Bear Brook Crossing Culvert Blockage (February 2018)

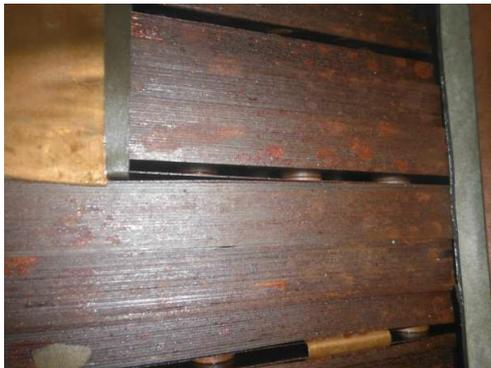
Rust formation on the top yoke near leg one.

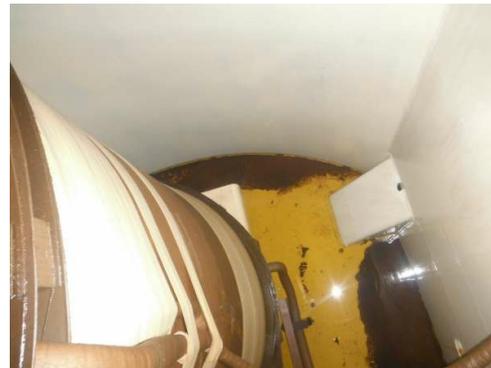
Rust deposits on the tank floor on the HV side

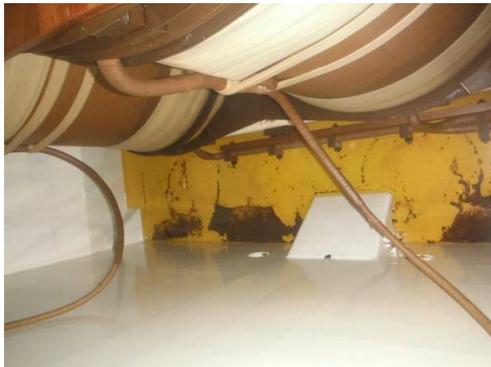
More rust deposits on the the HV side

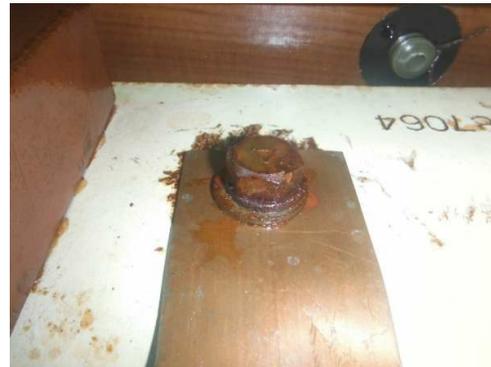
Rust formation on the ground bonding hardware on the top clamp.

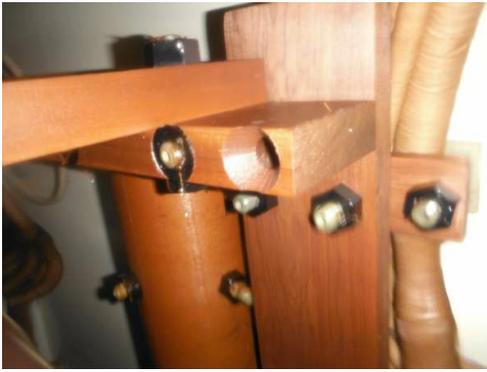
Missing bolt on the LV centre phase LV side lead structure. The bolt I found on the tank floor.

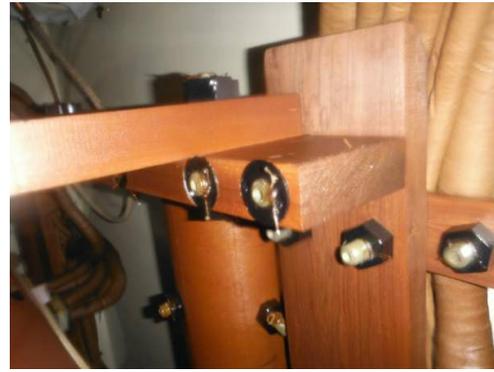
I re-secured the bolt.

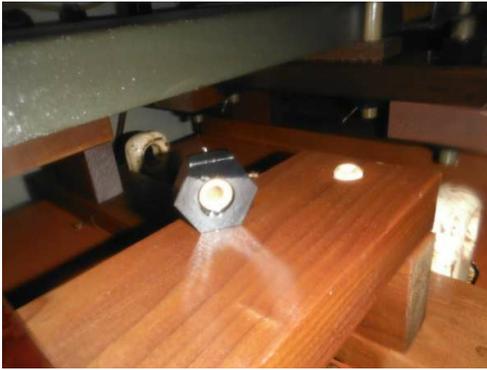
Broken stud on the top LV lead structure. The stud was not able to be repaired at the time as most of the lead work on the top of the yoke would have to be removed.

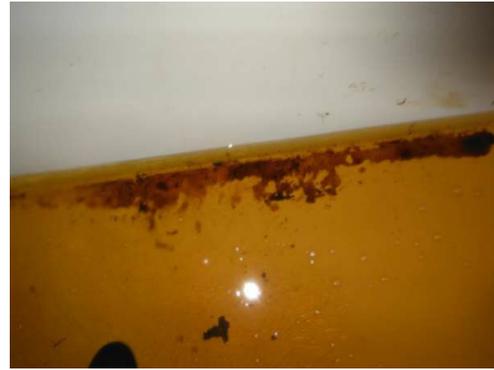
Rust deposits in the tap changer compartment.

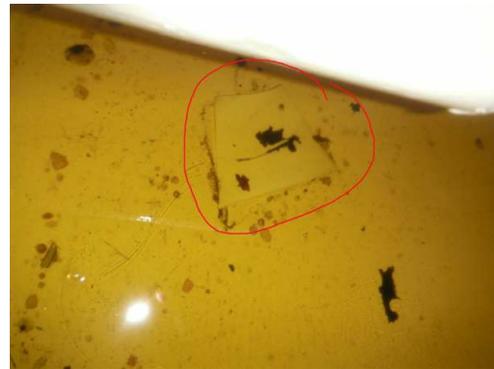
Large piece of plastic from the LV gas deflectors.

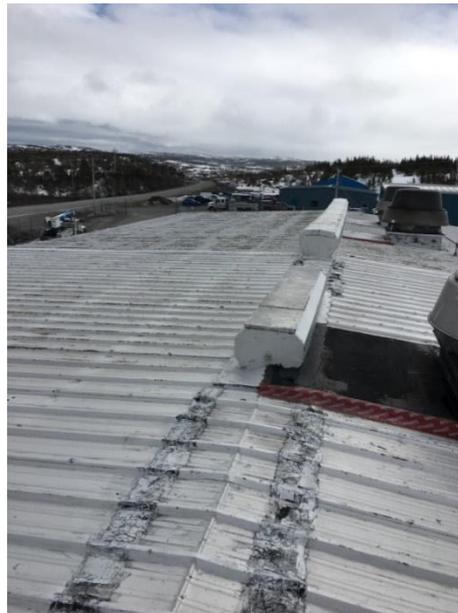
Figure 1: Typical roof panel condition

13 The roofing systems have generally performed well since their original installation; however, with both
14 systems at nearly 50 years of age they have developed leaks and are nearing the end of their anticipated
15 service life. Figure 1 provides typical condition of these roof systems.

1 Many of the roof panel fasteners have failed due to the effects of corrosion and movement of the panels
2 as a result of vibration and flexure throughout the years. In many cases the fasteners have widened the
3 holes in the panels, enabling the infiltration of water and compromising their connection to the
4 substructure. The St. Anthony and L'Anse Au Loup Diesel Plants are located in exposed areas,
5 frequented by high winds. Failure to replace the fasteners could inevitably result in catastrophic failure
6 of the roof panels. The movement of the roof panels have also caused the seams to fail over time, as
7 panels have deformed and no longer provide an adequate seal along their seam line. These failed seams
8 have contributed the formation of leaks throughout the buildings.
9
10 Attempts to repair the leaks through the application of an elastomeric roof panel coating system, as
11 shown in Figures 2 and 3, have only provided short-term elimination of leaks.

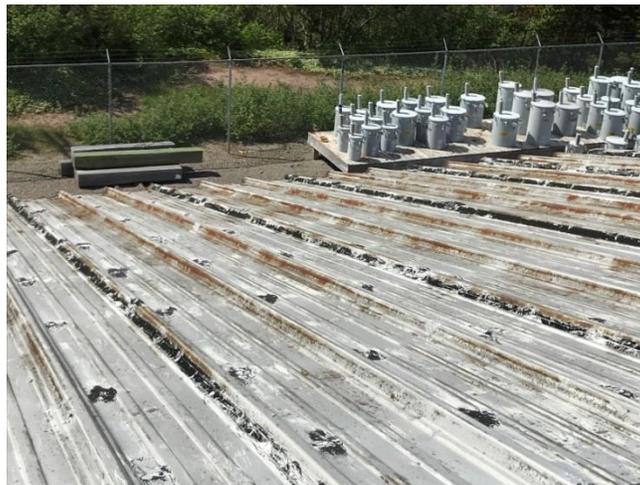
Figure 2: Previous attempt to repair leaks with elastomeric coating system

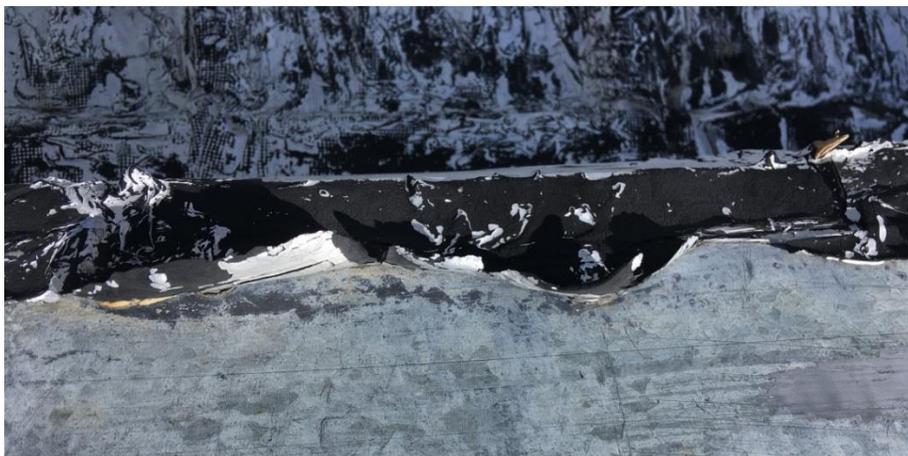
Figure 3: Ineffective elastomeric coating system

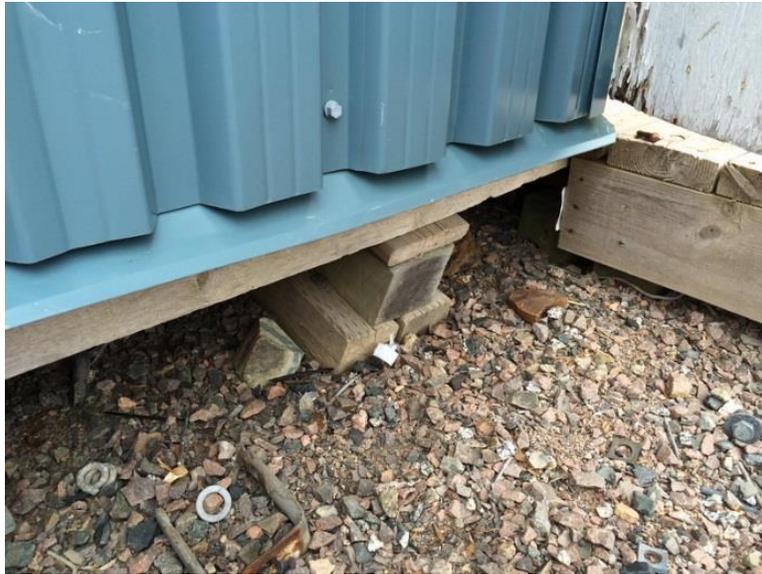
Figure 8: Pressure Treated Sleepers

- 9 The plywood floor is in poor condition from settlement and heaving due to shifting of the pressure
- 10 treated sleepers (See Figure 8).

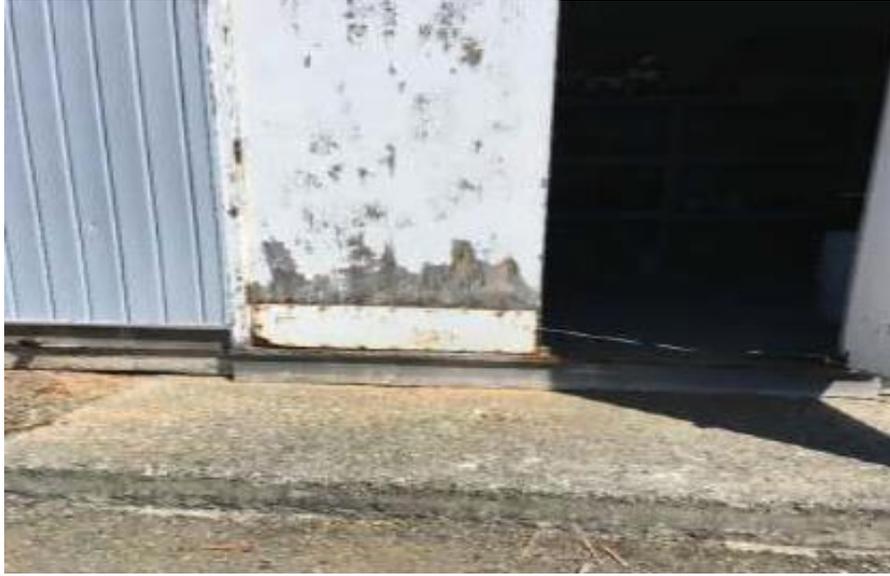
Figure 14: Storage Shed Doors

5 Burgeo Storage shed has wooden double doors and frames that are in deteriorated condition (See
6 Figure 14).

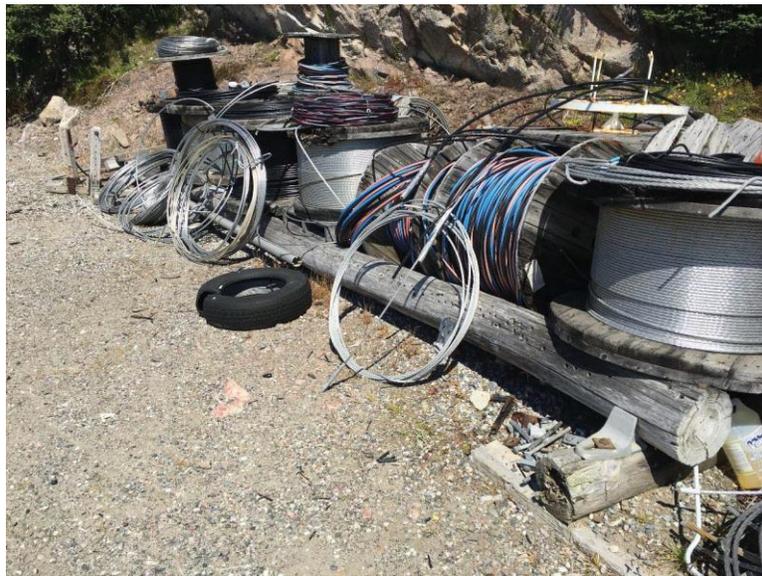
Figure 15: Burgeo Wire Storage Ramp

2 The wire storage ramps contain girders and sleepers that are rotted throughout (see Figure 15).
