1 Q. **Reference: Application, Schedule 1: Upgrade Report – Penstock 1 Life Extension – Bay**
2 **d'Espoir, Appendix J, Page 26 of 51..**

PENSTOCK NO. 1 INSPECTION AND EVALUATION

BAY D'ESPOIR HYDROELECTRIC DEVELOPMENT PENSTOCKS 1-3 INSPECTION PROJECT

2670021_003RP
April 2020

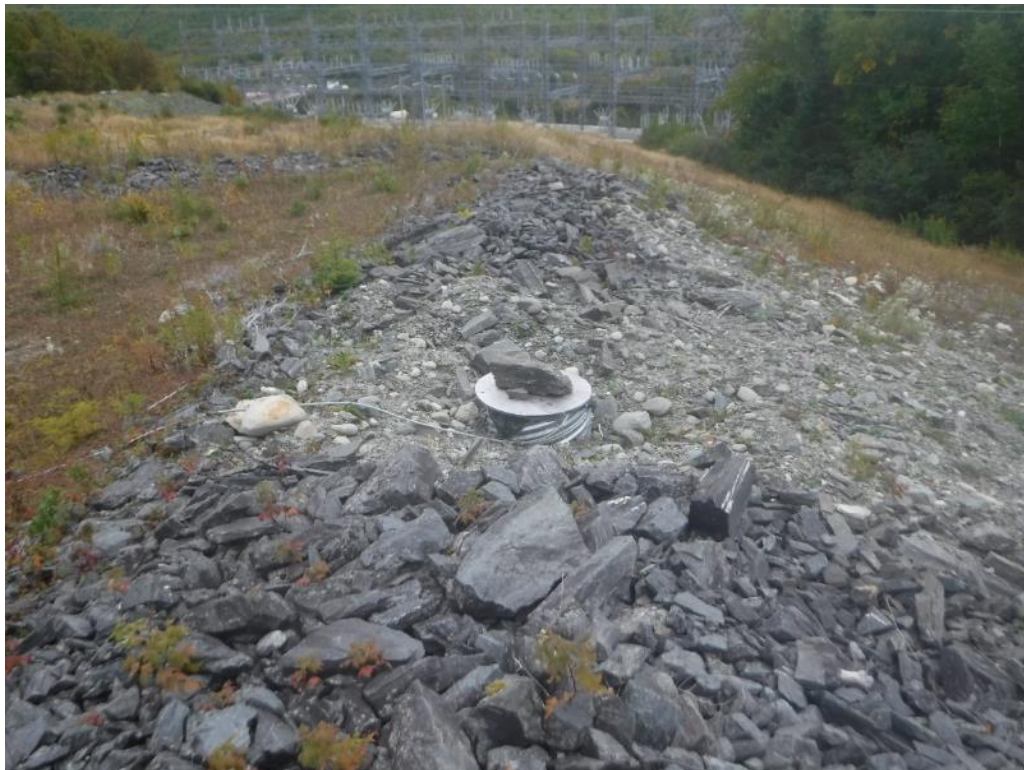
The crack location that resulted in the leak was covered with a tarp (Photo 28). Other features noted along the penstock route included open Manhole No. 1 (Photo 25), a piezometer just upstream of the crack location (Photo 27), and a pressure monitor (Photo 32) and closed Manhole No. 3 (Photo 33) that all appeared to be in good condition. No drainage wells were observed. It is recommended that bushes and alders growing in a few locations on the upper end of the penstock should be removed.

PHOTO 32 **PRESSURE MONITOR**

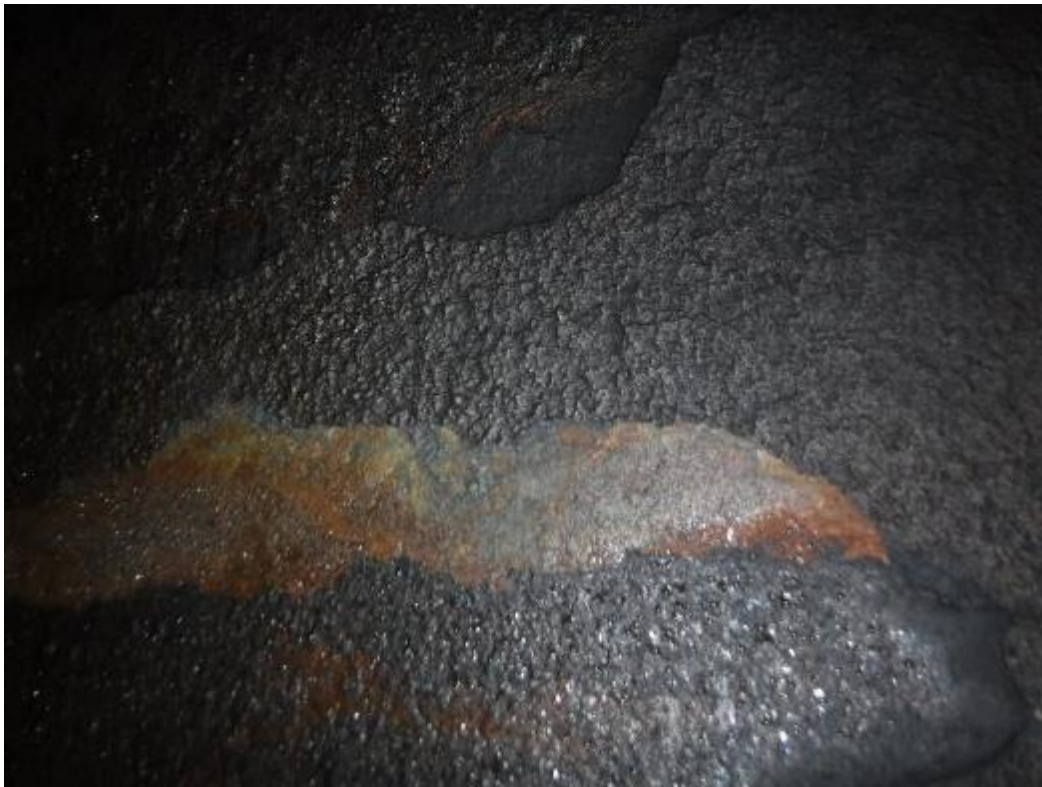
Photo 4 Old Organics and Bare Steel

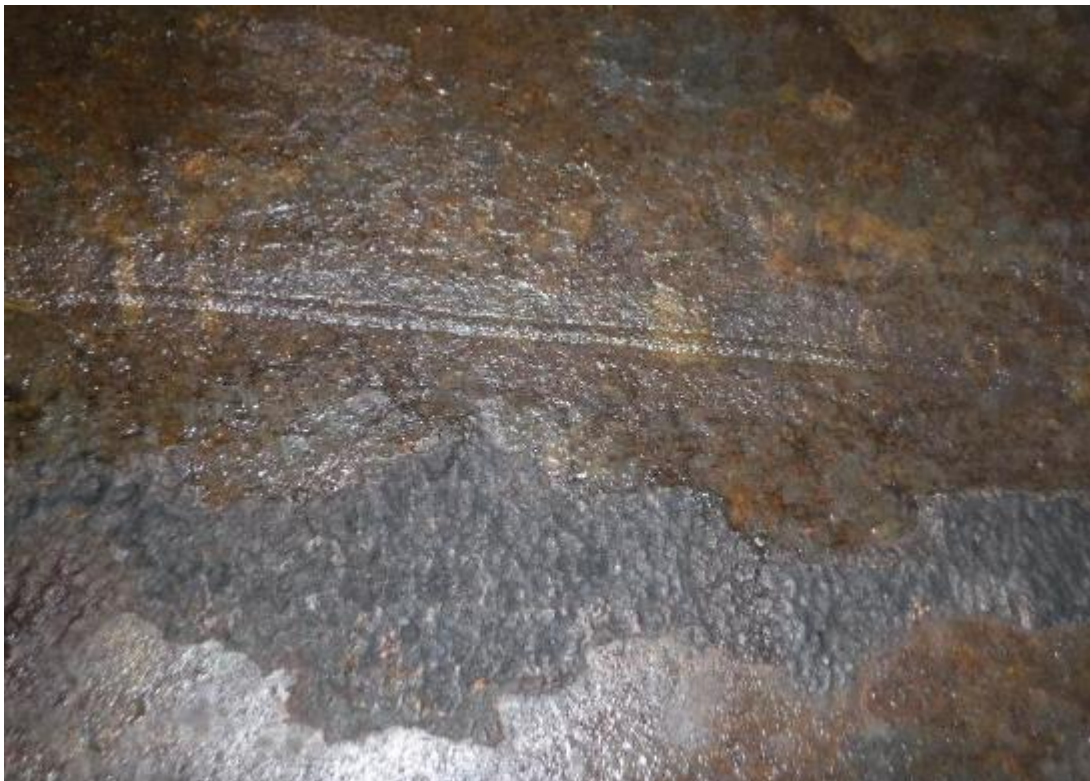
Photo 8 Typical original weld not previously tested

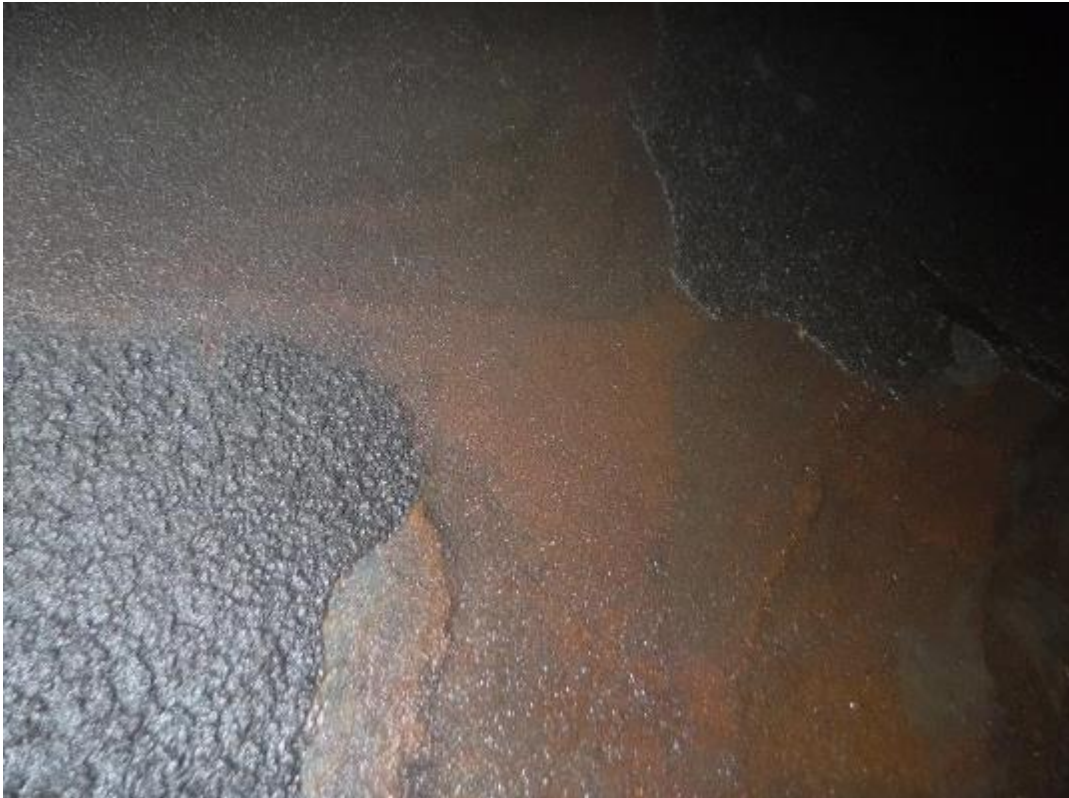
The interior of the penstock is generally in fair condition with scattered moderate corrosion and pitting with tubercles and growth (Photos 21 to 25). Pitting was minor to moderate, relative to the plate thickness, and detailed pit measurements were not taken.

Photo 21 Surface of plating Can 370

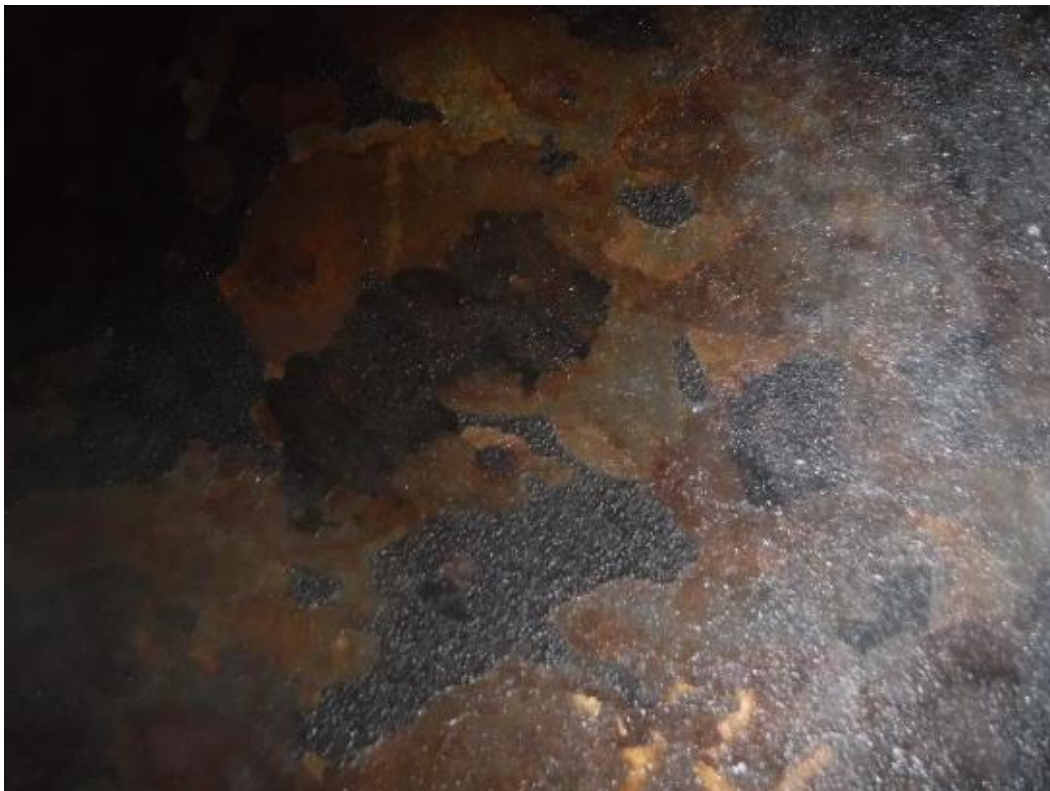
Photo 22 Surface of plating Can 400

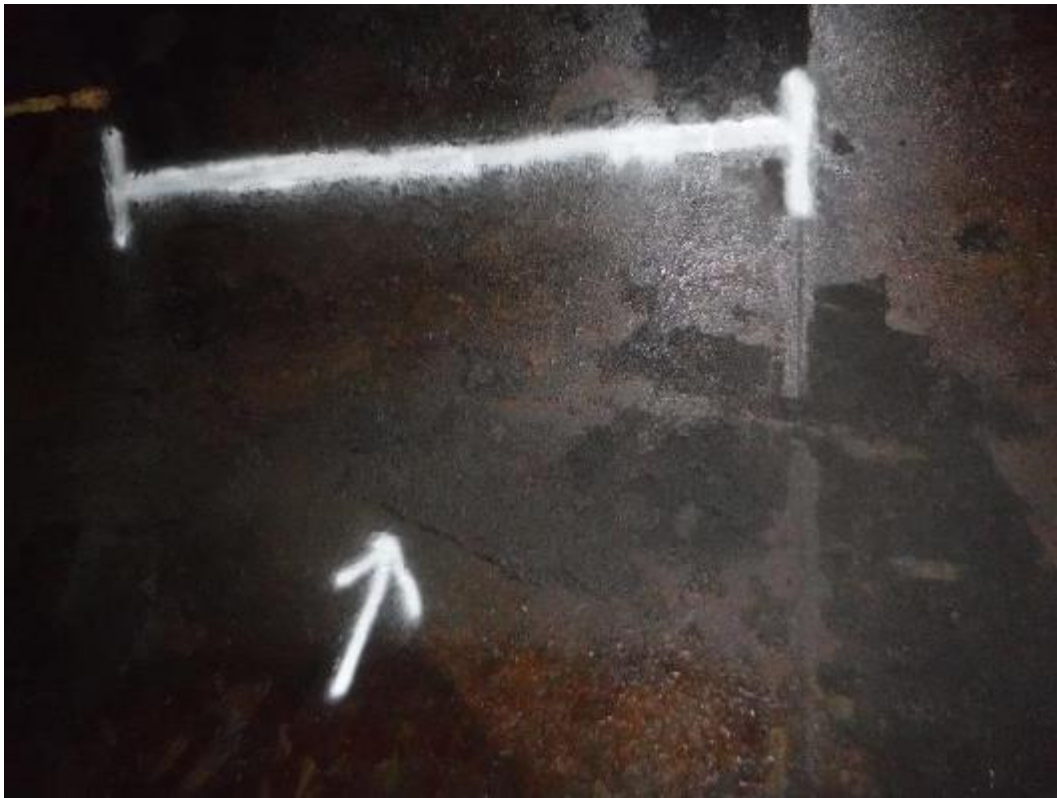
Photo 25 Surface conditions Can 190

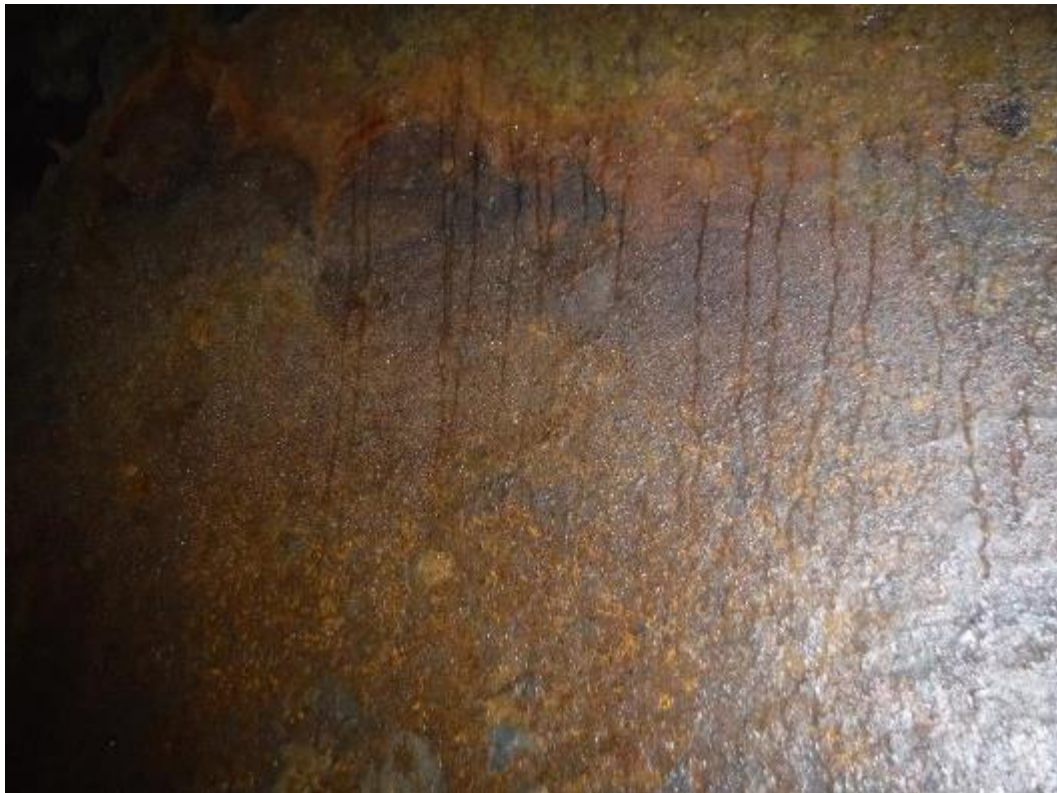
Photo 26 Surface conditions Can 130

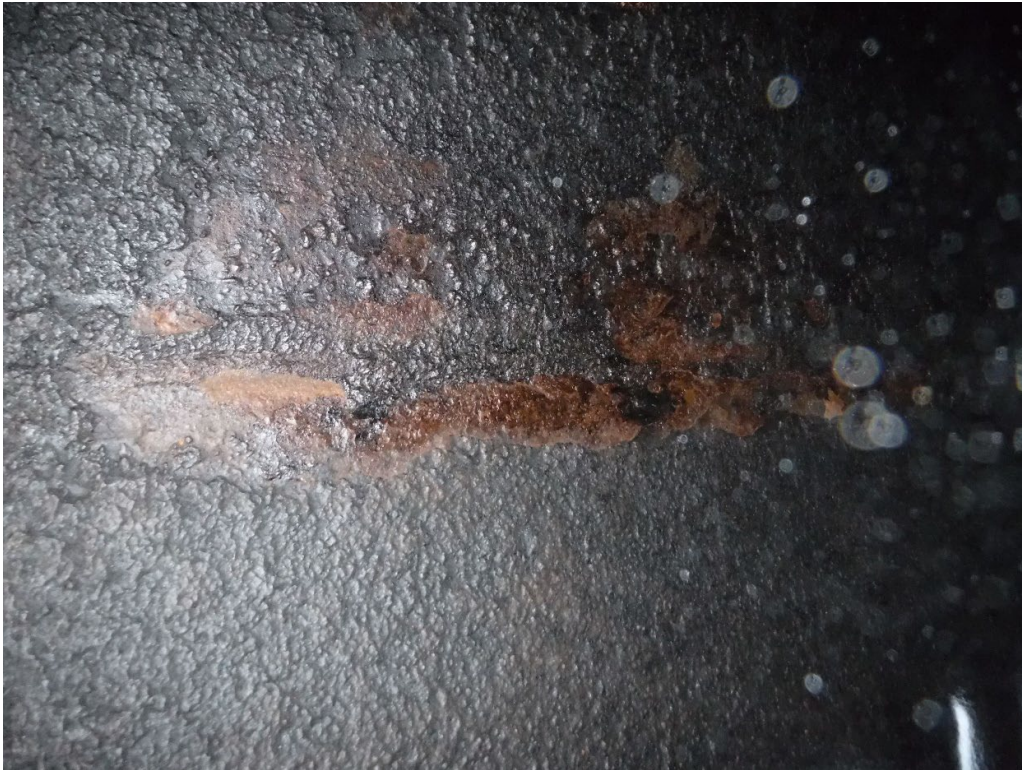
Photo 3 Typical Organic Coating

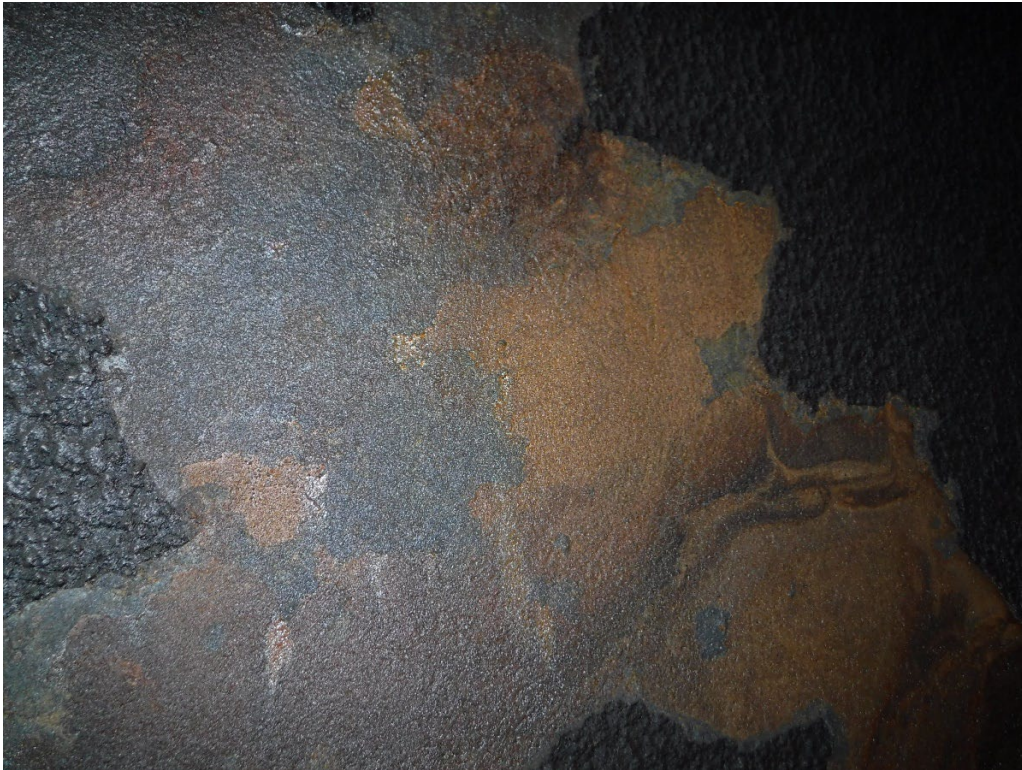
Photo 5 Steel Without organic layer and not scraped clean; Can 350

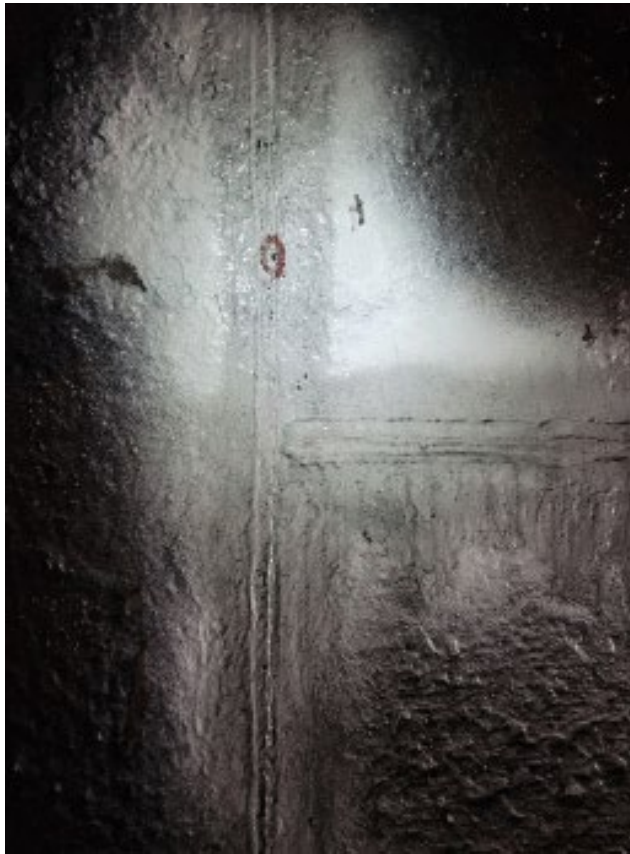
Photo 12 Indication in Circumferential Weld,;Can 98

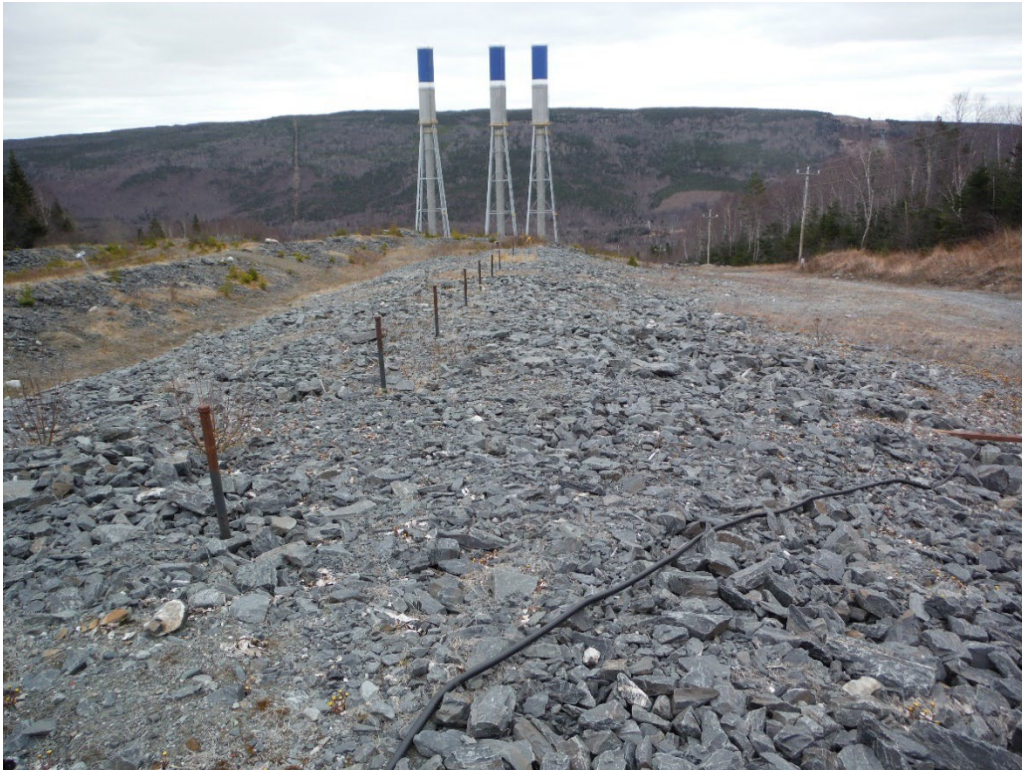
Photo 19 Previously repaired area; Rip-rap in good shape

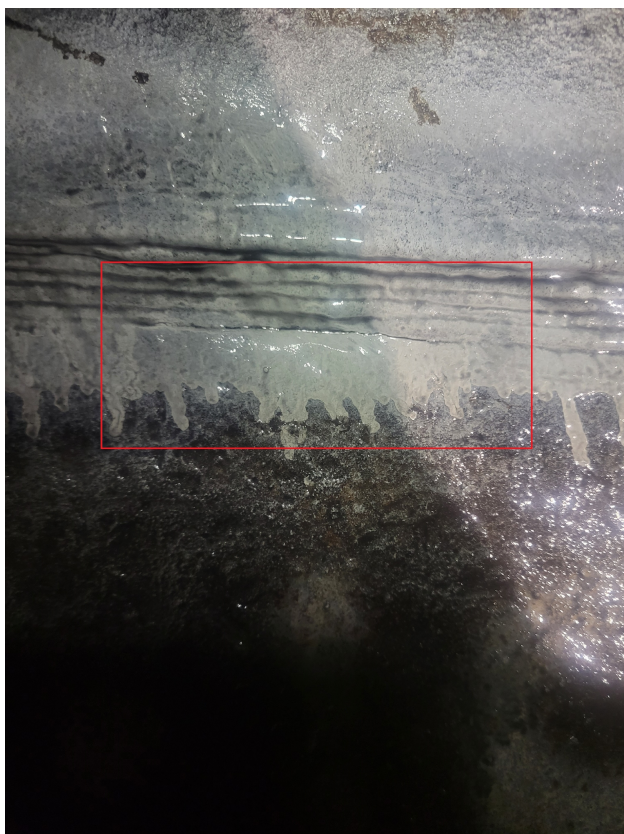
Figure 1. 145N 3" crack noted

Figure 2. 145N Crack Removed With Girding.

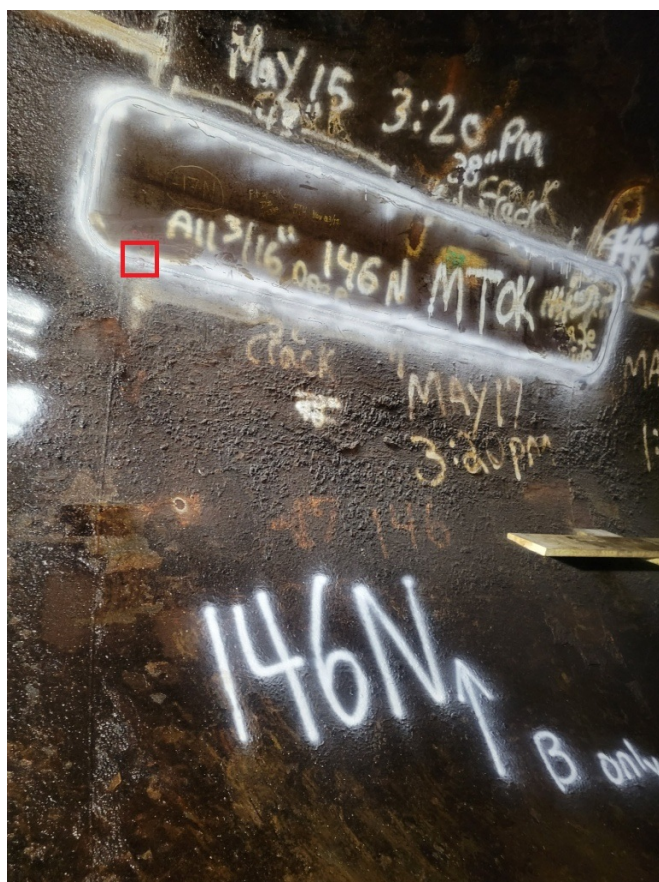
Figure 5. Can 146N - Indication Location
