PENSTOCK 3 INSPECTION AND EVALUATION

BAY D'ESPOIR HYDROELECTRIC DEVELOPMENT
PENSTOCKS 1-3 INSPECTION PROJECT

May 2026

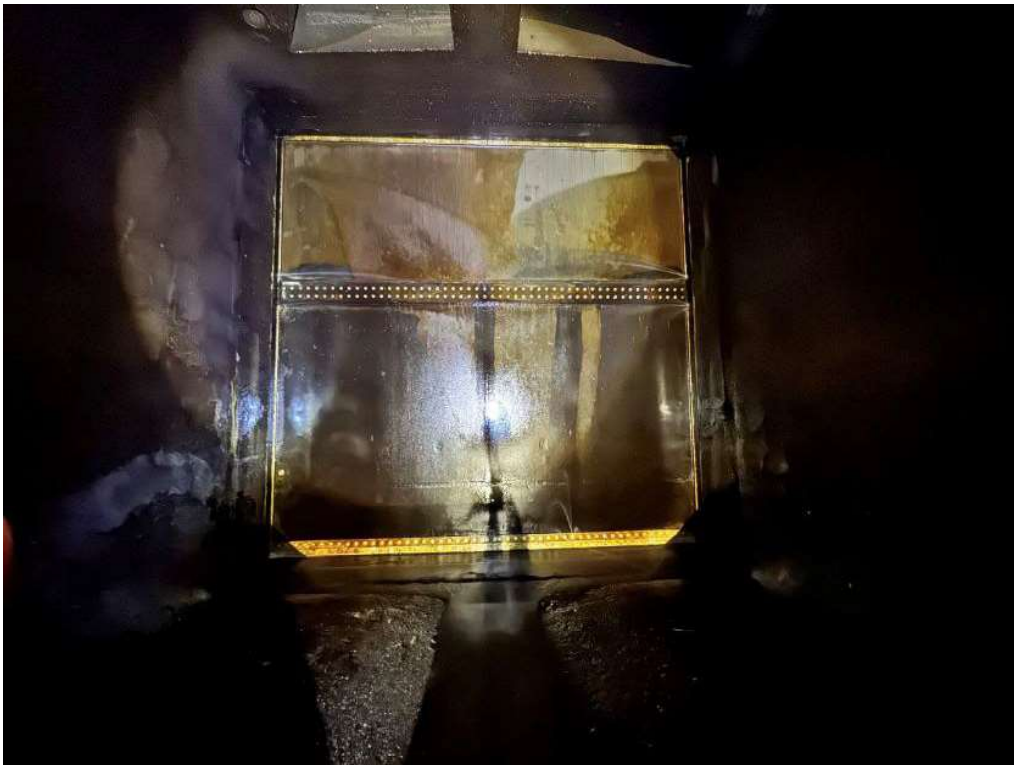
Photo 2 Overall view of gate

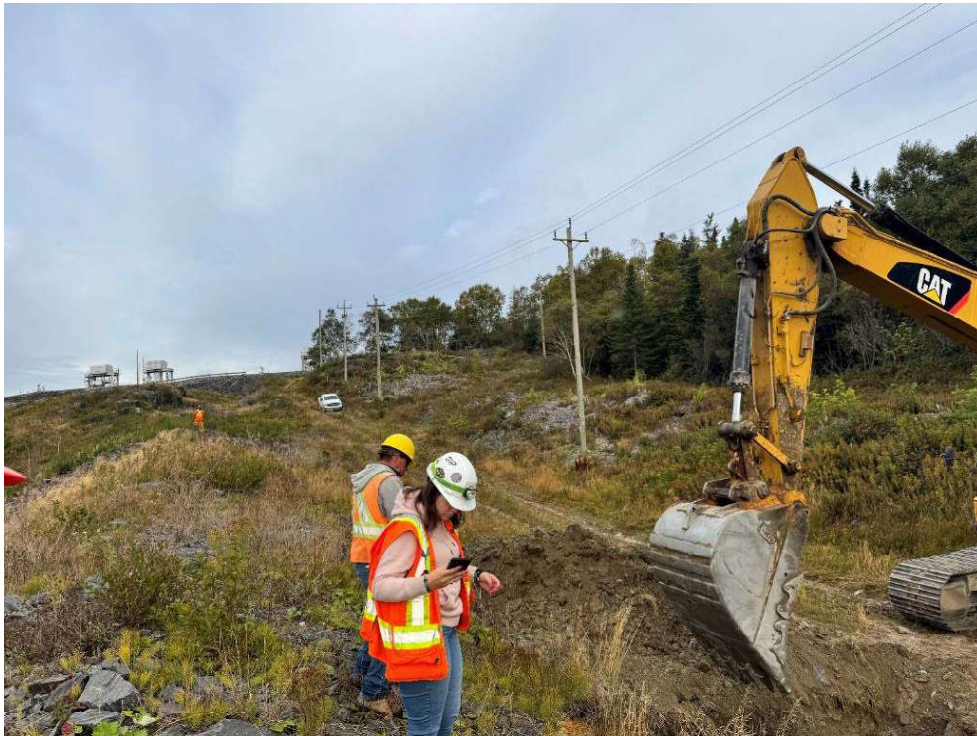
Photo 44 Approximate relative location of Test pit in Photo 42

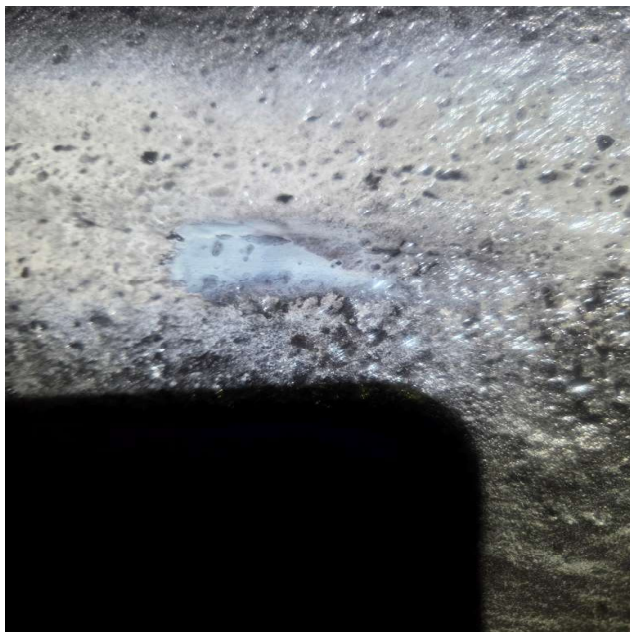
Figure 18. Can 273 North - Post Grinding - Indication Removed

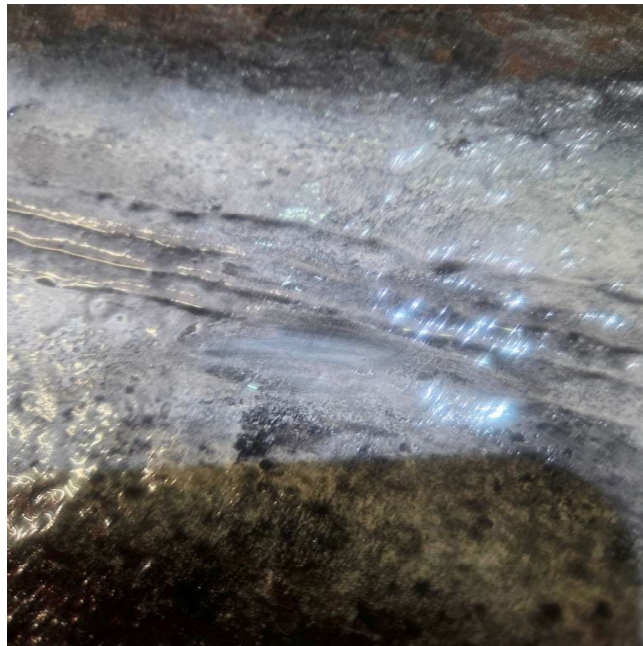
Figure 20. Can 322 North - Post Grinding - Indication Removed

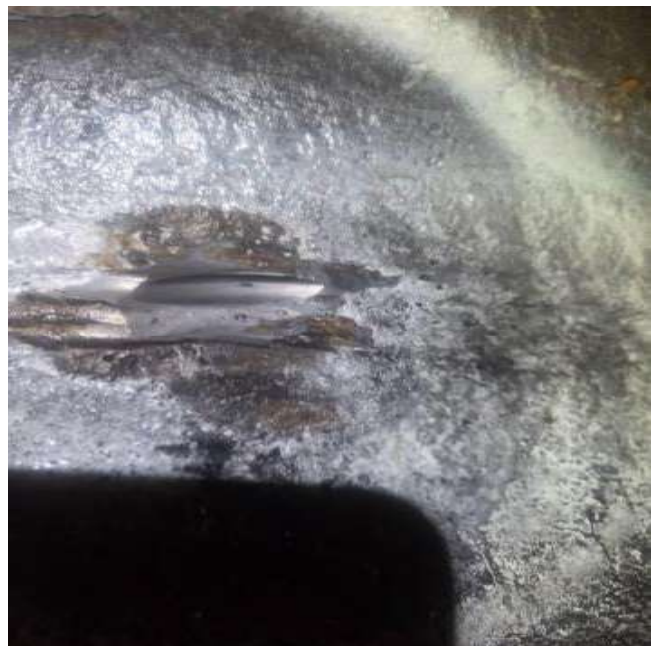
Figure 22. Can 332 North - Post Grinding
